APPENDIX D –
DRAFT ENVIRONMENTAL CONDITION OF PROPERTY REPORT

THIS PAGE INTENTIONALLY LEFT BLANK

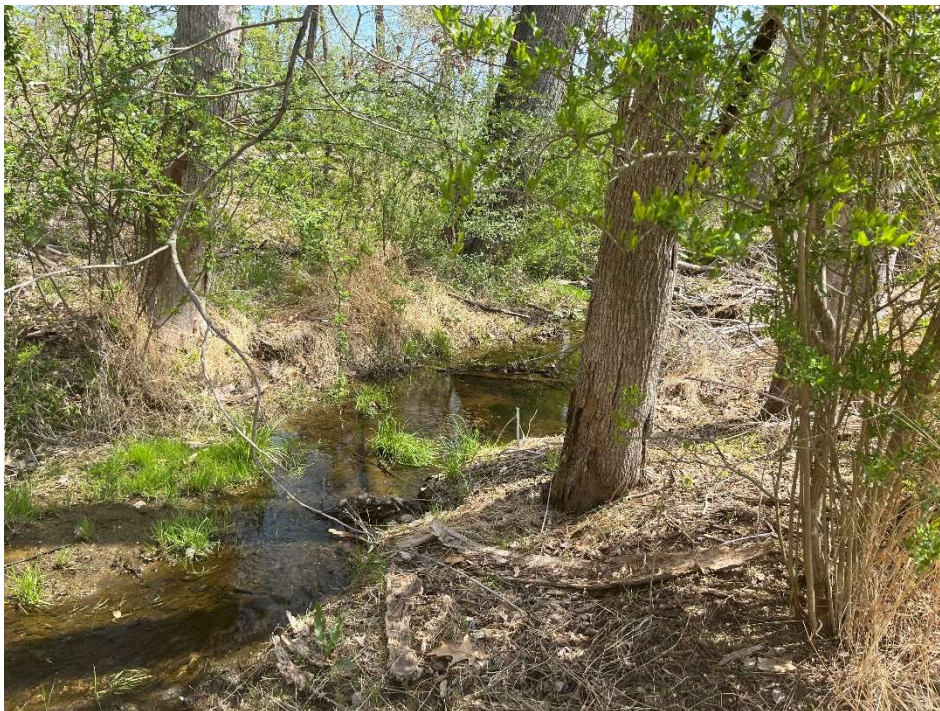
Figure 13: View of unnamed creek on eastern side of property. No sheen was observed.

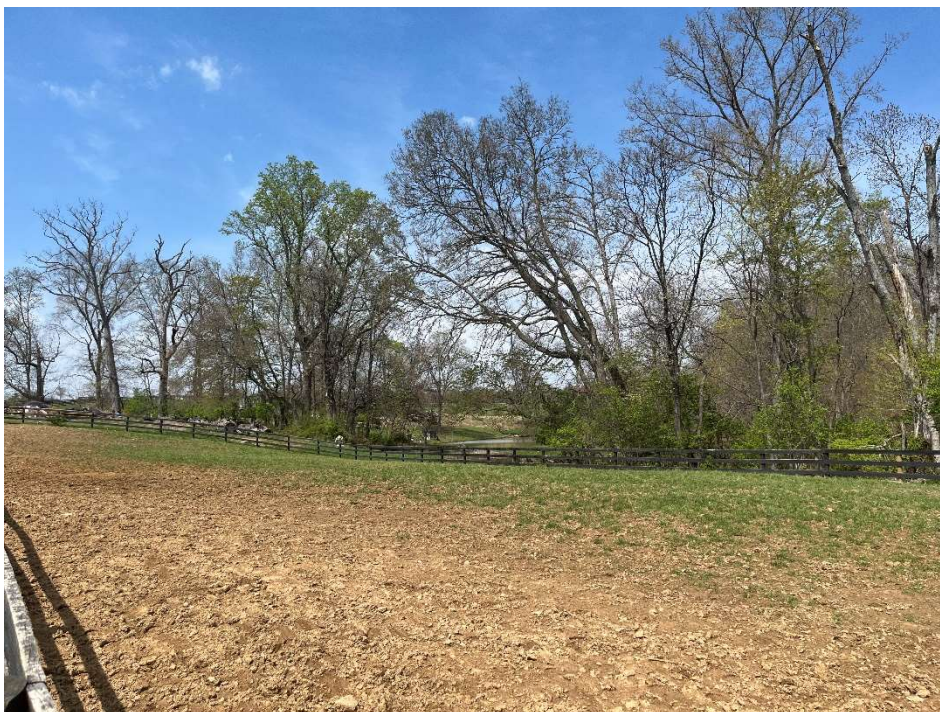
Figure 14: View of the northeastern side of the site.

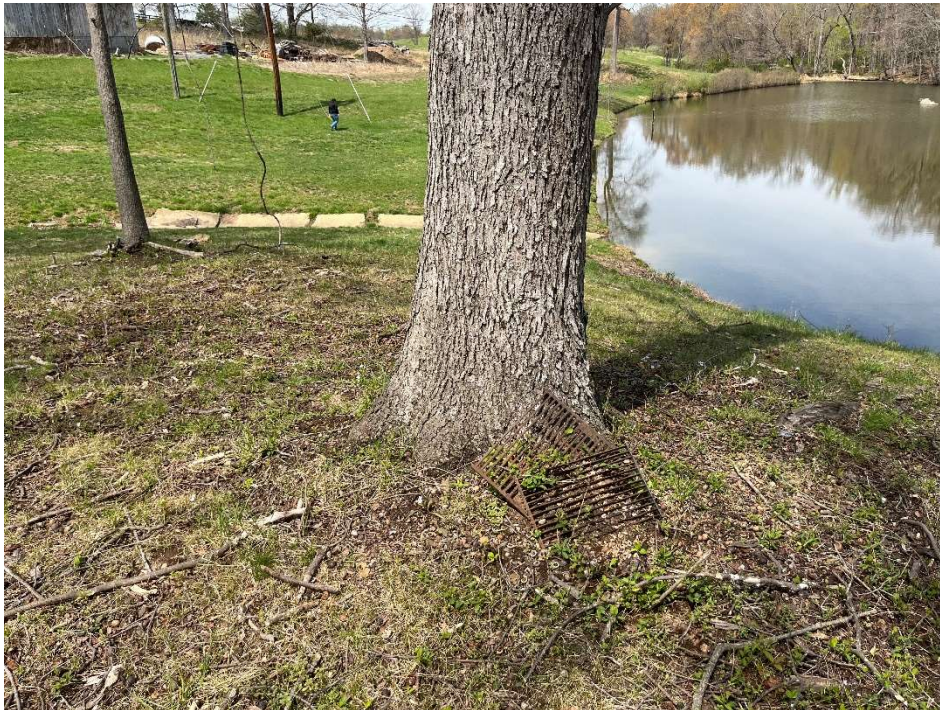
Figure 38: View of rusted metal located around the tree base by the onsite pond.

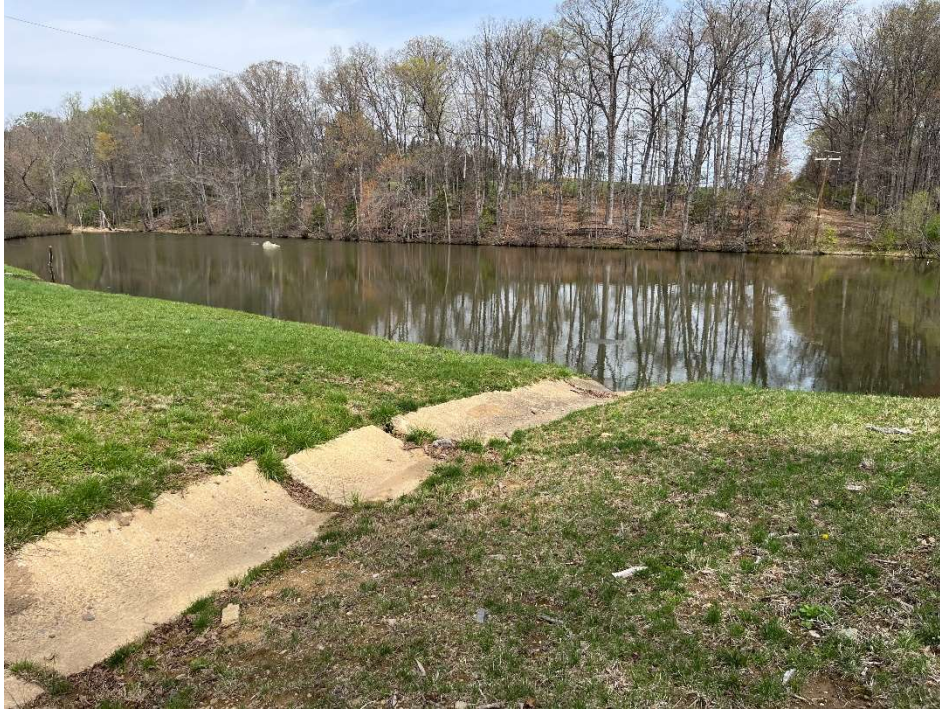
Figure 39: View of drainage channel that runs into the onsite pond.

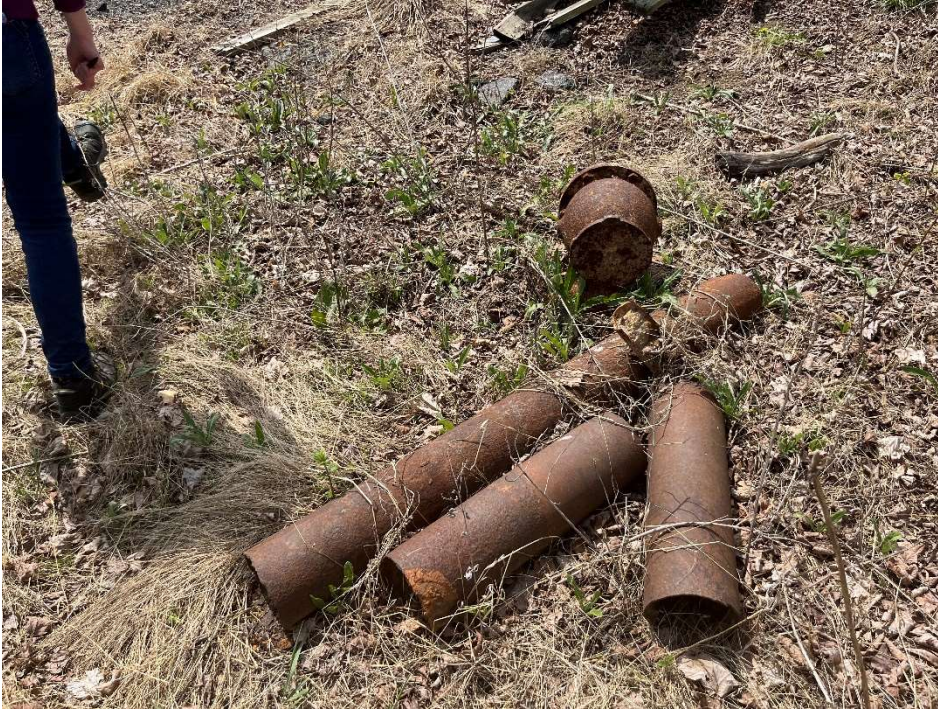
Figure 55: View of corroded pipes in the trash area.

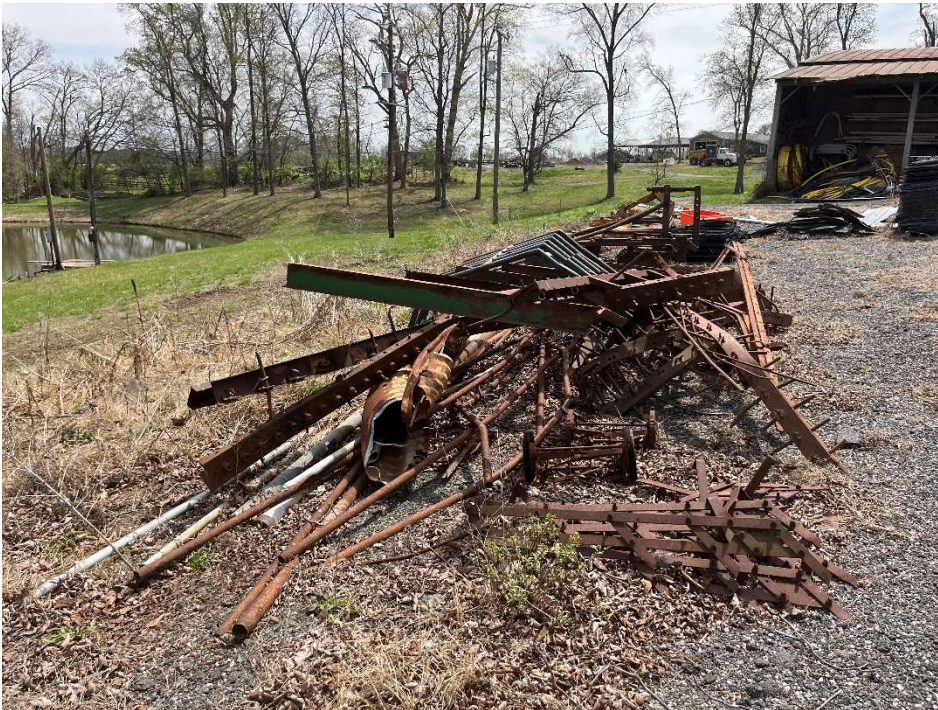
Figure 56: View rusted metal in the trash area.

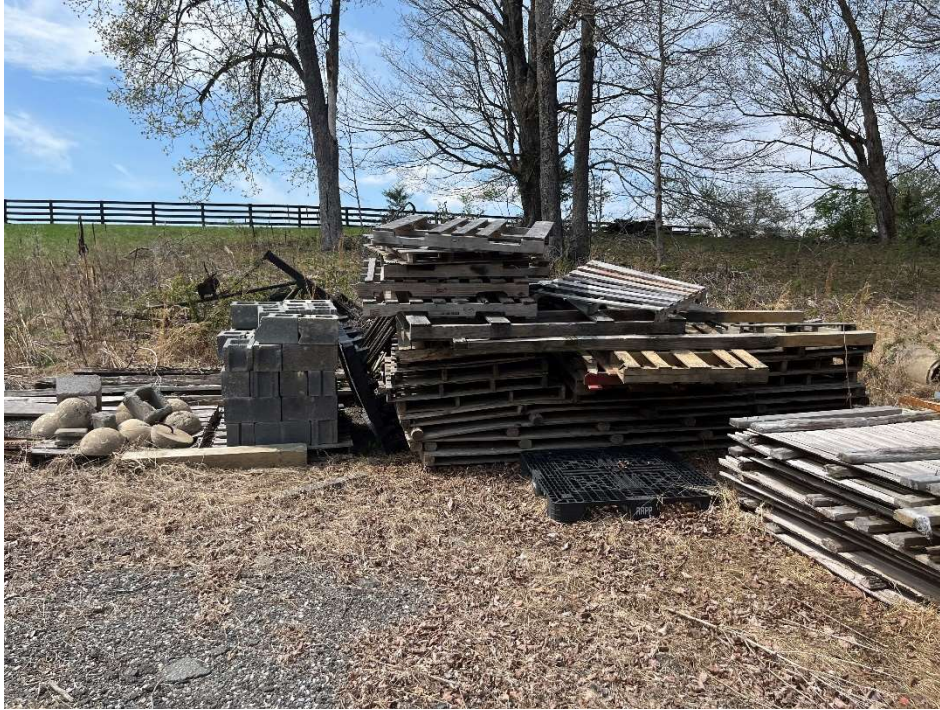
Figure 57: View of piled materials in trash area.

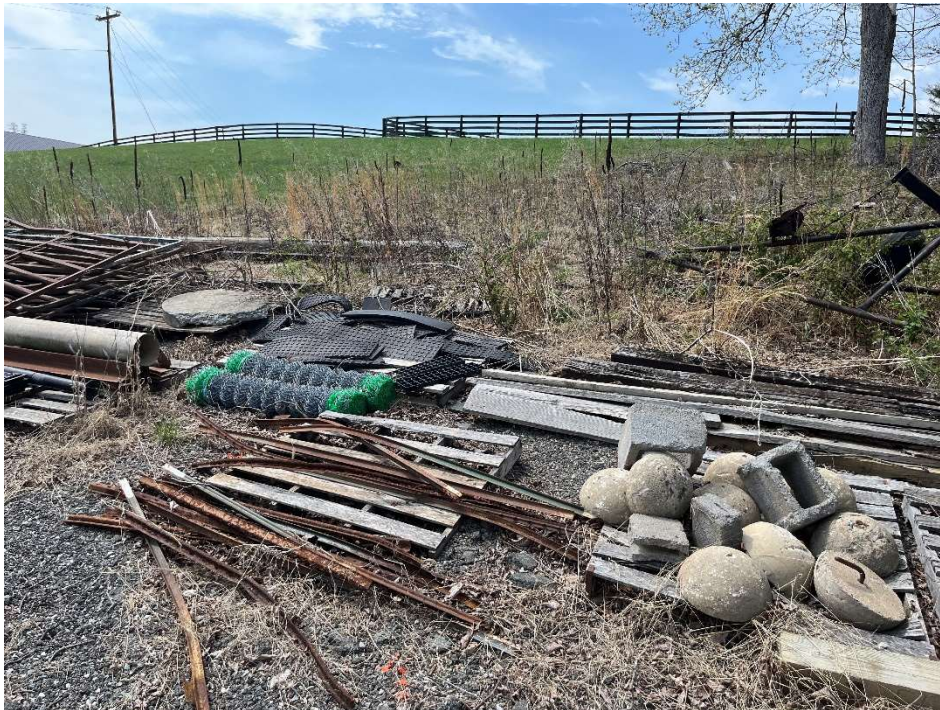
Figure 58: View of old mats, rusted metal, cement and other various materials in the trash area.

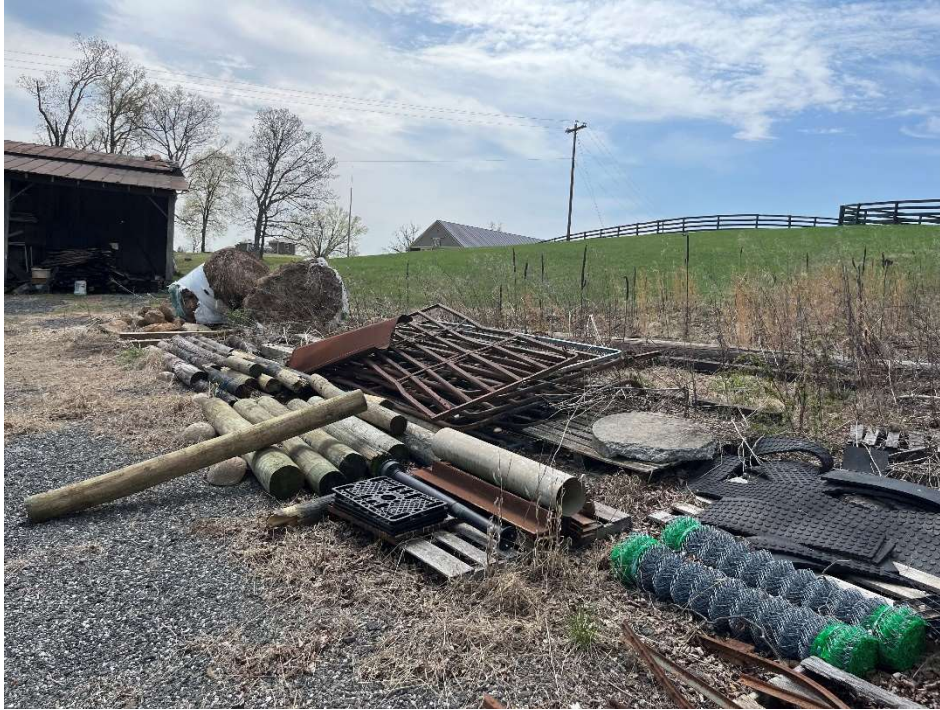
Figure 59: View of various material in the trash area.

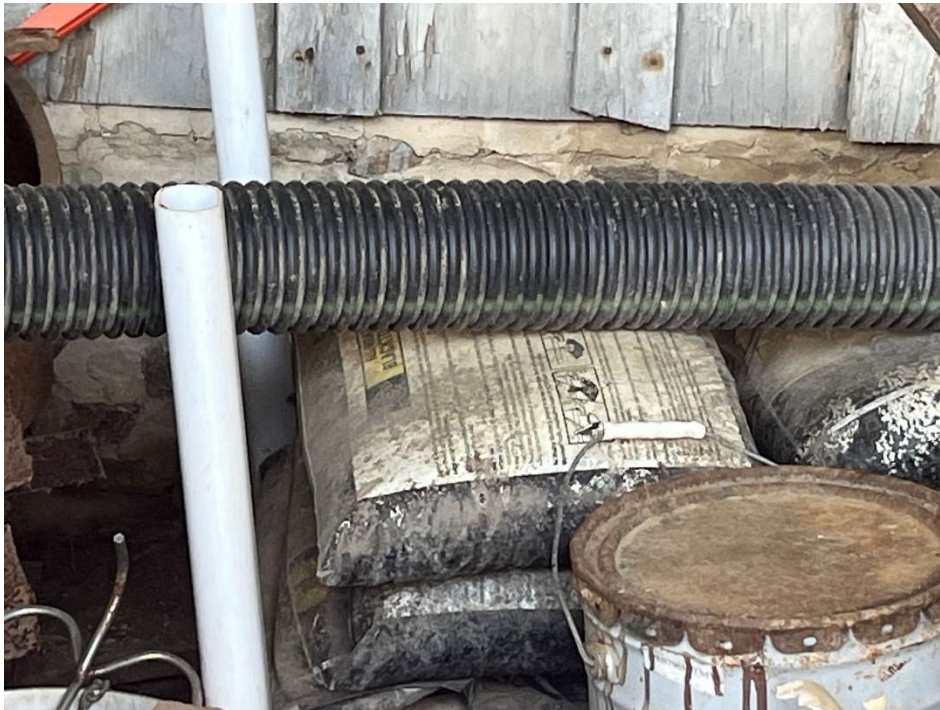
Figure 66: Close up view of asphalt repair bags.

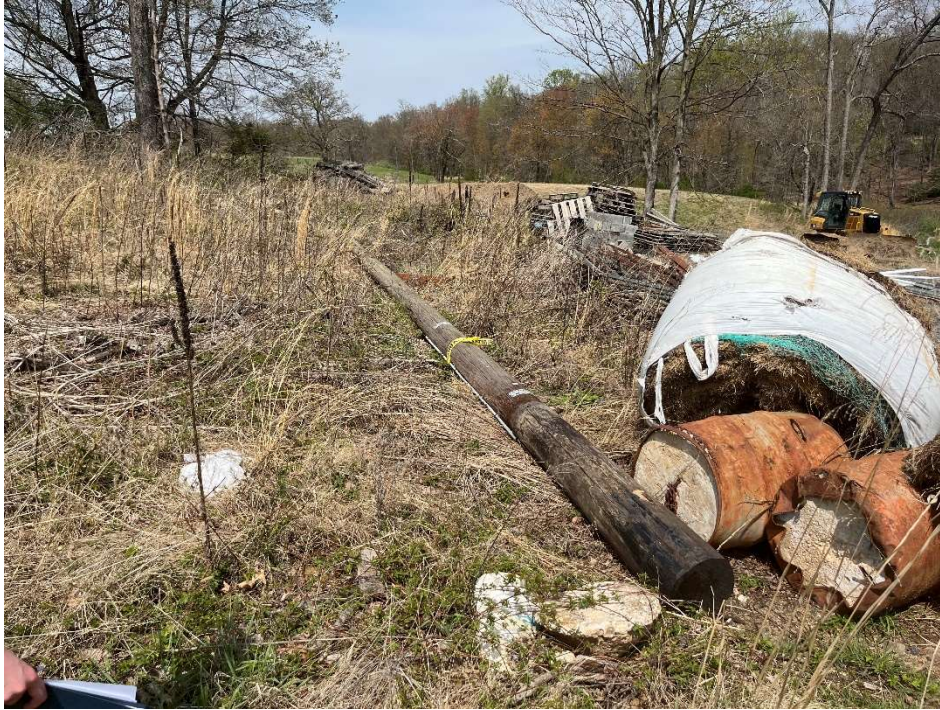
Figure 67: View of behind the hay in the stockpile area. Appears to be a discarded electrical pole.

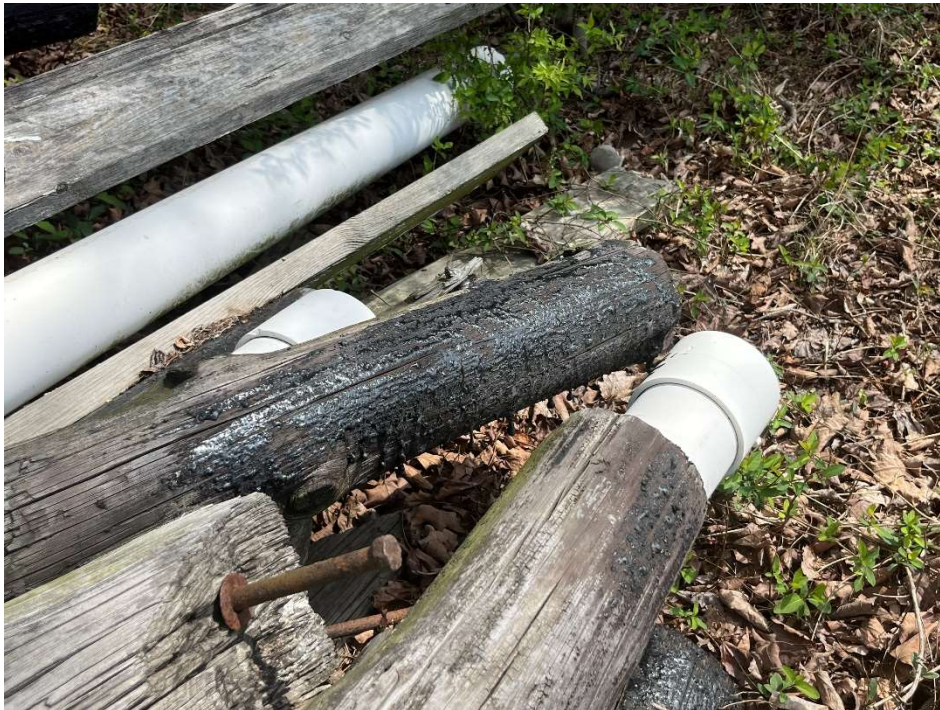
Figure 72: Zoomed in view of the ends of electrical poles. It appears a black substance is leaking off the poles.

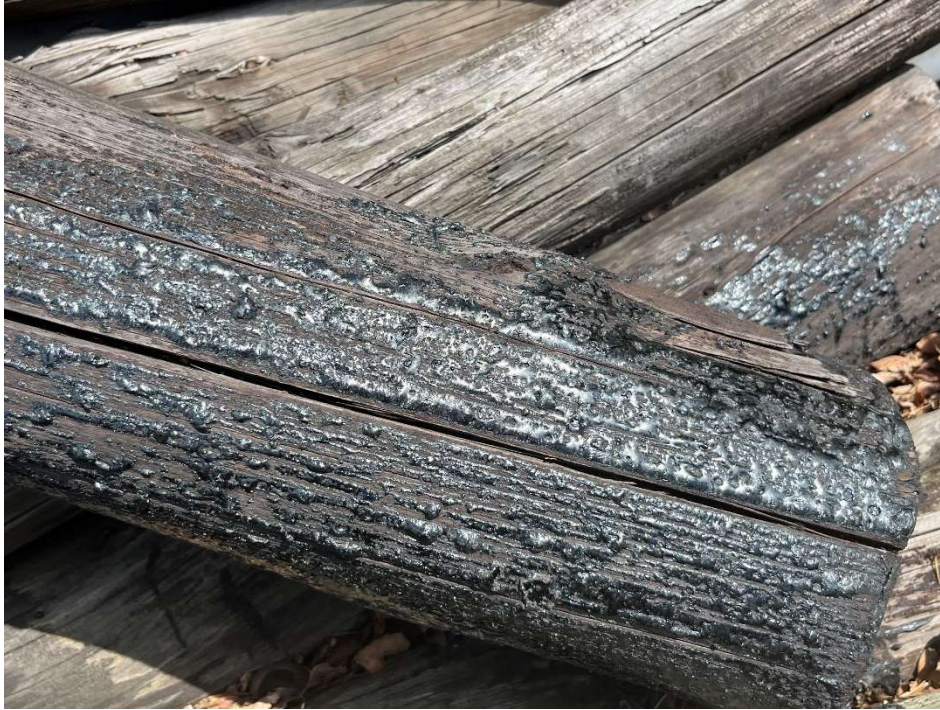
Figure 73: Close up view of the black substance on the ends of the poles.
