Ocean City Inlet and Harbor Scour Hole Study

U.S. Army Corps of Engineers

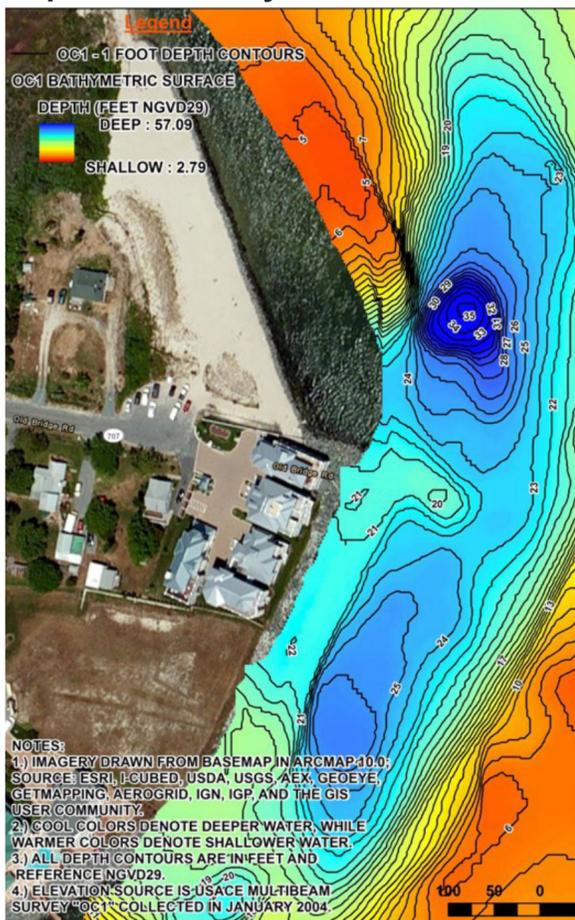
Depths in January 2004

Scour hole south of Homer Gudelsky Park is growing, threatening shoreline stability, nearby homes and shoaling in adjacent navigation channels
