**First Five-Year Review**  
**Military Munitions Response Program**  
**Buckroe Beach**  
**Formerly Used Defense Site (Property No. C03VA1011)**  
**Hampton, Virginia**  
**FINAL**  
July 2020

**FINAL**  
**FIRST FIVE-YEAR REVIEW**  
**FORMERLY USED DEFENSE SITE: BUCKROE BEACH**  
**MILITARY MUNITIONS RESPONSE PROGRAM (PROPERTY NO. C03VA1011)**  
**HAMPTON, VIRGINIA**

**JULY 2020**

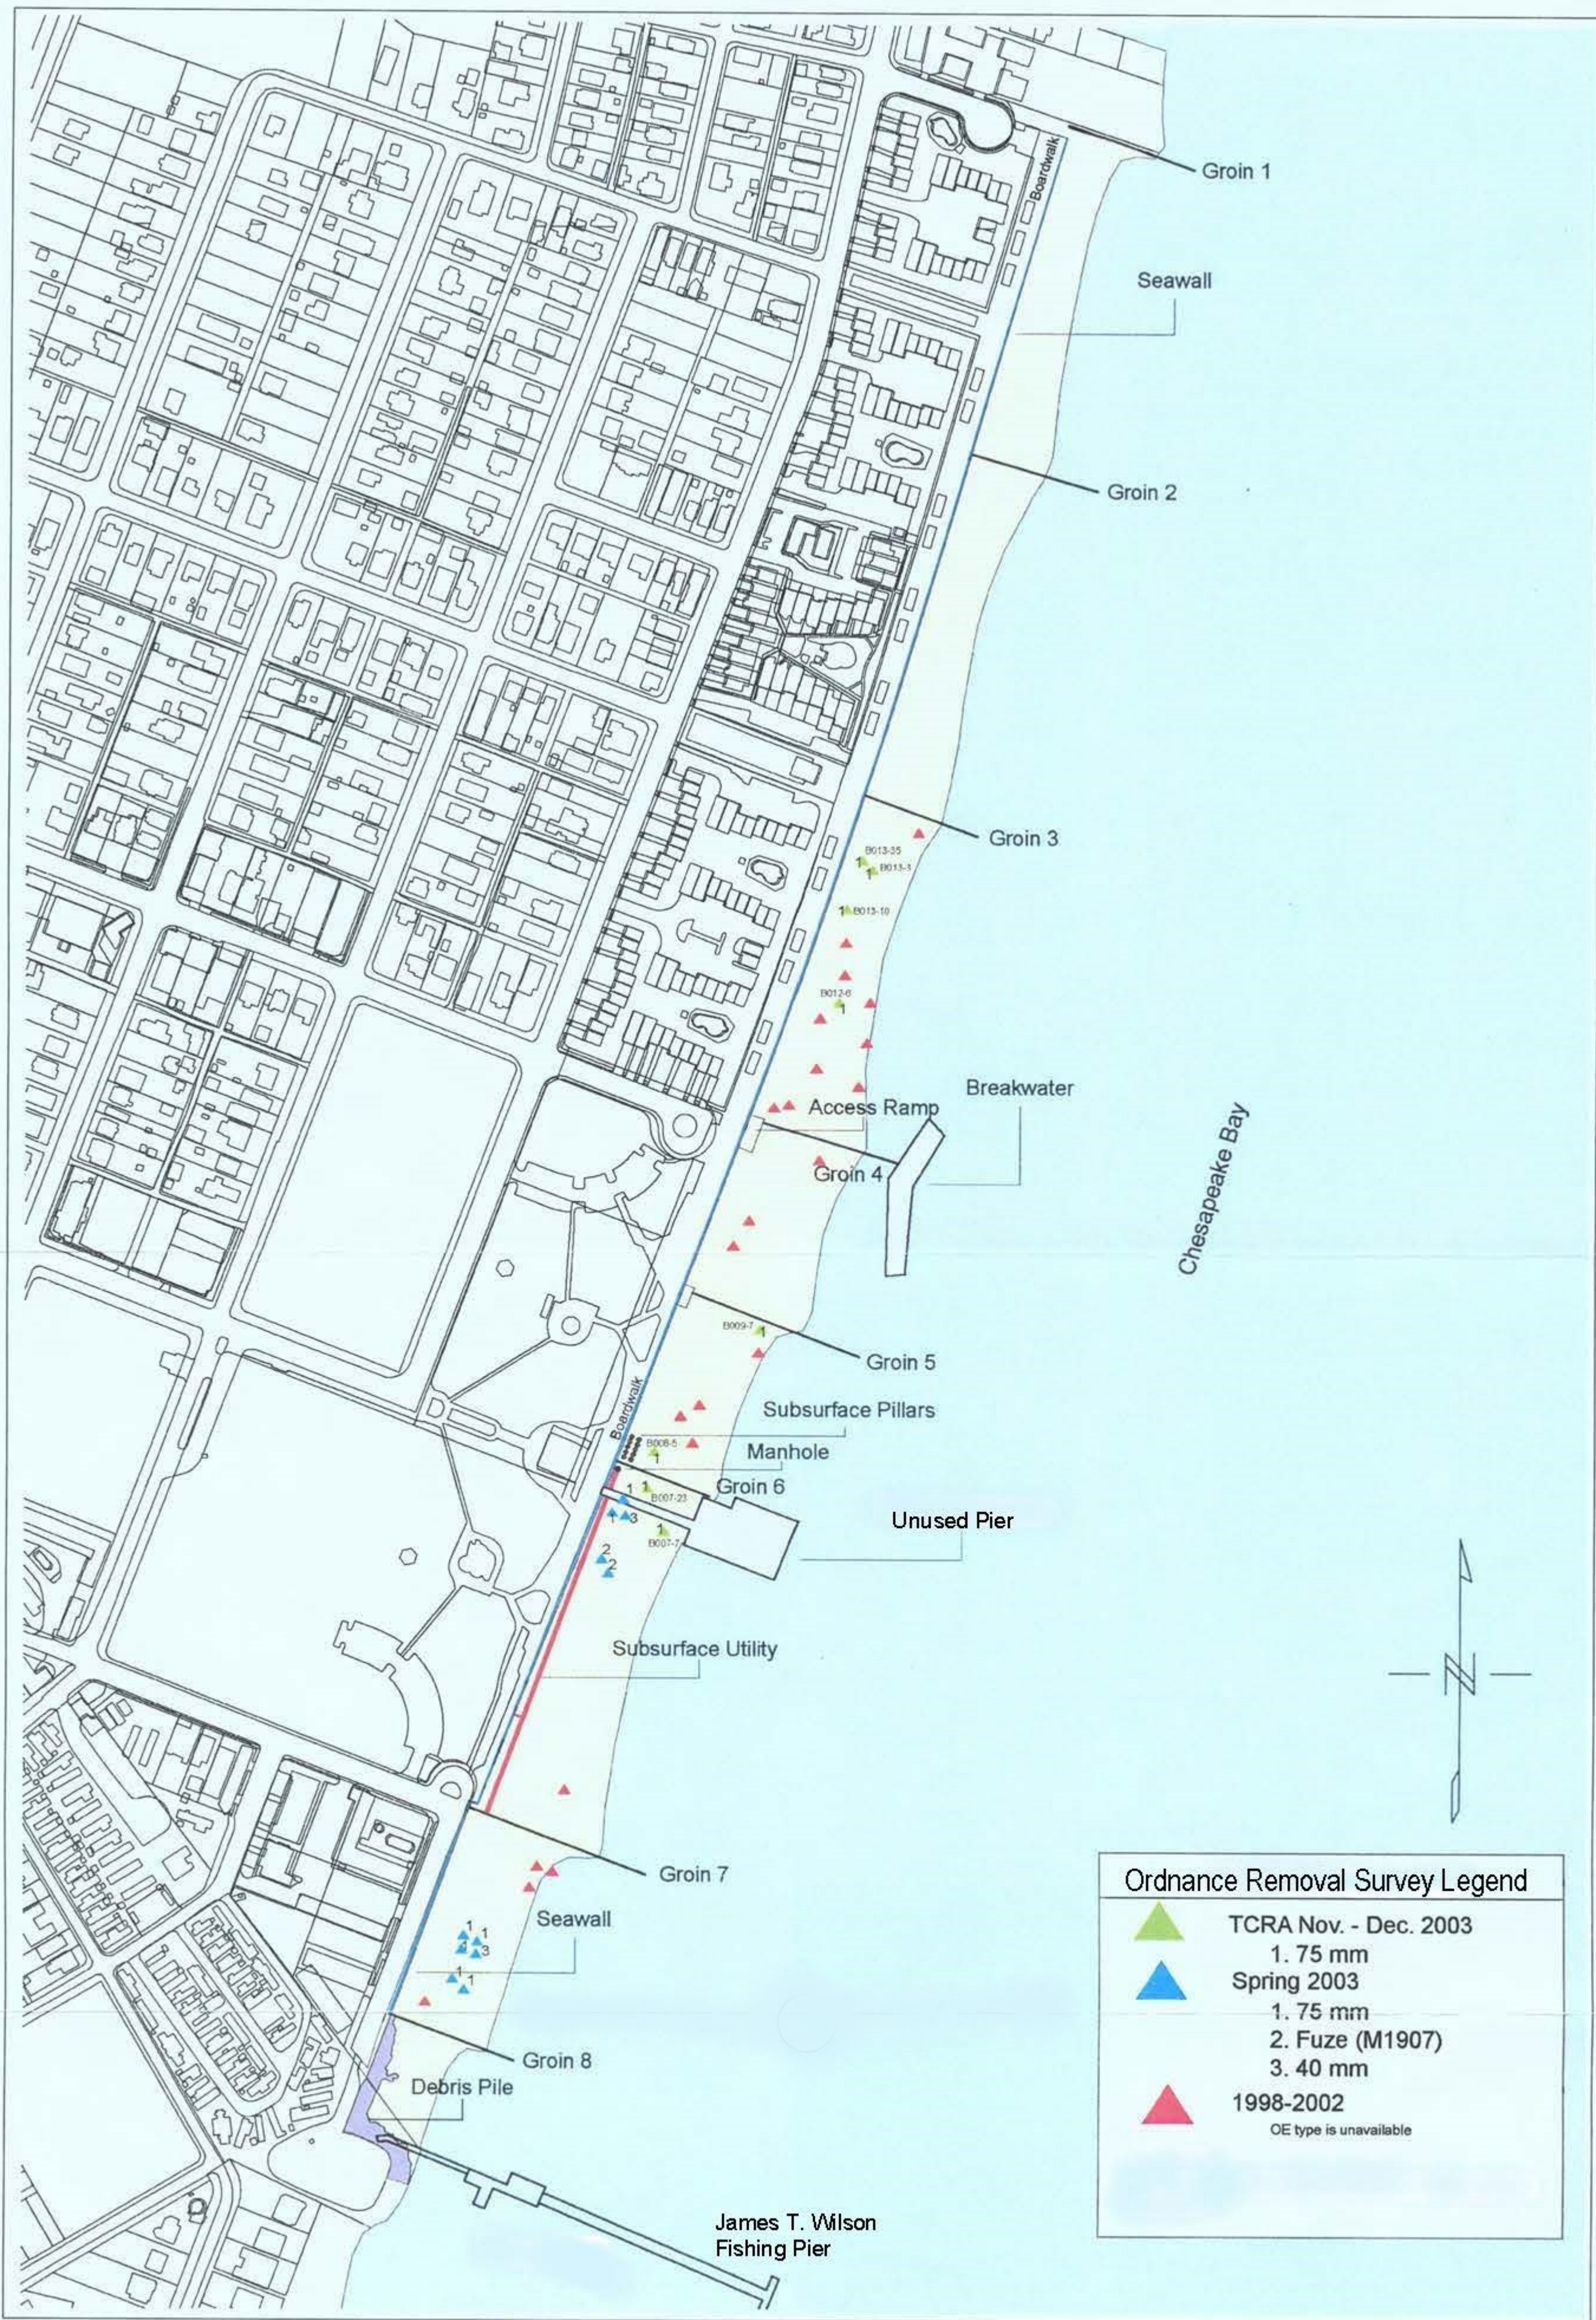
Figure 3  
 Buckroe Beach TCRA  
 Figure 3 Locations of Recovered MEC

Ordnance Removal Survey Legend	
	TCRA Nov. - Dec. 2003
	1. 75 mm
	Spring 2003
	1. 75 mm
	2. Fuze (M1907)
	3. 40 mm
	1998-2002
	OE type is unavailable

**FIGURE 3**  
 Figure is extracted from  
**Site-Specific Final Report**  
 for TCRA, Prepared by  
**WESTON** on February 2004
