Figure 4
 Lot 18 Area
 Perchlorate Detections
 Spring Valley FUDS
 Washington, DC

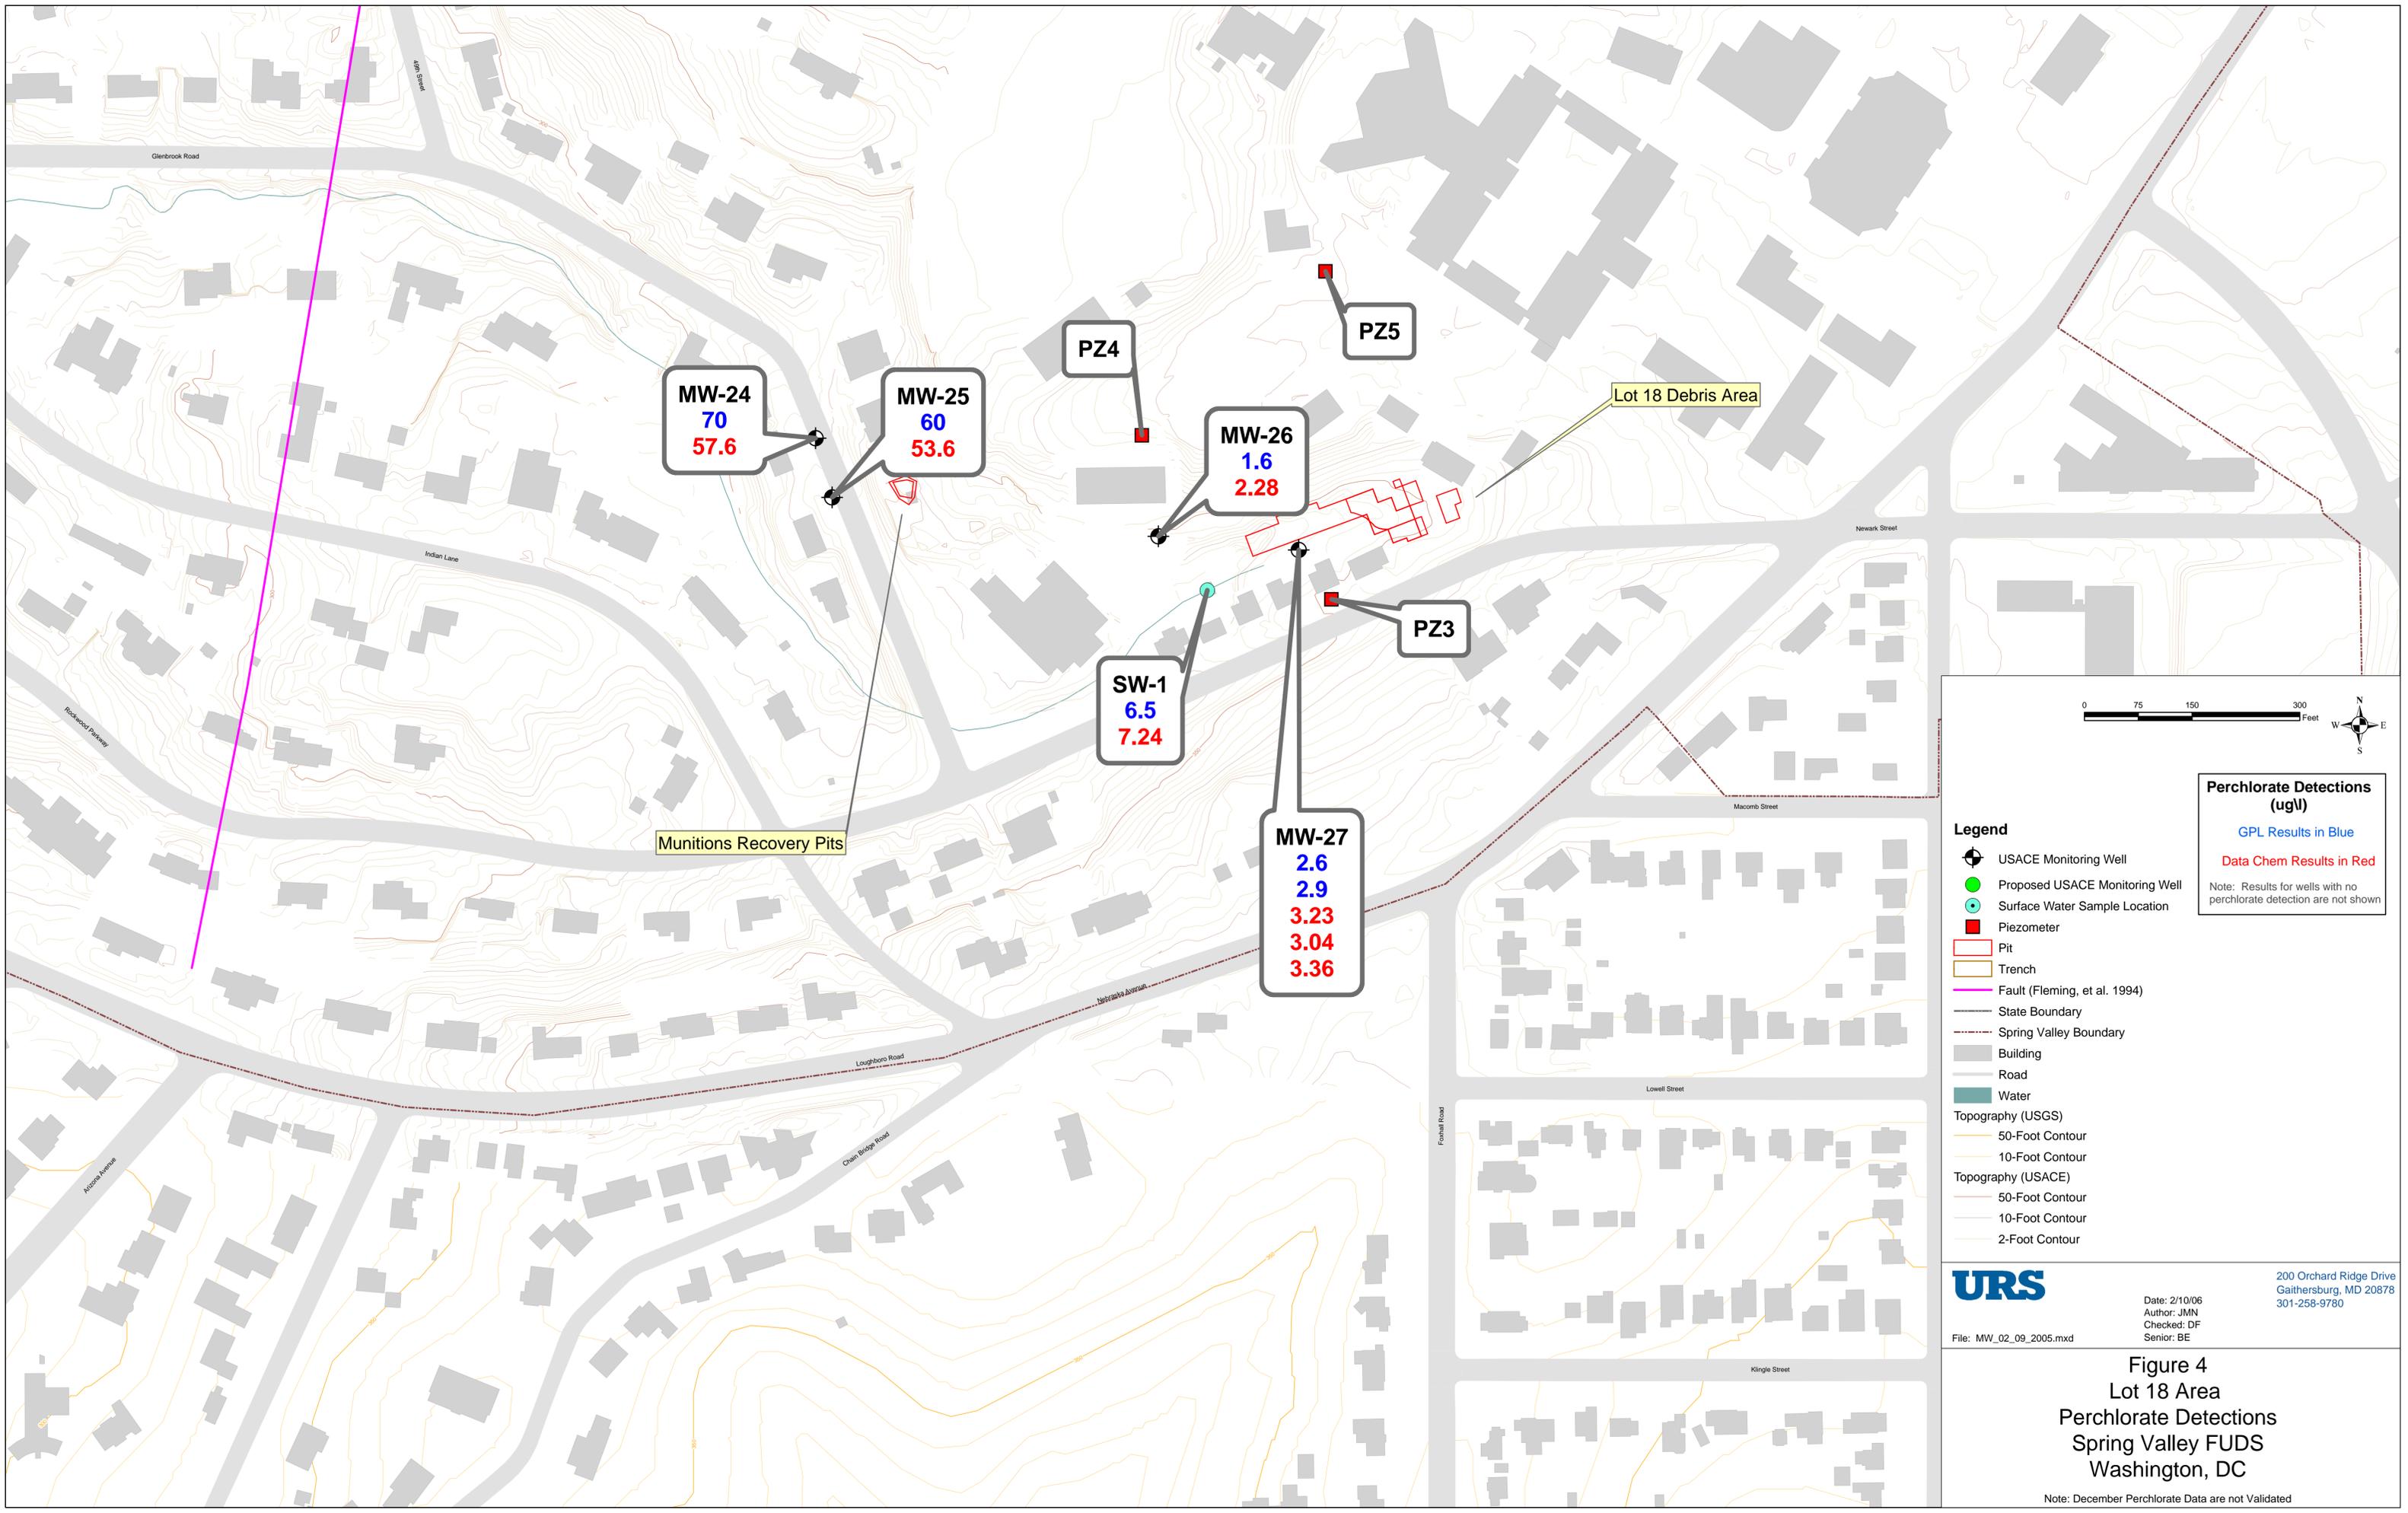
Perchlorate Detections (ug/l)
 GPL Results in Blue
 Data Chem Results in Red
 Note: Results for wells with no perchlorate detection are not shown

Note: December Perchlorate Data are not Validated
