APPENDIX B: EXAMPLE METRIC PHOTOS

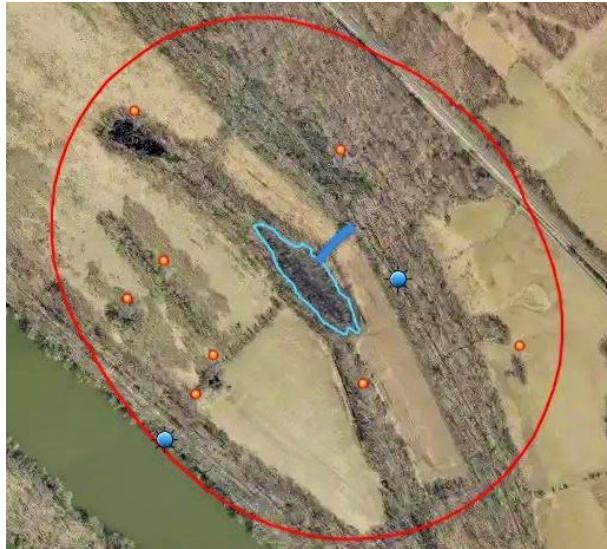
Figure B1 Aquatic Context Metric. The aquatic context metric is evaluated by drawing a polygon extending from the WAA boundary (blue polygon) outward 1000 feet (red polygon). All aquatic resources within the polygon are counted. The red points are wetlands (8) and blue points are streams (2), for a total of 10 aquatic resources within the 1000' polygon. This depressional wetland in the EMP ecoregion would score "4" for this metric. Source: Watershed Resource Registry (WRR).

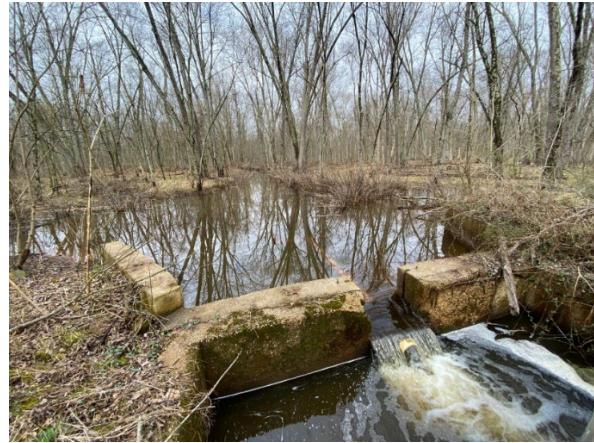
Figure B4 Water Source Metric (artificial control). Slotted weirs to control water levels in wetlands are a form of artificial control of a water source which impacts hydrologic processes. Management of “green tree” reservoirs disrupts the flow and circulation of waters within a wetland impacting a water source and several other MDWAM metrics such as hydroperiod, hydrologic flow, plant strata, species richness and others. This forested wetland in Montgomery County is seasonally flooded to promote waterfowl habitat. This wetland would score moderately for this metric due to the high artificial control from this structure.

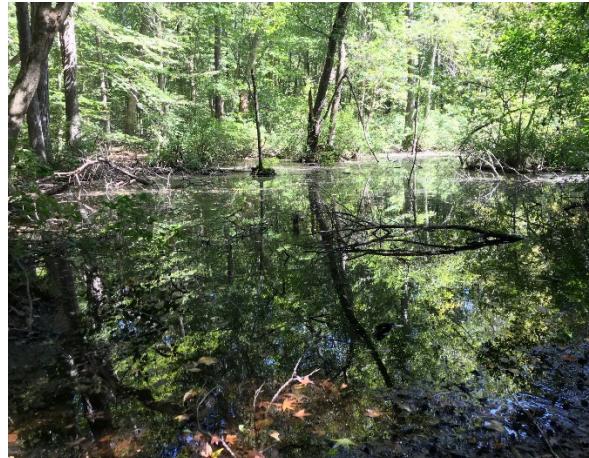
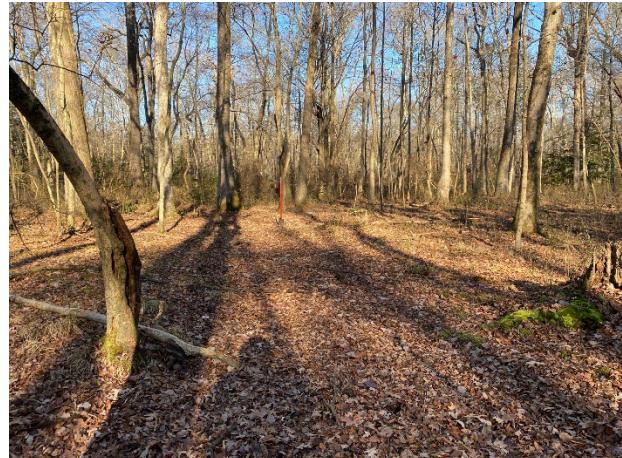
Figure B5 Water Source Metric (artificial control). Agri-drains are another common water control device used to manipulate water levels in wetlands. In addition to wildlife management areas, many restoration and mitigation areas have water control structures such as this. Wetlands with these structures would typically score moderate to low due to the potential for high control.

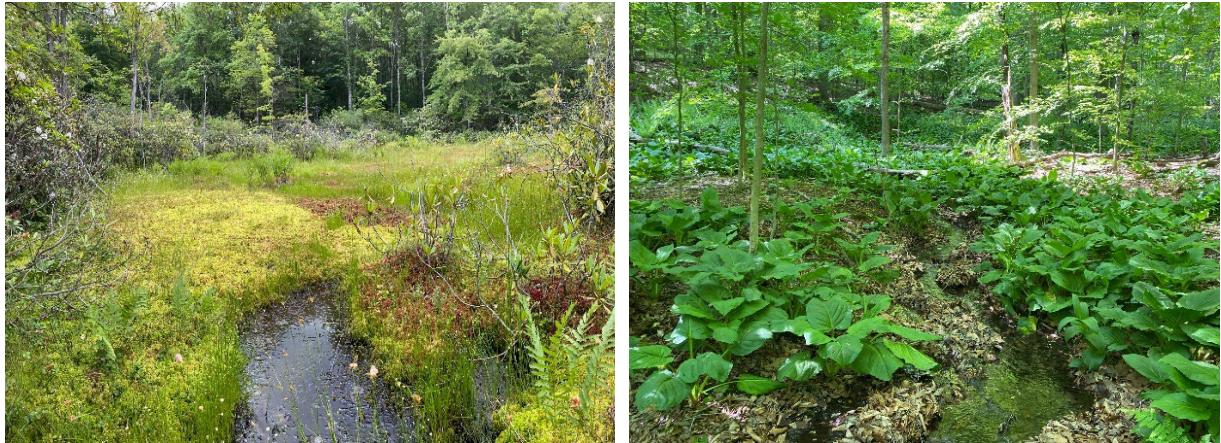
Figure B6 Hydroperiod Metric. Pictured above, two depression wetlands in the CP ecoregion with low variation of the hydroperiod. Low variation generally scores a maximum of “3” as the prolonged hydroperiod often has a negative effect to several of the biotic core element metrics such as species richness and plant strata. Both photos illustrate the lack of strata in the wet and dry seasons. Low variation is also reflected in the types of functions the wetland can perform.

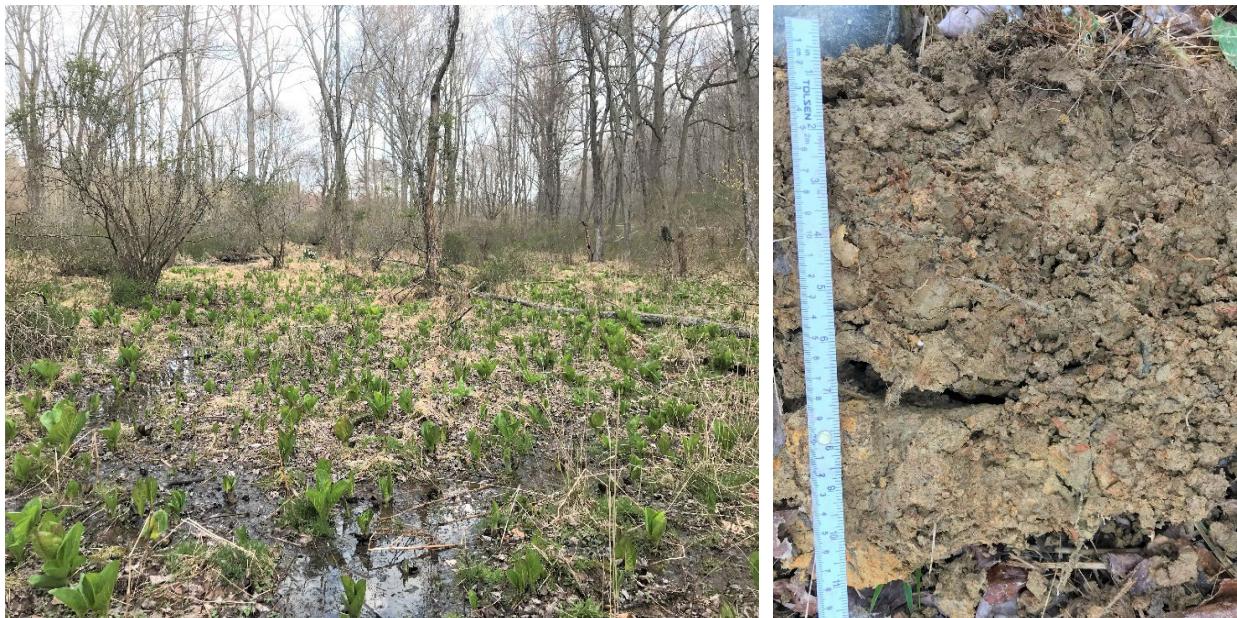
Figure B7 Hydroperiod Metric. This perennially saturated fen (backslope subclass) in Garrett County (left) is another example of low variation of the hydroperiod. This backslope wetland in Cunningham Falls (right) State Park is an example of perennial saturation and low variation of the hydroperiod. As above, these wetlands in the EMP ecoregion would each score a “3” for hydroperiod. Low species richness and organic accumulation are common indicators of low variation.

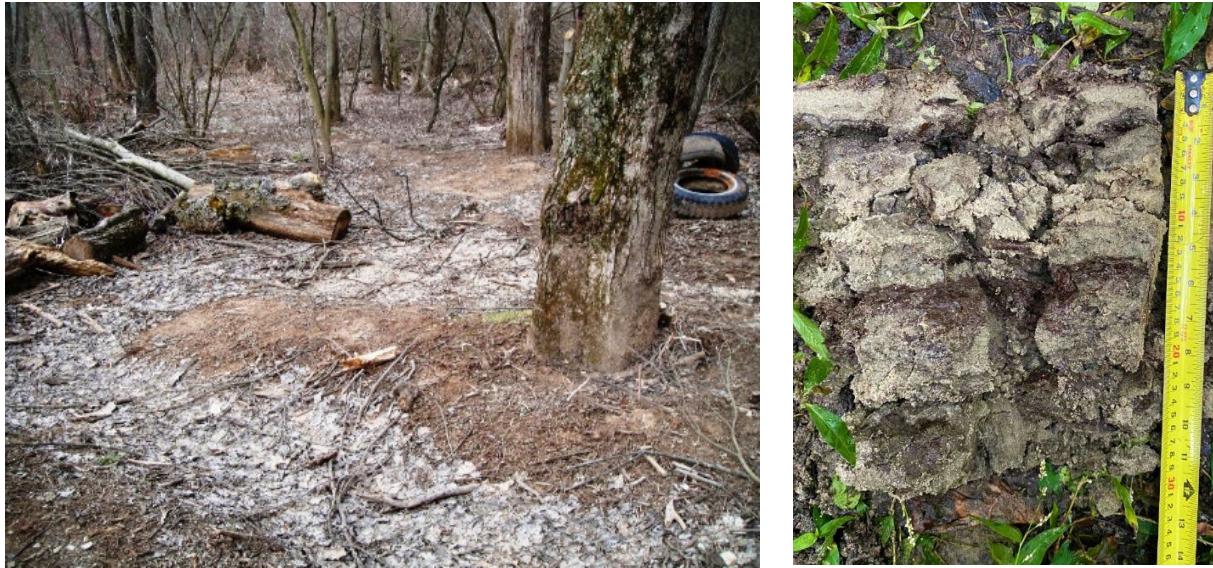
Figure B8 Hydroperiod Metric. Example of a toe slope wetland with high variation of the hydroperiod (Joe Branch, Carroll County) in the EMP ecoregion. This wetland would score “4” for the hydroperiod metric. High species richness, lack of organic accumulation and redoximorphic concentrations near the surface are indications of high variation in this case.

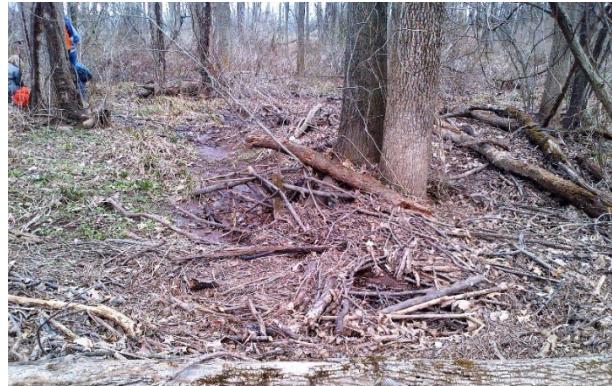
Figure B10 Hydrologic Flow Metric. This example of a riverine wetland (active floodplain subclass) also illustrates a wetland that would receive a high score for this metric. Note the large amount of floatable debris at the bases of the trees indicating high flowthrough. The transport of organics and sediments are important to the function of the wetland (e.g., carbon import or export, sediment retention, nutrient cycling, etc.) when they occur at natural rates.

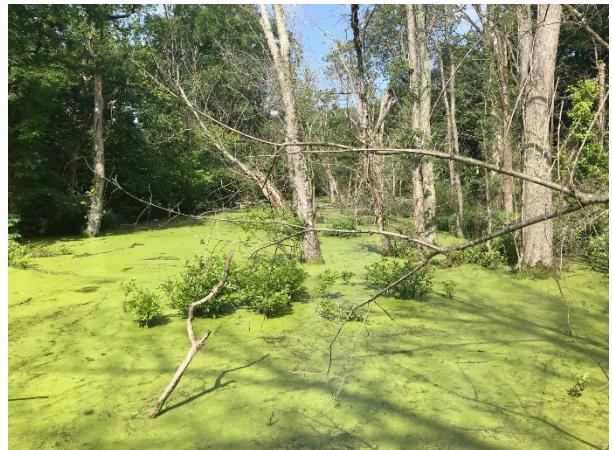
Figure B11 Hydrologic Flow Metric. This example illustrates indicators of low flowthrough and openness in this depressional wetland in the EMP ecoregion. Dead standing timber, floating plants (*Lemna minor*) and flood tolerant shrubs such as buttonbush (*Cephaelanthus occidentalis*) are indicators of stagnant or low movement of water. Other indicators of low flowthrough include water-stained leaves, algal mats, debris dams, iron deposits, constricted outlets, and surface roughness.

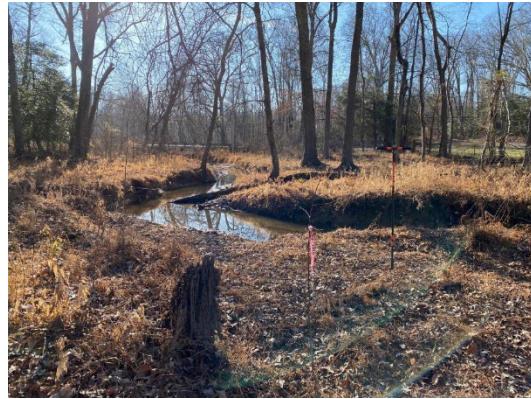
Figure B12 Surface Drainage Feature Metric. This example of a toe slope wetland (left) along Mill Swamp (Charles County - CP ecoregion) illustrates how an incised channel can impact wetland hydrology by lowering and even eliminating the water table in an adjacent wetland. Because the stream channel has become incised and no longer exhibits regular overbank flooding, groundwater discharge from the valley fringe is now the dominant water source to the wetlands. The wetland would score low for this metric as the incised channel has an ongoing negative effect on the water table of the adjacent wetlands.

Figure B13 Surface Drainage Feature Metric. In contrast to Figure B12, the channel of this riverine wetland (swamp forest subclass) adjacent to Nassawango Creek (Somerset County – CP ecoregion) is not negatively affected and scores a “4” for the surface drainage feature.

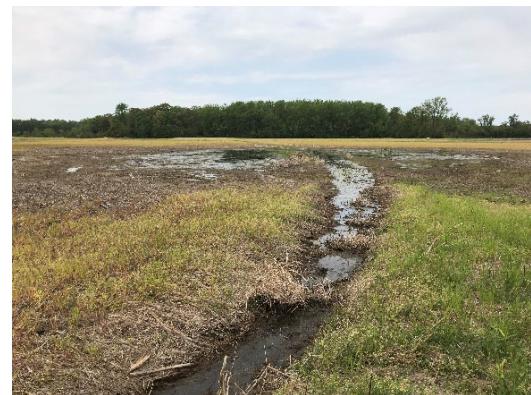
Figure B14 Surface Drainage Feature Metric. Surface drainage features include man-altered streams (ditched/excavated) as in this photo. This surface drainage feature has more than a minimal ongoing negative effect on the adjacent wetland hydrology (depression). The surface water level and water table have been significantly impacted and therefore would score “1” for this metric.

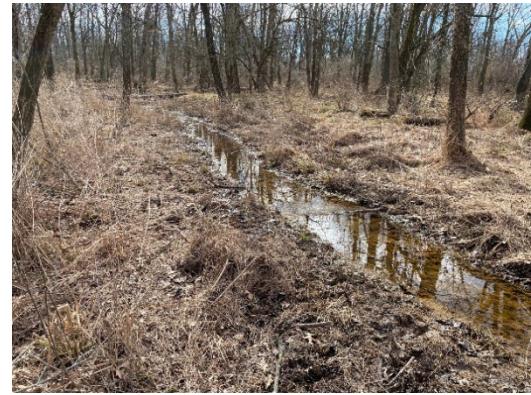
Figure B15 Surface Drainage Feature Metric. Surface drainage features also include ditches and swales but do not always have a significant effect on a wetland. The historic ditch in this photo has minimal or no negative effect on the adjacent wetlands. Therefore, it would score high for this metric. Of note, mineral flat wetlands have many miles of historic ditches from past agriculture and silviculture activities throughout the coastal plain. Many of which have little or no effect on the wetlands. Therefore, an investigator must be familiar with soil types and textures to determine the potential effect of old ditches.

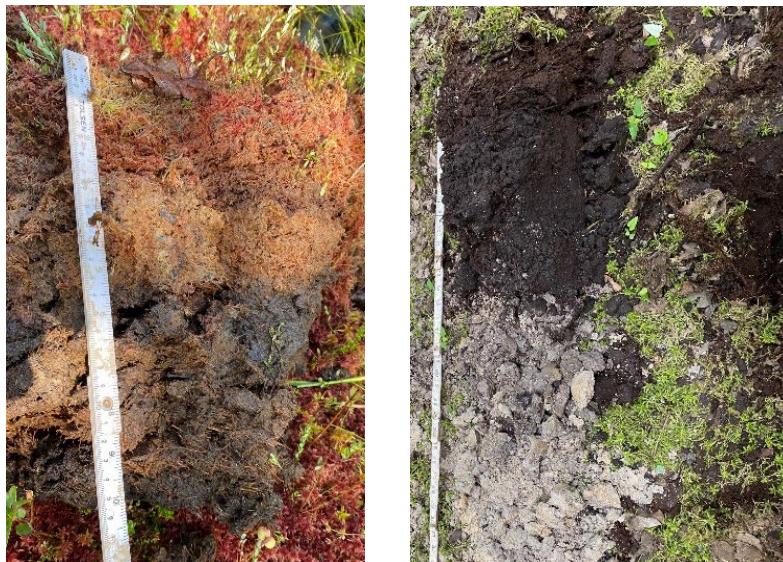
Figure B16 Organic Carbon Storage Metric. Soils with thick organic or dark mineral surfaces score high for this metric. They indicate accumulation of organic materials due to extended hydroperiods during their development. The photo on the left is from a backslope fen in Garrett County (histic epipedon) and the photo on the right is from a mineral flat wetland in Queen Annes County (umbric surface). Accurate and complete soil profile characterization during wetland delineations will provide the necessary data to evaluate this metric.

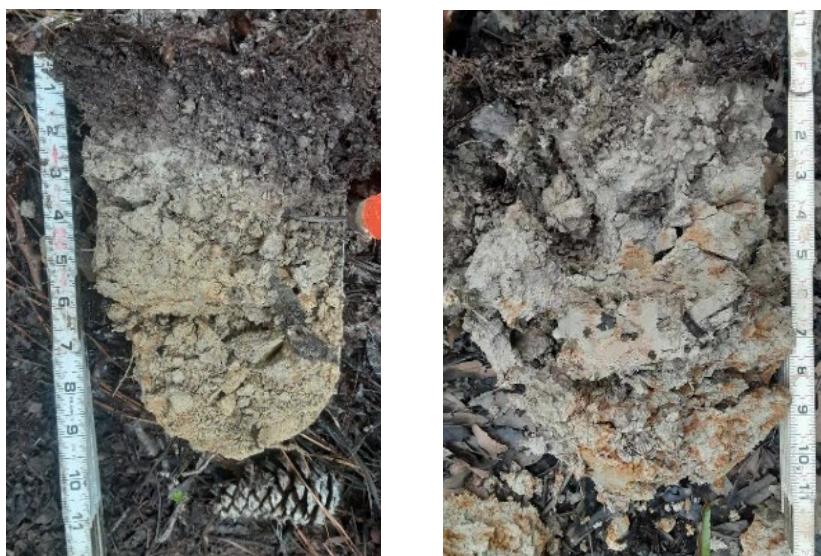
Figure B18 Biogeochemical Cycling (BGC) Metric. The BGC metric combines four sub metric scores to determine if important nutrient and chemical cycling functions are likely in the soil profile. The two soil profiles indicate high variation of the hydroperiod as common to many redoximorphic concentrations are located near the soil surface. Organic carbon storage, herbaceous cover and microtopography are other sub metrics that are measured to determine the overall BGC score. Soils with a depleted matrix can score high for this metric.

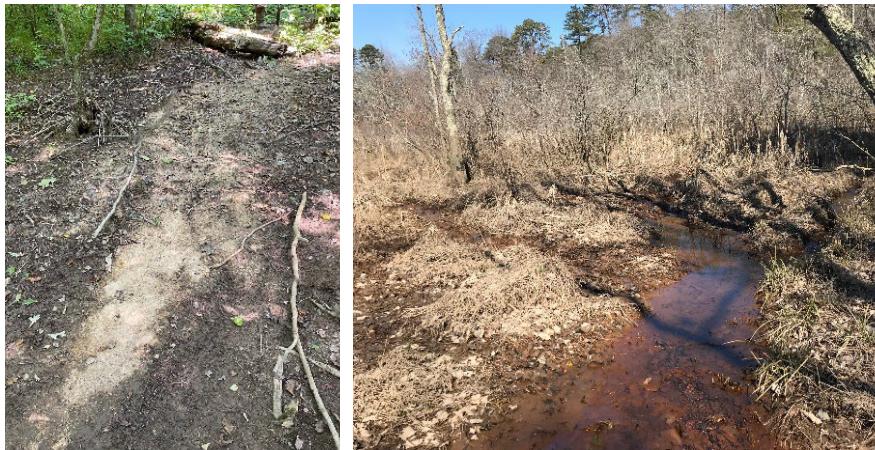
Figure B19 Sedimentation Metric. The photo on the left (Kent County) provides an example of sedimentation that is of a natural amount. The photo on the right (Anne Arundel County) also exhibits a natural rate of sedimentation as evidenced by the coated leaves in the foreground. These sediments were suspended by overbank flood waters and deposited far from the channel. In both cases, the wetlands would probably score a "4" for this metric.

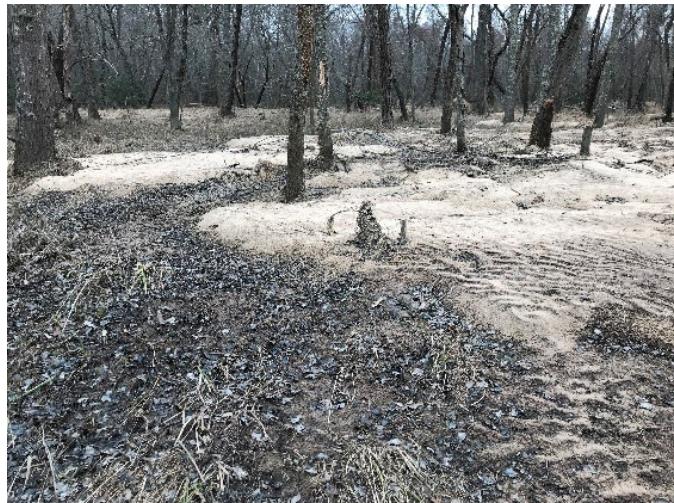
Figure B20 Sedimentation Metric. The sedimentation in this photo (Anne Arundel County) illustrates excessive and widespread sedimentation which would score a "1". The sedimentation is a product of frequent destructive flooding events from urbanization of the watershed.

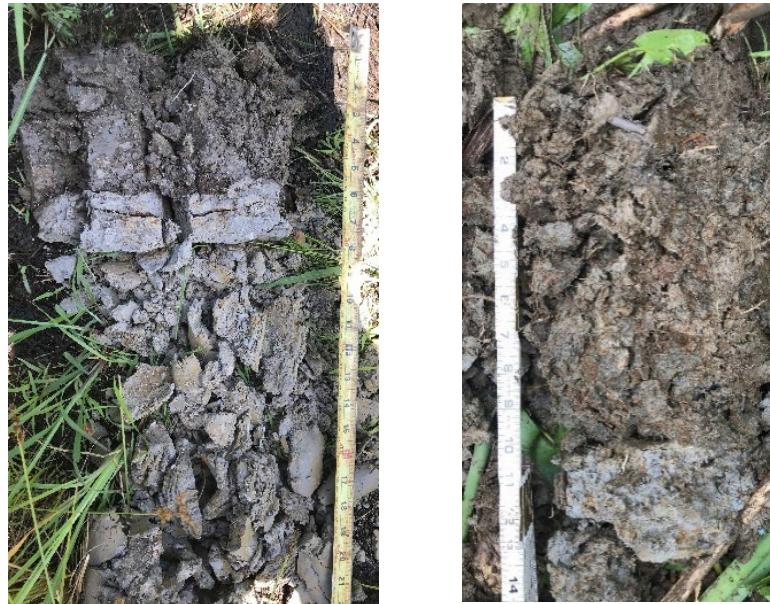
Figure B21 Soil Modification Metric. There are many indicators of human soil modifications such as land clearing, grading, tillage, and compaction to name a few. Recent alterations can often be very clear but past alterations and the degree of recovery often depend on the extent and severity of the alteration. These photos illustrate the effects of compaction from heavy equipment. The soil on the left is compacted near the surface while the photo on the right is compacted lower in the profile. In both cases, the effects can be long lasting.

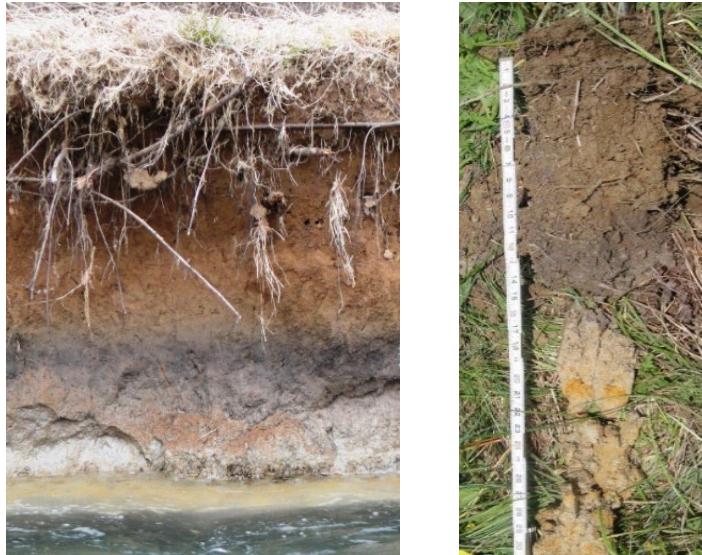
Figure B22 Soil Modification Metric. Legacy sediments are another form of human soil modifications resulting from historic dams, agricultural and other disturbances. In both photos, an original F3 hydric soil indicator has been buried by years of sedimentation. These sediments have since developed redoximorphic features now expressed as an F19 indicator (Piedmont floodplain soils). Note the original dark surfaces below the F19 indicator.

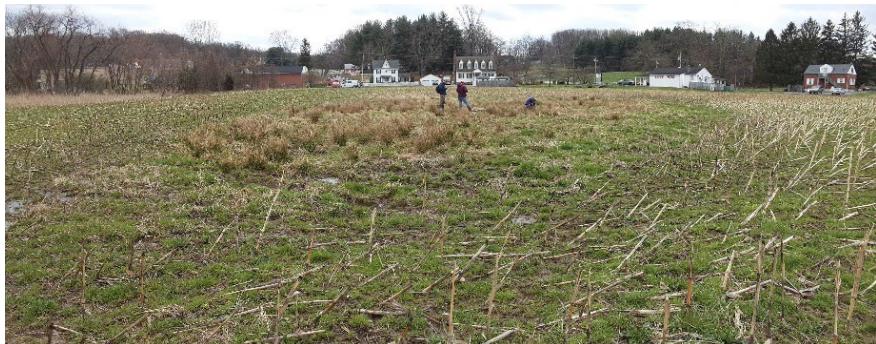
Figure B23 Soil Modification Metric. The severity of the alteration and its potential effect on soil recovery (morphological development) must be determined in scoring this metric. Tillage of the soil may not have as severe effect as other disturbances such as filling, grading, and dredging. This is a backslope wetland in Harford County.

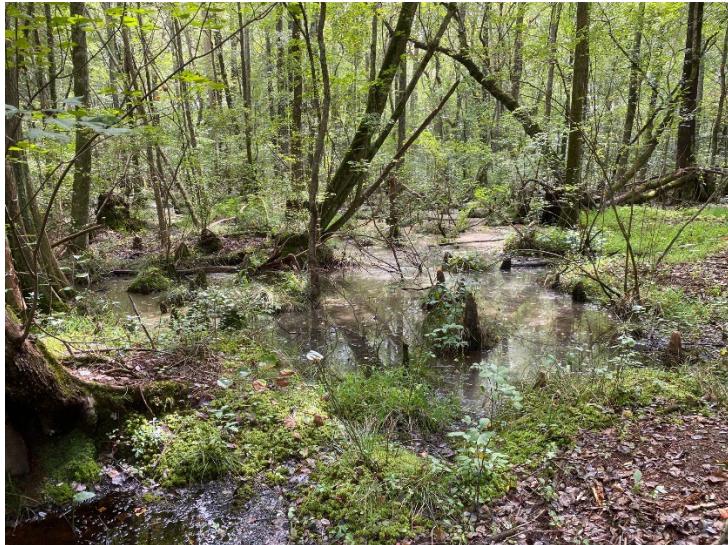
Figure B24 Topographic Complexity Metric. This metric measures the surface roughness which is expressed as microtopographic elevation change (3–6-inch change in surface elevation) or as a gradient or bench (>6-inch change). This wetland has moderate microtopography but because it has two gradients it would score high. The distinct vegetative communities reflect the change in gradient.

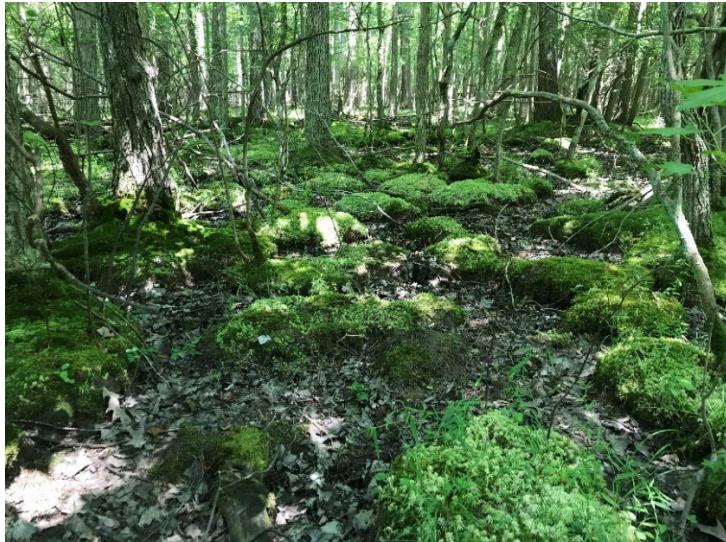
Figure B25 Topographic Complexity Metric. This hardwood mineral flat has only one gradient but greater than 50% microtopography. This wetland would score "4" for this metric. Notice the alternating micro highs and lows. This provides diversity in habitat and variation in duration of soil saturation.

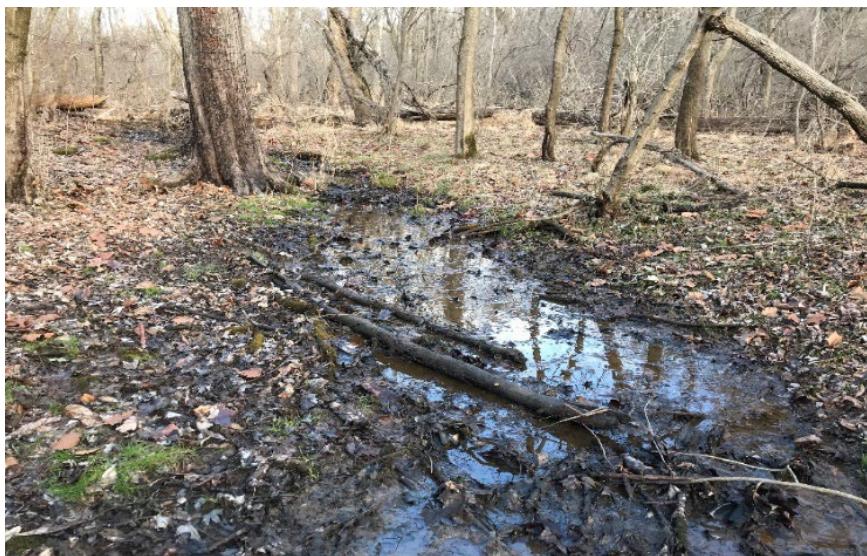
Figure B26 Topographic Complexity Metric. This wetland has two gradients but low microtopography (10-29%) and would score moderate for this metric.

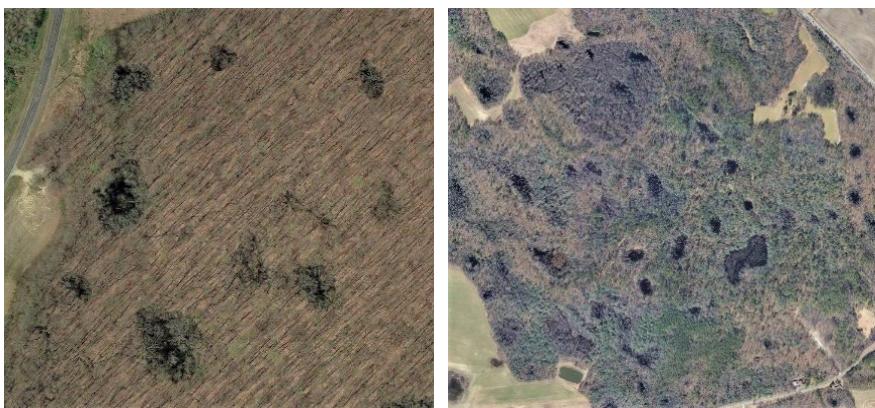
Figure B27 Edge Complexity Metric (horizontal). These Delmarva Bay wetland depressions typically have very low horizontal edge complexity and are surrounded by upland forest (low vertical complexity) resulting in a low score for this metric.

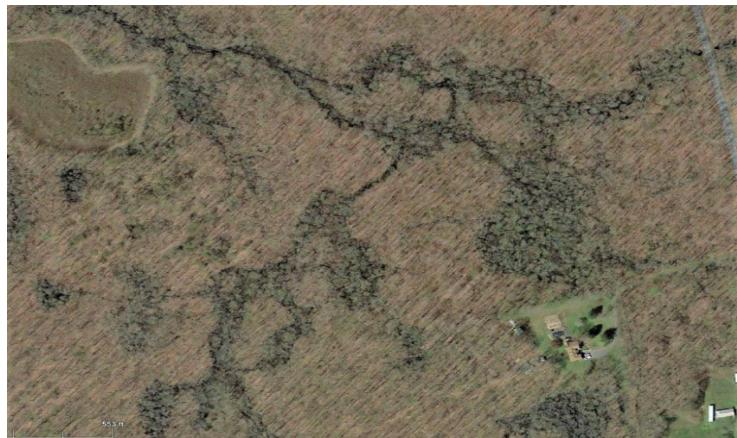
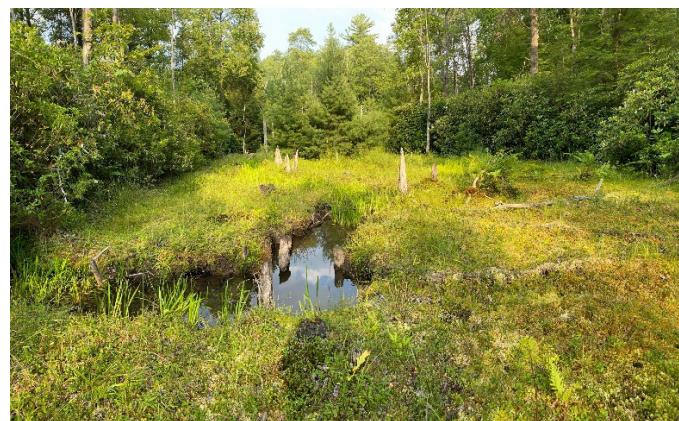
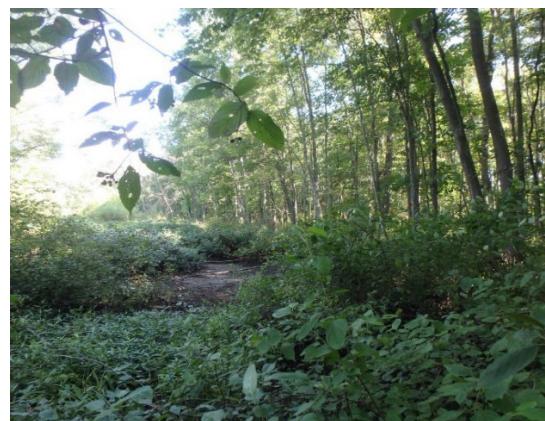
Figure B28 Edge Complexity Metric (horizontal). This wetland has very high horizontal edge complexity. Note the interconnecting fingers of wetlands and irregular boundaries.

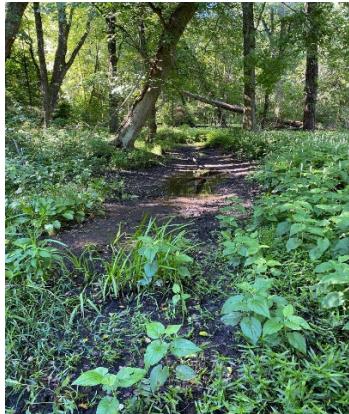
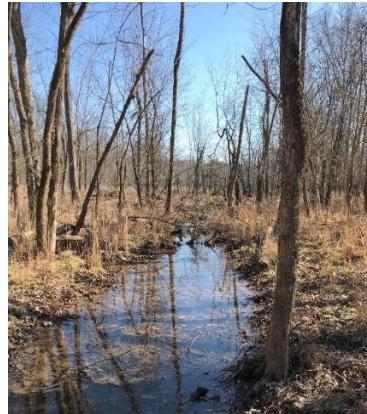
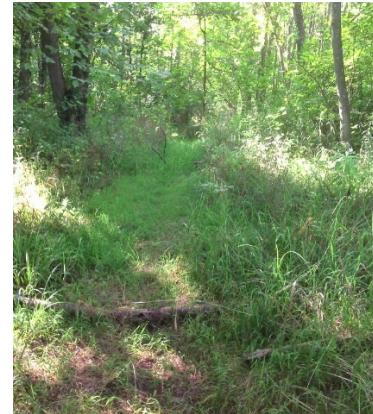
Figure B30 Physical Habitat Richness Metric – Secondary channels. These are seasonally active secondary channels that conduct surface flows seasonally and during high water periods. They generally exhibit channel morphology and are often ponded between flow episodes.

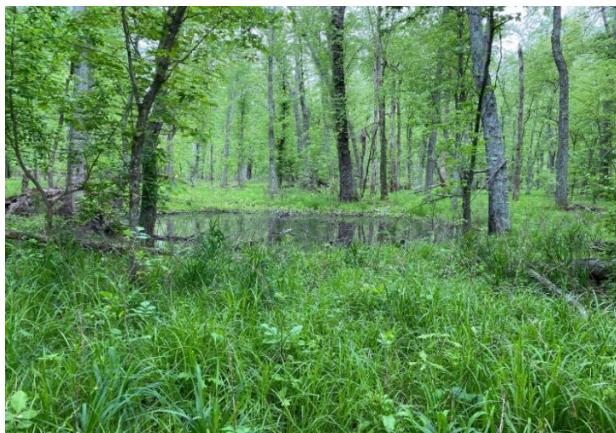
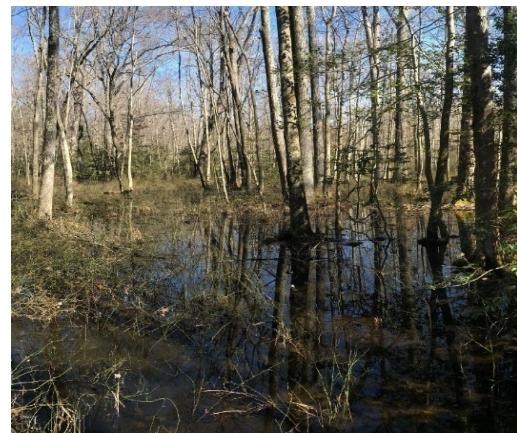
Figure B31 Physical Habitat Richness Metric – Seasonally inundated swales. Concave features that can conduct seasonal flows but are typically ponded most of the time. Flows are generally sluggish and do not produce well defined stream morphological characteristics. They are often unvegetated but may fill in with herbaceous vegetation during the dry season often causing them to be overlooked as shown in the right photo.

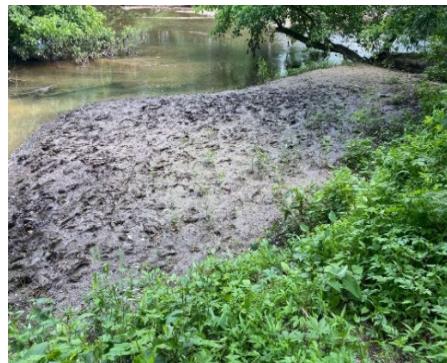
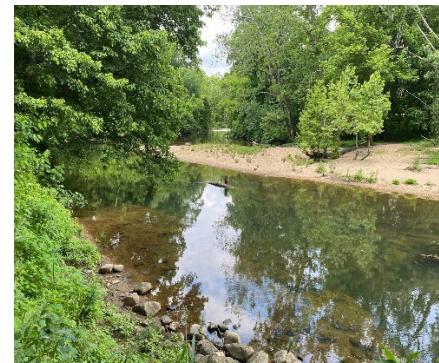
Figure B32 Physical Habitat Richness Metric – Unvegetated pools. These areas provide seasonal to permanent habitat for semi-aquatic and other wildlife species. Water-stained leaves and sparsely vegetated concave surfaces are hydrologic field indicators associated with physical habitat richness. Wood frogs and spring peepers are common inhabitants. They are distinguished from unvegetated swales by lacking a physical connection to a drainage feature.

Figure B33 Physical Habitat Richness Metric – Unvegetated flats. Areas of sediment or rock lacking vegetation seasonally or perennially that present potential resting and feeding area for shore birds, wading birds, waterfowl, etc. Exposed shorelines along impoundments or streams during natural or manipulated drawdown.

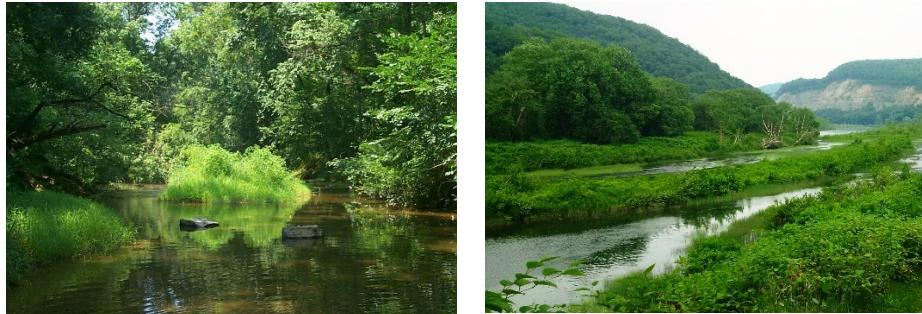
Figure B34 Physical Habitat Richness Metric – Vegetated islands. An area of land above the normal high-water level that is usually surrounded by open water and supports macrophytic vegetation.

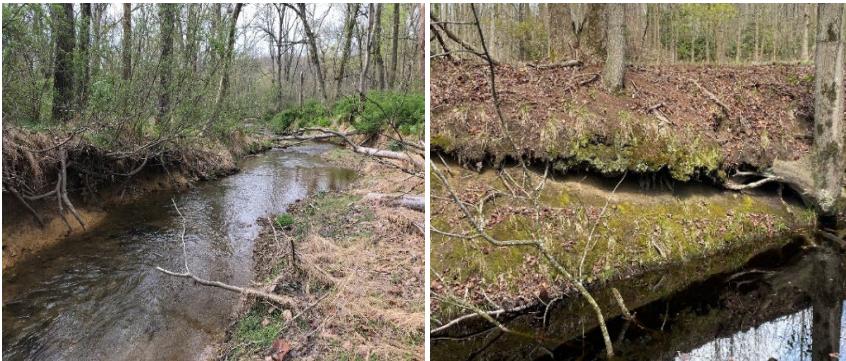
Figure B35 Physical Habitat Richness Metric – Slope with undercut banks. A slope (as on a stream bank or shoreline) with a portion of the soil that has broken away or has been excavated by water to form a hollow or void which provides habitat for fish or wildlife. Overhanging roots of trees are an example.

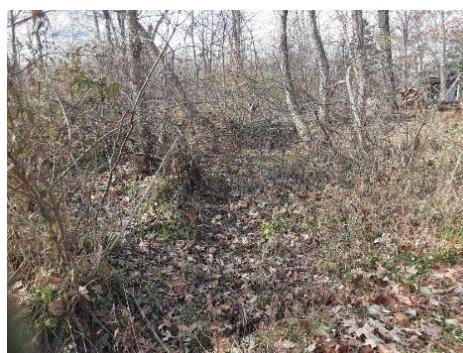
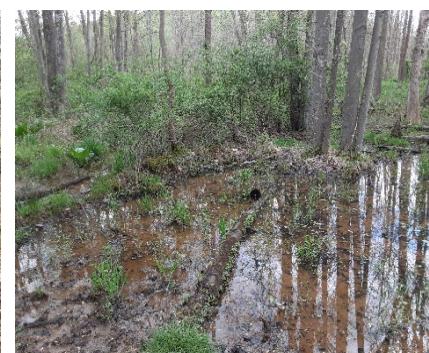
Figure B39 Physical Habitat Richness Metric – Dense herbaceous cover A layer of stems, leaves, and/or litter of herbaceous plant species with sufficient density to create a canopy that shades the soil surface and serves as cover for wildlife.

Figure B40 Physical Habitat Richness Metric – Brambles/thickets. A dense clump, patch, or layer of the stems/branches of woody plants (e.g., vines, shrubs, and saplings) that provide cover for wildlife. Thickets surrounding open depressions are an example.

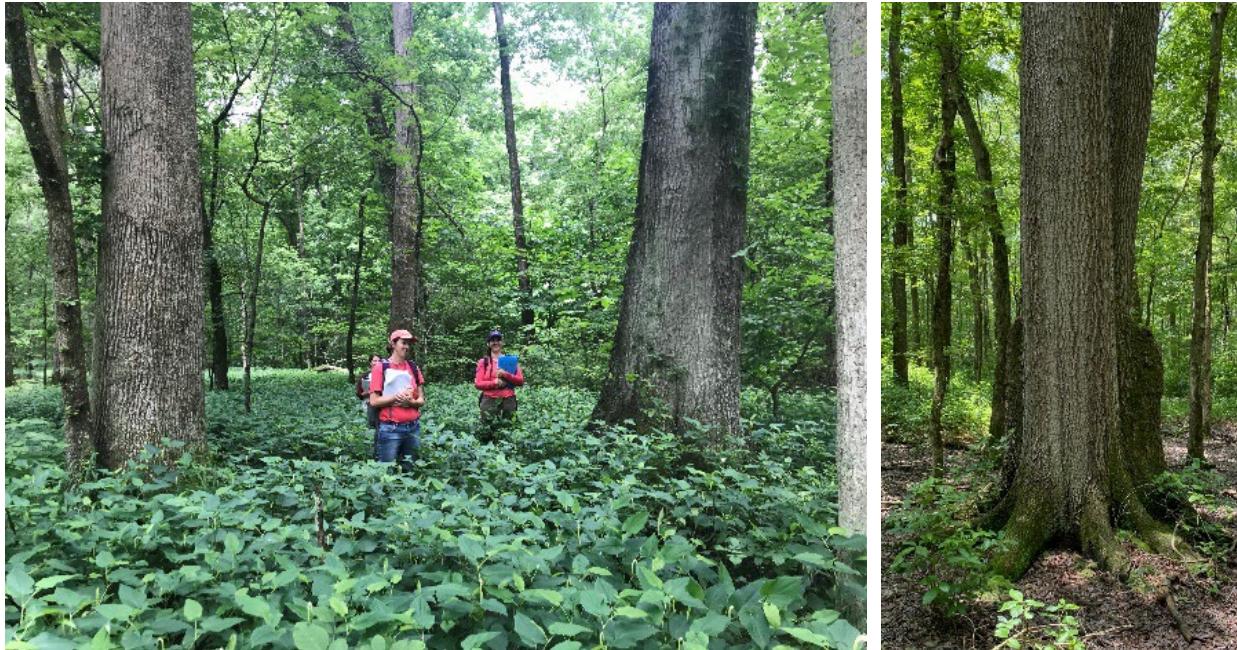
Figure B41 Physical Habitat Richness Metric – Mature/late successional stage of plant community. A community that has reached a state of maturity or equilibrium with natural environmental conditions and that provides unique and/or highly valuable habitat for wildlife (e.g., mature timber bottomland). Maturity or successional stage of a plant community is often determined by the amount of time since a disturbance or stress based on the species composition and/or age (e.g., trees >24" diameter breast height).

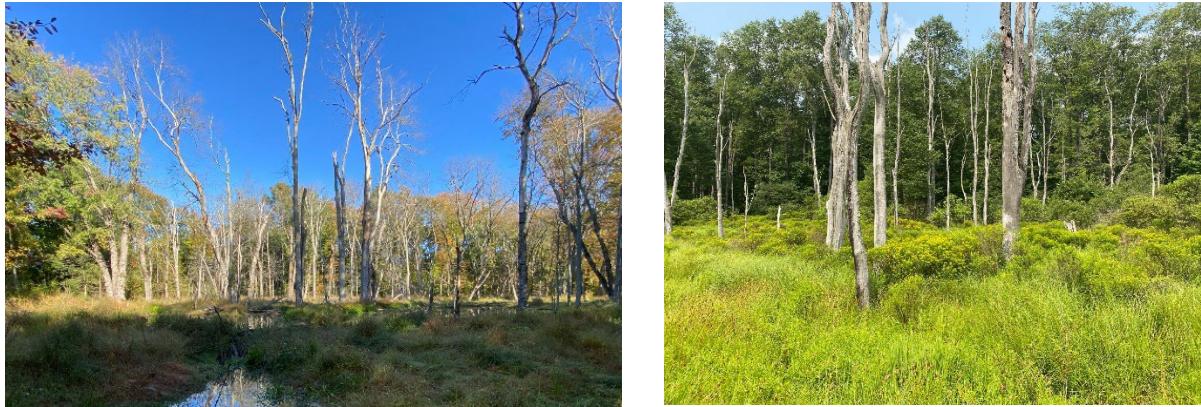
Figure B42 Physical Habitat Richness Metric – Drift deposits/organic debris/brush piles/fallen logs. The accumulation of woody and/or leafy debris, heaps of remnant vegetation, or dead tree trucks laying on the ground surface provides physical habitat for several levels of wildlife. However, excessive numbers often suggest other problems such as a drastic change in hydrology or pest infestations.

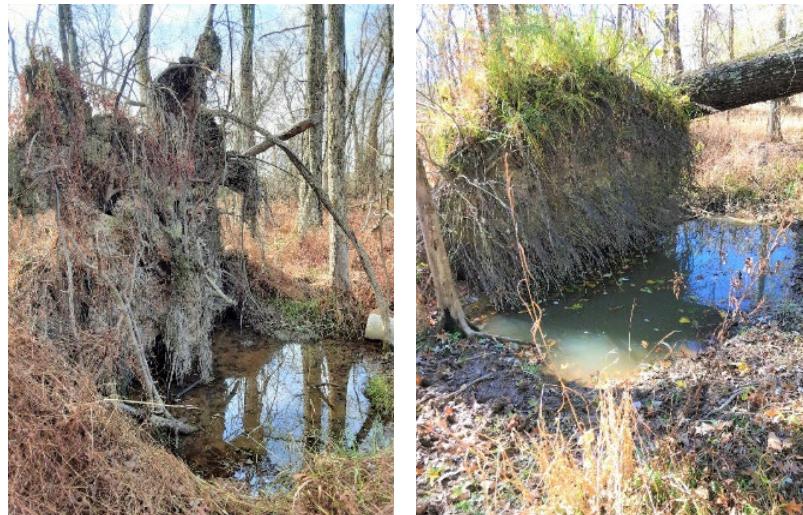
Figure B43 Physical Habitat Richness Metric – Standing snags/stumps. Any dead woody vegetation of significant size (>6" DBH) that remains standing and provides habitat for a variety of birds, small mammals, and insects.

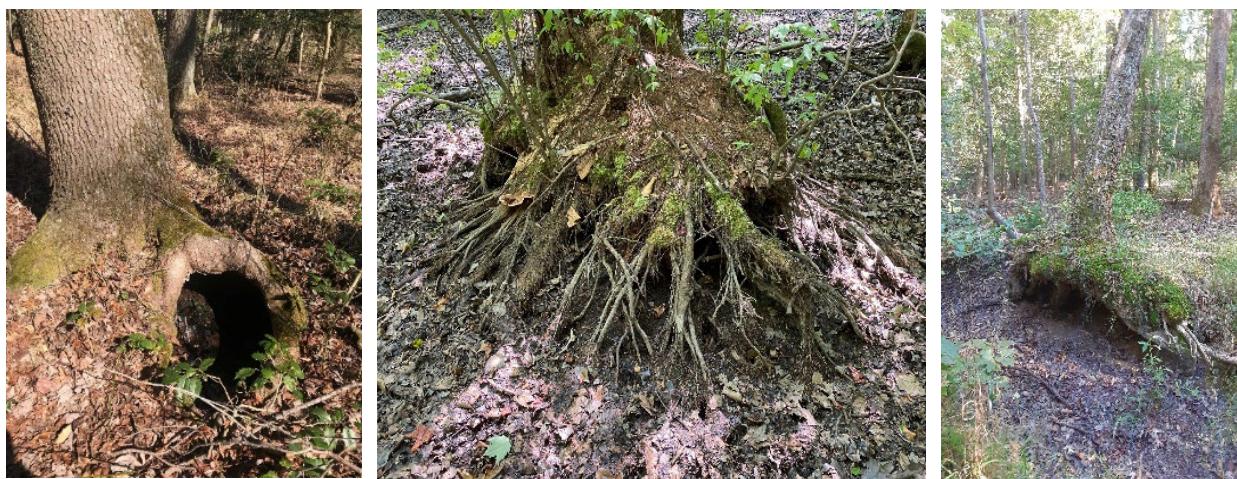
Figure B44 Physical Habitat Richness Metric – Wind thrown trees. This includes trees uprooted and blown over by wind leaving pooled depressions and exposed roots for wildlife habitat as well as patches for plant regeneration and increased diversity.

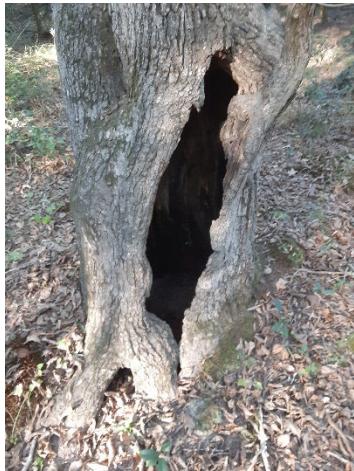
Figure B45 Physical Habitat Richness Metric – Tree root cavities are located at the base of trees or within the root systems. Trees that are not completely wind thrown may produce cavities for wildlife cover.

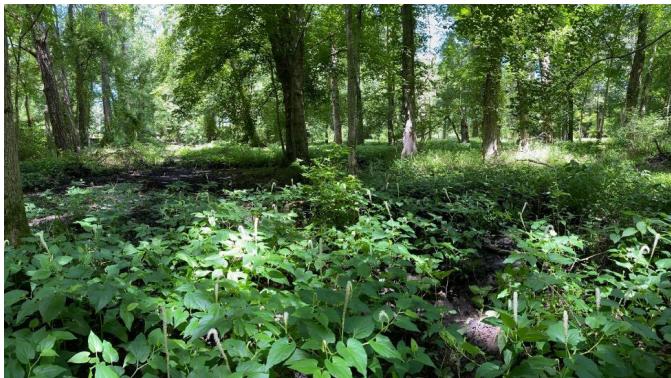
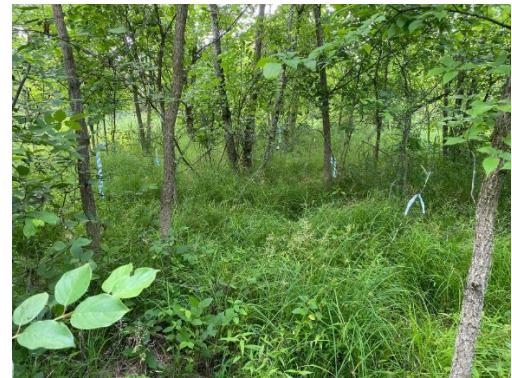
Figure B46 Physical Habitat Richness Metric – Nesting cavities/dens. A hole or hollow tree that provides cover for birds and small mammals.

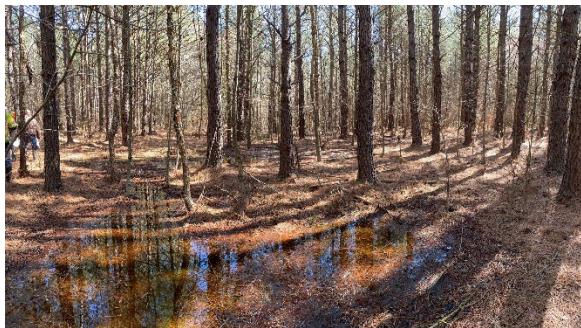
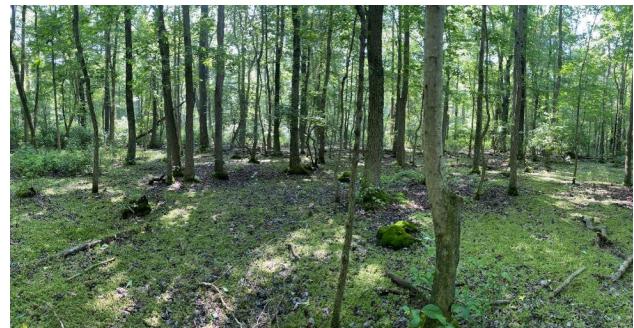
Figure B47 Plant Strata Metric. This forested wetland on the left in (Somerset County) has only two vegetative strata (herbaceous and tree stratum) with more than 5% total cover in the WAA. It would score a "2" for the plant strata metric. The forested wetland on the right on the right (Frederick County), has three strata and would score a "3" for this metric.

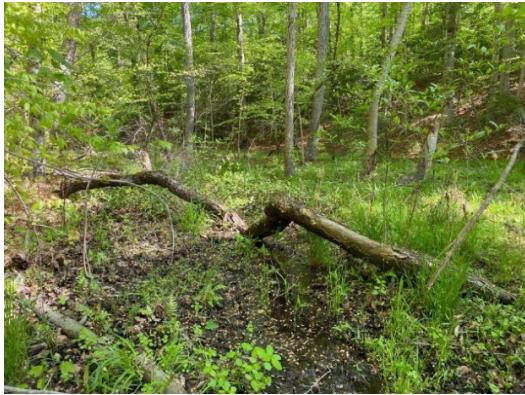
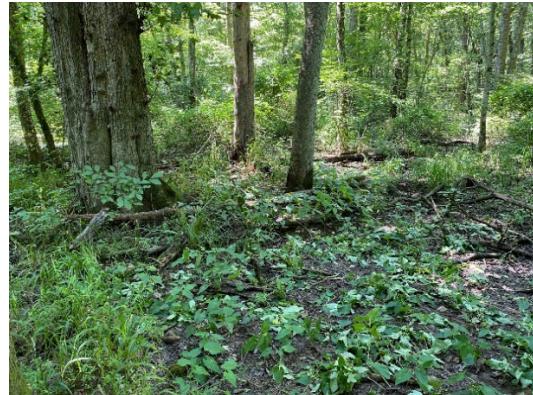
Figure B48 Plant Strata Metric. The forested pine flat wetland in Queen Annes County (left) has only a tree stratum with more than 5% total cover in the WAA. It would score a "1" for the plant strata metric. The forested wetland on the right on the right (Caroline County), has two strata (herbaceous and tree strata) and would score a "2" for plant strata. Both wetlands are in the CP ecoregion

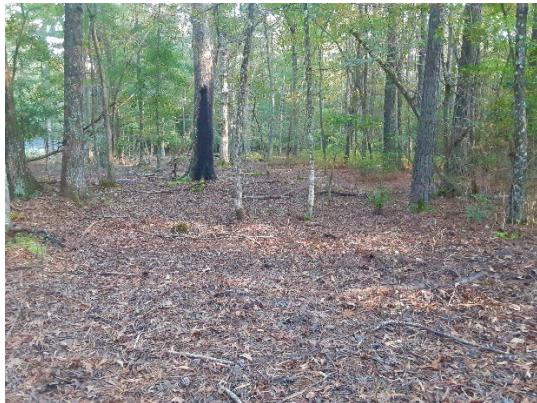
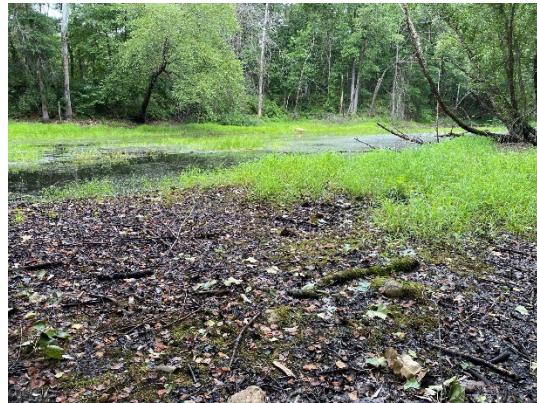
Figure B49 Species Richness Metric. The photo on the left is a narrow slope wetland near Jug Bay which scores a “4” for this metric. Note the numerous different species in the foreground. Species richness scores are dependent upon wetland class and ecoregion. The wetland on the right is a riverine active floodplain wetland in Kent County. This wetland scored moderately for this metric. Both wetlands are in the CP ecoregion.

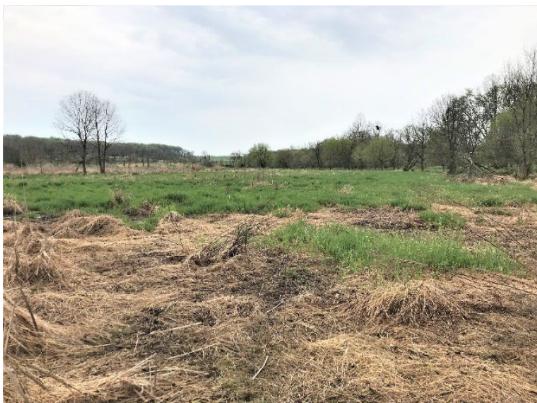
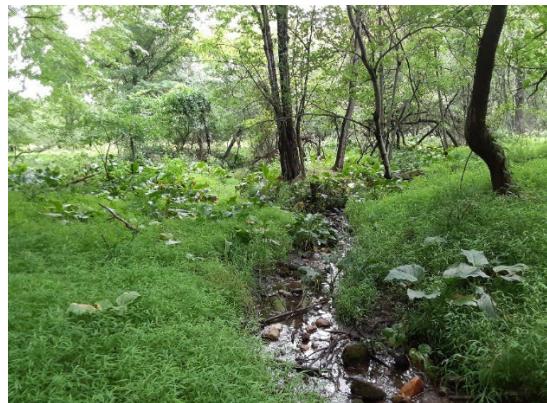
Figure B50 Species Richness Metric. Two examples of wetlands that score low for this metric. The photo on the left is a mineral flat wetland in Charles County (CP ecoregion) which is comprised of only a few woody species. The wetland on the left is an EMP depression wetland in Washington County dominated by only a few woody and herbaceous species. Both wetlands would score a “1” for this metric.

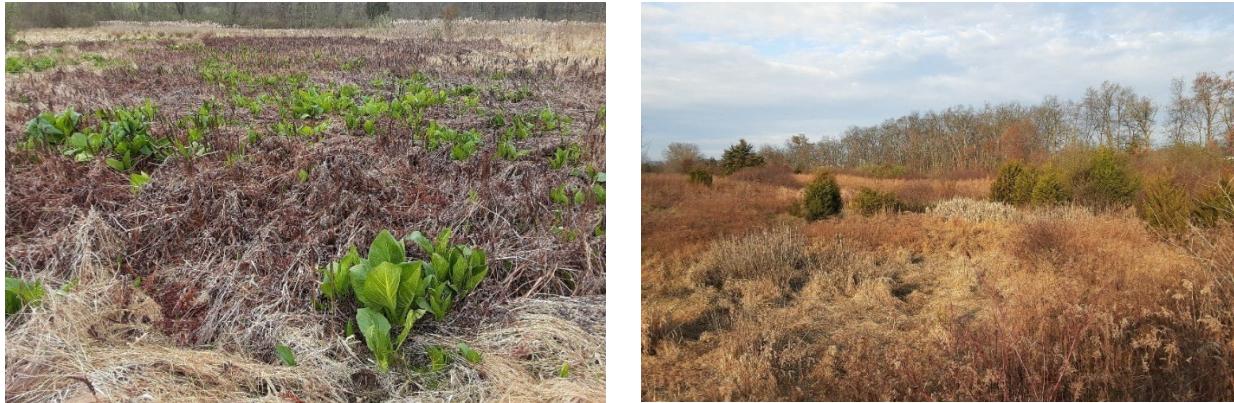
Figure B51 Non-Native/Invasive Species Metric. This slope wetland on the left is in the EMP ecoregion (Howard County) and is a near monoculture of reed canary grass (*Phalaris arundinacea*). This is a common scene in wetlands located on agricultural lands and would score a “0” for this metric. The photo on the right is another EMP ecoregion slope wetland (Carroll County) that has been invaded by a carpet of Japanese stilt grass (*Microstegium vimineum*). This wetland scores a “2” for this metric.

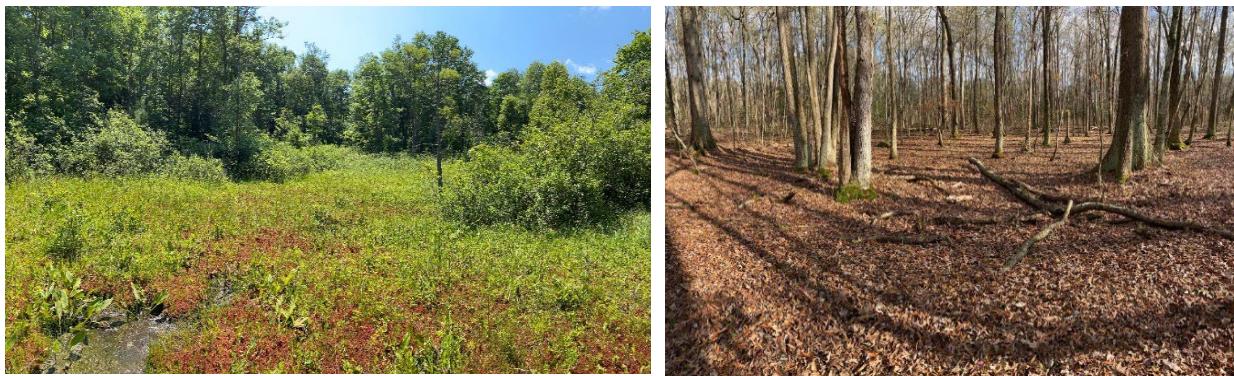
Figure B52 Interspersion Metric. Varying patches of plants or zones in wetlands which are often associated with minor elevation changes or gradients greater than six inches above the base or adjacent wetland elevations. The wetlands in both photos have a high degree of horizontal interspersion with vegetation patches intertwined and scattered throughout the WAA and would each score a “4” for interspersion.

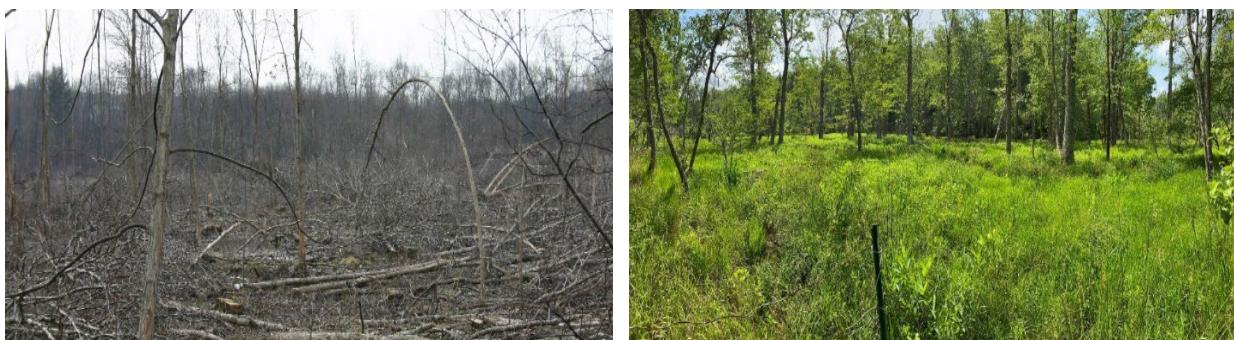
Figure B53 Interspersion Metric. The wetland on the left has moderate interspersion and would score a “3” while the wetland on the right has no horizontal interspersion and scores a “1”.

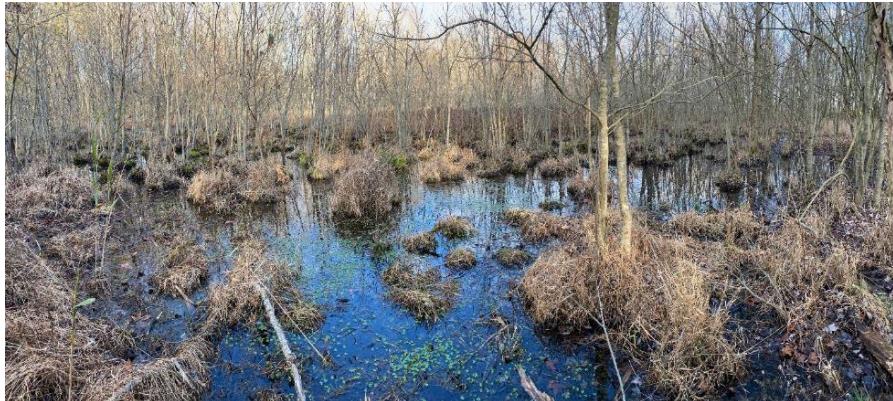
Figure B54 Vegetation Alterations. Examples of recent vegetative alterations such as logging (left) where one or more of the plant strata have been removed or impacted and would score low/moderate for this metric. The abandoned pastureland on the right suggests some level of recovery and would score moderate.
