APPENDIX B: EXAMPLE METRIC PHOTOS

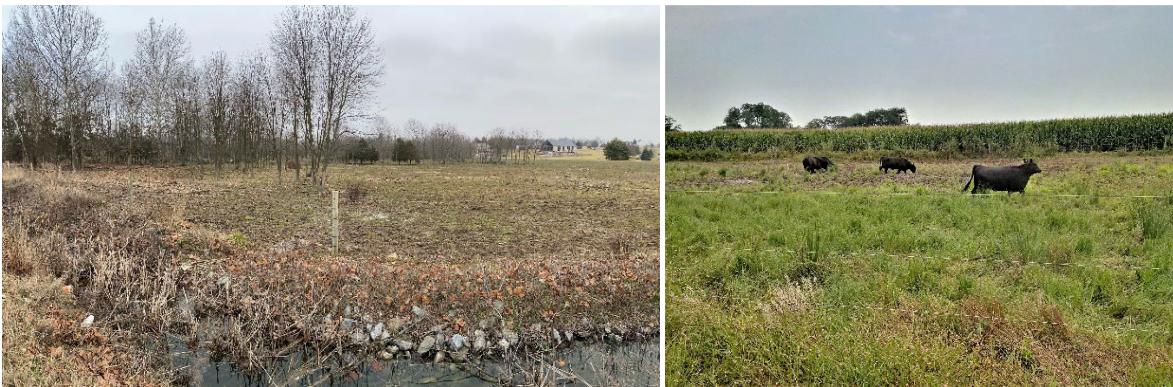
Figure B55 Vegetation Alterations. Example of a Delmarva Bay (depression) wetland that was historically drained but is now exhibiting moderate level of recovery. While it is anticipated that this area will recover completely, its current condition is moderate and would score a "2" for this metric.

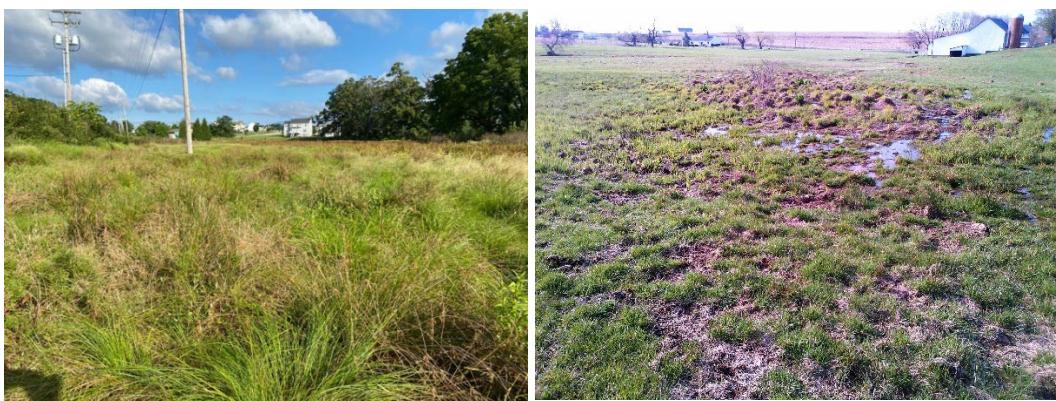
Figure B56 Vegetation Alterations. The wetland pasture on the left has both managed and unmanaged areas and potentially require two separate WAAs. However, both areas would score low for this metric due to the ongoing high intensity impacts. The wetland pasture on the right is also of high intensity and would score low due to the low potential for recovery.

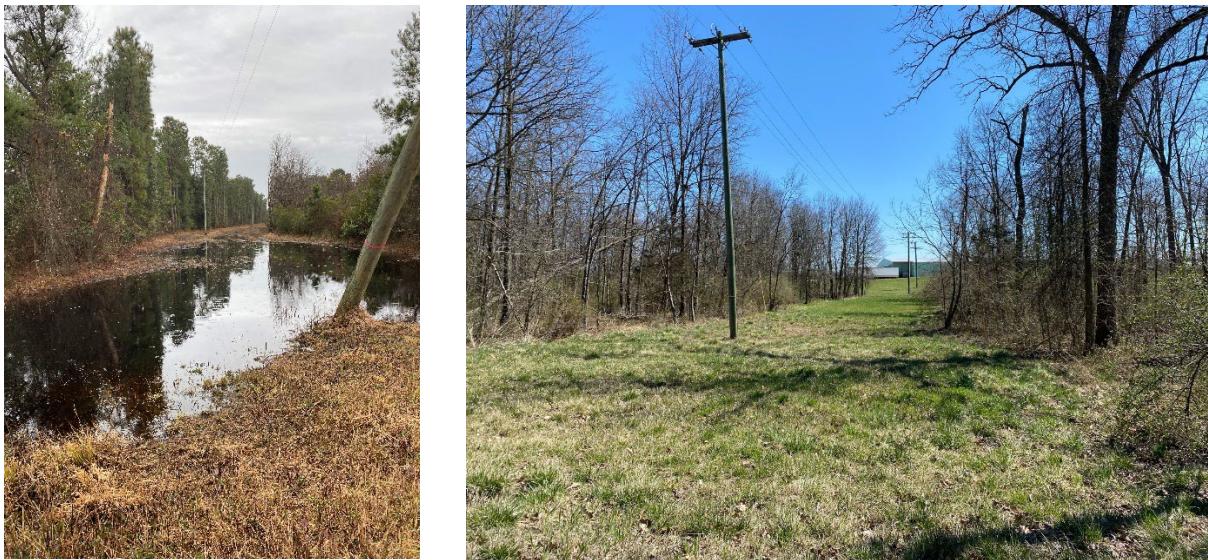
Figure B57 Vegetation Alterations. Both back slope wetlands above are subject to infrequent mowing, often by opportunity which is typically in the dry season. The wet meadow on the left has a diverse herbaceous community indicating less frequent mowing which would result in a low to moderate score. However, the photo on the right is an example of wet hay land which is typically mowed (harvested) 1-2 times annually also resulting in much lower diversity of the plant community. This area would score low for this metric due to the higher intensity and lack of recovery. Utility lines, stormwater management basins, and hay land are additional examples of wetlands that would score low for this metric.

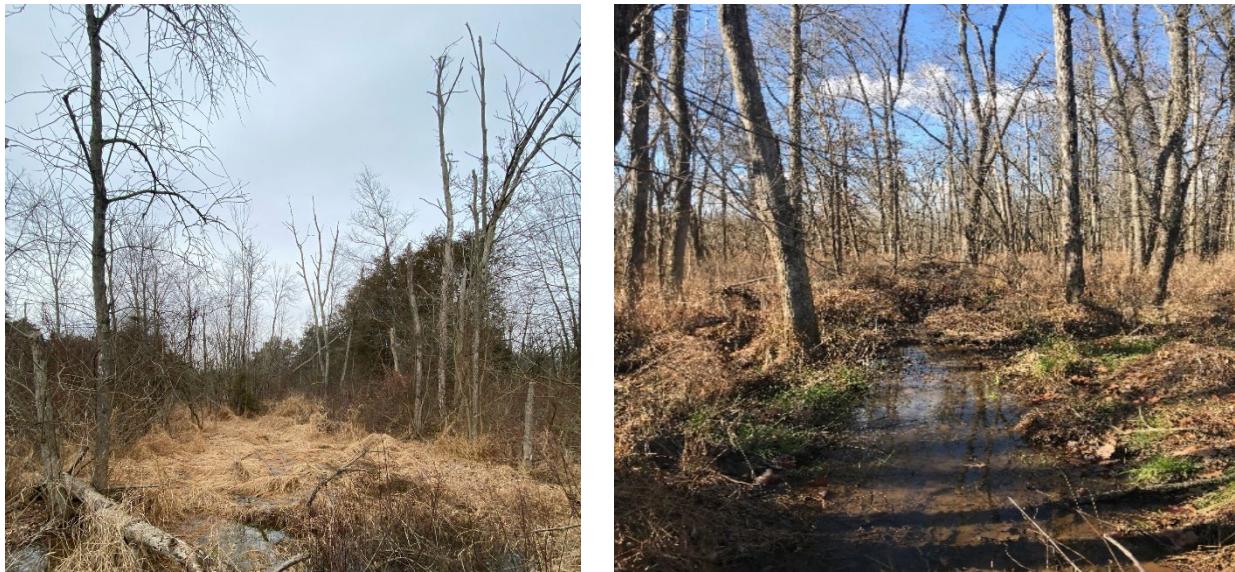
Figure B58 Vegetation Alterations. Utility line crossings are typically a permanent vegetative alteration. Regular maintenance prevents vegetative succession in most cases. The photo on the left is from the CP ecoregion and the photo on the right is in the EMP ecoregion. Regular maintenance of these utilities often involves mowing as well as the use of herbicides preventing forest succession resulting in low scores for this metric. Furthermore, the maintenance of these utility lines also reduces the scores for many of the biotic structure metrics such as species richness, plant strata, plant life forms and invasive species, which often invade the disturbance.
