**ANACOSTIA WATERSHED RESTORATION
MONTGOMERY COUNTY, MARYLAND
CONTINUING AUTHORITIES PROGRAM SECTION 206
AQUATIC ECOSYSTEM RESTORATION FEASIBILITY STUDY**

**DRAFT INTEGRATED FEASIBILITY REPORT AND
ENVIRONMENTAL ASSESSMENT**

APPENDIX B: PLAN FORMULATION

**APPENDIX B1: 2015 ANACOSTIA WATERSHED
RESTORATION: MONTGOMERY COUNTY AQUATIC
ECOSYSTEM RESTORATION FEASIBILITY STUDY REPORT
SYNOPSIS**

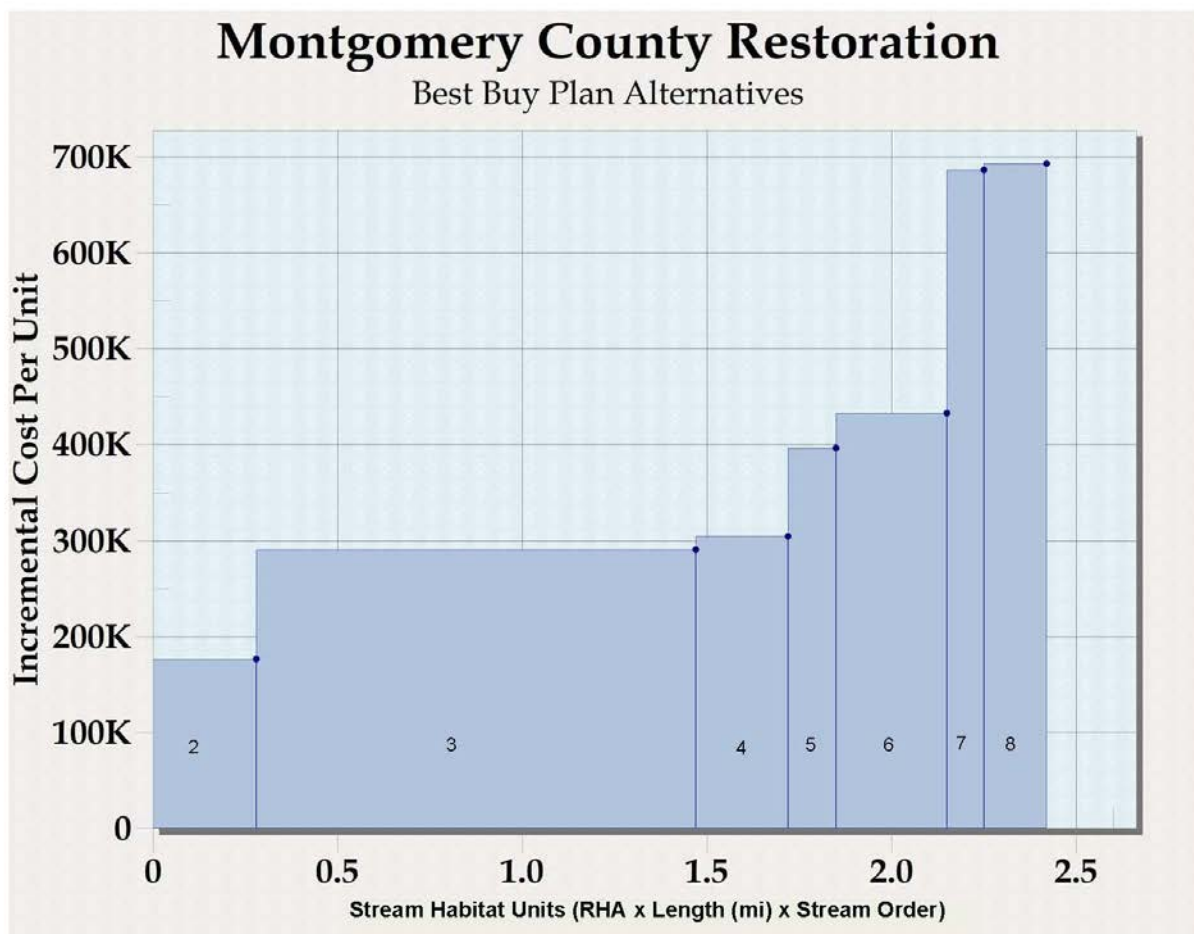
Figure 6. CE/ICA Results

A total of 6,561 possible plan combinations were evaluated in CE/ICA analysis. Of these 29 plans (including the No-Action Alternative) were identified as being cost effective and 8 were identified as best buys.

Based on the CE/ICA best buy plans for in-stream habitat benefits and the criteria for the evaluation of other benefits presented in Table 9, the PDT recommends the selection of Plan 4 as the TSP. This plan includes stream restoration of three of the study segments investigated in Montgomery County, with associated wetted area restoration and fish blockage removal. Analysis of these plans for the TSP selection is discussed in the following subsections. The conceptual design for each stream are presented in the Appendix. The final array of alternative plans is described below and identified in Figure 6 and Table 8.

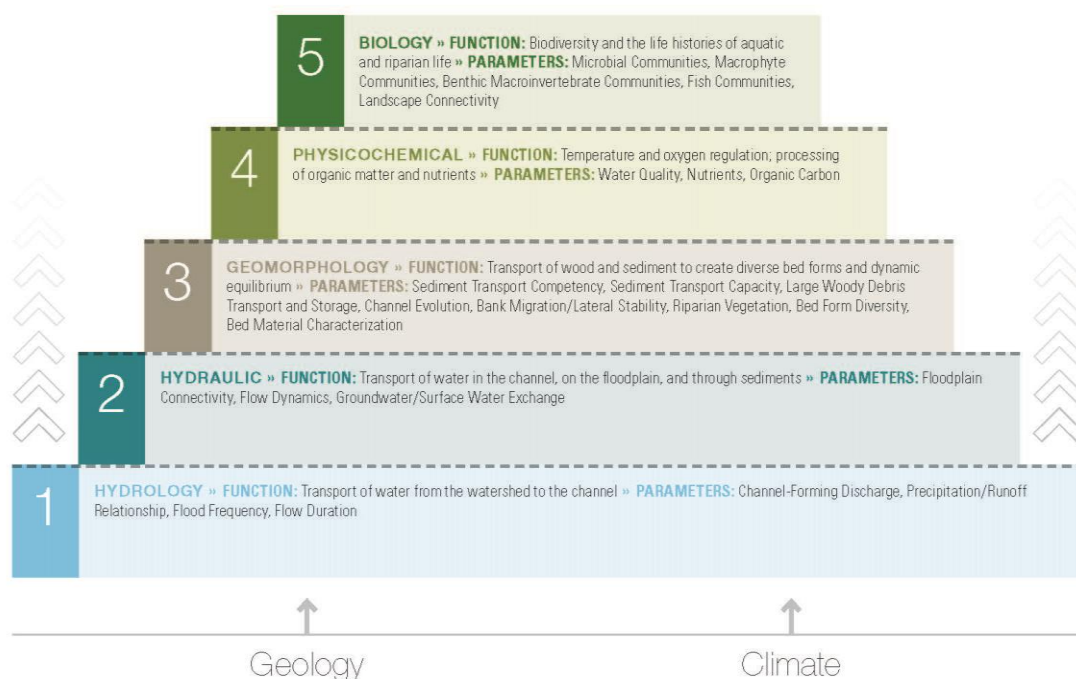
In a watershed context, the recommended plan helps to achieve levels 1 through 3 of the stream functions pyramid (Figure 7), leading to a functioning biological community (Harman et al. 2012). Together, restoration at all proposed stream reaches helps to ensure that a complete solution, with other stakeholder actions, can be achieved for restoration of the Anacostia River Watershed.

Figure 7. Stream Functions Pyramid (Harman et al. 2012)

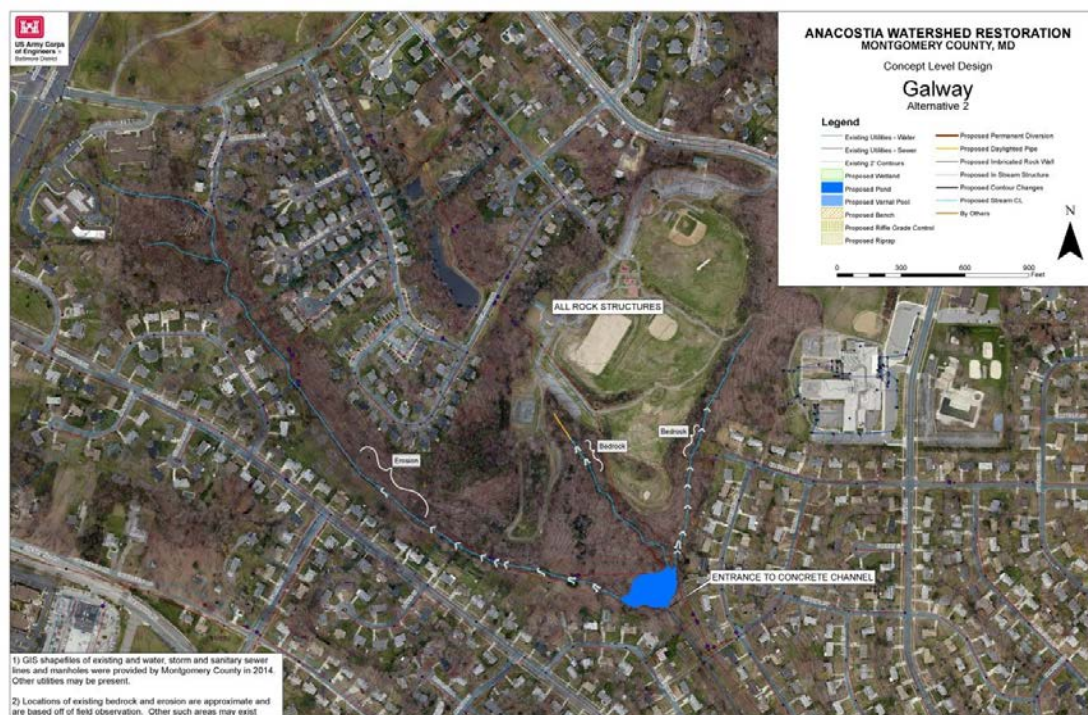
Figure 6. Galway Tributary Conceptual Design.

Approximately 19 structures (cross-vanes and J-hooks) are proposed for restoring the left and right fork of Galway tributary (Figure 6). The concept design includes realigning the stream just upstream of a concrete channel. The in-stream structures would increase connection to the surrounding forested floodplain. The stream is entrenched and disconnected from the floodplain. The stream bed would be raised utilizing the in-stream structures to reconnect to the floodplain. Outfall protection at the end of stream, leading into the concrete channel, would be constructed to eliminate/reduce storm runoff erosion. Initial designs include wetland cells near the downstream terminus. However, tree species there include mature upland species.

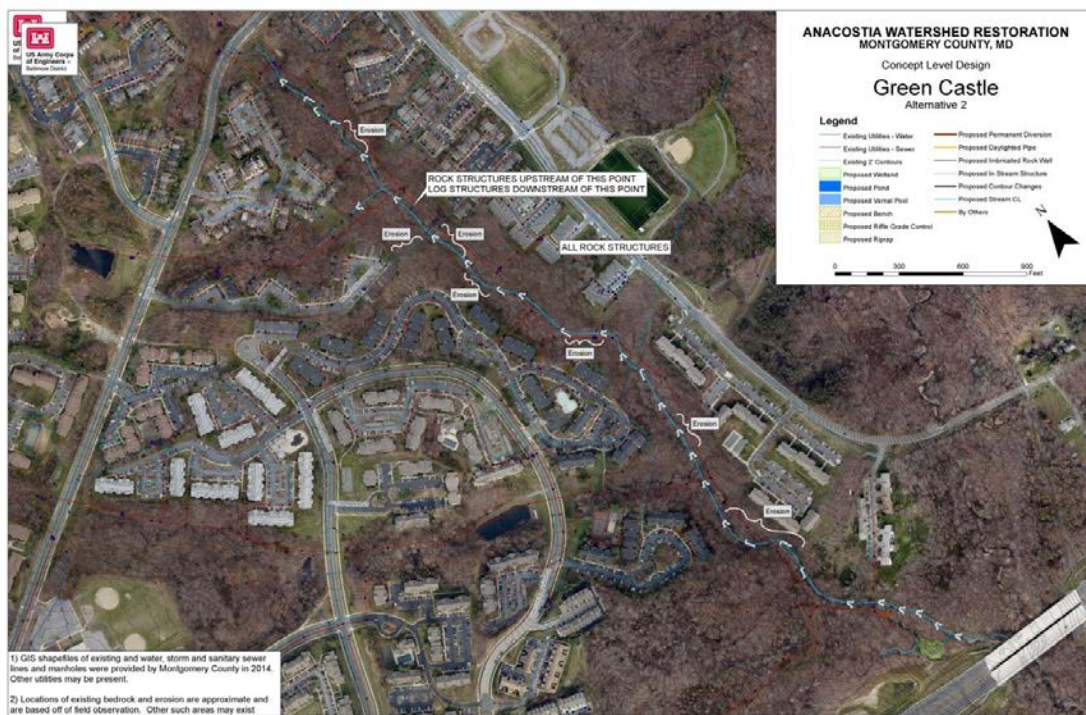
Figure 7. Green Castle Tributary Conceptual Design.

Approximately 29 structures are proposed to maintain stability in Green Castle tributary. Green Castle experiences frequent strong currents from storm outfalls (Figure 7). The stream is very entrenched to the extent that a few utilities are exposed. Due to the lack of a wide floodplain, a Rosgen Bc designed channel cross section would be most suitable for this reach. In-stream structures would provide grade control to eliminate bed scour, helping to protect exposed utilities. Access to this site would be challenging and some trees would be cut, which is why log-structures are used for many features.

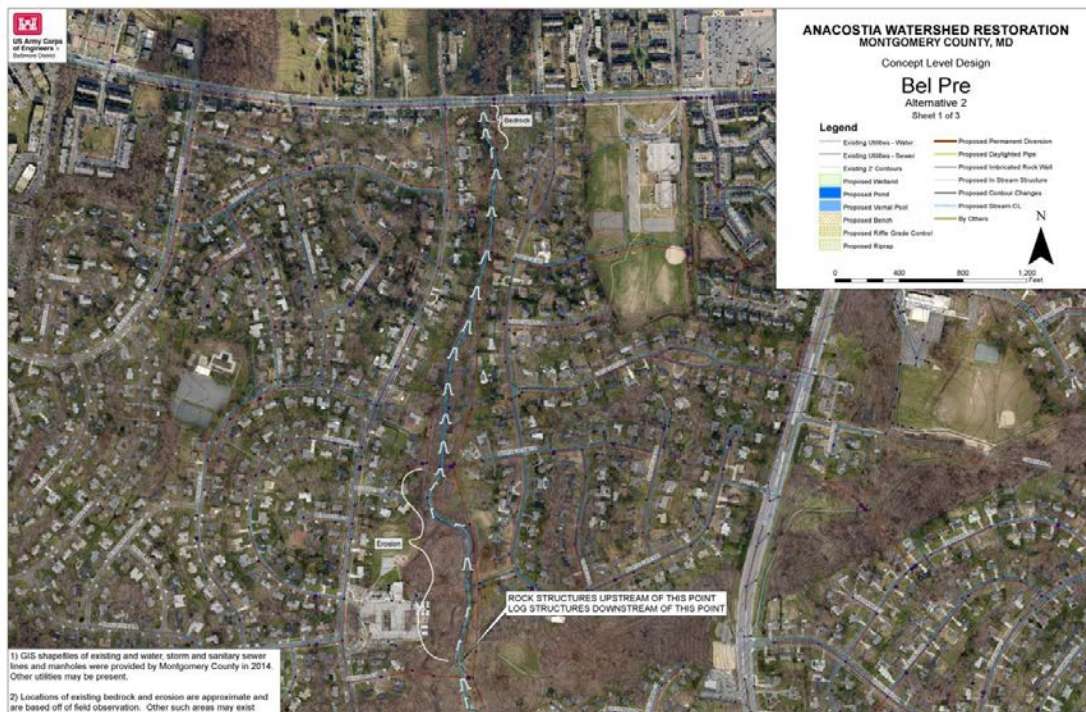
Figure 8. Bel Pre Tributary Conceptual Design, sheet 1.

Bel Pre tributary is roughly 3.1 miles long and requires different restoration methodologies for different segments (Figures 8-10). A total of 79 structures (cross-vanes, J-logs, J-hooks) have been proposed to maintain long term stability for the stream system. Some channel re-alignment is proposed to better convey the flow and reduce erosion to stream banks adjacent to private residential property. This realignment also would increase floodplain connectivity, which would capture the suspended sediment. Raising the stream water level could potentially raise floodplain groundwater levels as part of efforts to restore forested wetlands of floodplain degraded by excess drainage from stream incision. In the lower reach of this system there is a potential for wetland cells and vernal pools. In the vicinity of Layhill Road (Maryland Route 182), the stream has an unfavorable angle of approach to the roadway that is causing sediment loading and erosion downstream of the stream crossing. Riffle grade control would likely eliminate this problem and reduce scouring of sewer lines crossing the stream. Log structures are recommended in the center of the reach. Based on initial observations, it is likely

that log structures would not be feasible elsewhere along the reach due to the geomorphic and hydraulic conditions.

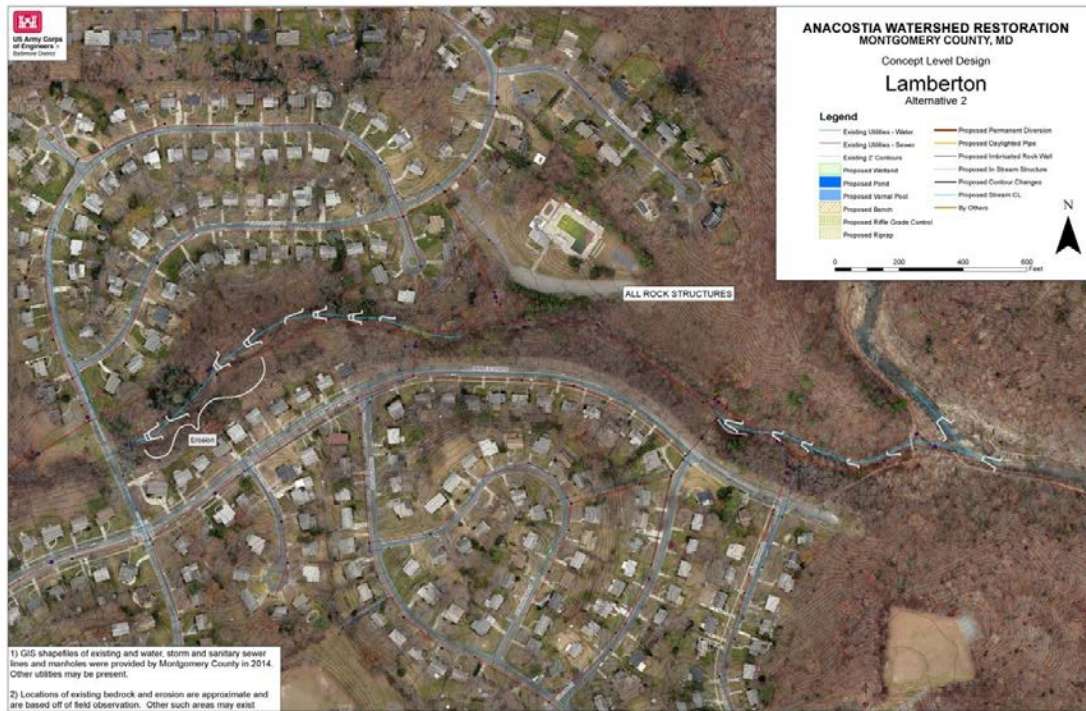
Figure 11. Lamberton Tributary Conceptual Design.

To correct the lateral movement and erosion problems in Lamberton tributary, about 19 structures are proposed for placement in the channel (Figure 11). The alignment would not change much, and a Rosgen B channel could be created. Downstream of Lovejoy Street, the proposed design would provide fish passage through an existing culvert. This is a very high energy system and rock structures with geotextile on the upper portion of this project are essential. An imbricated retaining wall was incorporated in the downstream portion where a riffle grade control at the lower portion is proposed.

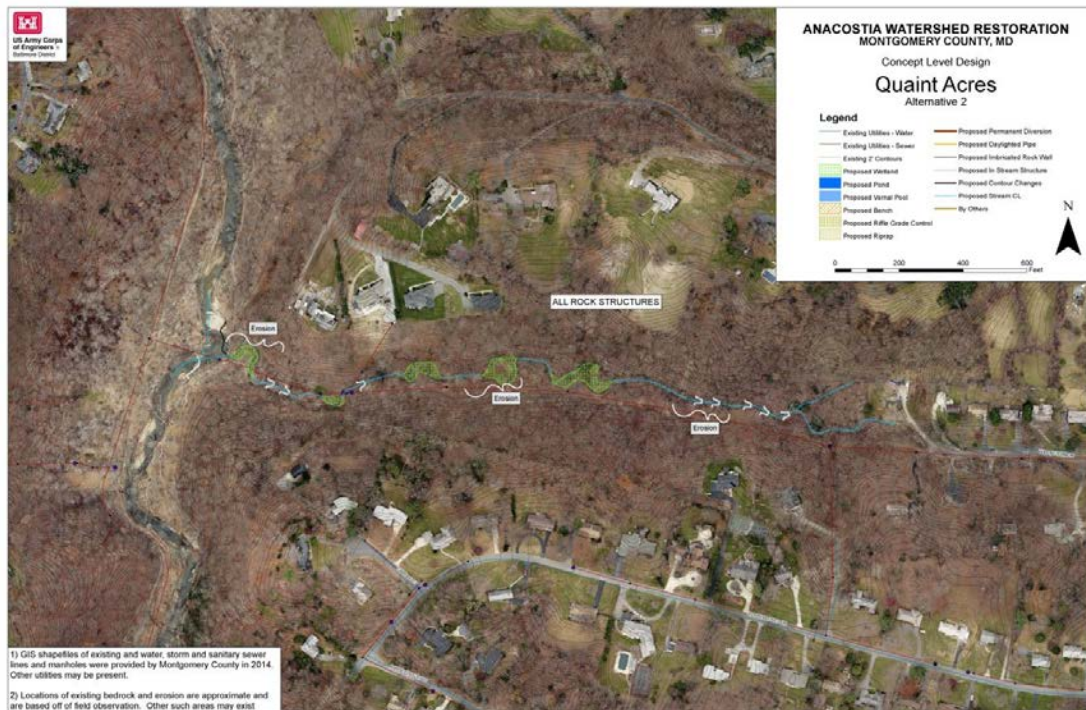
Figure 12. Quaint Acres Tributary Conceptual Design.

The restoration plan for Quaint Acres tributary (Figure 12) was based on the setting of the stream valley which has the lowest impervious cover of all the sites considered. Approximately 28 structures are proposed to restore the stream and eliminate two fish blockages. Most of the structures would be log-structures to blend in with the stream valley. The geomorphic and soil conditions present an opportunity for shallow vernal pools and wetland cells in this area, though this would need to be coordinated with WSSC and tree impacts evaluated. Shallow marsh cells are proposed (a stable D channel with shrubs) to slow the water and provide a functional system.

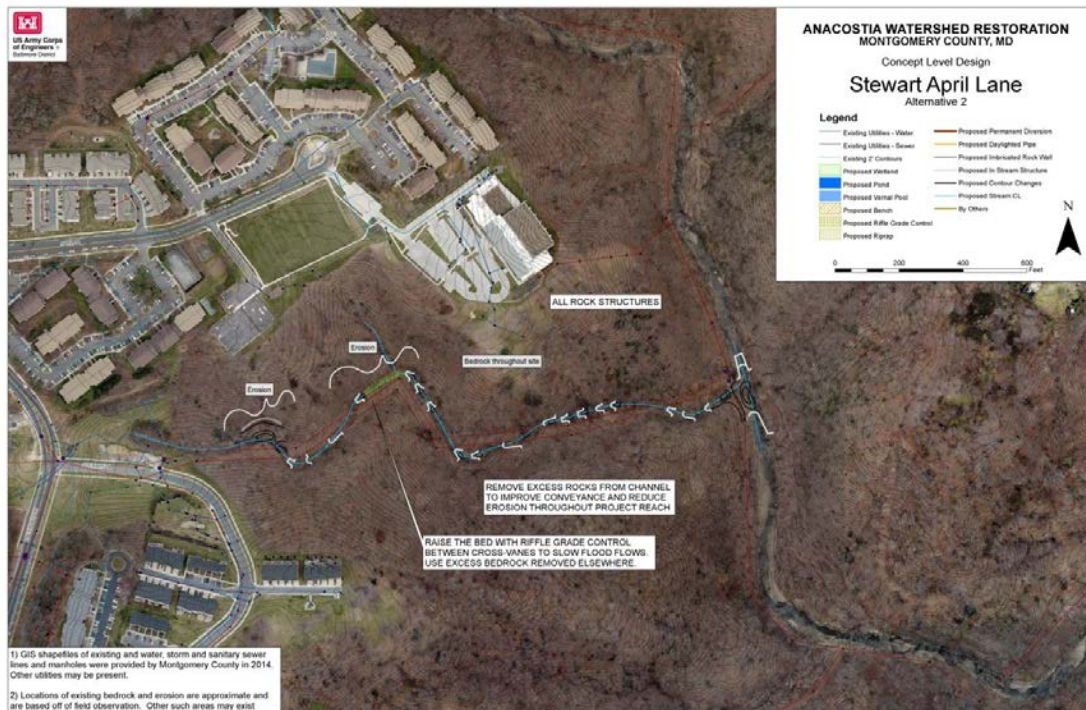
Figure 13. Stewart/April Lane Tributary Conceptual Design.

Due to the flashy nature of the Stewart/April Lane tributary and the presence of bedrock along much of the reach, 21 in-stream structures and two imbricated stone retaining walls are proposed to maintain stability (Figure 13). Removal of the excess boulders in the active channel would reduce stress, and the proposed structures would improve stability. A riffle grade control at two different locations would guide the water away from eroding embankments and provide more stability within the channel bed at sewer line crossings. A downstream fish blockage has been tentatively identified and it would be remediated through the placement of in-stream structures.

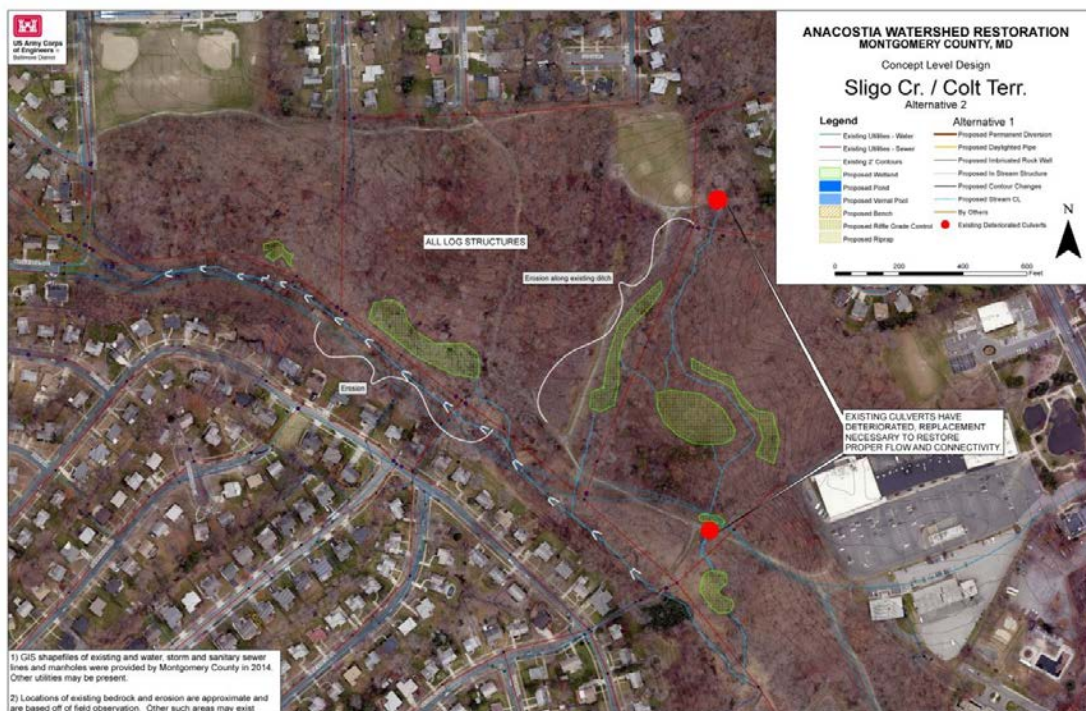
Figure 14. Sligo Creek/Colt Terrace Tributary Conceptual Design.

The main stem of Sligo Creek requires approximately 15 in-stream structures to elevate the streambed and reconnect it with its floodplain. These structures would provide stability and improve potential floodplain and physical aquatic habitat. There are some open areas where the proposed design would enhance their hydrologic connectivity, creating suitable wetland habitats. Most of the mature trees present in the reach are of species that tolerate temporary submergence or inundation.

The system from Colt Terrace requires two culvert replacements due to size and poor condition. No in-stream structures are proposed for this area. A shallow and wide system with planting is suitable because of the wide floodplain and presence of wetland soils. Additionally, relocation of the stream about 200 feet downstream of the first culvert would likely result in a more sustainable design. This area has large trees with ample room to create a system meandering between the trees without damaging the root system.

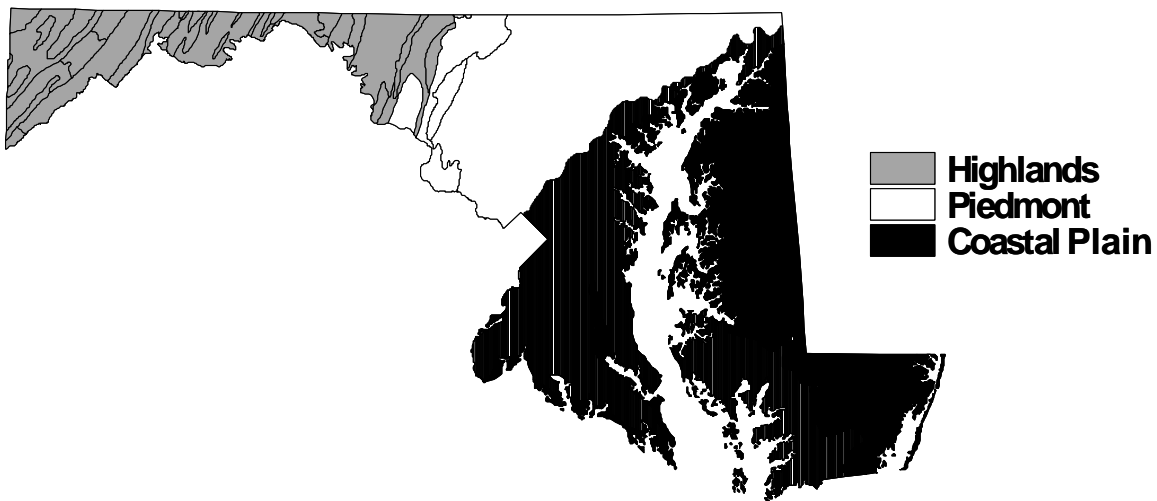
Figure 1 – Map of Maryland indicating ecoregions of the state. The Highland stream class was formed by joining the Blue Ridge, Valley and Ridge, and Appalachian Plateau ecoregions.

We investigated a number of different stream classifications for the state. We originally split study sites into Coastal Plain and Non-Coastal Plain sites, consistent with the original PHI approach. Non-Coastal Plain sites consisted of the Piedmont, Blue Ridge, Valley and Ridge, and Appalachian Plateau (Figure 1). Seeing as the Piedmont represents nearly a third of the state and has markedly different soils and land use history, we added the Piedmont region as a third class of streams and combined the remaining non-Coastal Plain sites into a Highlands class in our final classification. An additional reason for distinguishing the Piedmont class was that original reference criteria for the non-Coastal Plain sites led to a predominance of Highland streams serving as reference sites for the whole non-Coastal Plain class. Because Piedmont streams were so underrepresented, we were concerned that the two class approach would be biased against Piedmont streams.

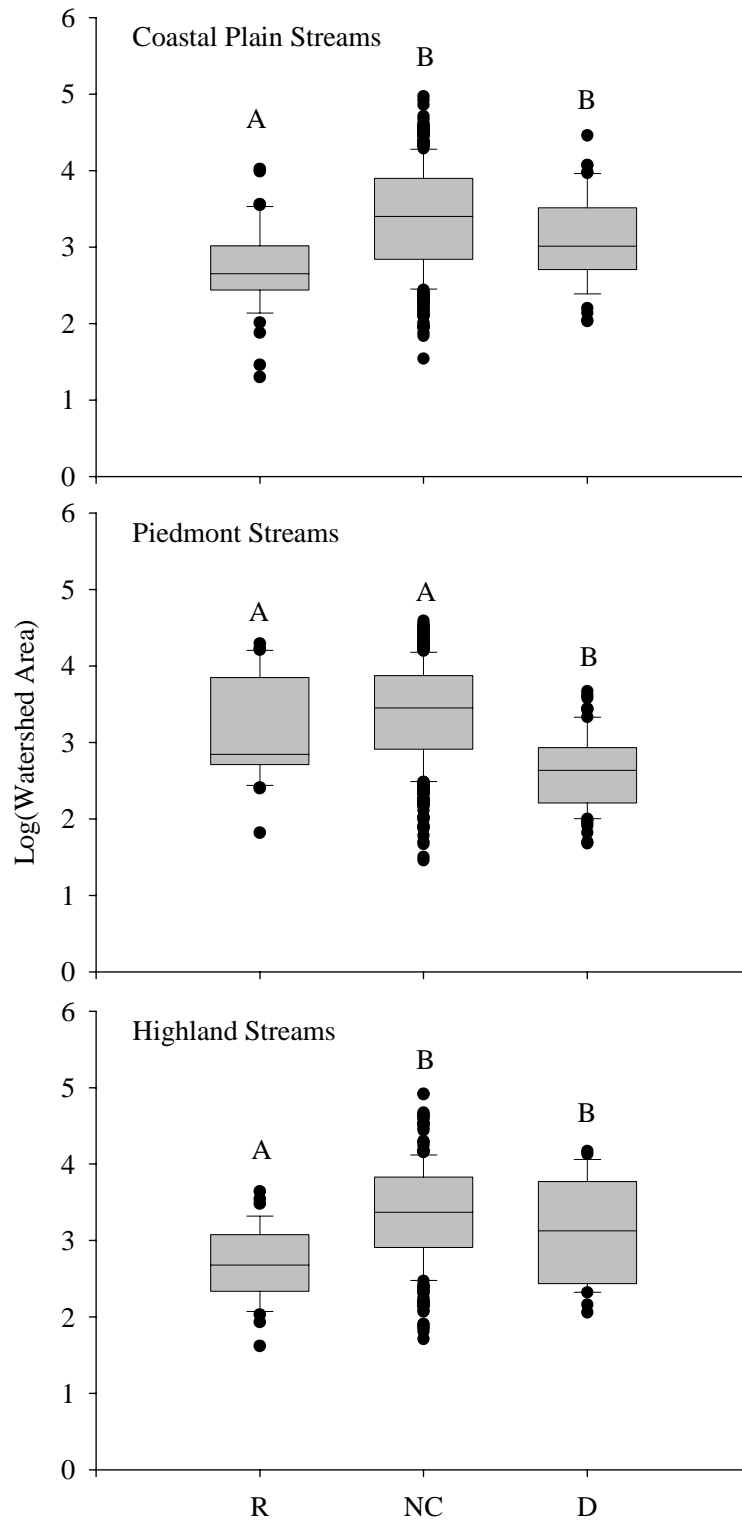
Figure 3 – Box and whisker plots of watershed area by reference category (R=reference, NC=non-categorized, D=degraded) and by stream class. Boxes indicate the median, 10th, 25th, 75th, and 90th percentiles. Within a stream class, categories with different letters above the boxes are significantly different ($p < 0.05$, one-way ANOVA, Tukey's HSD multiple comparisons test).

Reference streams did tend to be smaller than degraded streams in the Coastal Plain and Highland stream classes, but were actually larger, on average, than degraded streams in the Piedmont region (Figure 3). It is generally difficult to find large sized reference streams, because the patchy nature of land use disturbance tends to disrupt large contiguous patches of forested land. While this situation may affect this analysis, the box-and-whisker plots clearly indicate overlap in stream sizes among the reference and degraded conditions in each stream class. In addition, we corrected for area effects to isolate the effects of area on several potential metrics (see below).

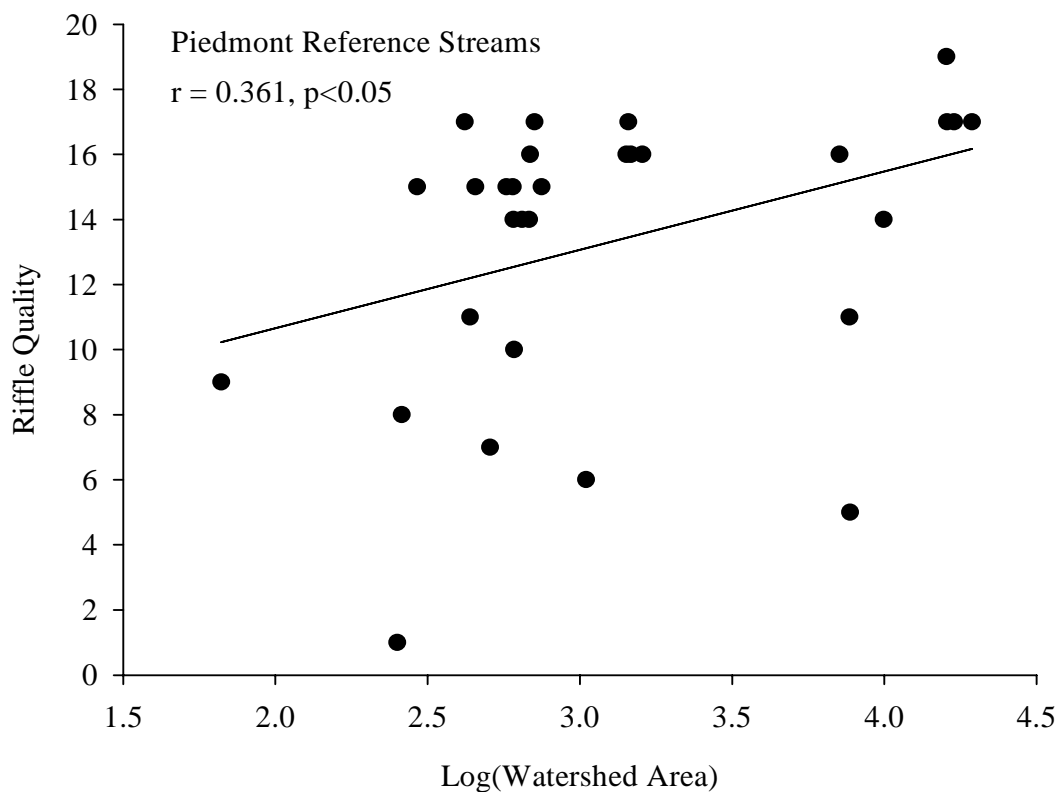
Figure 4 – Plot of watershed area against riffle quality scores in Piedmont reference streams. The pearson correlation coefficient is shown. Similar analyses were run for all metrics to check for watershed area effects.

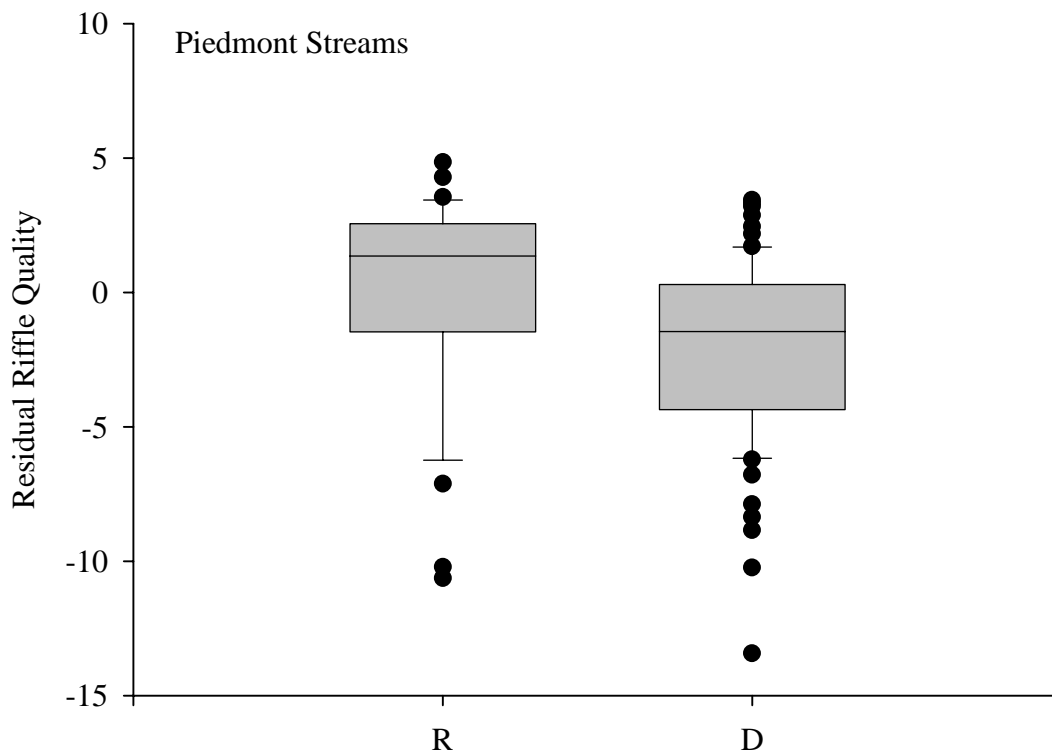
Figure 5 – Box and whisker plot of residual riffle quality in reference (R) and degraded (D) sites in Piedmont streams. Residual riffle quality was calculated by subtracting the riffle quality of a test site predicted based on the area of that watershed (estimated from the regression of area versus riffle quality in reference sites) from the observed riffle quality. Negative residuals indicate sites having worse riffle quality than that predicted for reference sites of similar watershed area. Boxes indicate the median, 10th, 25th, 75th, and 90th percentiles.

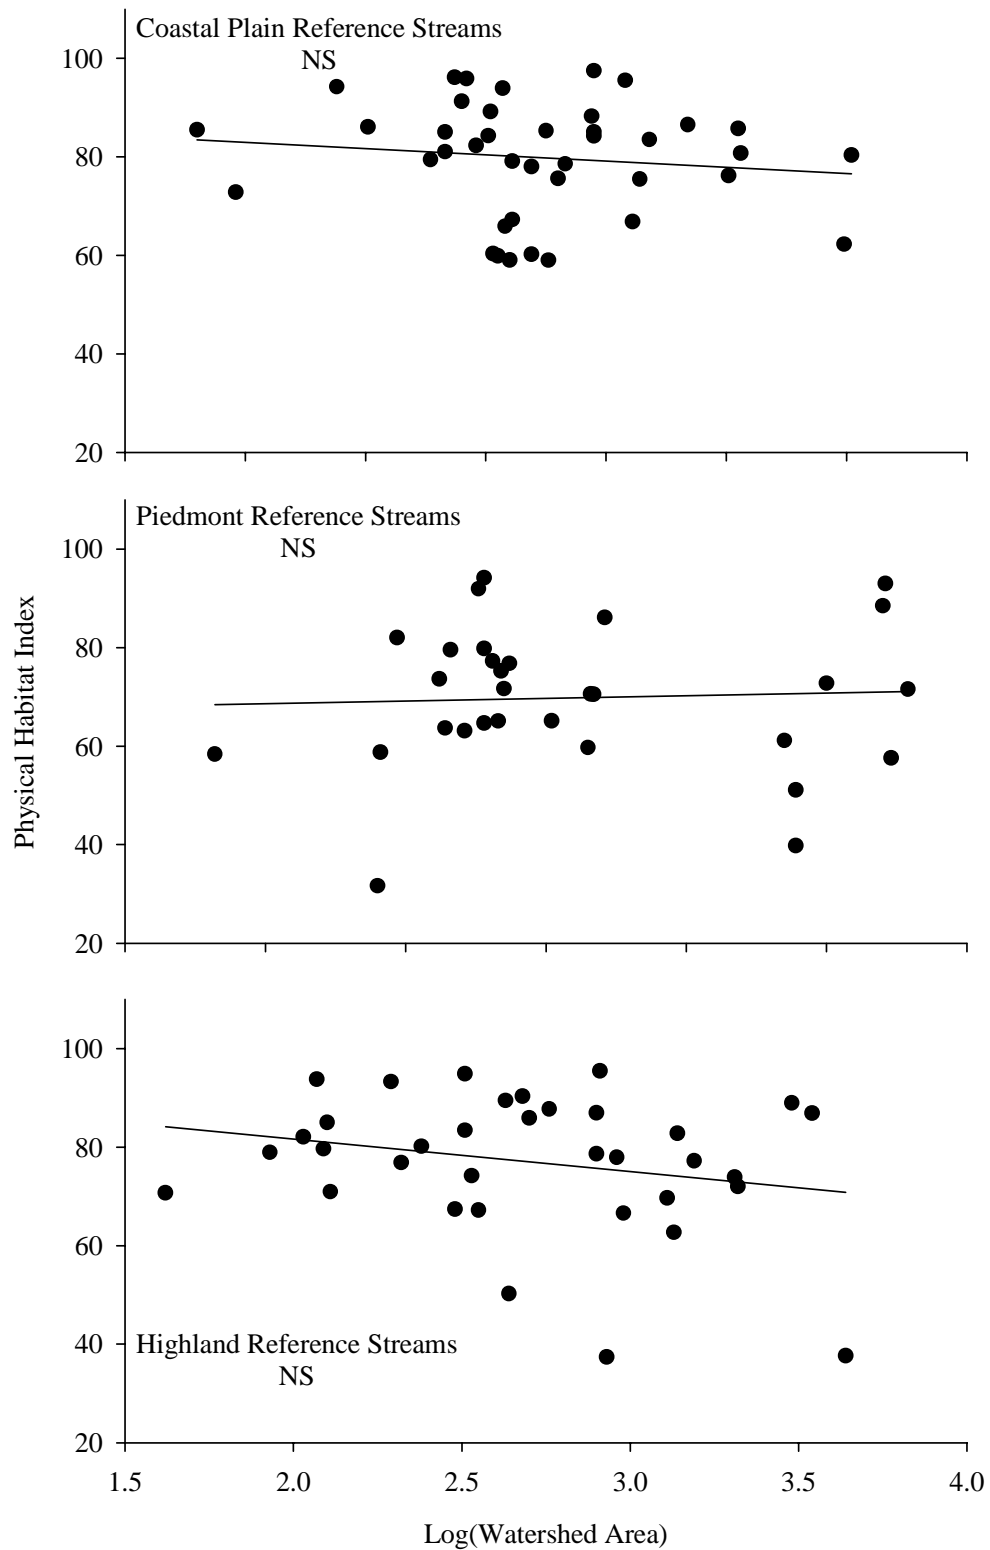
Figure 6 – Plots of watershed area versus the final PHI for reference streams in each stream class. None of the classes showed a significant correlation between area and PHI, indicating no watershed area effects. (NS = not significant).

After checking for watershed size dependence, we examined the ability of the overall multimetric indices to discriminate between reference and degraded streams in each stream class. Discrimination efficiency for the final PHI was highest for Highland streams (89%) and this was similar to the discrimination efficiency observed in the Coastal Plain region (84%). The discrimination in the Piedmont region was much lower

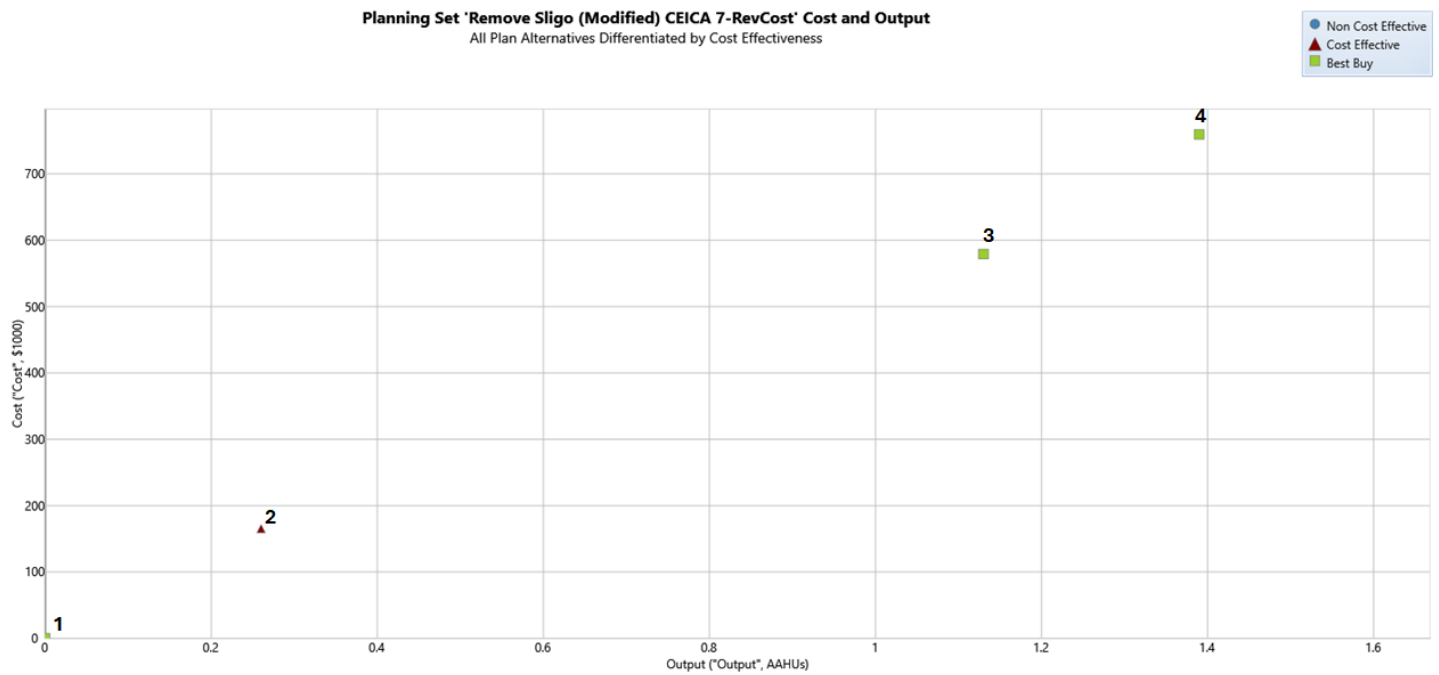
This chart provides an illustration of costs and benefits associated with alternatives generated during development of the Montgomery County CAP 206. Alternatives are charted based on their benefit (x-axis) and cost (y-axis) coordinates.

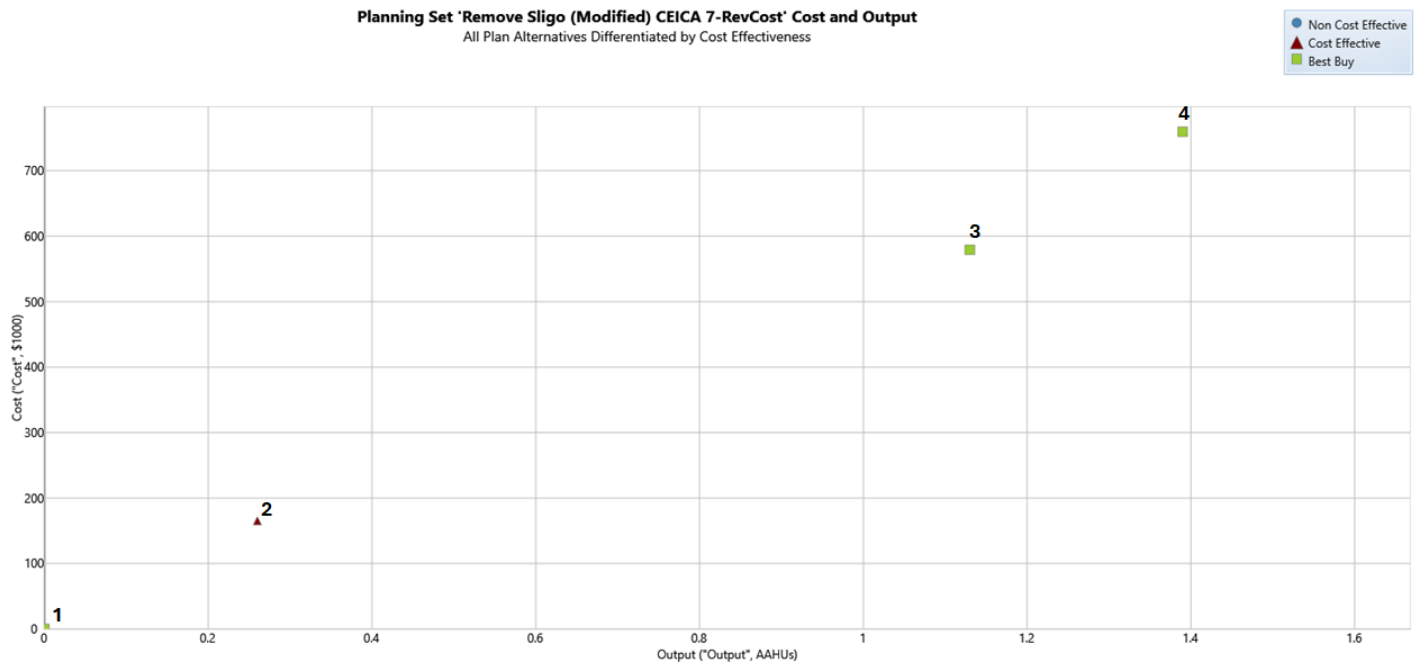
Chart of Cost-Effective Alternatives:

This chart provides an illustration of costs and benefits associated with cost-effective alternatives considered during development of the Montgomery County CAP 206. Alternatives are charted based on their benefit (x-axis) and cost (y-axis) coordinates. The depicted alternatives have been identified among the most cost-effective of the alternatives considered during development of the Montgomery County CAP 206.

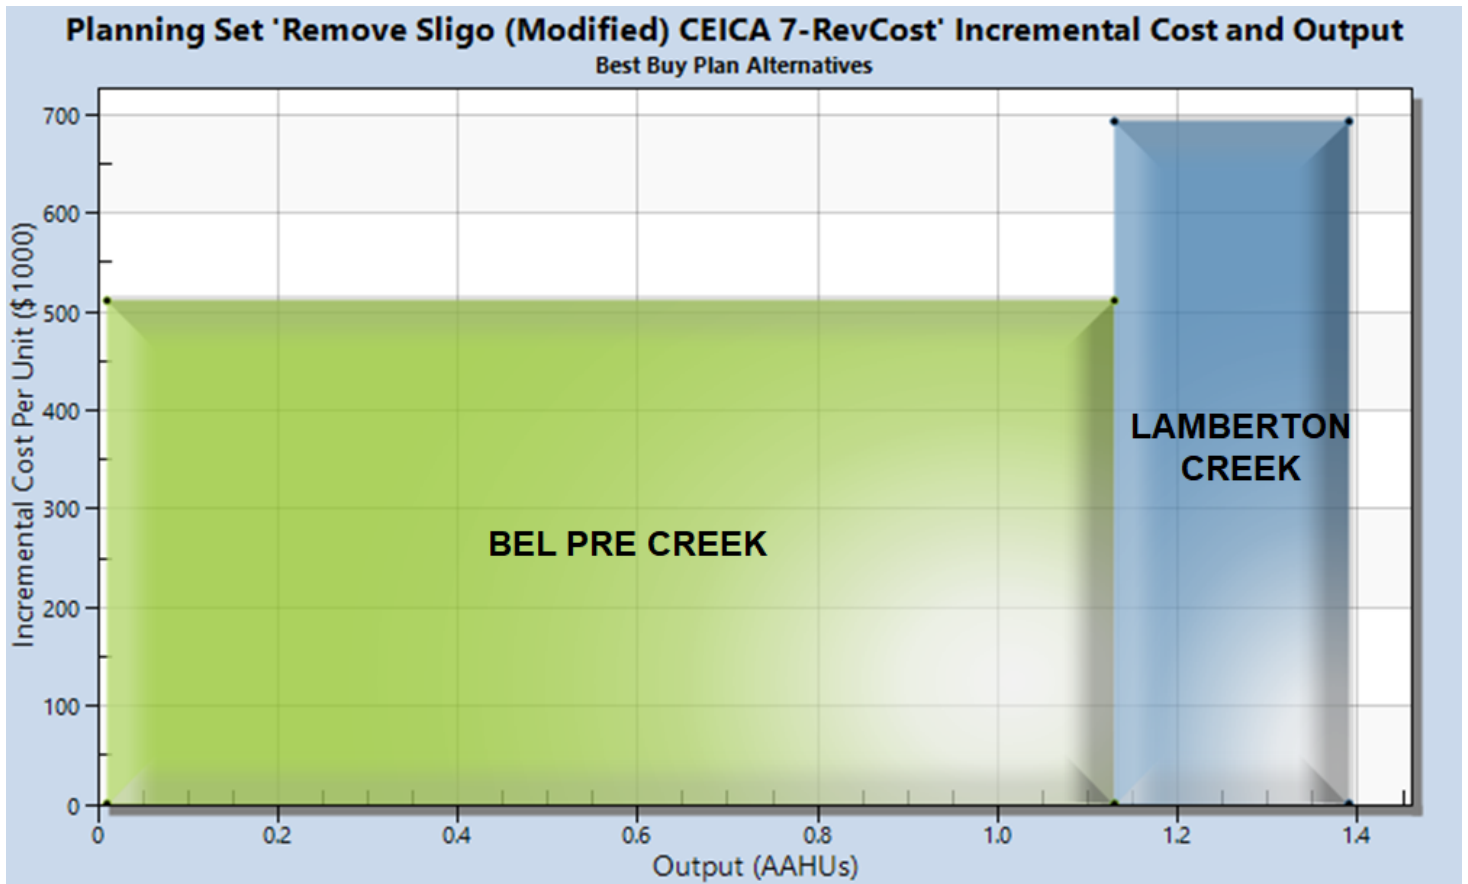
Chart of Incremental Costs and Benefits of Alternatives:

This chart provides an illustration of costs and benefits associated with alternatives considered during development of the Montgomery County CAP 206. The magnitudes of incremental benefits (width of rectangle) and incremental costs (height of rectangle) are represented to illustrate the relative magnitudes of each alternative's "added" costs associated with benefits exceeding the "next-best" cost-effective alternative.
