***APPENDIX C***  
***ARCHEOLOGICAL AND CULTURAL REPORT***

## Negative Survey Form

ER Number **2023PR02544**

Project Name &/or Agency Tracking #: Section 510 Plum Creek Stream Restoration Feasibility Study

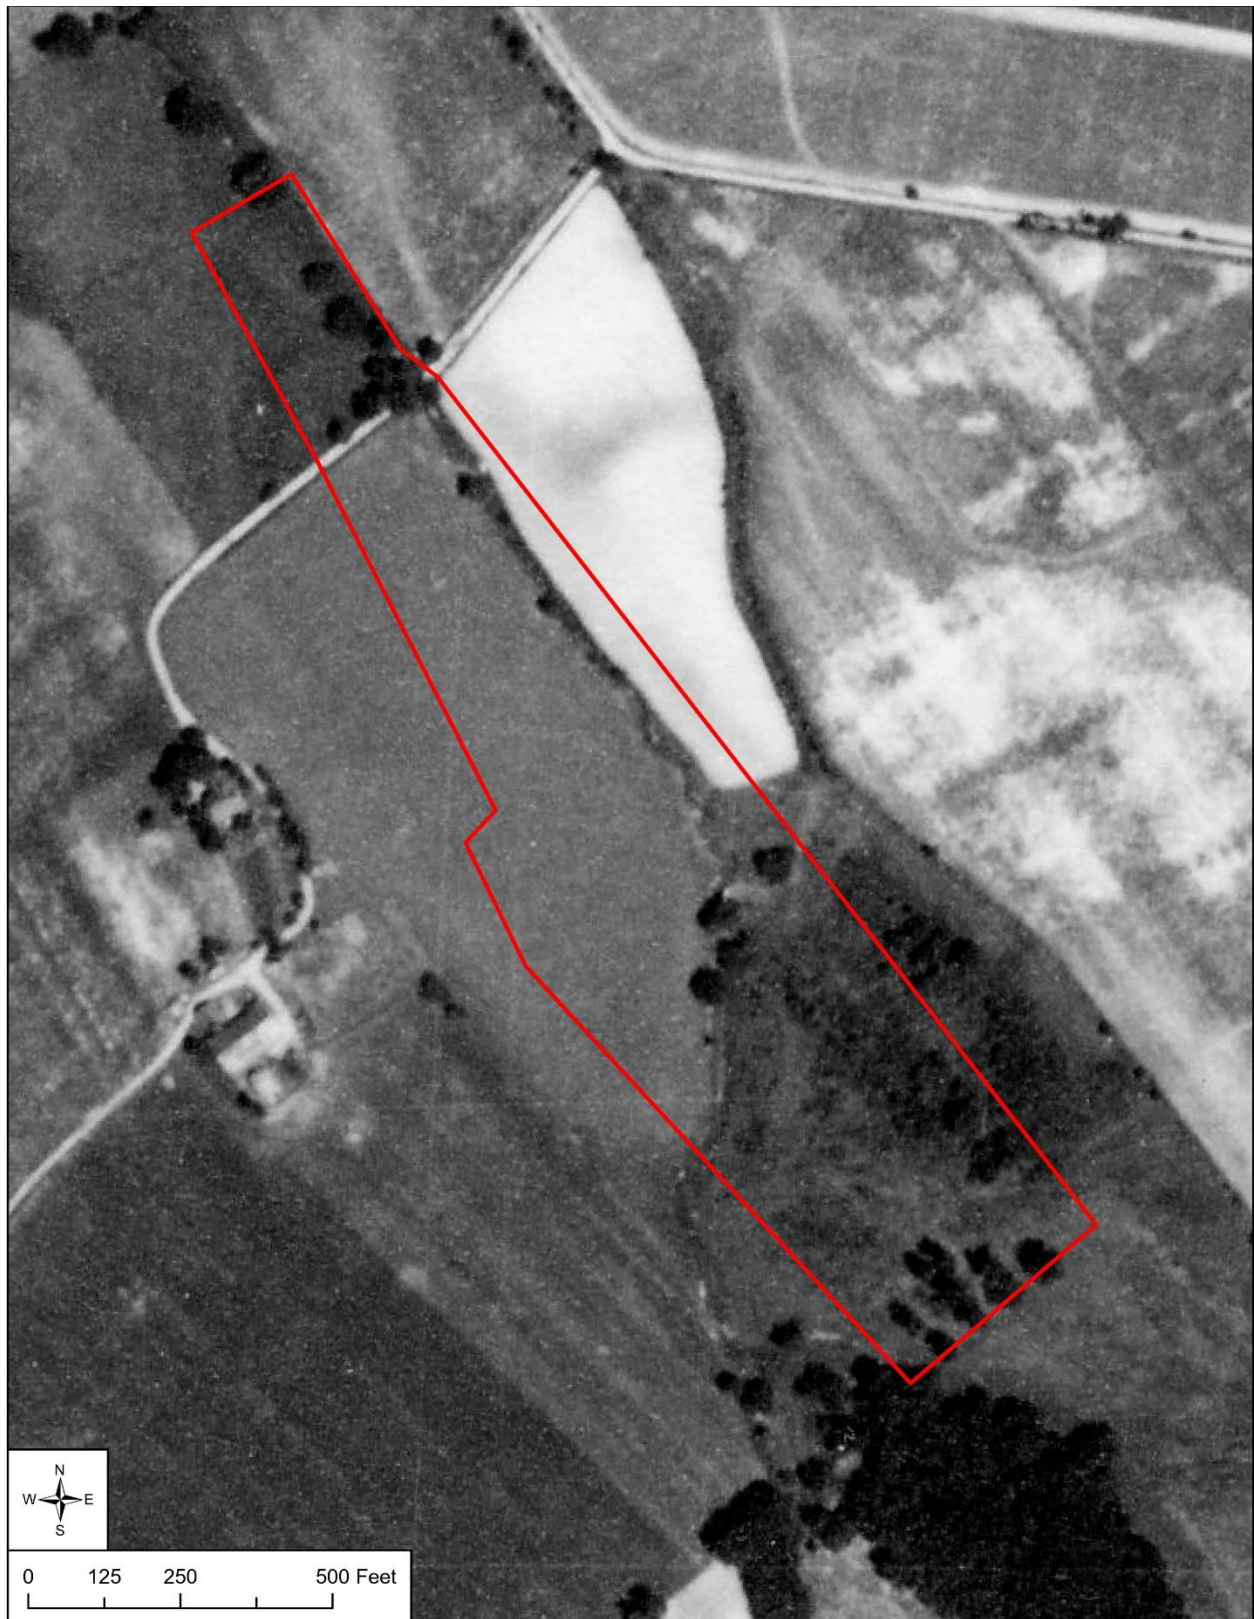
Figure 8. APE as shown in 1937 aerial imagery. Source: USDA, 1937.

The earliest aerial imagery of the APE was collected in 1937 and provides a characterization of the landscape prior to Plum Creek's channelization and creation of the Hanover Airport. North and south of Airport Road are open agricultural fields. Although Plum Creek shows an increasingly meandering pattern overall, the greatest meander begins just north of the present-day runway and flows south-southwest before turning to the east. The APE's southern extent, within the previously described meander, is wooded (USDA 1937).

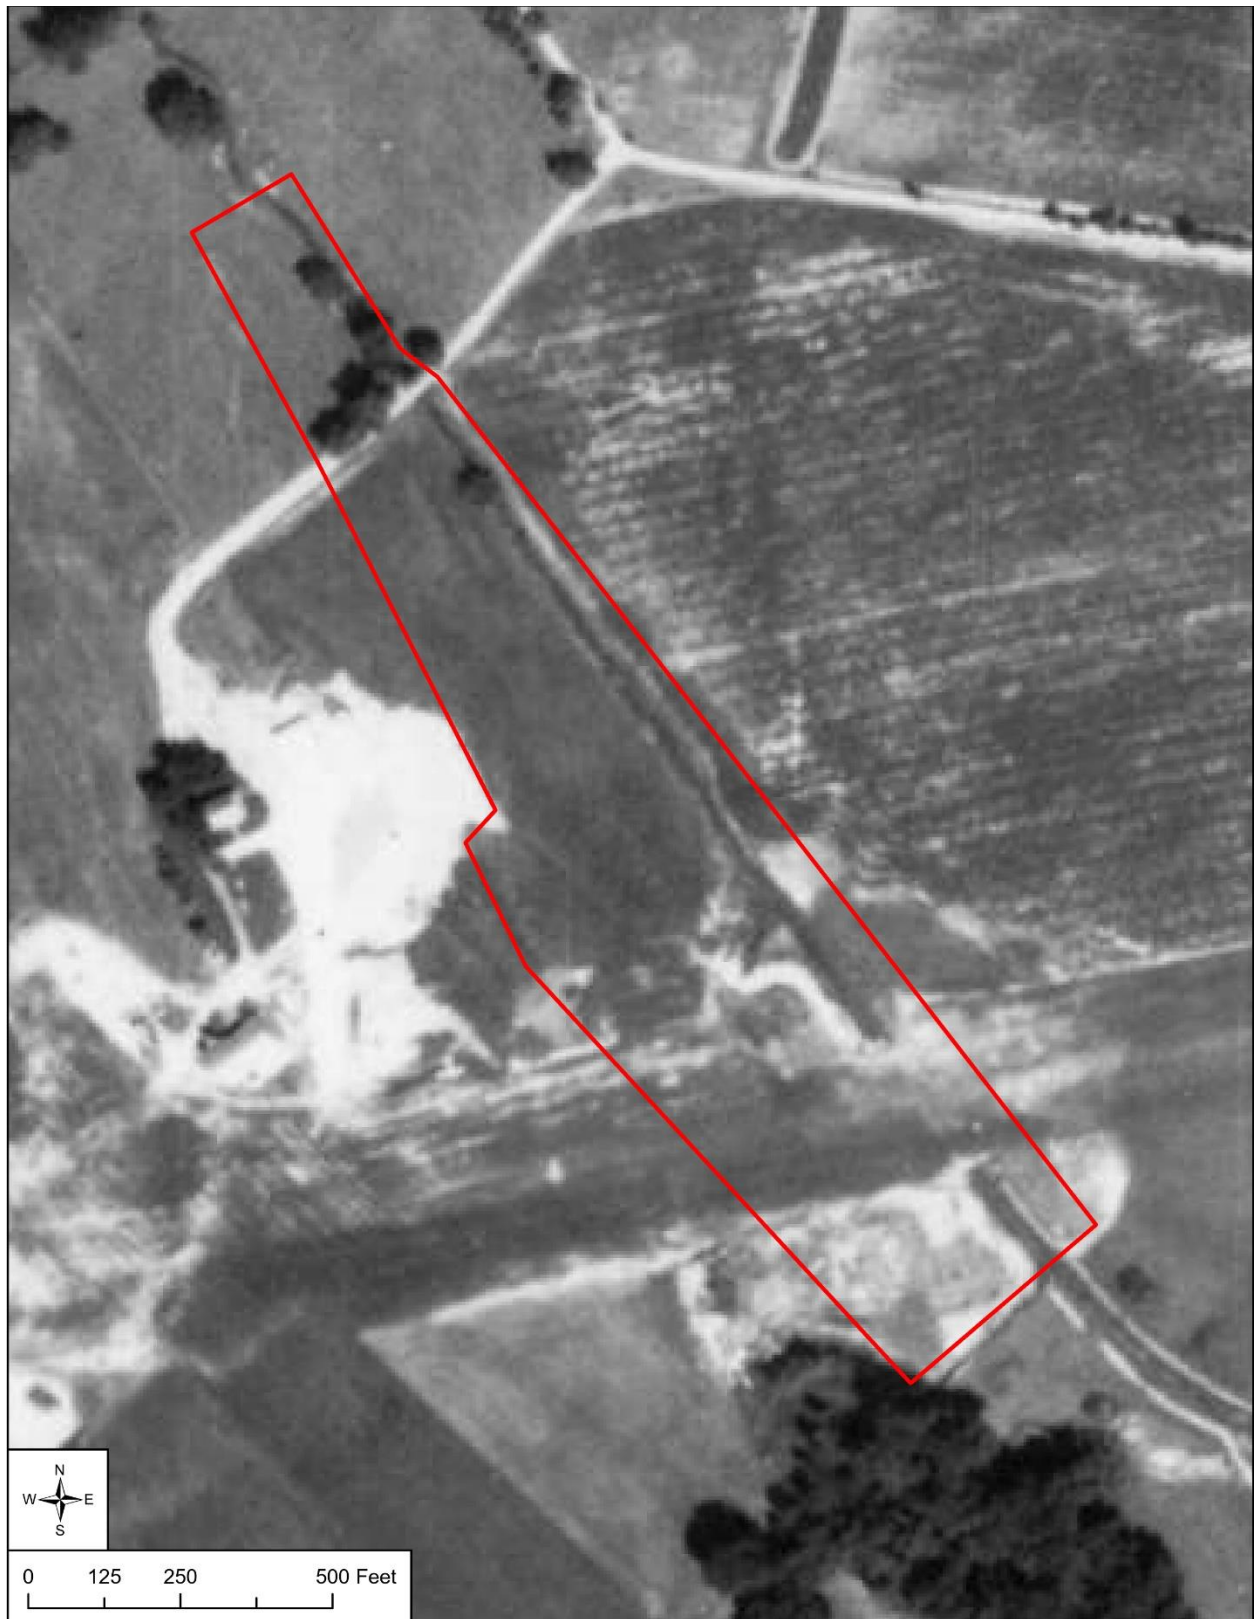
Figure 13. APE as shown in 1971 aerial imagery. Source: USDA, 1971.

Plum Creek appears to have been channelized by 1971. Aerial imagery shows a relatively straight channel moving south of Airport Road, with the previously existing meander having been filled. The imagery also shows ground disturbance east of the brick farmhouse as well as at the southern extent of the APE where tree clearing and grading appear to have occurred. A runway for the Hanover Airport bisects the APE in an east-to-west orientation by this time. The APE north of Airport Road appears relatively unchanged (USDA 1971).

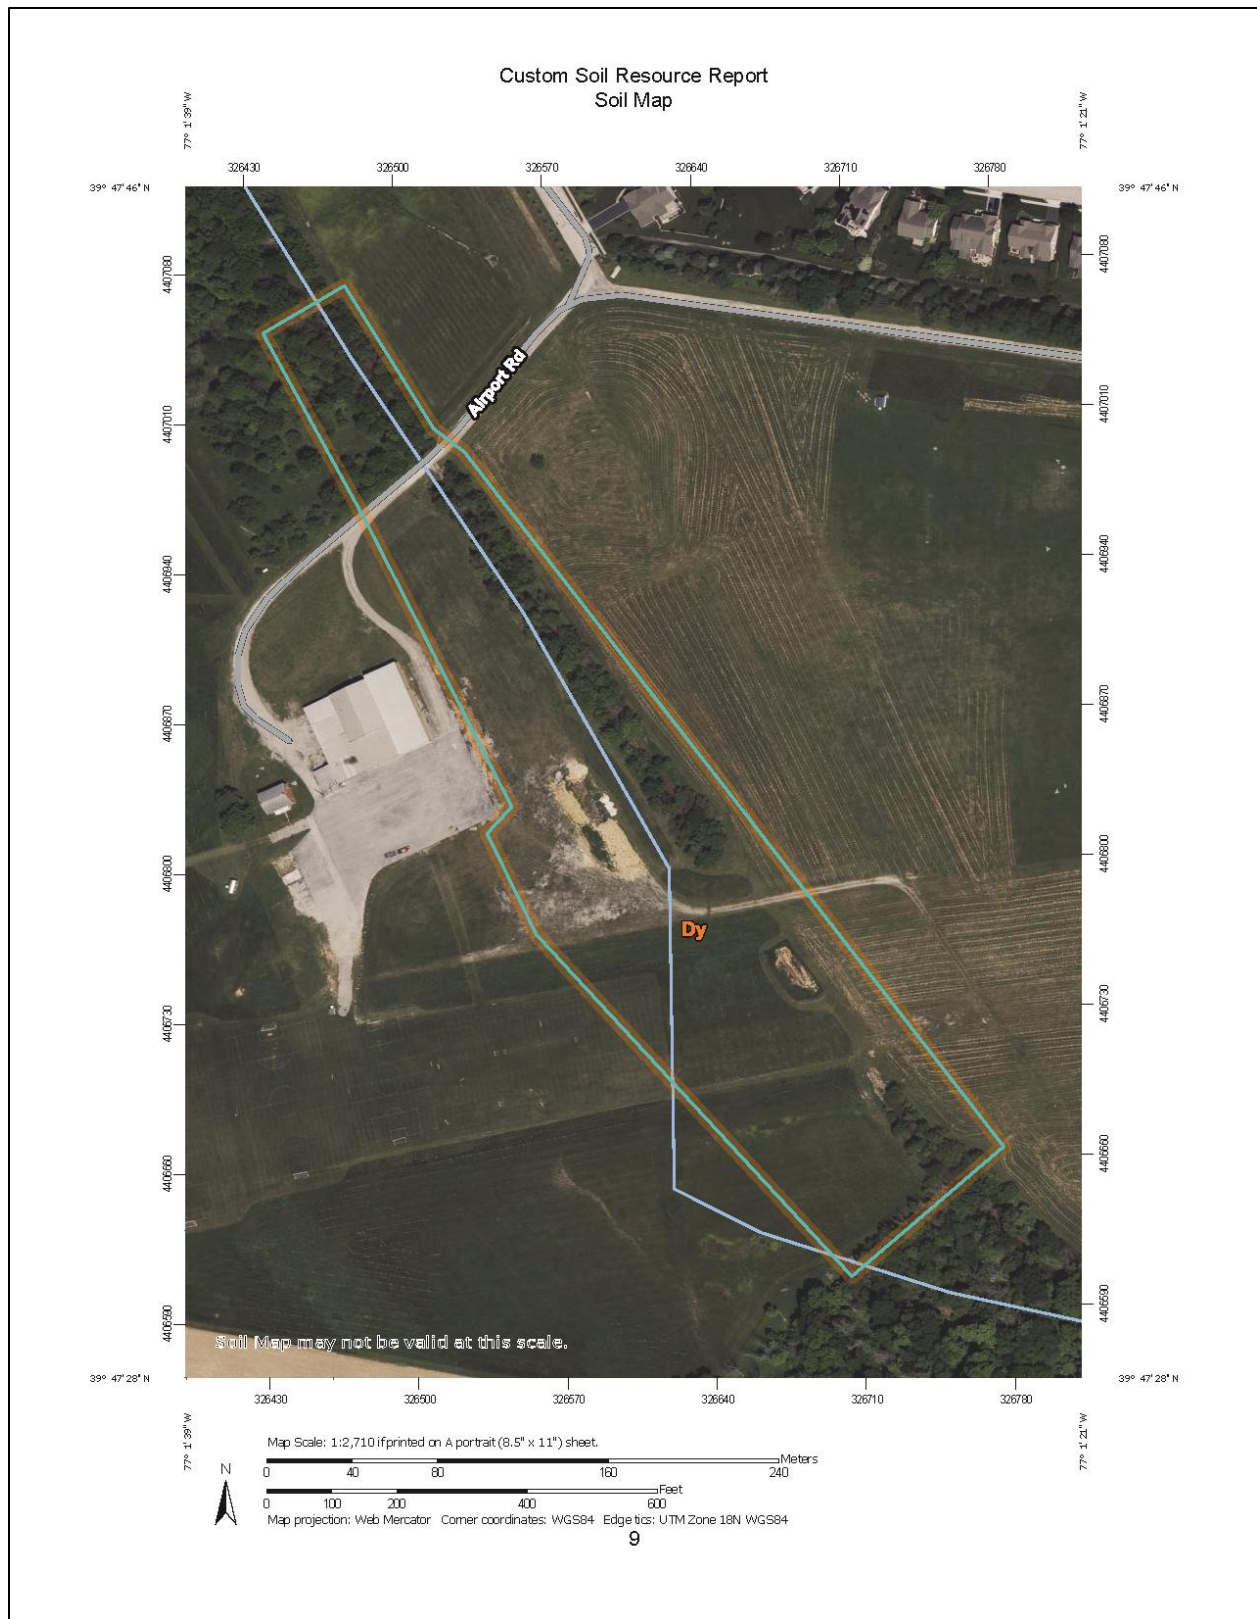
Figure 18. Dunning silt loam (Dy) soil series located within the APE. Source: USDA NRCS Web Soil Survey, 2023.

Lastly, USACE cultural resources staff reviewed soil data hosted within the USDA NRCS' Web Soil Survey. The entirety of the APE is located within the Dunning silt loam soil series, which consists of a very poorly drained hydric soil found on flood plains and in ponded areas. The series formed from slack water and recent fine-textured alluvium originating from limestone hillsides. Moving down through the pedon, the typical Dunning profile includes a very dark gray (10YR 3/1) silt loam Ap horizon from 0 to 9 inches; a very dark gray (10YR 3/1) silty clay loam Ag horizon with strong brown (7.5YR 5/8) masses of oxidized iron from 9 to 15 inches; a dark gray (2.5Y 4/1 or 10YR hue) silty clay loam Bg1 horizon with very weakly cemented strong brown (7.5YR 5/8) masses of oxidized iron from 15 to 28 inches; a dark gray (2.5YR 4/1 or 10YR hue) silty clay Bg2 horizon with black (10YR 2/1) nodules and dark brown (7.5YR 3/3) and strong brown (7.5YR 5/8) masses of oxidized iron from 28 to 48 inches. The last horizon consists of a gray (2.5Y 5/1 or 10YR hue) silty clay Cg horizon with black (7.5YR 2.5/1 or 10YR hue) nodules and dark brown (7.5YR 3/3) and strong brown (7.5YR 5/8) masses of oxidized iron from 48 to 96 inches. Redoximorphic features are typically documented throughout the profile, and clay content, structure, and plasticity tend to increase downward. The depth to water table is generally 0 to 6 inches (NRCS 2023).

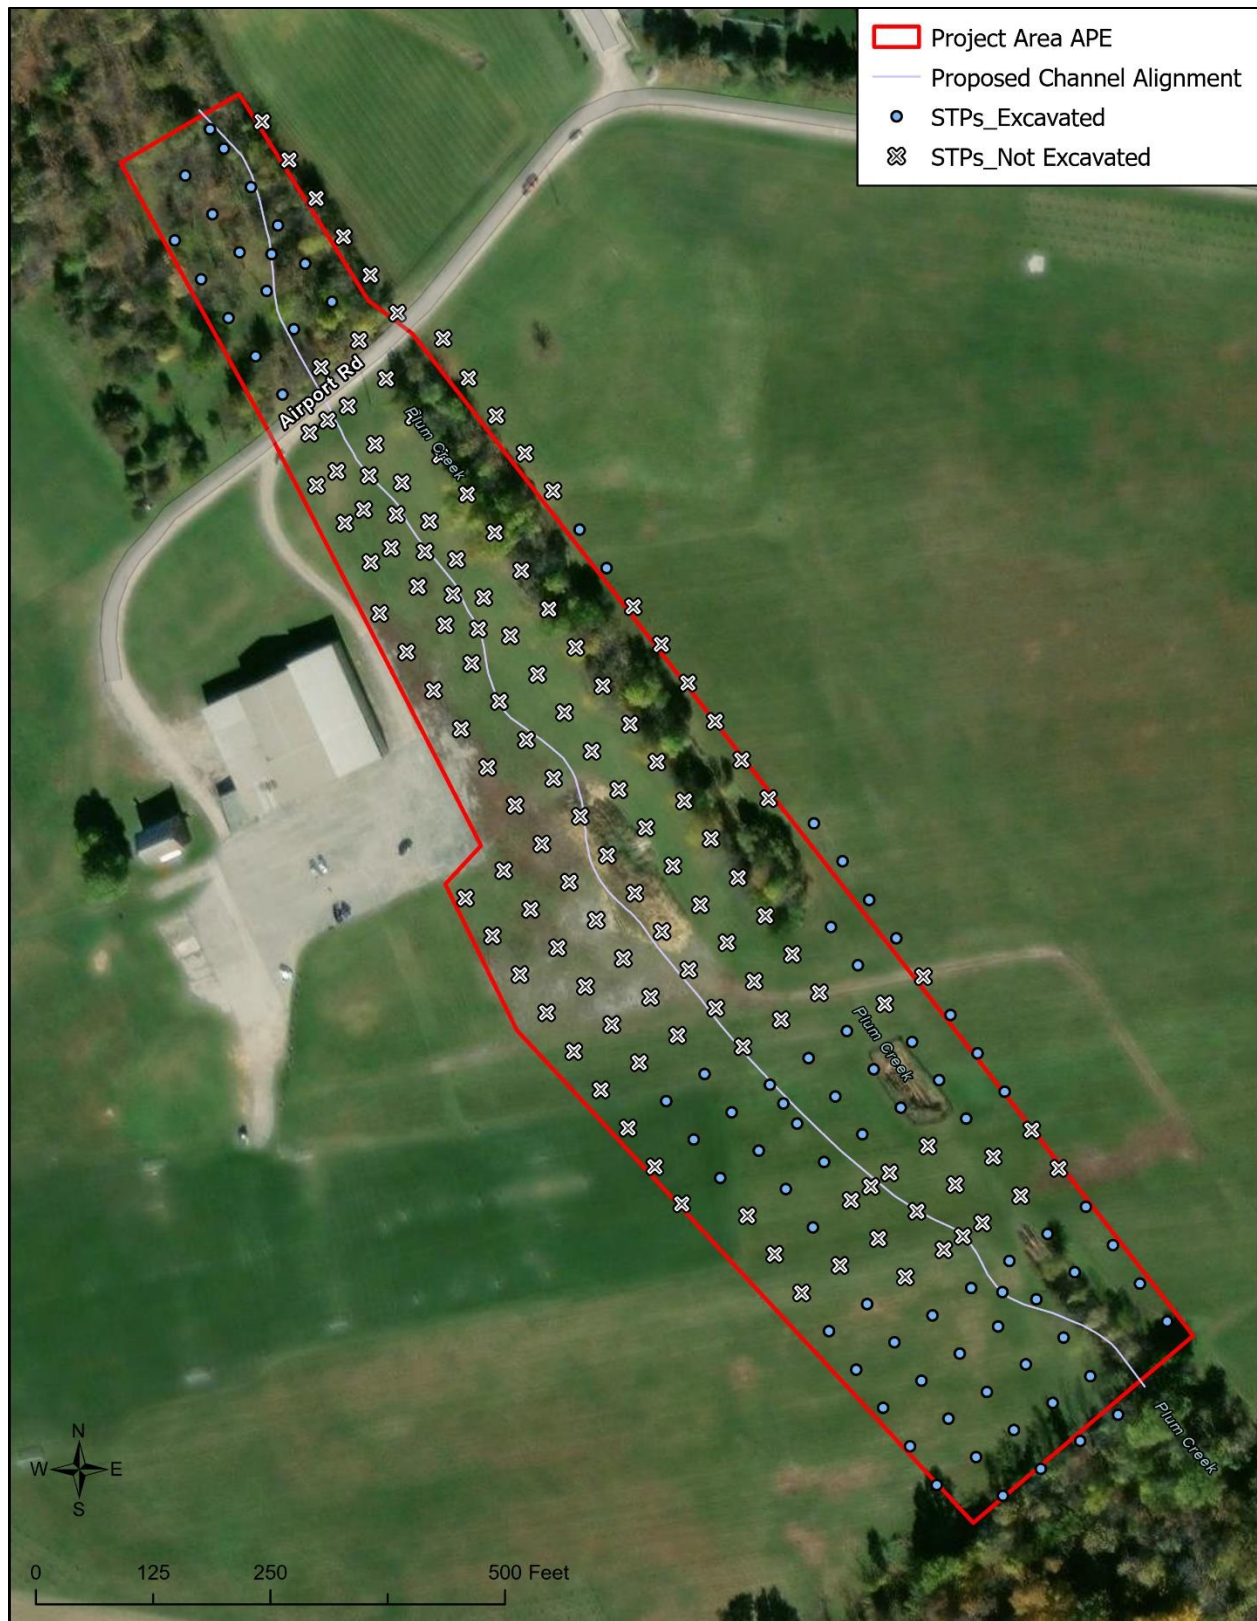
Figure 19. APE map showing excavated and unexcavated STPs.

Prior to the site visit, 209 shovel test pits (STPs) were plotted over aerial imagery using ESRI's ArcGIS Pro version 3.1. The STPs were placed in 50-foot intervals to cover the extent of the APE and were oriented approximately parallel with Plum Creek. STPs were also placed at 25-foot intervals in various locations to cover the full extent of the proposed stream alignment.

As mentioned previously, 209 STPs were plotted prior to the site visit to cover the extent of the APE. Although the PA pre-contact probability model shows that the southern half of the APE is within the high sensitivity tier, this is presumably due to the presence of the unverified Site 36AD0063 in that area. When considering previous disturbance and soil characteristics, it may be more likely that the APE is wholly within a low to moderate sensitivity tier, as is the case with the APE's extent north of Airport Road. However, due to the presence of Site 36AD0063, a testing methodology of 50-foot interval STPs was utilized throughout the course of the project. STPs were also placed at 25-foot intervals in various locations to cover the full extent of the proposed stream alignment. STPs were not placed within the fill landform due to the perceived depth of fill and previous disturbance in this location. STPs were also not placed in other areas where historic aerial imagery showed previous disturbance, such as along the APE's eastern boundary, the gravel road in the central portion of the APE, and Airport Road. STPs were attempted within the runway; however, a dense layer of fill caused either shallow excavations or refusal at the surface (as is the case with STPs 6, 7, 8, 9, 15, 17, 16, 80, 81, 82, 88, 121, 122, 123, 130, 159, 160, 161, 169, 204, and 205). In total, 82 STPs were excavated as part of the investigation, primarily focused on the APE north of Airport Road and its southern extent.

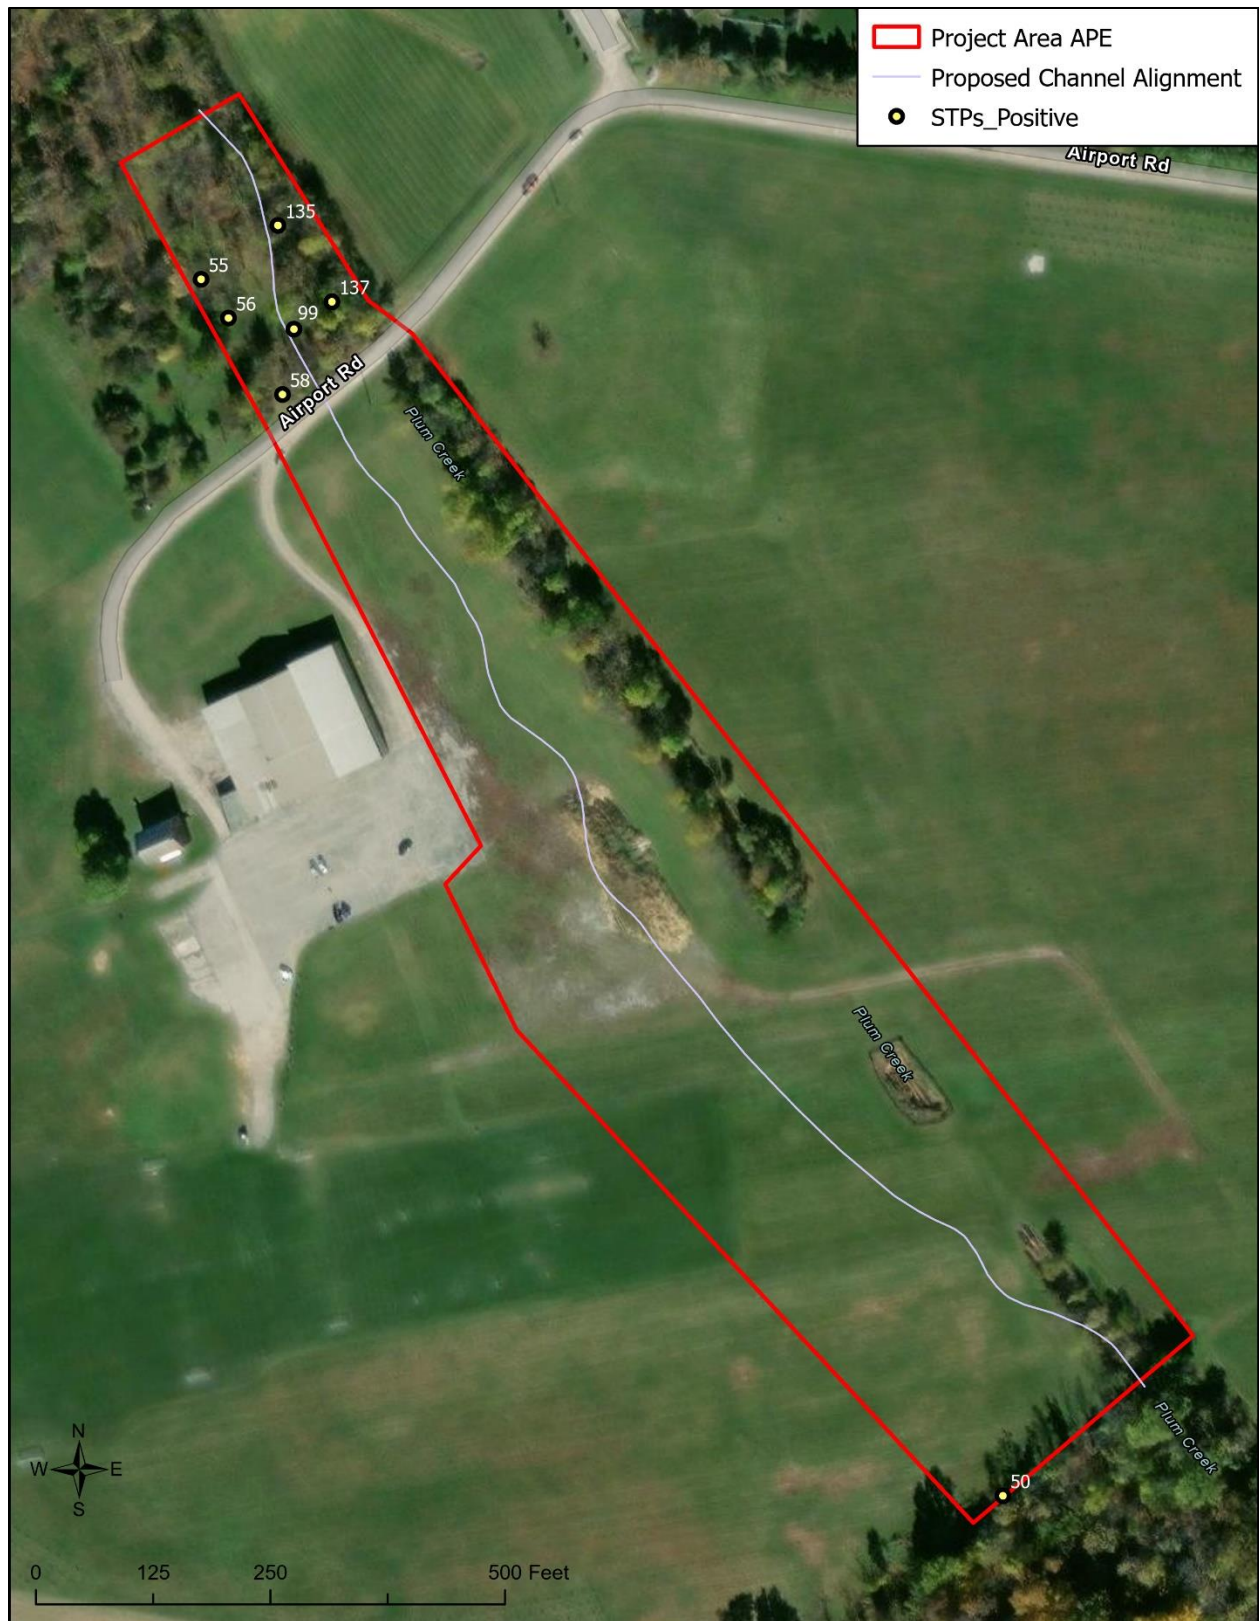
Figure 21. APE map showing positive STPs (all modern plastic).

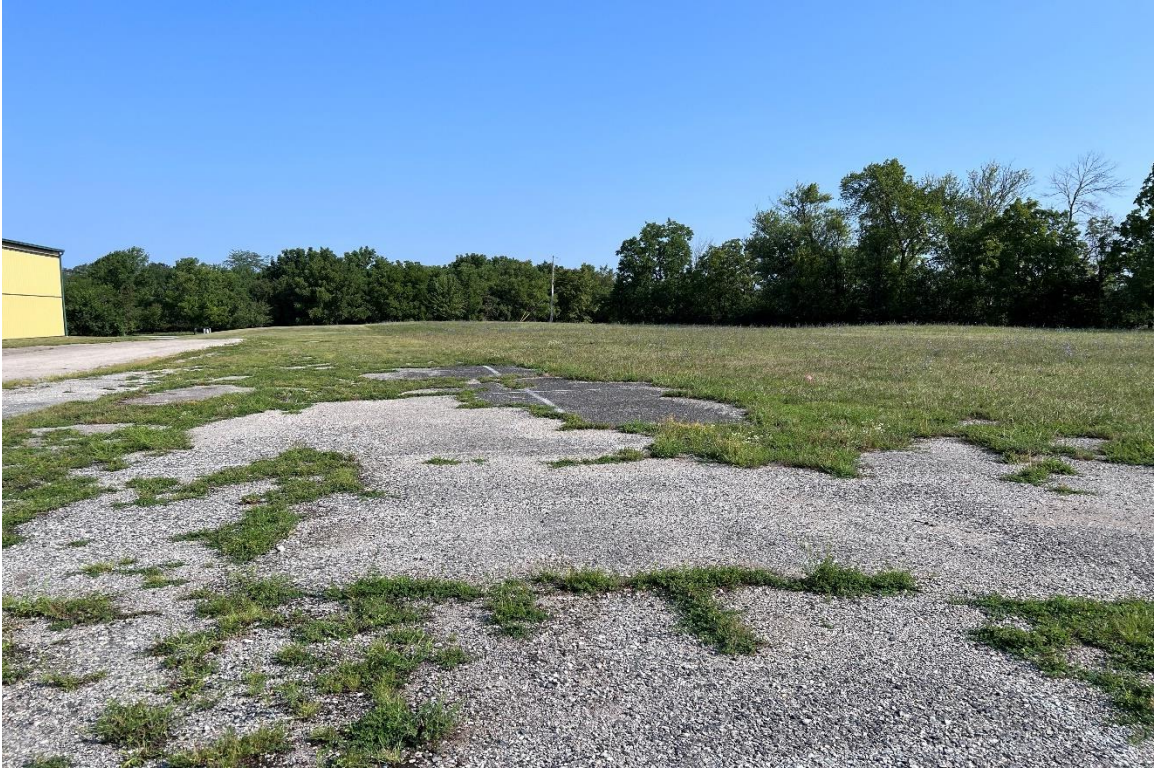
Photo 1. Fill landform showing asphalt. Facing north.

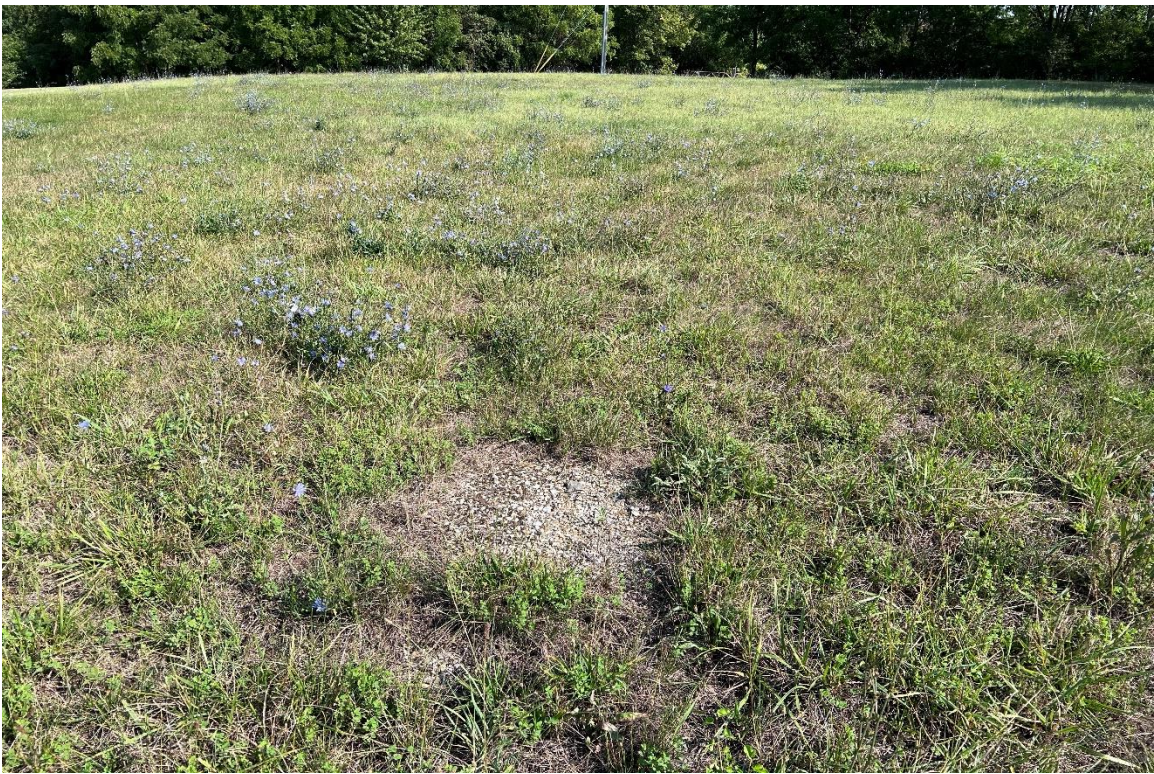
Photo 2. Common asphalt patch throughout fill landform. Facing north.

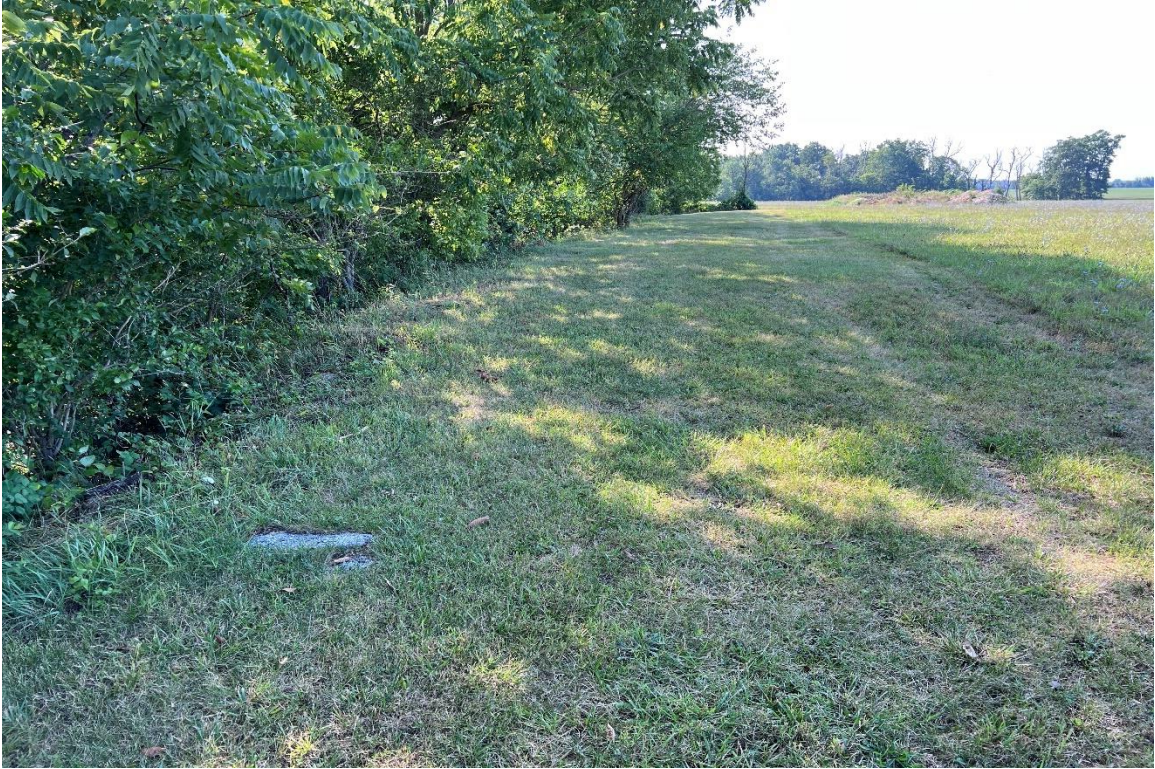
Photo 3. Asphalt extending to edge of creek along fill landform. Facing southeast.

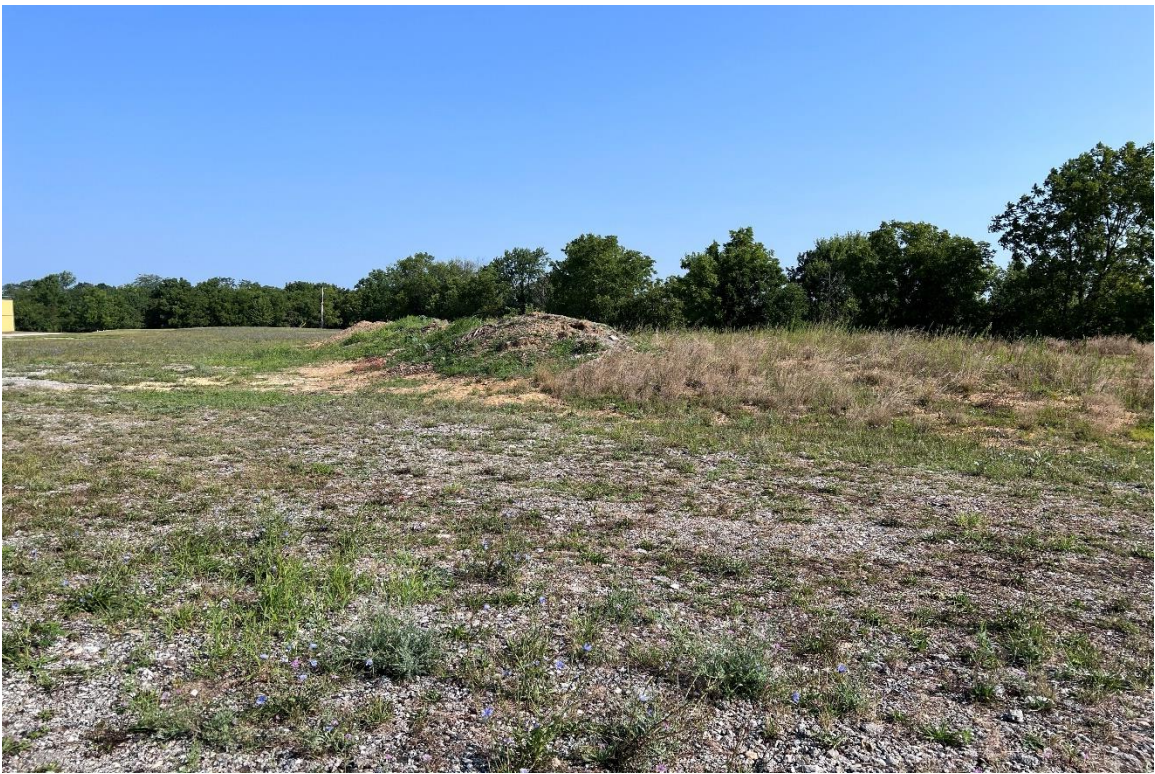
Photo 4. Debris pile on fill landform. Facing north.

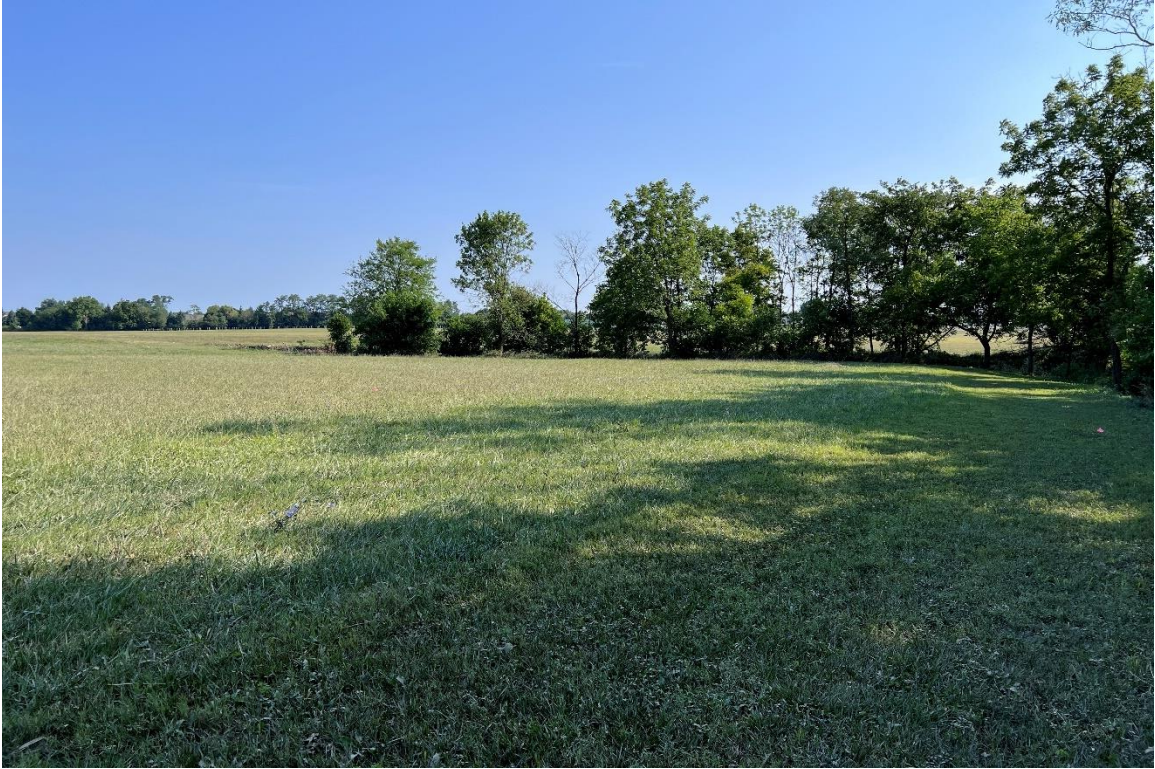
South of the runway was an open floodplain area situated approximately four feet above Plum Creek (Photograph 9). Visibility along this landform was also extremely low (less than 5 percent) due to grassy vegetation. At the southern extent was a dirt debris pile (Photograph 6) possibly remnant from Hanover Airport construction activities shown in aerial imagery.

Photo 9. View of floodplain. Facing north.

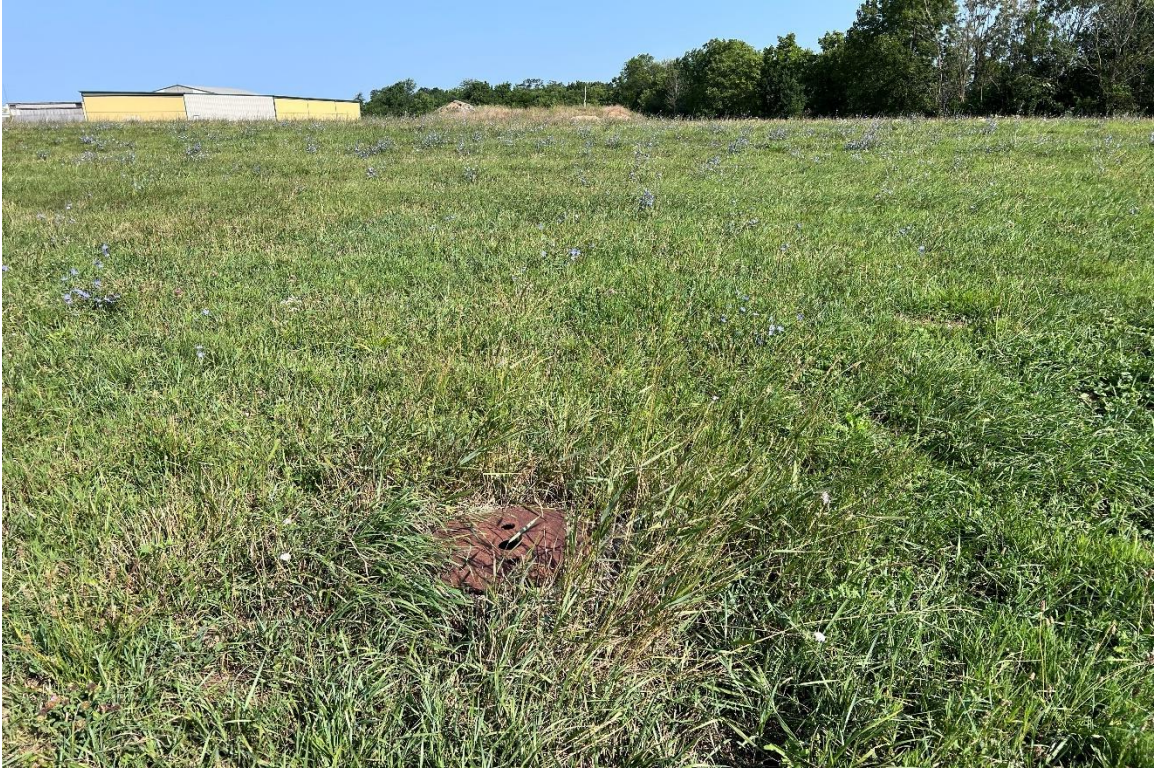
Photo 11. Utility disturbance. Facing north.

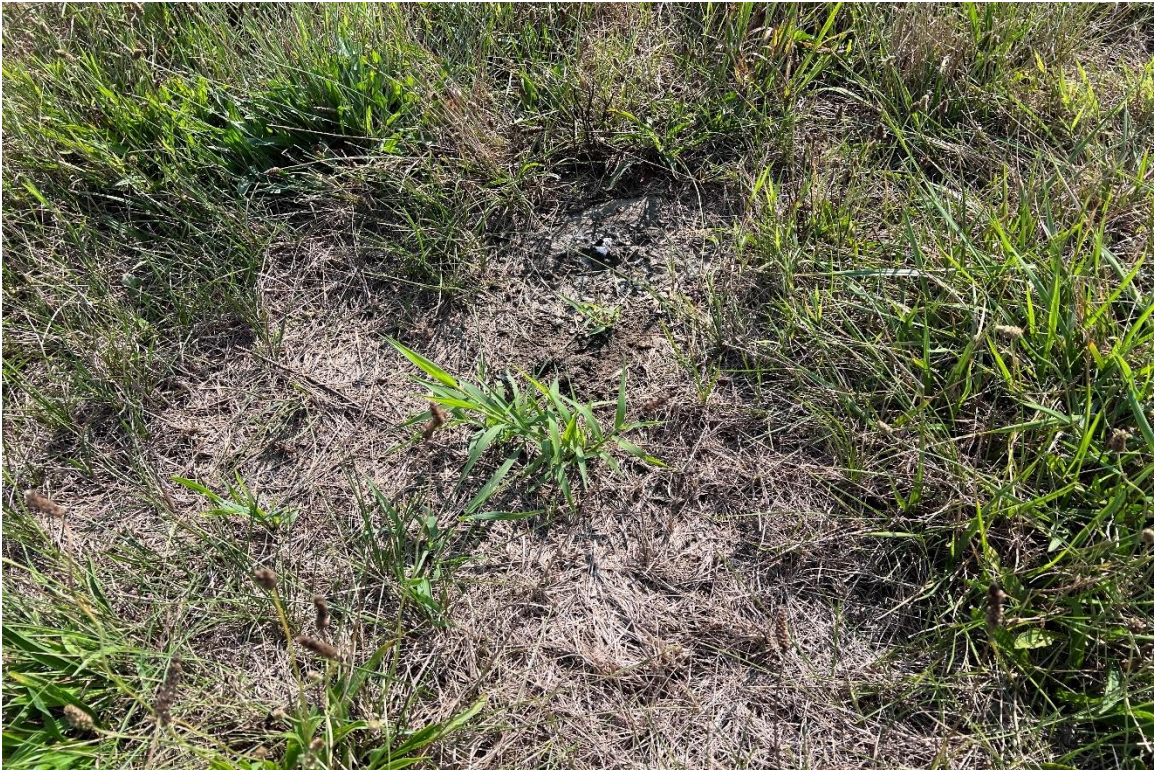
South of the fill landform was an approximately 260-foot-wide runway associated with the Hanover Airport. Small patches of bare soil and gravels were noted along the runway (Photograph 12); however, the vast majority of it was vegetated with no surface visibility. Towards the runway's eastern extent within the APE was the previously mentioned exposure of Plum Creek. This consisted of an approximately 23-foot by 55-foot excavated section with two large pipes placed within it (Photograph 19). The runway's western extent consisted of areas converted to athletic fields (Photograph 10).

Photo 12. Typical disturbance along runway. Facing south.

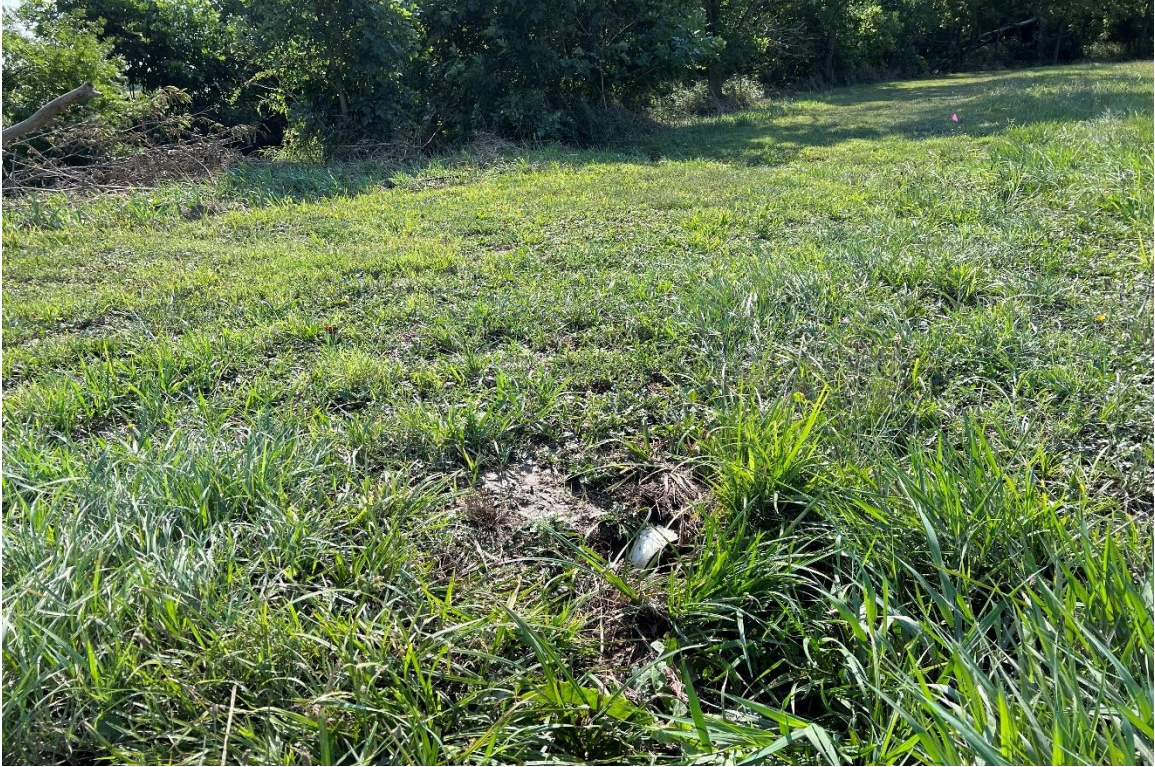
Photo 13. Drainage conduit adjacent to Plum Creek along the terrace. Facing southeast.

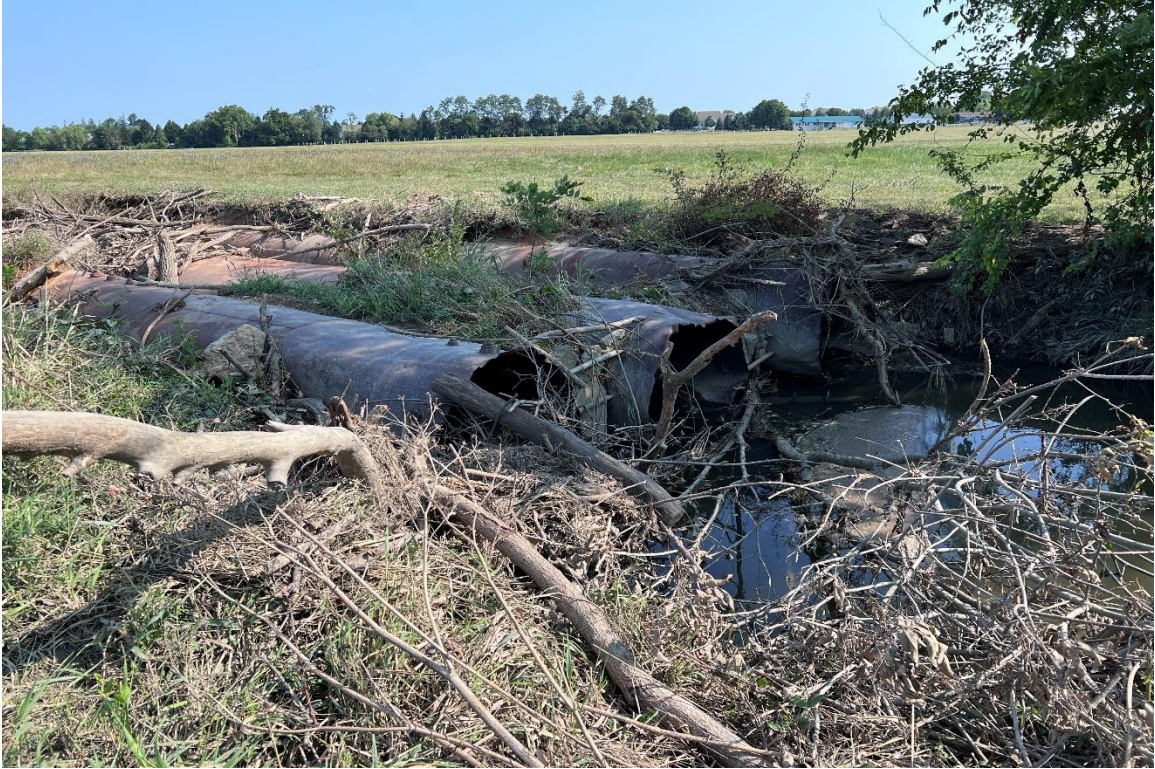
Photo 15. Pipes within Plum Creek. Facing north.

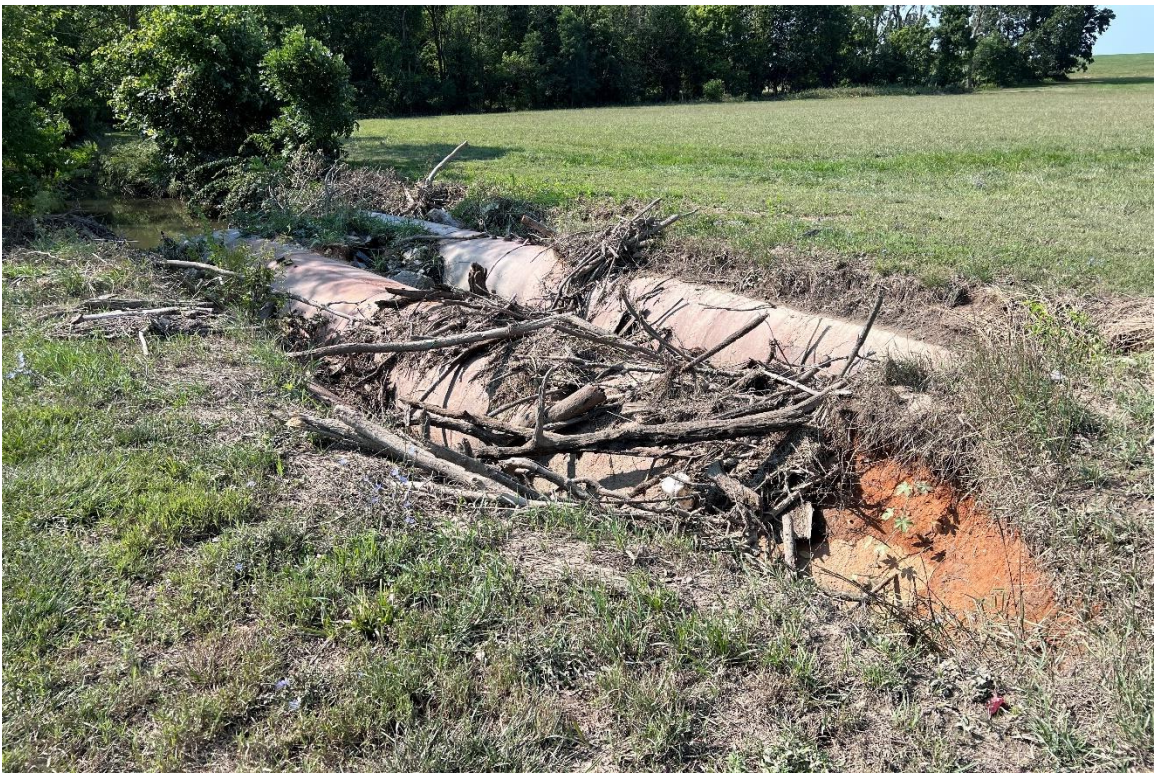
Photo 16. Pipes in Plum Creek showing fill profile. Facing south.

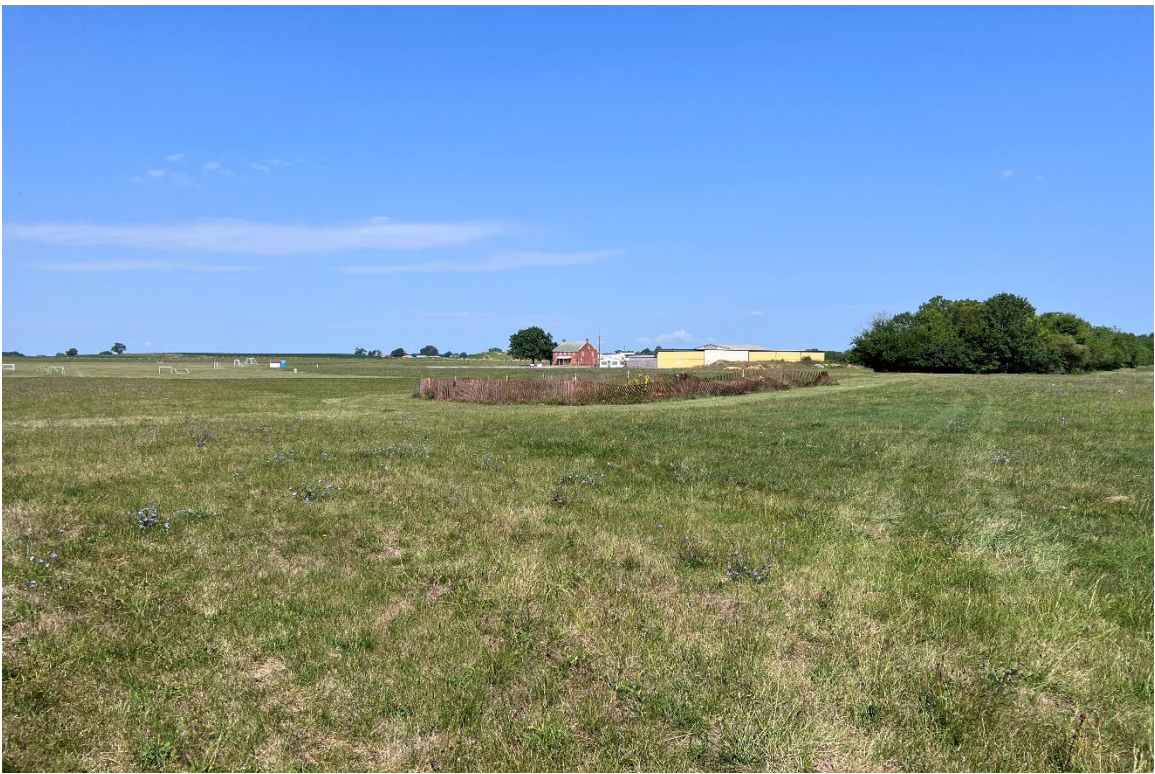
Photo 18. Plum Creek channel disturbance. Facing northwest.

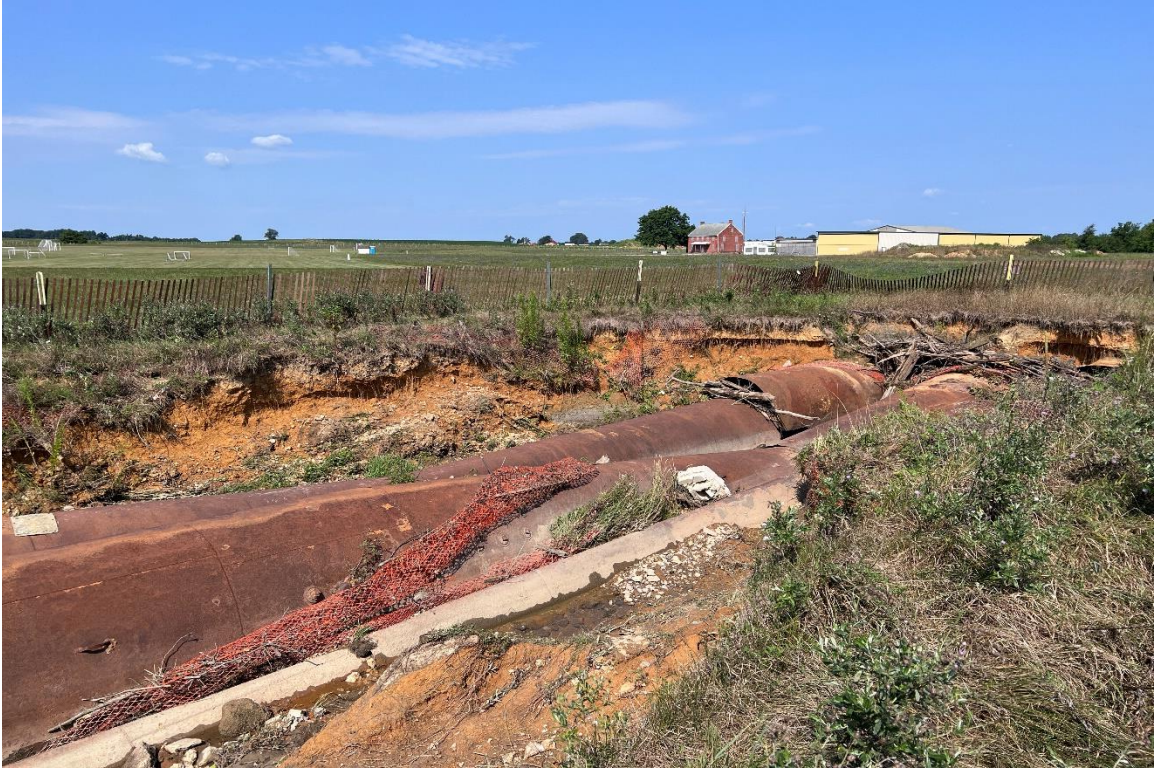
Photo 19. Pipes within Plum Creek showing debris and fill profile. Facing northwest.
