***APPENDIX C***  
***ARCHEOLOGICAL AND CULTURAL REPORT***

## Negative Survey Form

ER Number **2023PR02544**

Project Name &/or Agency Tracking #: Section 510 Plum Creek Stream Restoration Feasibility Study

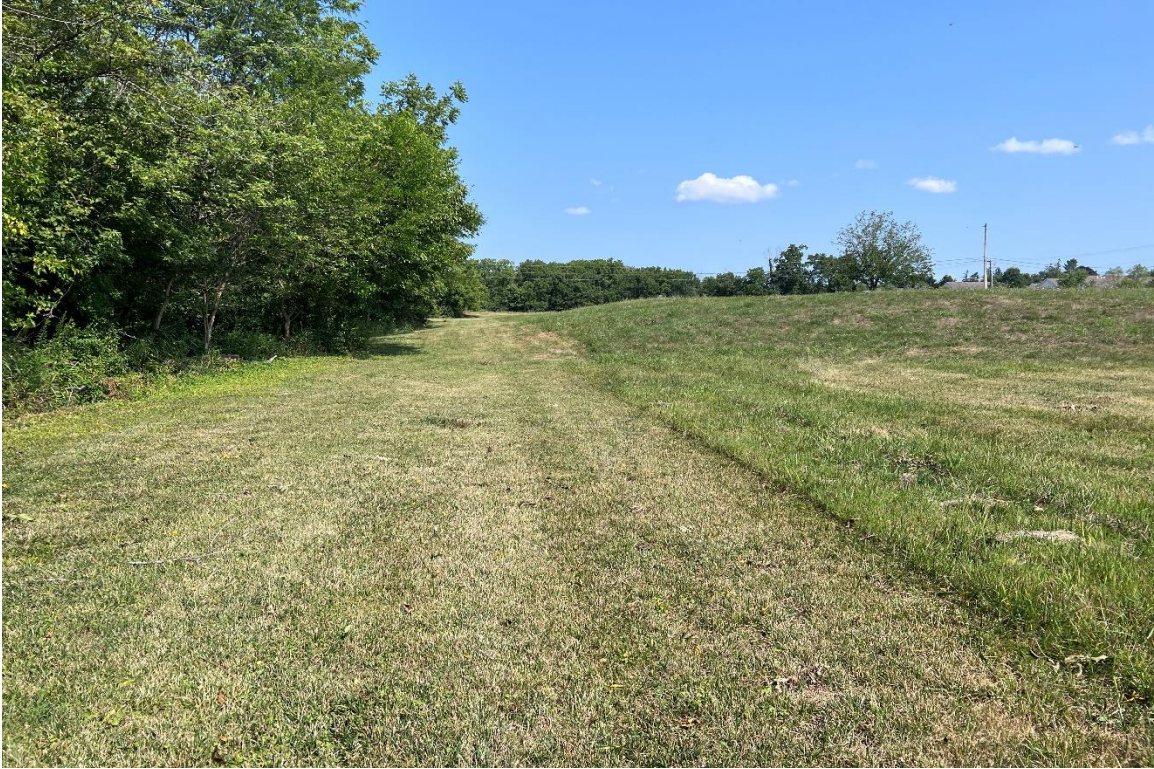
Areas east of Plum Creek, north and south of the runway, appeared as open vegetated fields (Photographs 17, 18, and 23). Closer to Airport Road was an elevated area of fill remnant of activities shown in 1992 and 2007 aerial imagery (Photograph 21).

Photo 21. Fill located east of Plum Creek. Facing northwest.

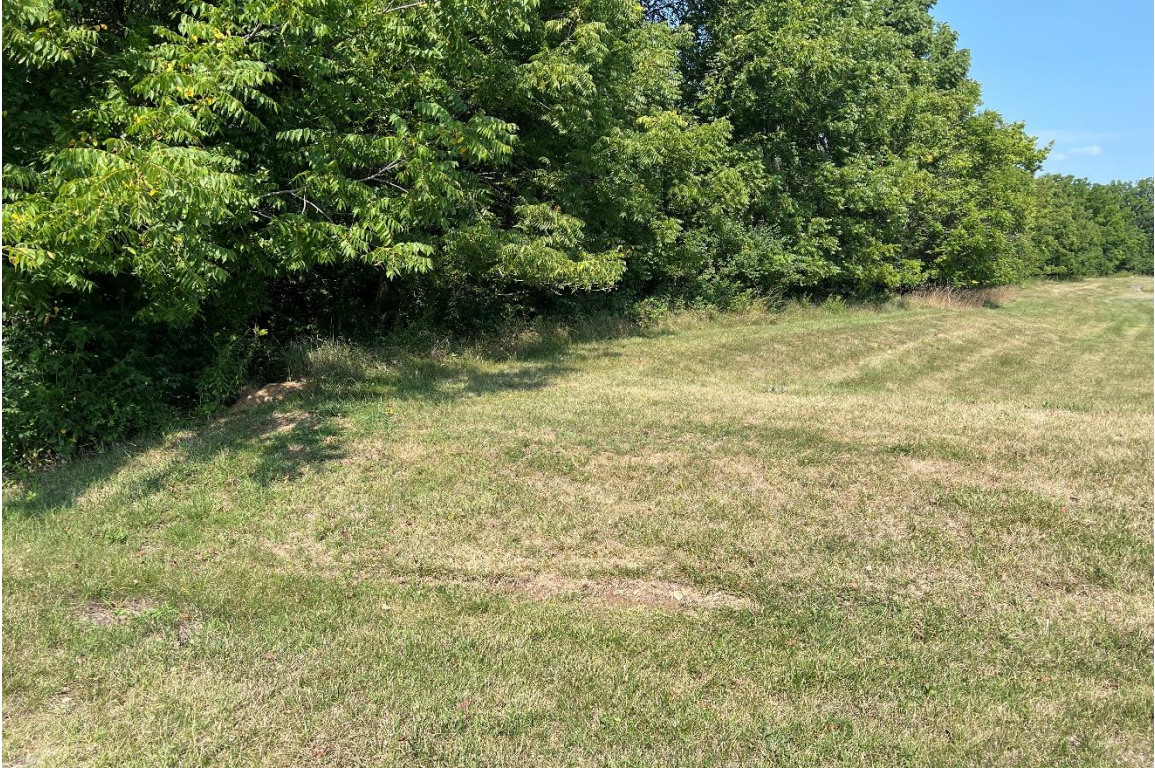
North of Airport Road, and east of Plum Creek, was an elevated berm moving along the length of the APE at this location (Photograph 29). The berm sloped towards the creek and was interpreted as a retention (possibly stormwater) feature associated with a neighborhood community to the northeast.

Photo 29. Berm sloping towards Plum Creek. Facing west.

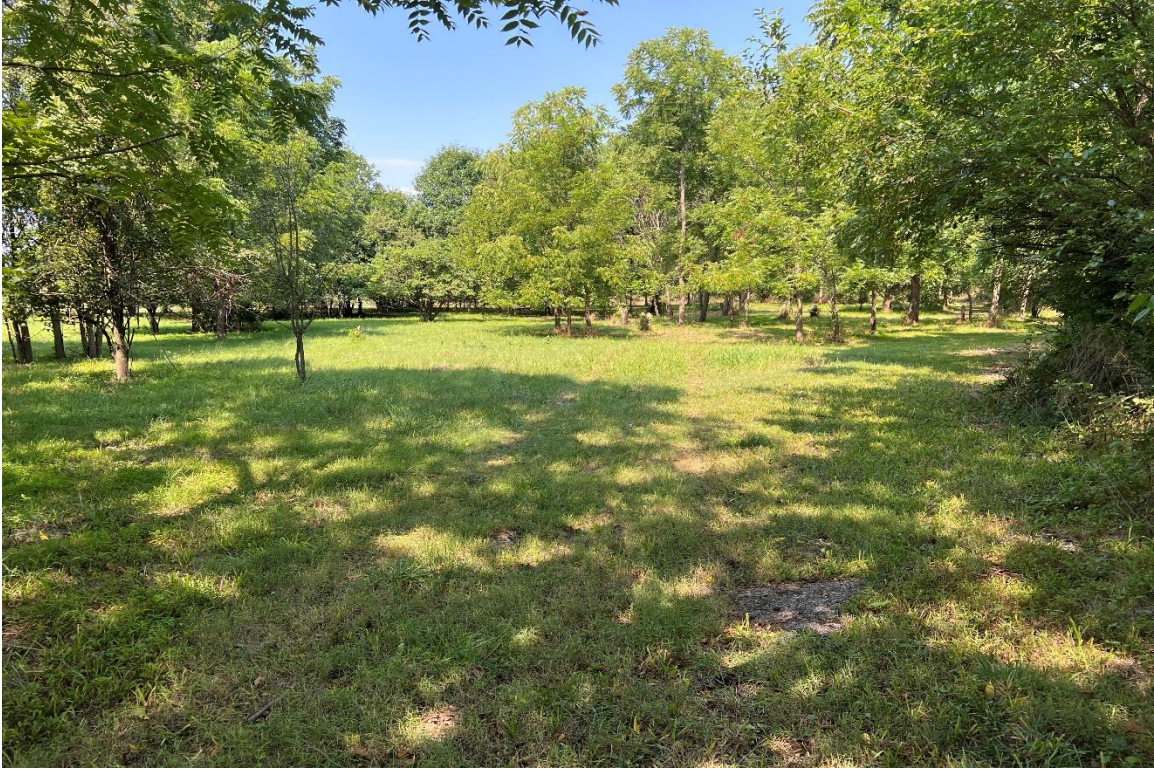
The portion of the APE west of Plum Creek in this area was relatively open but showed some evidence of prior maintenance activity and disturbance in the form of vehicle tracks and gravel patches (Photograph 31).

Photo 31. APE north of Airport Road. Facing west.

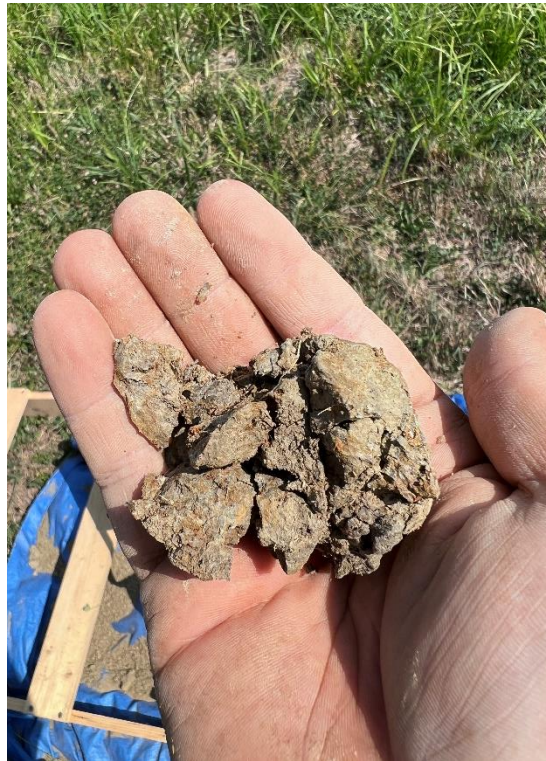
STPs north of Airport Road documented a gleyed, saturated floodplain with redoximorphic (redox) features in every STP. STPs generally had a 0.3-foot-thick friable Ap horizon of dark brown (10YR 3/3) silt loam overlying a 1.3-foot-thick Bt1 horizon of dark yellowish brown (10YR 4/4) silty clay loam with a blocky structure and clay films. Underlying the Bt1 horizon was a 1.0-foot-thick Bt2 horizon of mottled yellowish brown (10YR 5/6) and weak red (2.5Y 4/2) silty clay with blockier structure and clay films. Underlying the Bt2 horizon was a 0.7-foot-thick layer of very dark gray (10YR 3/1) and gleyed wet and sticky sandy clay alluvium with approximately 60 to 70 percent rounded gravels. Modern plastic was documented within the Ap horizon of STPs 55, 56, 58, 99, 135, and 137; however, this debris was discarded in the field.

Photo 32. Reduction-Oxidation (redox) features noted in APE north of Airport Road.

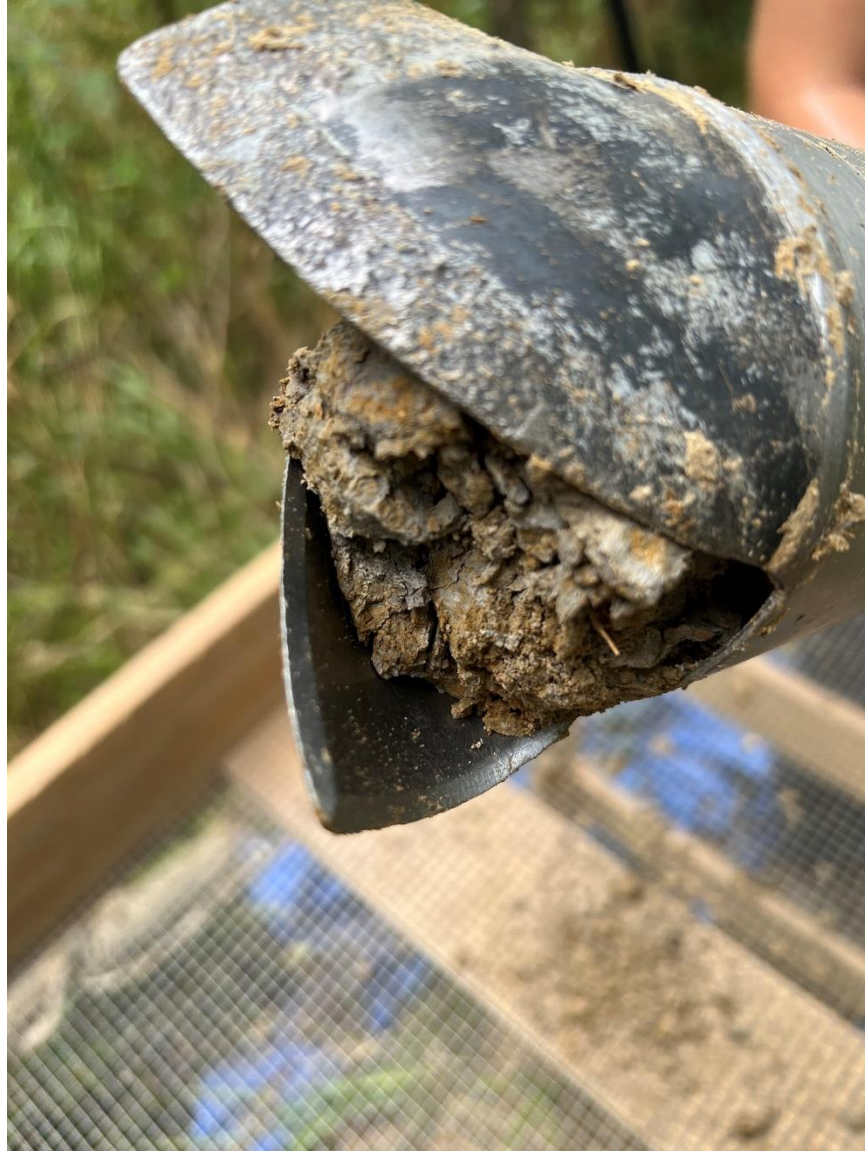
STPs south of the runway documented a gleyed, saturated floodplain with redox features in every STP. STPs generally had a 0.4-foot-thick Ap horizon of yellowish brown (10YR 5/4) silty clay loam with approximately 5 percent gravels noted within the soil matrix. Underlying this was a 1.8-foot-thick Bt1 horizon of yellowish brown (10YR 5/4) silty clay with decreasing amounts of gravels. Underlying this was a 1.0-foot-thick Bt2 horizon of mottled gray (10YR 5/1) and yellowish red (5YR 5/6) clay with blocky structure. Modern plastic was documented within the Ap horizon of STP 50; however, this debris was discarded in the field.

Photo 33. Redox features noted in APE south of Airport Road.
