Technical Memorandum

Project: Plum Creek Community Park Stream Improvements

Subject: Wetland and Waterway Presence/Absence Memorandum

Date: October 17, 2019

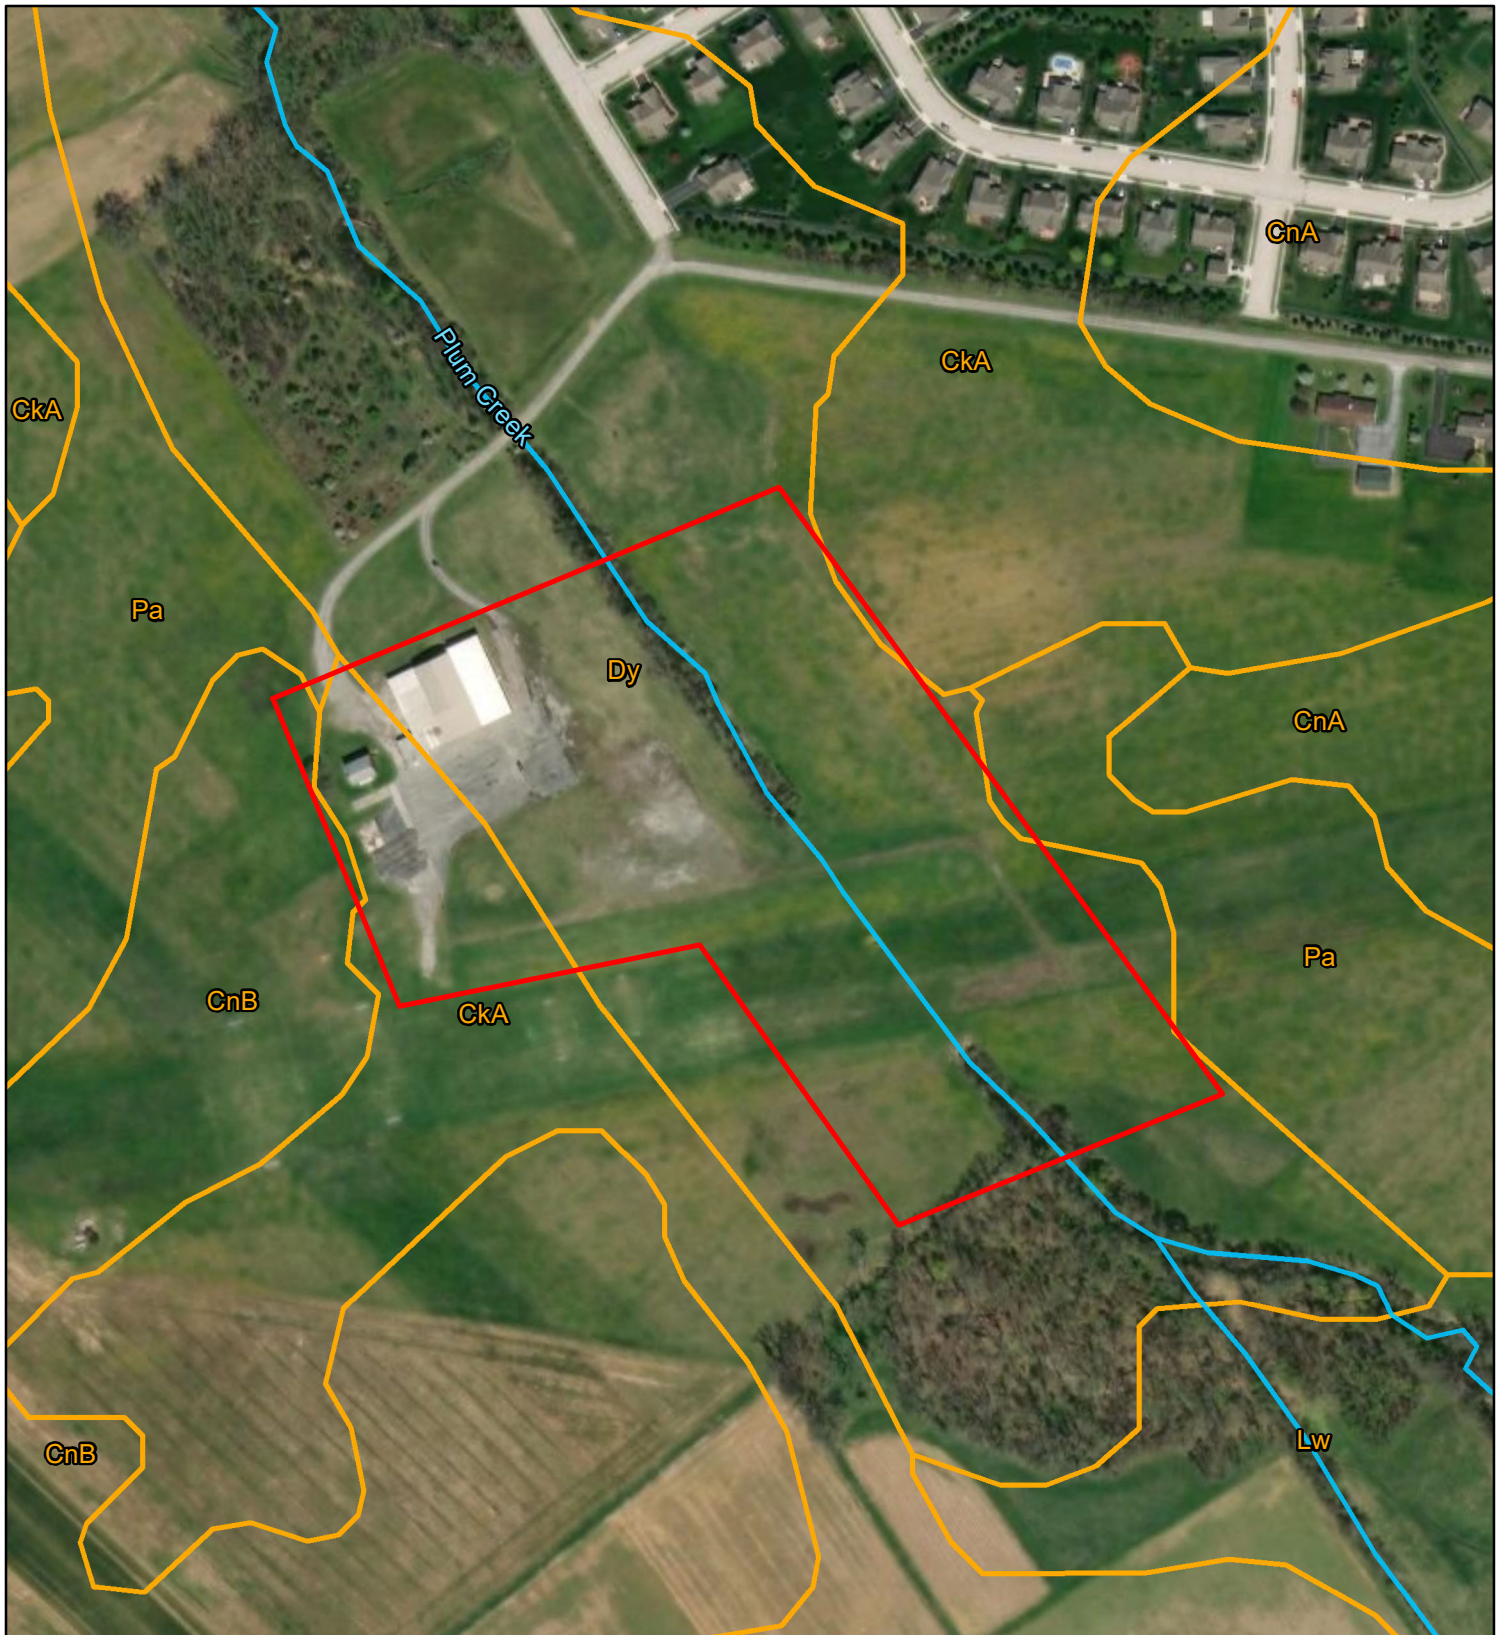
**FIGURE 3
SOIL SURVEY MAP**

According to the U.S. Department of Agriculture (USDA), Natural Resource Conservation Service (NRCS) Web Soil Survey, the dominant soil series underlying the project area is Dunning silty clay loam, (NRCS, 2019). According to the National Wetlands Inventory (NWI) online mapping tool, one R5UBH (Plum Creek) is present within the project area (NWI, 2019). Two PFO wetlands are located within 400 feet of the project area; however, they are far removed from the project area in a wooded area upstream that they will not be impacted. The project area is located within FEMA panel 42001C0292D (FEMA, 2019). Mapping indicates that the site is located within a FEMA-mapped floodway and floodplain of Plum Creek.

Soils were investigated in the project area. The soil throughout the site appeared to be a combination of silt clay loam and fill from the previous airport and sanitary sewer right of way. The primary soil mapped in the area is Dunning silty clay loam; however, the project area has been filled and intact soil horizons and potential hydrology was drained or filled for the runway development. Soils were consistent with upland conditions (Attachment 3).

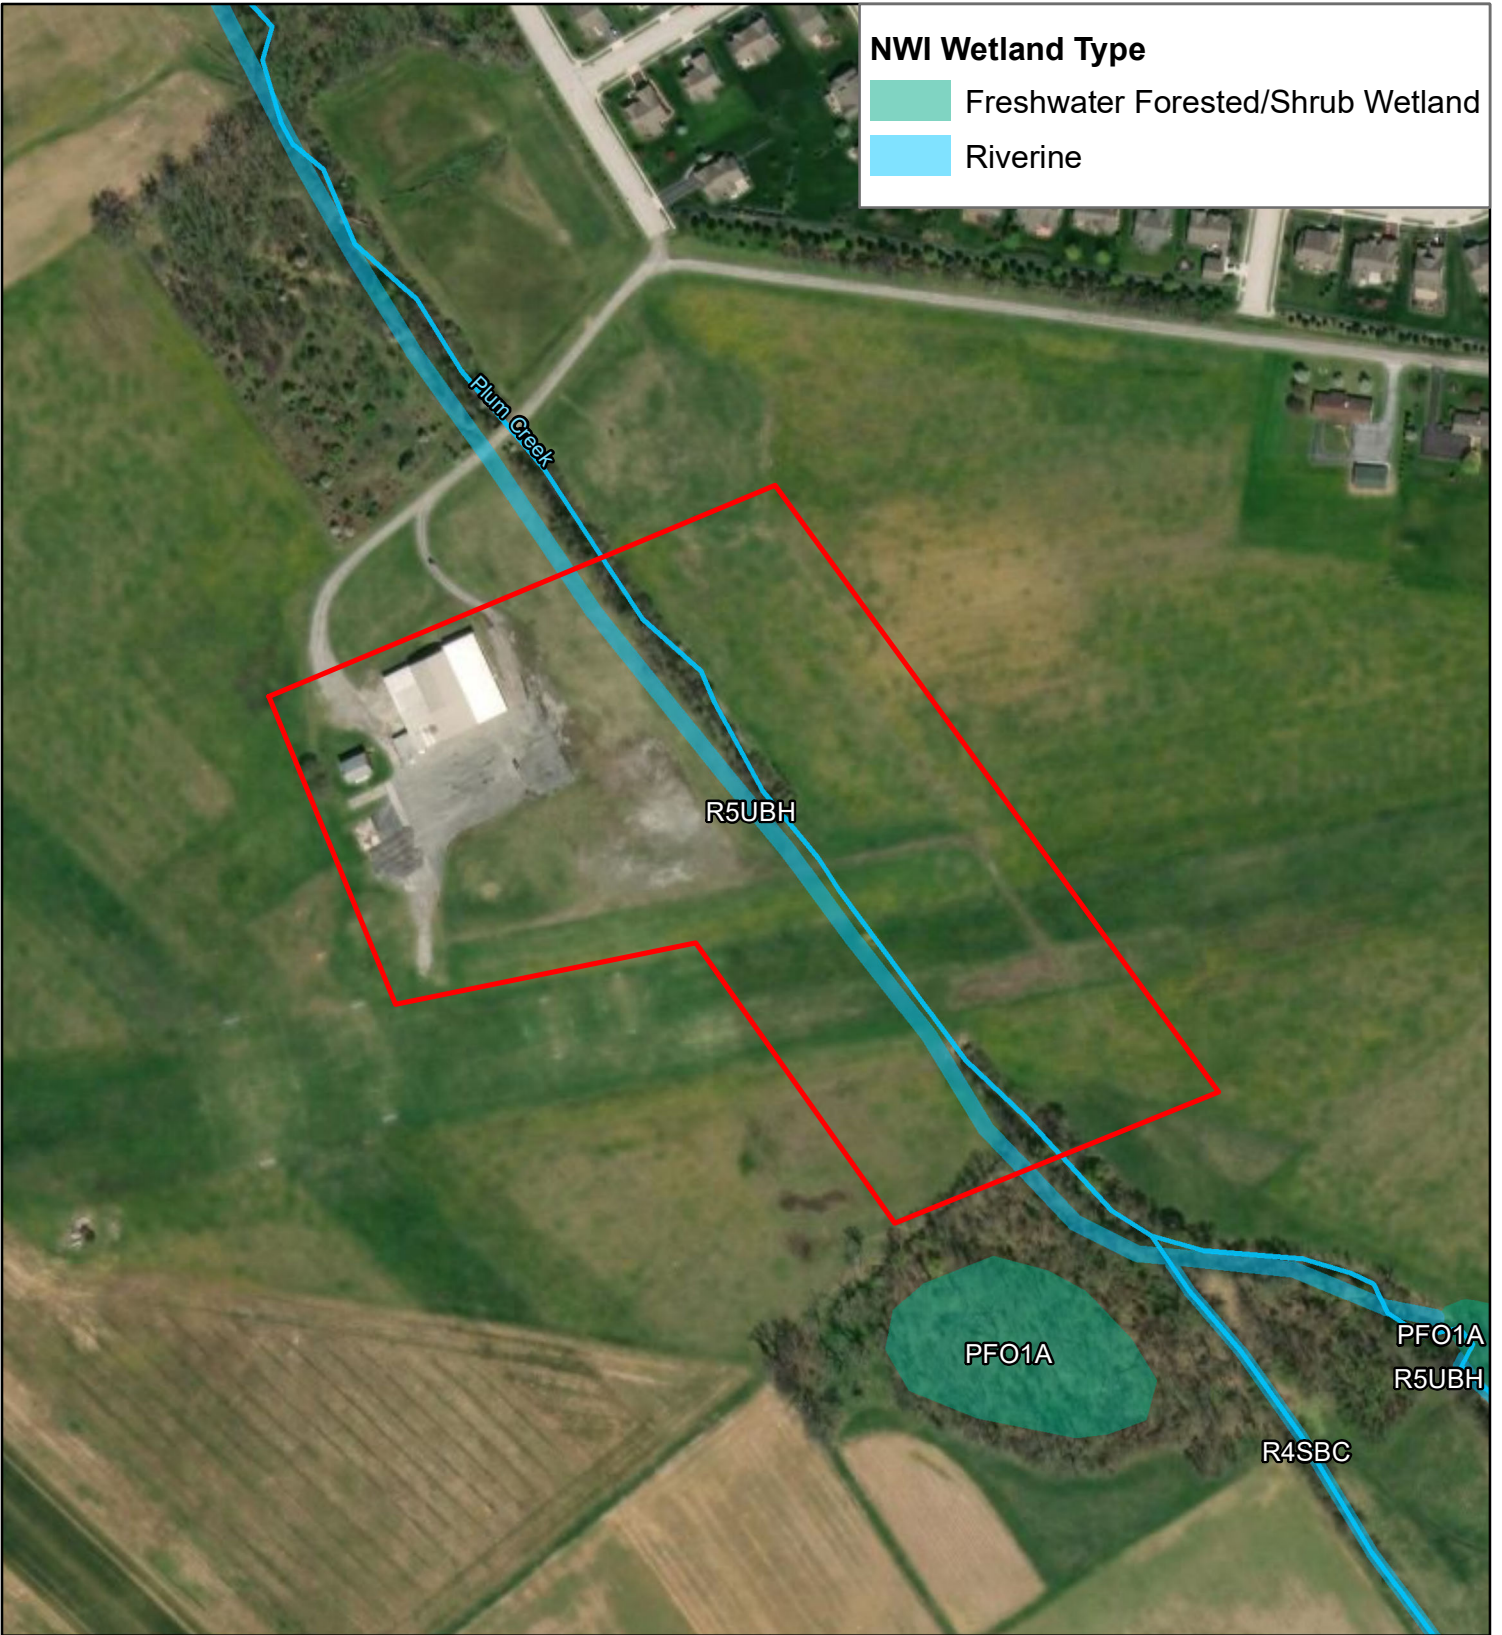
**FIGURE 4
NATIONAL WETLANDS INVENTORY MAP**

Plum Creek is a warm water fishery (WWF) perennial stream that originates south of Hanover Borough. Plum Creek classifies as a R5UBH which is a riverine, perennial, unconsolidated bottom, permanently

flooded stream (USFWS, 2019). A mapped FEMA floodplain exists for Plum Creek within the project area. No other waterways were identified within the project area.

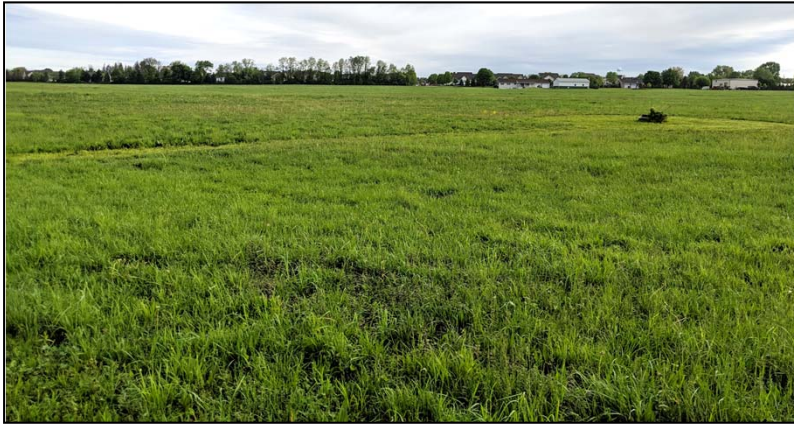
Photo 1 (5/6/2019)
Viewing the project area where culverts are proposed to be removed. Note sewer manhole in background.

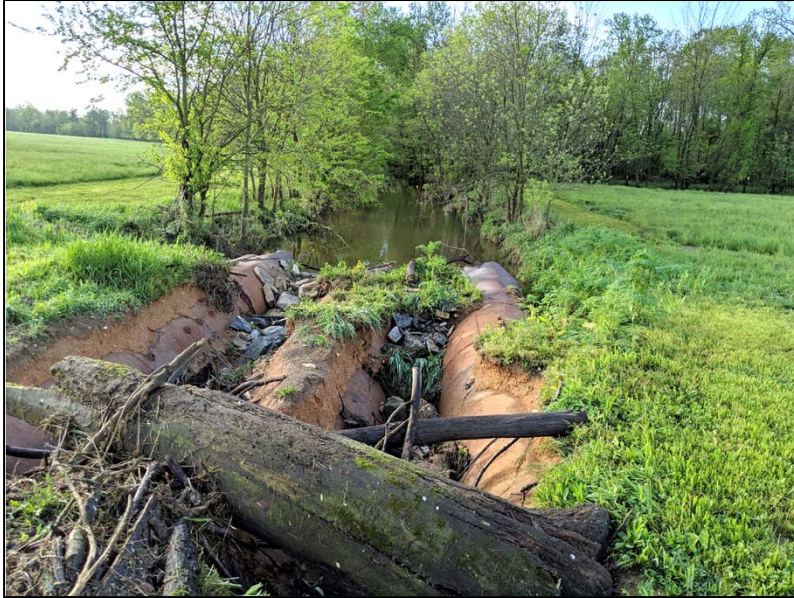
Photo 2 (5/6/2019)
Viewing upstream section of failing culverts in Plum Creek and downstream limits of project.

This project will remove the three side-by-side 6' diameter culverts (in their entirety). The channel will be daylighted the entire 500 feet and a natural channel will be constructed in its place. The stream will then be planted with a riparian buffer for long term stability. A future project could include construction of a single span (open bottom) structure to provide a road crossing and pedestrian walkway across the restored stream channel.

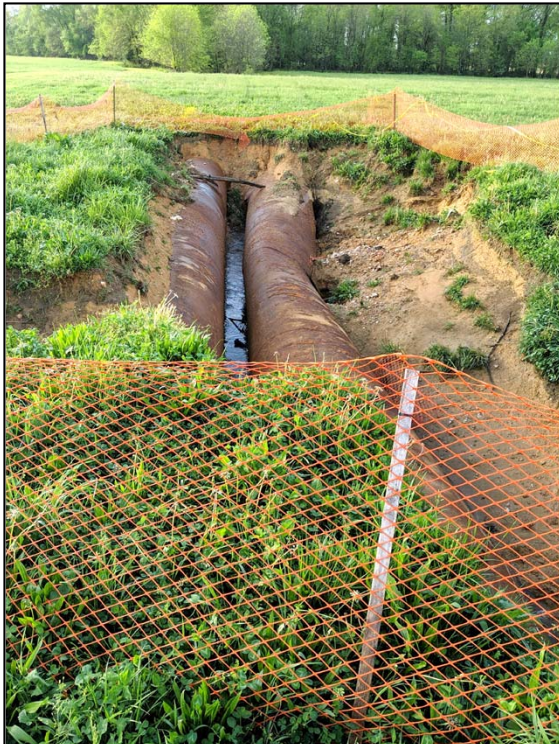
Photo 3 (5/6/2019)
Viewing sinkhole that developed along the culvert alignment within the project area.

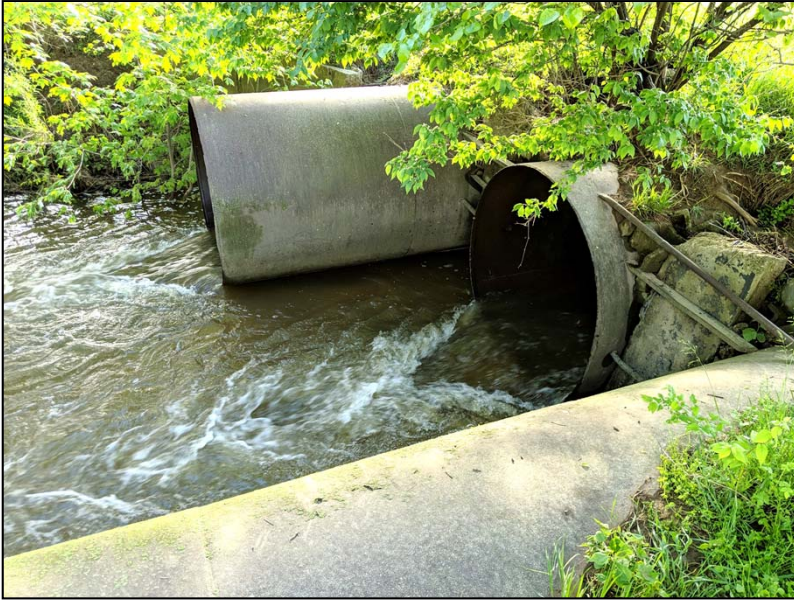
Photo 4 (5/6/2019)
Viewing culvert outfall and
downstream portion of the project
area.

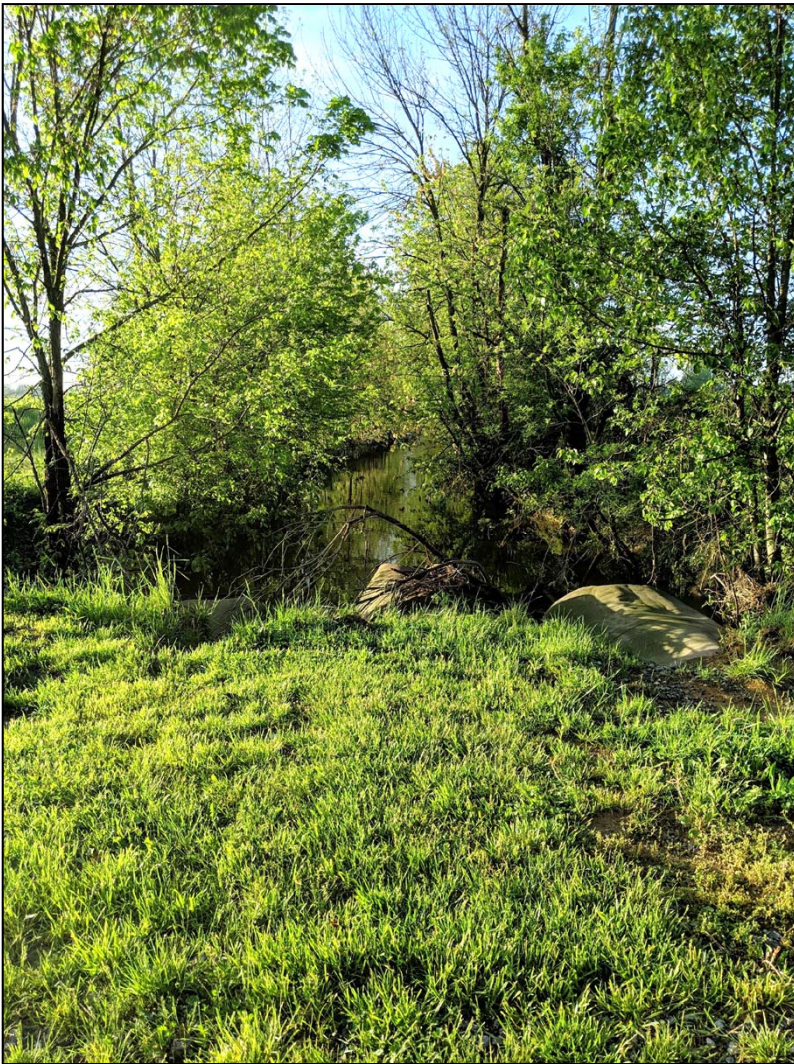
Photo 5 (5/6/2019)
Viewing downstream end of the
project area toward culvert outfalls.
