Ecotone, Inc.
Maryland Statewide Umbrella Mitigation Banking Instrument
Final Prospectus

PHEASANT RUN MITIGATION BANK PROPOSED CONCEPT MAP

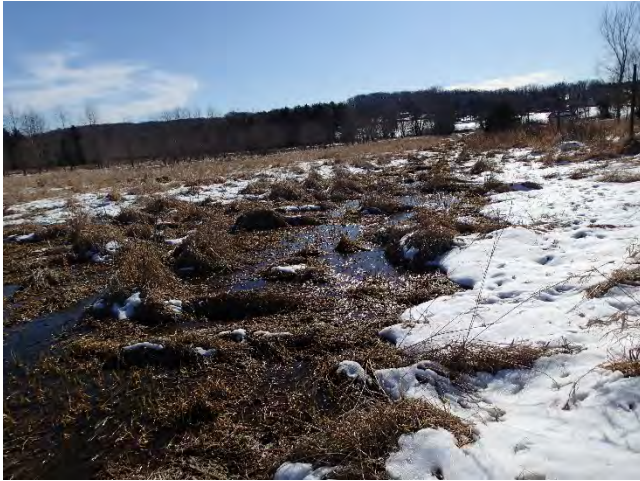
Wetland 1, February 14, 2019

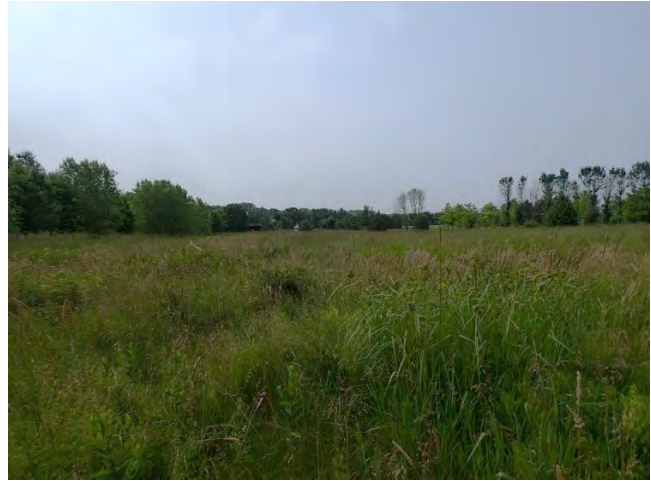
Wetland 1, June 5, 2019

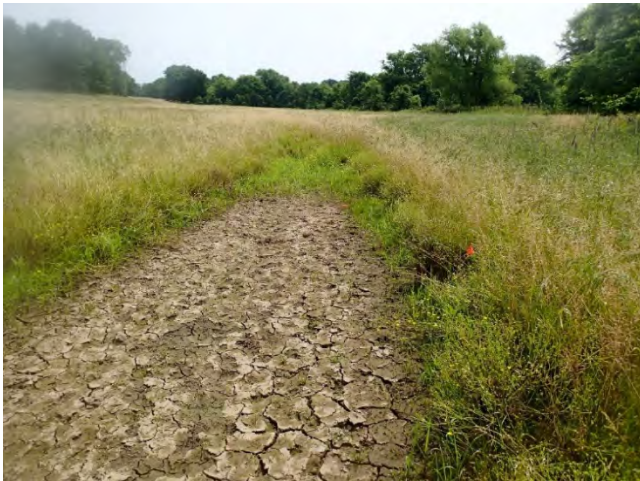
Wetland 2, June 5, 2019

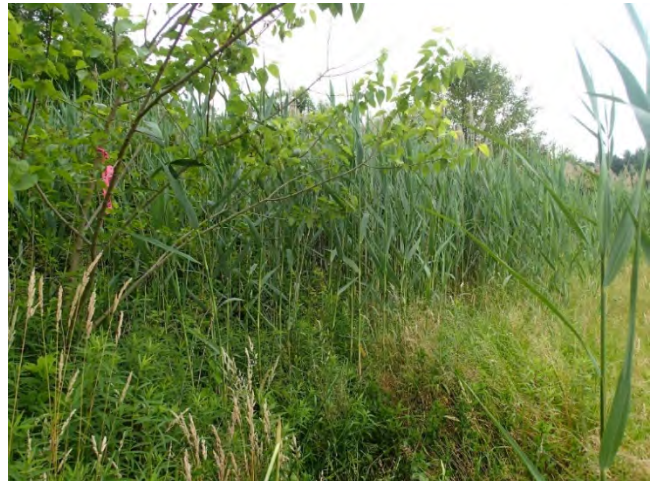
Wetland 3, June 5, 2019

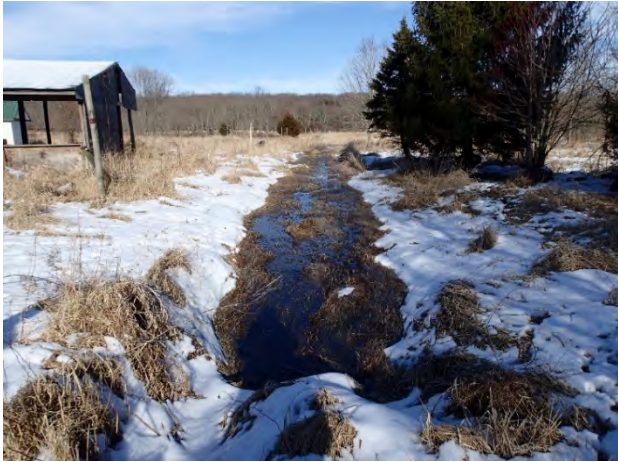
Unnamed tributary 1, February 14, 2019

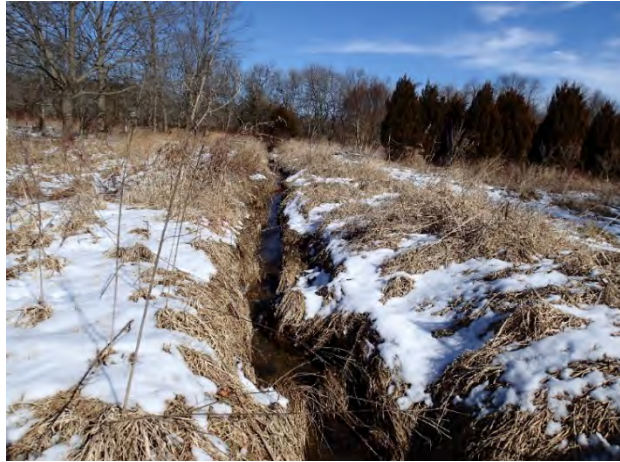
Unnamed tributary 2, February 14, 2019

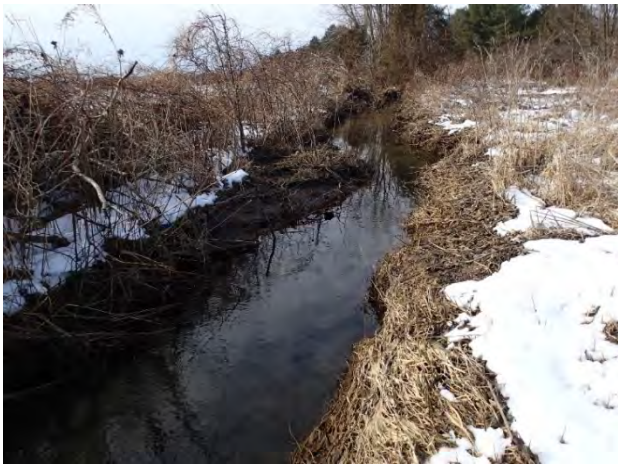
Unnamed tributary 3, February 14, 2019

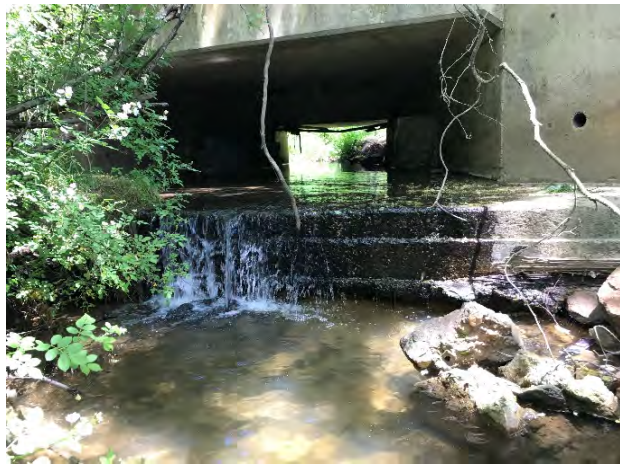
Mainstem @ Baldwin Mill Rd fish passage barrier

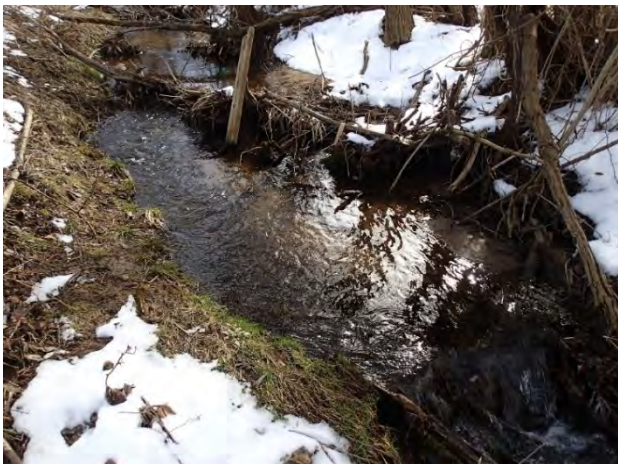
Unnamed tributary 4, February 14, 2019

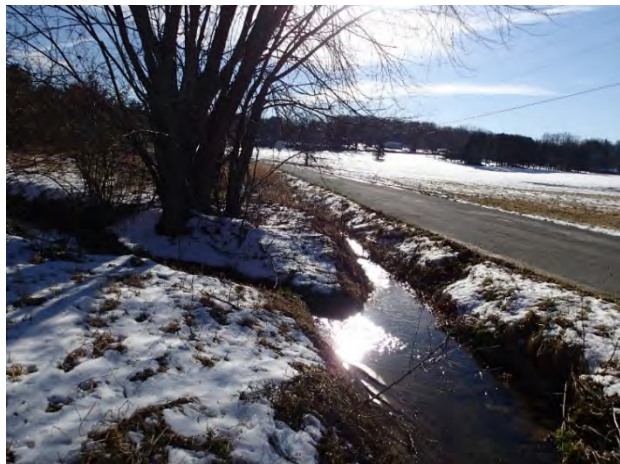
Unnamed tributary 5 at confluence with tributary 3.
