**Building 203 – Large Animal Building
USDA
Bureau of Engraving and Printing EIS
Beltsville, Prince George’s County, Maryland
1940**

MARYLAND HISTORICAL TRUST
DETERMINATION OF ELIGIBILITY FORM

Property Name: Building 203: Large Animal Building Inventory Number: PG:62-82
Address: 10300 Baltimore Avenue Building 203, Central Farm, Beltsville Historic district: yes no
Agricultural Research Center
City: Beltsville Zip Code: 20705 County: Prince Georges
USGS Quadrangle(s): Beltsville
Property Owner: U.S.A. - U.S. Department of Agriculture (USDA) Tax Account ID Number: 01-0070151
Tax Map Parcel Number(s): 0143 Tax Map Number: 0019
Project: Bureau of Engraving and Printing EIS Agency: USACE-Baltimore District
Agency Prepared By: AECOM
Preparer's Name: Kisa Hooks Date Prepared: 7/15/2020
Documentation is presented in: MIHP Form, PG:62-14
Preparer's Eligibility Recommendation: Eligibility recommended Eligibility not recommended
Criteria: A B C D Considerations: A B C D E F G
Complete if the property is a contributing or non-contributing resource to a NR district/property:
Name of the District/Property: Beltsville Agricultural Research Center

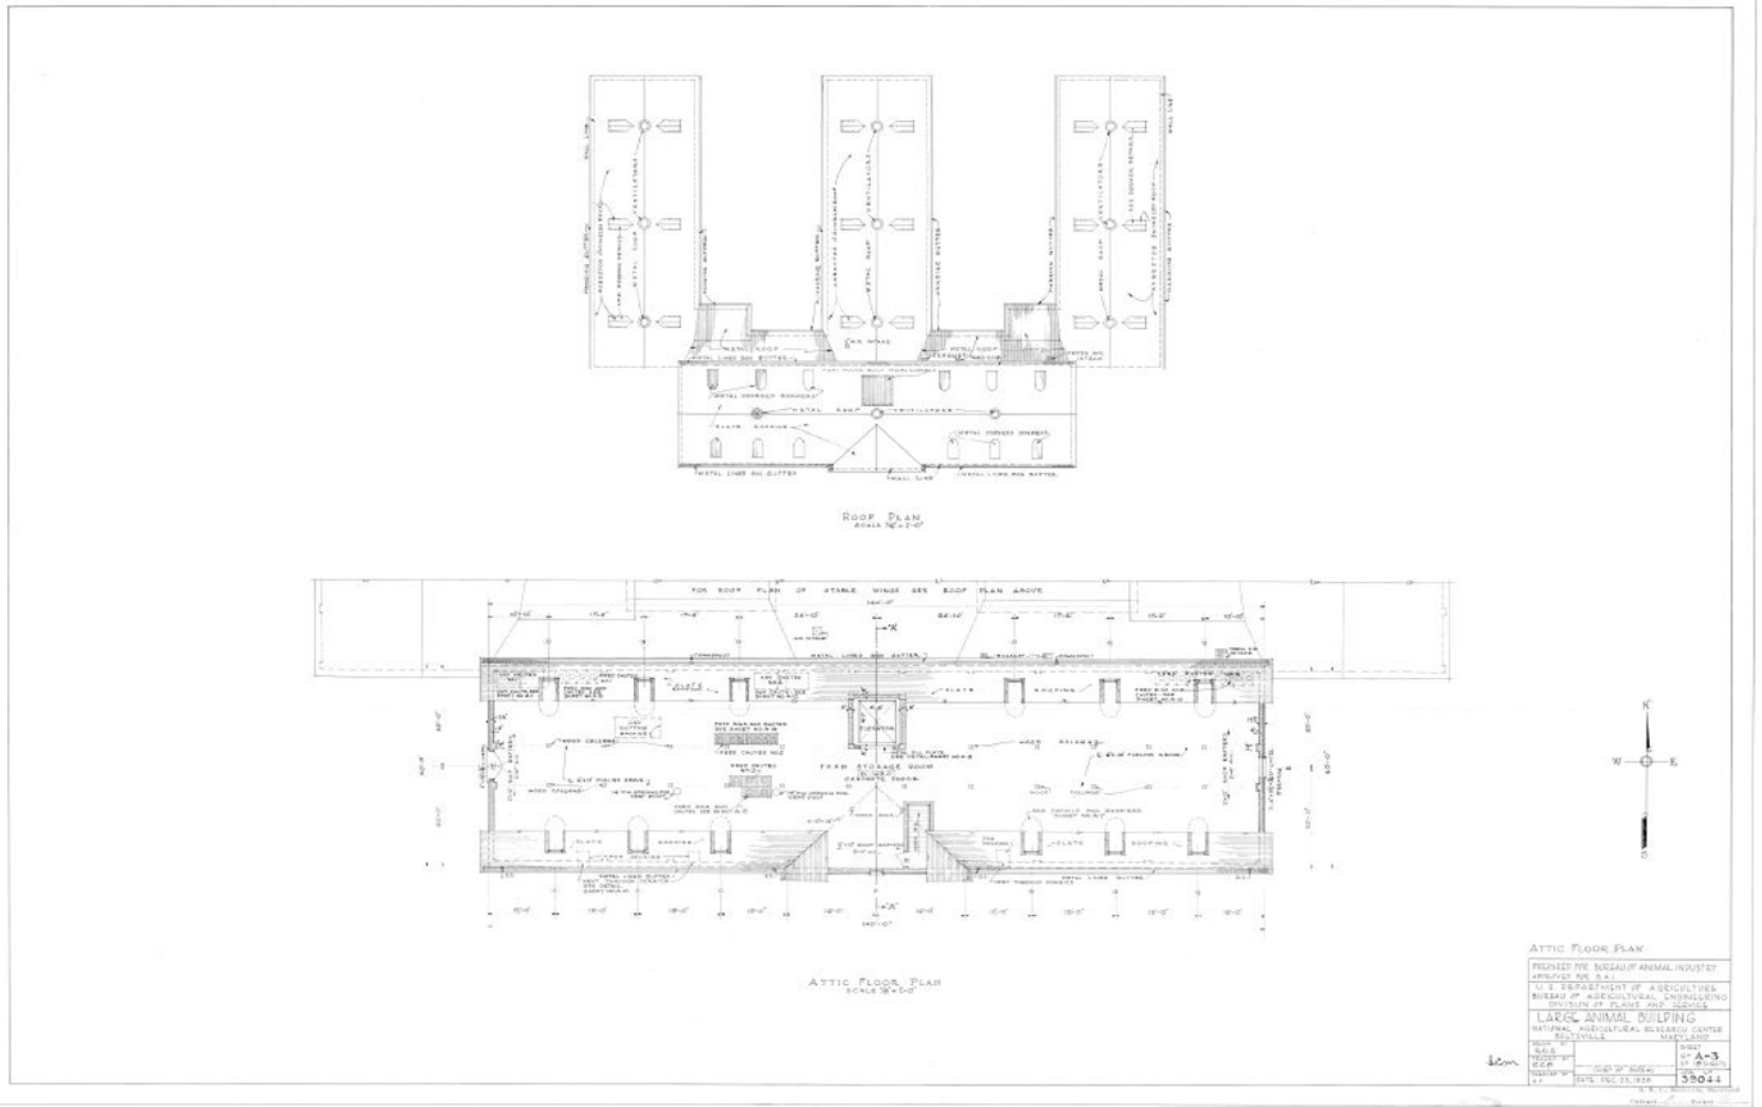
TITLE	Historic Drawing: Roof & Attic Plans
PROJ NO	
FIGURE	9

Review of Building 203's historic plans revealed a diverse programmatic use for the Central Section (Figure 9) and the North Wings (Figure 7) (USDA 1938). First floor interior programming of the Central Section was organized about a hallway and elevator aligned on the center axis of the building. West of the center axis was an office, laboratory, grain storage and small animal room. East of the center axis were the stairs, two adjacent metabolism rooms for horses and cows and a gas analysis room. The basement interior programming was also diverse and organized about the stair hall, elevator, refrigerator and transformer aligned on the center axis of the building. West of the center axis were the compressor room, feed weighing room, feed grinding room, dark room, operating room and hospital box stalls. East of the center axis were the stairs, men and ladies' restrooms, a colored

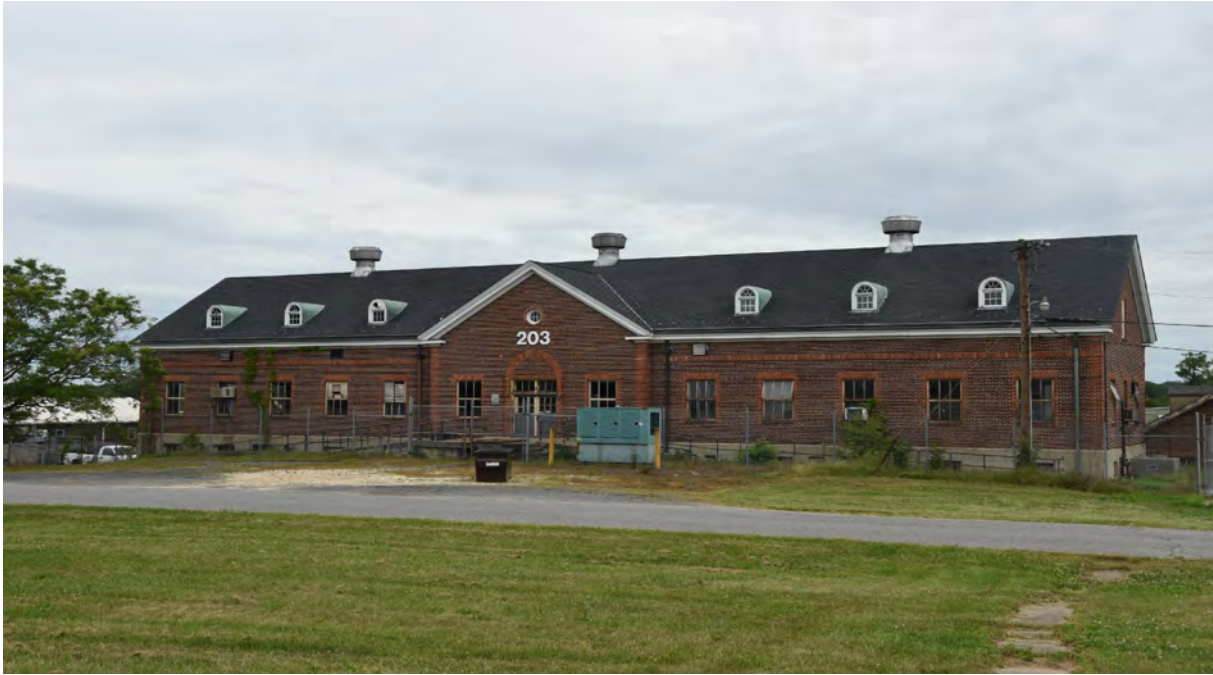
A projecting front-gabled entry with loading zone articulates the south façade (Photo 1; Figures 10 and 11). The entry has a pair of wooden doors with six-lites and a six-pane transom. Concrete steps with galvanized iron railing and concrete ramps provide access to the loading platform and entry. Fenestration includes six groupings of two-lite stacked three-pane steel sash awning windows on either side of the entry. According to historic plans, fenestration at the basement level were shorter or slimmer versions of those on the first floor; most were obscured from view but the two westernmost two-lite stacked three-pane steel sash awnings were visible. Exterior ornamentation includes fascia boards, wall vent grilles, a circular attic window above the entry, an arched brick surround about the entry, splayed brick lintels, brick window sills and a brick band between the lintels and fascia board. Some of the brick work may be a historic or sympathetic non-historic replacement to correct water damage about the window and door openings since the brick in these areas is of a lighter color.

Photo 1 - Building 03, Large Animal Building, Central Farm, View of South Elevation, Looking North

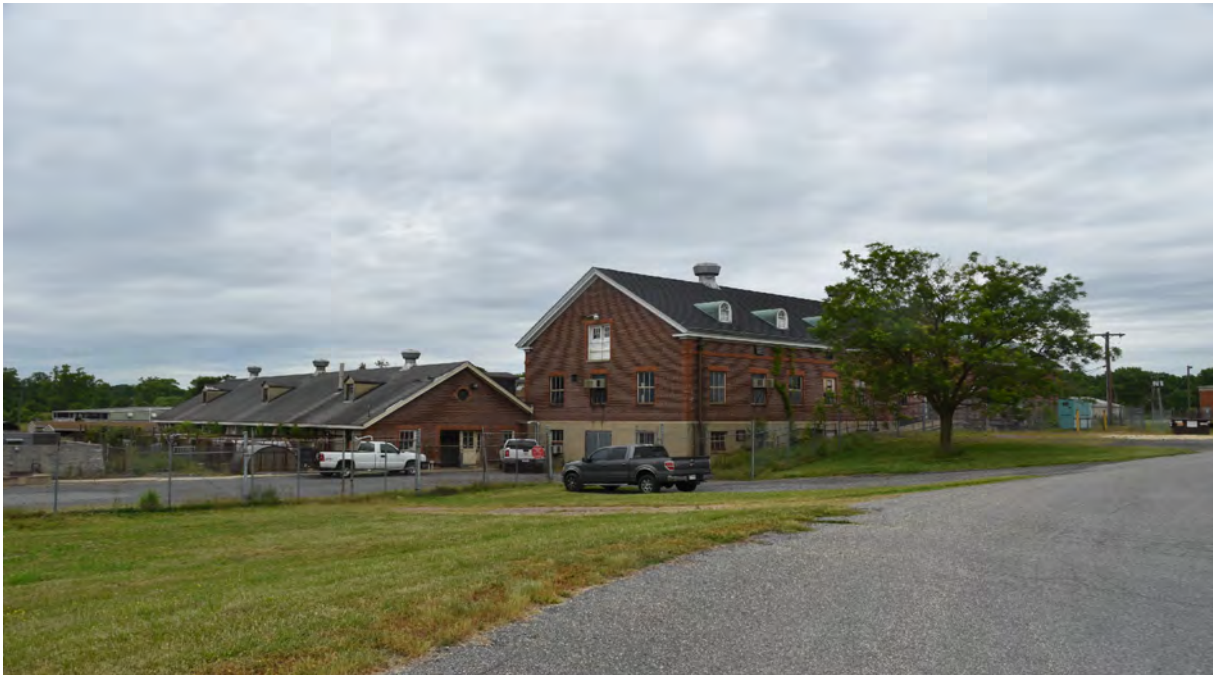
The west façade has a centered pair of hollow metal doors at the basement level flanked by a two-lite stacked three-pane steel sash awning window (Photo 2; Figures 10 and 11). There are three, two-lite stacked three-pane steel sash awning windows on the first floor. A secured pair of paneled wooden doors with six-lite panes centered exist at the attic level. Exterior ornamentation includes fascia boards, splayed brick lintels, and brick window sills. The corners, window, and door openings exhibit a different colored brick that suggests repairs to correct a water infiltration issue.

Photo 2 - Building 203, Large Animal Building, Central Farm, Oblique view of South Elevation, Looking Northeast

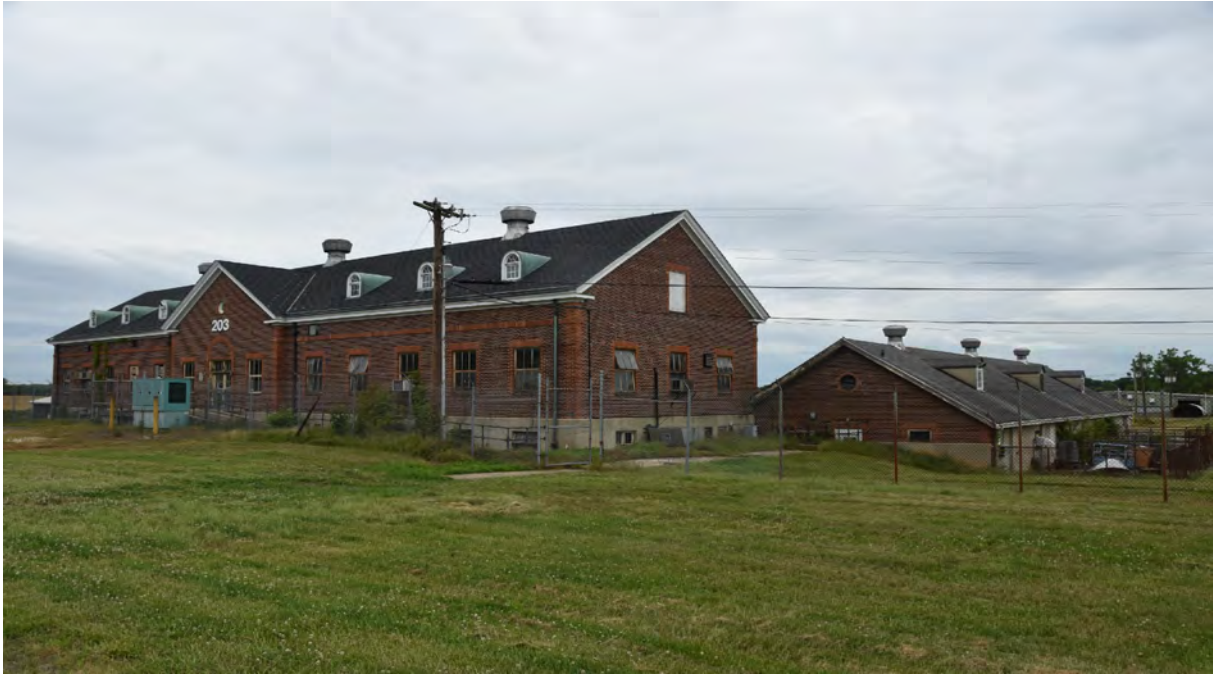
The east façade historically had three, three-pane steel sash awning windows at the basement level which now have non-historic replacements of unknown type as they obscured by the chain link fence and HVAC equipment (Photos 3 and 4; Figures 10 and 11). There are three, two-lite stacked three-pane steel sash awning windows on the first floor. An enclosed window exists at the attic level. Exterior ornamentation includes fascia boards, splayed brick lintels and brick window sills. The corners, window and door openings exhibit a different colored brick that suggests repairs to correct a water infiltration issue.

Photo 3 - Building 203, Large Animal Building, Central Farm, Oblique view of South Elevation, Looking Northwest

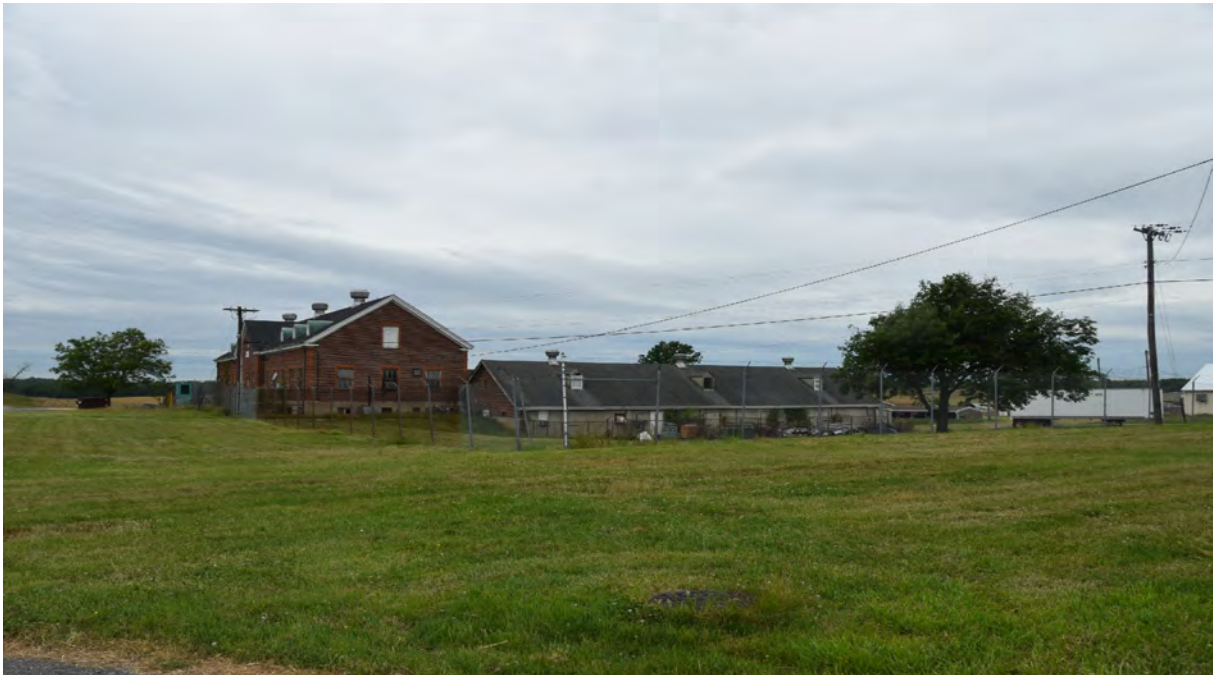
Photo 4 - Building 203, Large Animal Building, Central Farm, View of East Elevation, Looking West
