**MARYLAND HISTORICAL TRUST
DETERMINATION OF ELIGIBILITY FORM**

Property Name: Building 236: Poultry Record of Performance Brooder House, Beltsville Agricultural Research Center (BARC) Inventory Number: PG:62-56
 Address: 10300 Baltimore Avenue, Building 236, Central Farm City: Beltsville Zip Code: 20705
 County: Prince George's County USGS Topographic Map: Beltsville 7.5-Minute
 Owner: U.S.A. - U.S. Department of Agriculture (USDA) Is the property being evaluated a district? yes
 Tax Parcel Number: 0143 Tax Map Number: 0019 Tax Account ID Number: 01-0070151
 Project: DOEs for 69 Buildings at BARC Agency: USDA
 Site visit by MHT Staff: no yes Name: _____ Date: _____
 Is the property located within a historic district? yes no

Poultry Record of Performance Brooder House, Building 236

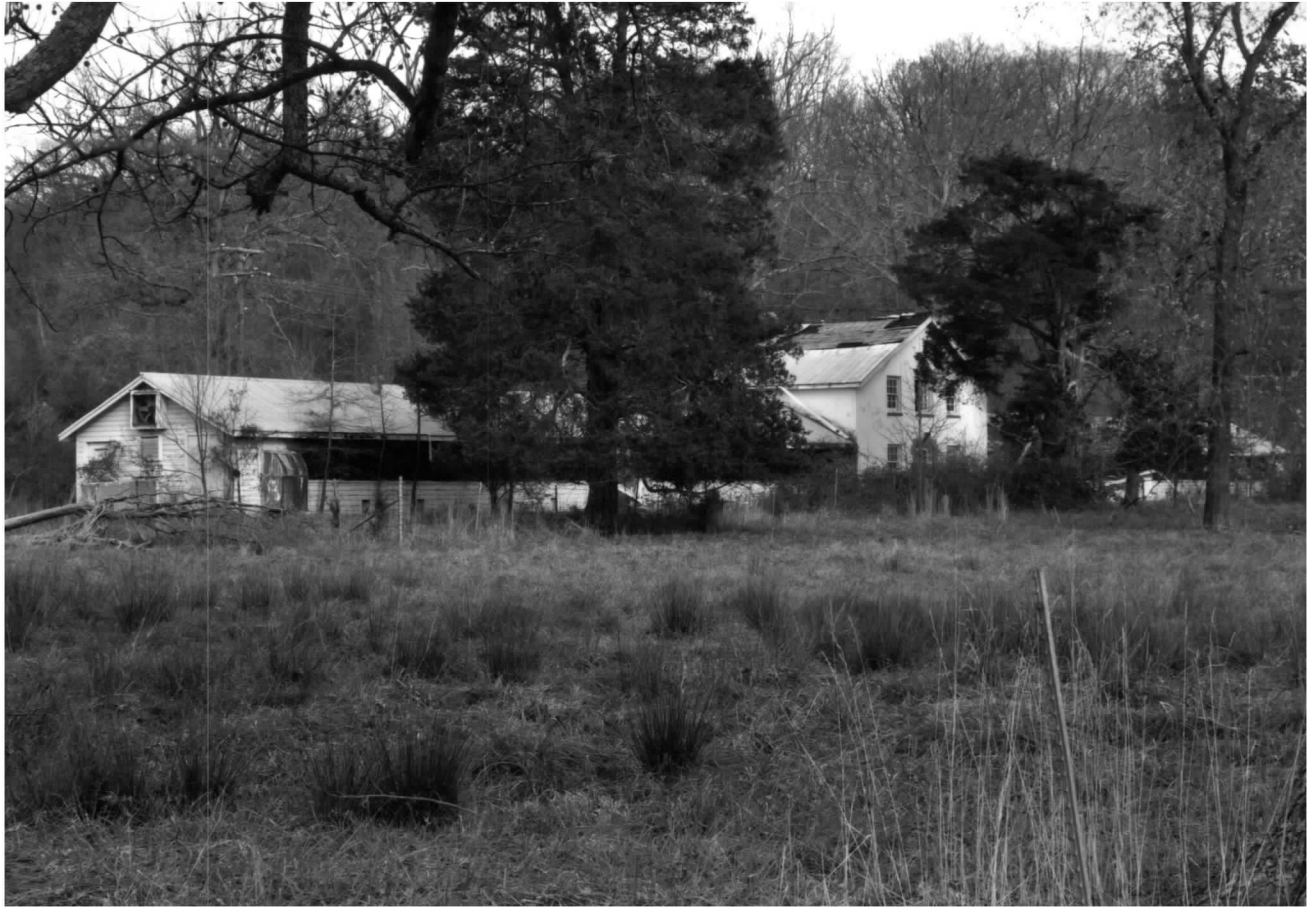
1 of 4

The central section of the north facade at the first story includes a central door with brick quoining (Photo 1). The central door is flanked on both sides by single windows. The second story has central double wood doors topped by a rounded brick arch header filled by a metal vent. Flanking both sides of the central double doors are single windows. Both the first and second story windows west of the central entrances are boarded over. The central section of the south elevation at the first story has a central door with brick quoining that is flanked on both sides by single windows (Photo 2). The second story has a central rounded window that is flanked by single windows.

1. PG;62-56_2017-12-07_01.tif, Building 236, PROP, Central Farm, View of North Elevation, Looking Southeast
2. PG;62-56_2017-12-07_02.tif, Building 236, Poultry Record of Performance Brooder House (PROP), Central Farm, View of West and South Elevations, Looking Northeast
3. PG;62-56_2017-12-07_03.tif, Building 236, PROP, Central Farm, View of East and North Elevations, Looking Southwest
4. PG;62-56_2017-12-07_04.tif, Building 236, PROP, Central Farm, View of South and East Elevations, Looking Northwest

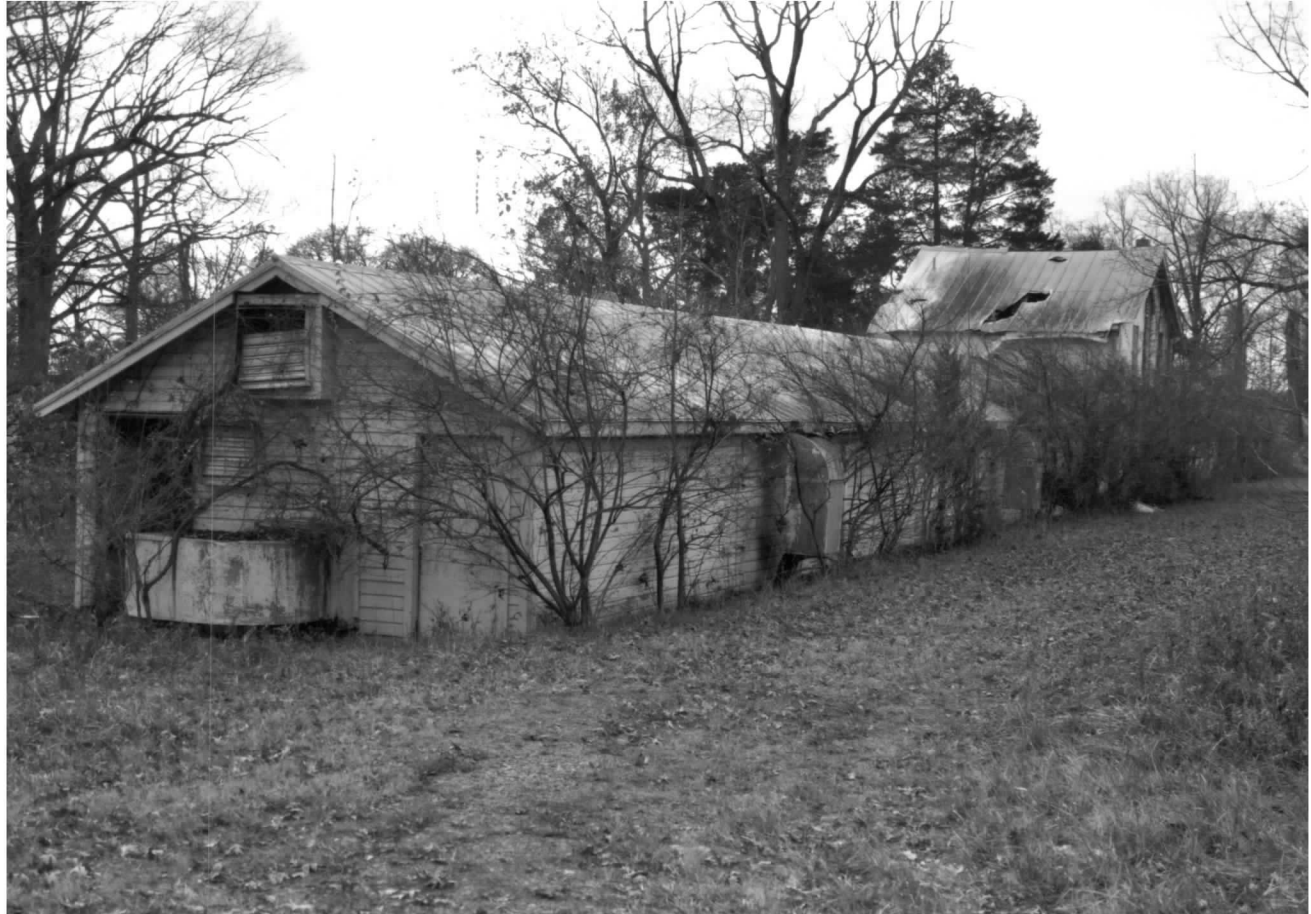
3 of 4

Projecting to the east and west of the central section are clapboard-sided wings (Photos 3 and 4). Each wing has partitioned areas for the hens. The north elevations of the east and west wings have three, three-light, awning, wood windows that are evenly spaced and arranged towards the roof eave. However, the awning windows are either boarded over or filled by large metal ventilators (Photo 3). Both the east and west gable ends of Building 236 have two door openings with wood doors near the north and south elevations (Photos 3 and 4). Between the doors is a large mechanical box, an off-center metal vent, and near the gable peak is a large projecting metal vent. The south elevations consist of half walls for the hen partitions. The lower portions of the half walls have small squares that were probably used for drainage, and the upper portions have open bays (Photo 4). The open bays are currently boarded over. Both of the south elevations have two, evenly spaced metal ventilators.
