**Building 267 – Turkey Brooder and Feed House
USDA – Beltsville Agricultural Research Center (BARC)
Bureau of Engraving and Printing EIS
Beltsville, Prince George’s County, Maryland
Ca. 1936**

**MARYLAND HISTORICAL TRUST
DETERMINATION OF ELIGIBILITY FORM**

Property Name: Building 267: Turkey Brooder and Feed House Inventory Number: PG:62-69
 Address: 10300 Baltimore Avenue Building 267, Central Farm, Beltsville Historic district: yes no
Agricultural Research Center (BARC)
 City: Beltsville Zip Code: 20705 County: Prince Georges
 USGS Quadrangle(s): Beltsville
 Property Owner: U.S.A. - U.S. Department of Agriculture (USDA) Tax Account ID Number: 01-0070151
 Tax Map Parcel Number(s): 0143 Tax Map Number: 0019
 Project: Bureau of Engraving and Printing EIS Agency: USACE-Baltimore District
 Agency Prepared By: AECOM
 Preparer's Name: Rebecca McGovern Date Prepared: 10/31/2019
 Documentation is presented in: MIHP Form, PG:62-14
 Preparer's Eligibility Recommendation: Eligibility recommended Eligibility not recommended
 Criteria: A B C D Considerations: A B C D E F G
Complete if the property is a contributing or non-contributing resource to a NR district/property:

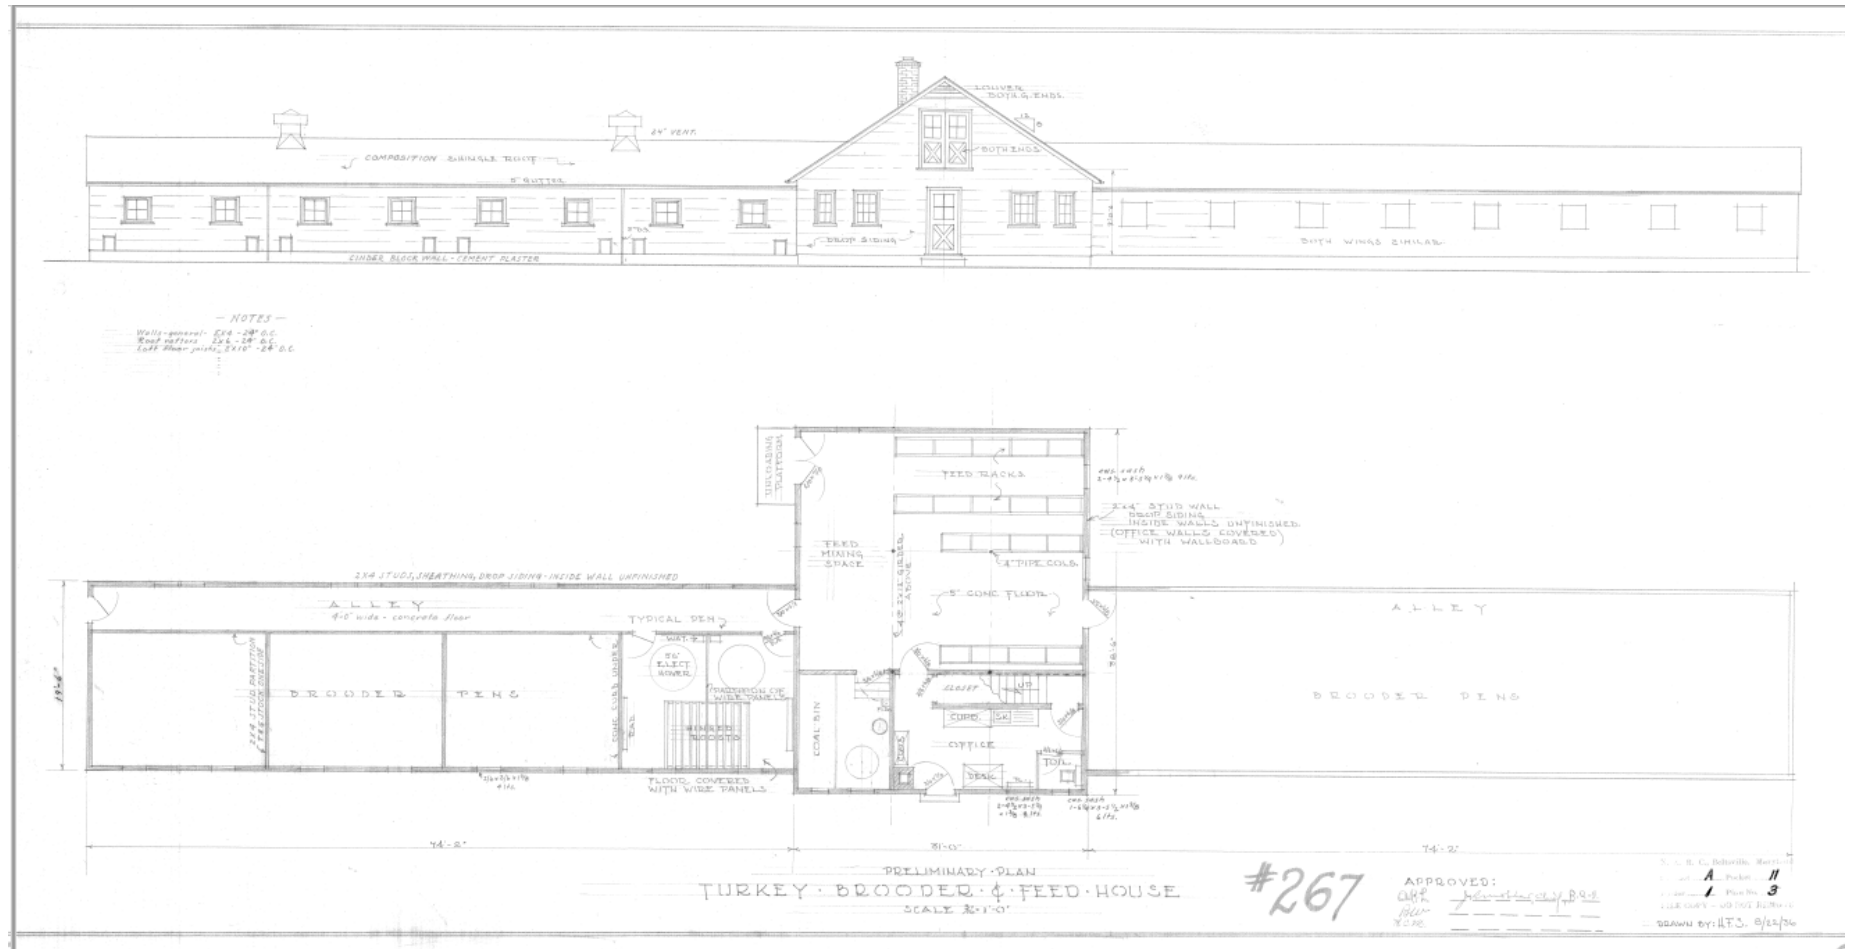
TITLE	Historic Drawing: Preliminary Plan and Front (South) Elevation	
PROJ NO		
FIGURE	7

According to original drawings, the interior plan of the central portion of the building contained an office, coal bin, and feed mixing space with concrete floors. The wings each feature an alley (Photo 5) on the north side that provided access to the brooder pens on the south side. A typical brooder pen consisted of hinged roosts, feeders, waterers and floors covered with wire panels (Figure 7).

Located in the USDA ARS BARC’s Central Farm (Figures 3 through 6), Building 267 (Photos 1 through 5) was built as a turkey brooder and feed house, ca. 1936 (Figure 7, USDA 1936). The one-to-two-story, wood frame building is built on a concrete foundation, has a rectangular footprint, and is oriented on an east-west axis, with a south-facing primary façade. The building (Photo 1) consists of a central, two-story section, with symmetrical one-story wings extending to the east and west. The wood stud walls, which are unfinished on the inside, are clad in wood lap siding. The cross-gable roof is covered in a non-historic elastomeric roof coating which has replaced the original composition shingles at an unknown date. There is a single brick interior chimney situated on the west roof slope of the central section, and four evenly spaced metal vents projecting from the roof ridge of the east and west wings.

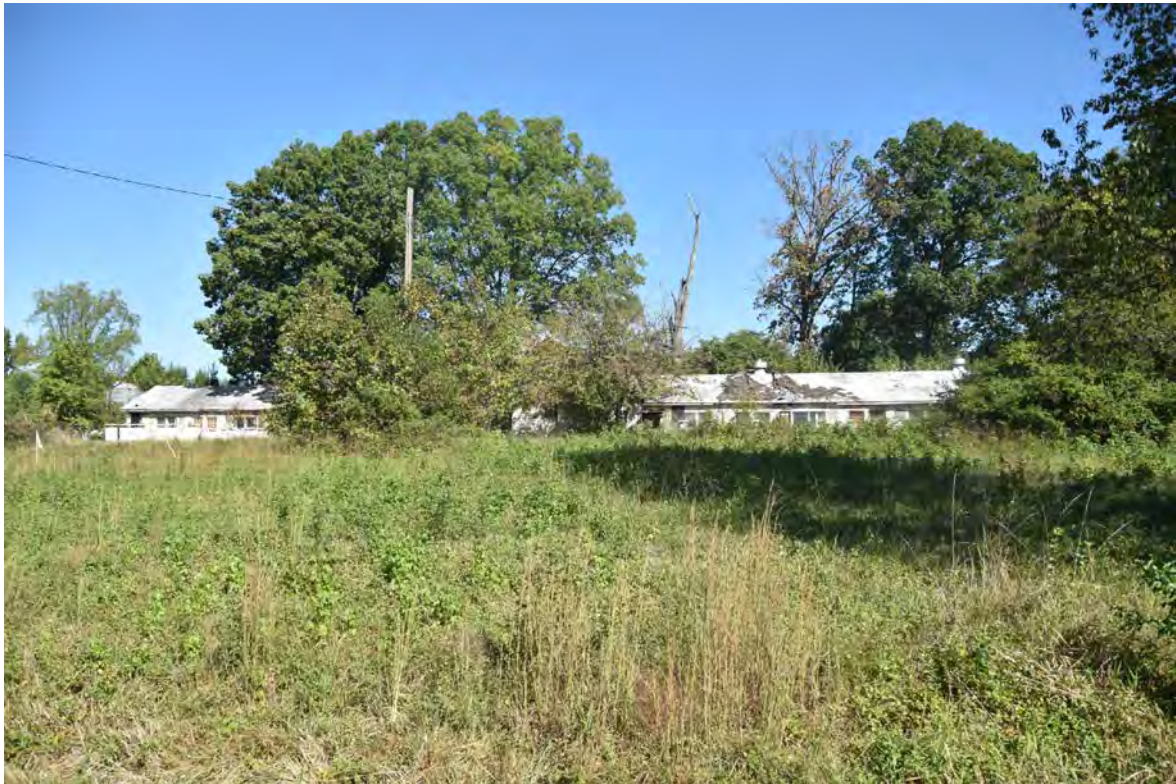
Photo 1 – Building 267, Turkey Brooder and Feed House, Central Farm, View of South Elevation, Looking North

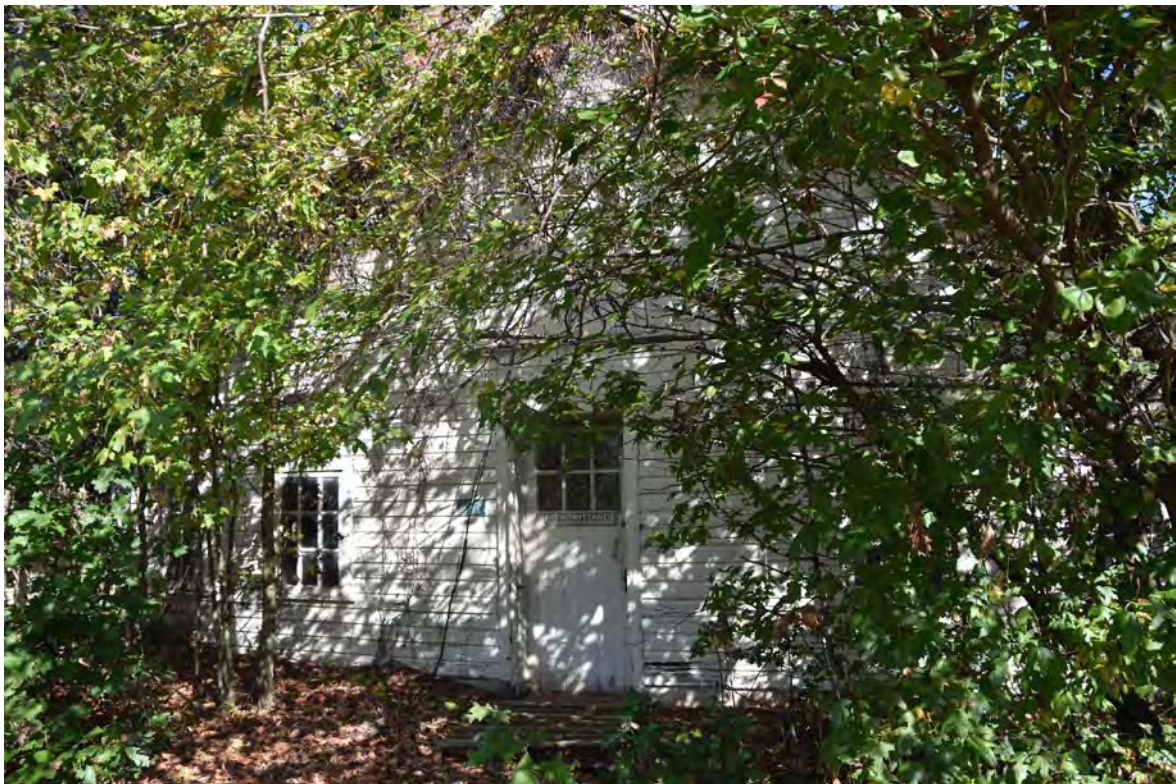
The central section of the building (Photo 2), where the main entrance is located, is two stories tall and features a hayloft on the second story. A single wood door, which may have been replaced at some point, with six lights is centered on the façade with original fixed six- and nine-light wood sash windows flanking each side. The hayloft double doors, located on the second story above, may also have been replaced. A louvered vent is in the gable end. Paired six light wood sash sliding windows covered with wire mesh are regularly spaced throughout the south elevation of the wings. Small square-sized doors for chickens are located along the base of the elevation.

Photo 2 – Building 267, Turkey Brooder and Feed House, Central Farm, View of South Elevation, Looking North

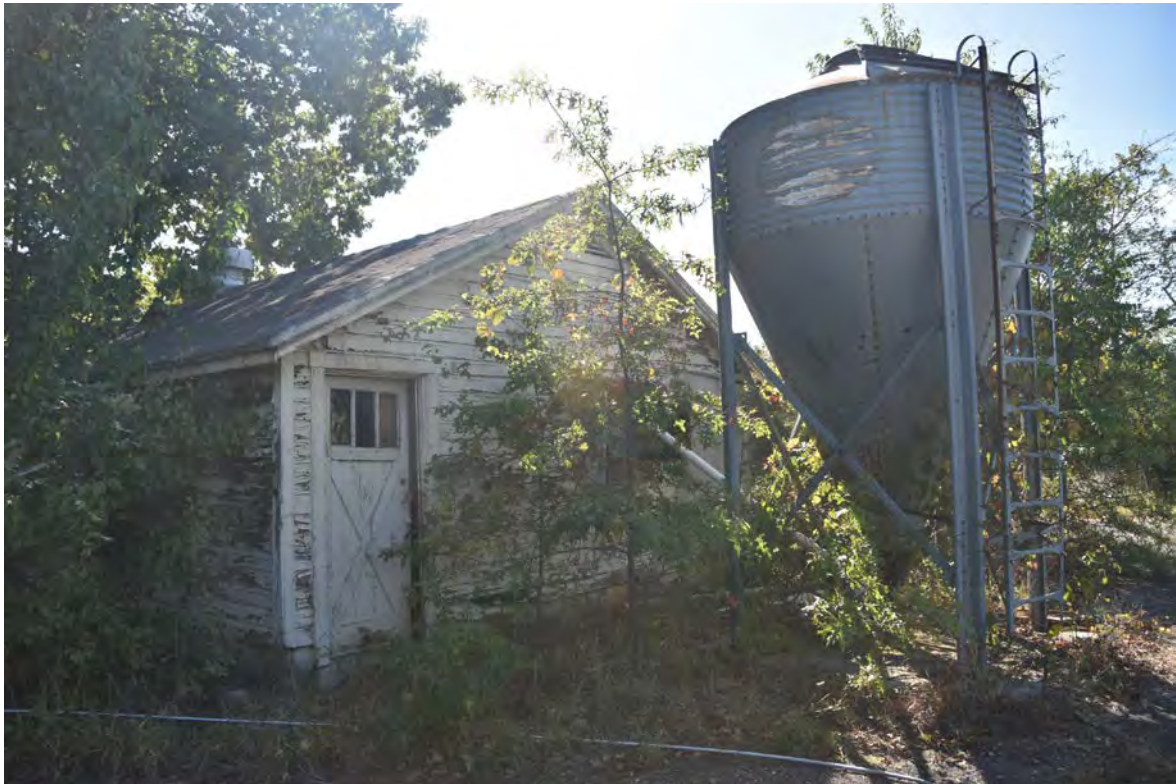
The east and west elevations (Photo 3) feature original three light wood doors with an “X” design and louvered vents in the gable end. Large metal grain bins are situated adjacent to each end of the building. Windows along the north (rear) elevation (Photo 4) of the wings are covered with plastic sheeting. The central section, which projects further at the rear, features double doors (possibly replacements) to a loading area and another set of possibly non-original hayloft doors. Windows are one-over-one double-hung wood sash that may have been replaced. Another louvered vent is situated in the gable end.

Photo 3 – Building 267, Turkey Brooder and Feed House, Central Farm, View of West Elevation, Looking Southeast

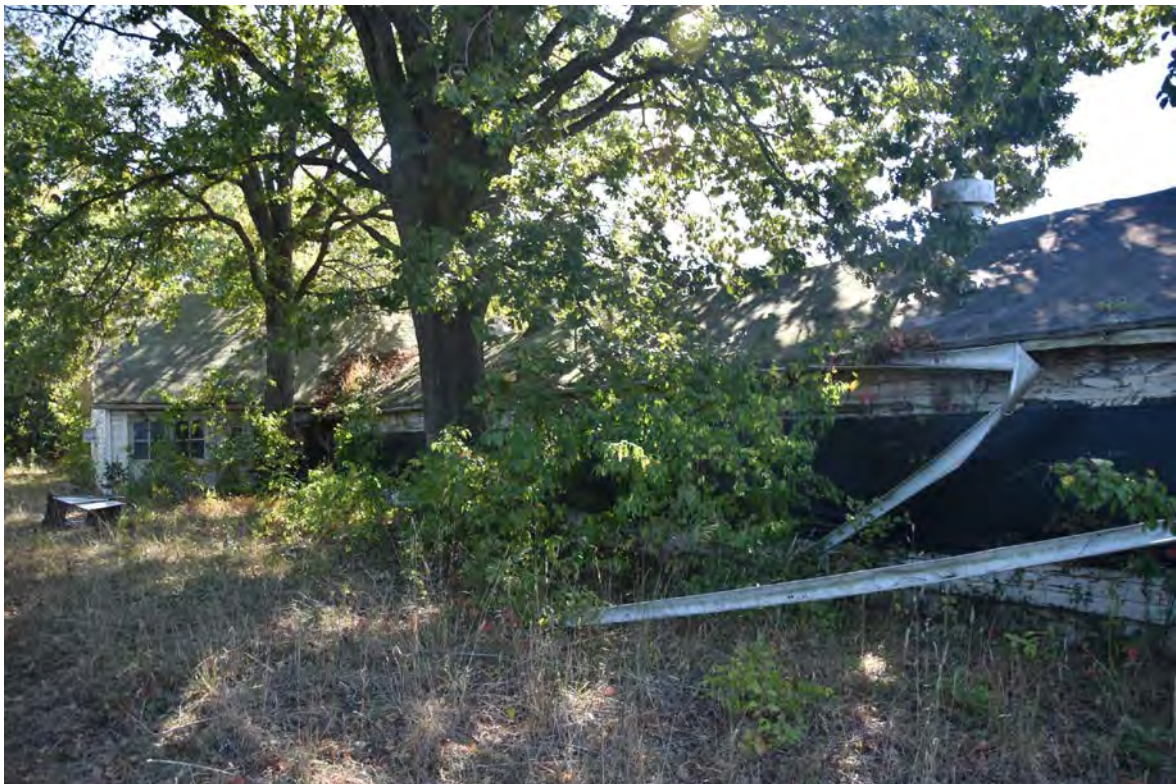
Photo 4 – Building 267, Turkey Brooder and Feed House, Central Farm, View of North Elevation, Looking Southeast

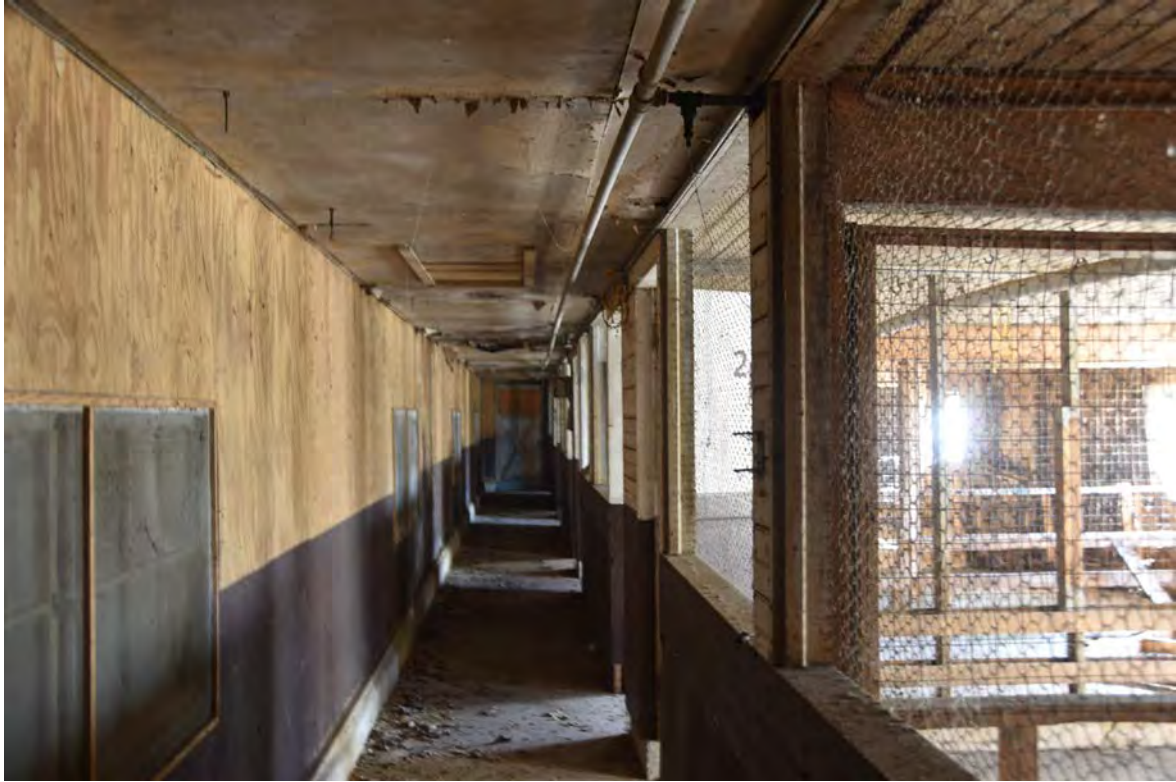
Photo 5 – Building 267, Turkey Brooder and Feed House, Central Farm,
View of East Wing Alley, Looking East
