APPENDIX B:
ENVIRONMENTAL, CULTURAL RESOURCES
AND NON-FEDERAL SPONSOR COORDINATION

Starrucca Creek CAP 14 Emergency Streambank Stabilization

SR 1005 USACE
STARRUCCA CREEK
PHOTOGRAPHS
THOMPSON TOWNSHIP
SUSQUEHANNA COUNTY

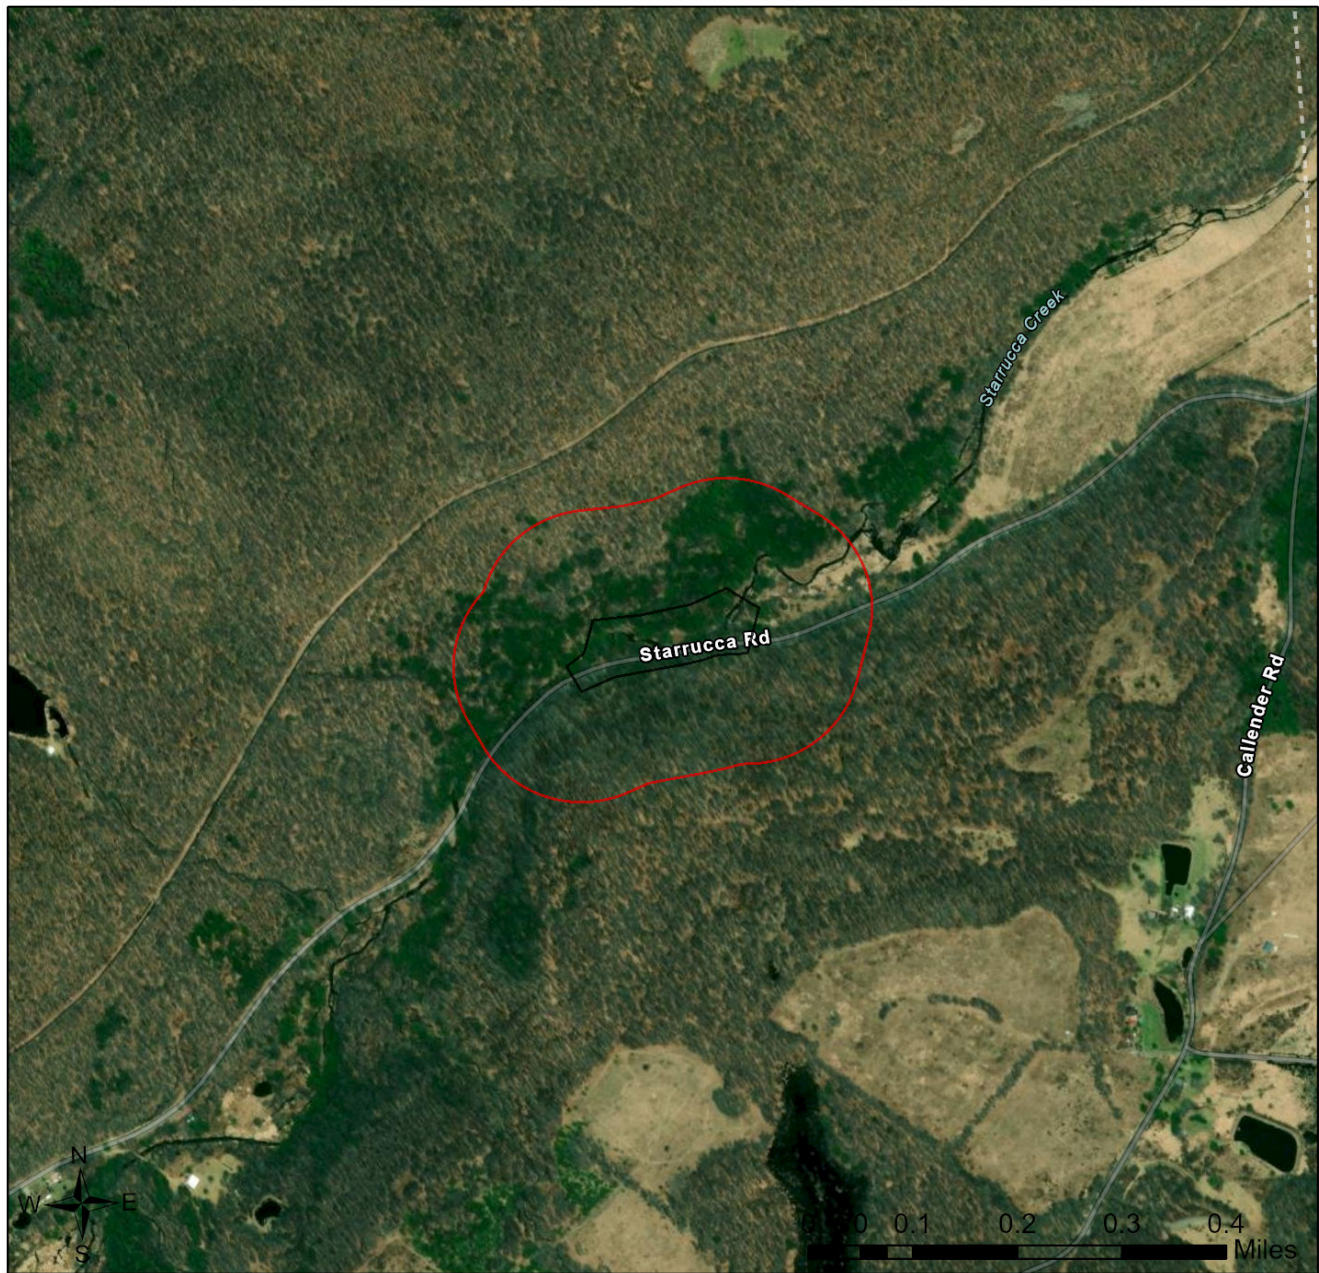
Project Boundary

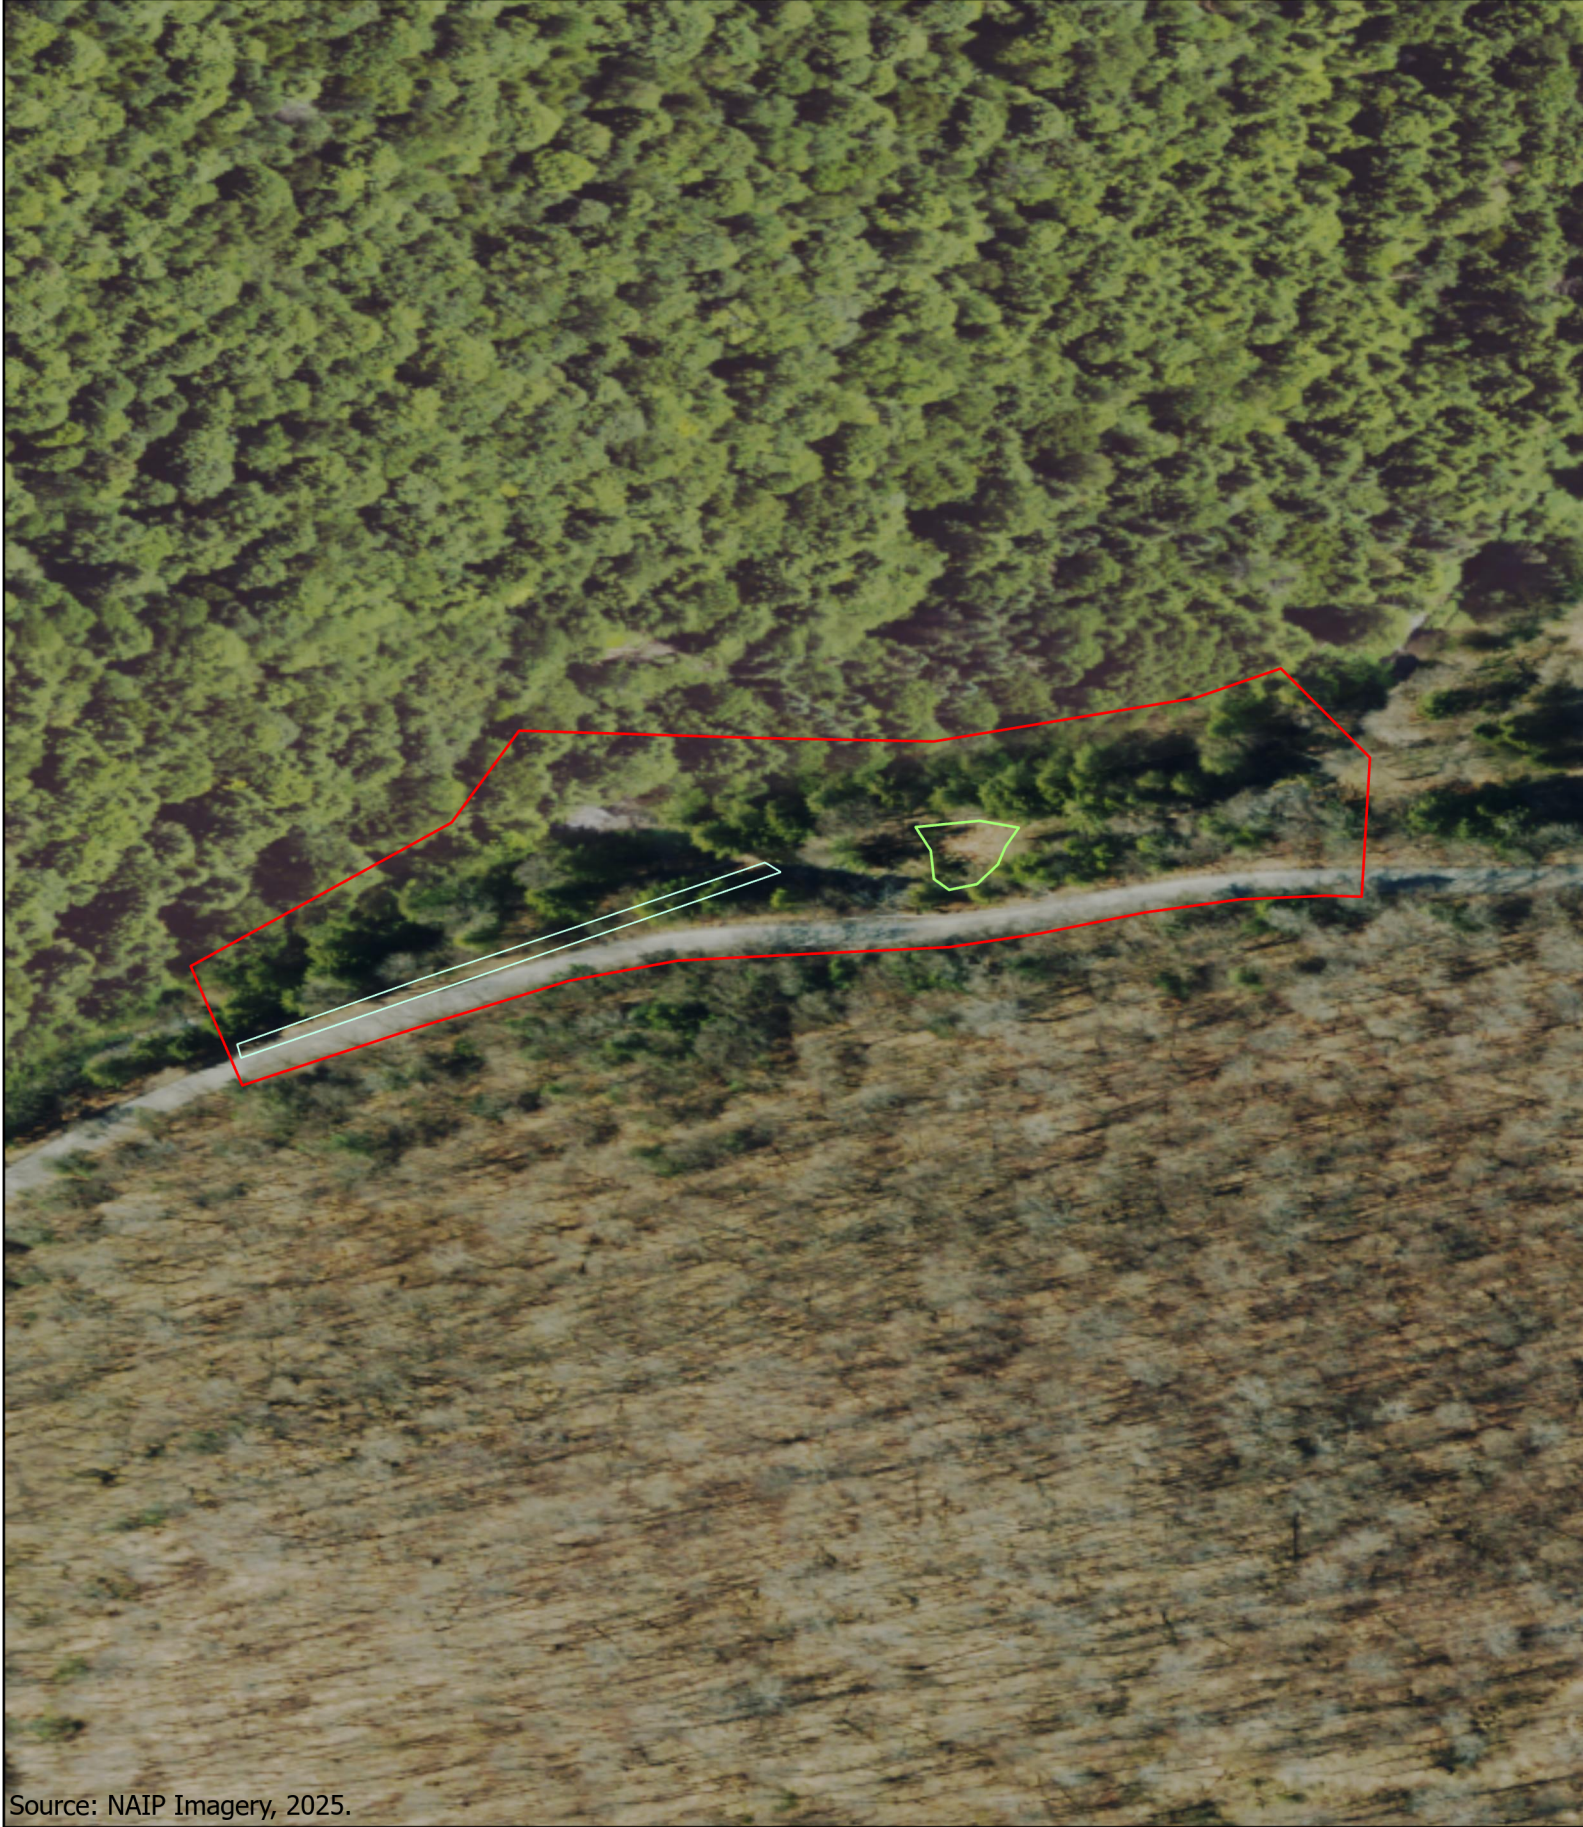
Area of Potential Effect

The project's area of potential effect (APE) may be defined as the area of direct construction impacts and the areas within which the undertaking may directly or indirectly cause alterations to the character or use of historic properties, including visual effects. A draft APE is included in Enclosure 1 for your review. A preliminary review of the Pennsylvania State Historic and Archaeological Resources Exchange (PA-SHARE) indicates that no historic properties have been identified within the APE. Additionally, the APE boundaries fall within an area that was surveyed in February 2016 by Circa CRM (*Phase I Cultural Resources Survey of Starrucca Creek Mitigation Project* [Report No. 2016RP00224]). The investigation did not document any resources and recommended no additional cultural resources investigations. Given the lack of previously identified resources within the APE, the proposed project would have no effects on historic properties.

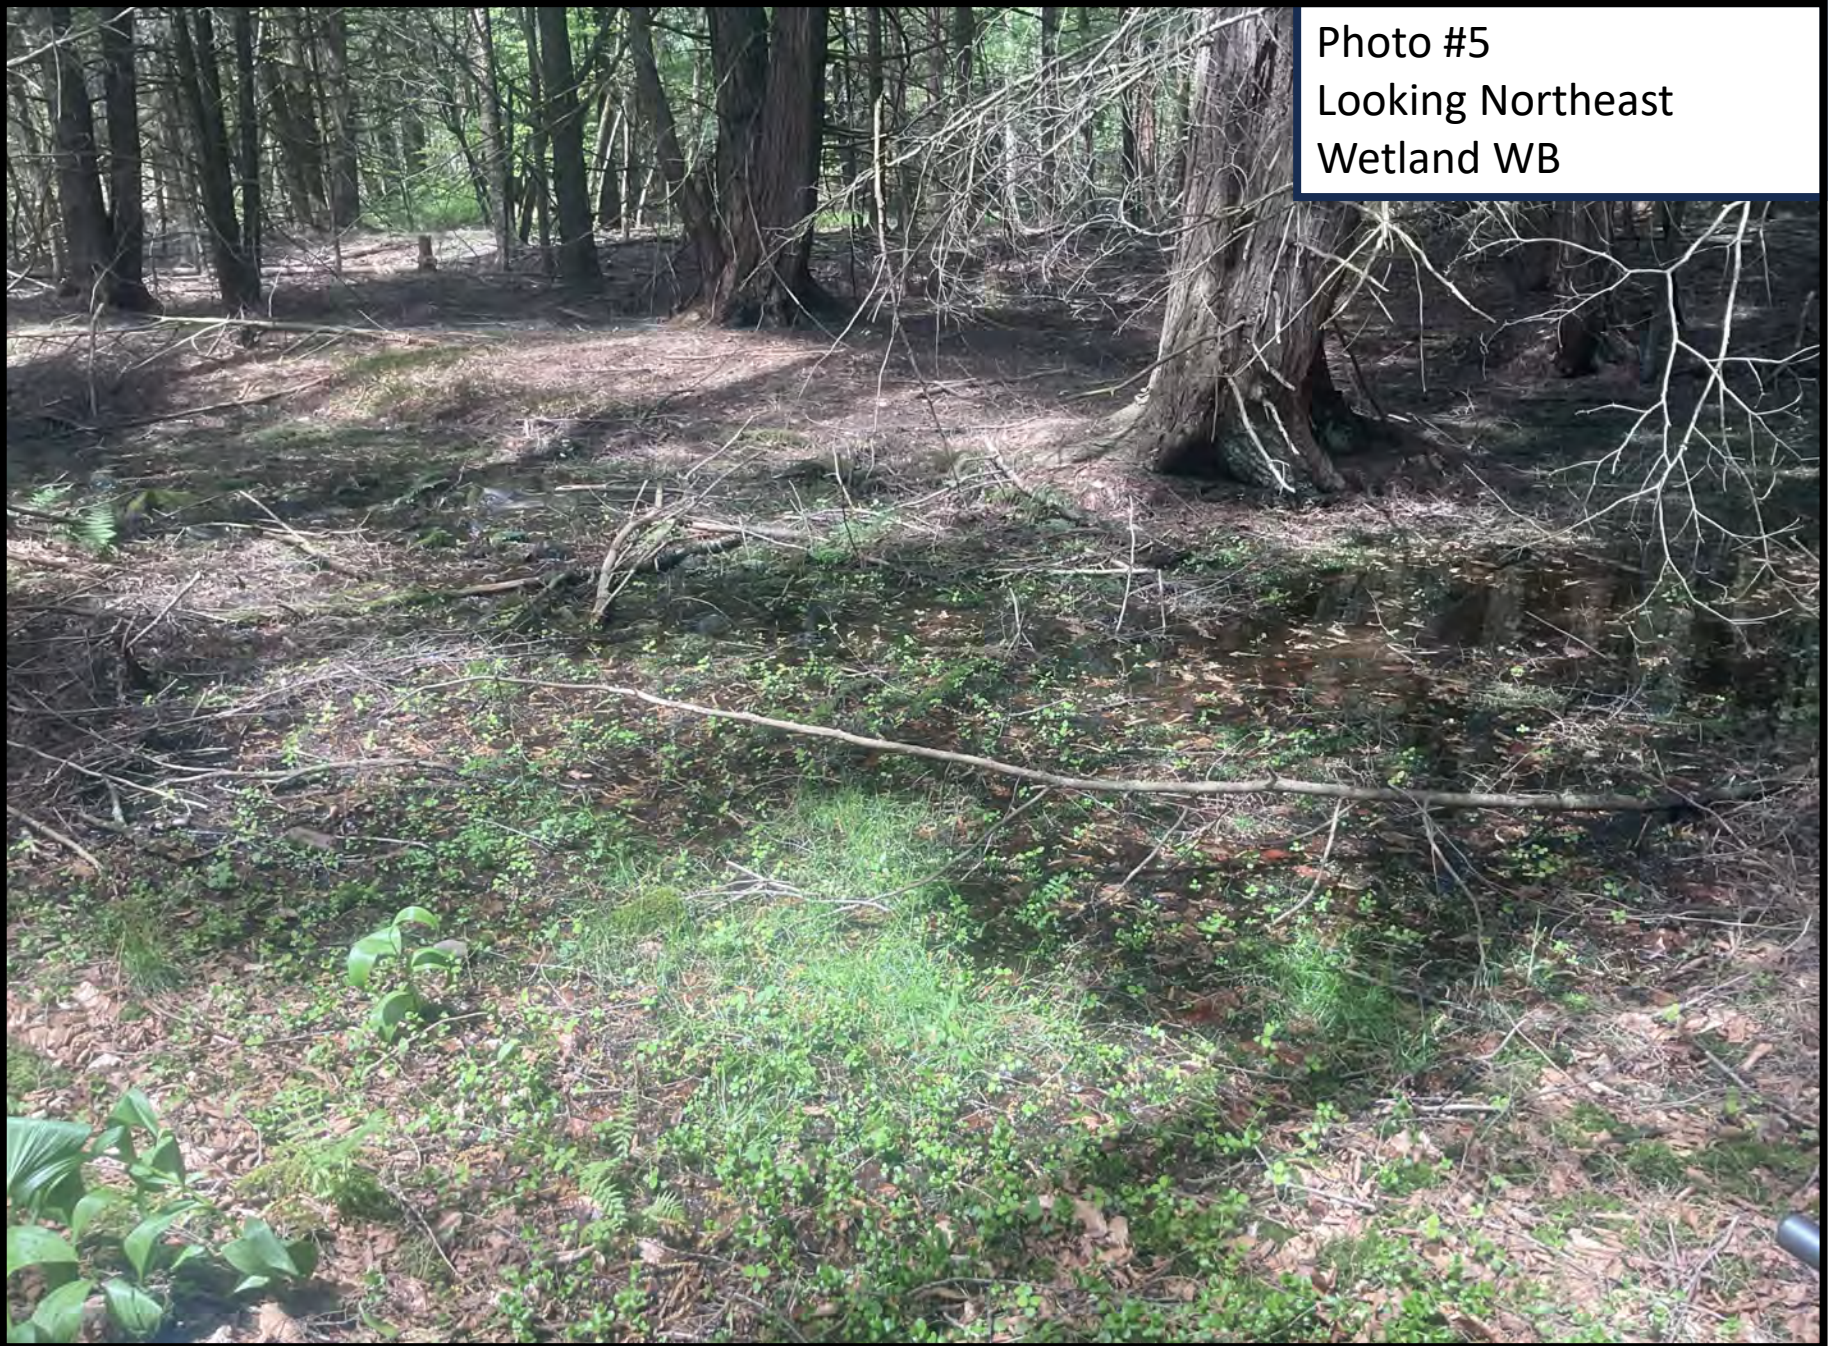
Photo #5
Looking Northeast
Wetland WB

Wetland B (SS-WB) is a Palustrine Emergent Wetland (PEM) system located along the floodplain of Starrucca Creek. This wetland is an open-ended wetland that parallels Starrucca Creek. The wetland system contains vegetation such as Eastern Hemlock, Yellow Birch, False Hellbore, Creeping Jenny, Jewel Weed, and Buttercup. The soil profile consists of one matrix color with total depth of 18 inches. 0-18" contains a matrix color of 10YR 4/2 at 85% with a redox concentration color of 10YR 6/8 at 15%. Hydrology Indicators observed were Surface Water at a depth of 1", Water Table at a depth of 2", Saturation at a depth of 0", Geomorphic Position, Drainage Patterns, and Water Marks. The source of hydrology for the wetland is from stormwater runoff and over-bank flooding from Starrucca Creek.

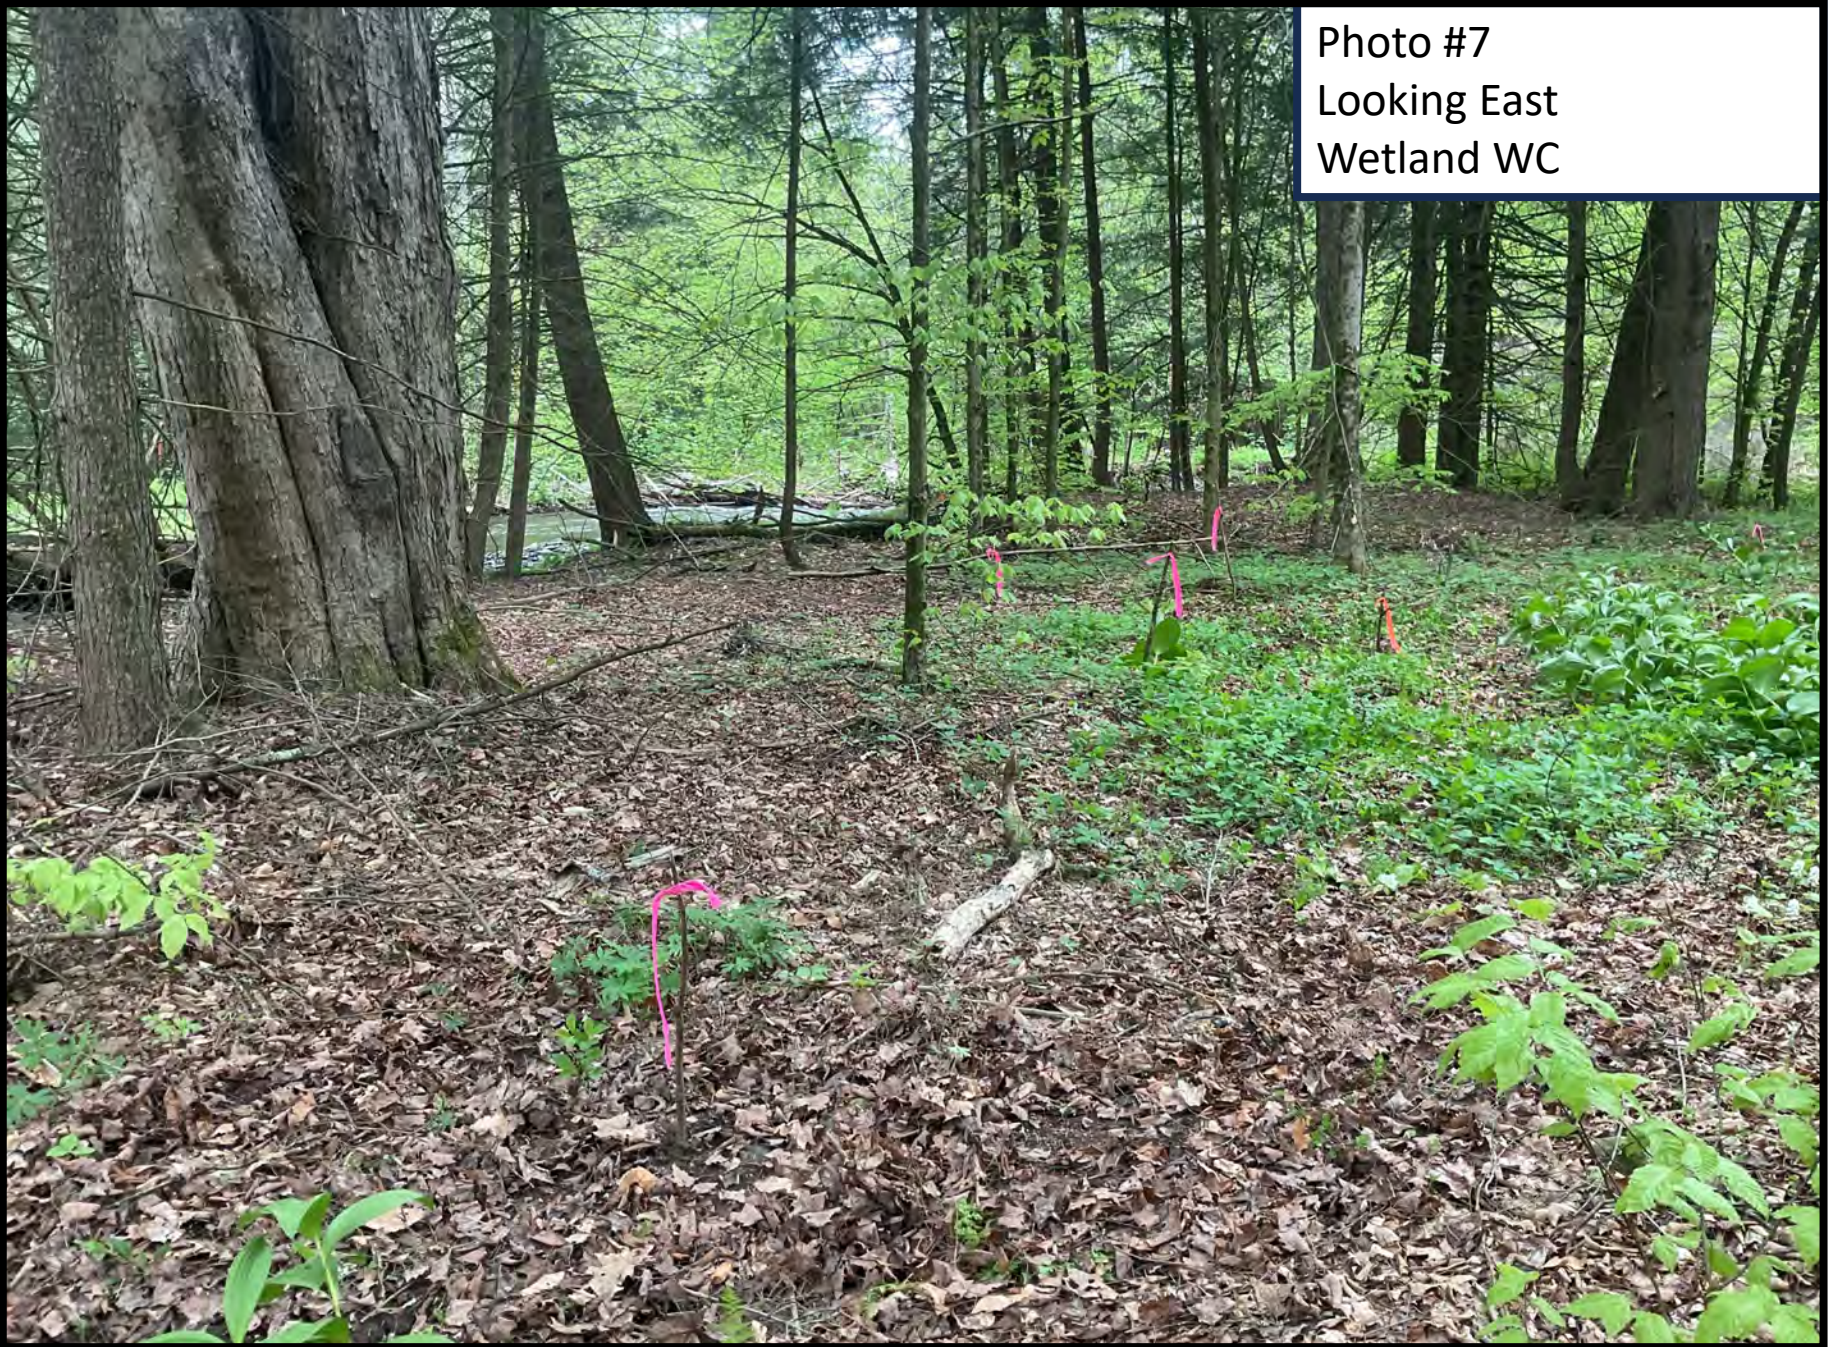
Photo #7
Looking East
Wetland WC

Wetland C (SS-WC) is a Palustrine Emergent Wetland (PEM) system located along the floodplain of Starrucca Creek. This wetland is an isolated wetland that parallels Starrucca Creek. The wetland system contains vegetation such as American Basswood, False Hellbore Foam Flower, Meadow Rue, Wood Leek, and Sensitive Fern. The soil profile consists of one matrix color with total depth of 14 inches. 0-14" contains a matrix color of 10YR 4/1 at 80% with a redox color of 10YR 5/6 at 20%. A restrictive layer was observed at 14" due to Hardpan. No surface water or water table observed. The hydrology indicator of soil Saturation was observed at a depth of 8 inches. The source of hydrology for the wetland is from stormwater runoff and over-bank flooding from Starrucca Creek.

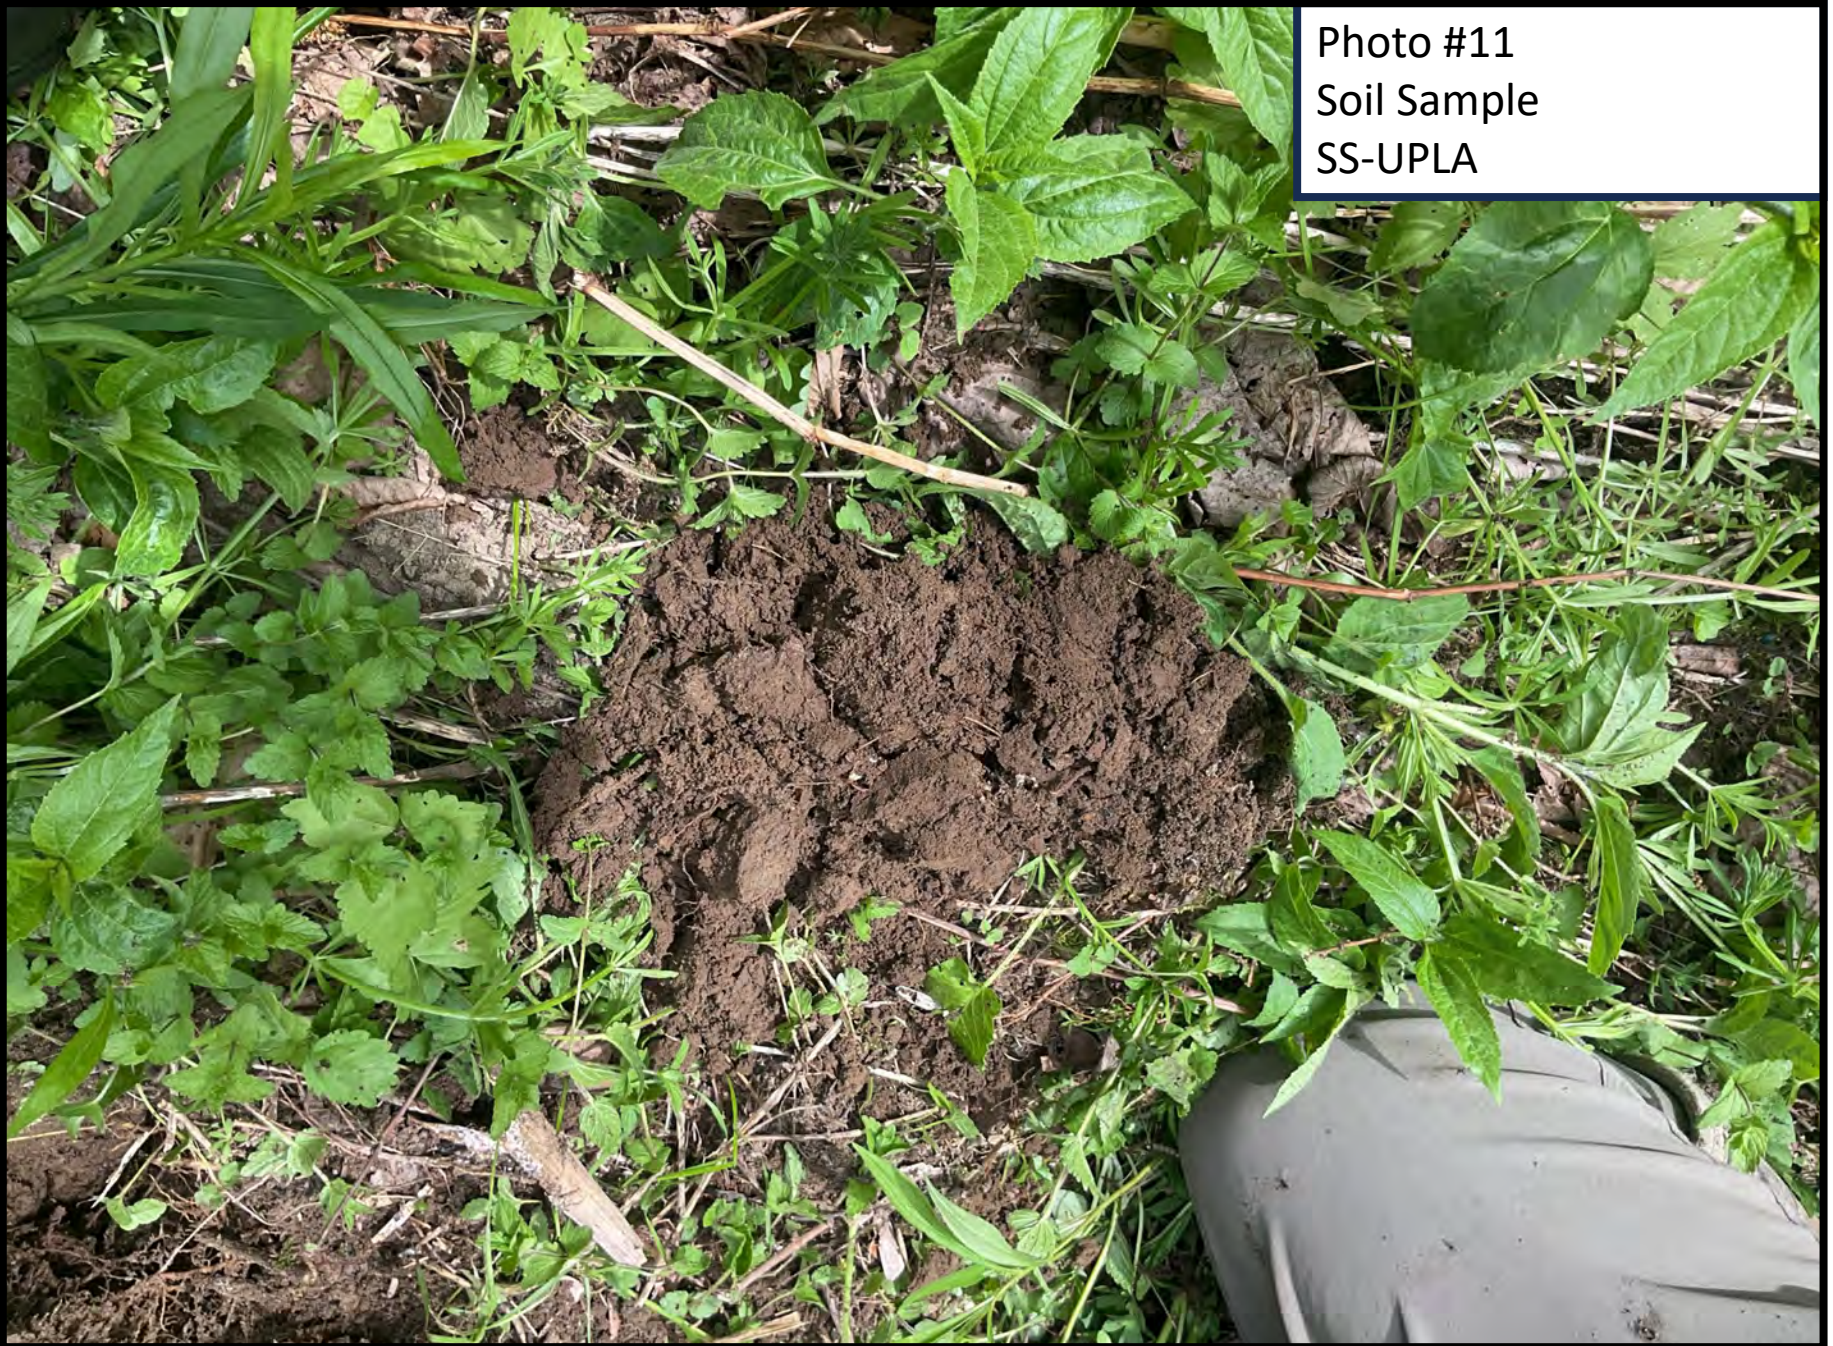
Photo #11
Soil Sample
SS-UPLA

Upland A (SS-UPLA) soil sample was taken on the upstream North side of Starrucca Creek. Soil in this area was dry and well drained. No restrictive layer was observed in this area. Plant species around the sample location include Eastern Hemlock, Goldenrod, Bedstraw and Japanese Knotweed. The soil profile consisted of one matrix color with a total depth of 18 inches. 0-18" contained a matrix color of 7.5YR 4/3 at 100%. No indications of wetland hydrology or hydric soil were observed in the upland testing area.

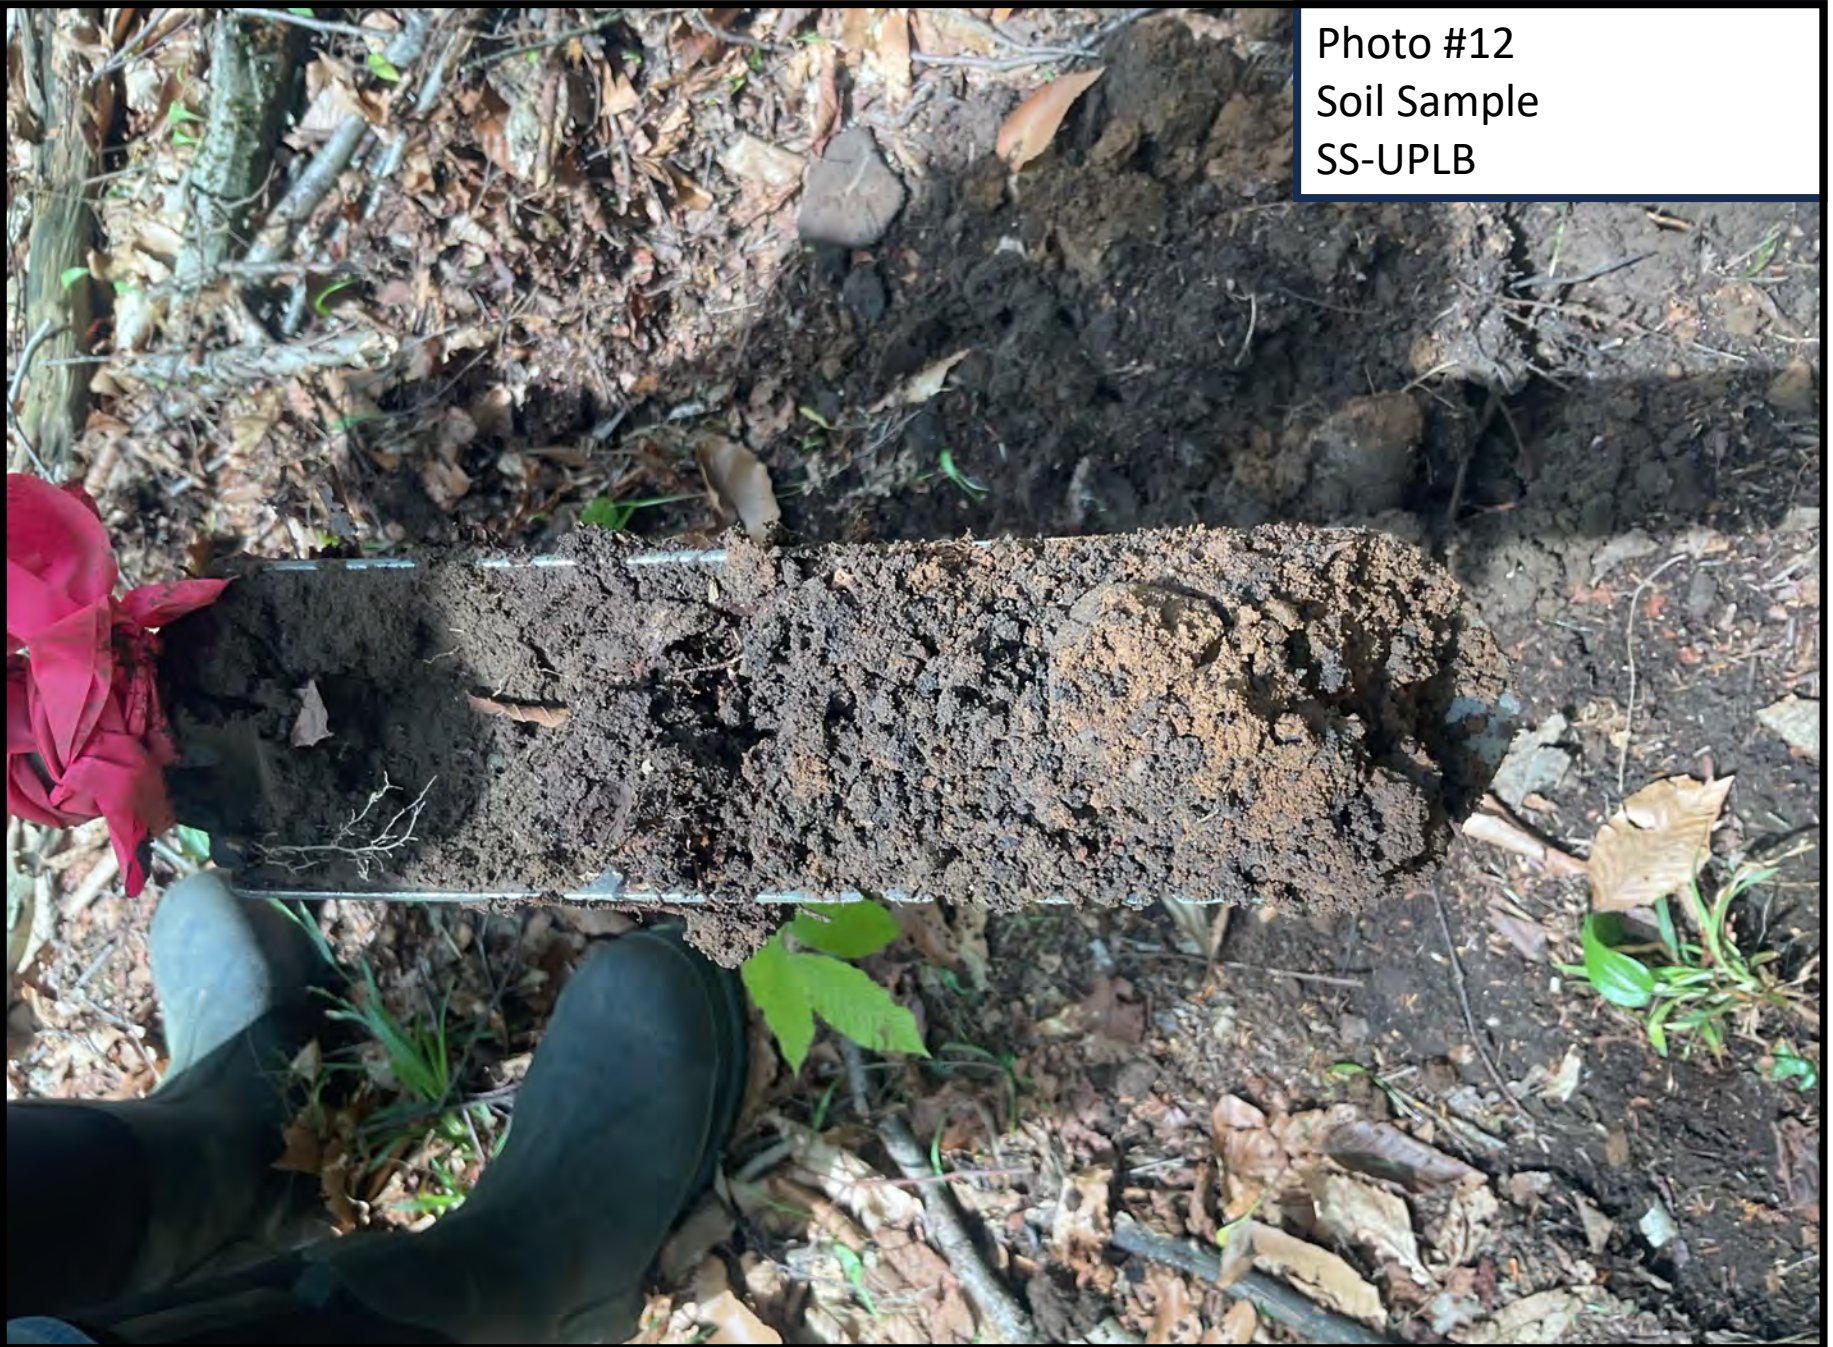
Photo #12
Soil Sample
SS-UPLB

Upland B (SS-UPLB) soil sample was taken on the downstream North side of Starrucca Creek. Soil in this area was dry and well drained. No restrictive layer was observed in this area. Plant species around the sample location include Eastern Hemlock, Ironwood, Christmas Fern, Canada Mayflower, Wood Anemone, and Wood Aster. The soil profile consisted of two matrix colors with a total depth of 18 inches. 0-4" contained a matrix color of 10YR 4/2 at 100%. 4"-18" contained a matrix color of 10YR 5/4 at 100% No indications of wetland hydrology or hydric soil were observed in the upland testing area.

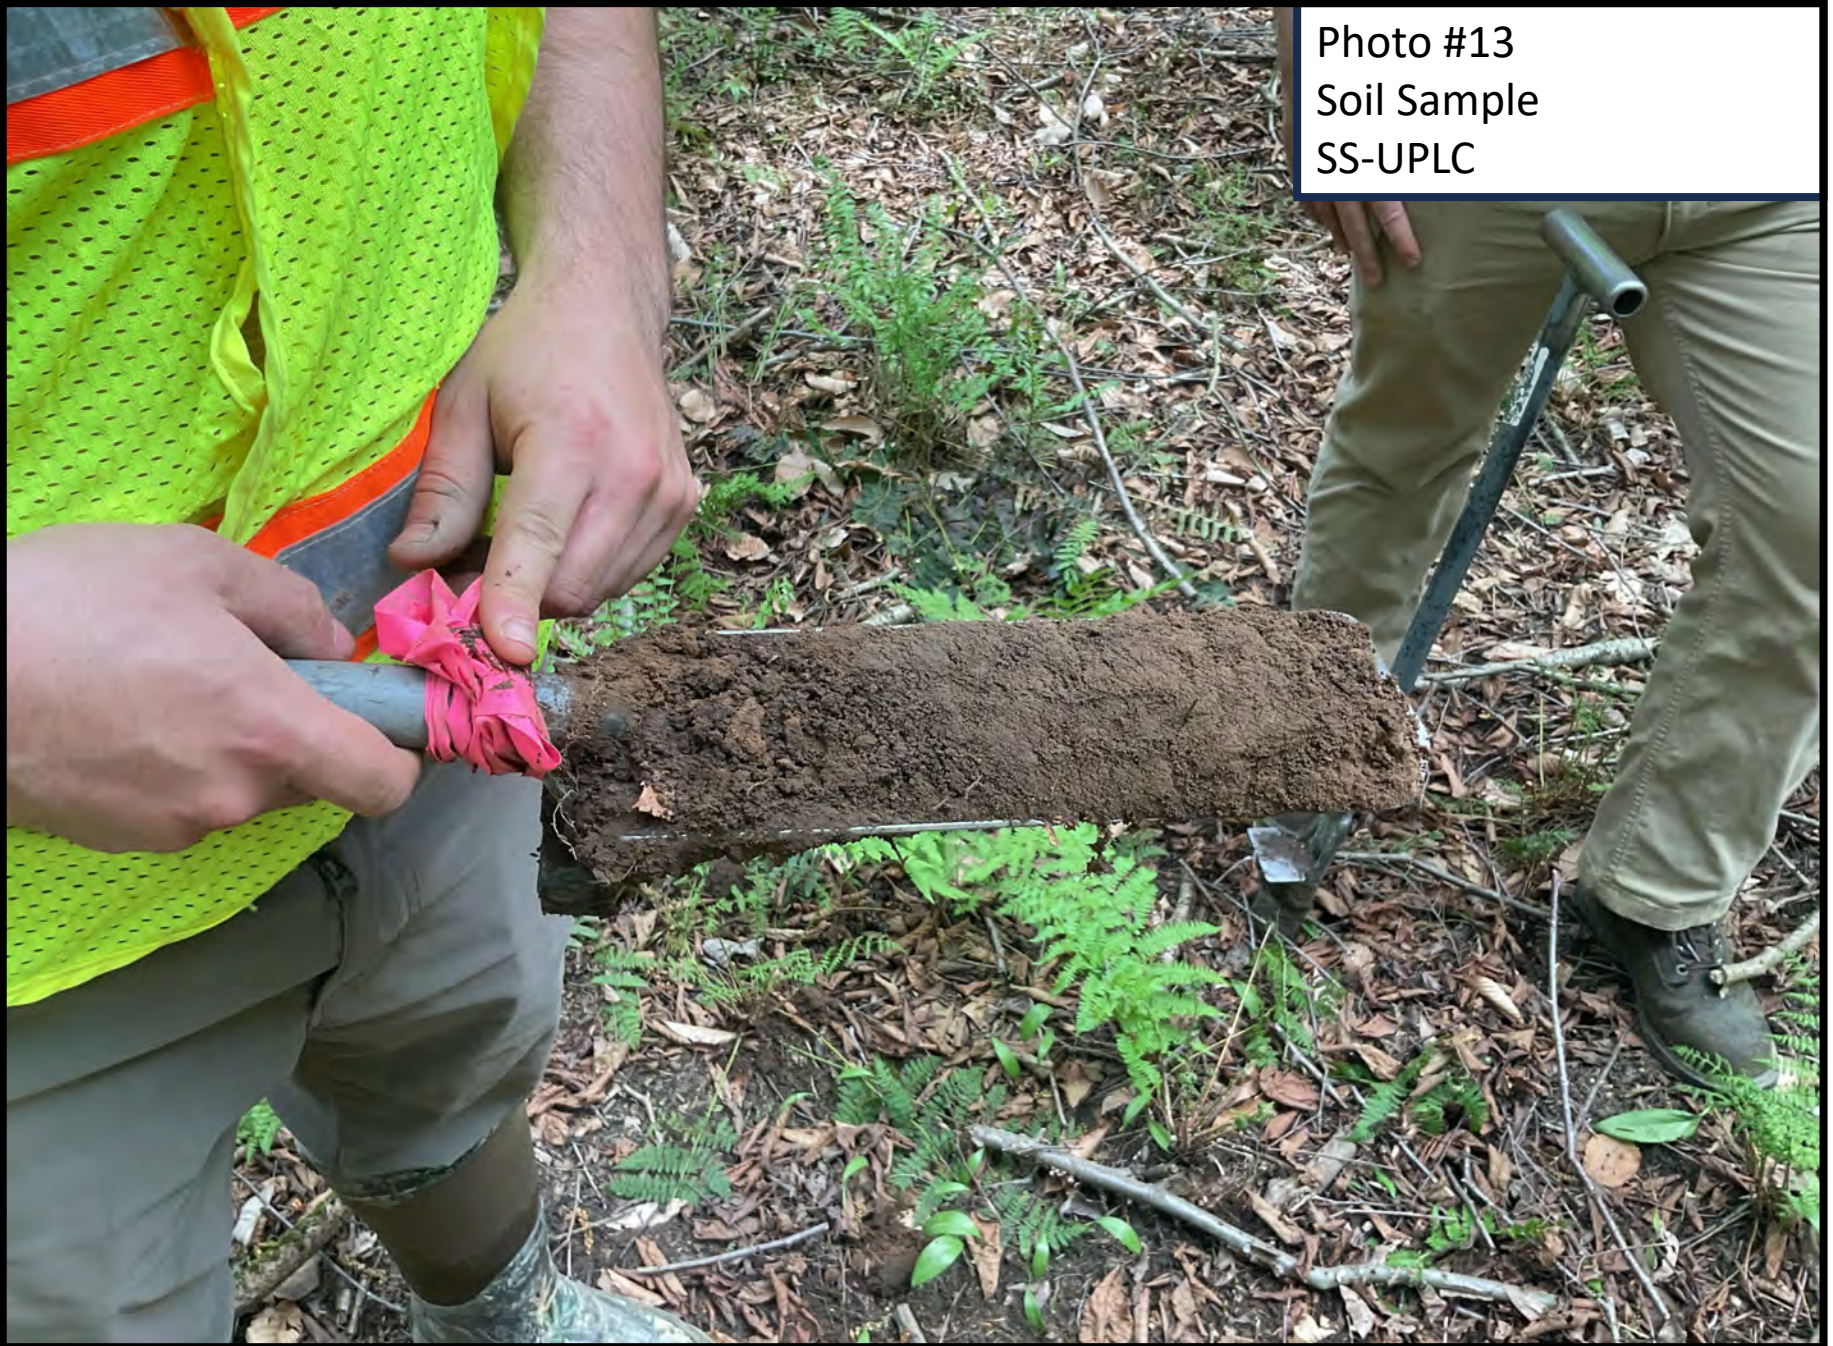
Photo #13
Soil Sample
SS-UPLC

Upland C (SS-UPLC) soil sample was taken on the downstream North side of Starrucca Creek. Soil in this area was dry and well drained. No restrictive layer was observed in this area. Plant species around the sample location include Eastern Hemlock, Ironwood, Hop-hornbeam,

Canada Mayflower, Christmas Fern, and Rattlesnake Root. The soil profile consisted of one matrix color with a total depth of 18 inches. 0-18" contained a matrix color of 7.5YR 3/3 at 100%. No indications of wetland hydrology or hydric soil were observed in the upland testing area.

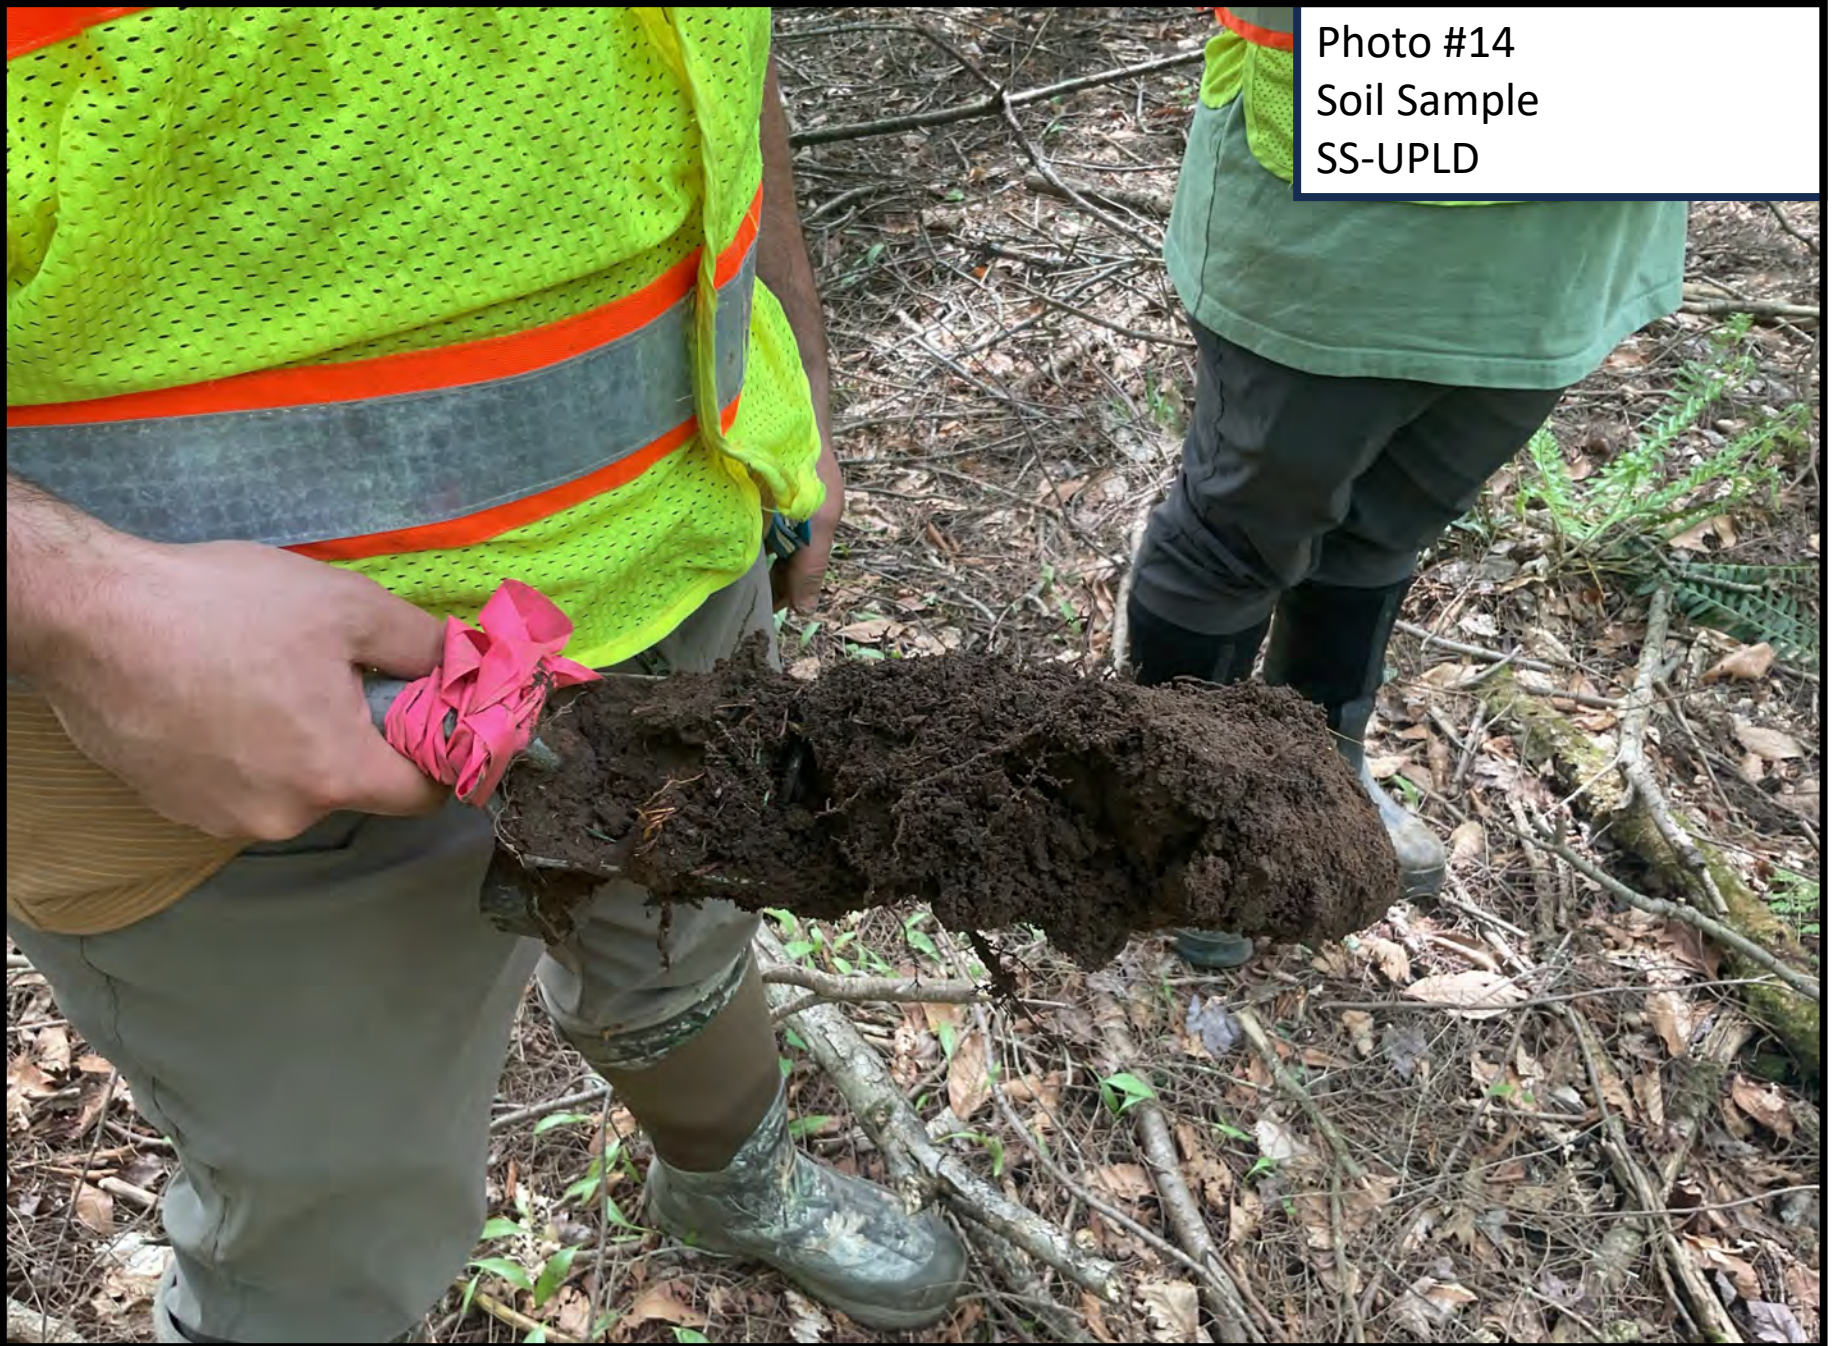
Photo #14
Soil Sample
SS-UPLD

Upland D (SS-UPLD) soil sample was taken on the upstream North side of Starrucca Creek. Soil in this area was dry and well drained. No restrictive layer was observed in this area. Plant species around the sample location include Eastern Hemlock, Ironwood, Hop-hornbeam, Japanese barberry, Canada Mayflower, Christmas Fern, and Rattlesnake Root. The soil profile consisted of one matrix color with a total depth of 18 inches. 0-18" contained a matrix color of 7.5YR 3/3 at 100%. No indications of wetland hydrology or hydric soil were observed in the upland testing area.
