APPENDIX B:
ENVIRONMENTAL, CULTURAL RESOURCES
AND NON-FEDERAL SPONSOR COORDINATION

Starrucca Creek CAP 14 Emergency Streambank Stabilization

SR 1005 USACE
STARRUCCA CREEK
PHOTOGRAPHS
THOMPSON TOWNSHIP
SUSQUEHANNA COUNTY

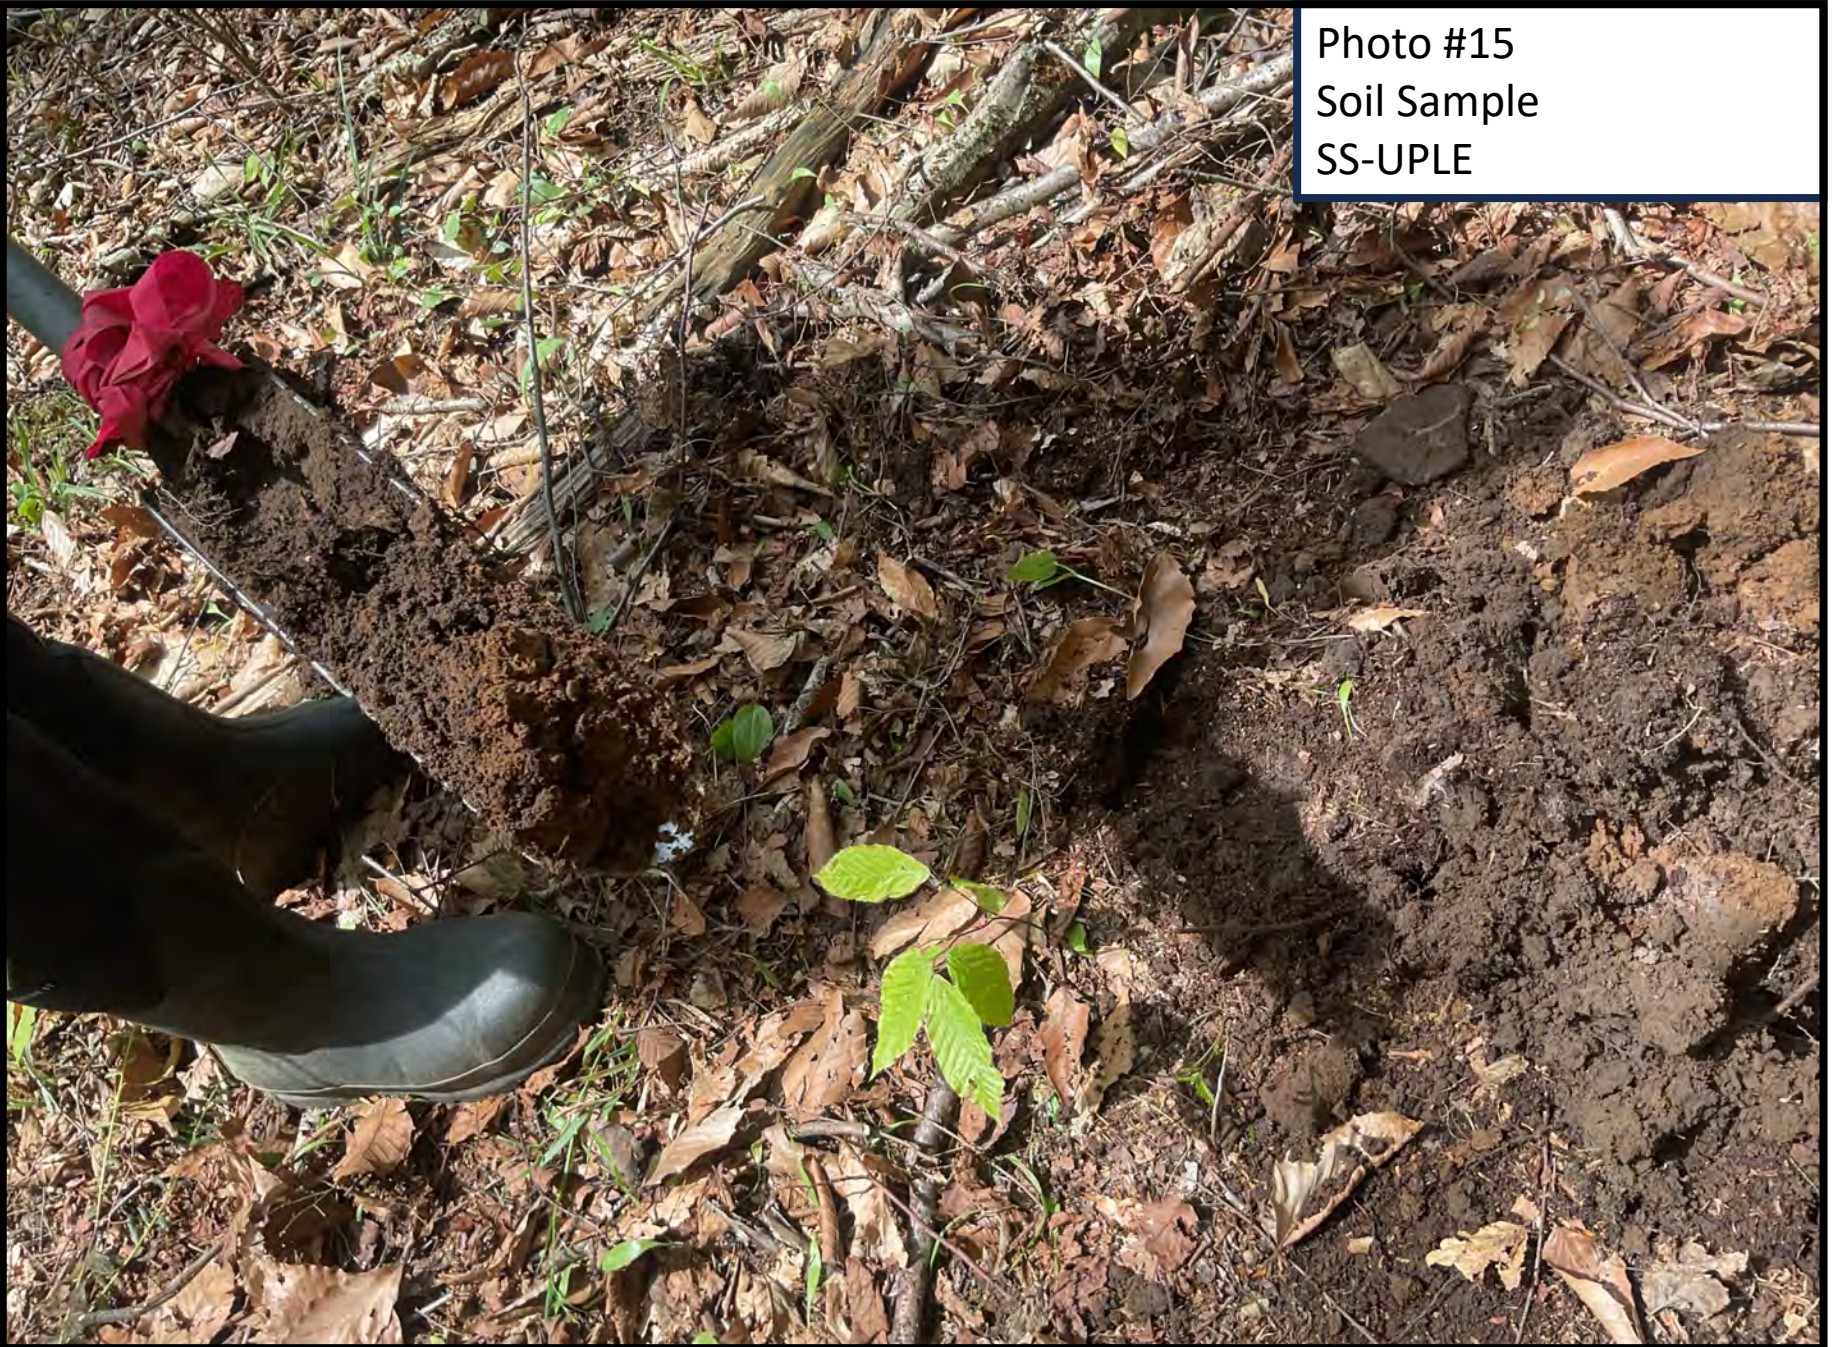
Photo #15
Soil Sample
SS-UPLE

Upland E (SS-UPLD) soil sample was taken on the downstream South side of Starrucca Creek. Soil in this area was dry and well drained. A restrictive layer was observed at 8" in this area due to hardpan. Plant species around the sample location include Eastern Hemlock, Ironwood, Lady Fern, Christmas Fern and Meadow Rue. The soil profile consisted of one matrix color with a total depth of 8 inches. 0-8" contained a matrix color of 7.5YR 3/3 at 100%. No indications of wetland hydrology or hydric soil were observed in the upland testing area.

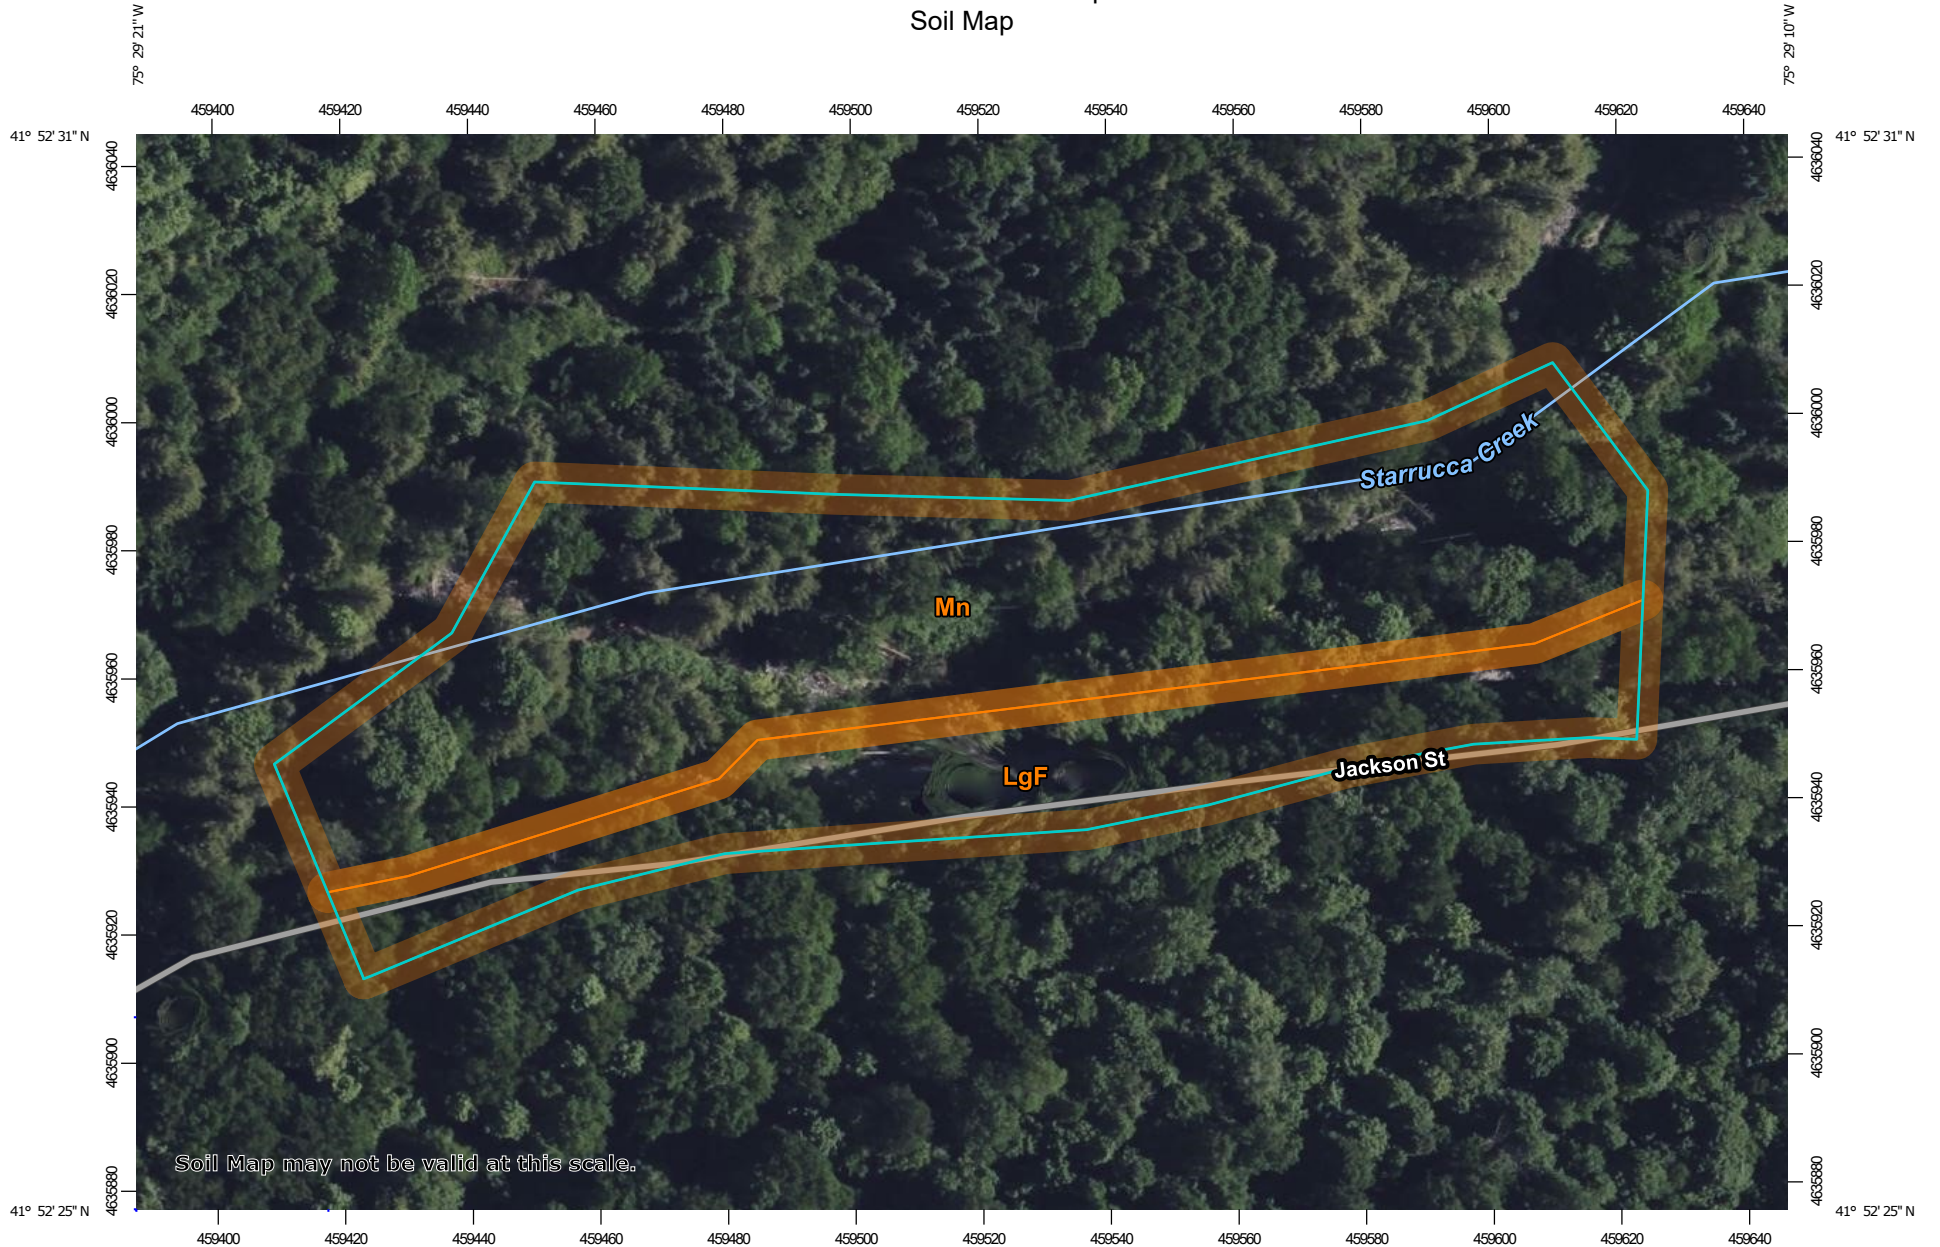
Custom Soil Resource Report Soil Map

The soil map section includes the soil map for the defined area of interest, a list of soil map units on the map and extent of each map unit, and cartographic symbols displayed on the map. Also presented are various metadata about data used to produce the map, and a description of each soil map unit.

Map Scale: 1:1,180 if printed on A landscape (11" x 8.5") sheet.
