Phase I
Environmental Site Assessment

Corporation of Shepherdstown Water Distribution System
Improvements Project

Jefferson County, West Virginia

July 2023

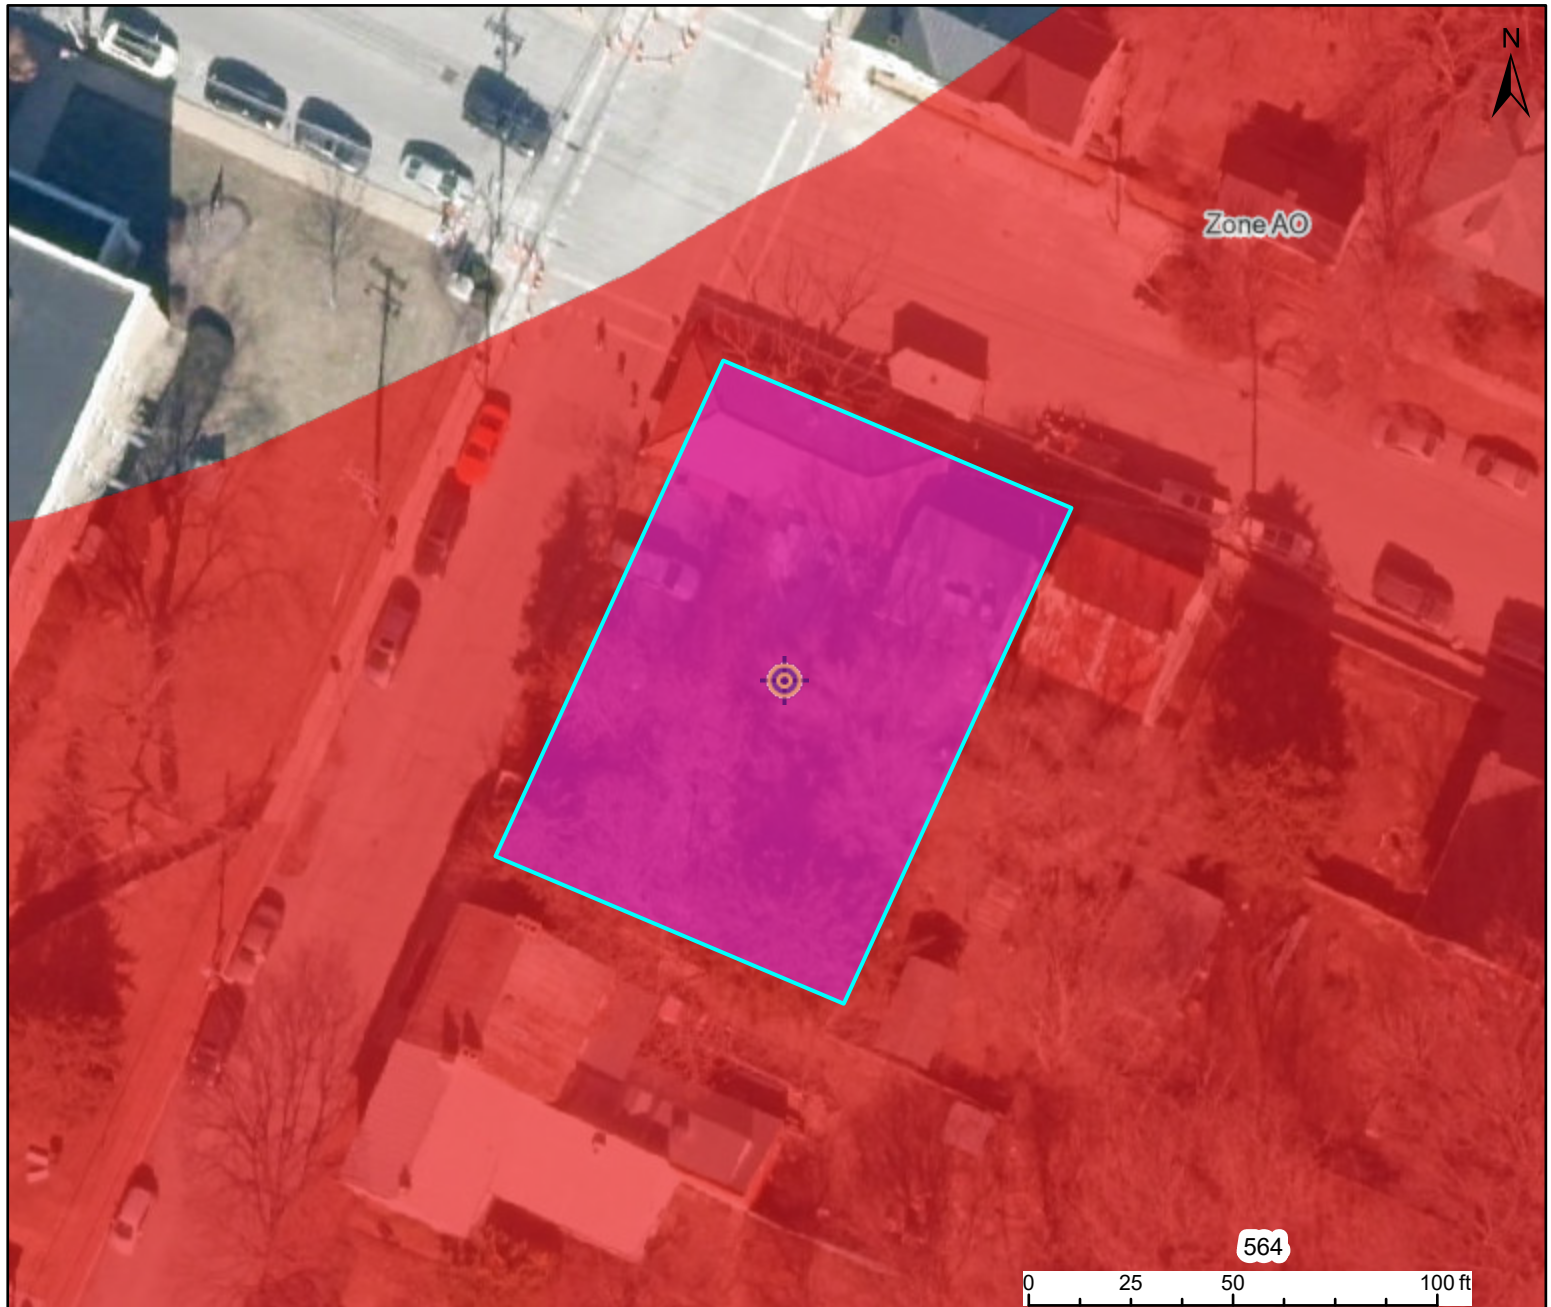
WV Flood Map

Flood Hazard Area		Location is WITHIN the FEMA 100-year floodplain.
Flood Zone		AO
Stream		Town Run
Watershed (HUC8)		Conococheague-Opequon (2070004)
Flood Height		
Water Depth		About 2.0 ft (Source: HEC-RAS)
Elevation		385.4 ft (Source: FEMA 2012) (NAVD88)
Community & ID		Town of Shepherdstown (ID: 540069)
FEMA Map & Date		54037C0041E; Effective Date: 12/18/2009
Location (lat, long)		(39.431265, -77.803504) (WGS84)
Parcel ID		19-10-0003-0013-0001
E-911 Address		200 E HIGH ST, SHEPHERDSTOWN, WV, 25443

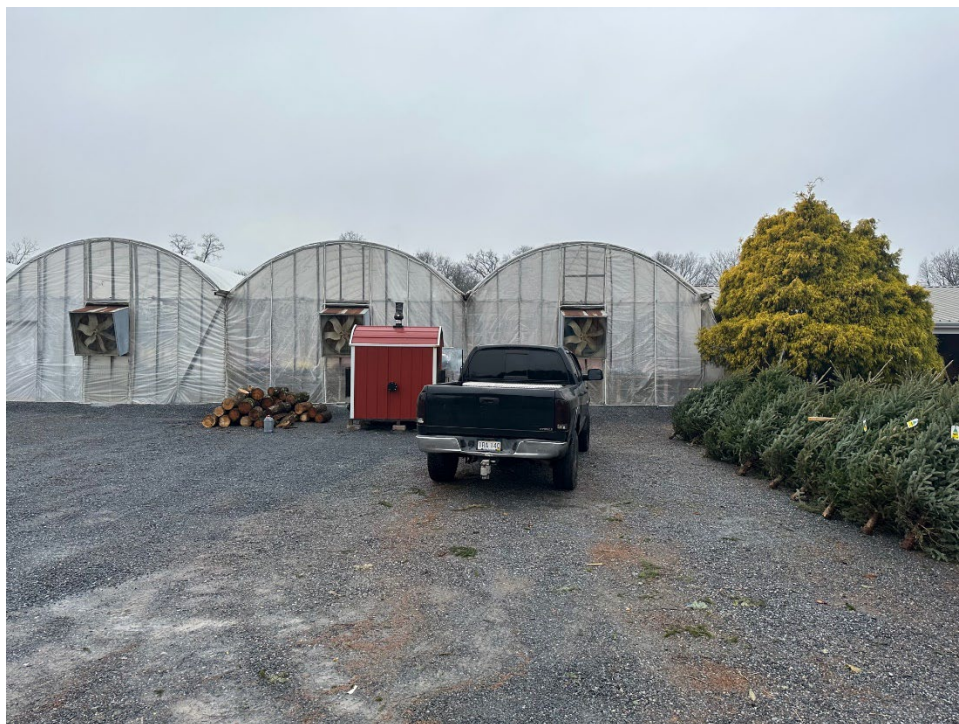
Photograph: 2 Greenhouses with outdoor wood burning stove

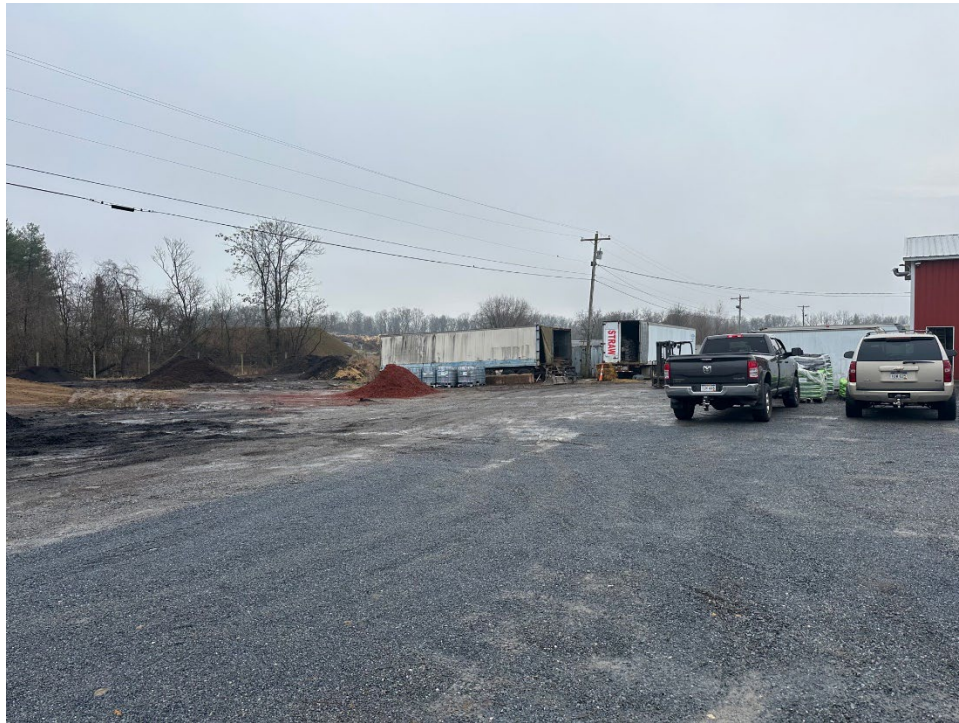
Photograph: 3 Mulch storage area, empty storage tanks that will be hauled off property

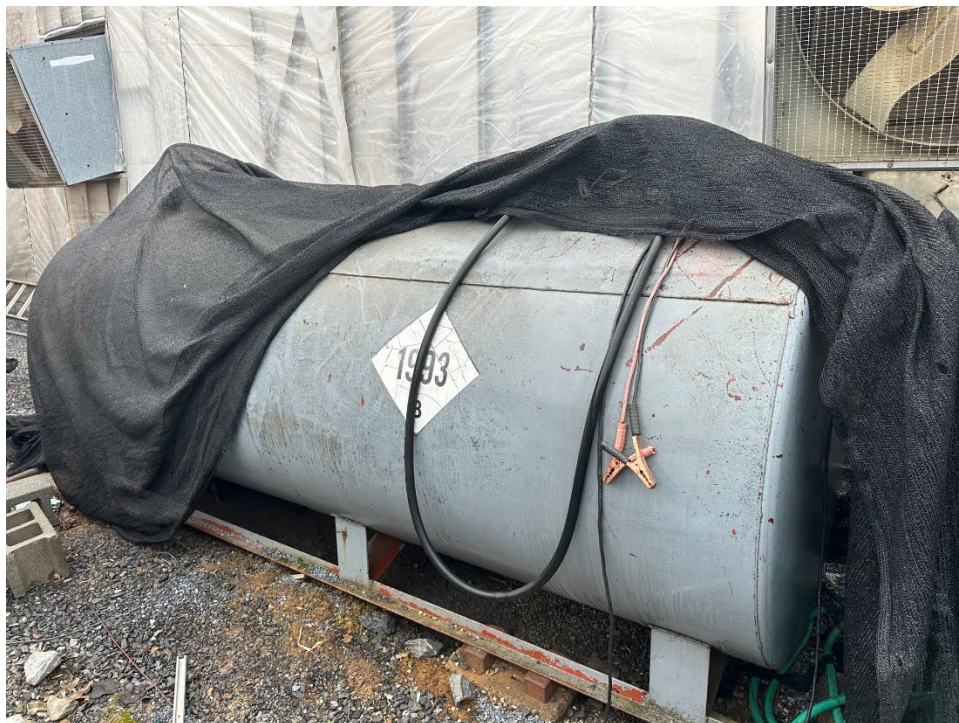
Photograph: 4 1,000-gallon oil tank used for heating purposes

Currently there are no ASTs listed on Subject Property 1 according to the EDR Radius Map™. However, two (2) ASTs were visually noted by Decota during the reconnaissance visit. One (1) 250-gallon oil tank and one (1) 1,000-gallon oil tank were located on Subject Property 1 during site reconnaissance. Neither of these tanks had secondary containment. Additionally, a few small propane tanks were observed to be stored in a cage close to the store, with a filling area. No ASTs are located within the LOD of the Project.

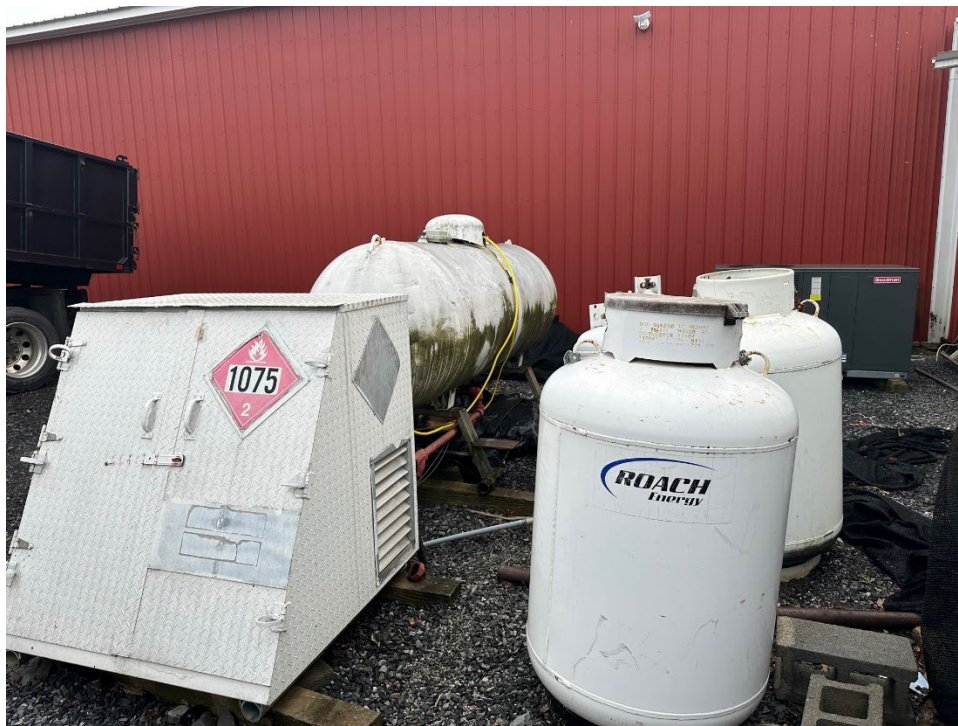
Photograph: 5 250-gallon oil tank used for heating purposes

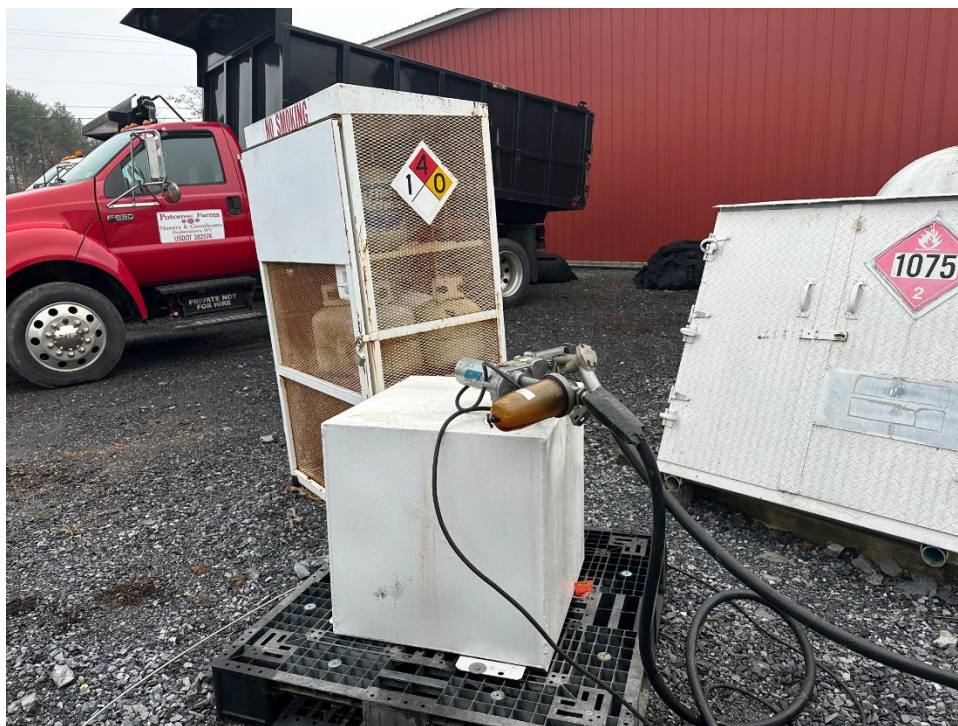
Photograph: 6 Cage with propane tanks and filling area

fluids that may leak, or from absorbing into the ground. A cage for storing propane tanks and a tank filling area was also observed on the property. Before the development of the nursery and greenhouse, the entire parcel was made up of a working farm. On average, five personnel currently work at the subject property at least six days a week.

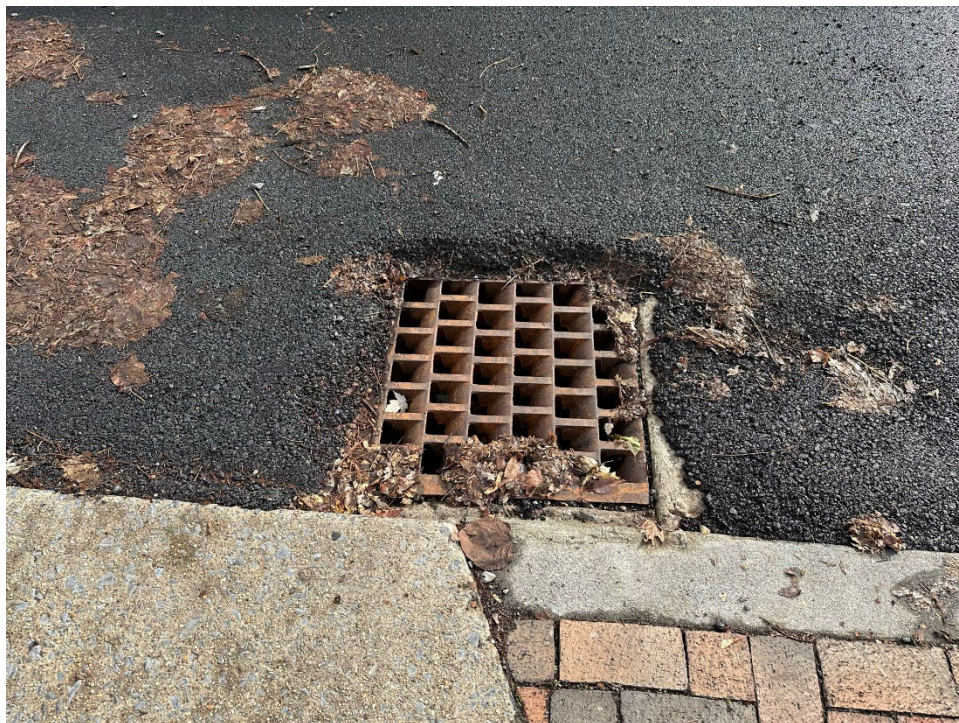
Photograph: 4 Storm drain in front of Blue Moon Café parking area

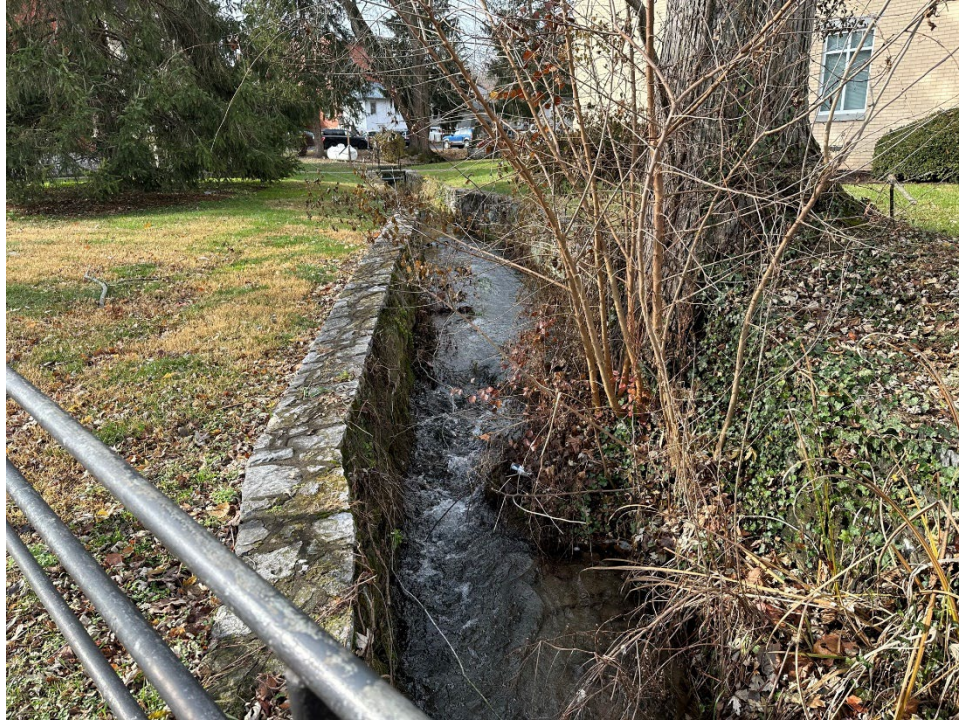
Photograph: 5 Town Run which flows under the Blue Moon Café

The Subject Property consists of the Blue Moon Café which is currently maintained as an operating restaurant. Outside of the restaurant is an outdoor dining area and a paved parking area along the street. A stream flows through a pipe under the street in front of the restaurant, under the restaurant, and exits to the northeast.
