# Appendix B. Plan Formulation and Environmental Benefits Model Appendix

# Anacostia Watershed Assessment Plan Formulation and Environmental Benefits Model Appendix

August 2017

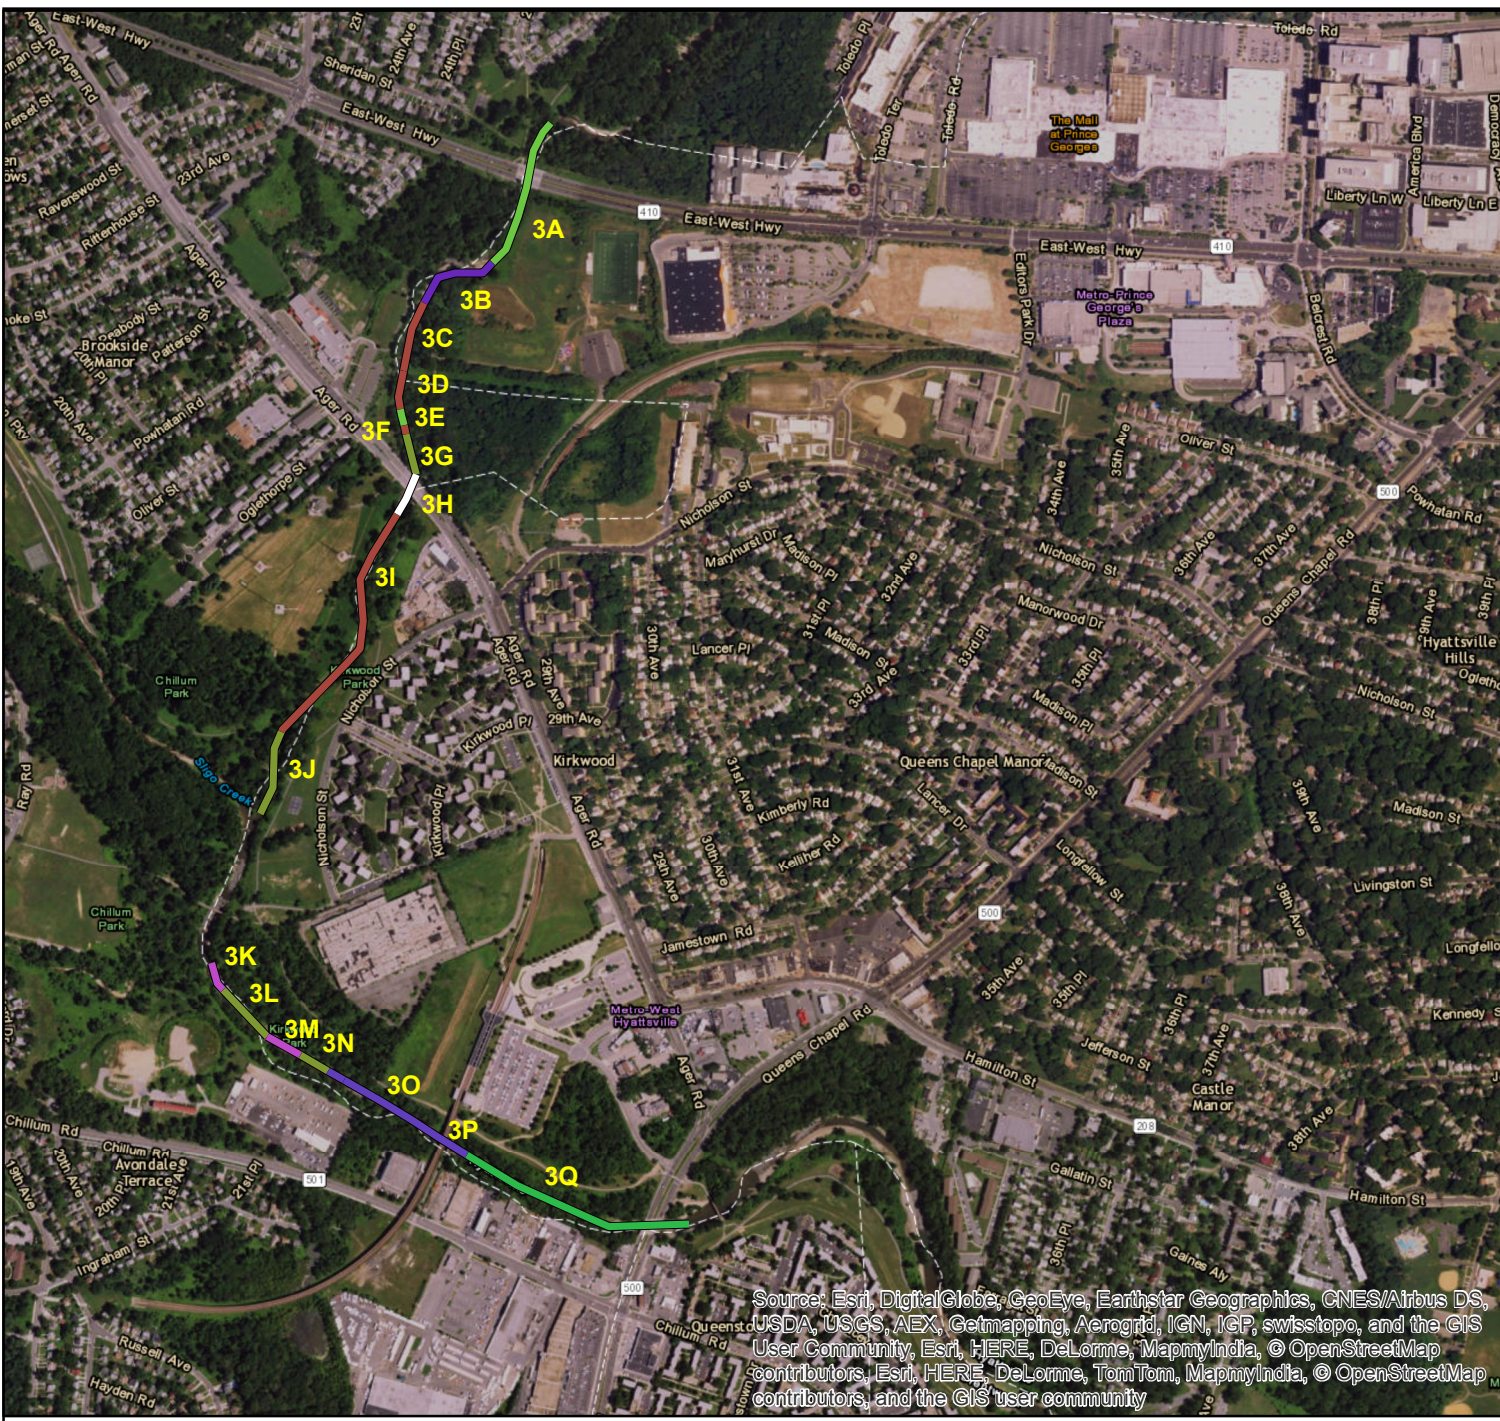
Subwatershed: Northwest Branch  
Site: Hyattsville  
Project Segment #: 3

Reach	Habitat Type Code	Legend	Length (ft)
3A	3Cce		817
3B	3Cm		470
3C	3Ccp		377
3D	3Ccp		208
3E	3Cce		86
3F	3Ccp		51
3G	3Cst		218
3H	None		235
3I	3Ccp		1375
3J	3Cst		456
3K	9Cs		156
3L	3Cst		339
3M	9Cs		203
3N	3Cst		171
3O	3Ccu		95
3P	3Ccu		761
3Q	3Ccp		1268

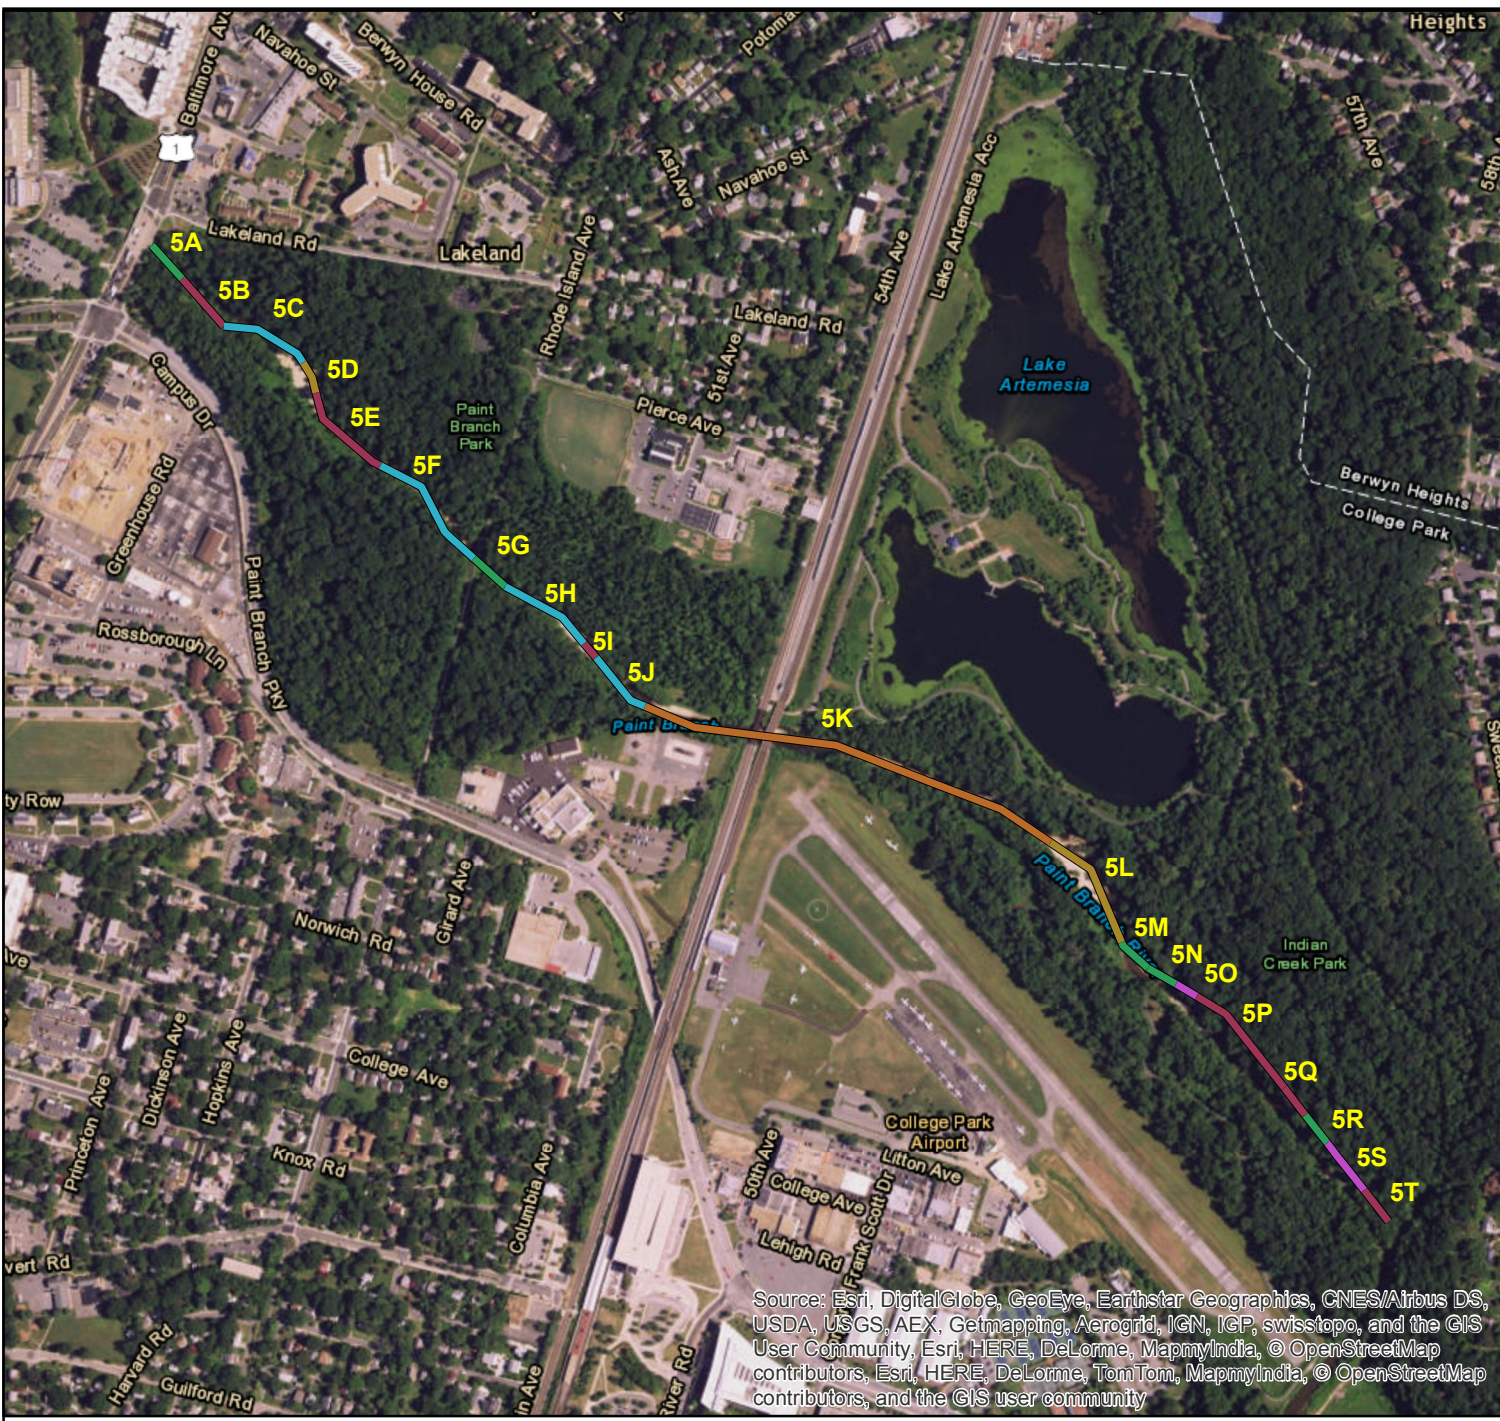
Subwatershed: Paint Branch  
Site: Paint Branch  
Project Segment #: 5

Reach	Habitat Type Code	Legend	Length (ft)
5A	5Ccst		176
5B	5Ccgu		244
5C	5Ccehu		359
5D	5Cw		128
5E	5Ccgu		396
5F	5Ccehu		534
5G	5Ccst		164
5H	5Ccehu		386
5I	5Ccgu		72
5J	5Ccehu		273
5K	5Ccle		1694
5L	5Cw		497
5M	5Ccst		146
5N	5Ccst		126
5O	9Cs		94
5P	5Ccgu		502
5Q	5Ccgu		135
5R	5Ccst		137
5S	9Cs		235
5T	5Ccgu		155

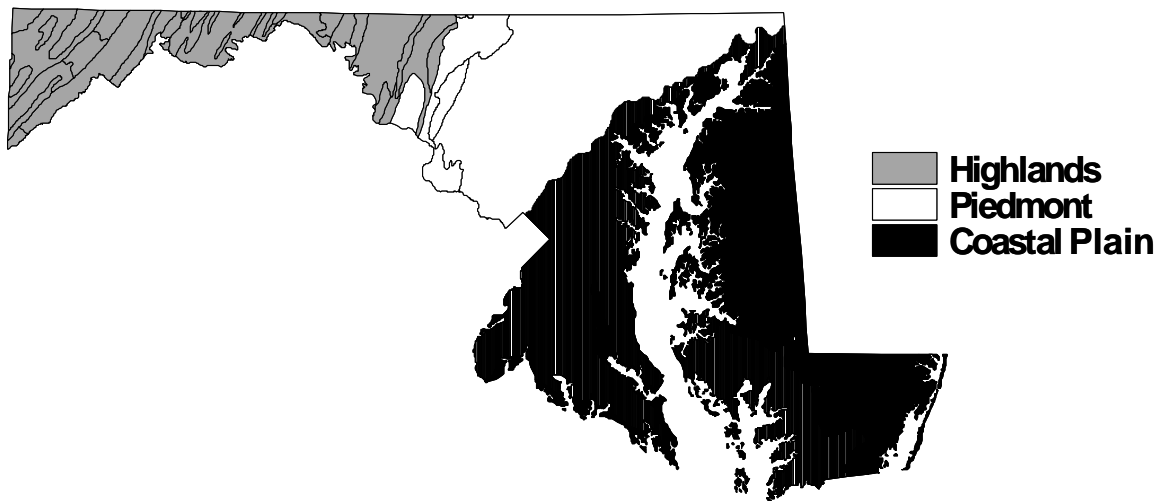
**Figure 1** – Map of Maryland indicating ecoregions of the state. The Highland stream class was formed by joining the Blue Ridge, Valley and Ridge, and Appalachian Plateau ecoregions.

We investigated a number of different stream classifications for the state. We originally split study sites into Coastal Plain and Non-Coastal Plain sites, consistent with the original PHI approach. Non-Coastal Plain sites consisted of the Piedmont, Blue Ridge, Valley and Ridge, and Appalachian Plateau (Figure 1). Seeing as the Piedmont represents nearly a third of the state and has markedly different soils and land use history, we added the Piedmont region as a third class of streams and combined the remaining non-Coastal Plain sites into a Highlands class in our final classification. An additional reason for distinguishing the Piedmont class was that original reference criteria for the non-Coastal Plain sites led to a predominance of Highland streams serving as reference sites for the whole non-Coastal Plain class. Because Piedmont streams were so underrepresented, we were concerned that the two class approach would be biased against Piedmont streams.

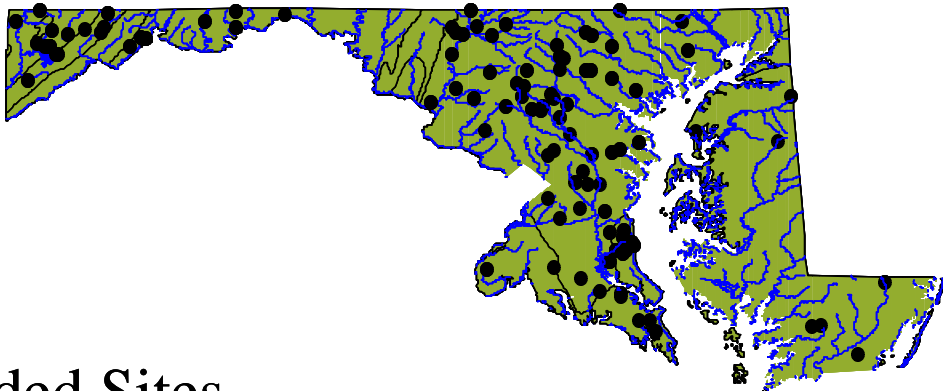
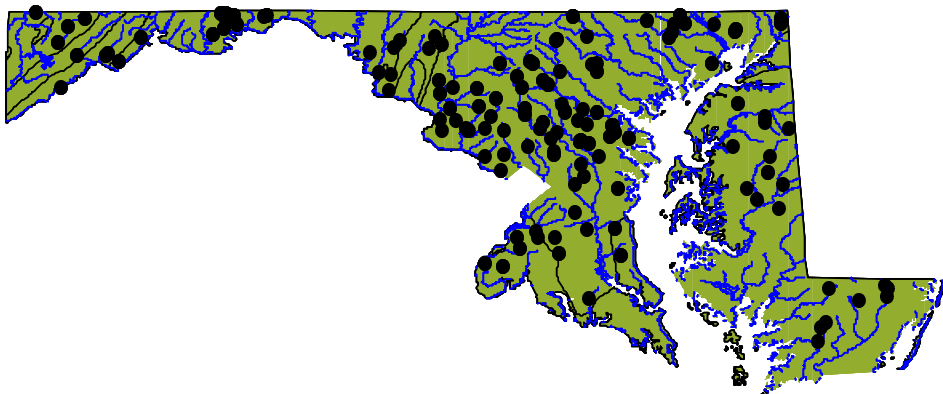
**Figure 2** – Map of the location of physical habitat reference and degraded sites across the state.

Reference streams did tend to be smaller than degraded streams in the Coastal Plain and Highland stream classes, but were actually larger, on average, than degraded streams in the Piedmont region (Figure 3). It is generally difficult to find large sized reference streams, because the patchy nature of land use disturbance tends to disrupt large contiguous patches of forested land. While this situation may affect this analysis, the box-and-whisker plots clearly indicate overlap in stream sizes among the reference and degraded conditions in each stream class. In addition, we corrected for area effects to isolate the effects of area on several potential metrics (see below).

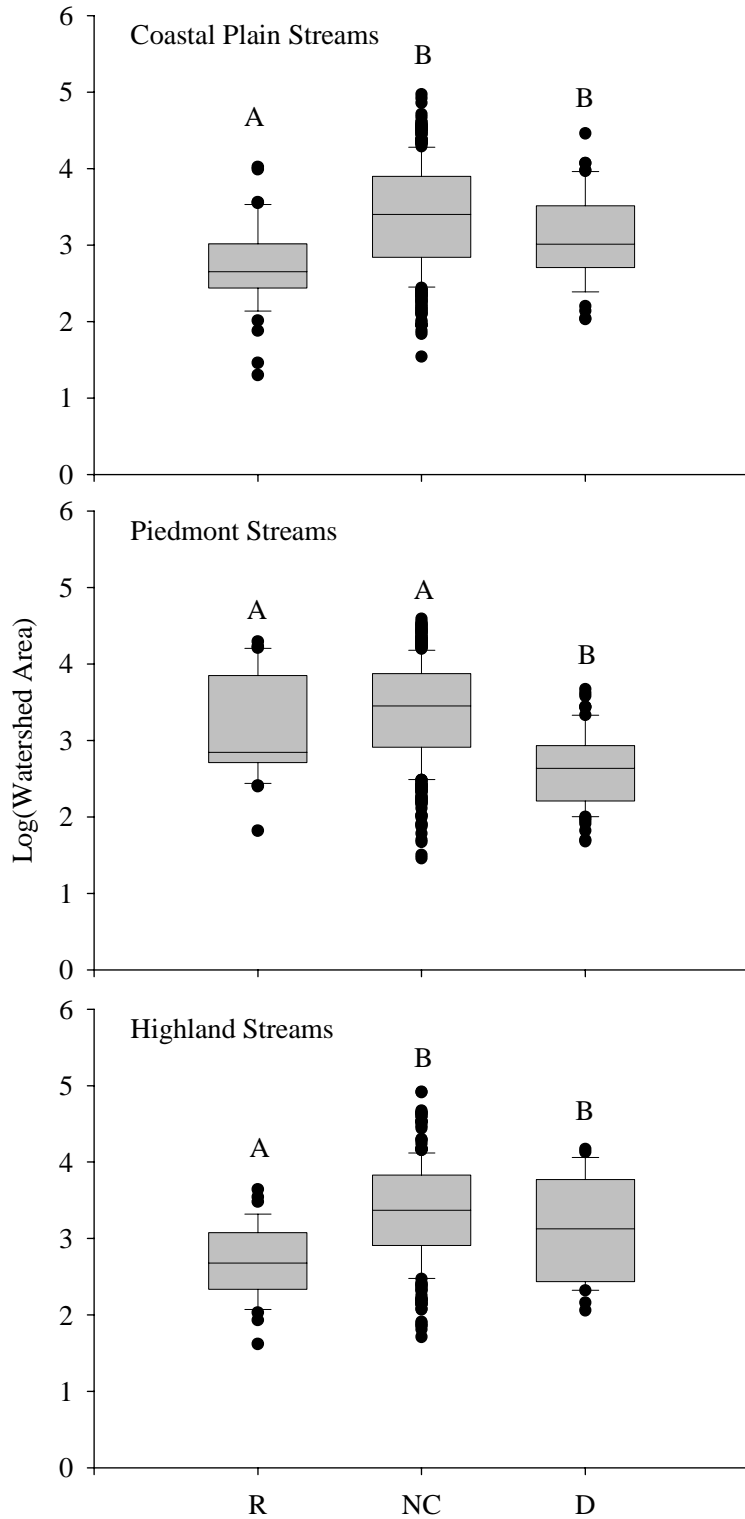
**Figure 3** – Box and whisker plots of watershed area by reference category (R=reference, NC=non-categorized, D=degraded) and by stream class. Boxes indicate the median, 10<sup>th</sup>, 25<sup>th</sup>, 75<sup>th</sup>, and 90<sup>th</sup> percentiles. Within a stream class, categories with different letters above the boxes are significantly different (p<0.05, one-way ANOVA, Tukey’s HSD multiple comparisons test).

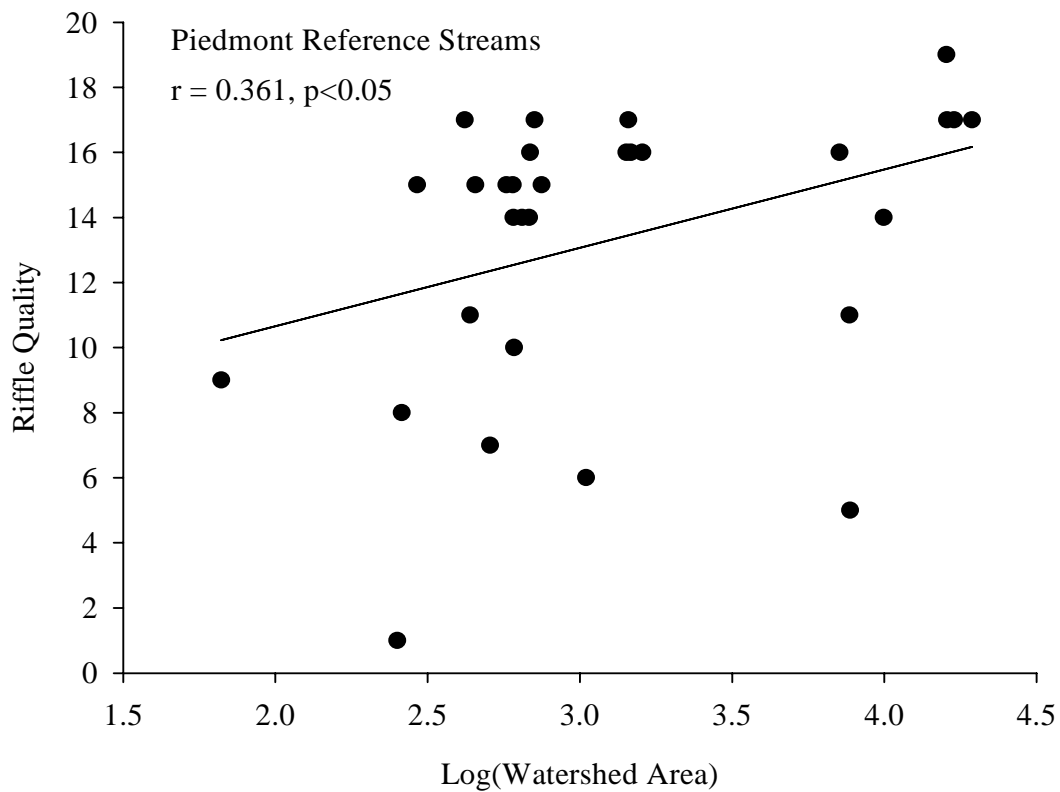
**Figure 4** – Plot of watershed area against riffle quality scores in Piedmont reference streams. The pearson correlation coefficient is shown. Similar analyses were run for all metrics to check for watershed area effects.
