**SECOND FIVE-YEAR REVIEW  
BUCKROE BEACH  
FUDS PROPERTY # C03VA1011  
HAMPTON, VIRGINIA**

**U.S. Army Corps of Engineers  
Baltimore District  
Baltimore, Maryland**

**7 August 2025**

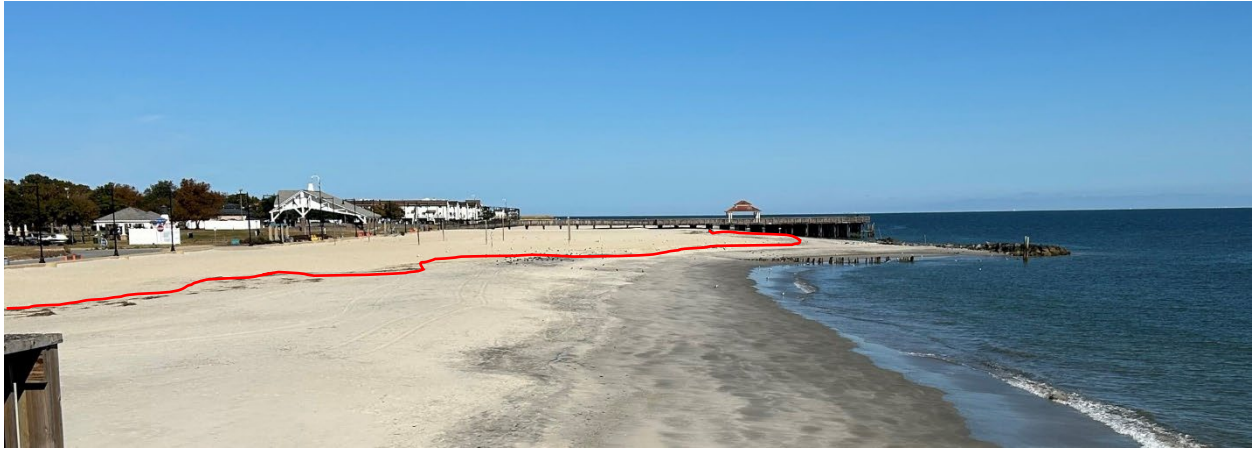
Photo 1 Buckroe Beach at James T. Wilson Fishing Pier, Looking North. Clear definition between the color of non-native soil from beach replenishment (outline with red line).

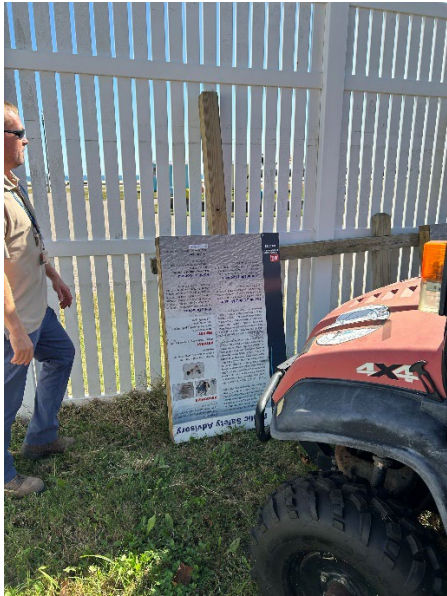
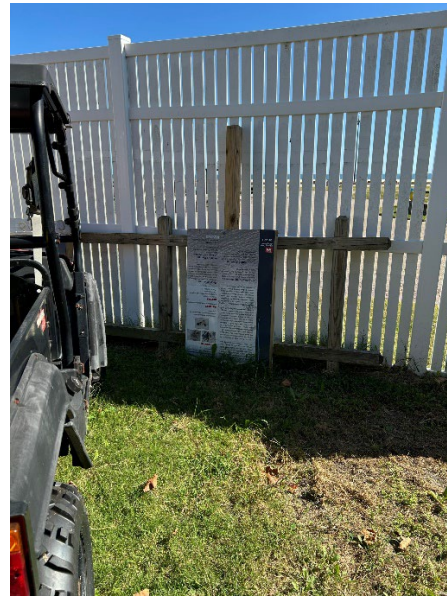
Photo 2 and 3: Public Awareness signs stored in fenced-in storage area (during site visit on 29 October 2024).

As identified Section 2.4, signage is a component of the LUCs to increase public awareness of the types of hazards that may remain at the Site and offer guidance on what actions to take. At the time of the site inspection, two double-sided informational signs had been removed due to the construction of a new boardwalk and beach replenishment project, which was completed approximately 18 months prior to the site inspection. The exact duration of the signs' absence is unclear. The third sign identified in the LUCIP as located at the north-end of the beach was additionally missing from this location. As noted in Table 4, this sign has been missing since the 2020 FYR and a recommendation to replace the sign was not implemented. In coordination with Mr. Lipscomb, the two double-sided informational signs were reinstalled at the center and southern-public access points on November 14, 2024.

| | Remarks: During the site investigation, two pairs (back-to-back signs) were observed in the storage shed on site. They were moved there approximately a year and a half ago during the construction of the new boardwalk. These signs were returned to their original locations at the center and southern beach entrances on 14 November 2024. Per the Land Use Control Implementation Plan (LUCIP), an additional pair of signs is needed at the northern entrance of the beach. | | |

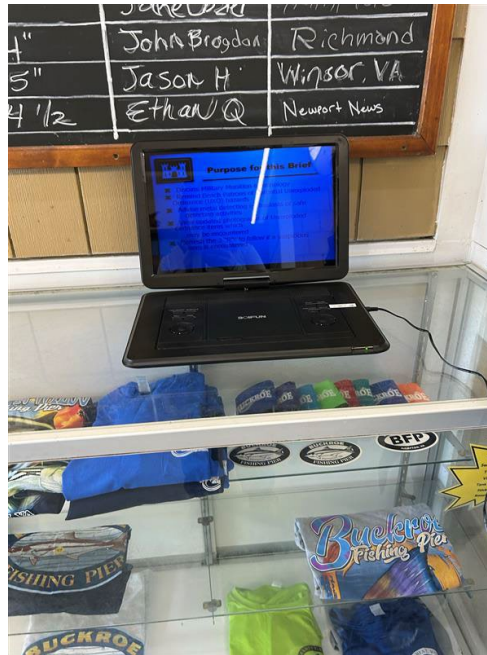
Photo 4: MEC Awareness Video available at the James T. Wilson Fishing Pier for visitors who wish to use metal detectors on site.

| | <b>Recommendation:</b> Update the contact information of the PAO in the 3Rs Explosives Safety Education” video for people who wish to survey Buckroe Beach sands with metal detectors. | | | |

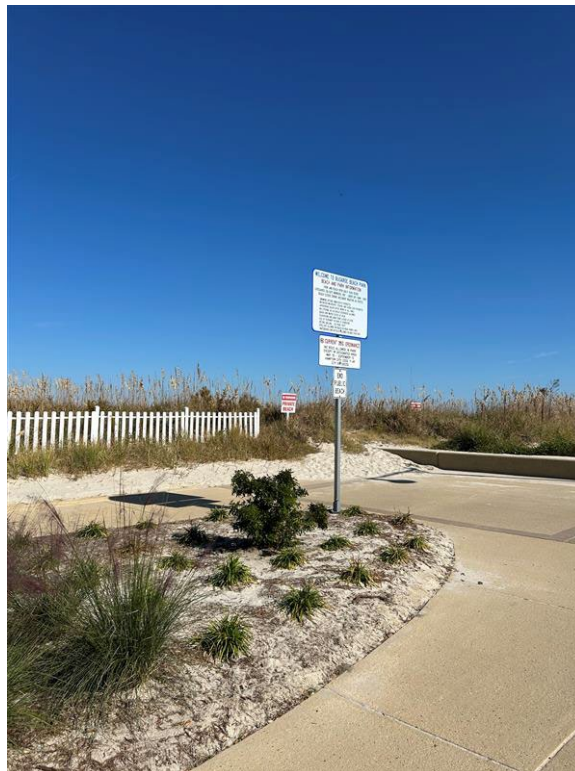
Photo 5: Northern boundary public access area where a third Public Awareness sign (two signs back-to-back) will need to be installed, looking northeast.

| | <b>Issue:</b> One of the three signs identified in the LUCIP was missing during the site inspection and not reinstalled in November 2024 with the other two signs. This sign has been missing since the 2020 FYR and the previous recommendation to replace the sign was not implemented. | | | |
| | <b>Recommendation:</b> Ensure that moving forward recommendations noted in the FYR are implemented in a timely manner. Install at least 1 more pair of signs (2 additional signs, total) at the northern-end of Buckroe Beach along the public access way. | | | |
