**FINAL  
REMEDIAL ACTION COMPLETION REPORT**

**LOW PROBABILITY FUDS WATER BUFFER MRS 08  
PLUM TREE ISLAND RANGE  
FORMERLY USED DEFENSE SITE, PROPERTY NUMBER C03VA0202  
POQUOSON, VIRGINIA**

Contract No.: W912DR-21-D-0003  
Task Order No.: W912DR21F0396

**U.S. ARMY CORPS OF ENGINEERS  
BALTIMORE DISTRICT**  
2 Hopkins Plaza  
Baltimore, MD 21201

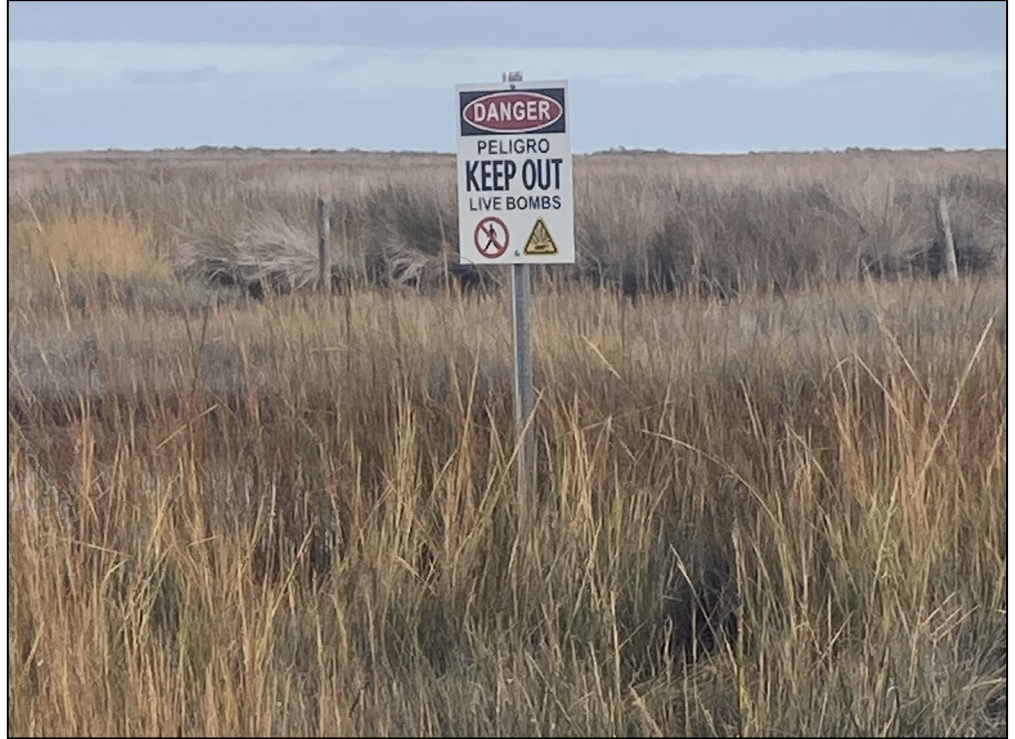
New sign and sign-post installed

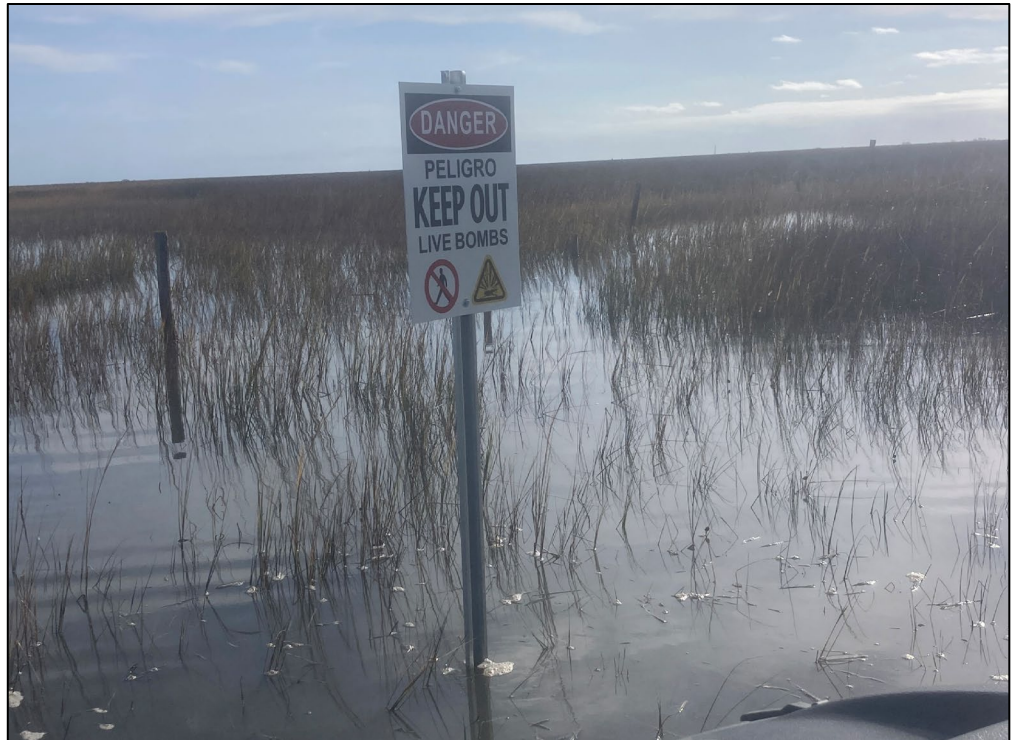
**Photo No. 2**

New sign and sign-post installed

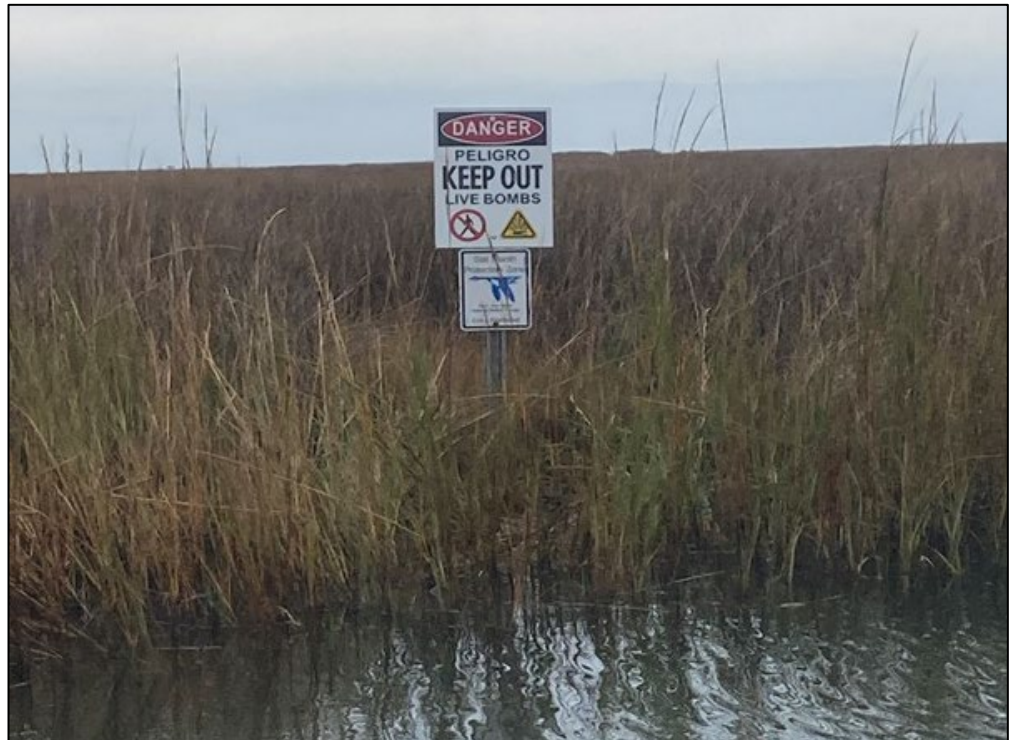
**Photo No. 16**

New sign installed on existing post

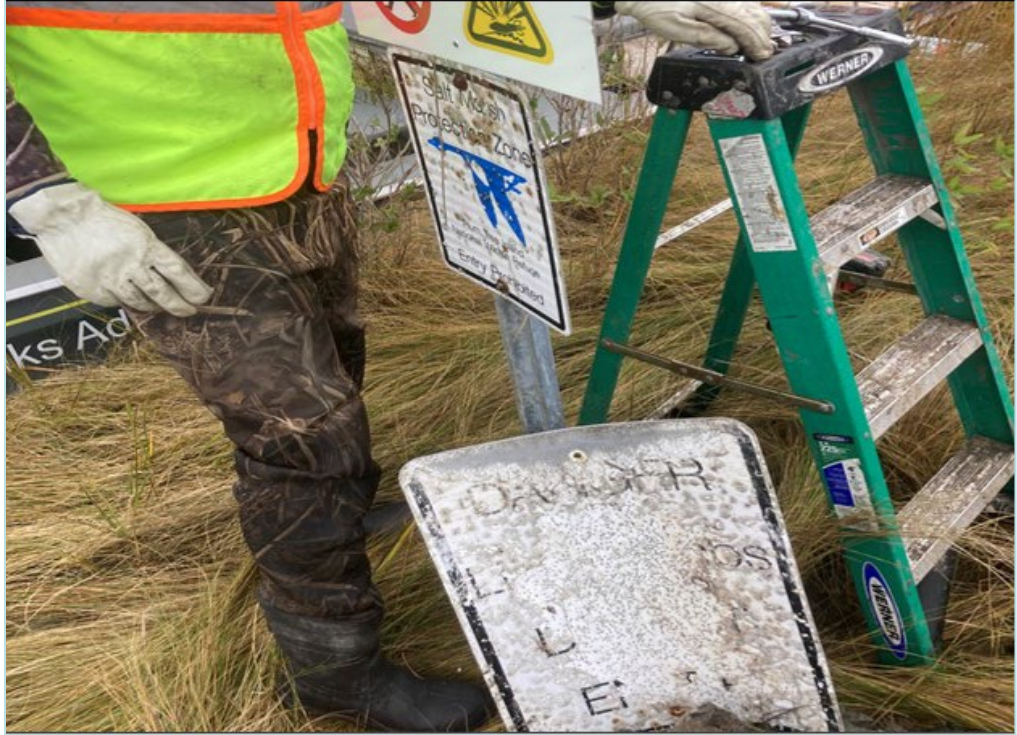
**Photo No. 17**

Damaged sign being replaced

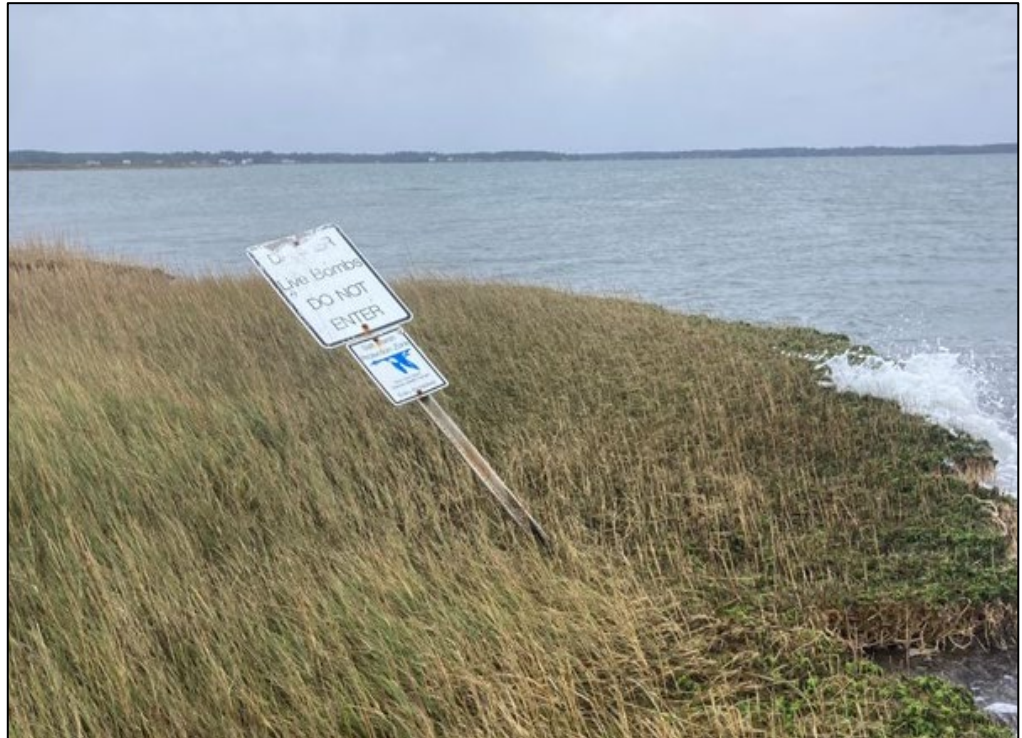
**Photo No. 18**

Bent over old sign

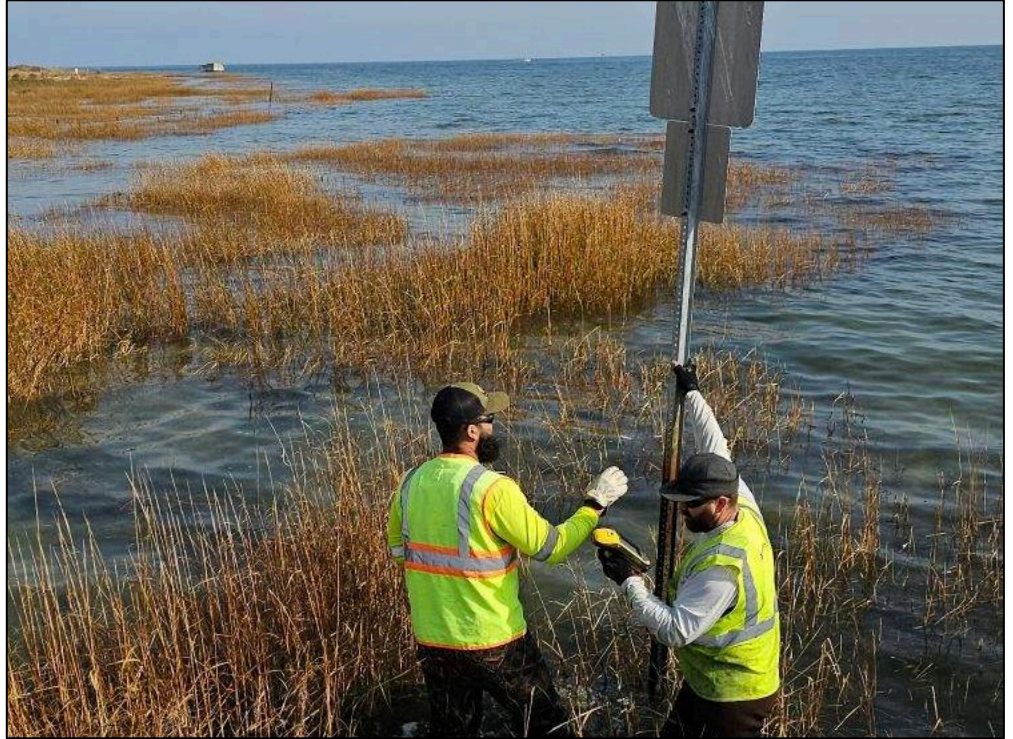
**Photo No. 25**

Field Tech and UXO  
Tech re-installing an  
existing sign-post that  
was bent over

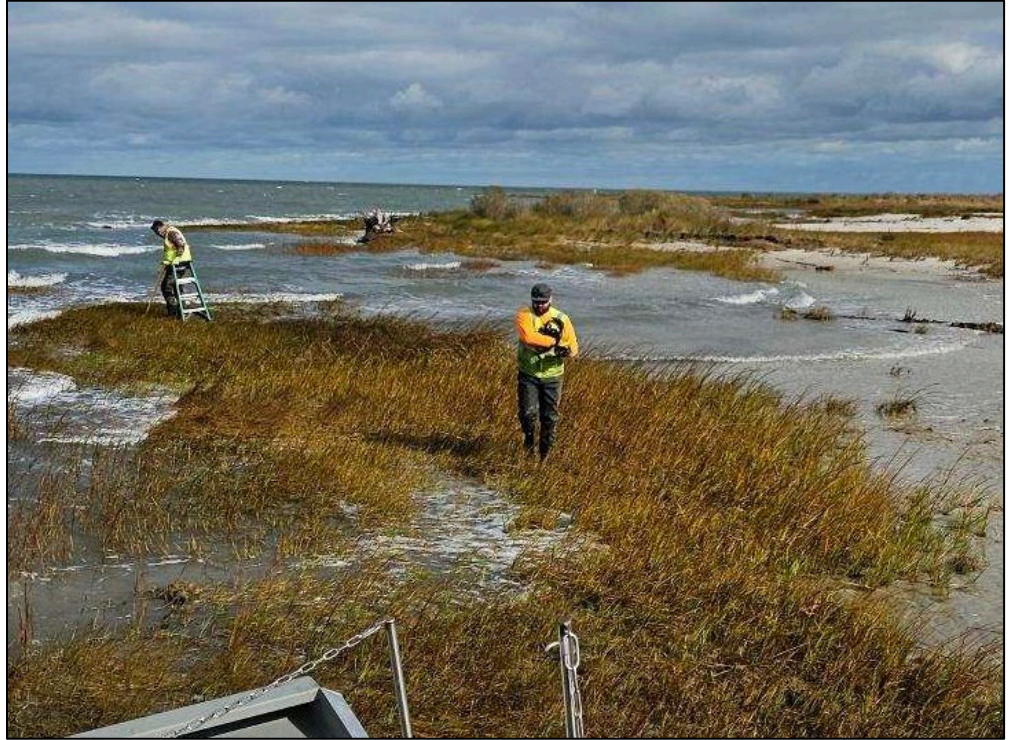
UXO Tech scanning area for new sign-post being installed

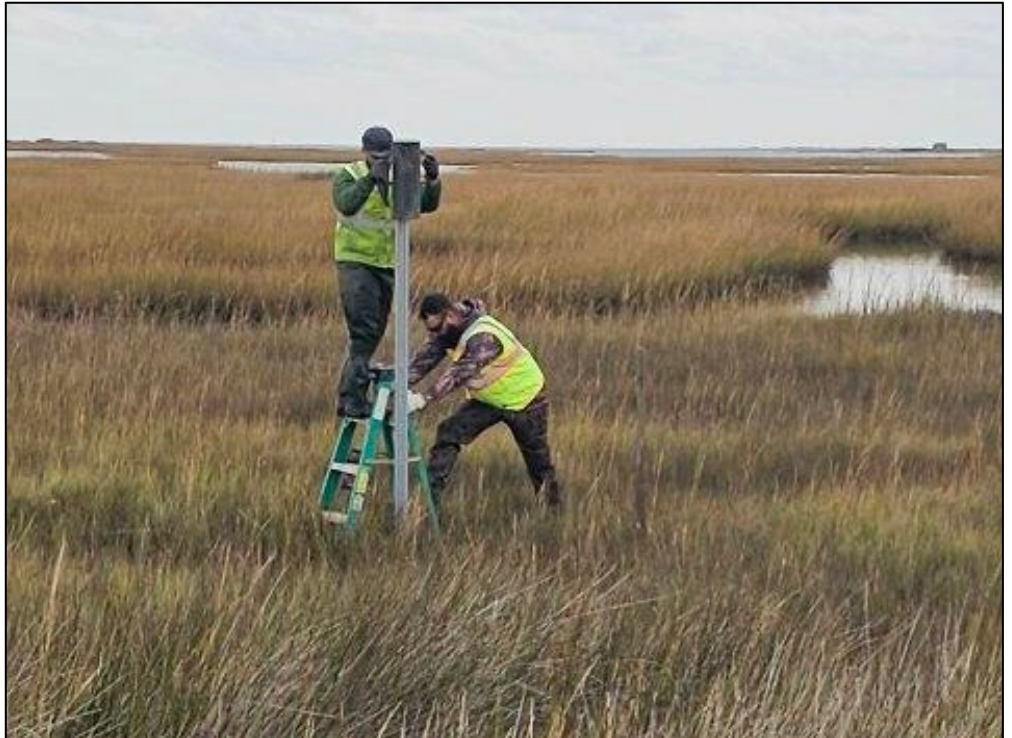
**Photo No. 28**

Field Tech and UXO Tech installing new sign-post
