**WETLAND DELINEATION REPORT
JOINT BASE MEYER-HENDERSON HALL
ACQUISITION OF MIDDLEBURG TRAINING CENTER
MIDDLEBURG, VIRGINIA**

November 2025

U.S. Army Corps of Engineers
Baltimore District, Planning Division
2 Hopkins Plaza
Baltimore, Maryland 21201

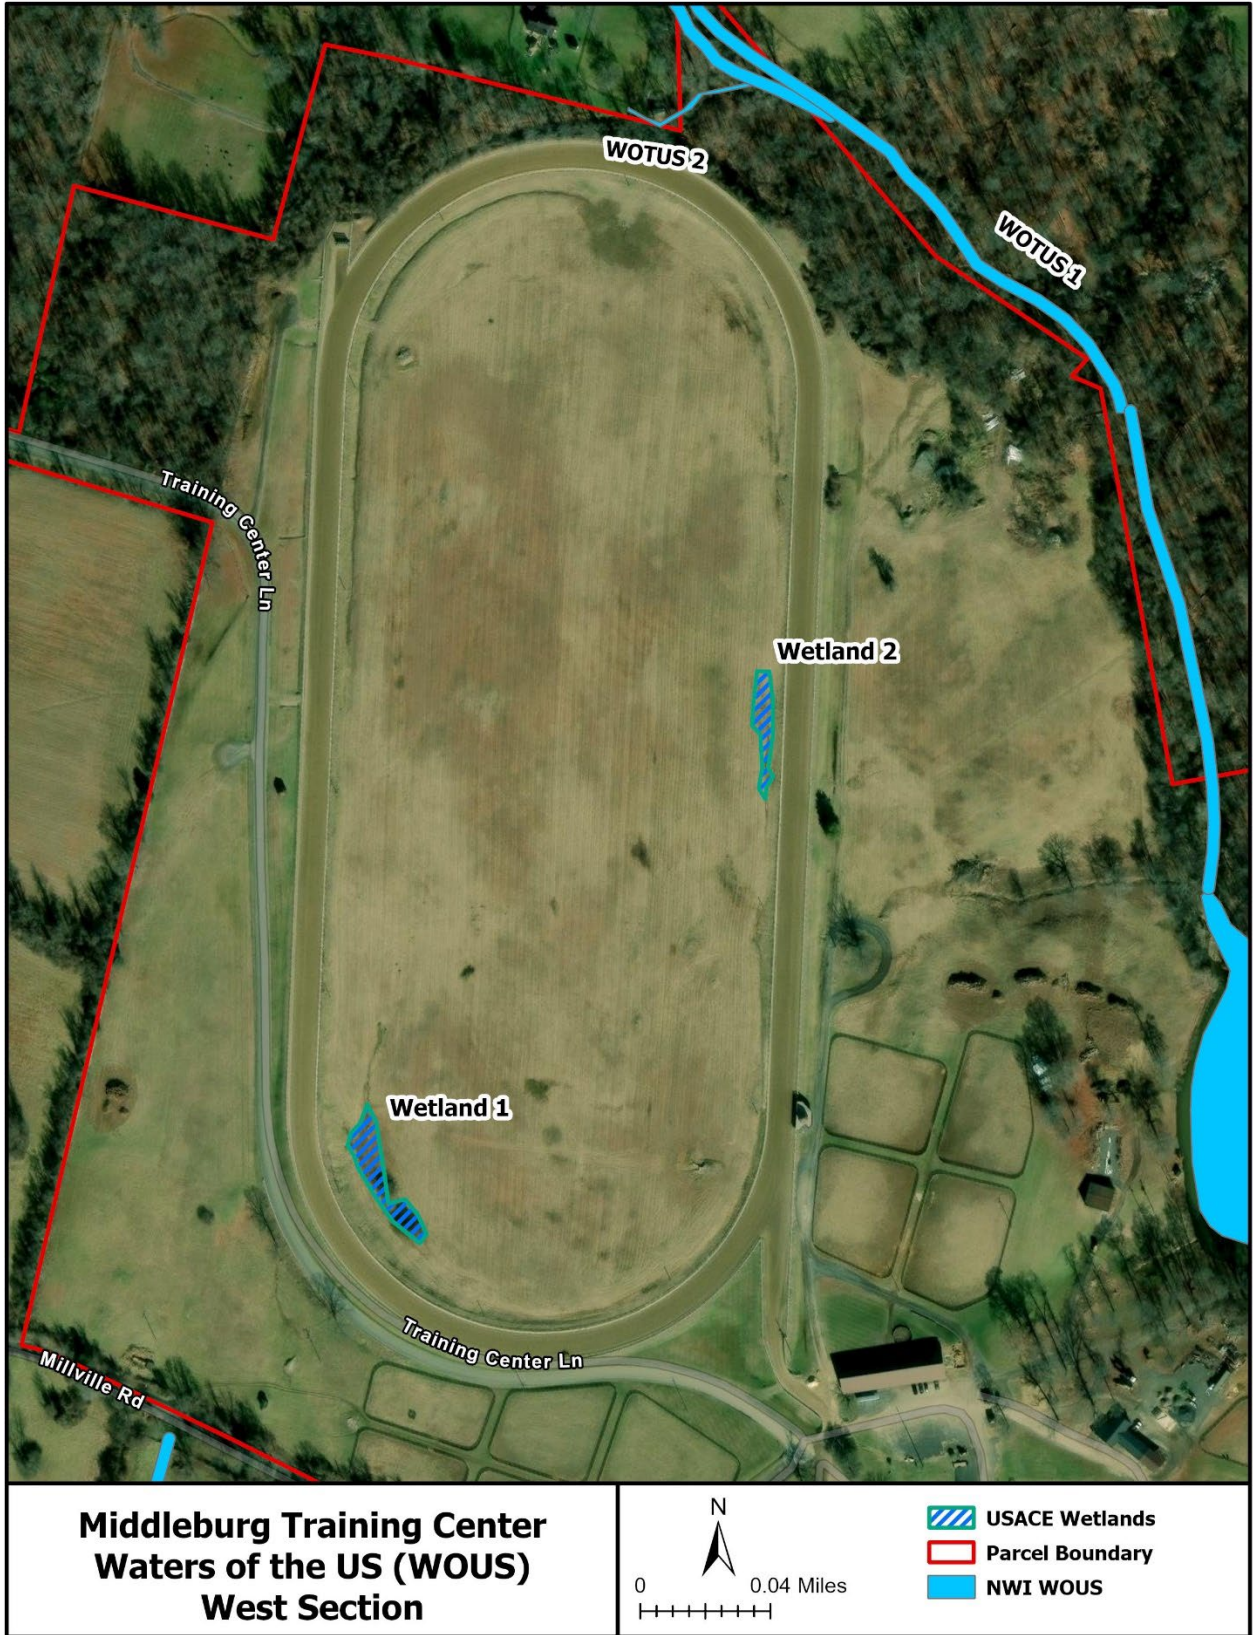
Figure 2: MTC Western Wetland

On-site investigation of the study area in September 2025 indicated the presence of wetlands. The USACE team placed numbered flags along the limits of wetlands. The flags were located using GPS survey methods. The delineated areas amount to approximately 0.48 acres of wetlands (Table 3, Section 3.6). The wetlands delineated at the project sites are shown in Figure 2, Appendix A.

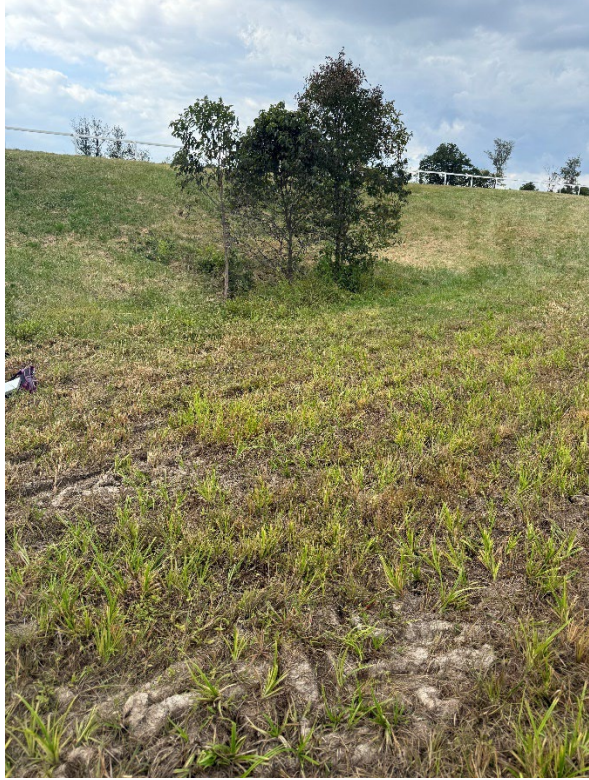
Wetland 1 is located within the racetrack, at the southwestern corner. This wetland drains into a culvert at its northern end, which then flows south underneath the track. The dominant species observed at the wetland were invasive barnyard grass (*Echinochloa crus-galli*) and invasive small carpetgrass (*Arthraxon hispidus*). Indicators for wetland hydrology were oxidized rhizospheres

Figure 1: Wetland 1 overview looking north

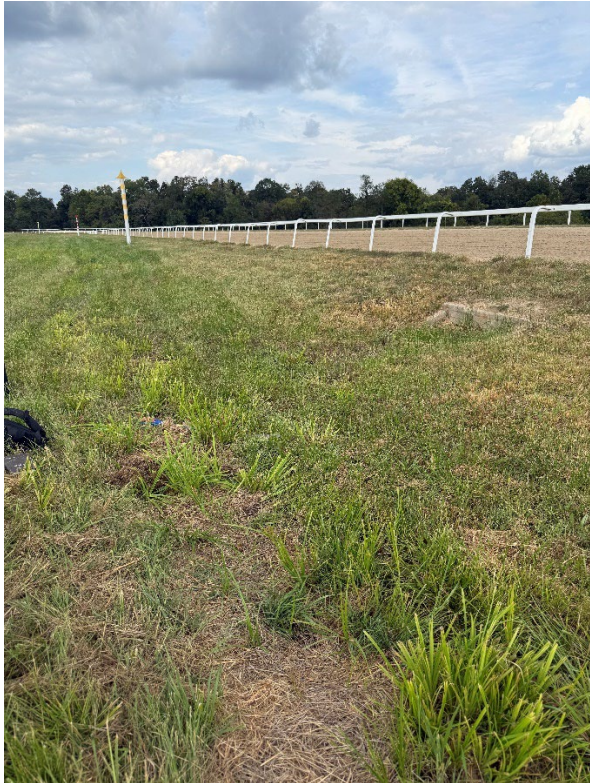
Wetland 2 is located within the racetrack on the eastern central section. This wetland flows out a culvert that goes underneath the track to the east. The dominant species observed at the wetland were false nutsedge (*Cyperus strigosus*) and invasive yellow foxtail (*Setaria parviflora*). Indicators for wetland hydrology were oxidized rhizospheres along living roots, drainage patterns, microtopographic relief, geomorphic position, and the FAC-neutral test. The soil matrix was predominately a 10YR 4/2 with 7.5YR 4/6 concentrations in the matrix which meet hydric soil criteria for a depleted matrix and redox depressions. Wetland 2 is a small, surface water-driven depressional wetland with no visible connections to other WOTUS, likely created by grading of the racetrack.

Figure 2: Wetland 2 overview looking north, with drainage culvert visible

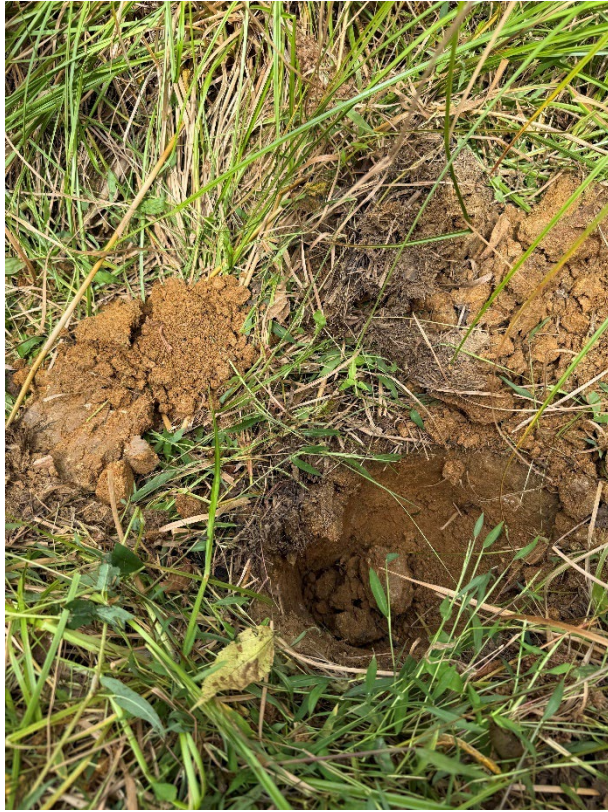
Wetland 3 is located at the northern end of the survey area, on the edge of a mowed field and a small section of forest. Wetland 3 flows into WOTUS 1 to the southeast with no visible connection. The dominant species observed at the wetland were false nutsedge and woolgrass (*Scirpus cyperinus*). Indicators for wetland hydrology were oxidized rhizospheres along living roots, drainage patterns, the FAC-neutral test, and microtopographic relief. The soil matrix was predominately a 7.5YR 4/6 with 10YR 5/3 concentrations in the matrix which meet hydric soils criterion for redox depressions. Wetland 3 is a depressional surface-water driven wetland created by the facility through excavation of soils for the racetrack. This is a disturbed wetland, palustrine emergent wetland that flows southeast.

Figure 3: Wetland 3 soils with problematic red parent material

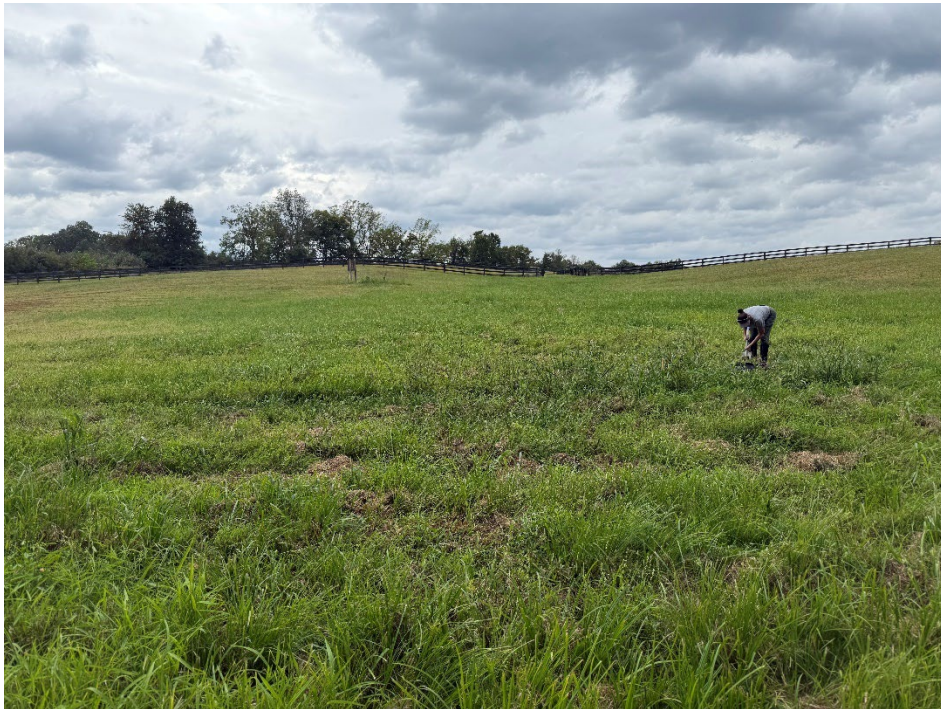
Figure 4: Wetland overview, facing south

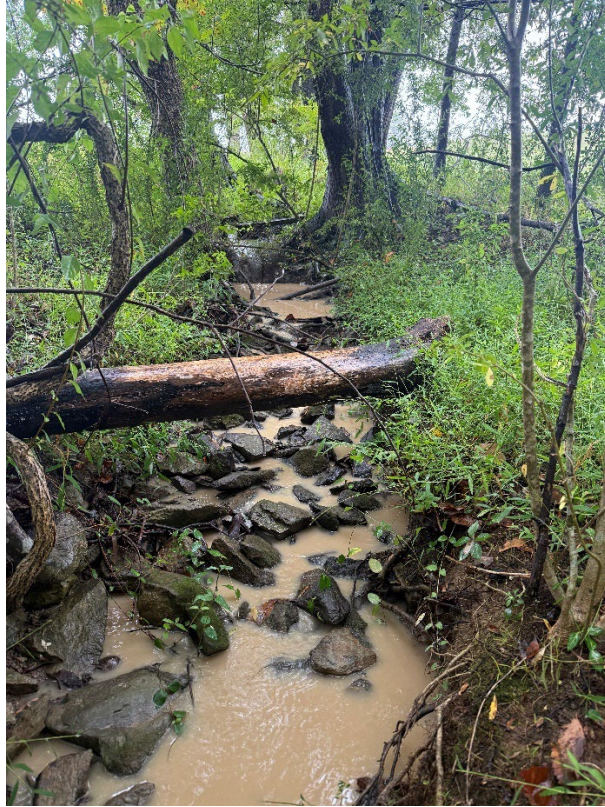
Figure 5: WOTUS 1 North of the Pond

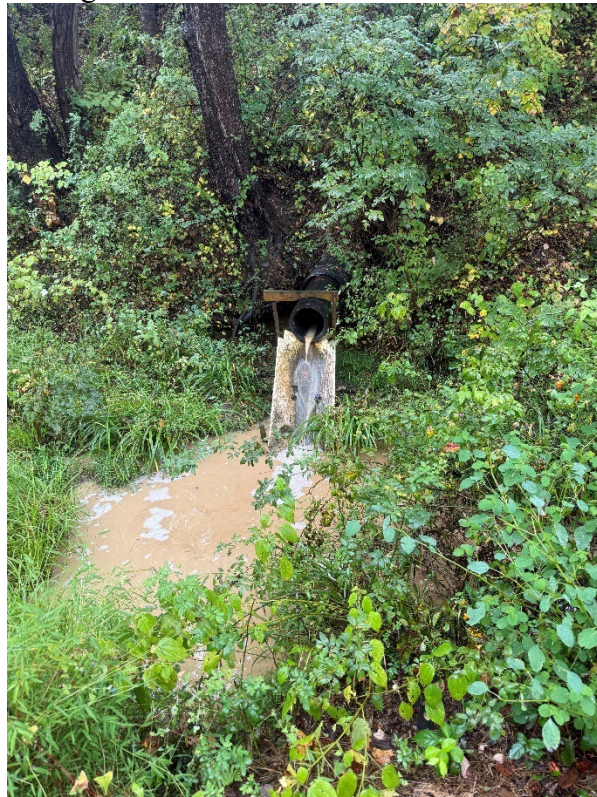
The dominant hydrologic feature on the proposed site is a Water of the US (WOTUS) that serves as an unnamed tributary to Goose Creek. Goose Creek is just south of the survey area, flowing southwest and emptying directly into the Potomac River. Descriptions are provided in Table 2. WOTUS 1 is classified as a perennial stream based on the presence of high flood marks, channel sinuosity, lack of leaf litter within the stream bed, and bank-full benchmarks. This is a change from the NWI classification of intermittent. WOTUS 2 is a small tributary to WOTUS 1 and was not shown on NWI data. This is an intermittent stream created by a culvert off the of the racetrack and flows directly into WOTUS 1 (Appendix C).

Figure 6: Culvert creating WOTUS 2, directly above northern section of racetrack
