US Army Corps
of Engineers

Indian Rock Dam 75th Anniversary

From the Flood of 1933 to Indian Rock Dam

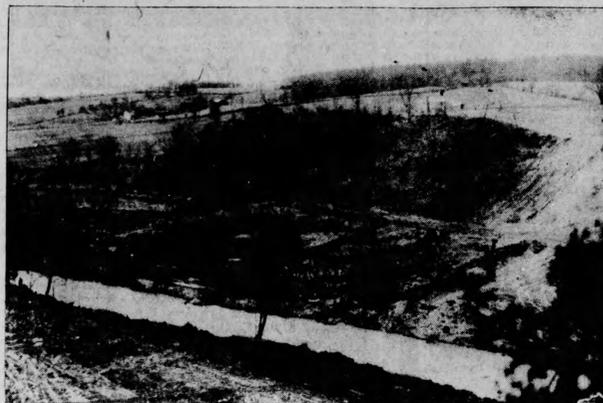
—Photo By The Gazette And Daily
While residents of cities up-state are fearing floods from the Susquehanna river, work is going forward on the Indian Rock dam project, which is being done by the U. S. Army engineers at a cost of more than one million dollars. The dam, when completed about four miles south of York, will put the Codorus river under flood control and never will the great August flood of 1933 be repeated to cause Yorkers untold financial losses. Shown above is a picture of the work now being done. The picture was taken from Indian Rock.

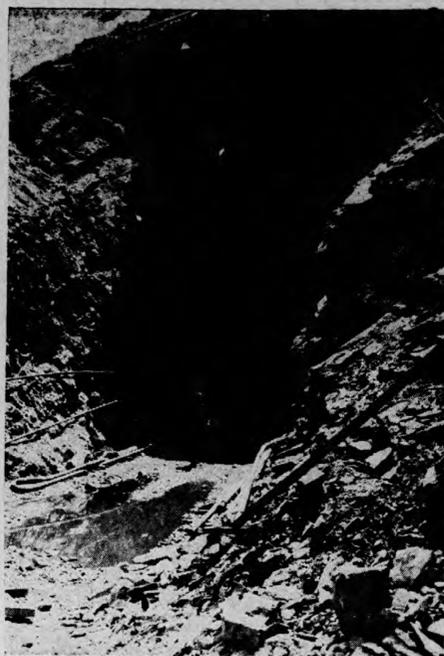
This picture shows the one end of the tunnel. This is being cut through a hillside and will be about 360 feet in length. This tunnel, when finished, will be solid concrete.

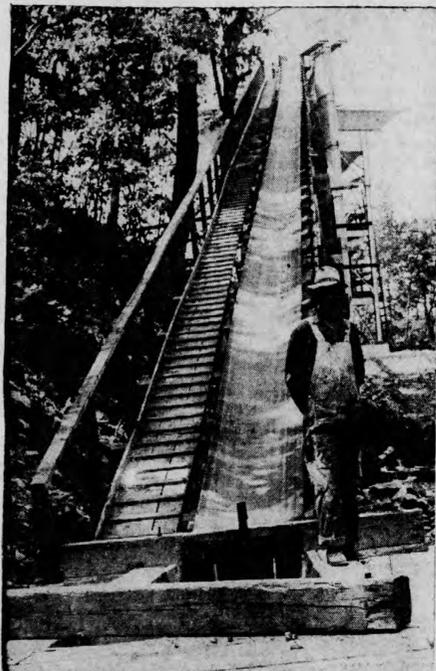
Here is a foreman pictured at the bottom of the conveyor from the opposite side to the picture at top.

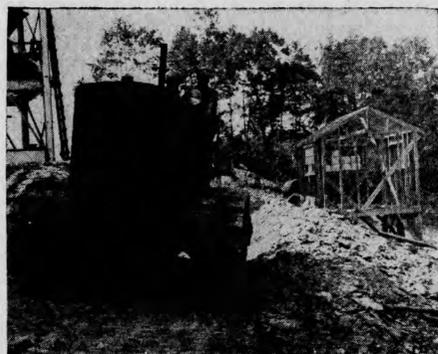
—Photos By The Gazette And Daily
This is just one of the many tractors the U. S. War department has at the construction scene.

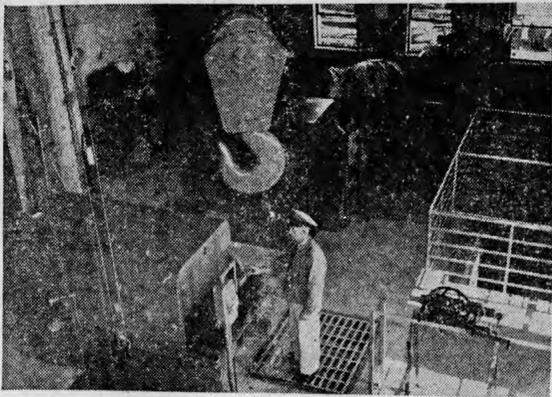
WHERE THE CODORUS IS TAMED—Dam Tender David Young throws the switch on one of the three machines which raise and lower the 36,000-pound floodgates. One hundred machines like this were employed to raise the battleship North Dakota from the bottom of Pearl Harbor. The power which actually works the lift machinery is amazingly, a simple five-horsepower electric motor. Power is increased by intricate gearing. In the event of power failure, the dam manufactures its own electric power in an emergency generating plant. If that fails, the huge flood gates can be raised and lowered by hand. Only 26 pounds of pressure are required to turn the cranks which raise the gates. Release of automatic magnetic brakes permits the gates to be lowered by their own weight. Floodgates are knife-edged to cut through heavy driftwood, but if they fail, the giant crane is available to lever such obstructions away.

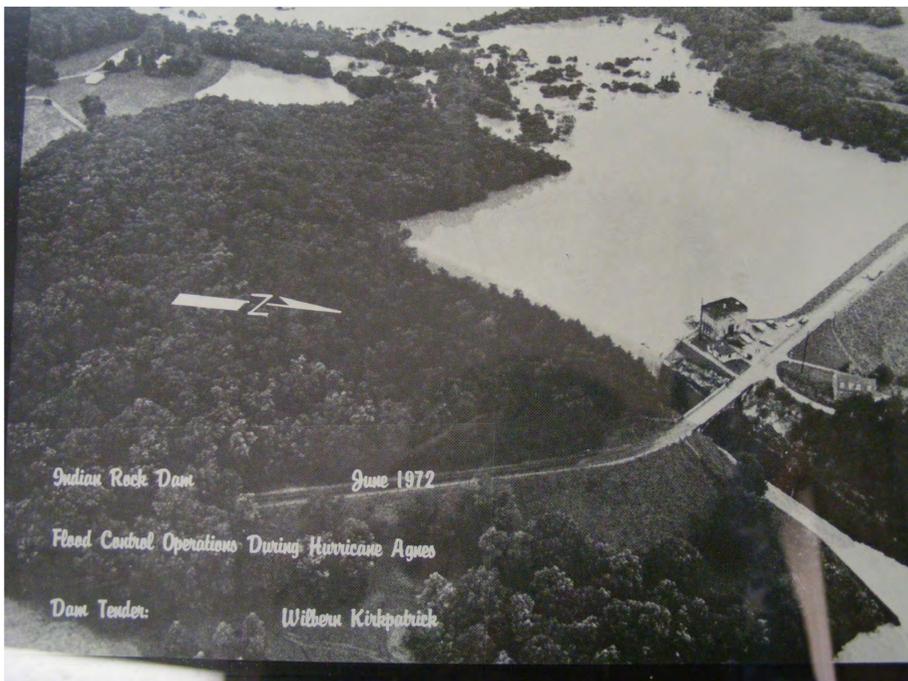
U.S. Army Corps of Engineers File Photo

Tropical Storm Agnes was the first and only time Indian Rock Dam has seen spillway flow. What that means, is that the area behind the dam filled to its capacity - holding back 9.1 billion gallons of water from downstream communities - and excess water flowed past the dam through its concrete spillway. All elements functioned as designed.

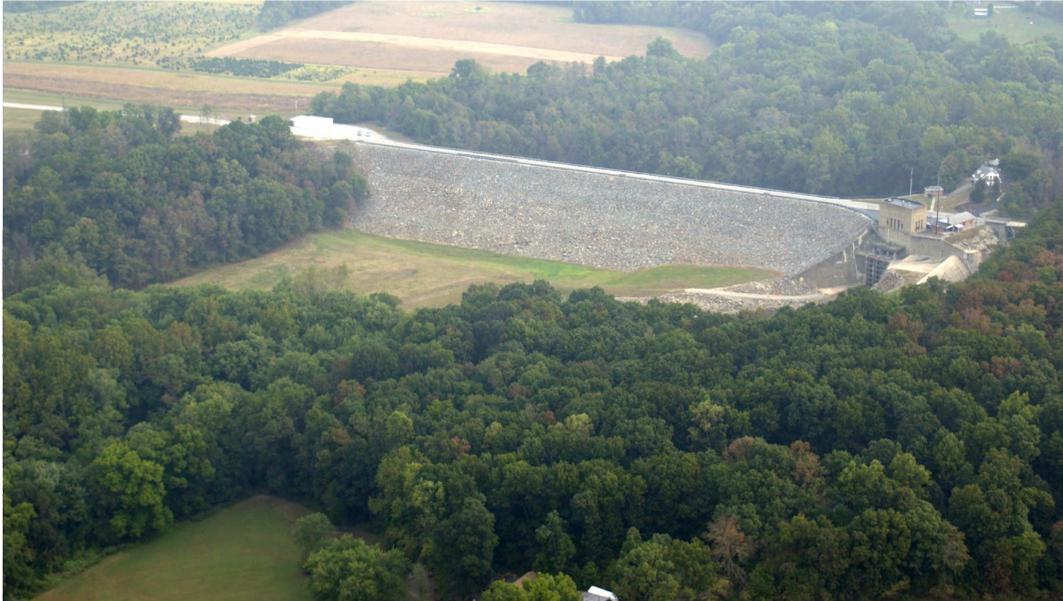
TOP: Aerial view of Indian Rock Dam. Codorus Creek flows into the intake below the gatehouse visible in the right of the aerial and in the photo to the right. The reservoir is normally dry as seen here, though the dam can close gates to control water flowing downstream and hold water behind the dam to reduce flood risks.

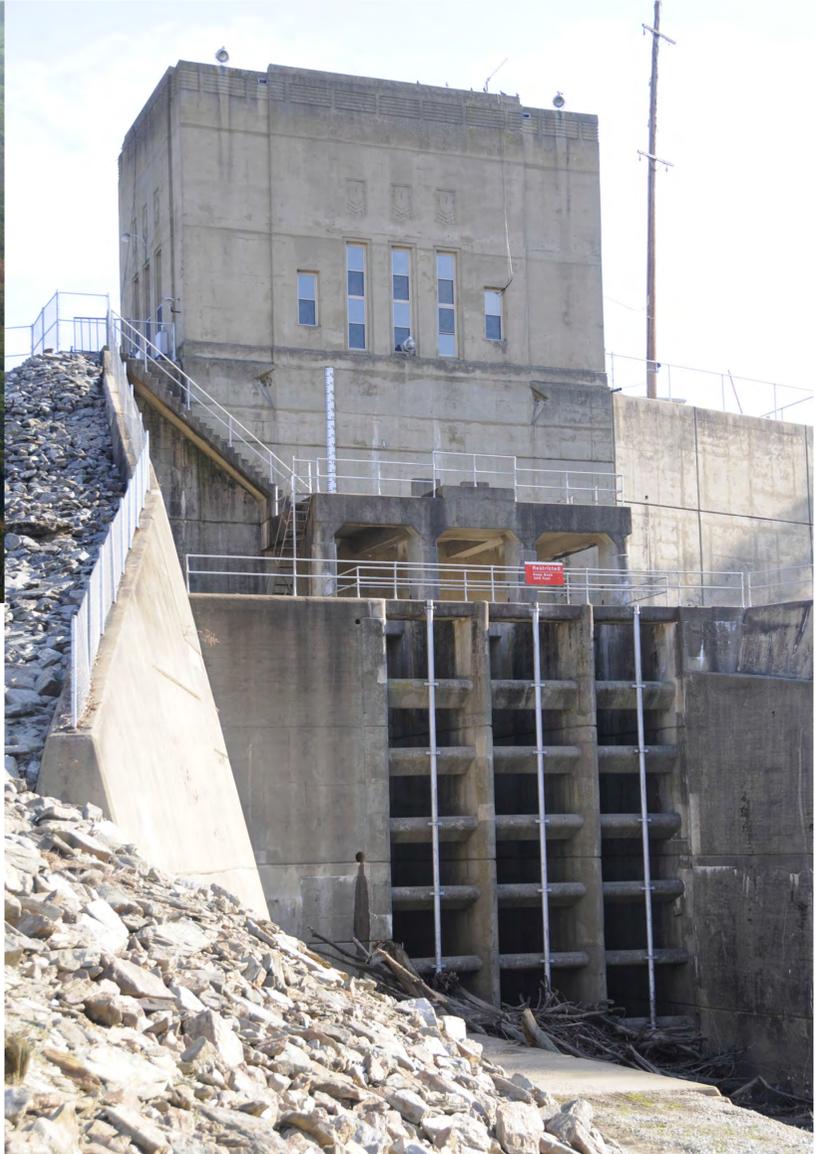
RIGHT: A closer view of Indian Rock Dam's intake. (Note: this photo was taken just after Hurricane Sandy in 2012, which is why there is debris visible. Part of the maintenance of the dam is clearing debris like pictured here to ensure the dam operates as designed). During high water events, one or more of three gates are closed, causing water to build up behind the dam in the normally dry reservoir.

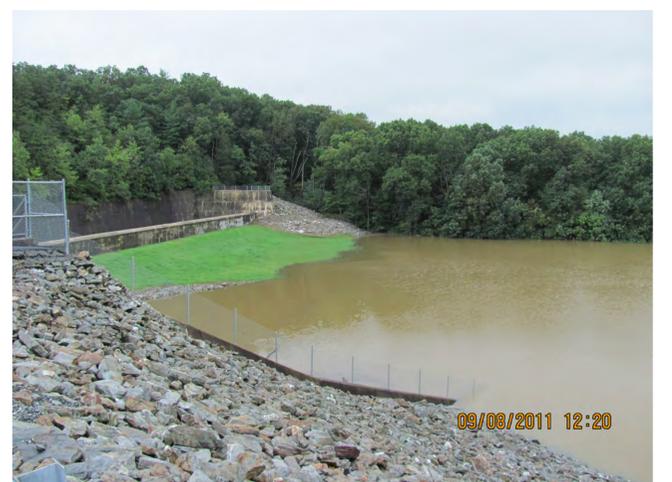
Waters from Tropical Storm Lee are seen here in the normally dry reservoir behind Indian Rock Dam. To the left is the dam's concrete overflow spillway. The water in the reservoir peaked at 44.1 percent capacity during Tropical Storm Lee. Had the reservoir's capacity been exceeded, water would have flowed into the concrete spillway and made its way downstream so as to not risk putting too much pressure on the dam. Tropical Storm Lee caused devastating flooding in parts of Pennsylvania and other states, but in York its impacts were greatly reduced by Indian Rock Dam. (U.S. Army photo by Steve Young, Indian Rock Dam Head Dam Operator)

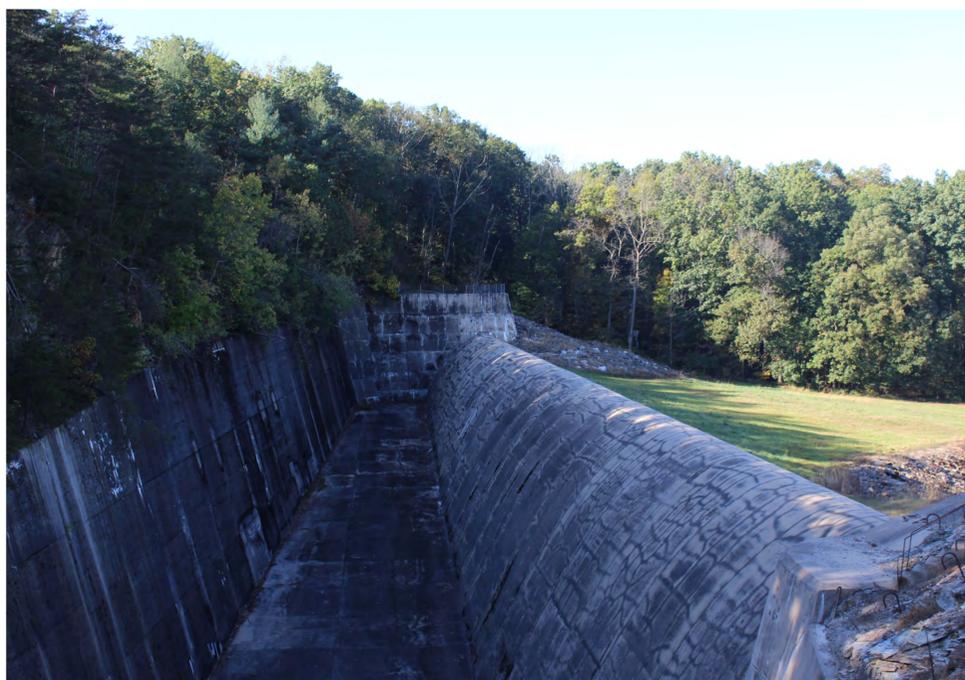
When does Indian Rock Dam's spillway "see flow"? At Indian Rock Dam, when the gates have held back enough water that the reservoir reaches 435 feet above sea level (and is holding back roughly 9.1 billion gallons of water), water begins to flow over the concrete wall seen on the left in the image below and into the spillway. It then flows down the spillway and continues downstream past the dam. This, like other spillways, is too avoid too much pressure building behind the dam.

How does Indian Rock Dam's spillway work? Indian Rock Dam has what is called an uncontrolled spillway. That means that the spillway sees flows of water when the water in the reservoir reaches a certain height, rather than being operated or activated by personnel.

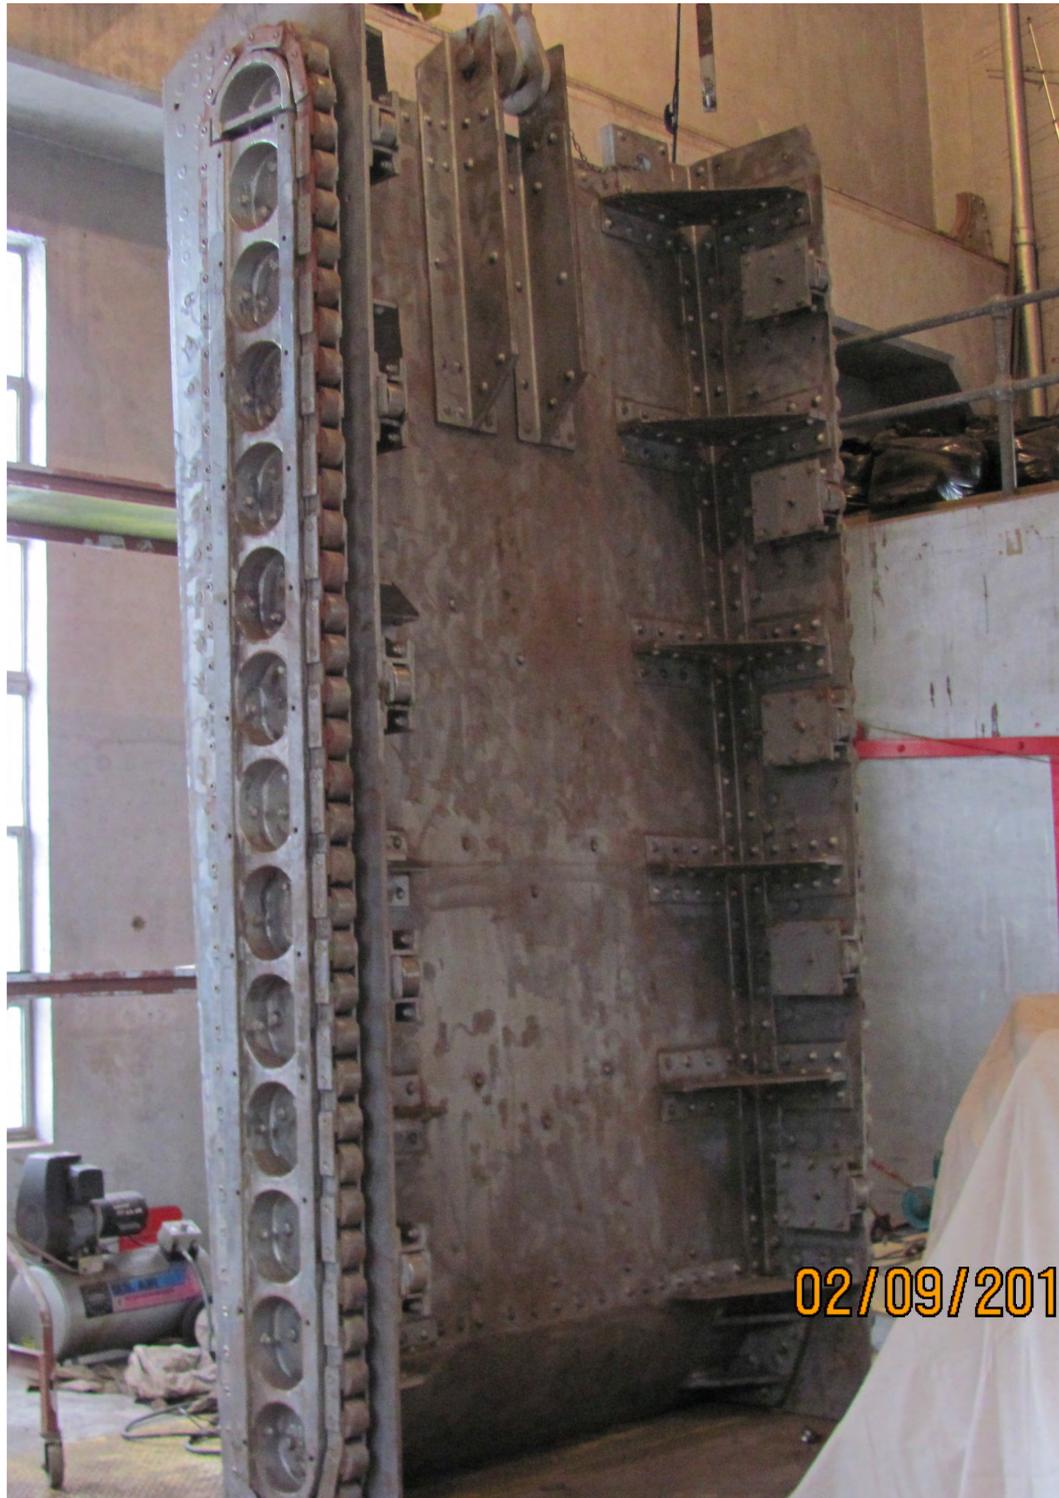
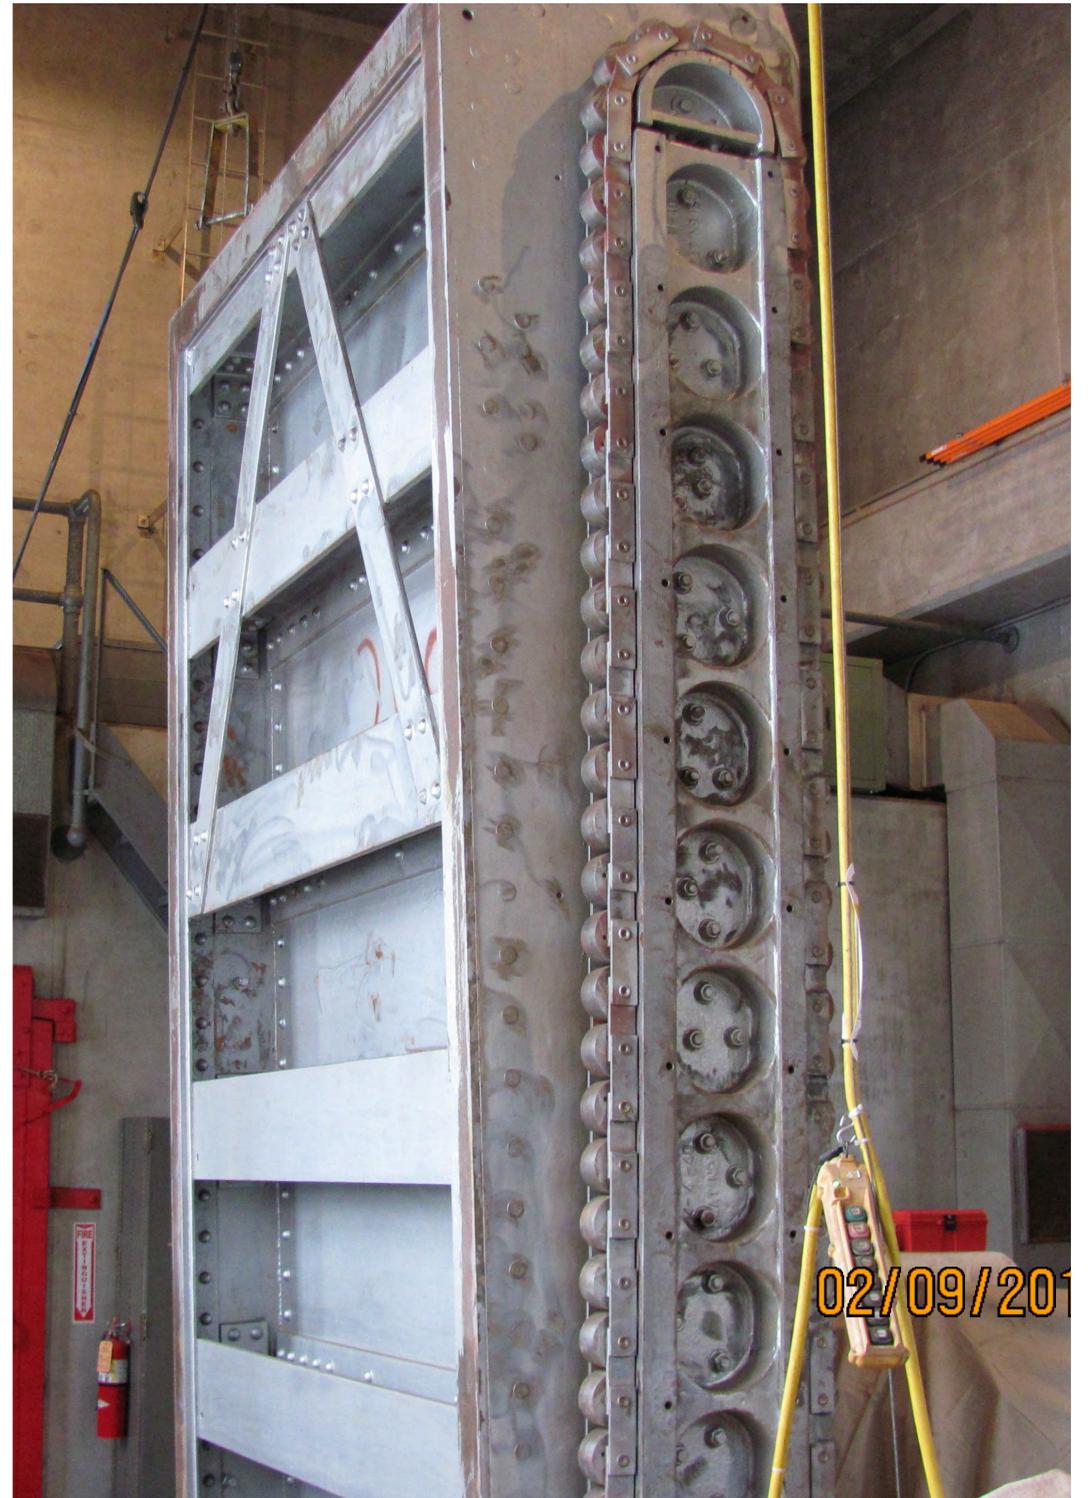
Below are pictures of one of the gates during routine maintenance in February 2011.

Maintenance is critical to keeping a structure like Indian Rock Dam operating for 75 years. Annually, the team removes, takes apart, cleans and inspects one of the dam's three gates.

Indian Rock Dam manages the flow of water downstream by raising and lowering its three 20-ton steel gates. The gates are not visible because they are below the three hoists you see in the middle of the gatehouse.
