### **BAT CONSERVATION AREA COMPENSATORY MITIGATION PLAN**

**Sunoco Pipeline L.P.  
Pennsylvania Pipeline Project  
Raystown Lake Recreation Area  
Bat Conservation Area No. 2  
Compensatory Mitigation Plan**

May 2016

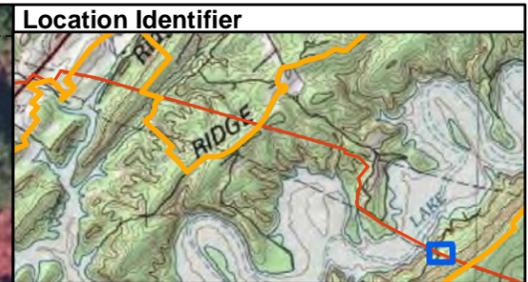
**Figure 2 - Project ROW Through Raystown Lake Bat Conservation Area**

Note: The permanent and temporary ROWs within the BCA will be treated and monitored for invasive plant species pre-construction and one (1) year post-construction, respectively.

Impacted Bat Conservation Area:  
 Total area in construction ROW - 2.2 Acres  
 Total area tree clearing - 1.4 acres

Invasive plant species will be treated using herbicides approved by Raystown Lake staff and will be dependent upon the type of invasive plant species found in the area.

Tree Girdling/Artificial Roost Structures will be installed within the Temp ROW. Specific locations will be field determined in consultation with Raystown Lake staff.

temporary ROW, additional temporary workspace, staging areas) that would be reforested/revegetated as part of the Project (Figure 2). The cleared land that would be reforested (0.4 acre) has been selected as the location for creation of bat habitat, while the entirety of cleared land (1.4 acres) would be treated and monitored for invasive species. A location map showing the locations of the impact and where mitigation will occur is provided in Figure 2.

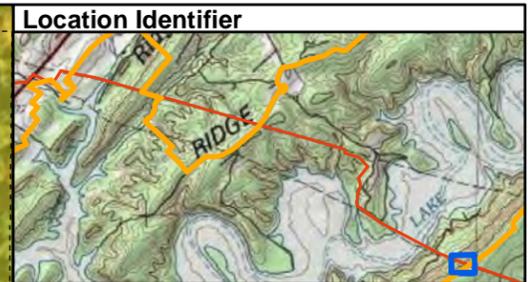
**Figure 2 - Project ROW Through Raystown Lake Bat Conservation Area**

Note: The permanent and temporary ROWs within the BCA will be treated and monitored for invasive plant species pre-construction and one (1) year post-construction, respectively.

Tree Girdling/Artificial Roost Structures will be installed within the Temp ROW. Specific locations will be field determined in consultation with Raystown Lake staff.

Impacted Bat Conservation Area:  
Total area in construction ROW - 2.2 Acres  
Total area tree clearing - 1.4 acres

Invasive plant species will be treated using herbicides approved by Raystown Lake staff and will be dependent upon the type of invasive plant species found in the area.

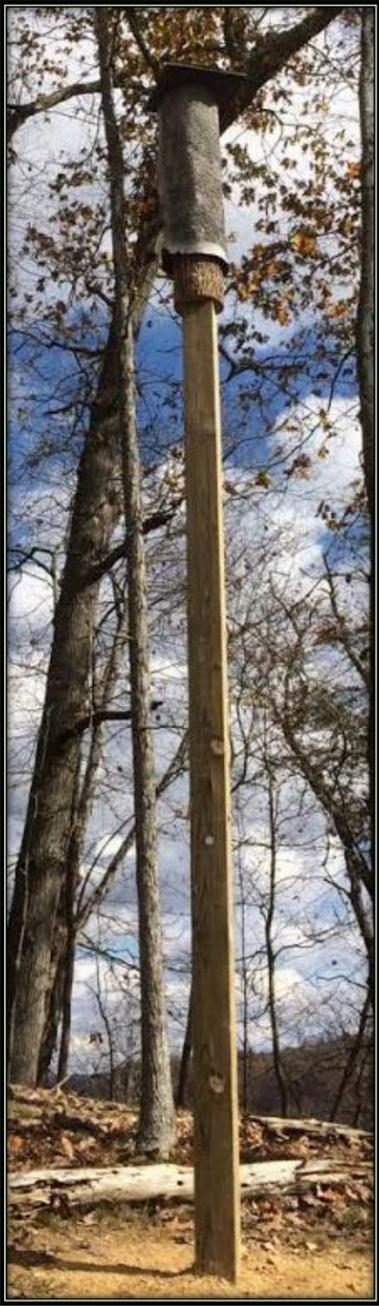
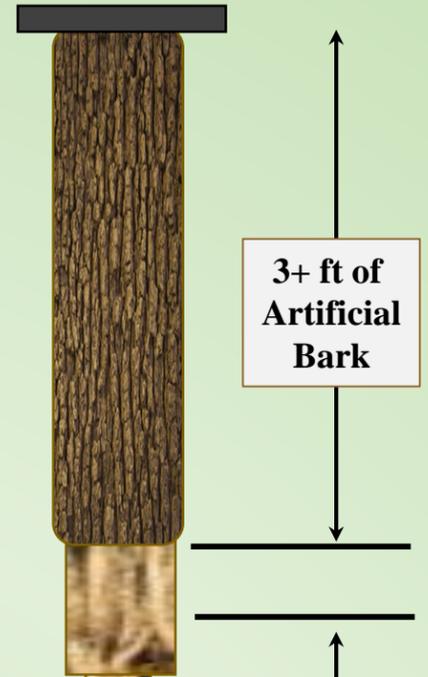
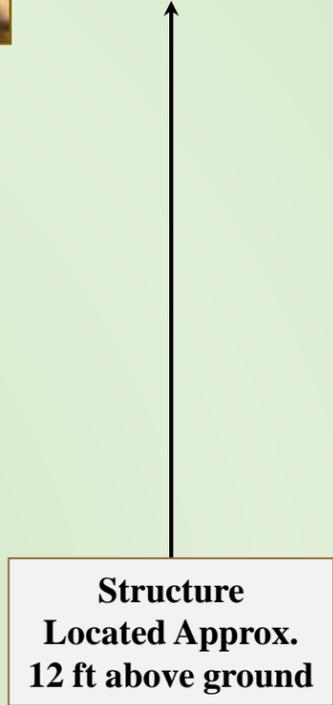
## Option 1: Constructed Artificial Bark Structure

**16 ft 6x6 post**

**Buried 4 ft into ground**

SPLP proposes to create new bat roosting locations through the installation of artificial roost structures, to be installed after construction of the Project is completed. Specifically, SPLP contractors will install approximately six (6) structures to compensate for the loss of approximately 1.4 acres of forested habitat at BCA No. 2 as a result of the Project. Artificial roost structures (refer to Appendix A) mimic the natural roosting habitat of bats and have been demonstrated as preferable for roost creation for forest bats when compared with traditional nursery style bat boxes. The artificial bark imitates the loose bark and thermal mass of a wildlife snag simulating the multiple cavities of a hollow tree providing habitat and space for bat usage. The structure will stand approximately 16 feet tall with the upper 3 feet of the structure containing artificial bark. Bat netting will also be attached to the structures to provide a rough surface to which bats can cling.

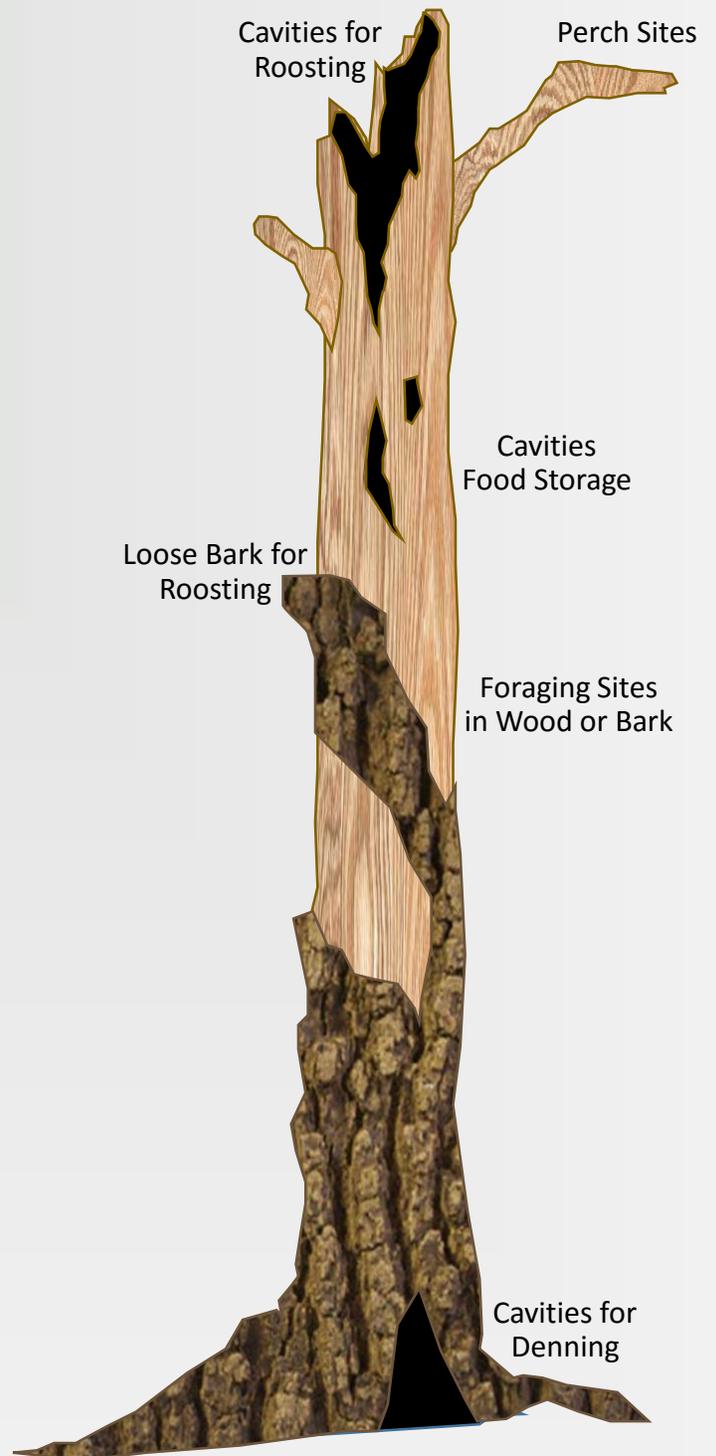
## Typical Wildlife Snag

Snags can be created by killing a tree without removing it. Methods for snag creation vary and can determine the longevity and fate of the snag.

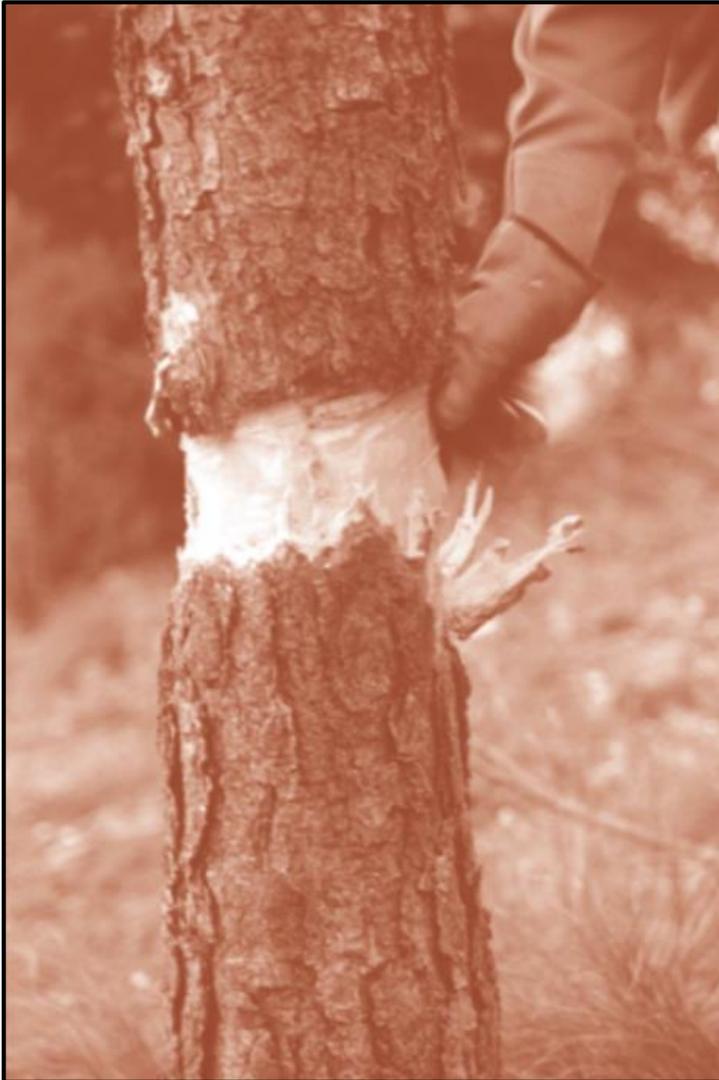
# Girdling for Snag Creation

Girdling is the traditional method for killing a tree without felling. The outer rings of a tree house the phloem and xylem, both necessary for the transport of vital water and nutrients throughout the tree. Girdling severs the bark, cambium and sometimes the sapwood in a ring entirely around the trunk of the tree effectively halting the exchange of sugars, minerals and water between the roots and the rest of the tree.

Once the cambium is severed and the bark is removed, the transport of water and nutrients ceases and the tree will die over time. Decay will slowly create habitat and foraging areas. Bark will slowly fall off the tree creating roosting habitat for wildlife.

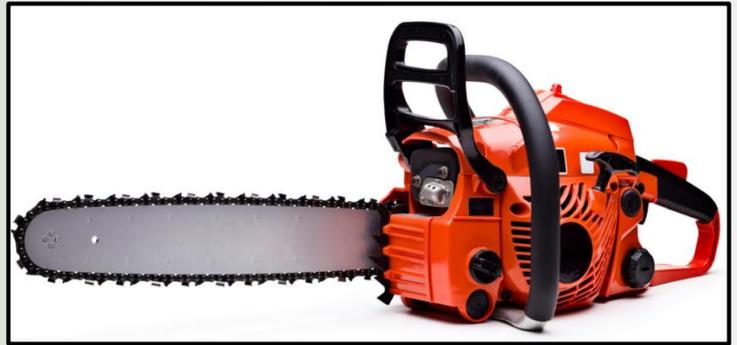
### Chainsaw

Chainsaws are efficient tools to use for girdling trees. Two cuts are made and the bark and cambium between the two cuts are removed. Trees should be de-limbed beneath the cuts to inhibit regrowth and sprouting.

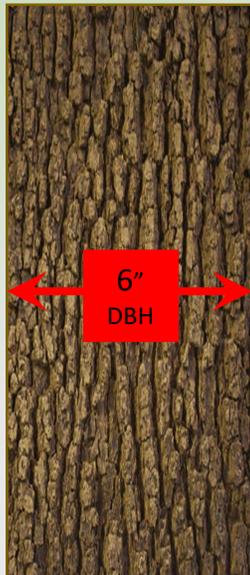
When using a chainsaw to girdle a selected tree, cut one groove completely around the tree at chest height. The groove must be deep enough to completely sever the phloem and cambium. For larger trees (greater than 10 in DBH) a groove cut 1.5 inches deep into the tree will be sufficient.

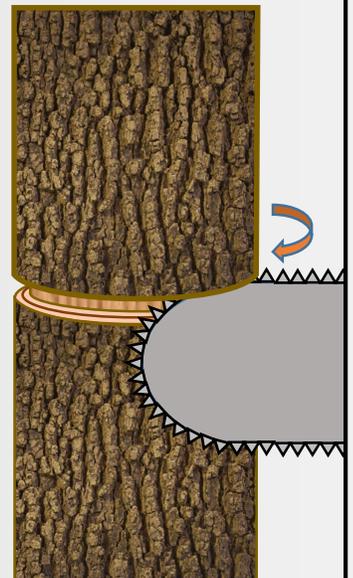
After the first groove, cut a second groove, completely around the tree, 2-3 inches below the first groove. The groove must be 1.5 inches deep.

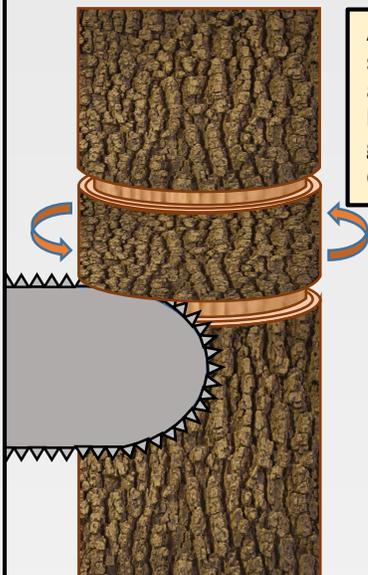
Once the two grooves are cut, the bark and the cambium between the two chainsaw cuts must be removed completely around the tree through the use of a wood chisel or sharp wedge. This removed area is called the kerf. A kerf, 2-3 inches wide should be sufficient to prevent the regrowth of the cambium and should successfully kill the tree.
