STARRUCCA CREEK MITIGATION BANK

FINAL PROSPECTUS

(DRAFT MITIGATION SITE PLAN)

**Thompson Township, Susquehanna County,
Starrucca Borough, Wayne County,
Pennsylvania**

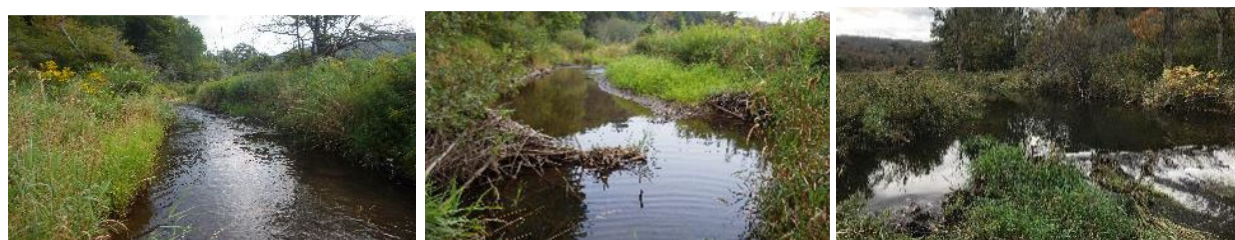
Diagram 1: Sequence of channel evolution of an incised stream due to beaver activity, adapted from Pollock et al. 2014 and B. Goldfarb 2018.

Incised Channel

Stream Rebuilding-Beaver Activity

wetland types, with anastomosing stream channels that continually evolved while migrating across the valley bottom laterally, as shown in Appendix A: Figure 5A: 1939 Historic Aerial Map. These systems were highly influenced and regulated by the activities of the North American beaver (*Castor canadensis*), which is described as an “ecosystem engineer” due to its unique ability to build dams and its role in physically modifying habitat structure and resource availability for themselves and other species (Batzner and Sharitz 2006; Jones et al. 1994). Currently, streams are trapped along the valley margins and remain in a static condition due to installed berms, ditches, channelization, and armored banks. This has reduced hydrologic interaction with the system’s floodplain and neighboring wetlands while also increasing geomorphic instability and reducing habitat diversity. In addition, the active management of beavers by landowners has impeded their ability to modify the stream corridor, which over a long period of time (>100 years) may have returned to a dynamic and stable, multi-thread, braided stream and floodplain complex, as illustrated in Diagrams 1 and 2 provided below.

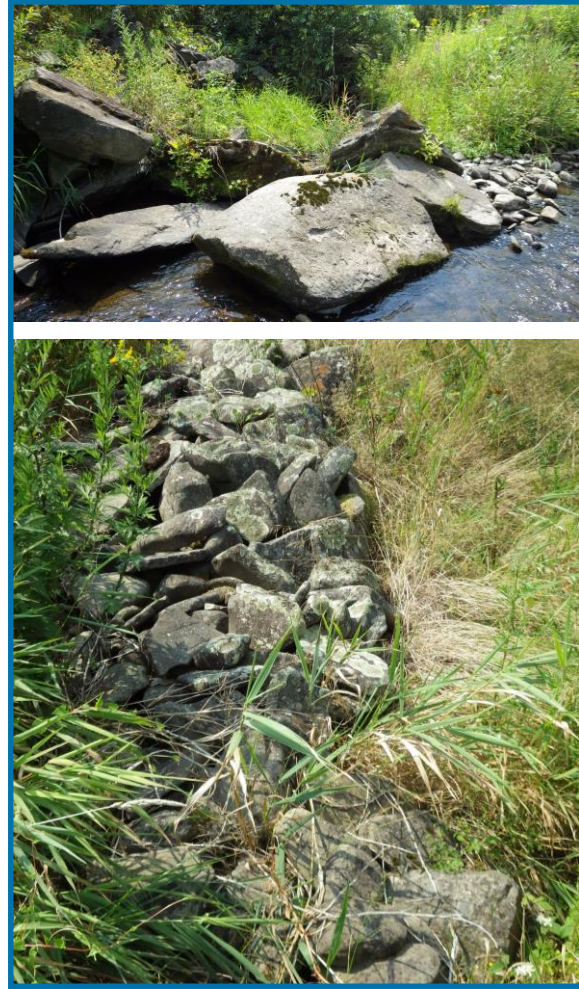
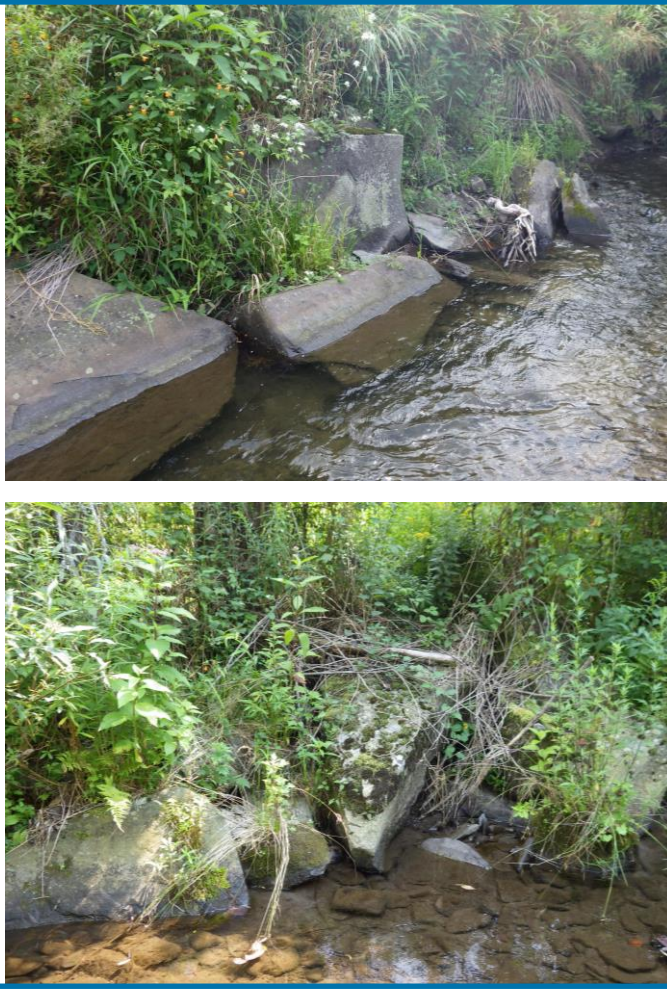
LAYOUT 1: PHOTO SERIES OF RIP RAP BANK ARMORING OCCURRING THROUGHOUT THE SITE.

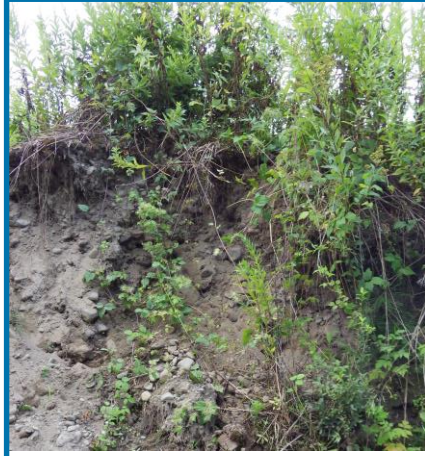
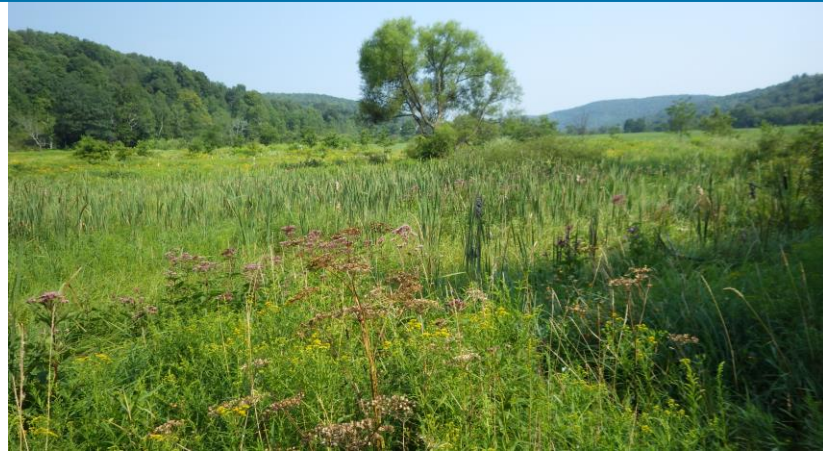
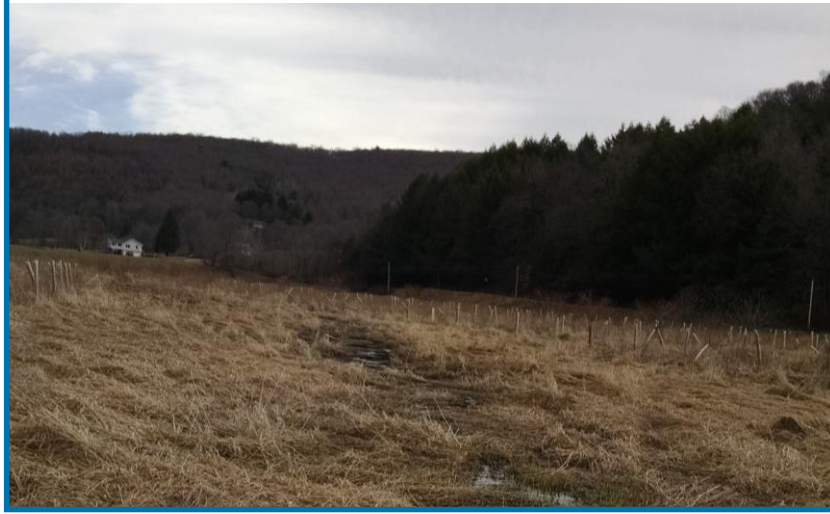
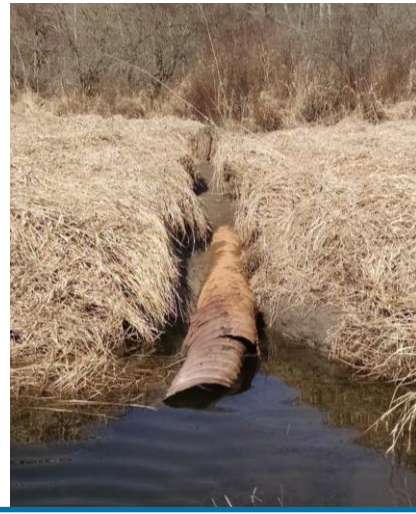
LAYOUT 3: ADDITIONAL IMPACTS. SEVERE BANK EROSION (TOP LEFT). INVASIVE CATTAIL (TOP RIGHT). INVASIVE REED CANARY GRASS AND WETLAND DITCHING (BOTTOM LEFT). ARTIFICIAL DRAINAGES (BOTTOM RIGHT).

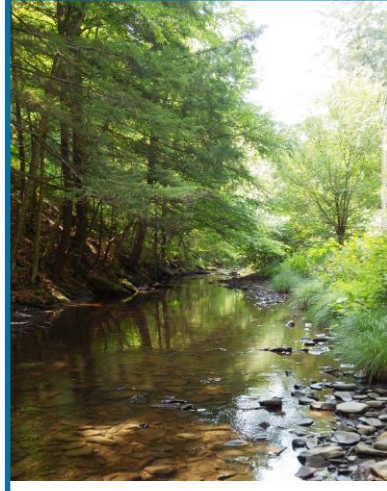
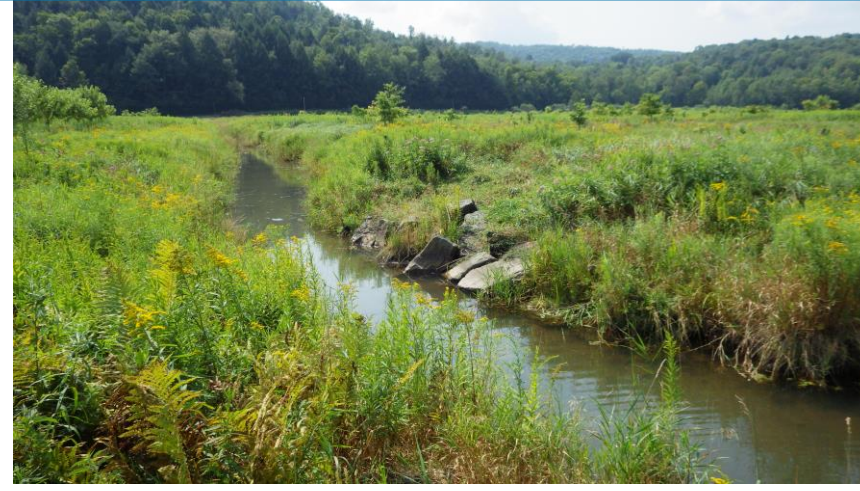
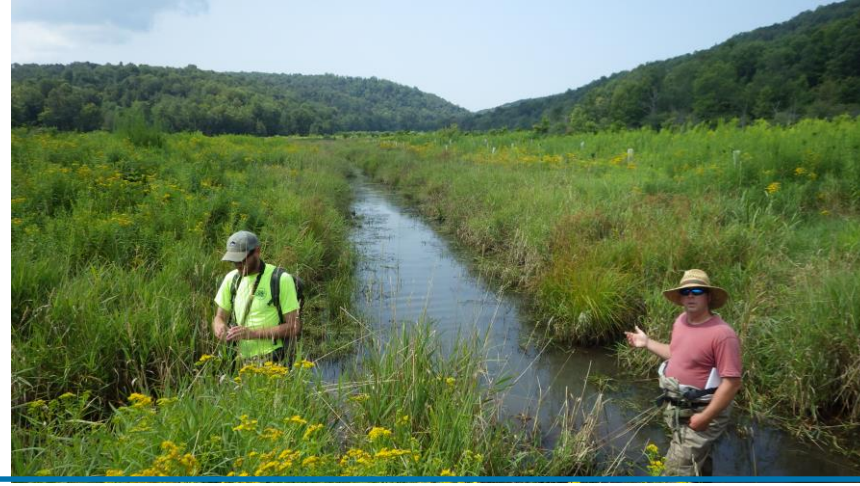
LAYOUT 2: PHOTO SERIES OF STREAM DITCHING AND STRAIGHTENING OCCURRING THROUGHOUT THE SITE.

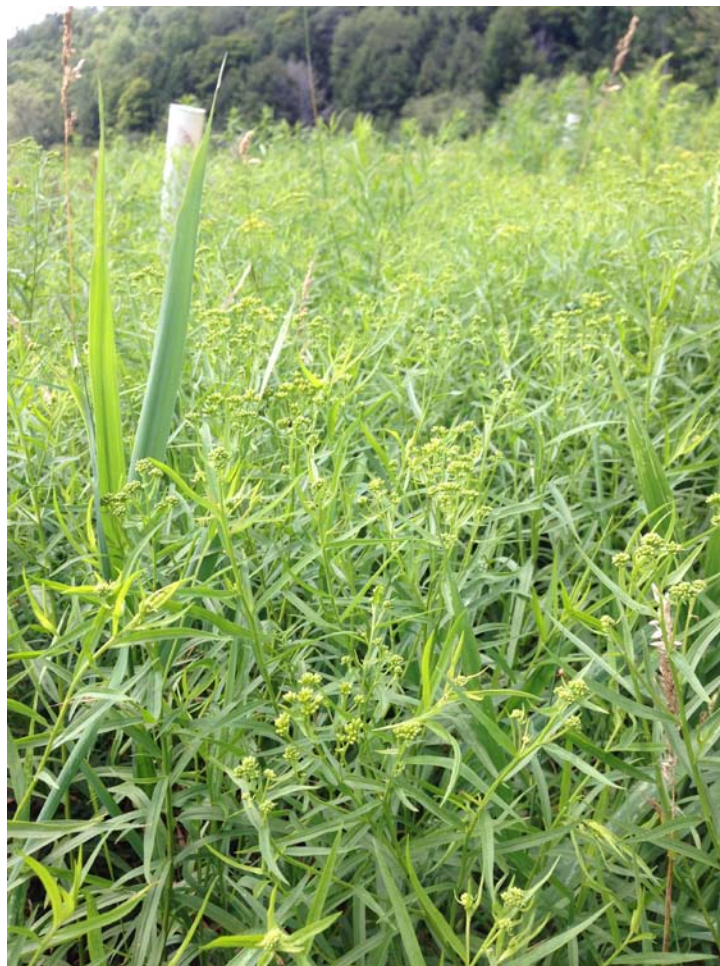
Vegetation in Wetland A is dominated by Reed Canary Grass (*Phalaris arundinacea* – FACW) and Bog Goldenrod (*Solidago uliginosa* – OBL) with areas of dominance changing, including pockets of Green Bullrush (*Scirpus atrovirens* – OBL) and Blunt Spikerush (*Eleocharis obtusa* – OBL) based on the hydrologic regime within the wetland. This area was previously planted to trees by the USDA Farm Service Agencies Conservation Reserve Enhancement Program (CREP) Farm Bill Program as a Conservation Practice 22 (CP22) Forest Riparian Buffer. Tree tubes within the wetland are void of trees or are stunted and an estimated (80%) eighty percent tree mortality was observed, this was suspected due to the field's hydrology.

Soils were consistent with the USDA mapped hydric Wyalusing Silt Loam. A Hydric soil indicator A11 (Depleted below Dark Surface) was present (DP-1).

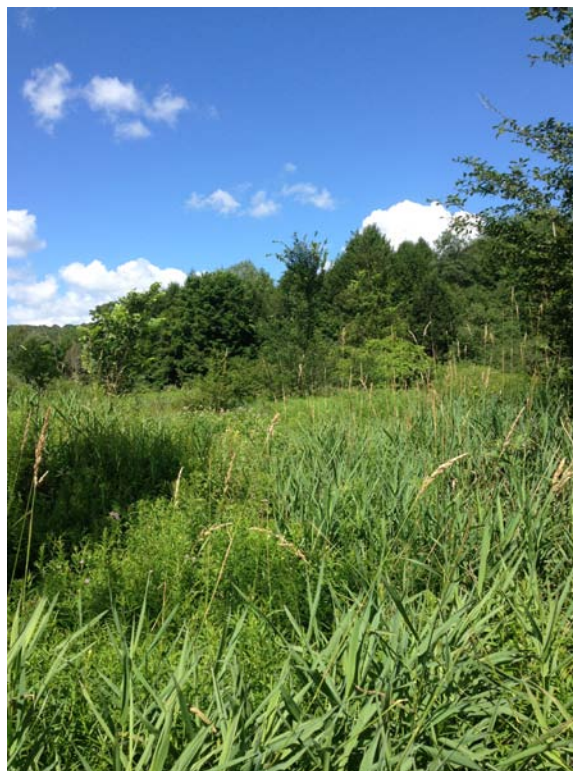
PSS6E: (Palustrine Scrub-Shrub, Deciduous, Seasonally Flooded/Saturated)

This wetland type consists of wetland B. Wetland B is located to the southwest of the open field area. National Wetlands Inventory (NWI) Mapper classifies this as a PSS1/EM5E wetland. Wetland B is 189,937 SQ. FT. (4.4 AC.), exhibiting hydrology features such as, oxidized rhizospheres on living roots (C3) and passing the FAC-neutral test (D5) from the secondary indicator listing. The oxidized rhizospheres occurred at 6 inches of depth and remained consistent through a twenty inch soil profile.

Vegetation is dominated by Giant Goldenrod (*Solidago gigantea* – FACW), Reed Canary Grass (*Phalaris arundinacea* – FACW), and Bog Goldenrod (*Solidago uliginosa* – OBL) in the herbaceous stratum, and Gray Birch (*Betula populifolia* – FAC) in the tree stratum.

Soils were consistent with the USDA mapped soil as a Mixed Alluvial Land, and textures consisting of a gravelly, sandy loam with 50 percent (50%) cobbles present below the top six inches. A hydric soil indicator A11 (Depleted Below Dark Surface) was recorded at Data Point 3 (DP-3). Soil within the top six inches was identified to have a matrix of 10YR 3/2, and was determined to be a sandy loam in which many roots were present. The remaining depth of the soil profile (6-20 inches) was identified to have a matrix of 10YR 3/3 (85%), exhibiting pore lining redox concentrations of 2.5YR 3/6 (15%). The soil at this depth remains a sandy loam, but additionally contains fifty percent (50%) cobbles.

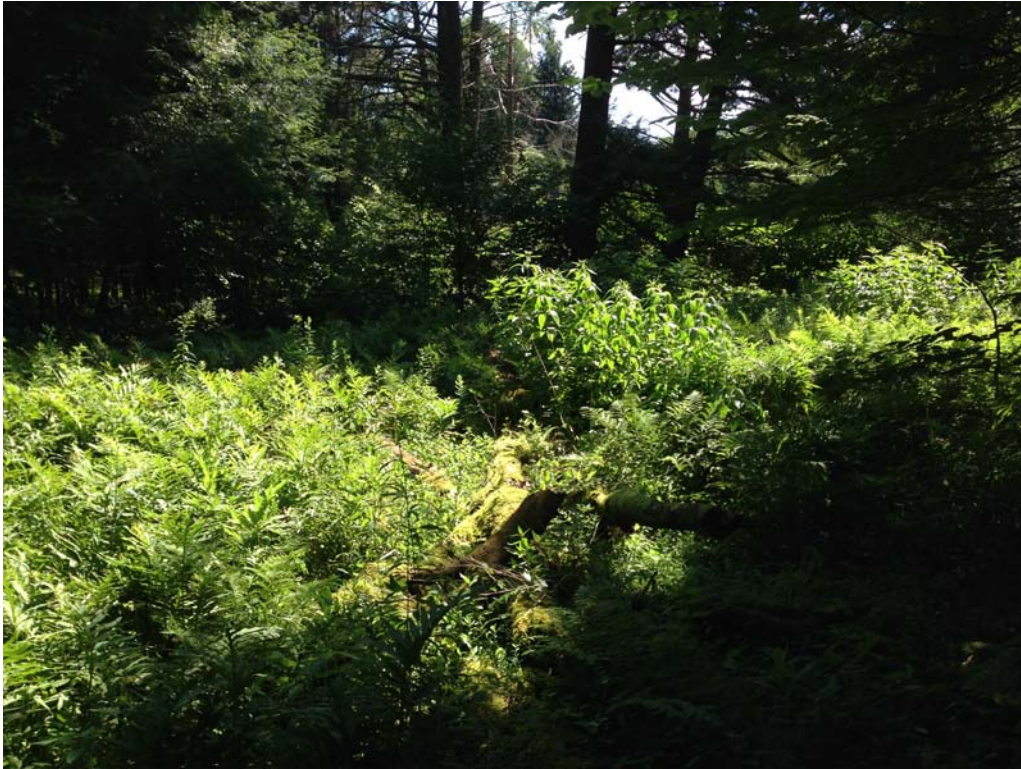
PEM2Y: (Palustrine Emergent, Nonpersistent, Saturated/Semipermanent/Seasonal)

This wetland type consists of wetlands (C-J, and L), which are all located to the northern side of Starrucca Creek. Several of these wetlands were located at higher elevations with steeper slopes than wetlands to the south of Starrucca Creek. The combined area of this wetland type is 18,425 SQ. FT. (.42 AC.) Two primary hydrology indicators were identified, High Water Table (A2) and Saturation (A3). The ground was saturated to the surface, and the water table was present at five inches (5in.) roughly fifteen minutes after the soil pit was dug. These primary indicators along with the FAC-neutral test (D5) as a secondary indicator prove positive for hydrology features present in the area. These wetlands are associated with hillside seeps and depressions that exists along and adjacent to seep runoff and the braided streams in the forested area. Although these areas are within the forest we classified them as PEM since they exhibit an open canopy and do not appear to be associated with the forest community.

Vegetation is dominated by Sensitive Fern (*Onoclea sensibilis* – FACW) and Jewelweed (*Impatiens capensis* – FACW) in the herbaceous stratum, while River Birch (*Betula nigra* – FACW) and Eastern Hemlock (*Tsuga Canadensis* – FACU) were within the tree stratum but appeared to be more associated with the adjacent upland community.

Soils in this area were identified as hydric with proof positive hydric soil indicator A11 (Depleted Below Dark Surface). This soil profile was broken up into three separate depths due to varying matrices and redox features. The top five inches (0-5 in.) were identified to have a matrix of 2.5YR 7/1 at (70%), exhibiting pore lining redox concentrations of 7.5YR 5/6 at (30%), this particular section was identified to have a silt loam texture and proved positive for mottling. The middle depth, (5-11 in.) was identified to have a matrix of 2.5YR 7/1 at (60%), exhibiting pore lining redox concentrations of 7.5YR 5/6 at (40%), eighty percent (80%) cobbles present at this depth. The bottom portion of the soil profile (11-20 in.) was identified to have a matrix of 2.5YR 5/1 at (60%), exhibiting pore lining redox concentrations of 7.5YR 5/6 at (40%). Soil texture at this depth remained a silt loam, and cobbles were highly present.

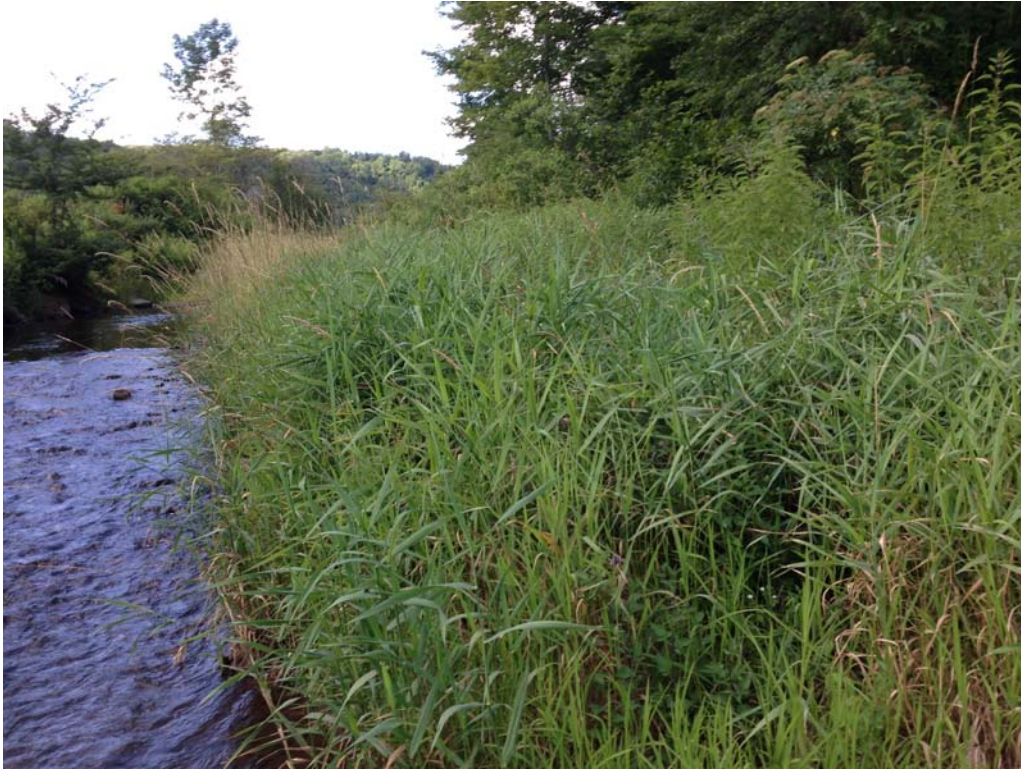
R3US5Jb: (Riverine, Upper Perennial, Unconsolidated Shore, Vegetated, Intermittently Flooded, Beaver)

This wetland type consists of wetlands (M-R), which are all located to the northern side of Starrucca Creek. The combined area for this wetland type is 41,647 SQ. FT. (.95 AC.). These wetlands are associated with point bar depositions along Starrucca Creek that extend from the toe of the steep upland slope to the open flowing water within Starrucca Creek. These were listed as riverine since they were within the bank full elevations of Starrucca Creek. Several Beaver dams along Starrucca Creek were identified in this area which had an effect on the hydrology of the system.

Vegetation is dominated by Reed Canary Grass (*Phalaris arundinacea* – FACW), Late Goldenrod (*Solidago gigantea* – FACW), and Spotted Joe-Pye (*Eutrochium maculatum*-OBL) (DP-8)

Soils are a dark surface above a depleted matrix (DP8) consistent with A11 and the edgemere component of the 7B USDA soil description. Many cobbles exist below 6”.

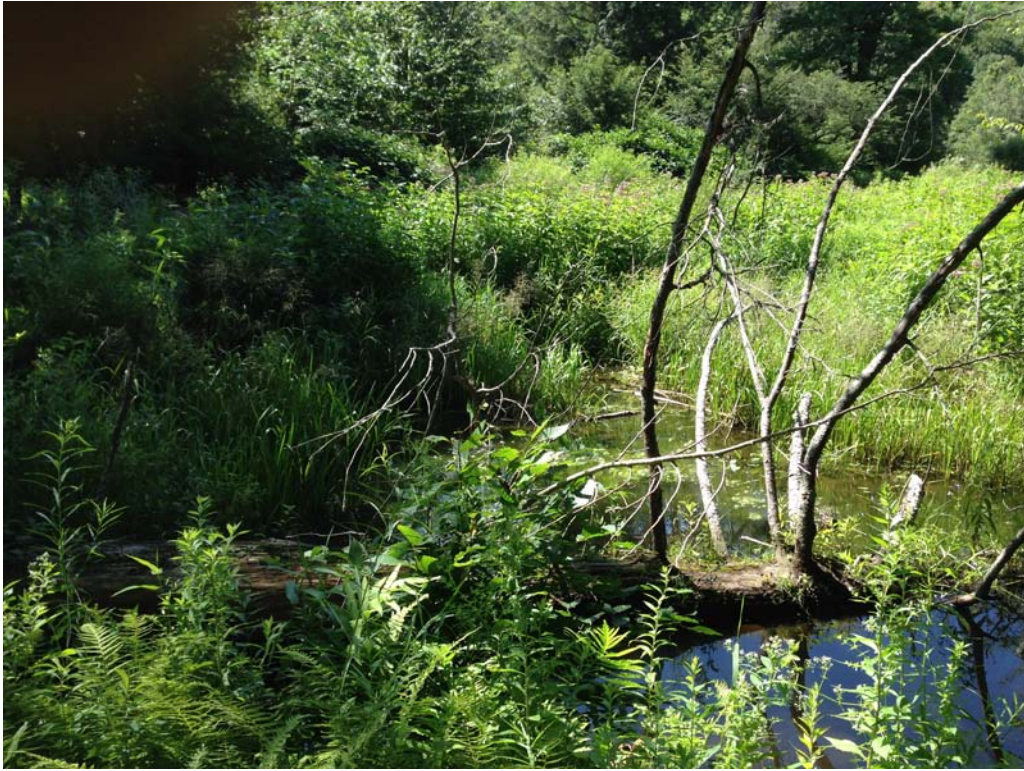
PEM1F: (Palustrine Emergent, Persistent, Semipermanently Flooded)

This wetland type consists of wetlands (K1-K5), which have been identified as an oxbow region along the stream edge, with a fair sized opening in the canopy. The wetlands in this oxbow region have a combined area of 73,389 SQ. FT. (1.68 AC.) Open pools of water ranging from 6-12 inches ranging to saturated soils exist along the historic channels that once flowed through this area. The hydrology of the area was typical with that of an oxbow, exhibiting standing water and truly aquatic fauna species. With the presence of aquatic fauna and standing water, which appeared to be present throughout the year, hydric soils were assumed without conducting a soil profile.

Vegetation was dominated by Cattail (*Typha latifolia-OBL*) and Arrow Arum (*Peltandra virginica-OBL*) (DP-7)

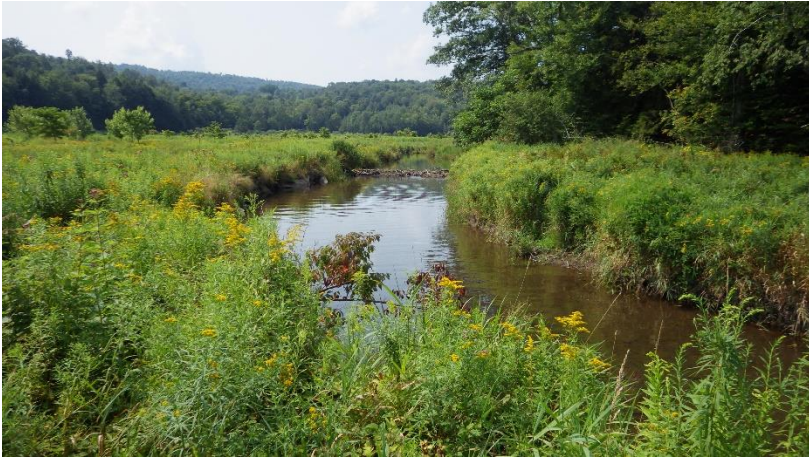
Photo 1: Mainstem Stream facing small beaver dam upstream.

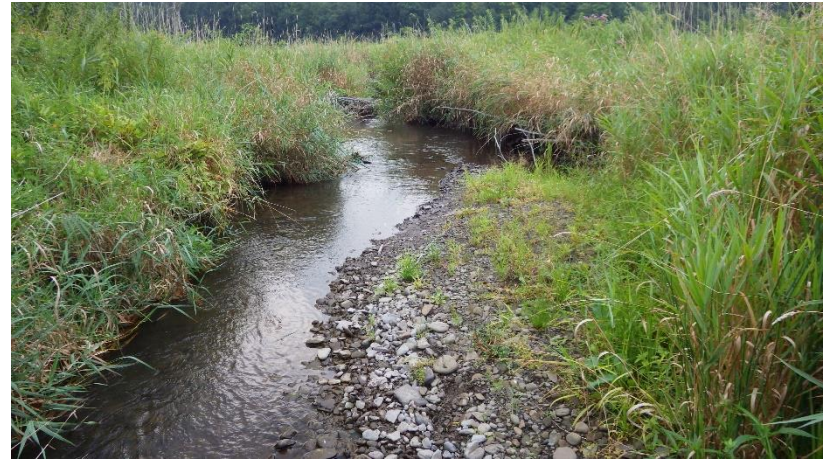
Photo 4: Mainstream braided channel.

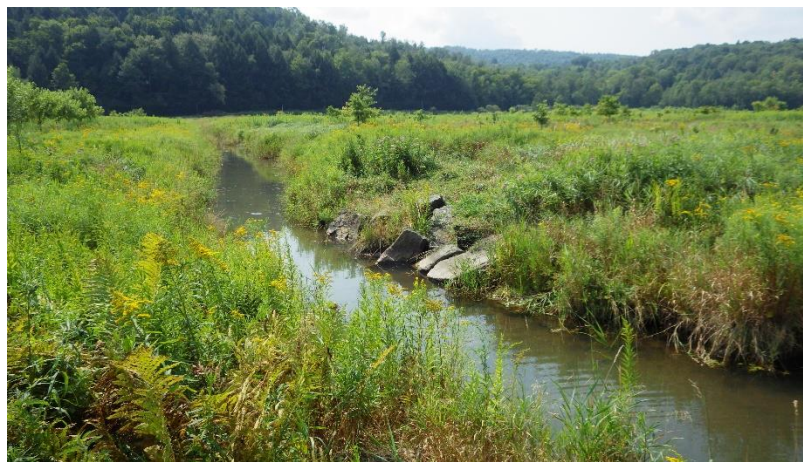
Photo 10: Stream 14 Jurisdictional Ditch.

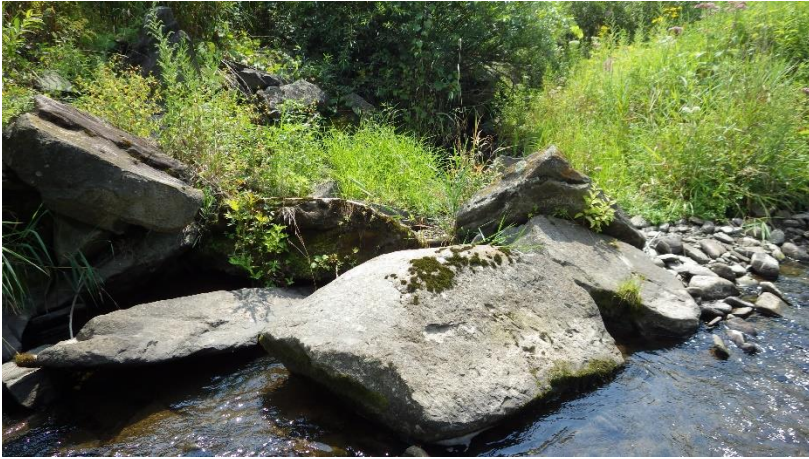
Photo 13: Rip-Rap on mainstem.

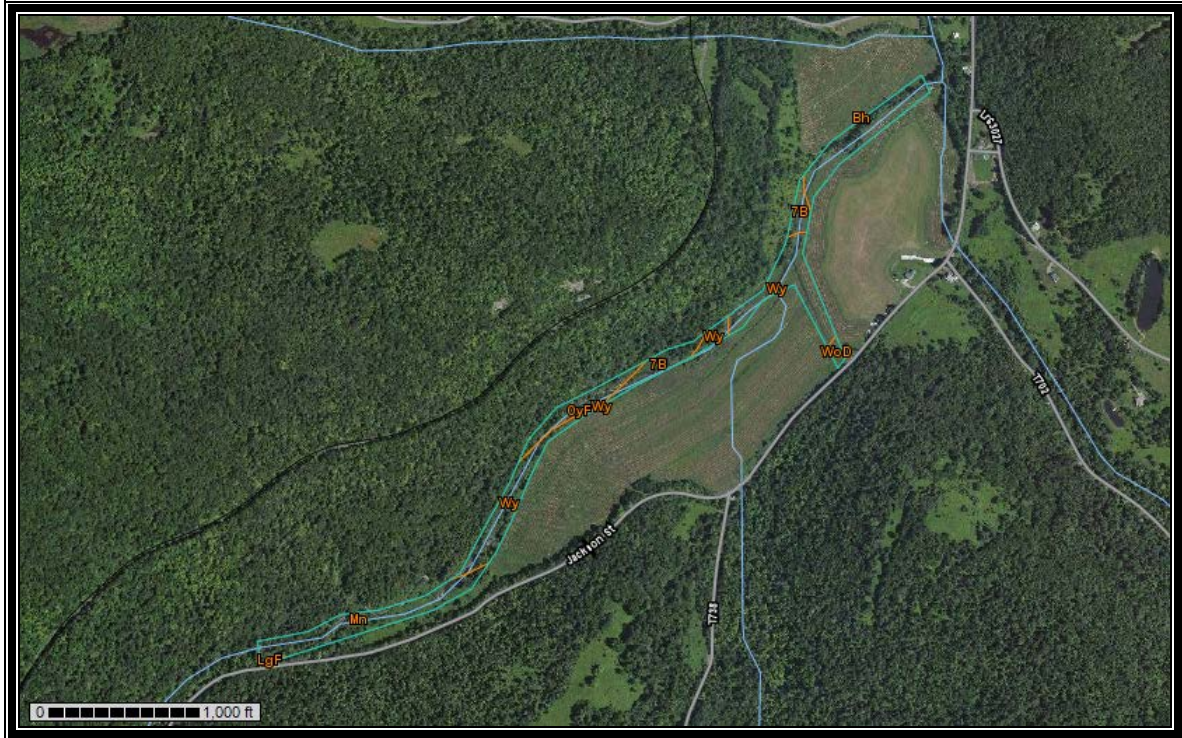
Figure 9. APE soil map, from NRCS website.

Most of the soils found in the APE contain slopes ranging from 8% to 70% (Table 2 and Figure 9). These soils are typically poorly-drained with a slow to very slow internal drainage. Large portions of these soils have reverted to woodland or brush, as they are unsuitable for crops.

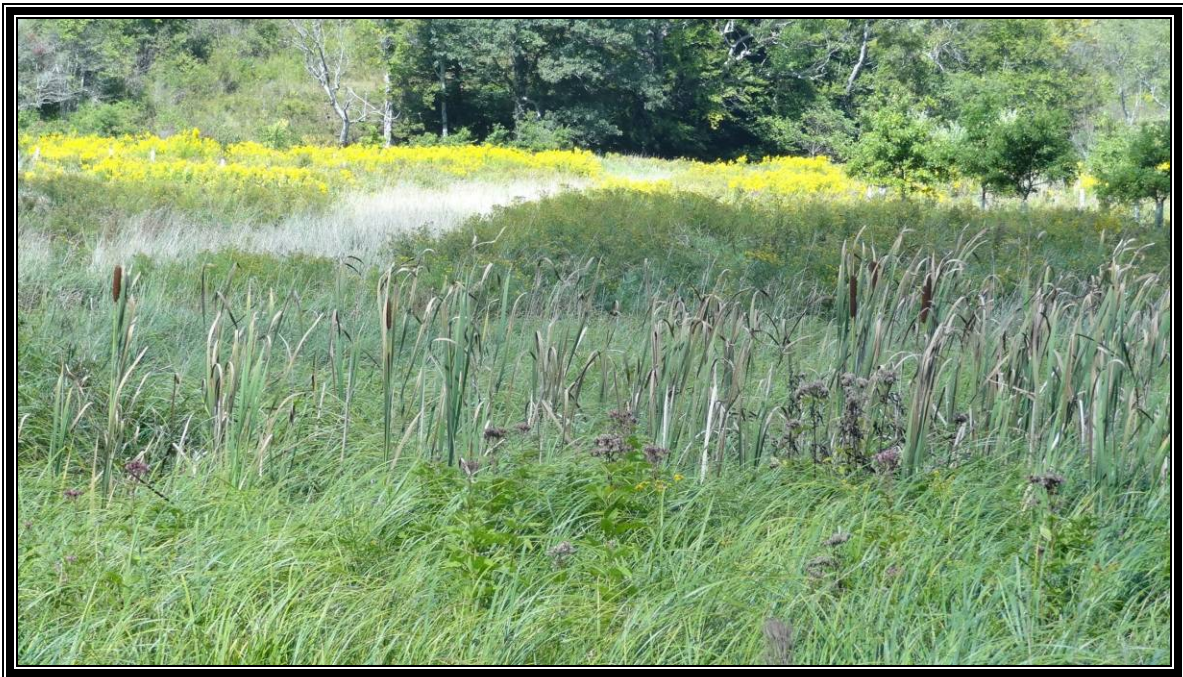
Plate 9. View of a wetland with the slightly elevated area within the floodplain, looking northeast.

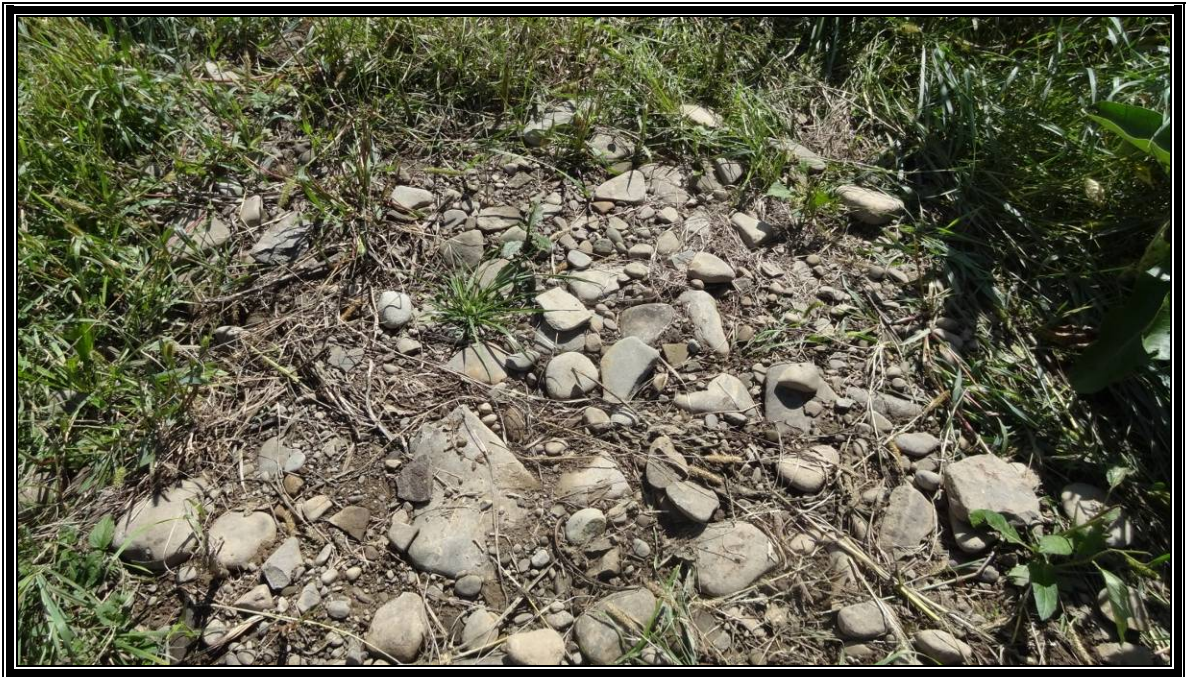
Plate 13. Detail view of recent flooding.
