SITE-WIDE REMEDIAL INVESTIGATION REPORT SPRING VALLEY FORMERLY USED DEFENSE SITE

SPRING VALLEY, WASHINGTON, DC

**Contract No.: W912DR-09-D-0061, Delivery Order 0011
DERP FUDS MMRP/CWM Project No. C03DC091801 and
DERP FUDS HTRW Project No. C03DC091802**

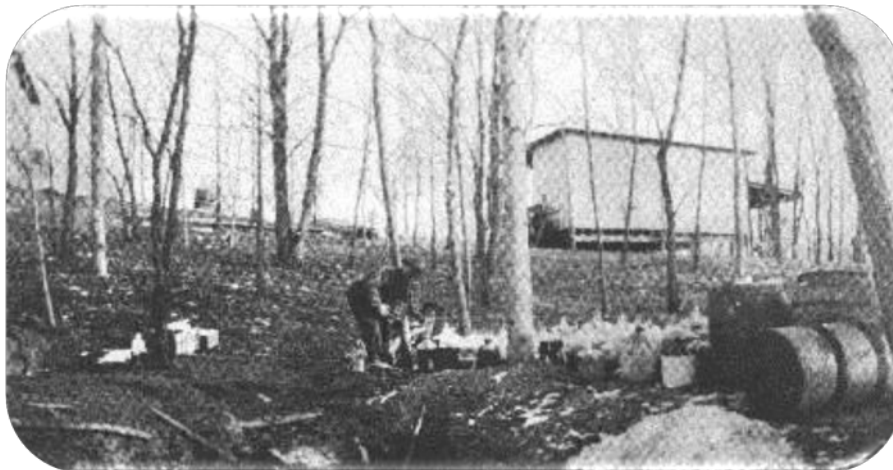
17
18 **Exhibit 1-2. SGT Maurer Photo**

9 The student newspaper articles provide the clearest written reference to potential burials. Only
10 one known photograph exists, showing disposal of chemicals and munitions at an unidentified
11 location presumably on AUES grounds (Exhibit 1-2). The photo referred to as the SGT Maurer
12 photo was provided to USACE following the initiation of SVFUDS investigations, around 1994.
13 The inscription on the back of the photo states: "The Pit, the most feared and respected place in
14 the ground. The bottles are full of mustard, to be destroyed here in Death Valley. The hole called
15 Hades. You know me? C.W. Maurer at A.U."
16

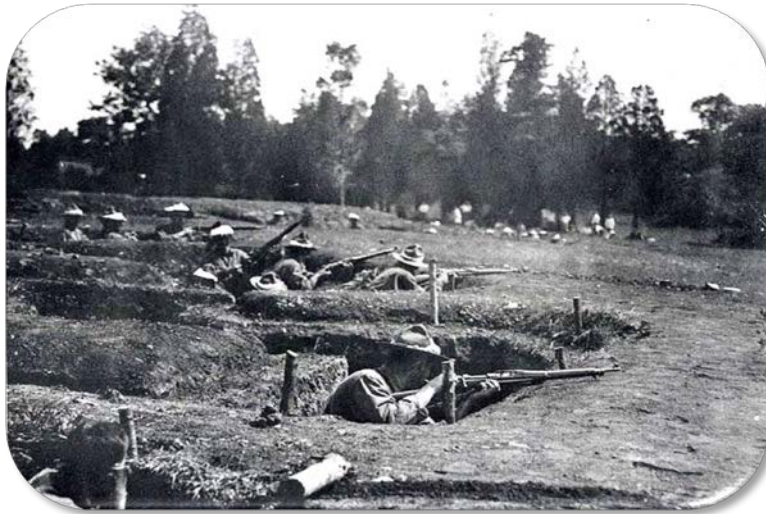
10
11 **Exhibit 1-3. Trench Training at Camp Leach**

32 of tents and barracks, along with staging and training areas for troops (Exhibit 1-3). When space

1 was required for additional drill fields and training trenches, the Construction Division of the
2 Quartermaster Corps leased adjoining properties owned by Mary E. Patton, Charles C. Glover,
3 and other area residents. By the end of the war, Camp Leach contained some 67 structures,
4 including facilities sufficient to quarter, feed, and train 4,400 troops (USACE, 1994).
5 On December 23, 1918, the immediate cessation of operations was ordered for Camp Leach.
6 Engineer Units were demobilized from the camp, temporary buildings were salvaged, and
7 remaining supplies, transportation, and equipment were disposed of as appropriate for the time.
8 Prior to transfer back to AU and private property owners, the Chief of Engineers ordered training
9 trenches, pits and dugouts be filled in, per agreements regarding the properties (USACE, 1994).

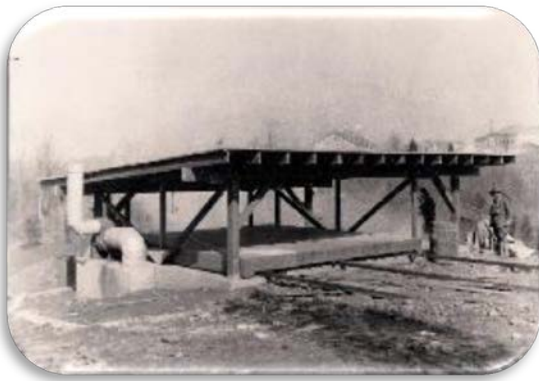
Exhibit 1-4. Bunker with Roof on Rollers

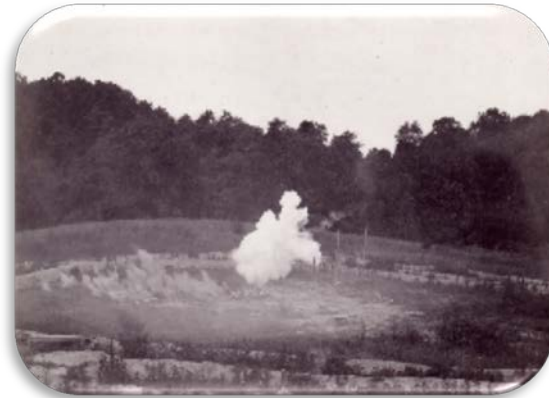
Exhibit 1-5. Shell Containing Chloracetophenone Matrix

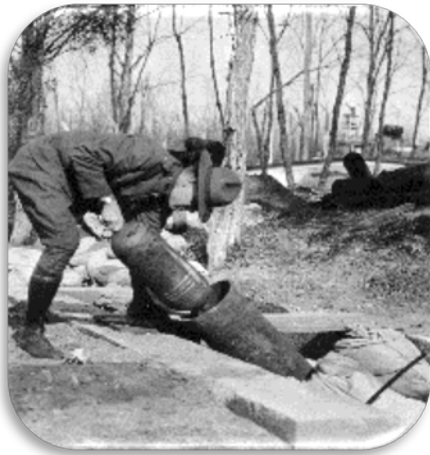
Exhibit 1-6. Loading Livens Projector

2 The Range Fan is an elongated, cone-shaped area defined by a firing point and potential impact
3 areas down range (Figure 1-8). Historical records for the AUES suggest that Livens projectiles,
4 and 3-inch and 4-inch Stokes mortars may have been fired from the Livens Battery Pit and
5 Stokes Mortar Gun Placement near AU and Woodway Lane and, in turn, may have impacted
6 downrange locations to the northwest towards the Federal property. Historical photographs
7 including Exhibit 1-6 and Exhibit 1-7, established the historical use of a firing range and range

1 targets but could not accurately define the location for use as an evaluation tool to plan
2 investigations. In 2003, the concrete gun pit for the Livens projectors was discovered in OU-2.

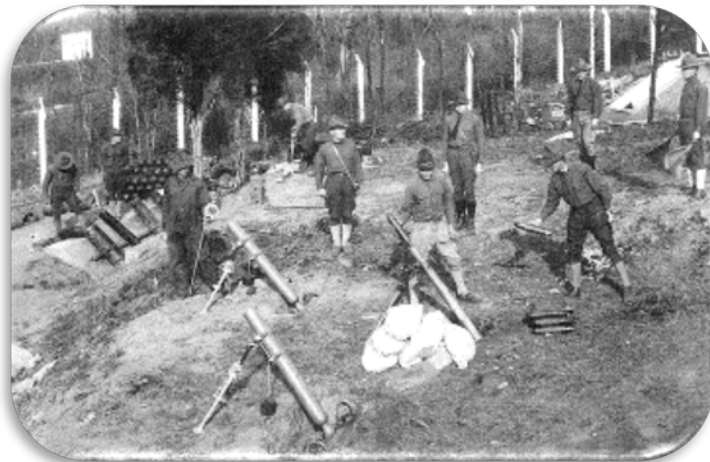
Exhibit 1-7. Loading Stokes Mortars for Firing

Note: Livens gun pit is located in left background

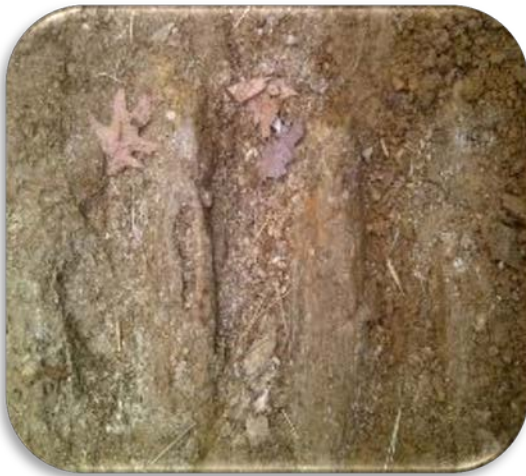
Exhibit 2-8. Competent Saprolite

1 from which it was derived, thus providing a strong indication that man-made activities have not
2 impacted the layer. For this reason saprolite has been used throughout SVFUDS investigations
3 to provide an indication of the limits of past intrusive activities. That is, field geologists can
4 often determine that the saprolite layer in a given area has not been disturbed, and that therefore,
5 it is unlikely that AUES intrusive activities (burial pits, penetrating munitions, etc.) occurred
6 there. Exhibits 2-1 and 2-2 show examples of saprolite at the SVFUDS.

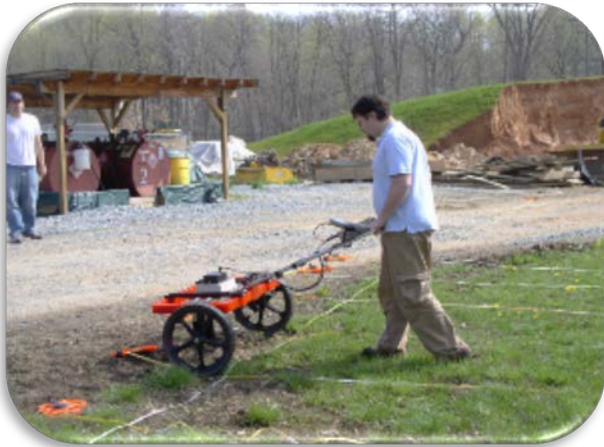
Exhibit 4-10. EM61 used at GPO

6 Exhibits 4-1 and 4-2 show the EM61 and the G-858, respectively, being used at the GPO.

- 1 ▪ The EM-31 performed poorly. Though used in the early SVFUDS geophysical
2 investigations, the EM-31 is not well suited for detecting small metallic items. This
3 instrument was not retained for use on future geophysical investigations.
- 4 ▪ The primary instruments to be used to conduct geophysical surveys at the SVFUDS were
5 both the EM-61 and G-858.

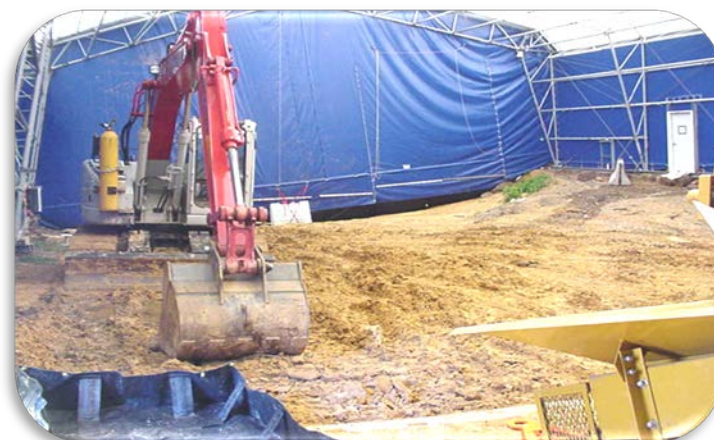
Exhibit 4-3. High Probability Work Inside an ECS

24 The Site-Wide Work Plan (USACE, 2007d) is the current SVFUDS document intended to be all-
25 inclusive and tailored to address all foreseeable potential investigation actions at various sites
26 throughout the SVFUDS. However, since that work plan could not realistically address all site-
27 specific contingencies, Site-Specific Work Plans were prepared for each individual site to be
28 investigated at the SVFUDS, whether under low or high probability protocols.

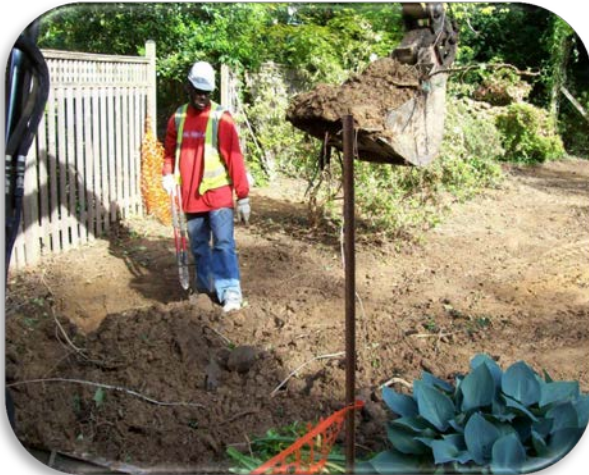
Exhibit 4-4. During Grid Excavation

26 The procedure was to remove soils from grids in two foot lifts. Excavation utilized standard
27 construction equipment such as excavators, loaders and backhoes to remove contaminated soil
28 and place it into shipping containers. For removals on private residential properties, the smallest,
29 most efficient construction equipment was used, when possible, to minimize noise and to reduce
30 homeowner concerns regarding property damage risks. Care was taken to minimize the impact
31 of construction traffic in the work area and to keep open access to homes. During excavation
32 activities, dust abatement and control procedures were employed to minimize the transport and
33 inhalation of fugitive dust by site workers and nearby personnel. These procedures included the
34 monitoring and cleaning of visible surface soil on roads, dust suppression with water, and air
35 monitoring for dust downwind of excavation operations.

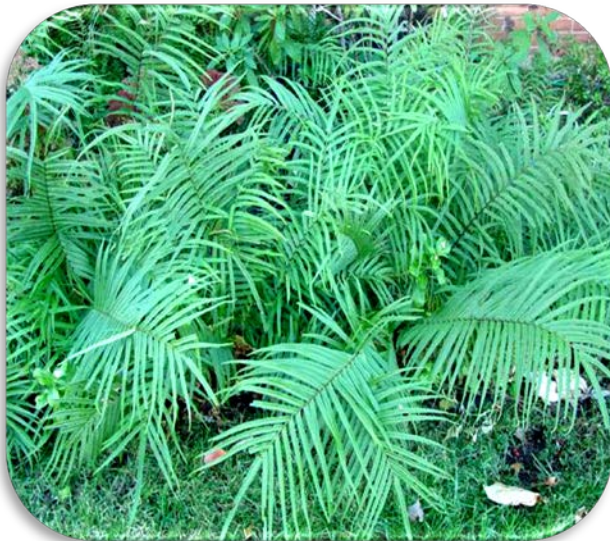
Exhibit 4-6. *Pteris vittata* Ferns

15 At each residence, a surface irrigation system was designed and installed to accommodate the
16 moisture requirements of the ferns at each plot. Plant growth and development was monitored
17 by USACE. During the growing season, diagnostic leaf and frond samples were obtained on an
18 as needed basis, depending on weather conditions and the physiological condition of the plants to
19 monitor the progress and status of the plants for removing arsenic. Samples of the biomass were
20 collected for laboratory analysis; all remaining biomass was properly disposed. Post-harvest soil
21 samples were collected after the collection of the plant samples in the same manner as in the pre-
22 planting soil sampling. At the conclusion of site activities, the plots were restored and former
23 grass areas were resodded. Bare soil areas were mulched to prevent erosion. Exhibits 4-6 and 4-
24 7 depict different varieties of ferns planted at two of the selected SVFUDS properties.

6 Each plot area was fertilized prior to transplanting. Fern plants were then established in the test
7 plots through transplanting of four-inch high live plants. Where existing turf grass or sod was
8 present, the soil was rototilled to a maximum depth of four inches or turned over by hand using a
9 shovel in preparation for planting. Where existing vegetation or other landscape features
10 prevented rototilling, the ferns were transplanted directly into the soil to avoid disruption of
11 existing vegetation. The selected Edenfern species (*Victory*, *Moonlight*, *P. cretica nervosa*,
12 *Pteris vittata*, *P. cretica parkerii*, or *Arctic*) were transplanted into the soil using a 12-inch plant
13 spacing. The fern species were selected based on site specific conditions favoring growth of a
14 specific variety with a goal of maintaining uniformity and consistency in experimental design.
