**FINAL**  
**FIRST FIVE-YEAR REVIEW REPORT FOR**  
**SPRING VALLEY**  
**FORMERLY USED DEFENSE SITES**  
**Property Number C03DC0918**  
**Project 01 and Project 02**  
**WASHINGTON, D.C.**

**U.S. Army Corps of Engineers  
Baltimore District  
Baltimore, Maryland**

**4 APRIL 2024**

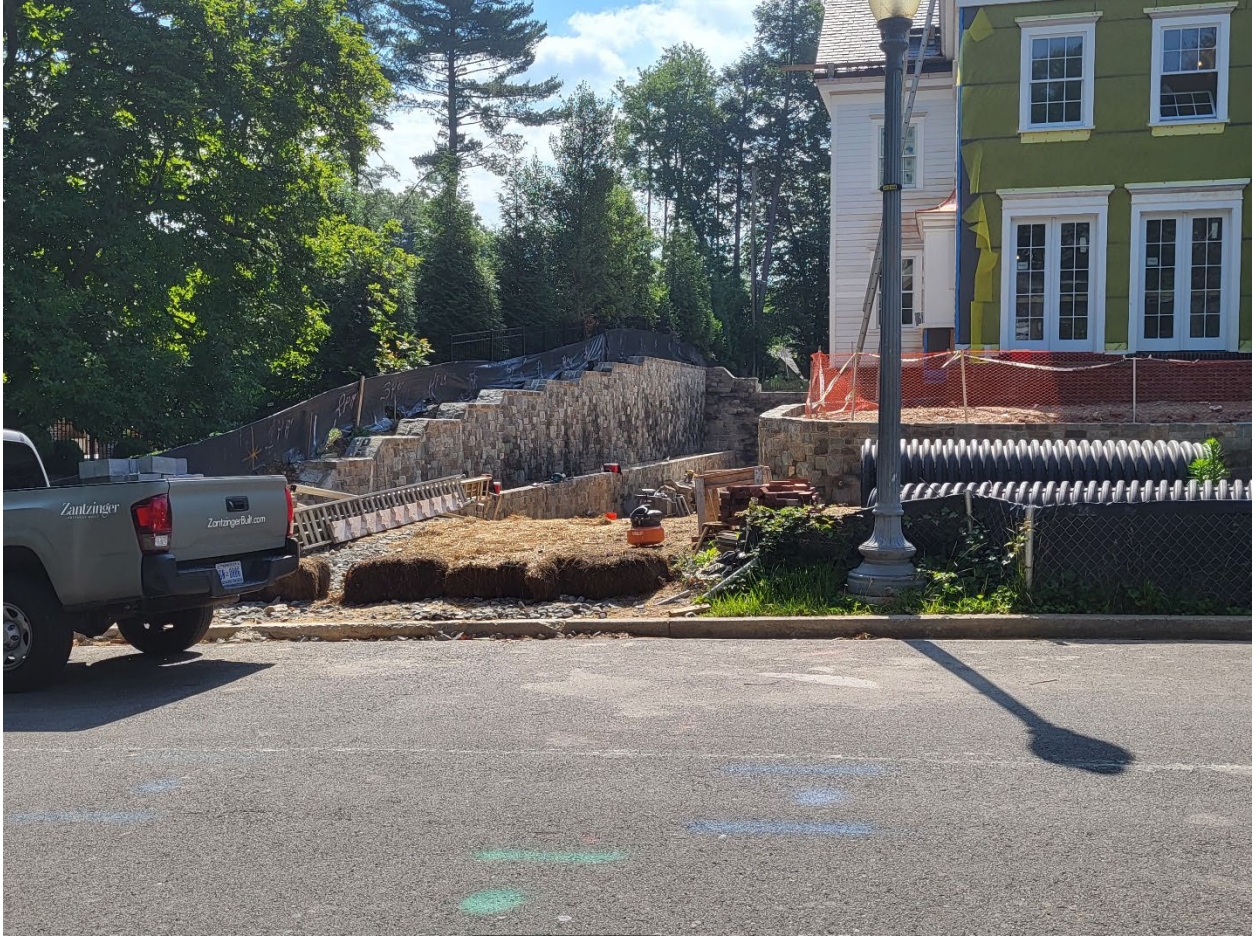
Photo 10

9. Flat spot in residential area of former trench
  10. Residential house under renovation – former target area was remediated during remedial action (RA)

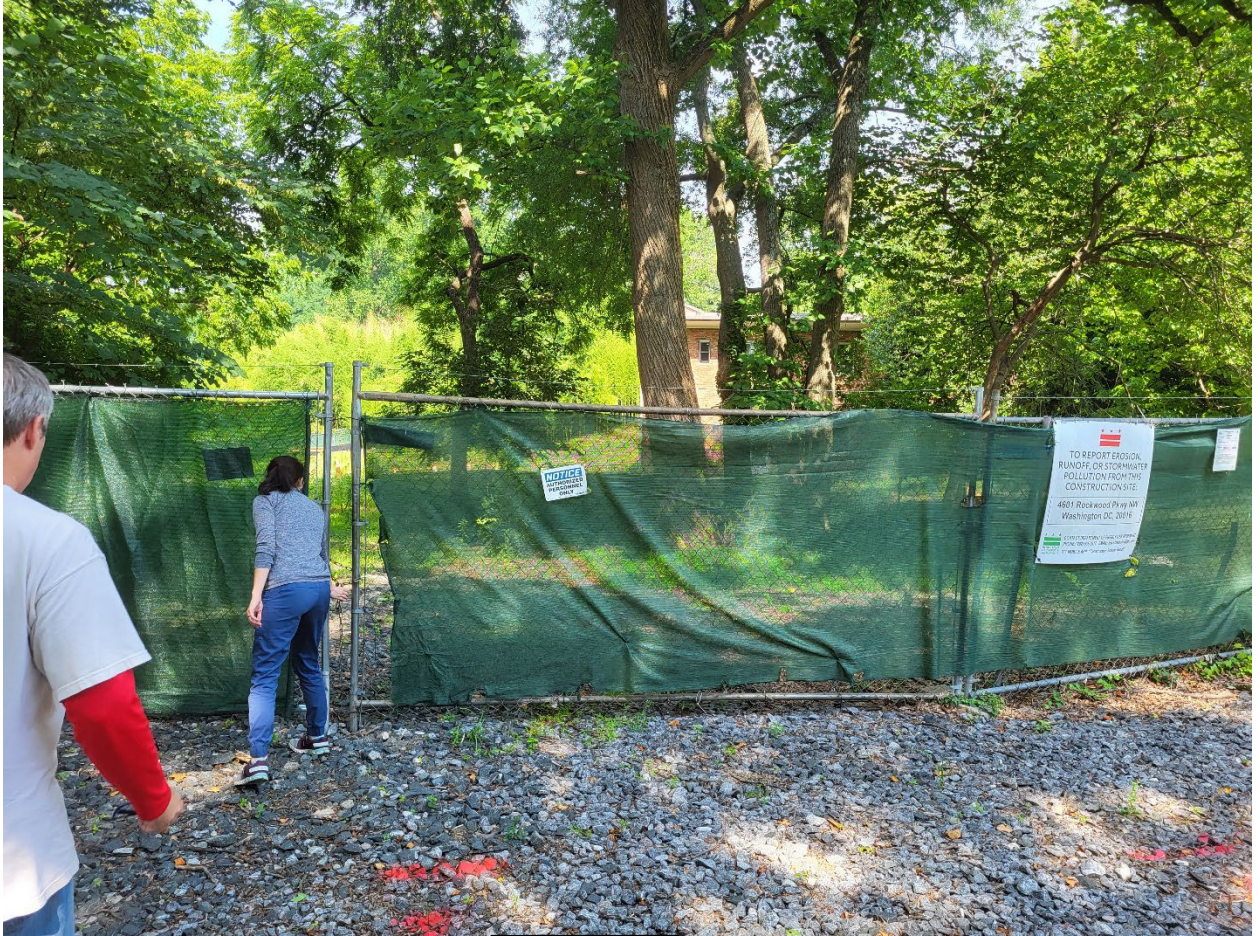
Photo 11

11. Fenced area for former Public Safety Building that is pending further remedial action
  12. PSB area for upcoming remedial action
  13. PSB remedial action area setting

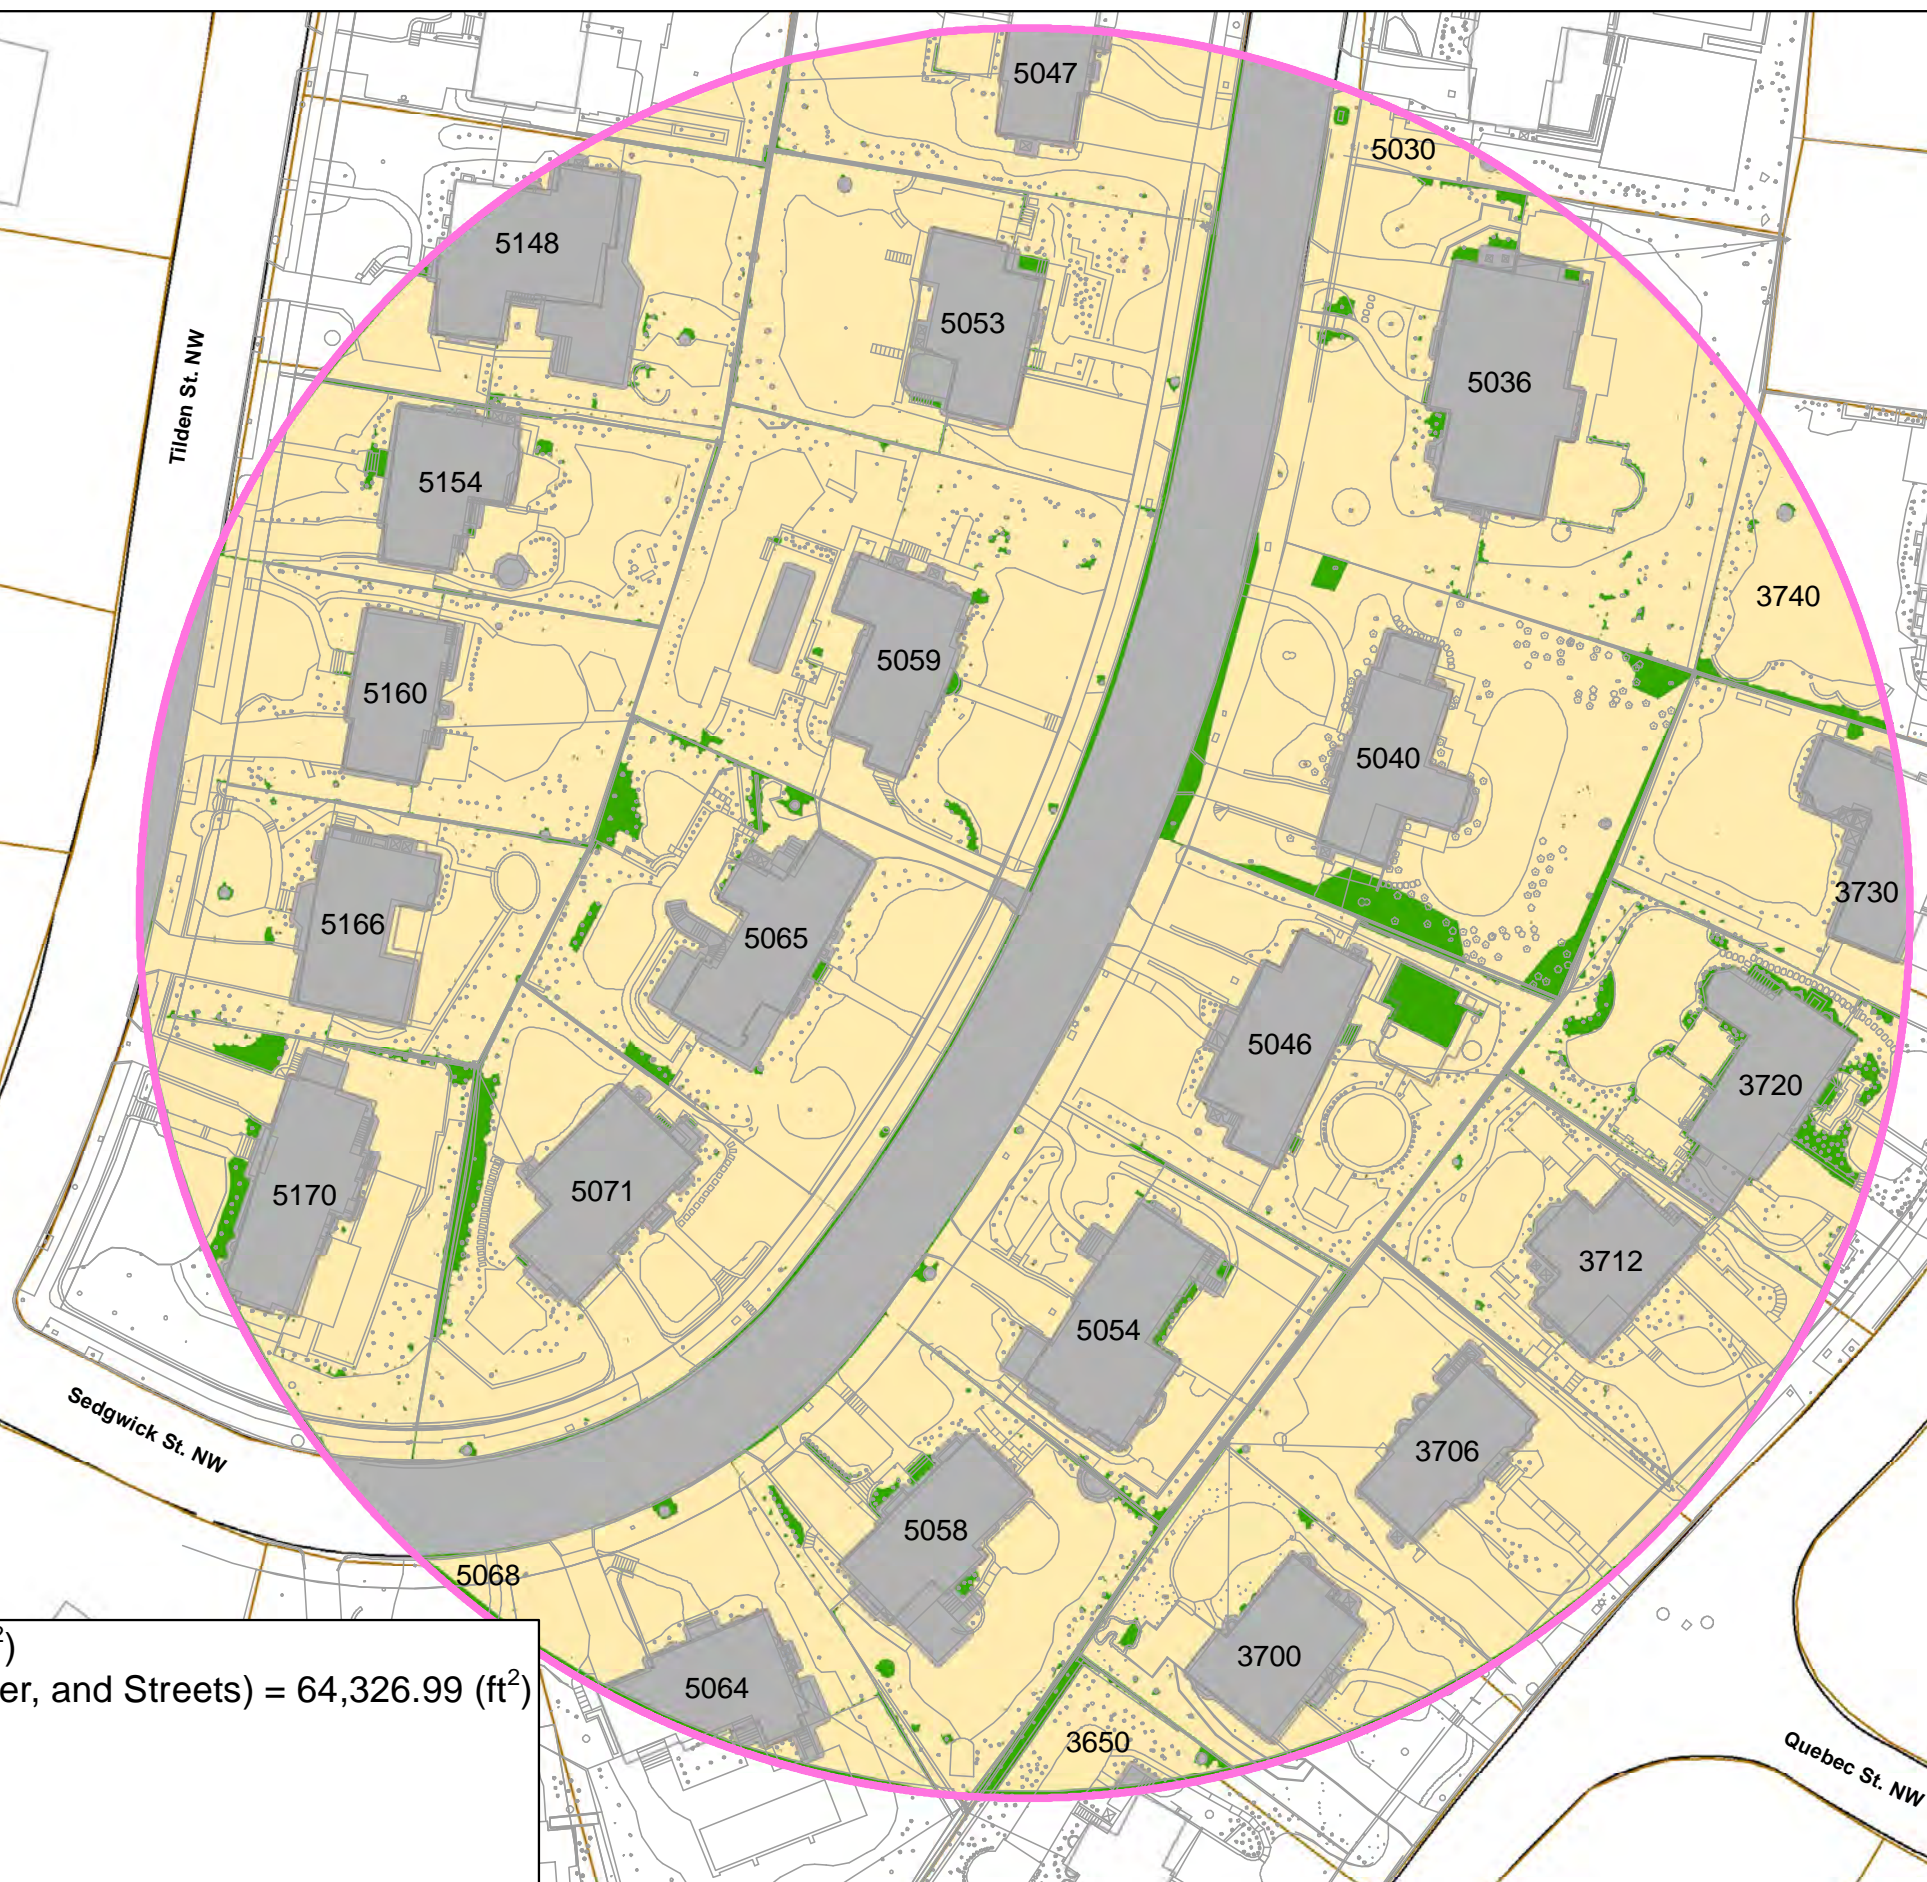
**Figure 9**  
**Static Test Fire Area East**  
**Intrusive Investigation Results**

- ★ Cannonball (MEC)
- Stokes (MD)
- 75mm (MD)
- Unidentifiable Fragmentation (MD)
- Livens Projectile (MD)
- Nose Pipe (MD)

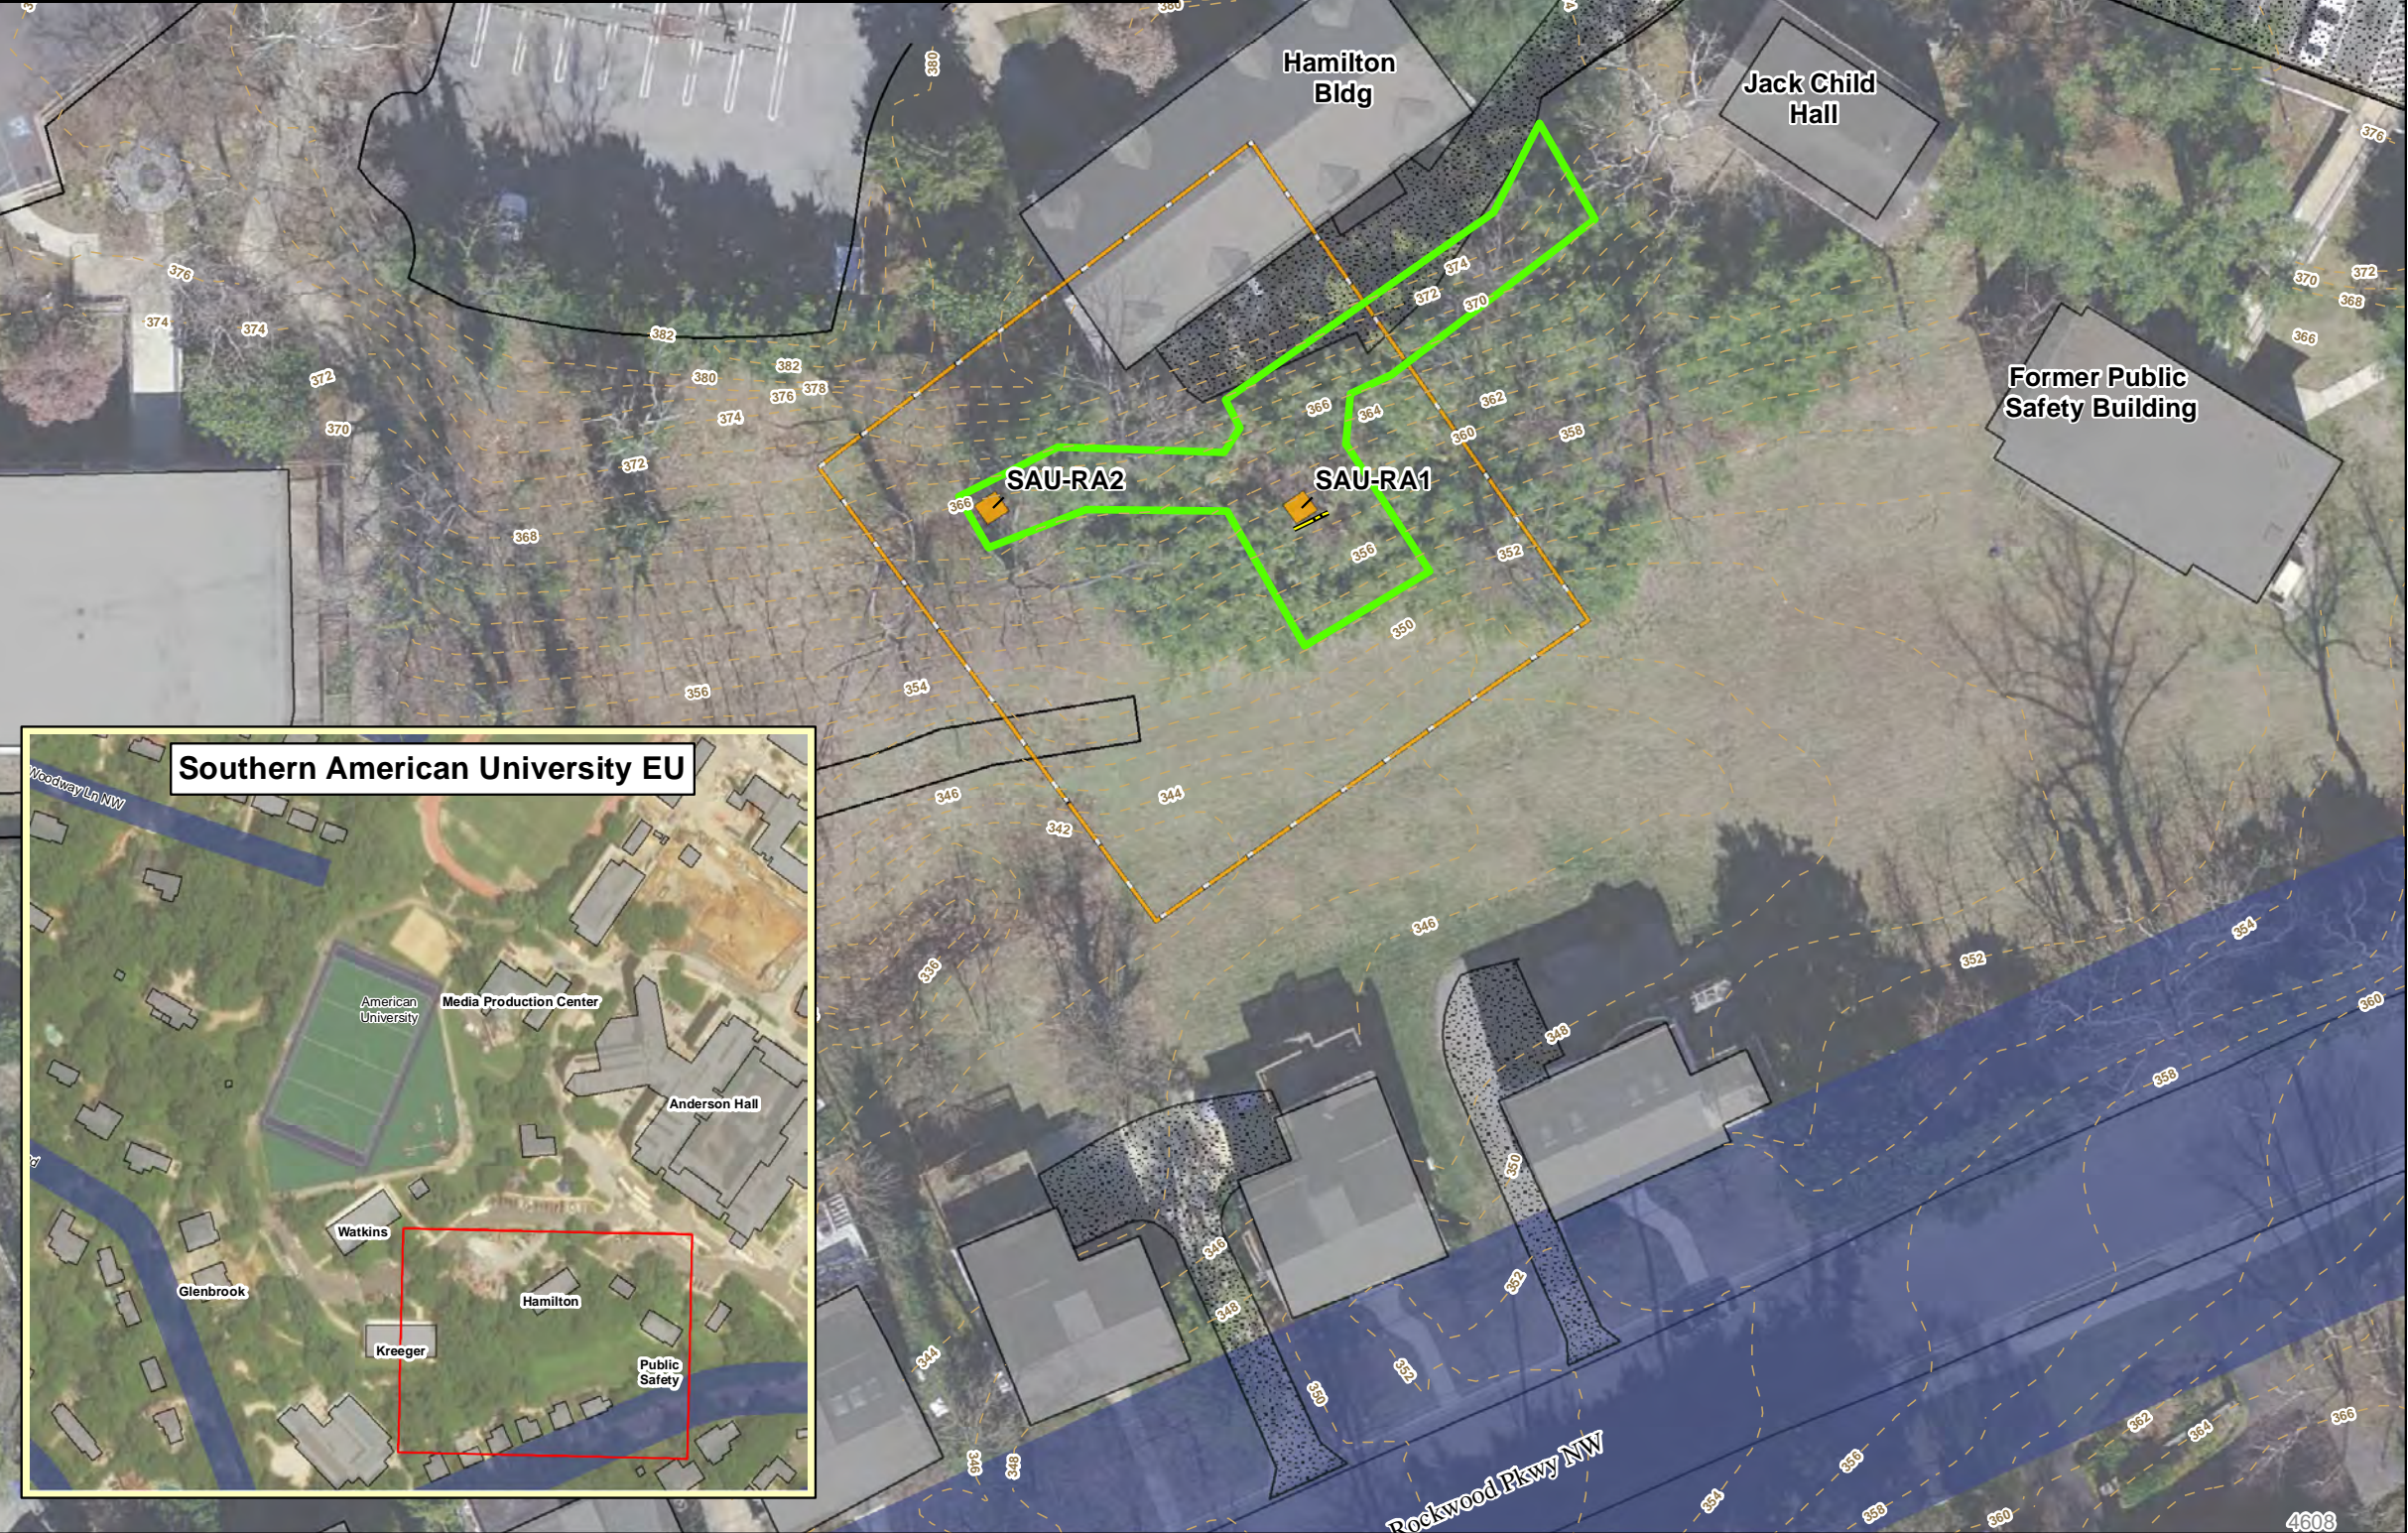
**Figure 16**  
**Southern AUEU Soil Excavation Locations**  
Spring Valley FUDS  
Spring Valley, Washington, D.C.

Southern AU Excavation Details - 1/21/20						
Location	Excavation Length (ft)	Excavation Width (ft)	Excavation Area (ft <sup>2</sup> )	Depth of Excavation (ft)	Excavation Volume (ft <sup>3</sup> )	Excavation Volume (cy)
SAU-RA1	5	5	25	10	250	9.3
SAU-RA2	5	5	25	1	25	0.9
		Total (ft <sup>2</sup> ) =	50	Total (ft <sup>3</sup> ) =	275	10.2

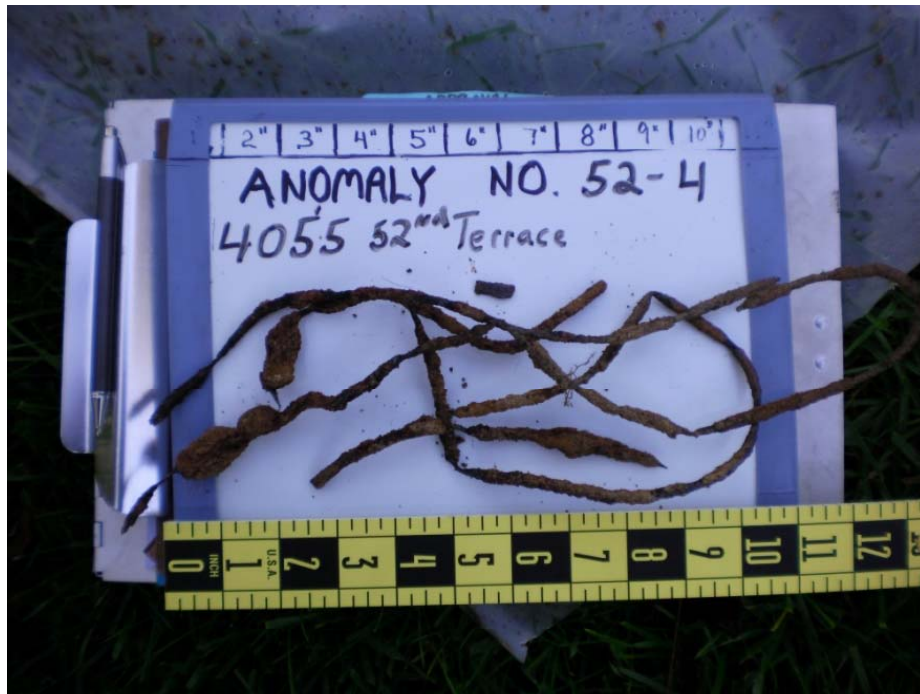
Enclosures: *3Rs Safety Guide* brochure  
Spring Valley Formerly Used Defense Site Boundary Map  
Spring Valley Munitions Safety Video

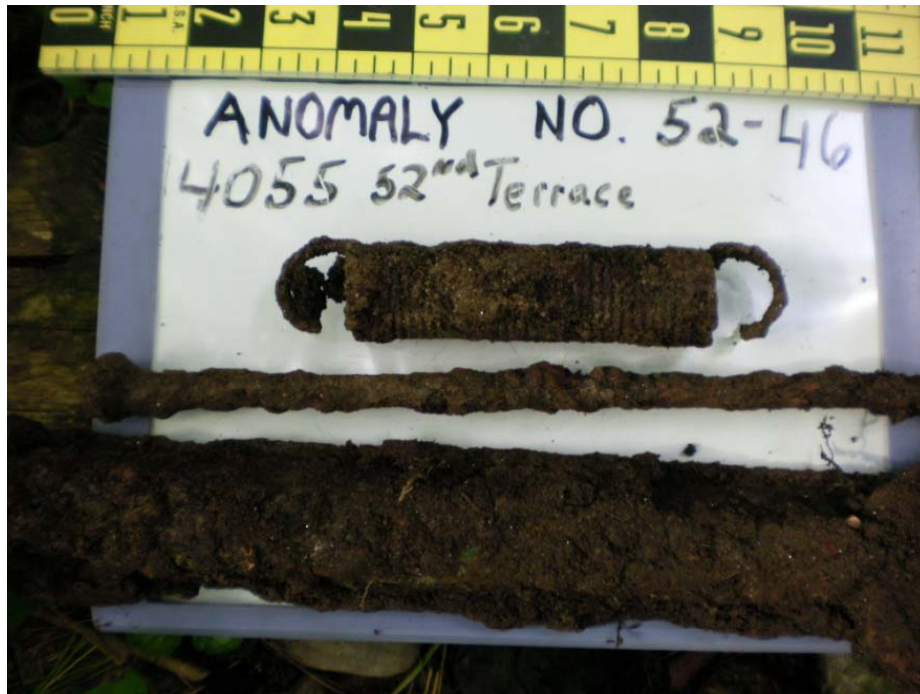
The U.S. Army Corps of Engineers, Baltimore District appreciates your time in learning about munitions safety and participating in the Spring Valley Formerly Used Defense Site cleanup process. If you have any questions, please contact the **Baltimore District Public Affairs Office** at **NAB-PAO@usace.army.mil**.

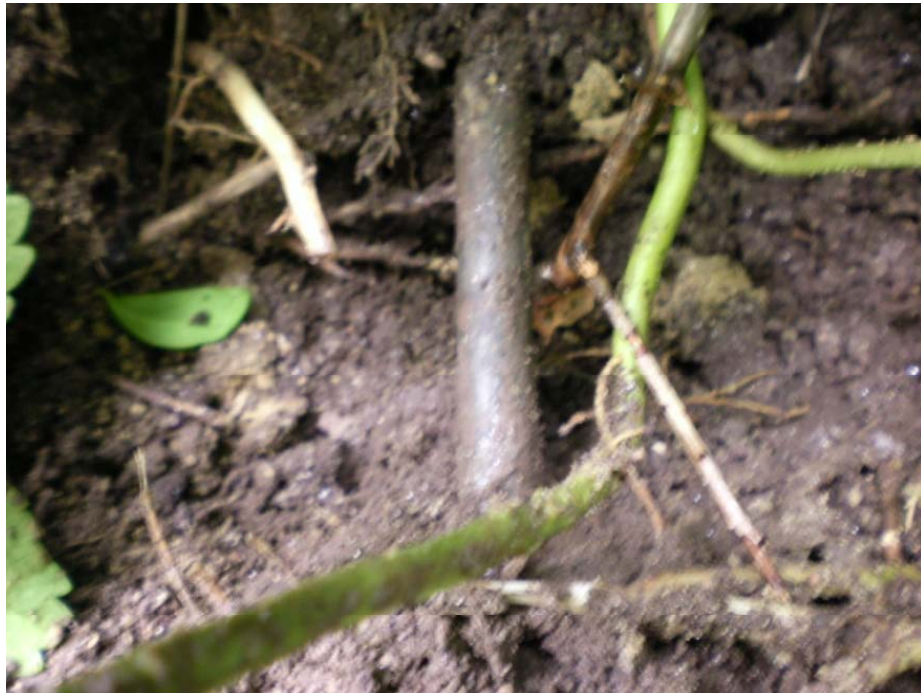
Enclosures: *3Rs Safety Guide* brochure  
Spring Valley Formerly Used Defense Site Boundary Map  
Spring Valley Munitions Safety Video
