SVFUDS PUBLIC SAFETY HILLSIDE REMEDIATION AT AMERICAN U. PROJECT STATUS

Weston Solutions, Inc.

July 18, 2024

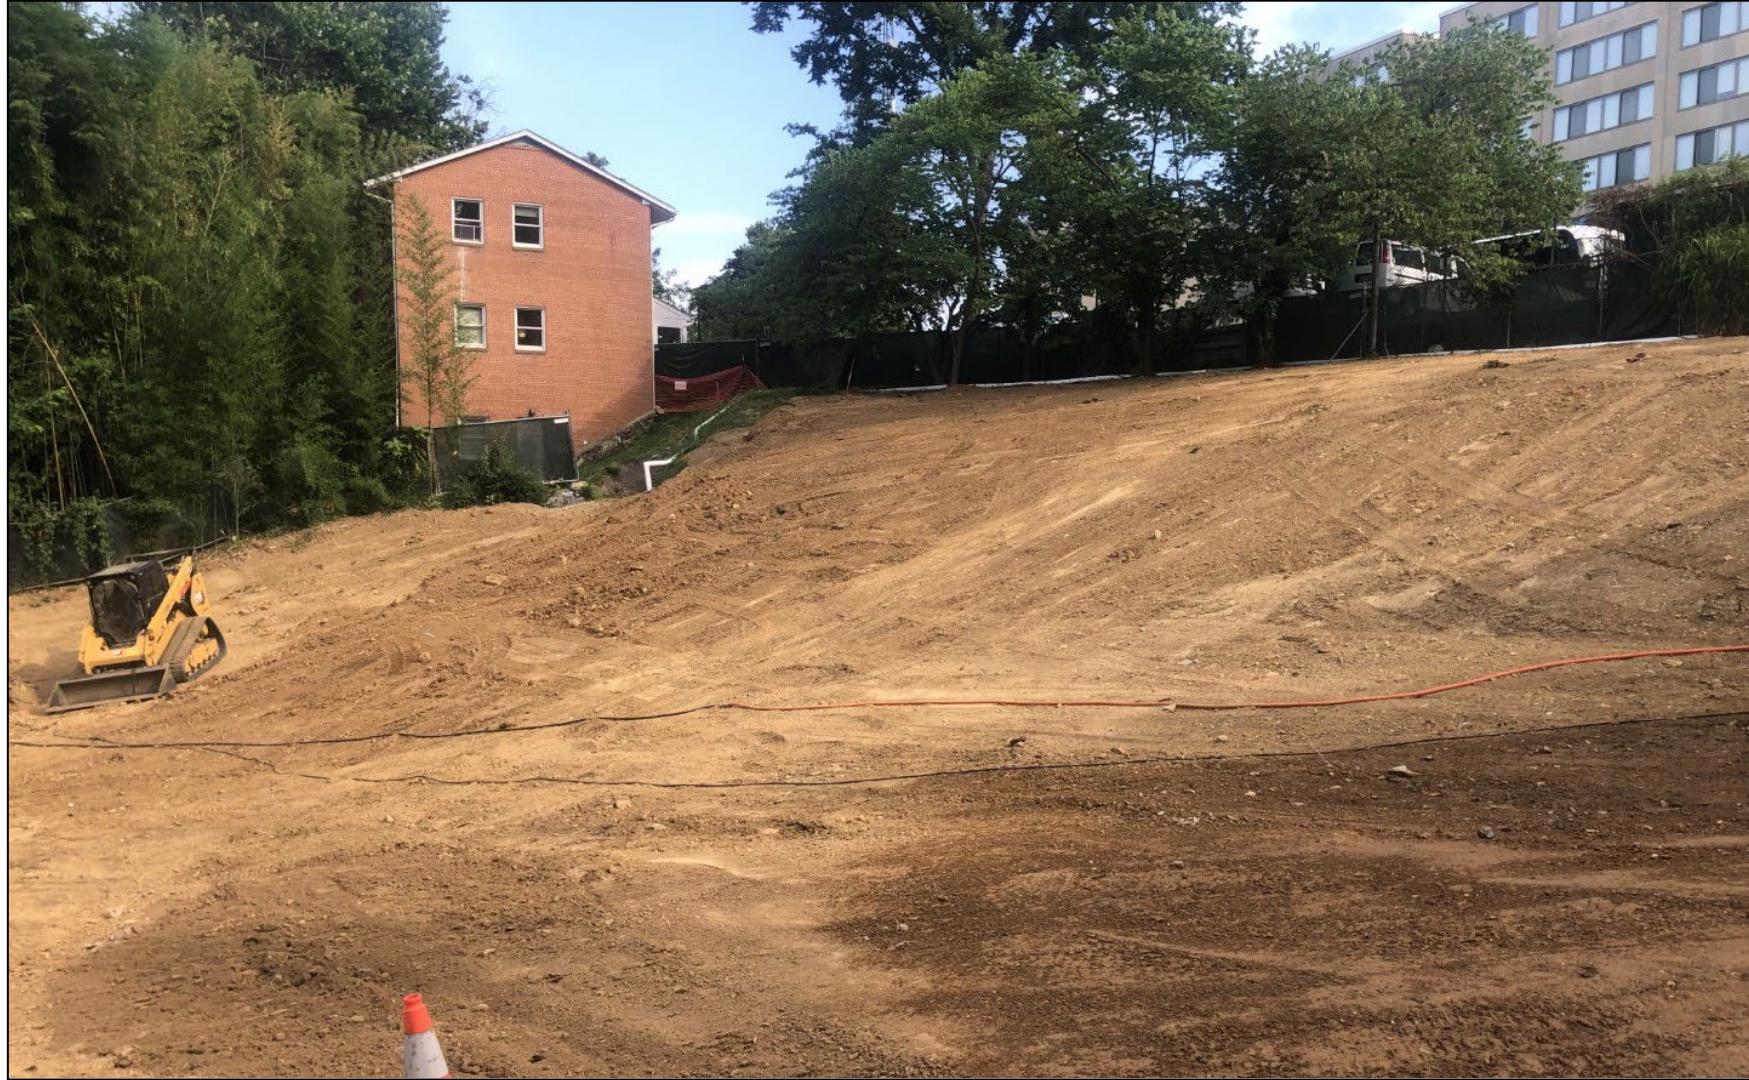
CURRENT PSB HILLSIDE SITE – JULY 9, 2024

- Looking northwest at the former location of the American University Public Safety Building and the ongoing hillside slope reconstruction on July 9, 2024. Jack Child Hall is in the background on the left.
- Backfill and slope reconstruction operations will be completed during the week of July 8th.
- The former Public Safety Building foundation, which was excavated and backfilled was located near the center of the photo at the base of the slope.

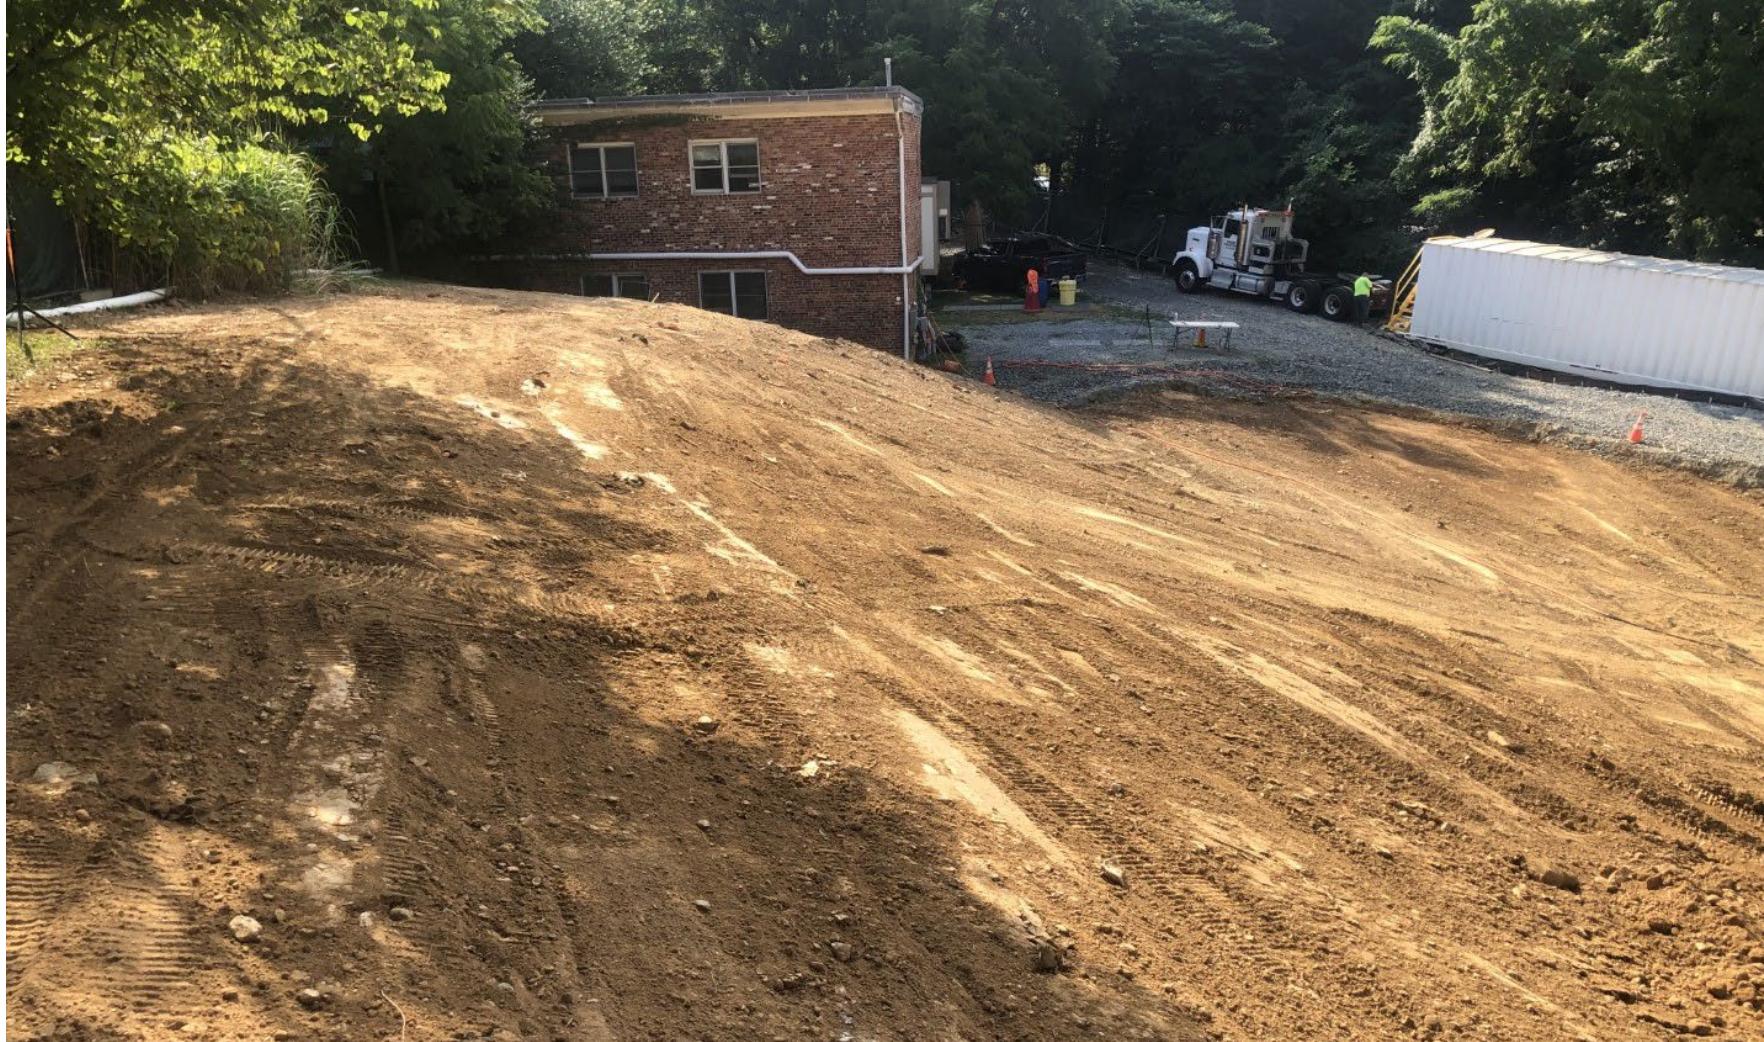
CURRENT PSB HILLSIDE SITE – JULY 9, 2024

- Looking southeast at the former location of the American University Public Safety Building and the ongoing hillside slope reconstruction on July 9, 2024. Rockwood Building is in the background on the left.
- The former Public Safety Building foundation, which was excavated and backfilled was located near the lower right of the photo at the base of the slope.

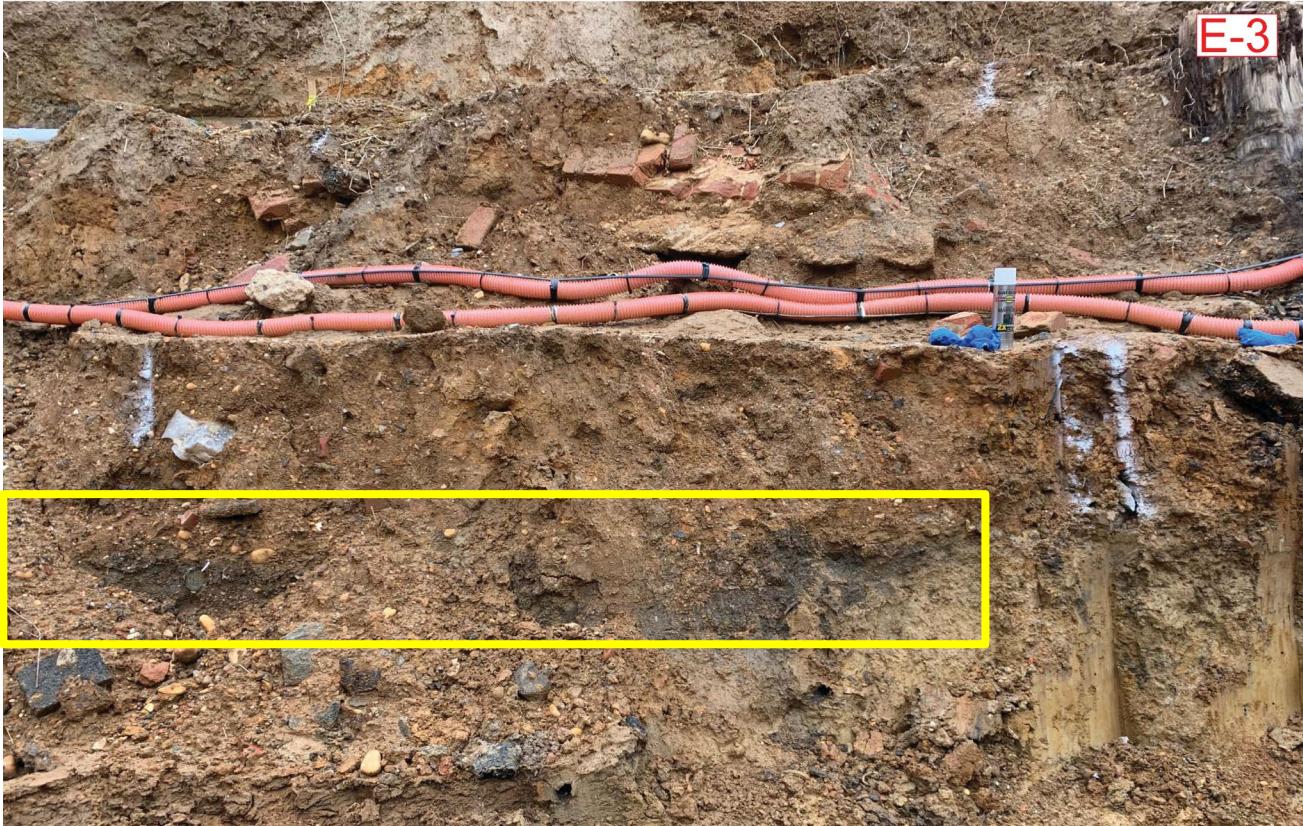
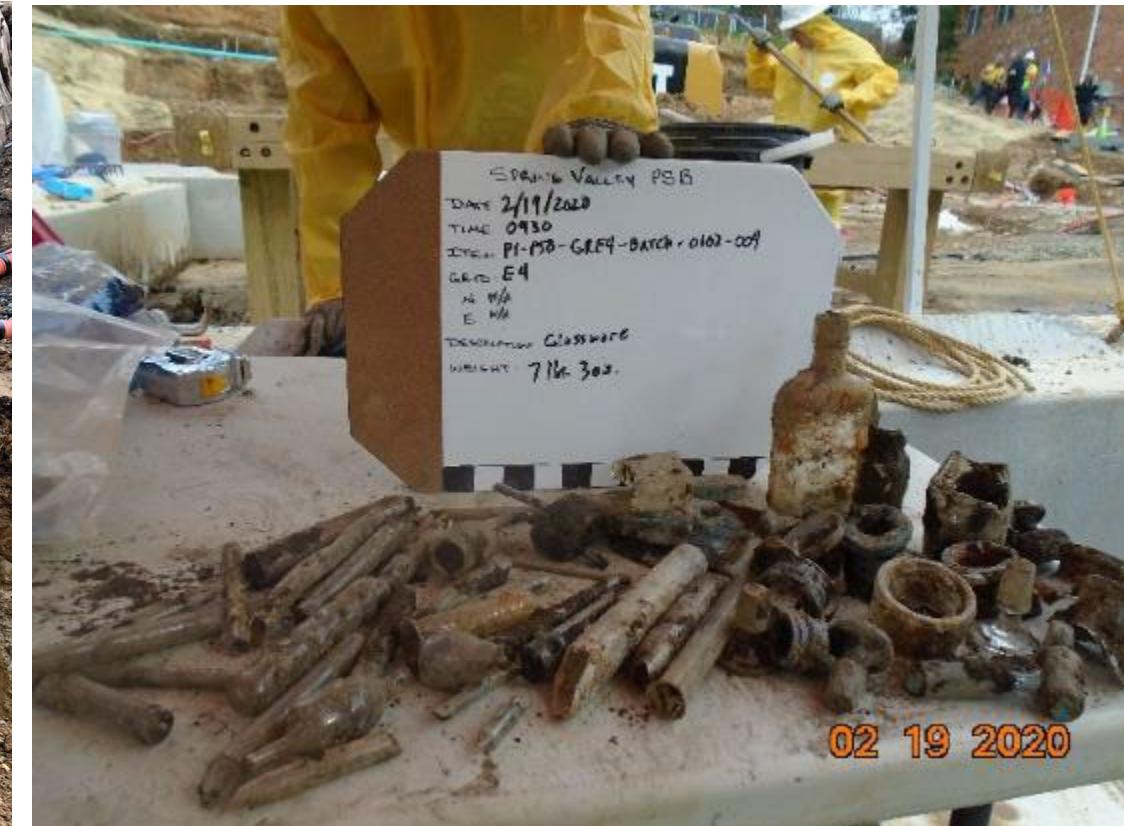
AUES DEBRIS LAYER & EXAMPLE ITEMS - 2020

Photo of North Wall of PSB Foundation Excavation with yellow box showing Black AUES Debris layer about 1 foot below the former PSB basement slab elevation. During the PSB Foundation excavation, AUES Debris was observed extending beyond the excavation wall.

Examples of AUES Debris recovered: broken glass, glass jars, test tubes, ceramics, and metal pieces. No Chemical Warfare Agent (CWA) was detected.

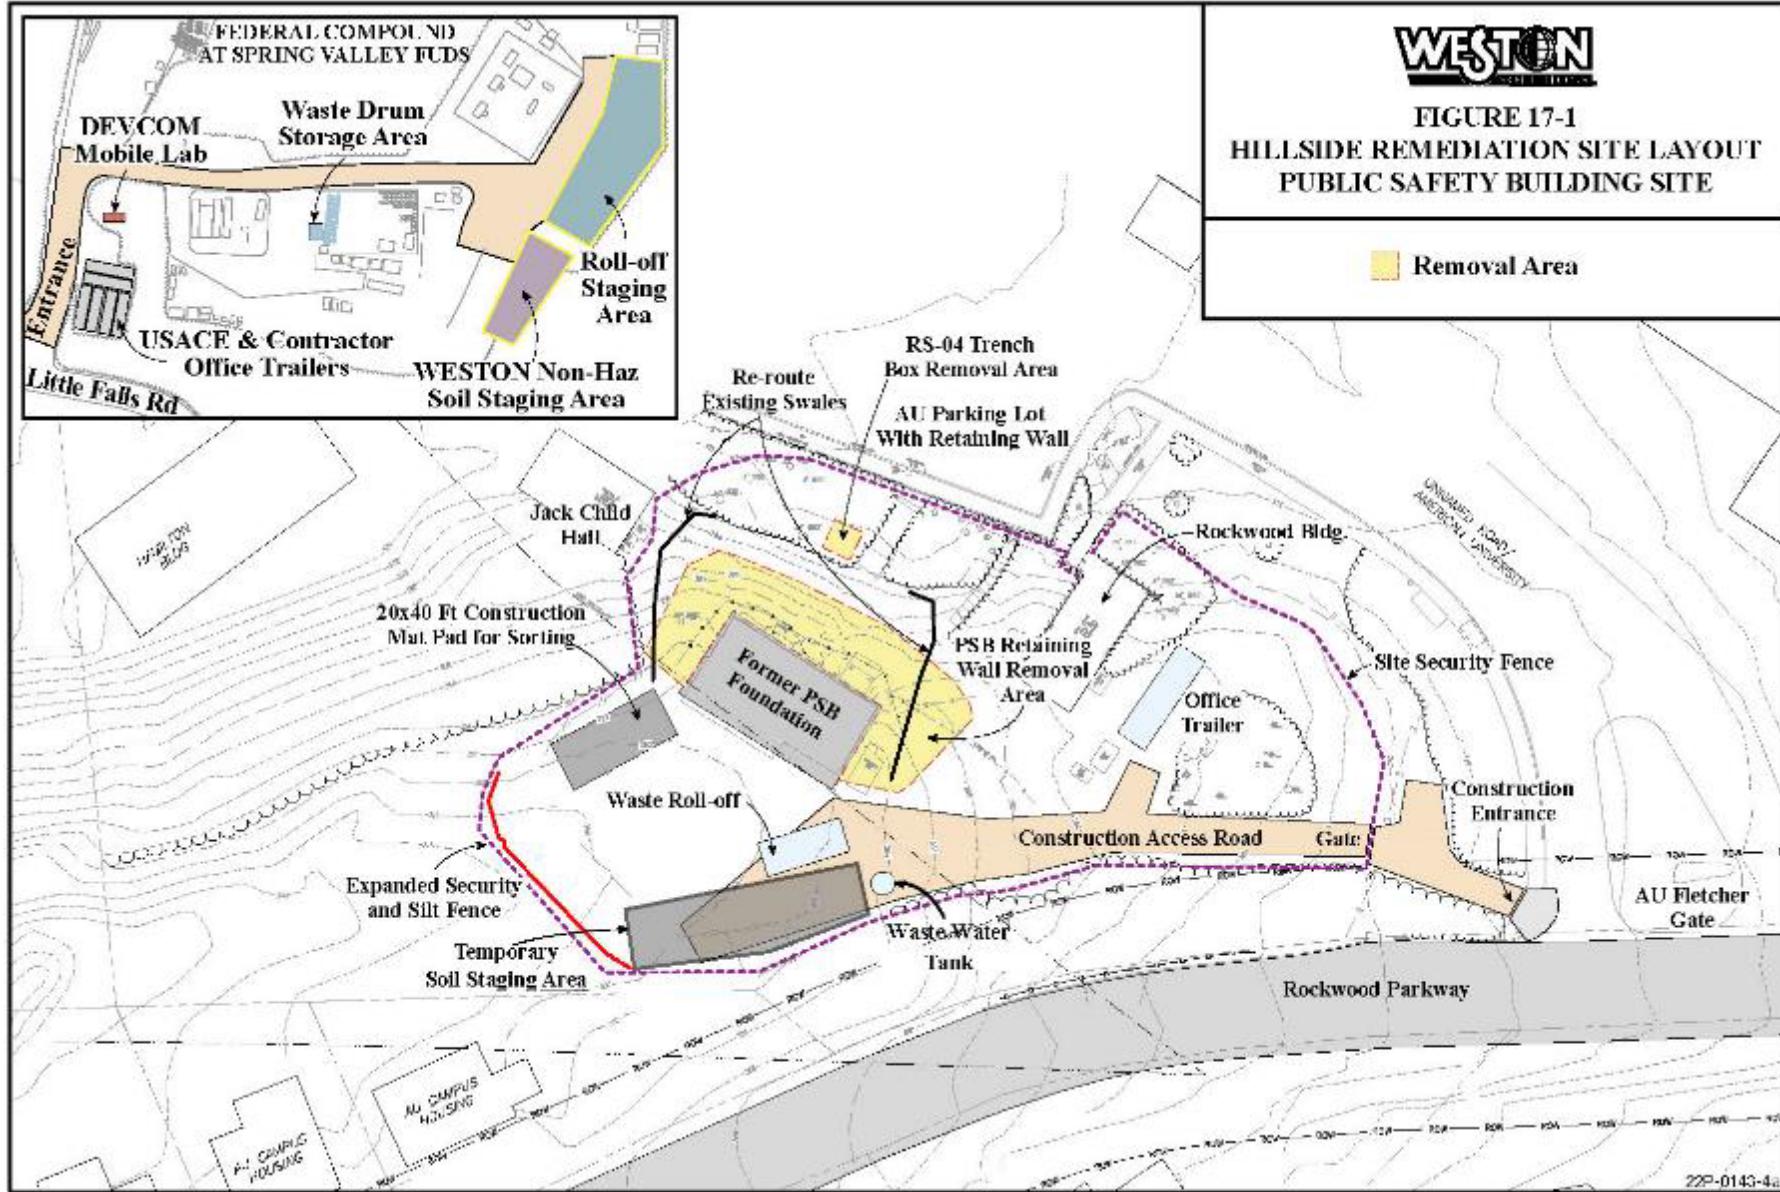
FIGURE 17-1
HILLSIDE REMEDIATION SITE LAYOUT
PUBLIC SAFETY BUILDING SITE

Removal Area

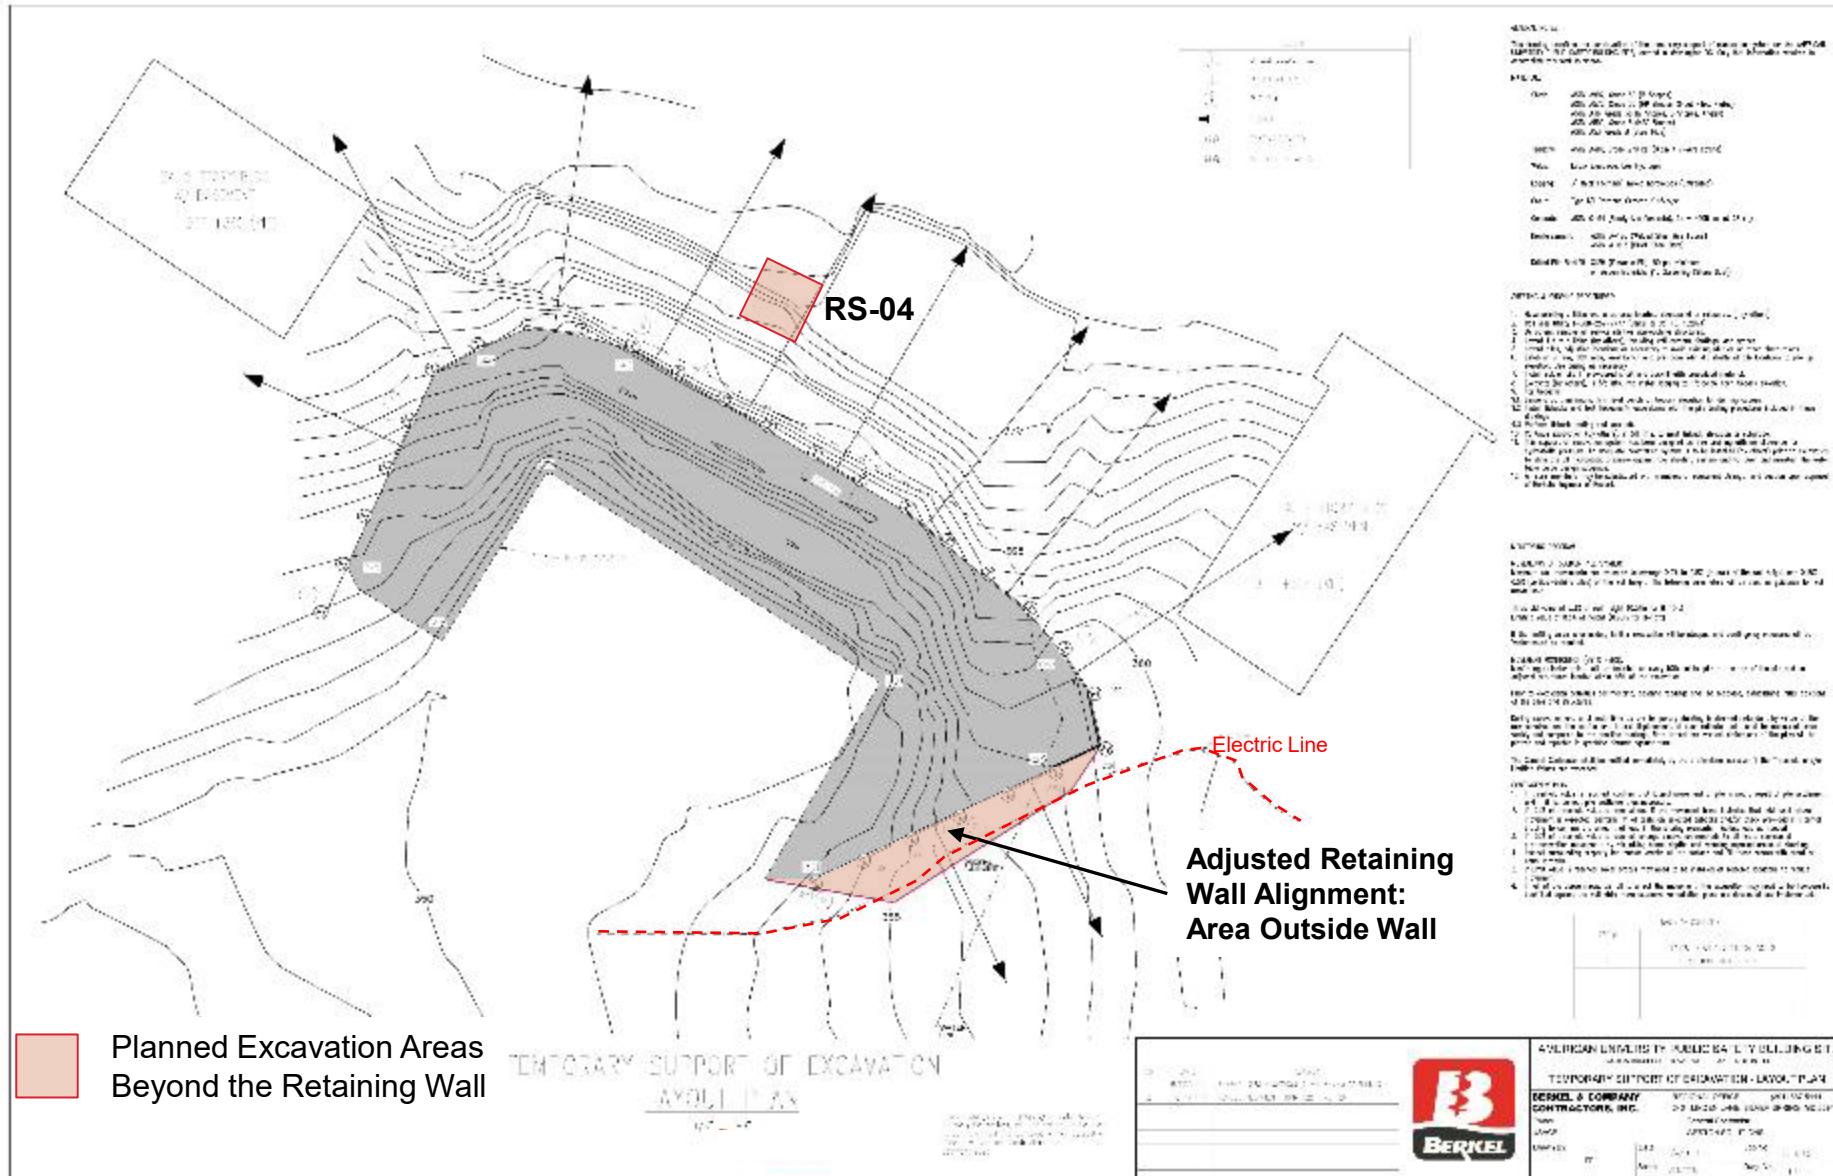
RETAINING WALL DESIGN – ADJUSTED FOR ELECTRIC LINE

- Completed installing Soil/Debris Storage Area at the PSB Site – 25 October 2023
- Adjusted Retaining Wall location to avoid nearby Electric Line – approved 7 November 2023

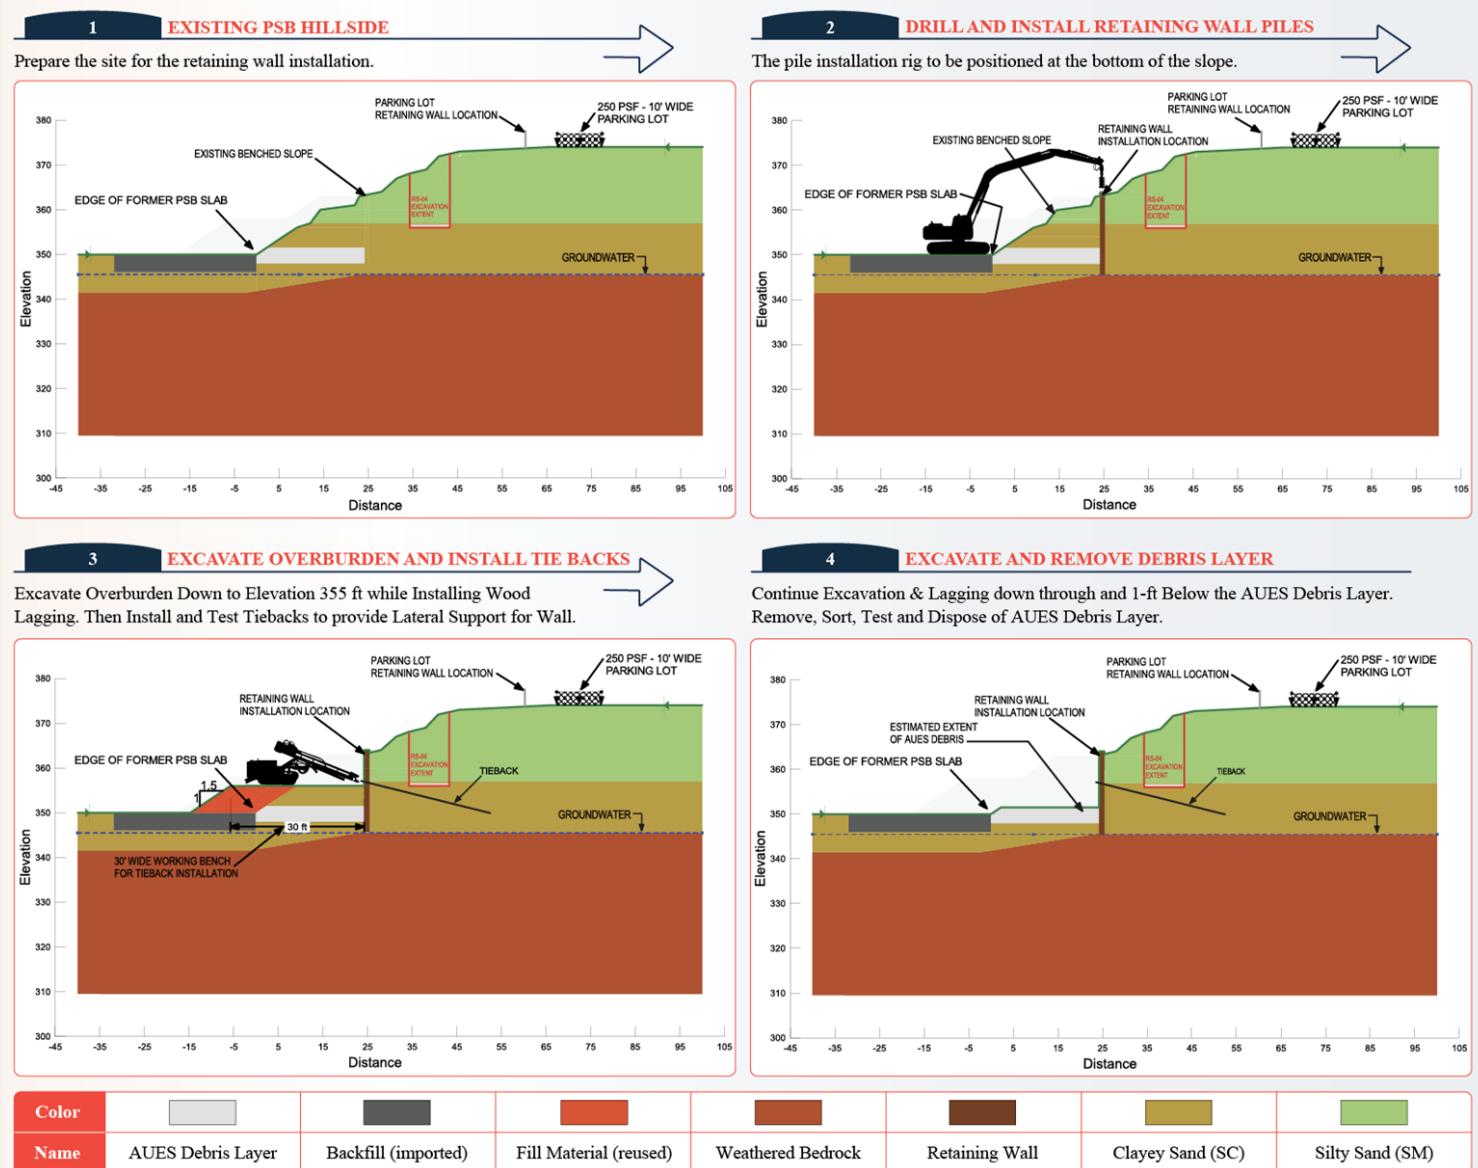
PSB HILLSIDE REMEDIAL ACTION- OVERVIEW

Hillside Excavation, Former Public Safety Building,
SVFUDS, Washington, DC

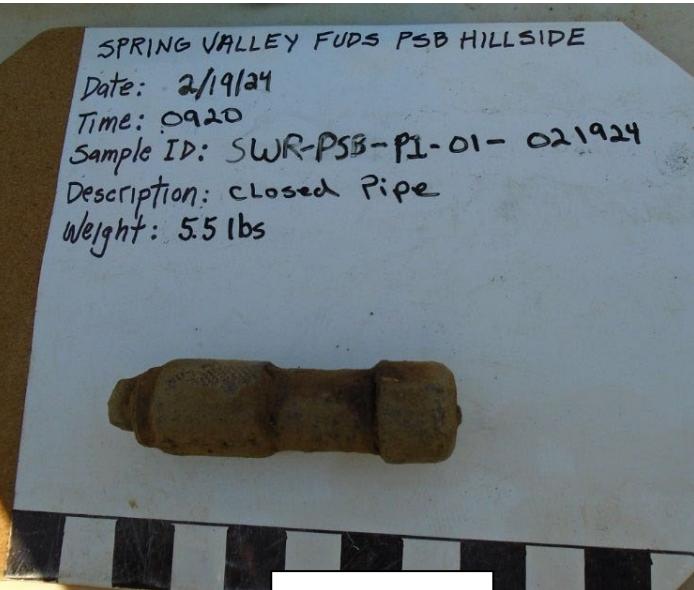
ITEM #1

1. **19 Feb 2024 – Sealed/capped 7-inch steel pipe.** Tested by X-ray and JCAD detectors – non detect for CWA and X-ray confirmed empty pipe. Item removed for demolition in case there was a residue inside. Relinquished to US Army 55th Explosive Ordnance Disposal (EOD) for disposal.

1. **19 Feb 2024 – Sealed/capped 7-inch steel pipe.** Resolution: Screening was conducted by EOD using JCAD. Result was non-detect. EOD transported item off site for explosive disposal. No further action.

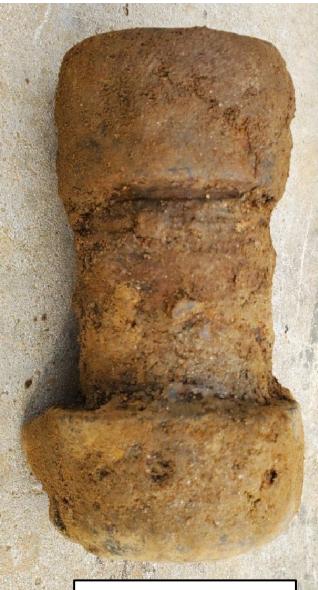
ITEM #2

2. **13 Mar 2024 – Sealed/capped 6-inch steel pipe.** Tested by X-ray and JCAD detectors – non detect for CWA and X-ray indicated pipe contained a liquid. Item relinquished to CARA for analysis.

2. **13 Mar 2024 – Sealed/capped 6-inch steel pipe.** Resolution: Screening was conducted by EOD using JCAD. Result was non-detect. X-ray analysis indicated item contained a liquid. CARA responded and took custody of the item for PINS analysis at the Federal Compound. Contents appeared to be water and antifreeze. No further action required.

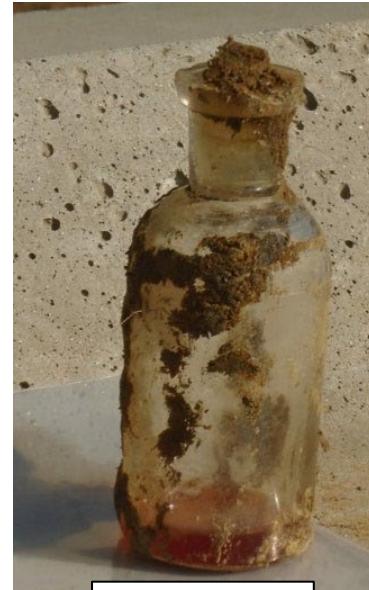
ITEM #3

3. **14 Mar 2024 – Sealed/capped lab glass bottle with red liquid.** Item was screened by EOD using JCAD and First Defender RMX Chemical Identification Analyzer and by CARA using Raman spectroscopy. Results were inconclusive. CARA transported the item to Edgewood for laboratory analysis.

3. **14 Mar 2024 – Sealed/capped lab glass bottle with red liquid.** Resolution: Liquid was an “unknown organic solvent” with trace amounts of 2-Chloroacetophenone or Tear gas (CN), which is not CWM.

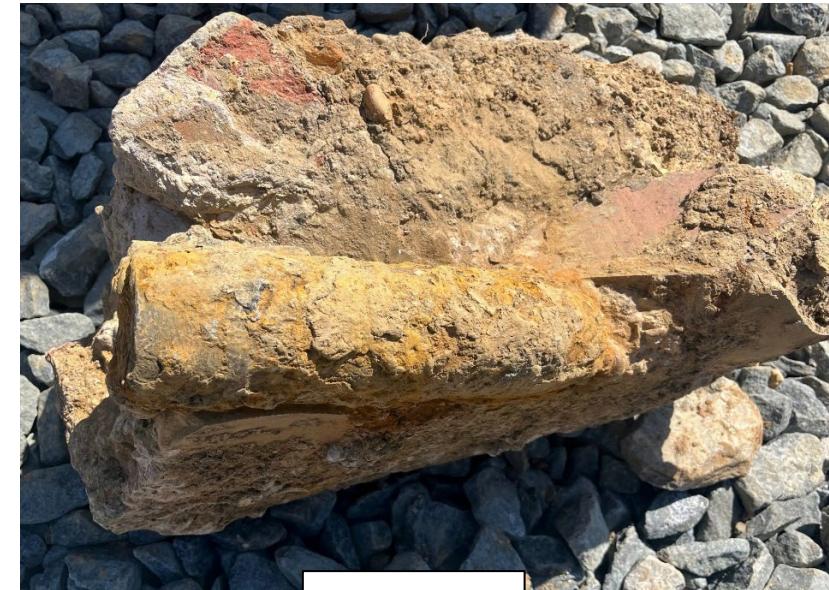
ITEM #4

4. **19 Mar 2024 - 75mm projectile partially encased in concrete.** Tested by X-ray and JCAD detectors – non detect for CWA and X-ray indicated item was empty - relinquished to 55th EOD for disposal.

4. **19 Mar 2024 - 75mm projectile partially encased in concrete.** Resolution: Relinquished to 55th EOD for explosive disposal. No further action.
5. **04 Apr 2024 – Sealed/capped 6-inch steel pipe.** Resolution: Relinquished to 55th EOD for explosive disposal. No further action.

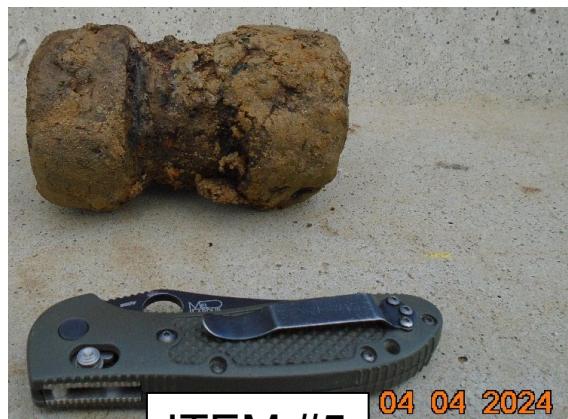
ITEM #5

5. **04 Apr 2024 – Sealed/capped 6-inch steel pipe.** Item was X-rayed and appeared to be empty. Relinquished to 55th EOD for disposal.
6. **24 Apr 2024 – Two Sealed/capped 6-inch steel pipes.** Item was X-rayed by USACE and appeared to be empty. USACE took custody of the items.

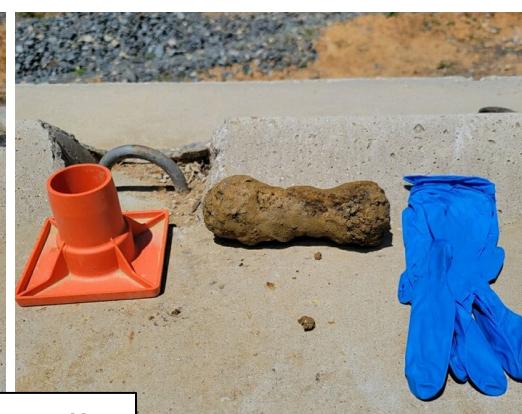
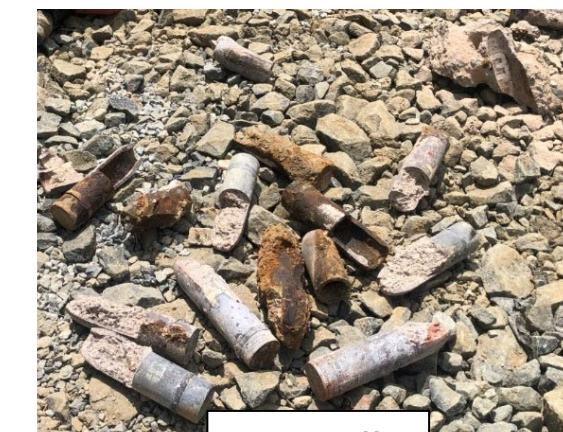
ITEM #7

7. **04 Jun 2024 – Two closed cavity 75mm projectiles with liquid/solid fill.** Removed from concrete by US Army 55th EOD. Items were X-rayed by EOD and appeared to contain liquid. Items were relinquished to Chemical, Biological, Radiological, Nuclear and Explosive (CBRNE) Analytical and Remediation Activity (CARA) for analysis.

7. **04 Jun 2024 – Two closed cavity 75mm projectiles with liquid/solid fill.** Resolution: Item **SVM-24-205** was determined to contain 100% solid fill. PINS assessment was possible high explosive. Relinquished for explosive disposal. No further action. Item **SVM-25-205** was determined to contain 40% solid and 40% liquid fill. PINS assessment was possible water, not CWM. Relinquished for disposal.

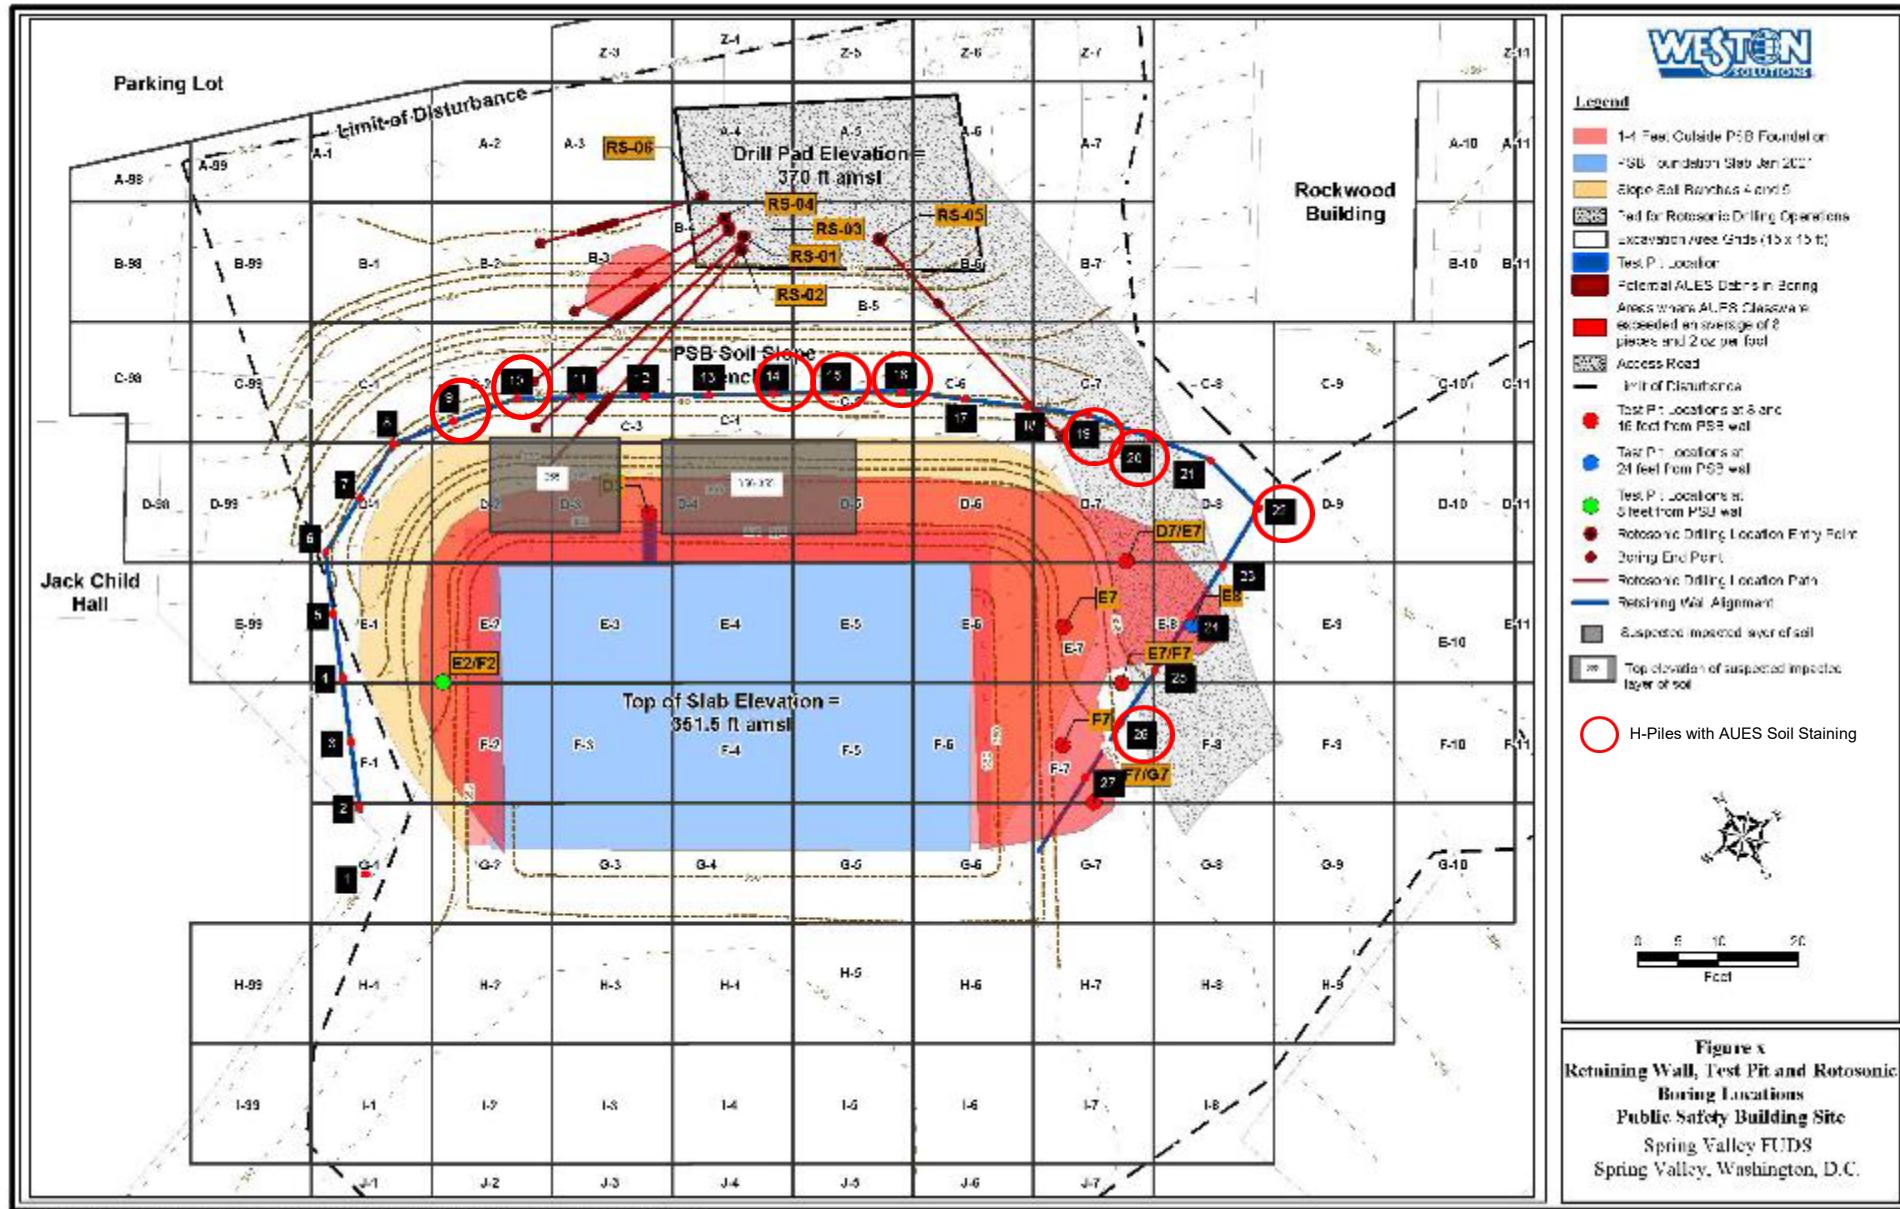
PSB RETAINING WALL – H PILES WITH AUES DEBRIS

- Rotosonic Borings
- Test Pit Locations
- Estimated Areas with AUES debris
- Retaining Wall alignment
- PSB Sampling Grid
- 27 H Pile Locations
- 9 H-Pile Locations where AUES stained soil observed are circled – but no AUES Debris. Soil cuttings at H-Pile 10 had the darkest staining and a sample was sent to CCDC for Low Level CWA and Agent Breakdown Product analysis.

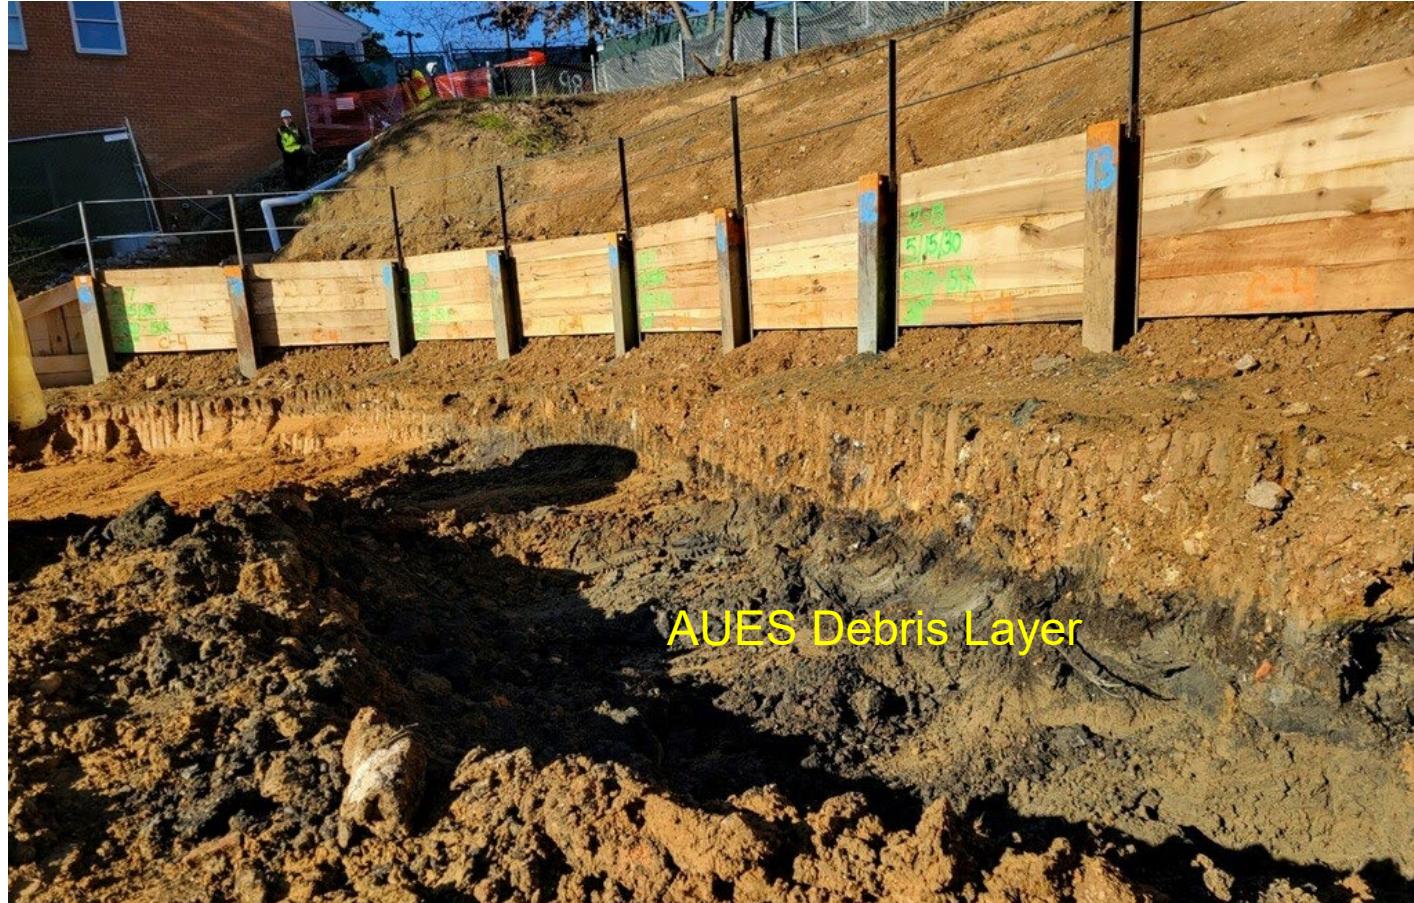
Dark Stained Soil and Glassware (see adjacent photo) Indicative of AUES Debris was First Encountered Excavating Soil at Elevation 355 ft, approximately 7 ft below the top of the Retaining Wall and extended down to Elevation 347 ft. The AUES layer was 7-8 ft thick between Piles 14 and 15.

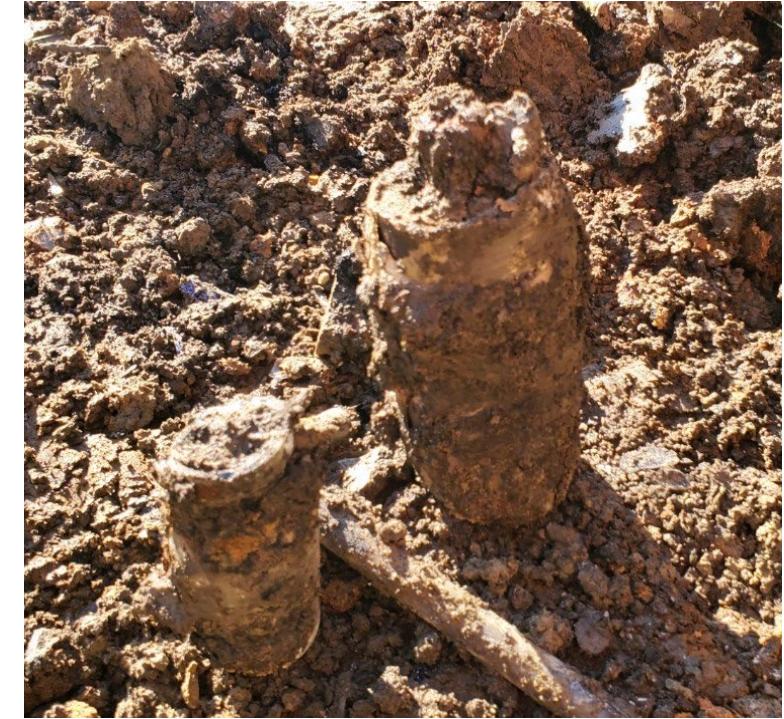
Uncapped/open intact glass bottle appeared to be filled with soil, possible battery, and glass pipet that was included in batch soil & glass samples for Headspace analysis: soil & glass results were negative for HD & L.

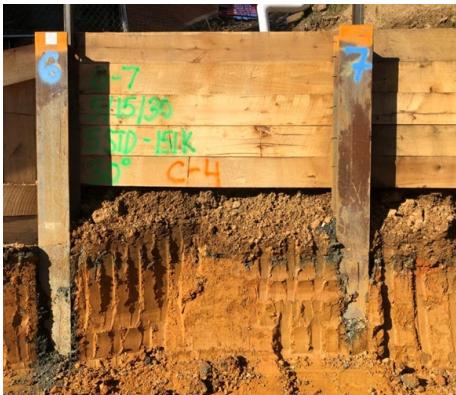
Excavation sidewall at Piles 6 & 7. No impacted material

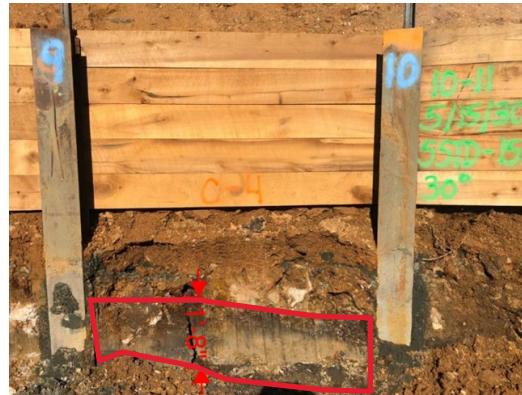
Sidewall at Piles 9 & 10. Dark AUES layer at wall, 1 ft 8 in thick

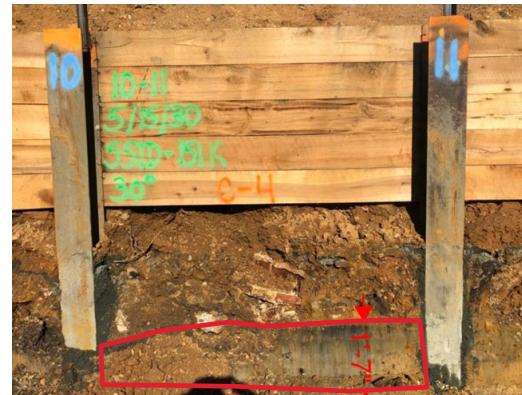
Sidewall at Piles 10 & 11. Dark AUES layer at wall, 1 ft 7 in thick

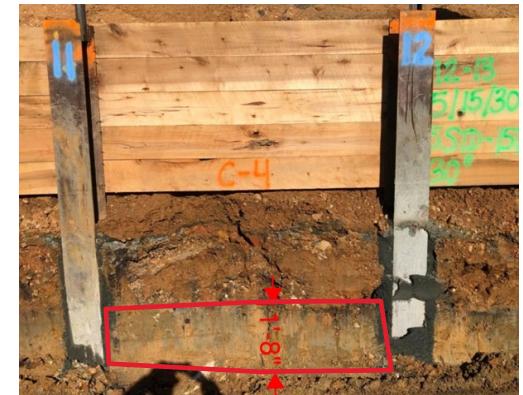
Sidewall at Piles 11 & 12. Dark AUES layer at wall, 1 ft 8 in thick

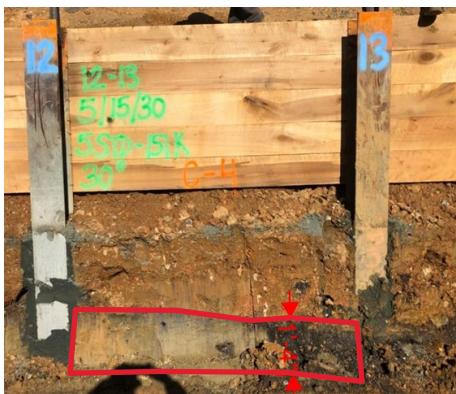
Sidewall at Piles 12 & 13.
Dark AUES layer at wall, 1 ft 4 in thick

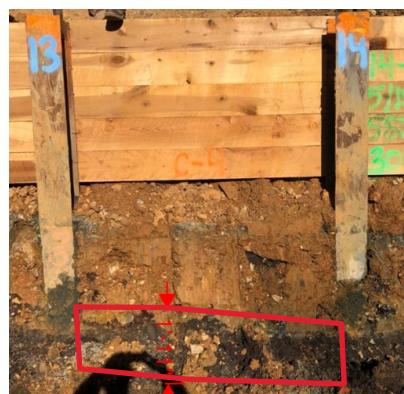
Sidewall at Piles 13 & 14. Dark AUES layer at wall, 1 ft 11 in thick

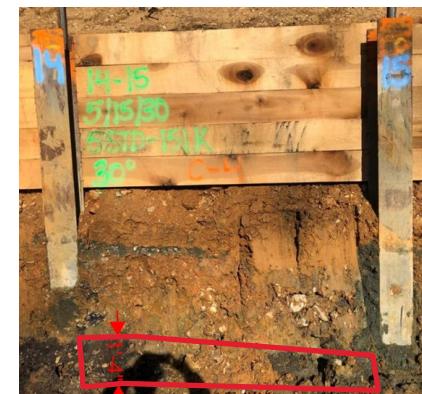
Sidewall at Piles 14 & 15.
Dark AUES layer at wall, 1 ft 4 in thick

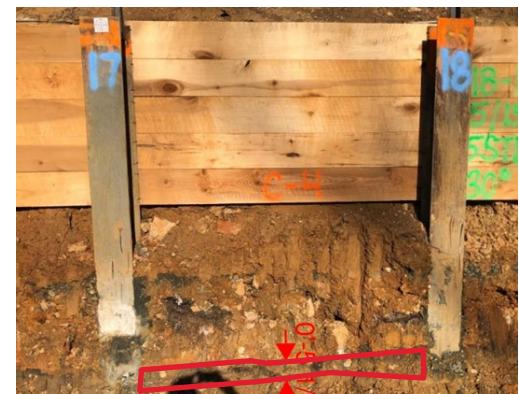
Sidewall at Piles 17 & 18.
Dark AUES layer at wall
thinning out, 5 in thick

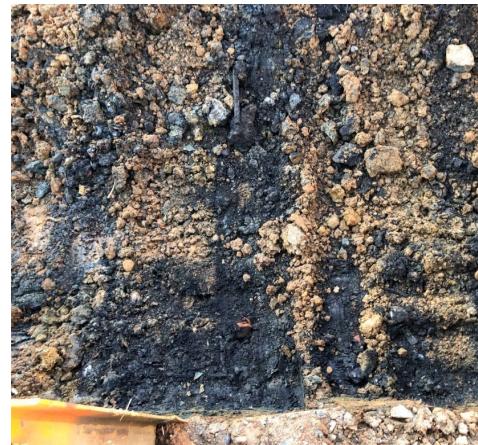
Top of Dark AUES Debris layer at elevation 355 ft amsl

AUES Debris Layer extends from H Pile 9 to H Pile 18 along the North edge of Retaining Wall
