SVFUDS PUBLIC SAFETY HILLSIDE REMEDIATION AT AMERICAN U. PROJECT STATUS

Weston Solutions, Inc.

July 18, 2024

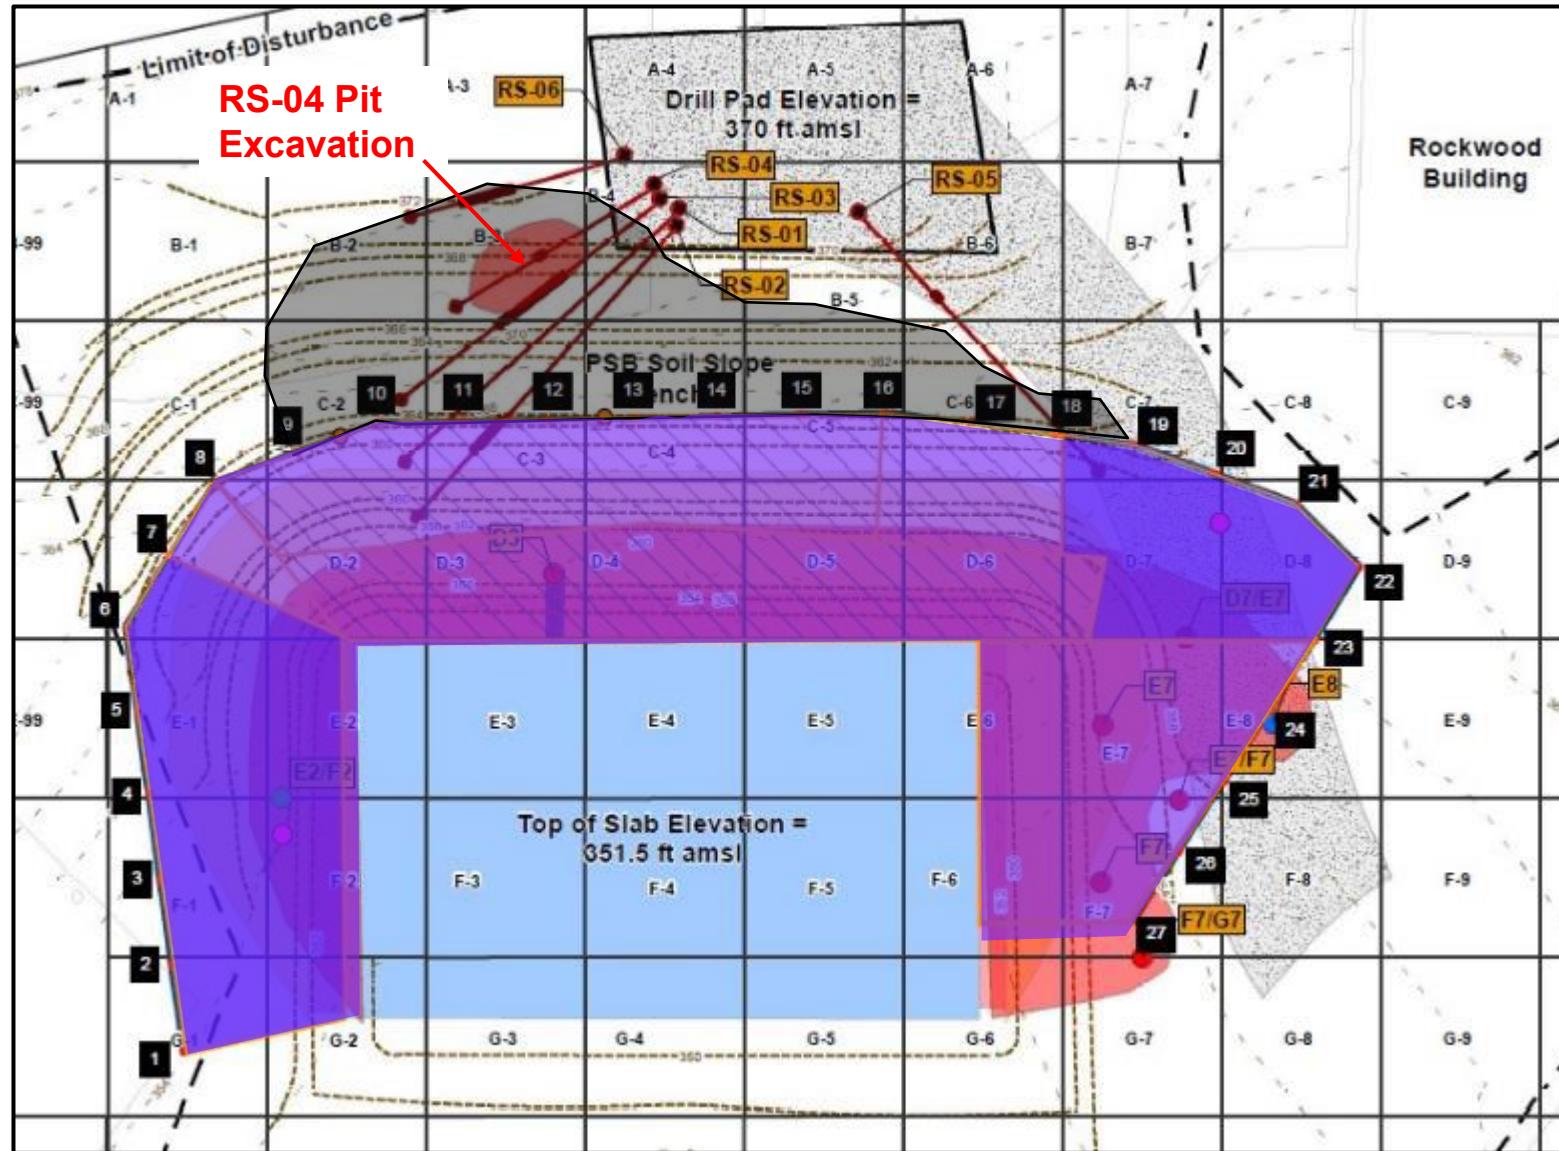
POTENTIAL AUES DEBRIS AREA – BEYOND RETAINING WALL

Potential AUES Debris Area
Beyond Wall based on test pit,
sidewall & drilling data

RS-04 Pit Excavation Area

Hillside Excavation Area Inside
Retaining Wall

Former Public Safety
Building Foundation

- No AUES Debris layer was observed west of H Pile 9 or east of H Pile 19 along the north wall.
- The AUES Debris layer was observed to continue beyond the retaining wall to the north between H Piles 9 and 19. The debris layer is between 2 and 7 feet thick along the retaining wall. North of the retaining wall at pit RS-04 the observed AUES Debris layer was 3 to 4 ft thick and extended in all four directions. The AUES debris in the RS-04 pit was excavated and transported offsite for landfill disposal. One extra foot of clean soil was excavated below the AUES Debris layer in RS-04.

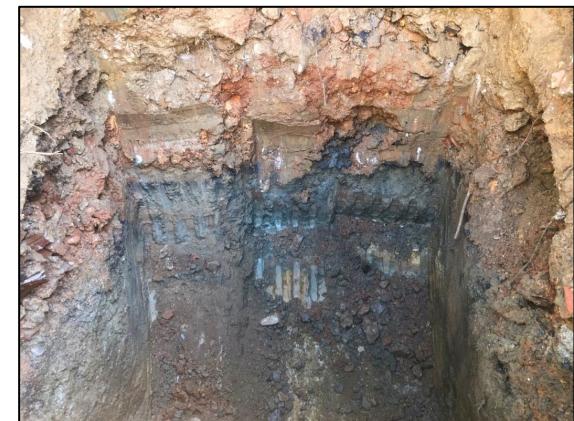
RS-04 Excavation - Dark
AUES Debris Layer extends
in all 4 directions

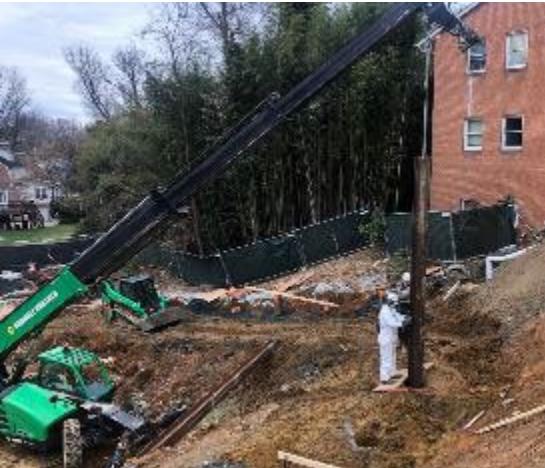
Lifting & Setting H Pile #14 in the Auger hole

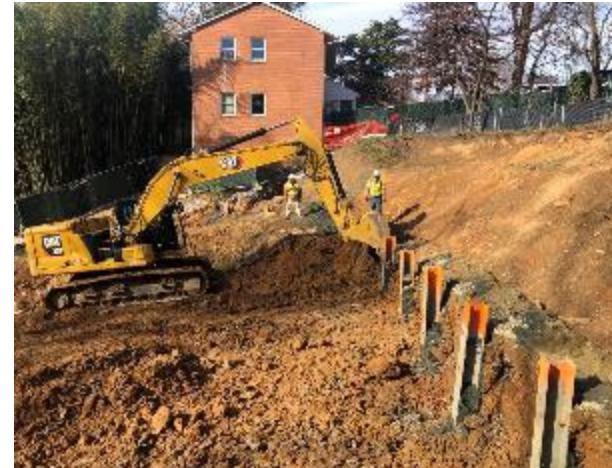
Excavating the first 5-Foot of "clean" Overburden soil

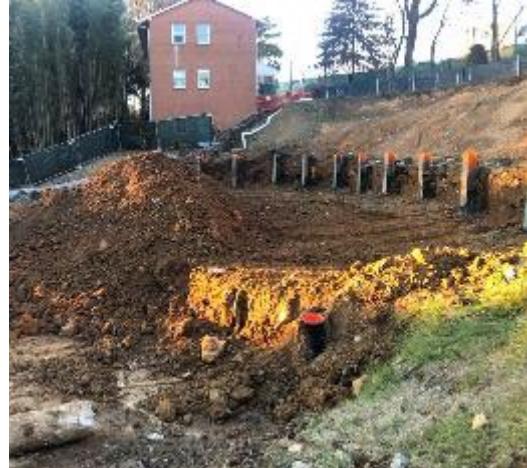
First soil bench completed on the north wall – ready for Laging

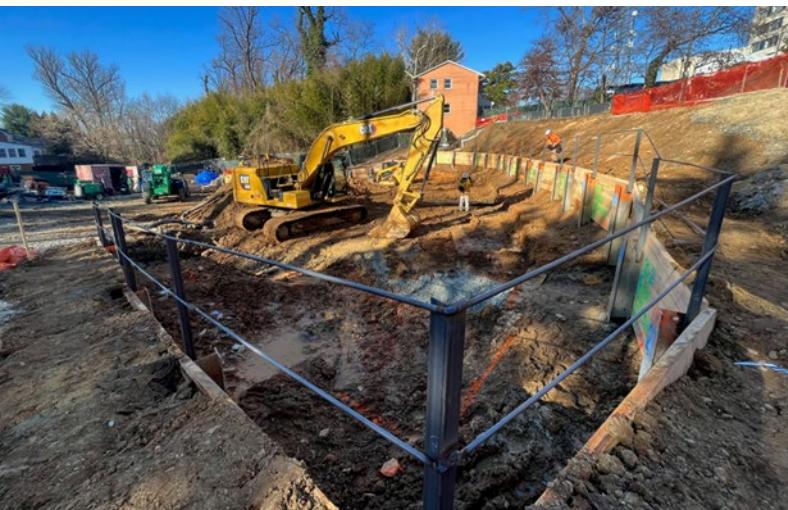
Overview of the First 5 Feet of Completed Retaining Wall

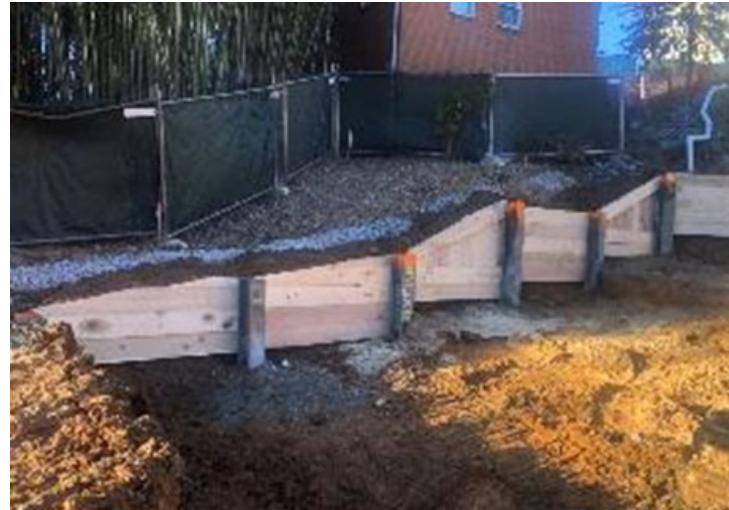
Wood Lagging Installed between the H Piles on the Western wing of Wall

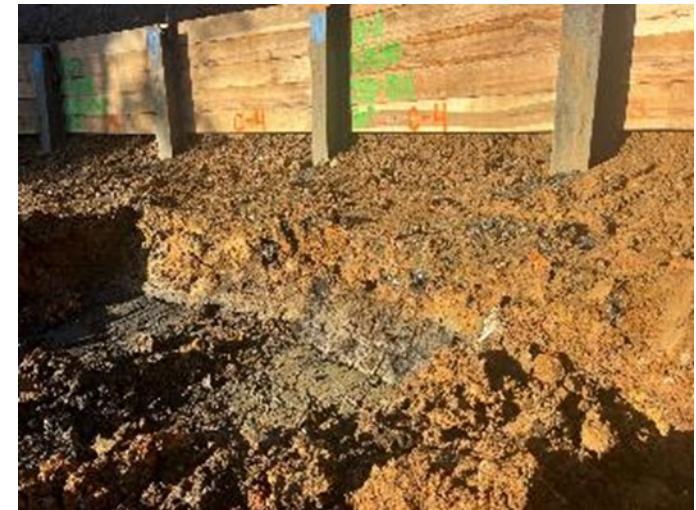
First Encounter of dark AUES Debris layer in second cut at H Piles #9 and #10

- Encountered dark AUES Debris layer at 355 ft amsl along the north side of the retaining wall (H-Piles 9–18): 4 feet above former PSB slab – higher than expected & extending to the wall

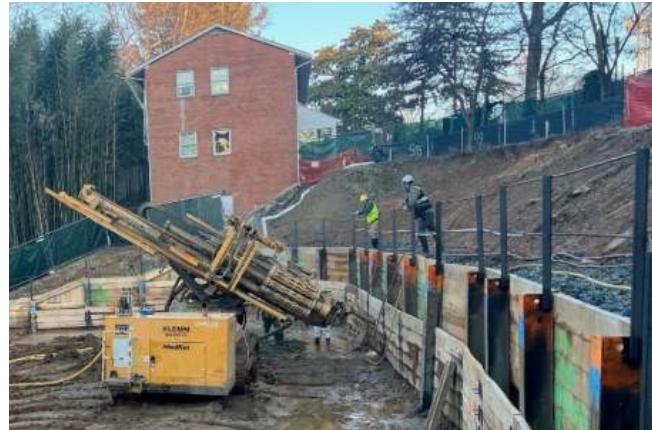
Berkel starting initial tieback installation at location between H piles 12 and 13.

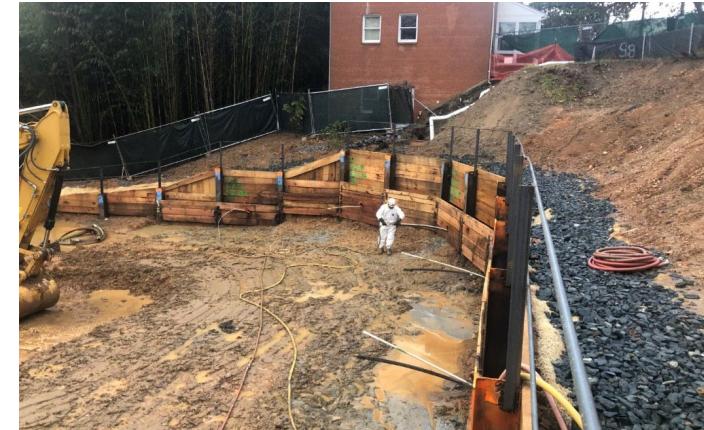
Berkel pumping grout into tieback between H piles 8 and 9.

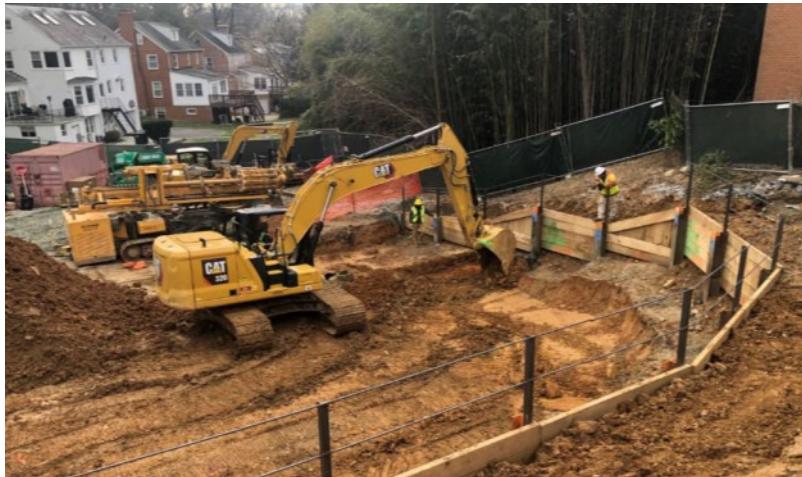
Excavation in progress along the west end of the retaining wall for the second tier of lagging

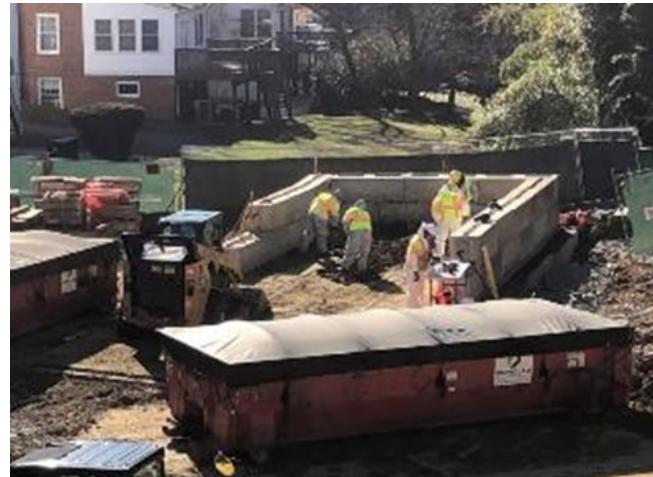
UXO Team screening soil on AUES Debris sorting pad with rakes/hoes

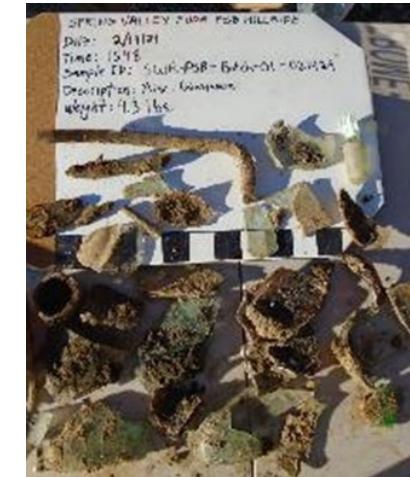
AUES broken glassware sent for CWA headspace analysis

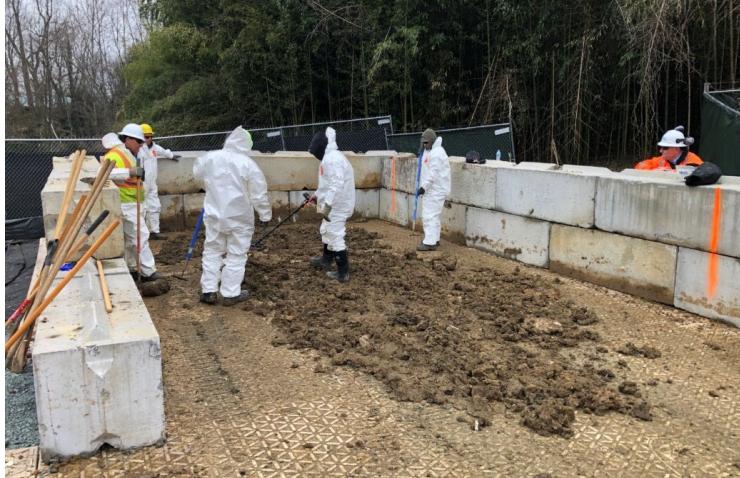
UXO Team screening soil on AUES Debris sorting pad with a metal detector

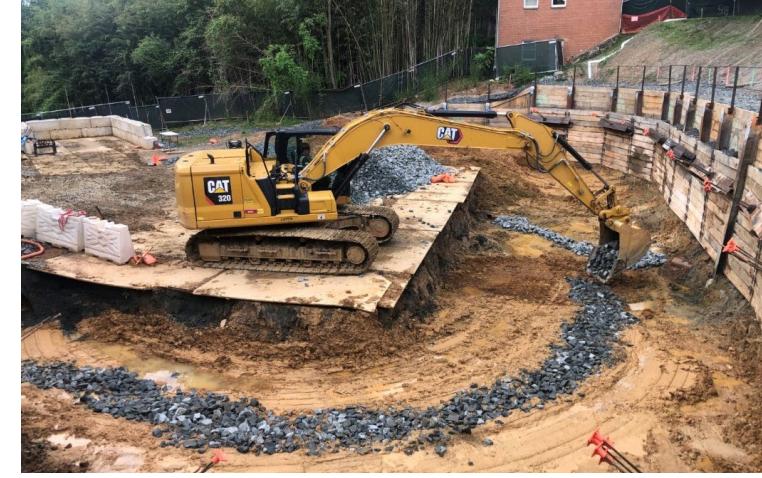
Excavator placing stone at the start of excavation backfill operations.

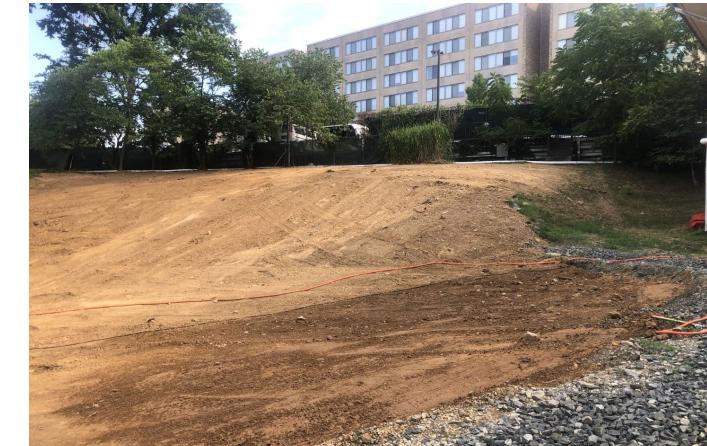
Reconstructed PSB Hillside Slope.
