SPRING VALLEY FORMERLY USED DEFENSE SITE PROJECT RAB Meeting

January 14, 2020 7:00 – 8:30 p.m.

Restoration Advisory Board Meeting 14 January 2020

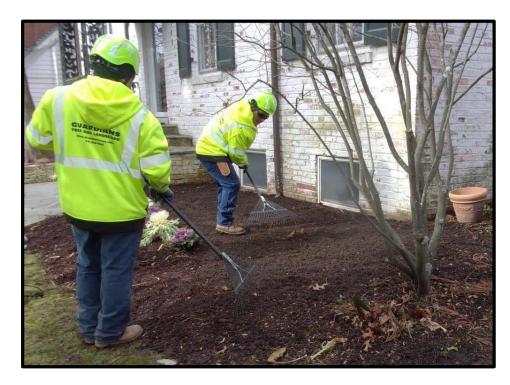
Landscape removal team leveling area where vegetation was removed.

Despite leaving properties with less vegetation, the landscape removal team aims to leave each property neat, both during the preparation for the geophysical surveys and for the re-landscaping during the following planting season.

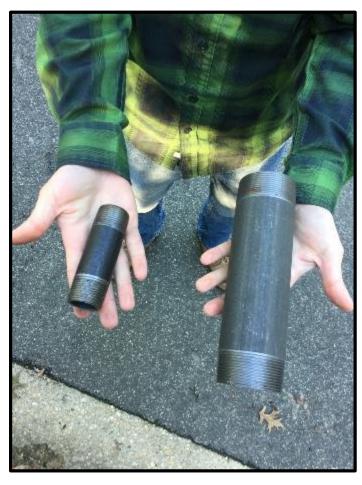
Industry standard objects (ISO)

The "blind seeds" are industry standard objects (ISO) (a metal pipe) that range in size buried at various depths and orientations.

Once the vegetation is removed, the crews place blind seeds on private properties. The blind seeds are industry standard objects (ISOs), metallic pipes that are buried at different depths and orientations. Quality Control (QC) seeds are placed by Weston Solutions to perform an internal check of their data processing and data collection. Quality Assurance (QA) seeds are placed by USACE to act as validation for Weston Solutions' data processing and data collection and to ensure Weston Solutions' processes meet the requirements included in the workplan.

The locations of the seeds are recorded via global positioning system (GPS). The geophysical survey teams and excavation teams do not know the locations of the seeds. The seeds are recovered during the anomaly removals.

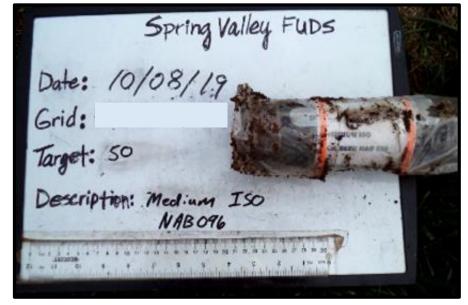
Recovered "Blind Seed"

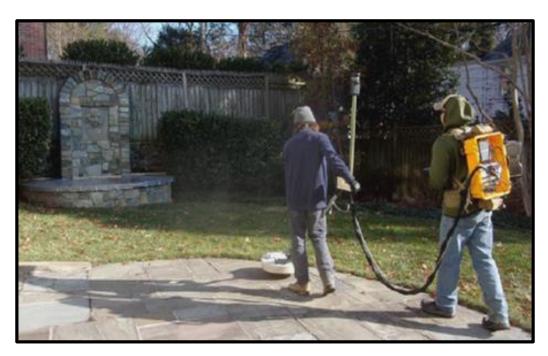
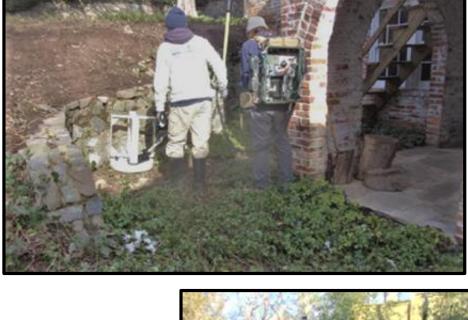
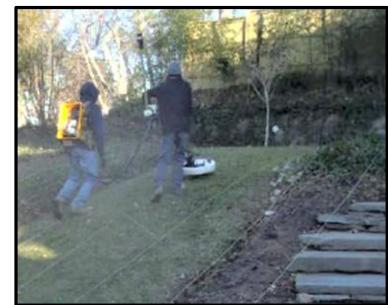
Geophysical Surveys

The team closely examines each location during the property site walk to determine if there are any complexities that may cause interference to the equipment.

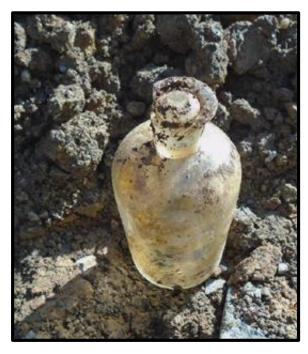
Recovered glass bottle with stopper

Crews continued benching the upslope soils of the basement slab. During soil removal activities, two intact glass bottles were encountered in the soil around the former PSB on December 3rd and work was paused immediately.

- One of the glass bottles was unsealed and the other was sealed with a stopper.
 No stained soils or unusual odors were observed in the area where the bottles were found.
- The glassware was secured and sent for analysis.
 It was determined to be non-hazardous.
- Crews resumed work and completed the upslope soil benches.

- The glassware was secured and sent to Edgewood Chemical Biological Center (ECBC) for analysis after the glassware cleared headspace analysis at the Federal Property. The glassware was determined to be non-hazardous and cleared for agent.

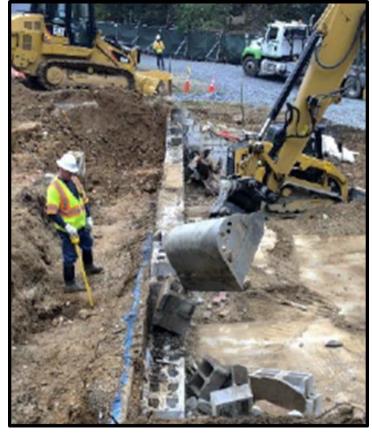
Excavator pulling down concrete wall in preparation for the last soil bench

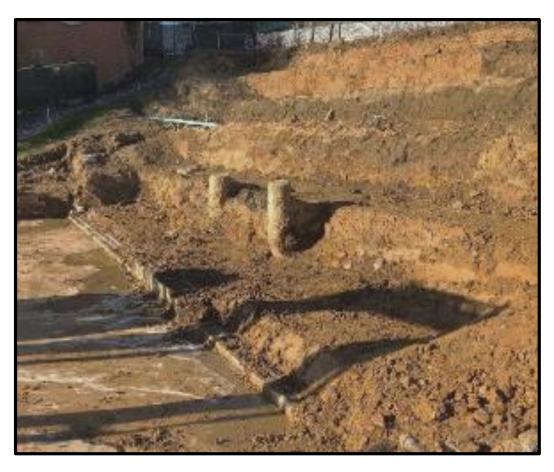
Completed upslope stabilization benches

- Crews resumed work and completed the upslope soil benches for safe excavation of the former PSB.
- The crews began to cut the concrete foundation slab into manageable pieces in preparation for the excavation of the soils beneath the former PSB.

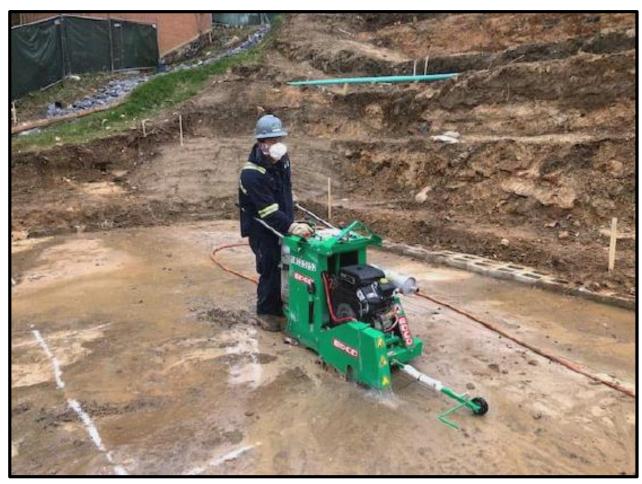
The crew using a walk-behind saw to cut the PSB foundation slab into sections. This saw distributes water to minimize the concrete dust.

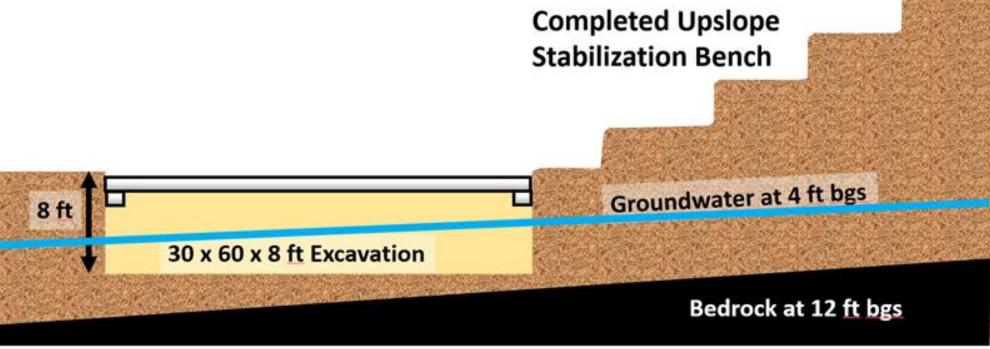
PSB Excavation Cross Section

*Not to scale

- Once the slab is removed the crews will excavate the soils to eight feet in depth across the former footprint of the PSB and perform confirmation sampling.

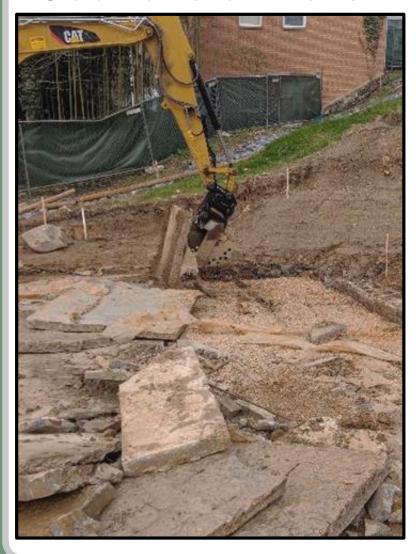
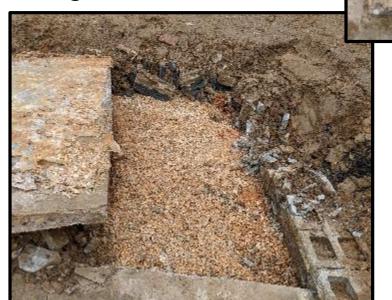
Crews started removing the sectioned pieces of the foundation slab, in preparation for the excavation of the soils beneath the former Public Safety Building.

Sections of the PSB foundation slab

- The crews encountered a substantial layer of pea gravel and a plastic barrier under the foundation slab. This means the concrete is clean and had no contact with the soil. The clean concrete may be recycled, minimizing the amount of the waste going into the landfill system. The soils beneath the slab will be excavated over the next few weeks.

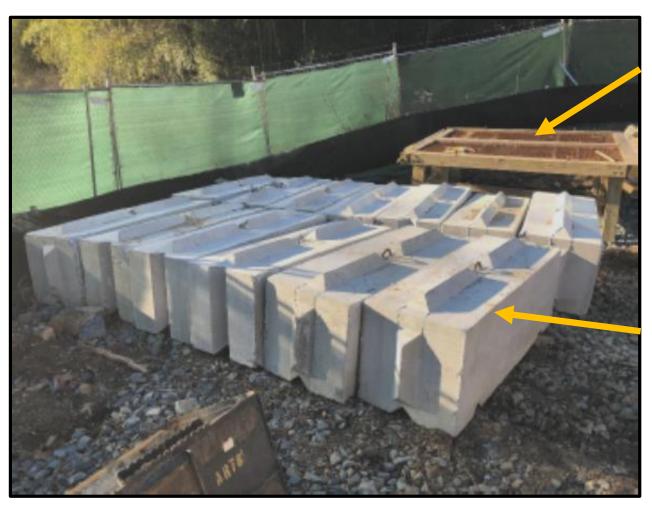
Crews began staging the soil screening station in preparation for the removal of the soils beneath the former Public Safety Building.

Bin blocks

Staging of the soil screening station

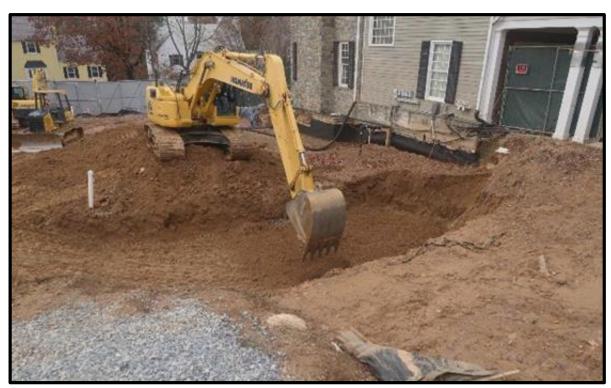
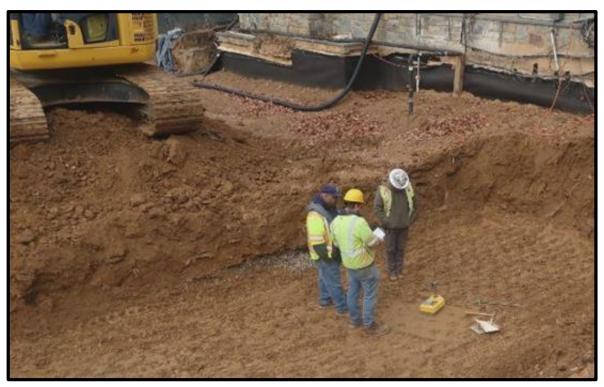
Crews continued to bring in clean soil, one truck load at a time, or use clean backfill already at the site, to fill in sections of the excavated site. The soil compaction is performed to construction site standards, with soil added in layers, compacted, and then tested.

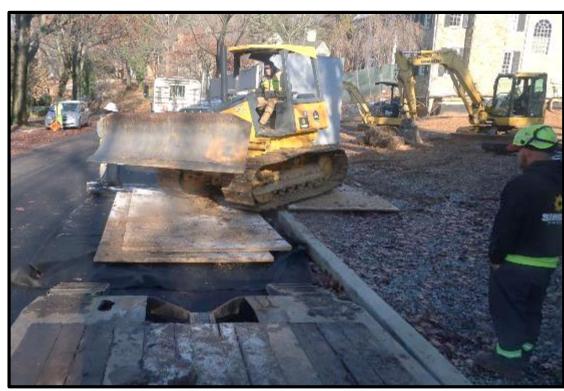
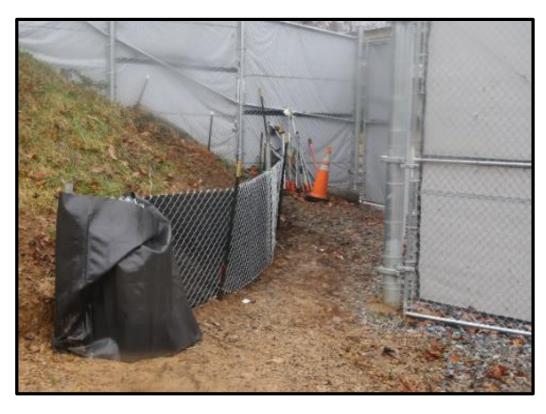
GLENBROOK ROAD – RECENT EFFORTS

In December, we returned rented construction equipment until it is needed in 2020.

The crew installed a super silt fence near the south front corner of the property. The silt fence is an erosion control measure in the area where the soldier pile removal effort is ongoing. It provided greater site stability and security, including when the crew was largely demobilized over the holiday break.

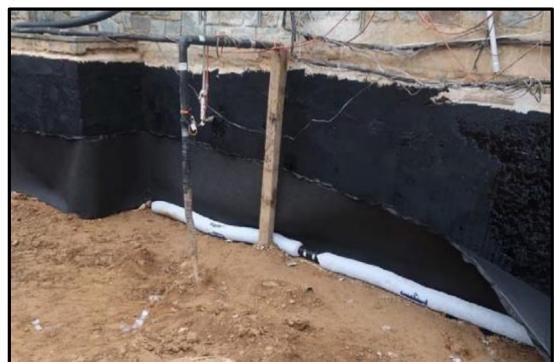
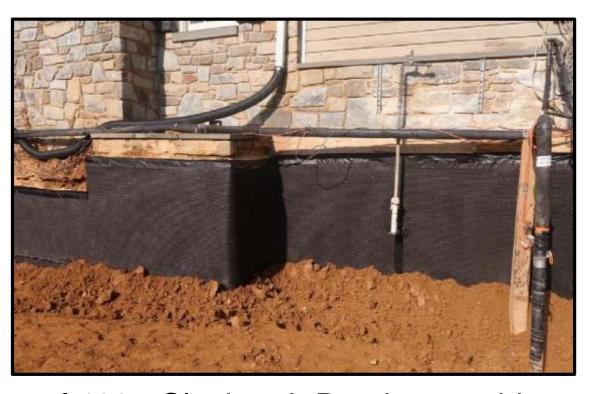
Excavated a trench around the foundation of 4835 Glenbrook Road to provide access for waterproofing the foundation wall.

The crew then installed J-Drain waterproofing near the shared property line, and completed backfilling the trench next to the 4835 Glenbrook Road foundation.

- A trench was excavated around the foundation of 4835 Glenbrook Road to provide access for waterproofing the foundation wall.
- The crew then installed J-Drain waterproofing near the shared property line and completed backfilling the trench next to the 4835 Glenbrook Road foundation.

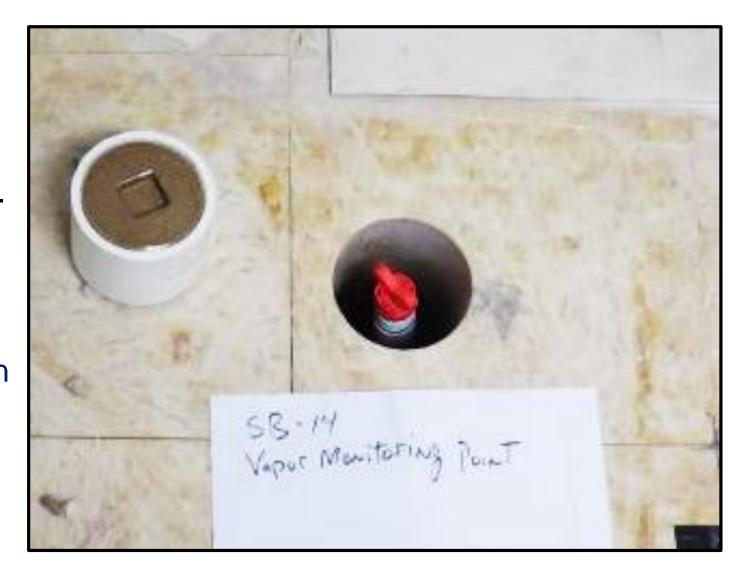
ECBC team's second round of soil gas sampling completed in November at 4835 Glenbrook Road, detected no agent or agent breakdown contamination.

The Corps of Engineers is discussing with the Partners whether to conduct another round of soil gas sampling, when the weather is warmer this year, to confirm these sampling results as an added measure of caution.

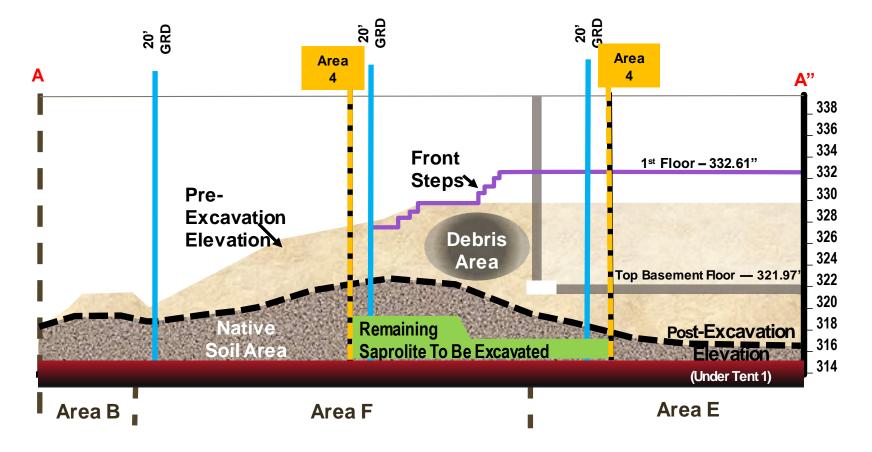
The site team will return to Area 4 to complete deeper excavation into bedrock.

Area 4 has a small area of remaining saprolite where HTW contamination has been detected.

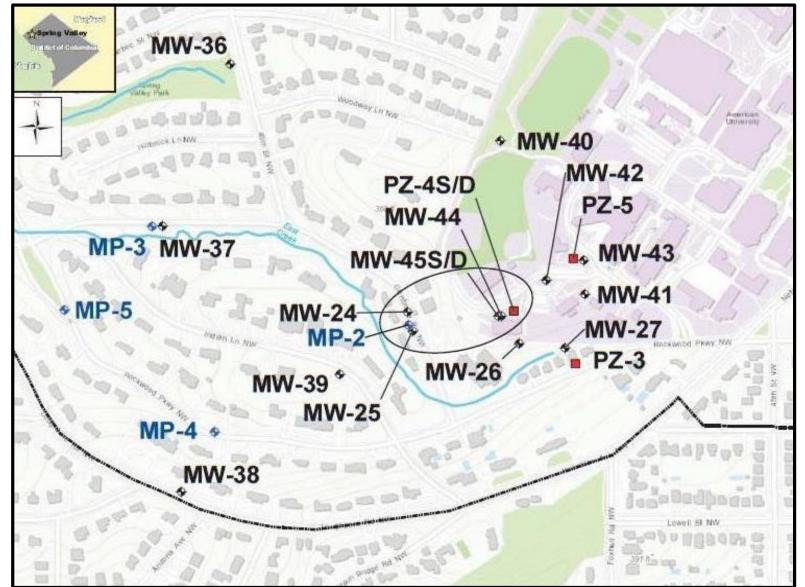
Key

- Area encompassing the EU2 Monitoring Wells
- Spring Valley FUDS
 Boundary
- Piezometer
- ◆ Monitoring Well
- ◆ Multiport Well

S/D = Monitoring well or piezometer with screened intervals in the same borehole.

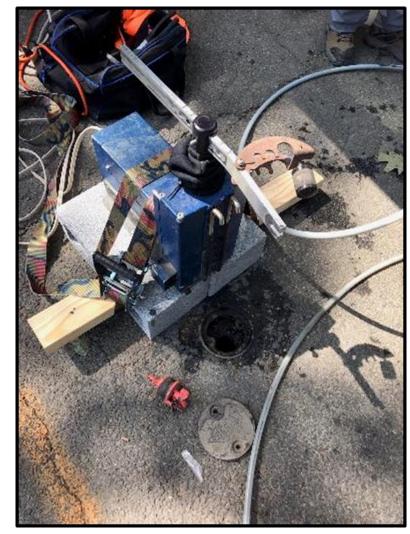
Groundwater sampling well
