SPRING VALLEY FORMERLY USED DEFENSE SITE PROJECT
RAB Meeting

**May 14, 2019
7:00 – 8:30 p.m.**

**U.S. Army Corps of Engineers
Spring Valley Restoration Advisory Board
St. David's Episcopal Church
Minutes of the May 2019 Meeting**

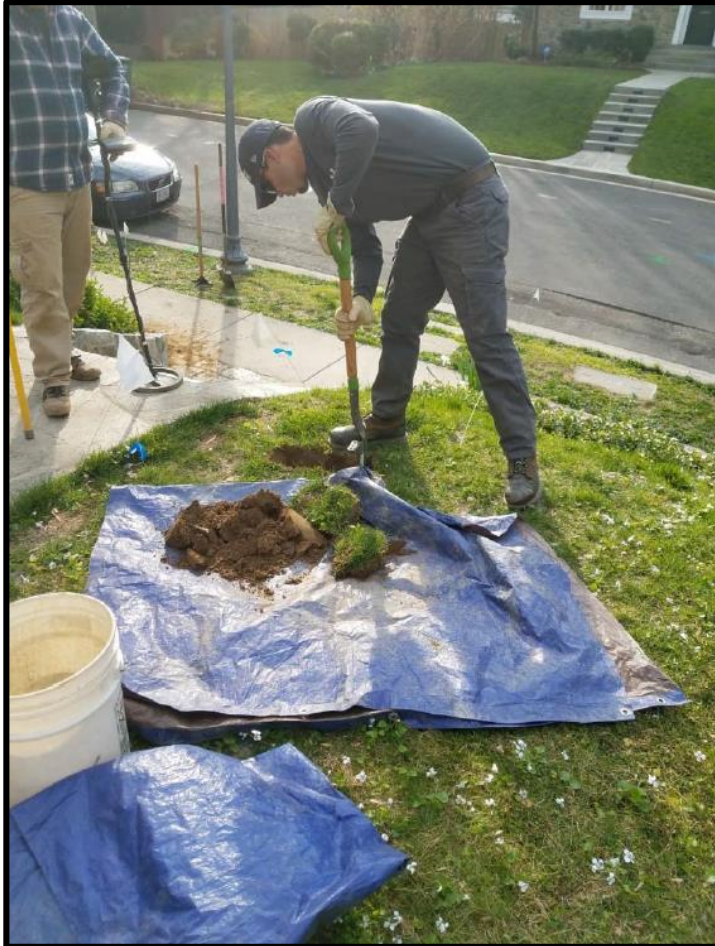
Anomaly Excavations Completed at Nine More Private Properties

The team carefully excavates each target, checks each location with a metal detector to ensure the metal anomaly was removed, and fills the clear hole with soil.

The team conducts hand-excavation for target removal and places the soil on a tarp to minimize damage to the property. The team has received several compliments from homeowners because of the team's careful handling of the excavations. In many instances there have been ~30 to ~40 excavations on a property and only ~6 showed signs of excavation activities. The excavation team leaves each property as close to pre-excavation condition as possible.

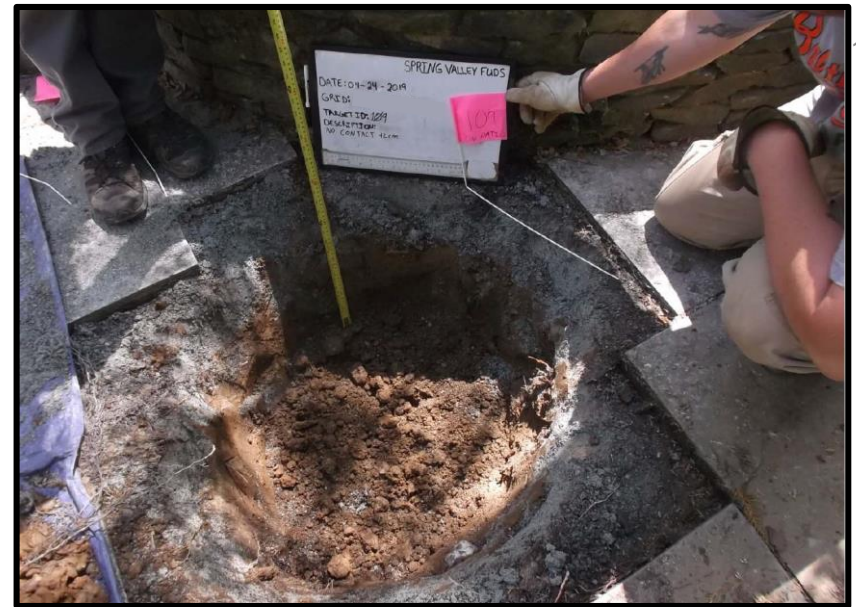
Some anomalies are removed from under hardscape

The depth of each recovered anomaly is documented

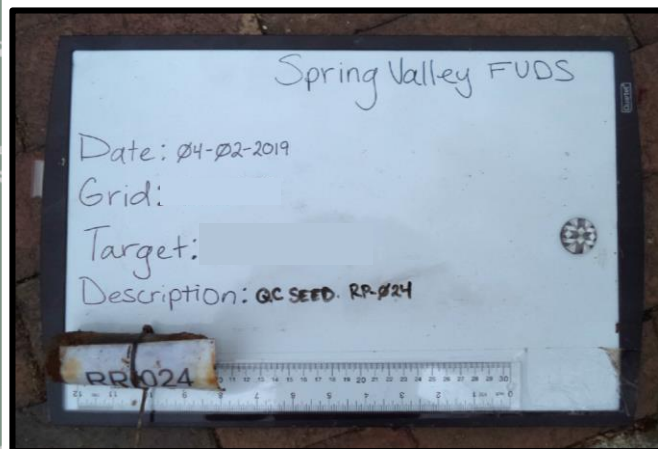
**Recovered
quality control
'blind seed'**

Double-blind seeds are buried on every property to confirm the equipment is working properly for Quality Assurance/Quality Control (QA/QC). The exact coordinates and depth of the blind seed locations are known within a few centimeters. Each blind seed must be found to ensure the instruments are working properly. The contractor buries several industry standard objects (ISOs) that mimic different munitions items on the property and then survey the blind seed locations. The ISOs typically resemble steel pipe, ~1 ½ to 3 inches long. A second team must find the blind seeds without knowing the locations of the blind seeds. Additionally, USACE buries a second set of blind seeds with undisclosed locations as a double-blind test.

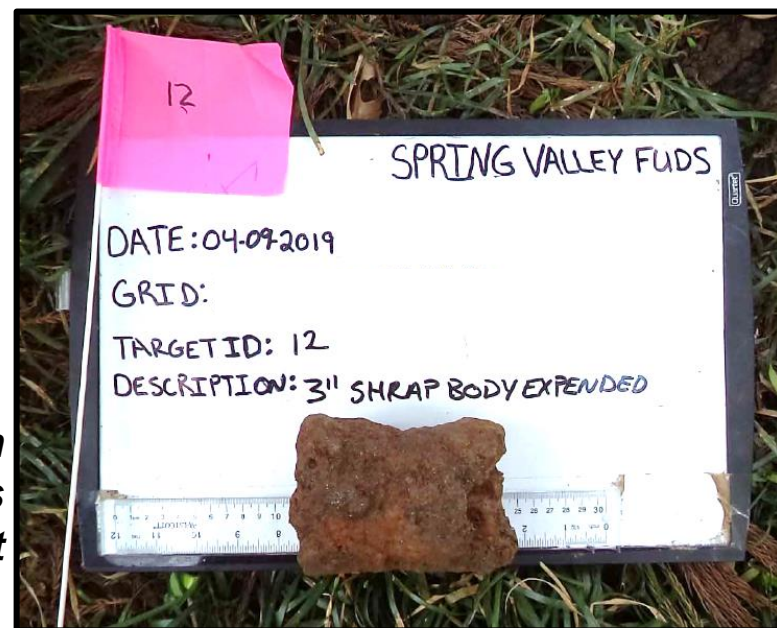
**Recovered 3-inch
non-hazardous
munition fragment**

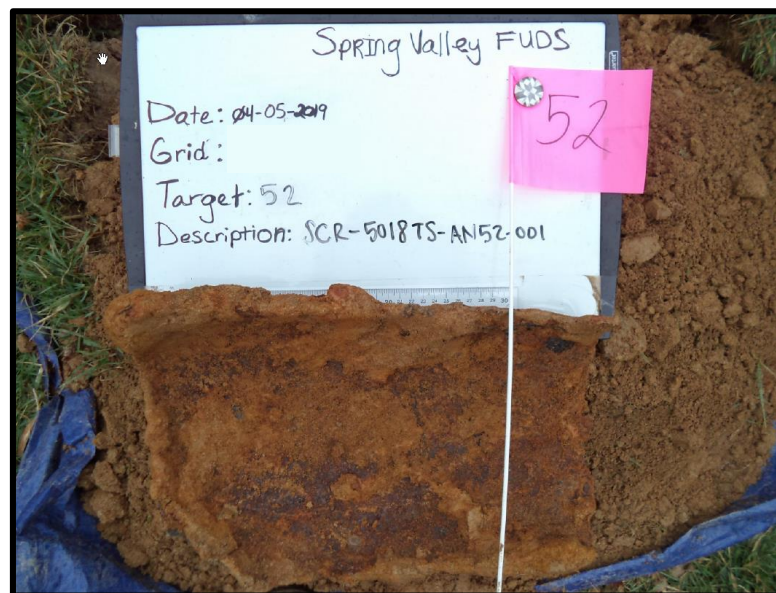
Recovered Munition Debris

Some of the items found are munitions debris (MD), fragments of exploded ordnance. When MD items are recovered, each item is double bagged in plastic bags and transported to the Federal Trailer. Each item is then headspace scanned by Edgewood Chemical Biological Center (ECBC) to analyze for traces of mustard (HD) and Lewisite (L). To date, no traces of HD or L have been detected from the MD items analyzed.

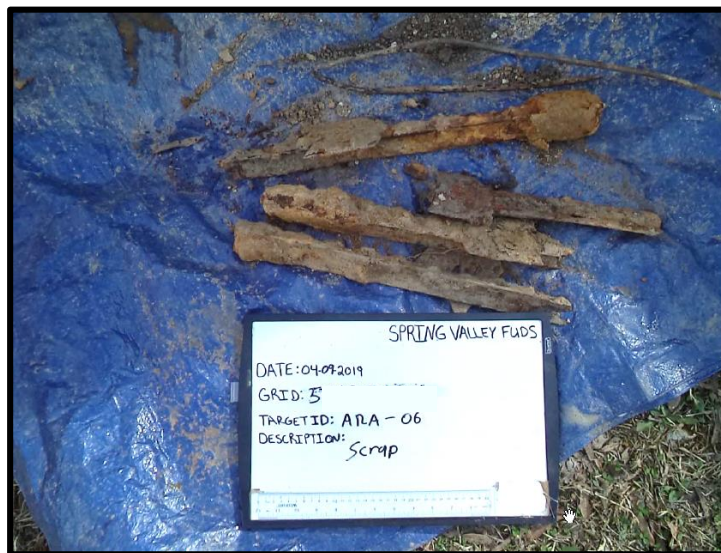
**Non-munition
related scrap
metal**

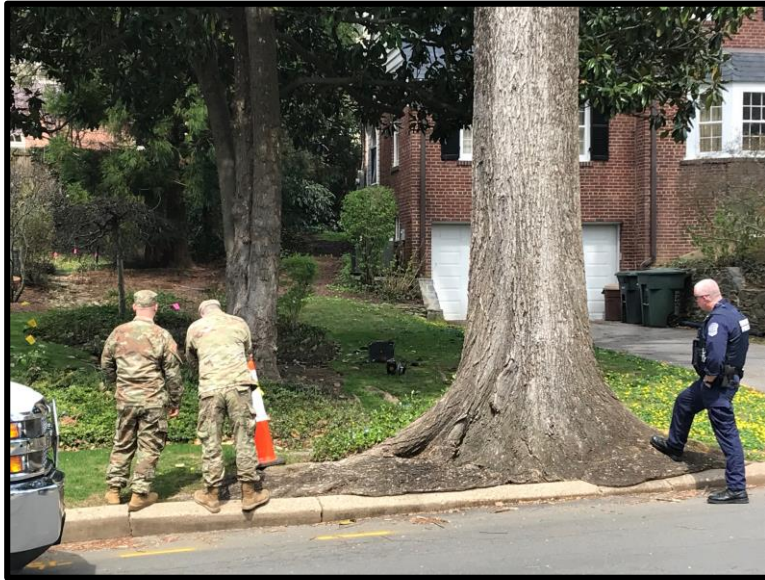
The X-ray helped the Army EOD (Explosive Ordnance Disposal) team confirm that this item was fuzed and filled with shots. Since it's being classified as having an explosive hazard (it was most likely made to detonate upon landing and send the shot out like shrapnel), they removed it from the property and will safely destroy it at Fort Belvoir, VA.

A recovered item was classified as a Civil War era 3.5-inch, smooth bore, 6-lb case shot cannonball. It was found at about 9.5 inches below ground surface.

A recovered item was classified as a Civil War-era, 3.5-inch, 6-lb. case shot cannonball, with fuze intact. Union Civil War gun placements were known to be in the area facing away from Spring Valley, with no known live-fire actions. The cannonball displayed characteristics of a munition item, such as thick walls and spherical shape. Even though the team was not searching for Civil War-era munitions, one of the Unexploded Ordnance (UXO) technicians recognized that the item appeared to be a munition, a type of cannonball with a fuze and a charge inside the item. The team notified the Explosive Ordnance Disposal (EOD) Unit from Ft. Belvoir. EOD responded, x-rayed the cannonball, and confirmed the fuze was intact, the cannonball was filled with case shot, and that the cannonball could have exploded. The cannonball was removed by EOD the same day it was found. The cannonball was likely brought to the site as part of fill material.

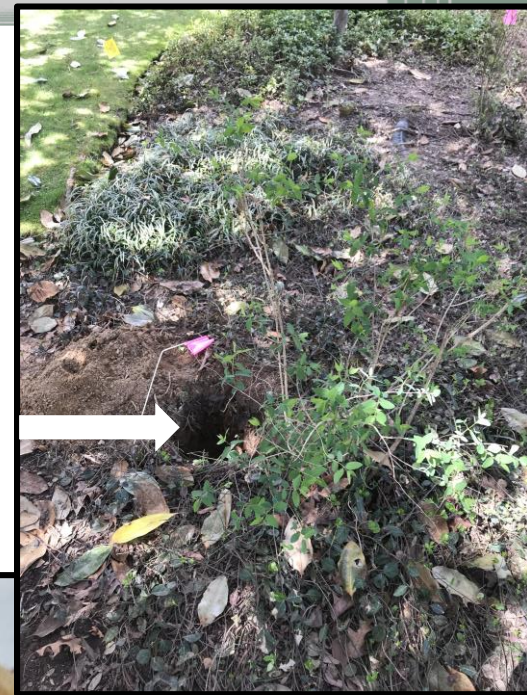
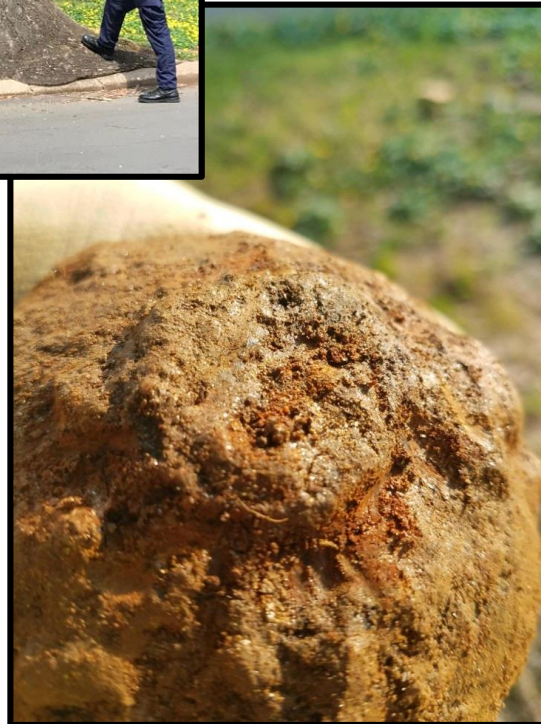
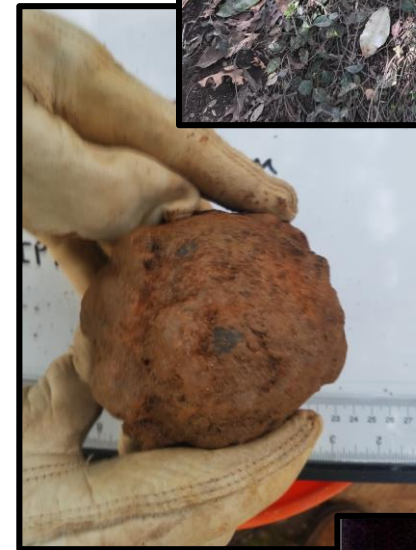
This x-ray image shows a cannon ball LIKE the one found (size, shape, etc).

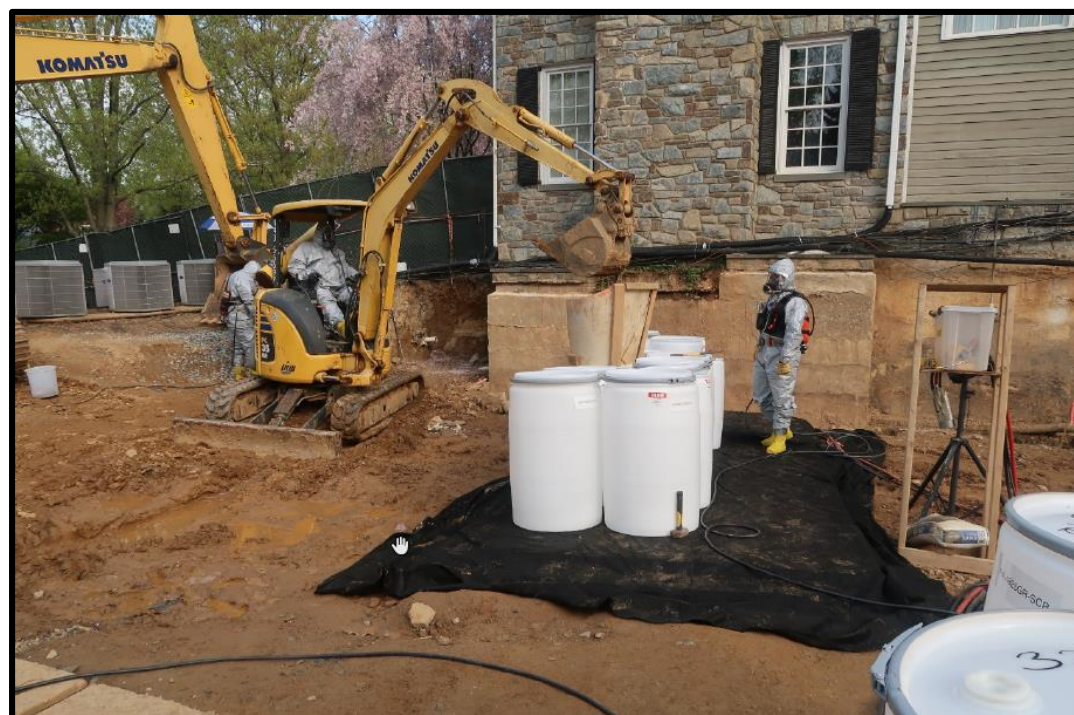
4825 GLENBROOK ROAD – EXCAVATION AREAS

- As a reminder, Areas A and B are the original low probability excavation areas.
- Area C was the area that represented the former Burial Pit 3 efforts; no excavation work was required in this area.
- Areas D, E, and F were the original high probability excavation areas.
- Areas 1-5 and the driveway apron were created to illustrate the extent of remaining work that remained after the August 2017 safety shutdown.

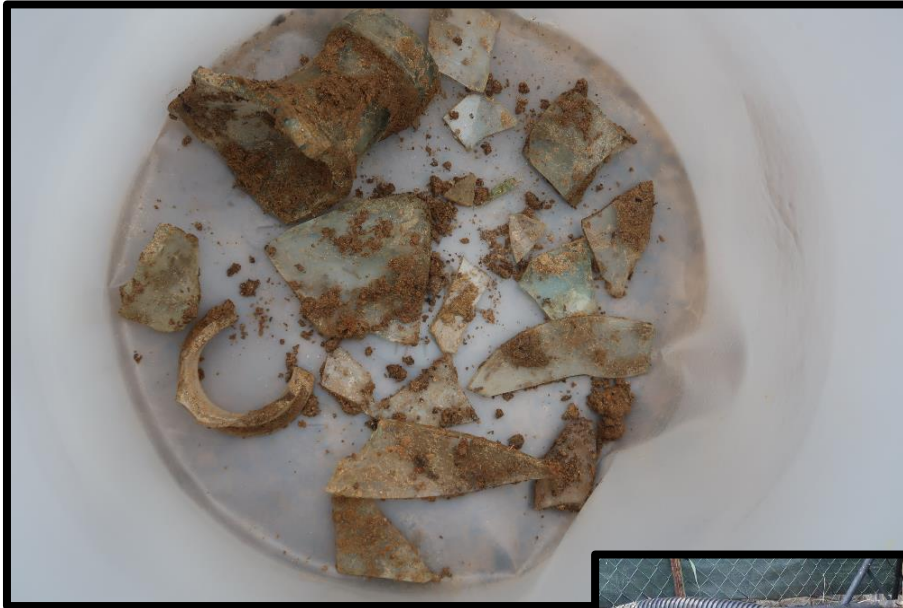
4825 GLENBROOK RD – AREA 2

Due to encountering glassware in Area 2 earlier this year, the team plans to over-excavate this area next month.

**Markers showing where
the broken glassware
was recovered.**

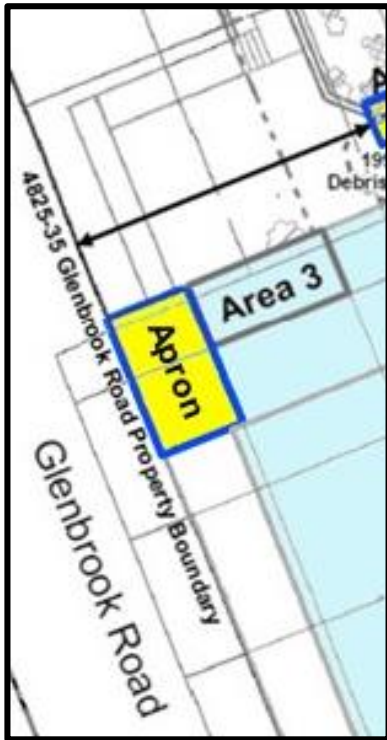
4825 GLENBROOK RD – AREA 3

Backfill in Area 3

The Army Corps' geologist also confirmed that the excavation team had fully reach saprolite during the first round of sampling in Area 3.

Area 3 is in the front portion of the front yard adjacent to where the air conditioning units for 4835 Glenbrook Road were re-located. Area 3 was previously excavated under low probability, and at that time the confirmation samples failed. The team over-excavated the area and collected another round of confirmation samples. The sample results indicate no residual chemical contamination remains, confirming Area 3 is complete.

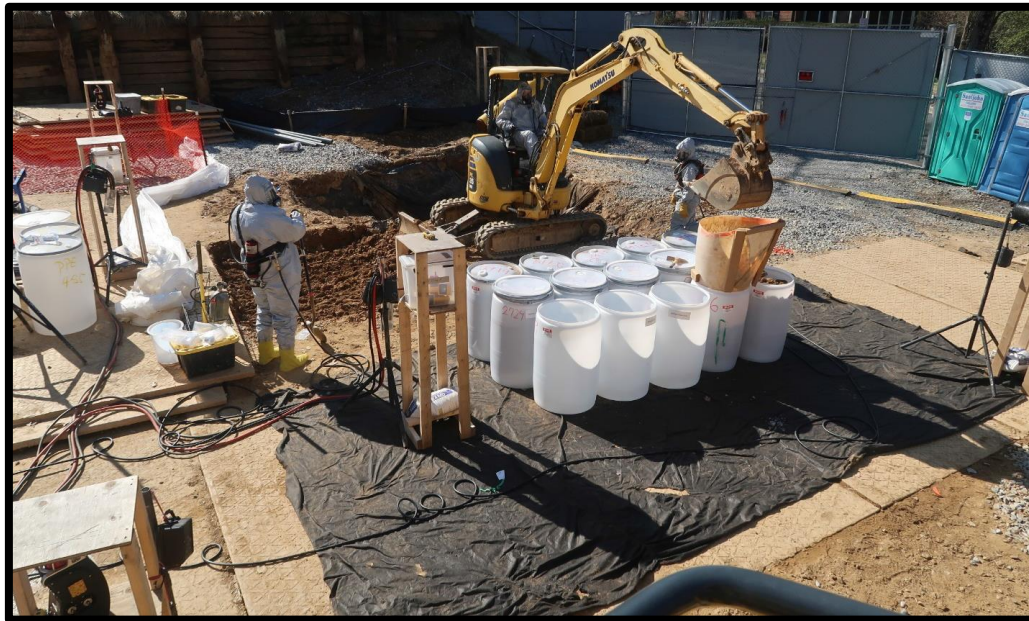
**Area 4 Drum
filling area with
air monitors**

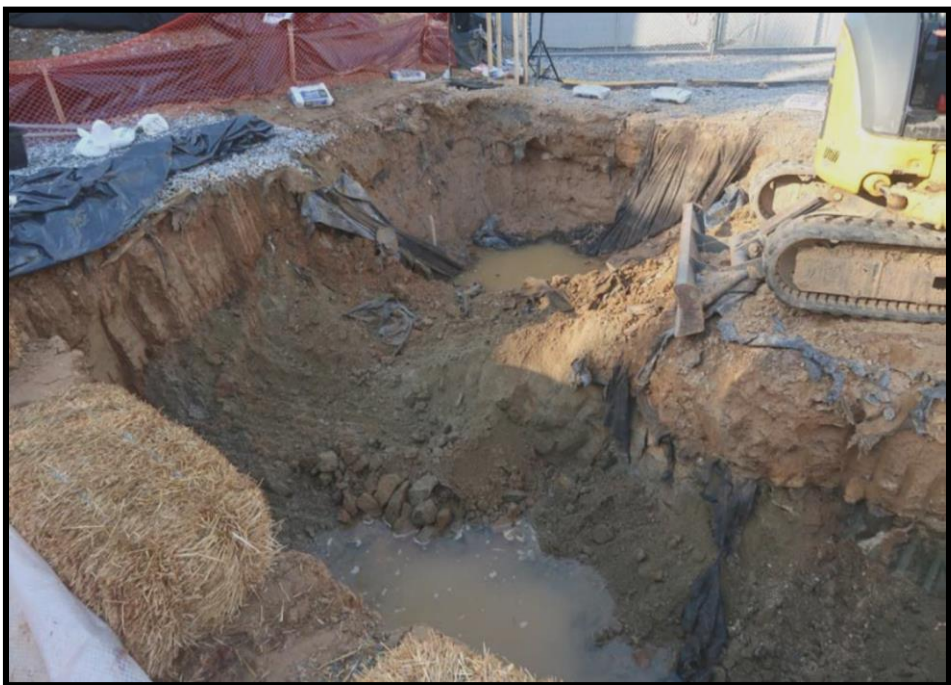
AREA 4 – MARCH 28TH MINICAMS DETECTION

The MINICAMS alarmed again during operations. The alarms were at the excavation and drum loading area. The team immediately stopped work and mitigated the area.

Area being excavated within Area 4 when MINICAMS alarms were triggered (looking southwest towards Glenbrook Rd.)

- The MINICAMS at the drum loading station alarmed during the morning operations at the site.
- There were no other detections or alarms on any of the other downrange instruments or MINICAMS positions
- The soil being drummed was not discolored or unusual. There were no fuel spills.
- Temperature outside was approximately 43°F.
- Lewisite (L) was not detected in any the DAAMS or soil analysis.
- This grid is adjacent to where we previously found an interferent that was being detected as L where Dichloronaphthalene was determined to be a likely interferent.

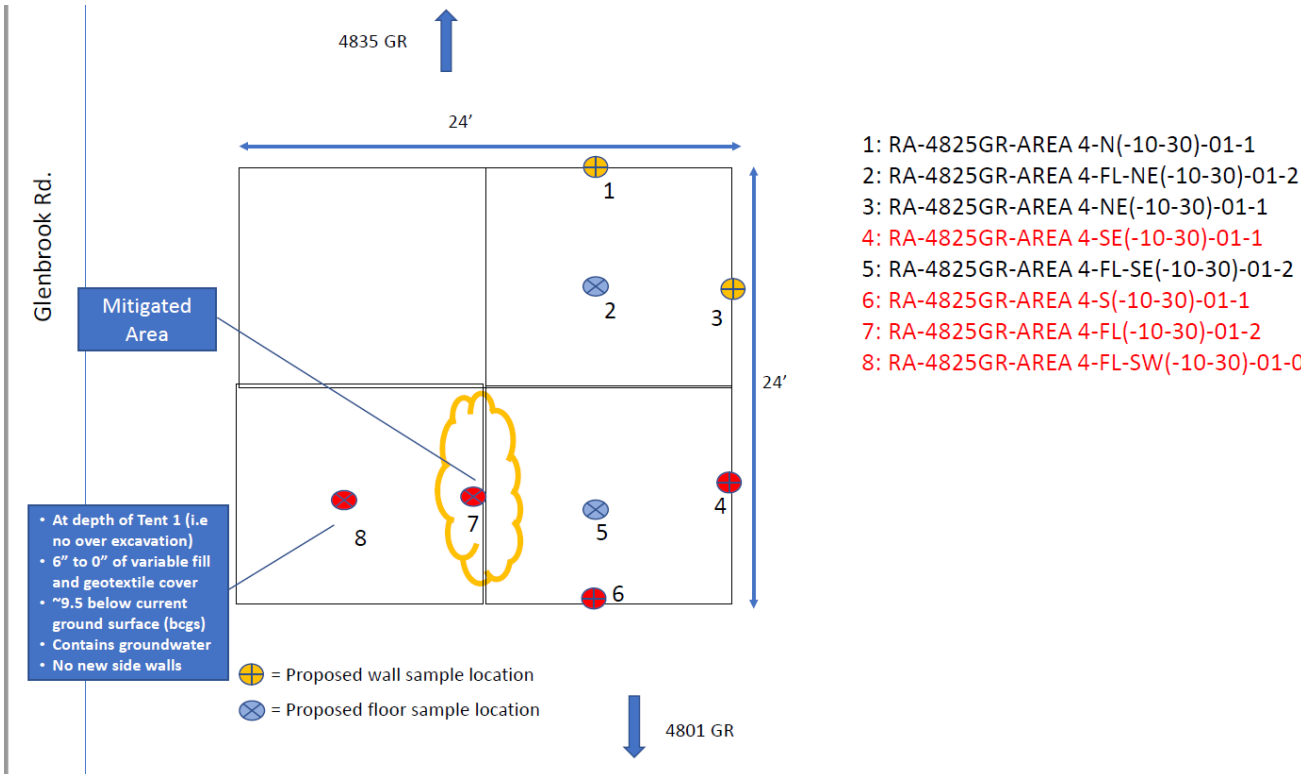
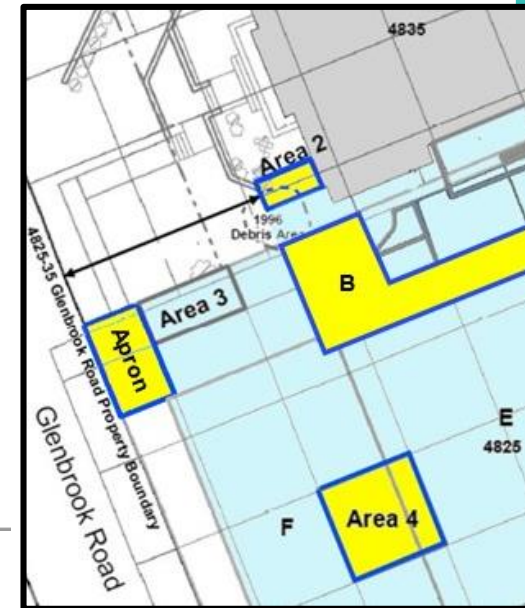
- A total of eight (8) confirmation samples were collected.
- Four (4) samples cleared low level clearance and were sent to our standard commercial lab.
- Four (4) samples failed low level clearance (agent breakdown products detected). The team agreed to send these samples to RTI lab for processing.
- Results are pending.

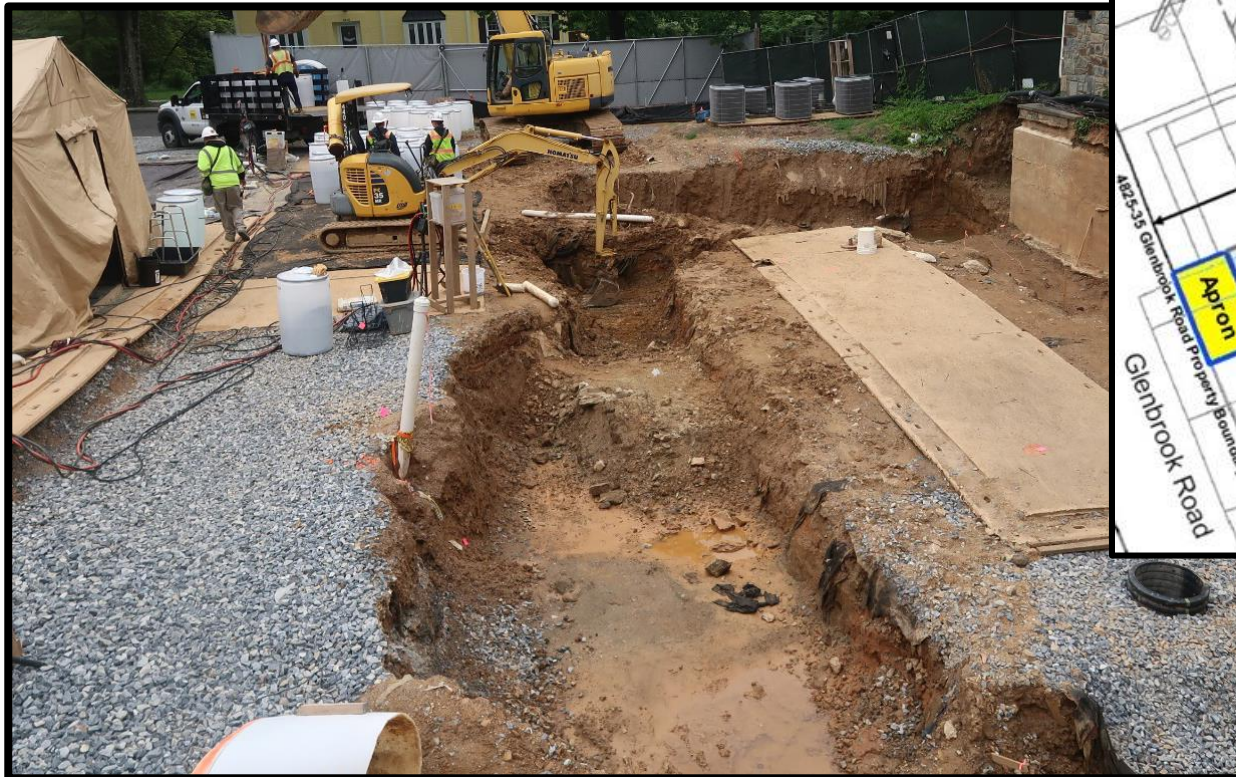
4825 GLENBROOK – AREA B

The crew set up a portion of Area B for further low probability excavation work along the shared property line. Once this excavation work was complete, the USACE geologist confirmed that saprolite has been reached in Area B along the shared property line, and confirmation samples will be taken, when the weather allows.

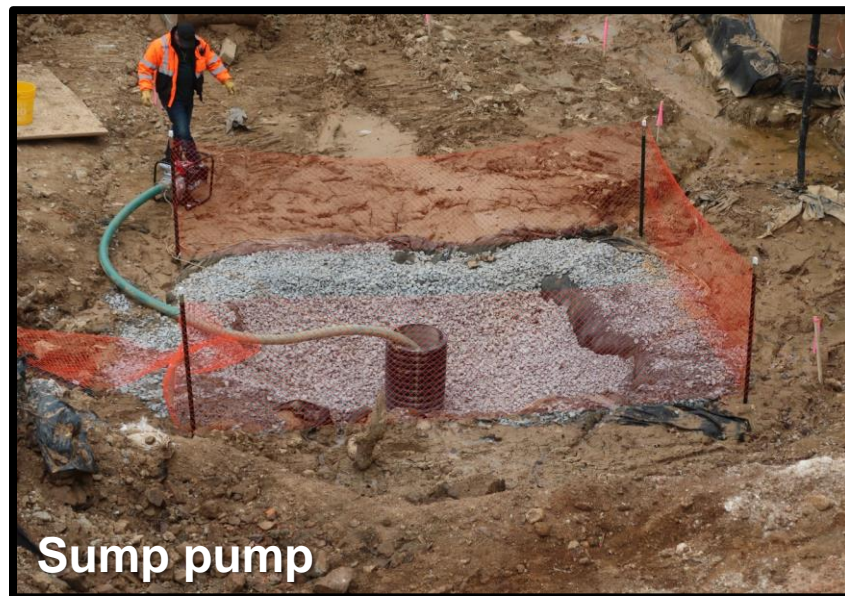
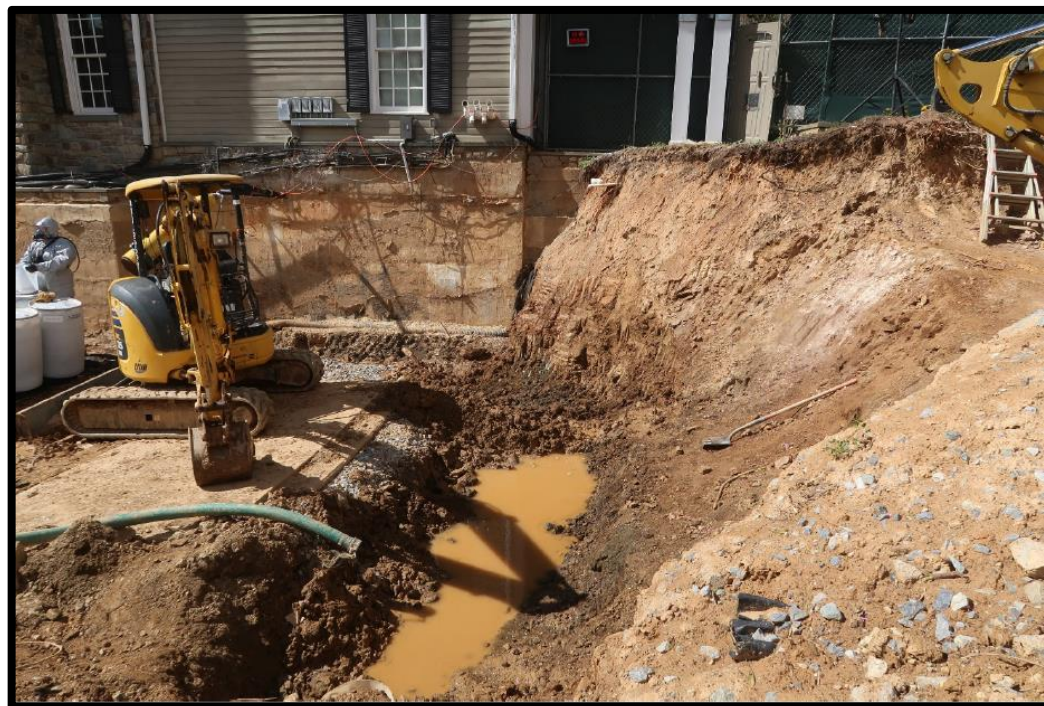
4825 GLENBROOK – DRIVEWAY APRON AND AREA 5

- **The remaining excavation areas, which include the former driveway apron and Area 5, will be scheduled for completion once the work plans are finalized.**
