# SPRING VALLEY FORMERLY USED DEFENSE SITE

Restoration Advisory Board Meeting  
JANUARY 2021

## SITE-WIDE REMEDIAL ACTION (RA)

92 Properties - USACE Updates

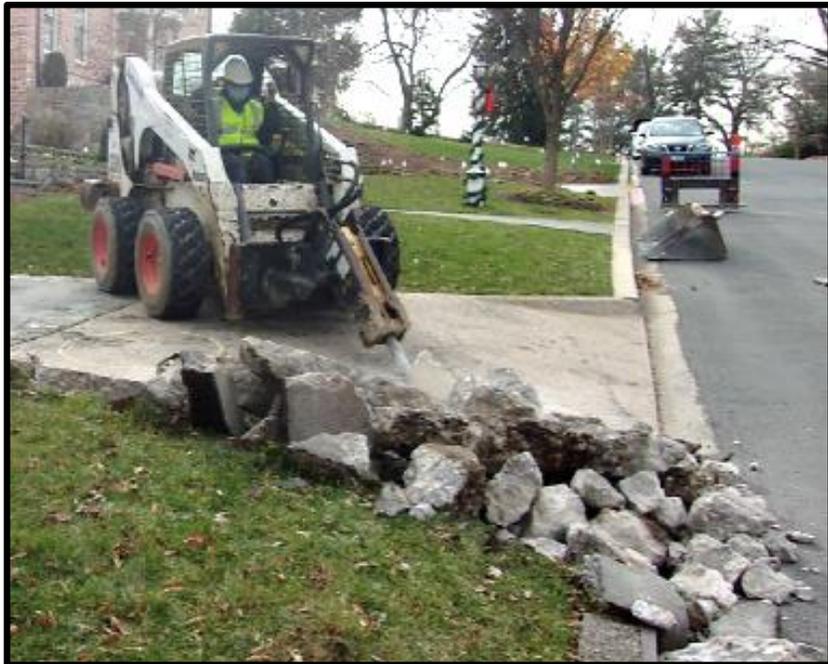
Hardscapes including patios, sidewalks, and driveways are all surveyed during geophysical surveys. If an anomaly is detected under hardscape, a section is removed, the dig team removes the anomaly, and the hardscape is repaired.

***Breaking up a concrete driveway apron to complete the investigation and removal of an anomaly under a driveway.***

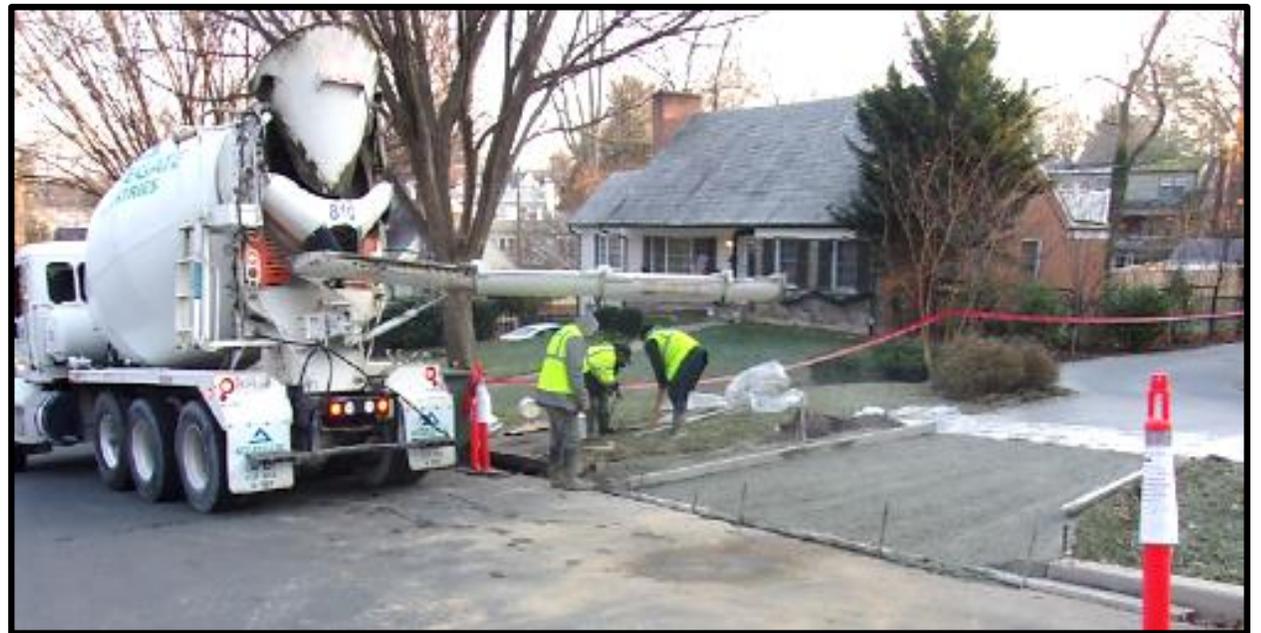
***Crews pouring concrete to restore the driveway apron during site restoration.***

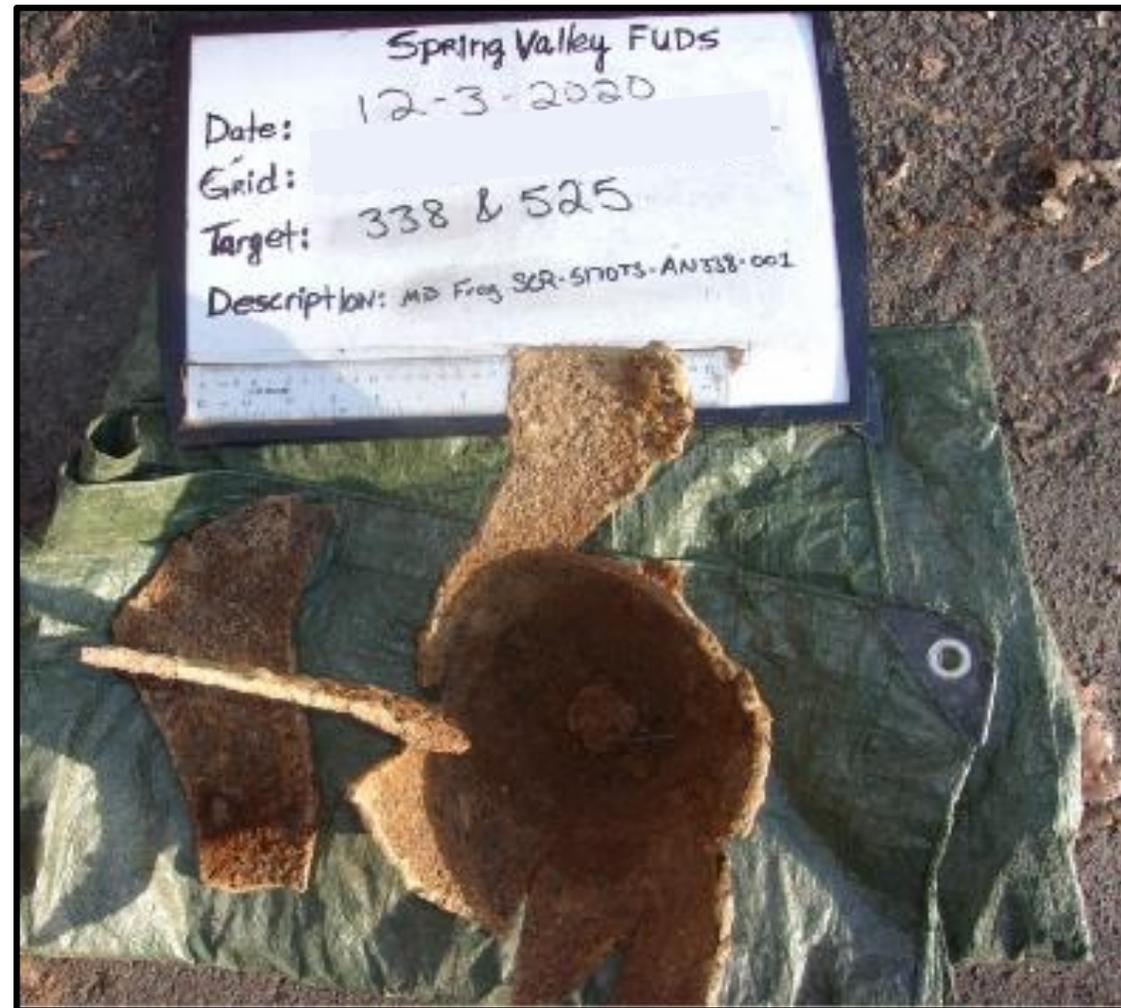
**Recovered Livens fragment**

*During the most recent round of intrusive investigations in December, the team encountered and removed a fragment of a livens projectile with an empty burster tube on Tilden Street.*

- The item was removed from the property and a head space analysis was performed. There were no chemical agents detected in that analysis.

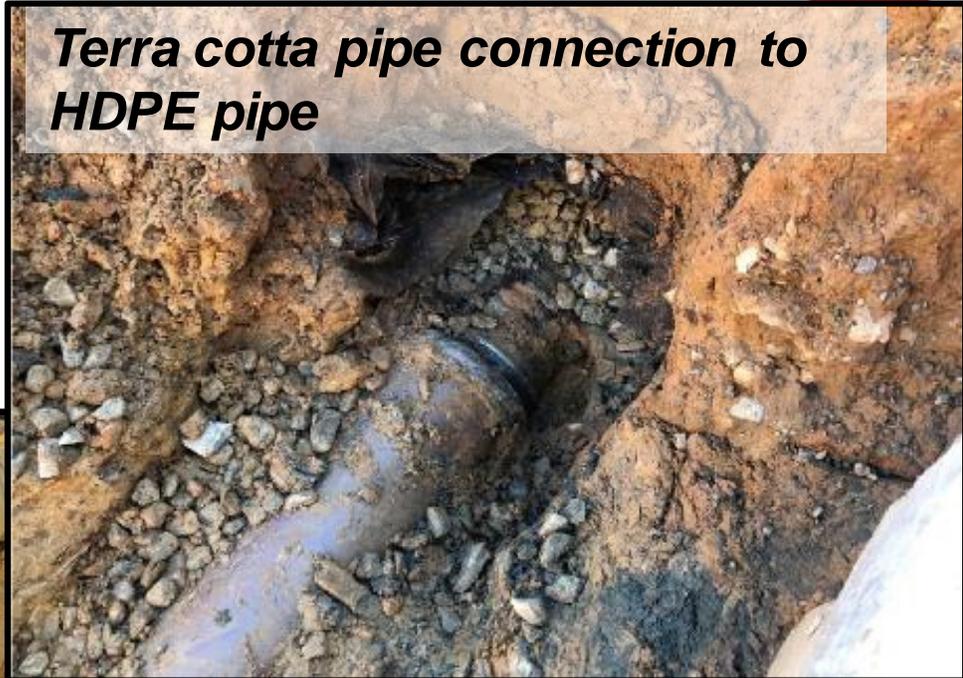
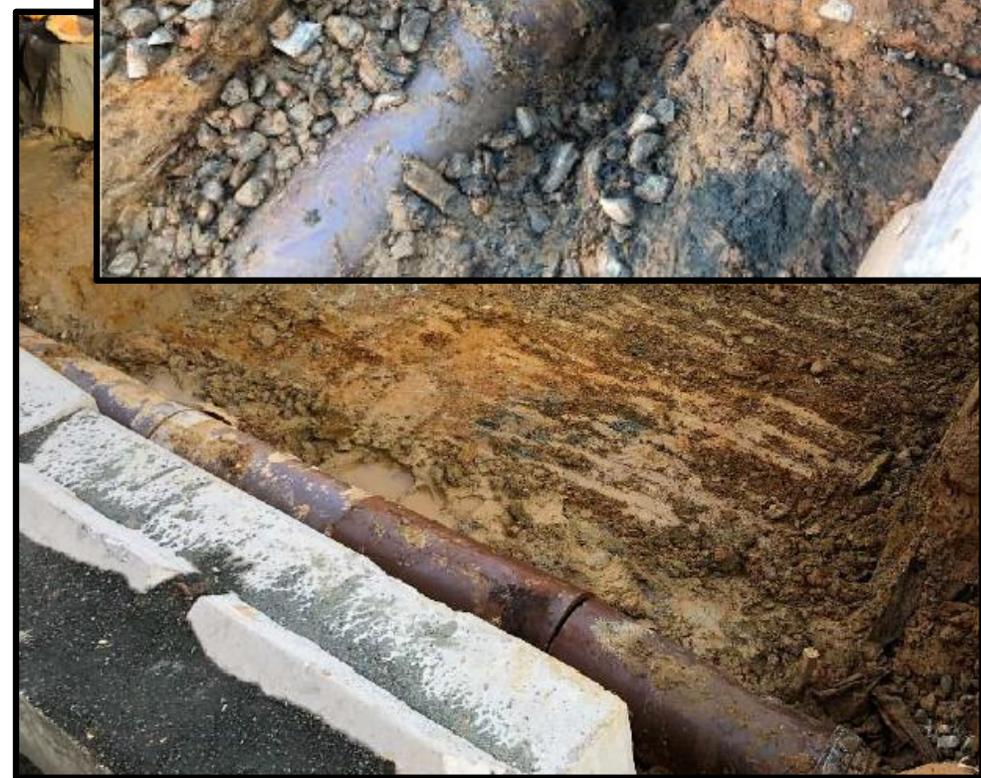
- The team continued excavation efforts to the final boundaries in each grid cell of the PSB excavation area. The team continues to encounter small amounts of lab-grade glassware, as the excavated material is transferred to the sorting table, processed, and transferred off-site for analysis and disposal.
- A terra cotta drainage pipe was encountered during excavation efforts and was connected to a High-Density Polyurethane (HDPE) pipe previously installed by Parsons. A section of the terra cotta pipe was removed and the excavation down to the final 8-foot depth completed in grid cell F3. The replacement of the terra cotta pipe with HDPE pipe is planned for the remaining section in grid cell E3.

***Terra cotta pipe removed from Grid Cell F3***

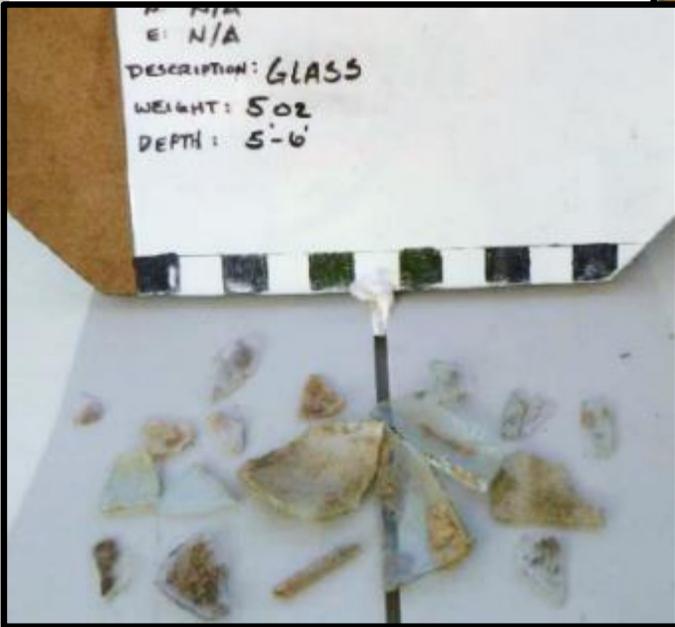
**Batch glass collected at 5-6 feet Grid Cell F-3**

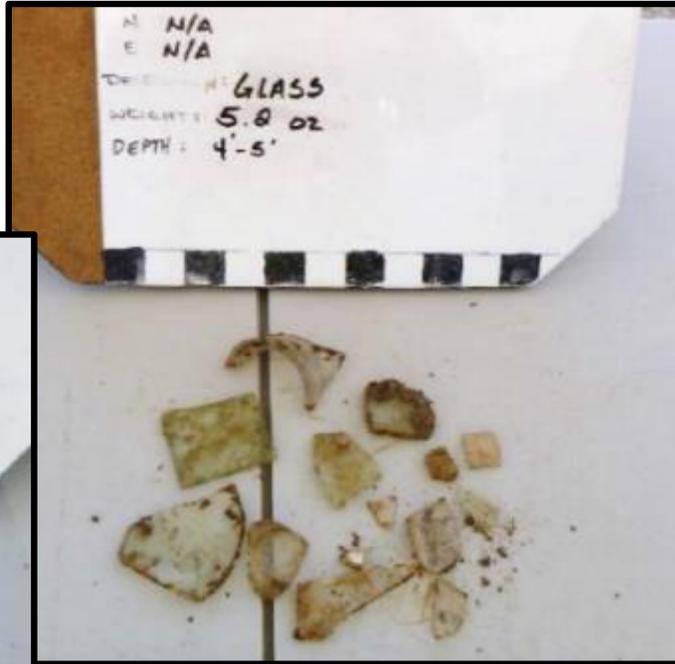
**Batch glass collected at 4-5 feet Grid Cell F-3**

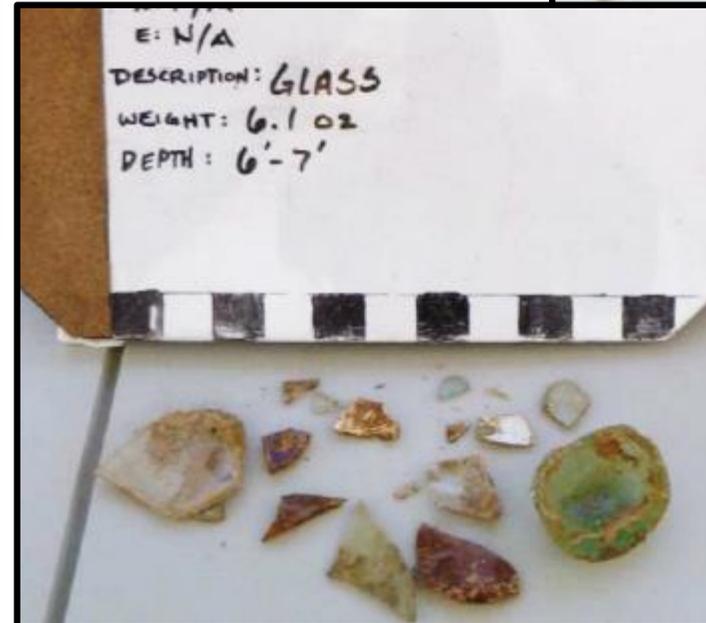
**Batch glass collected at 6-7 feet Grid Cell F-3**

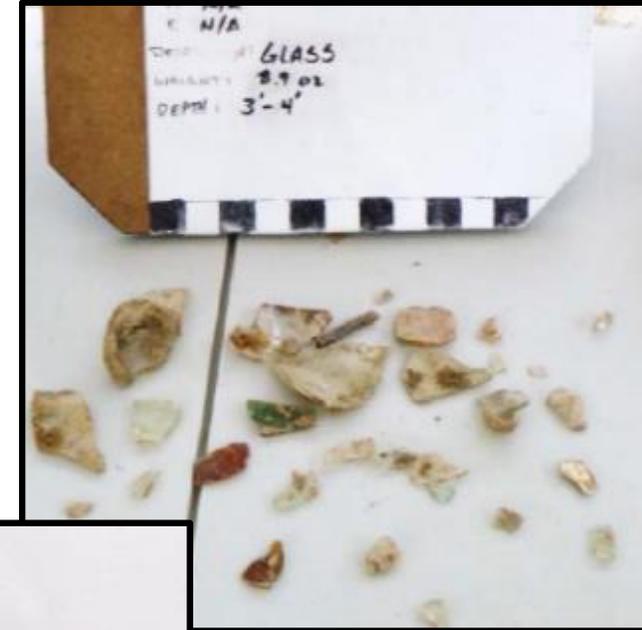
**Batch glass collected at 3-4 feet Grid Cell F-3**

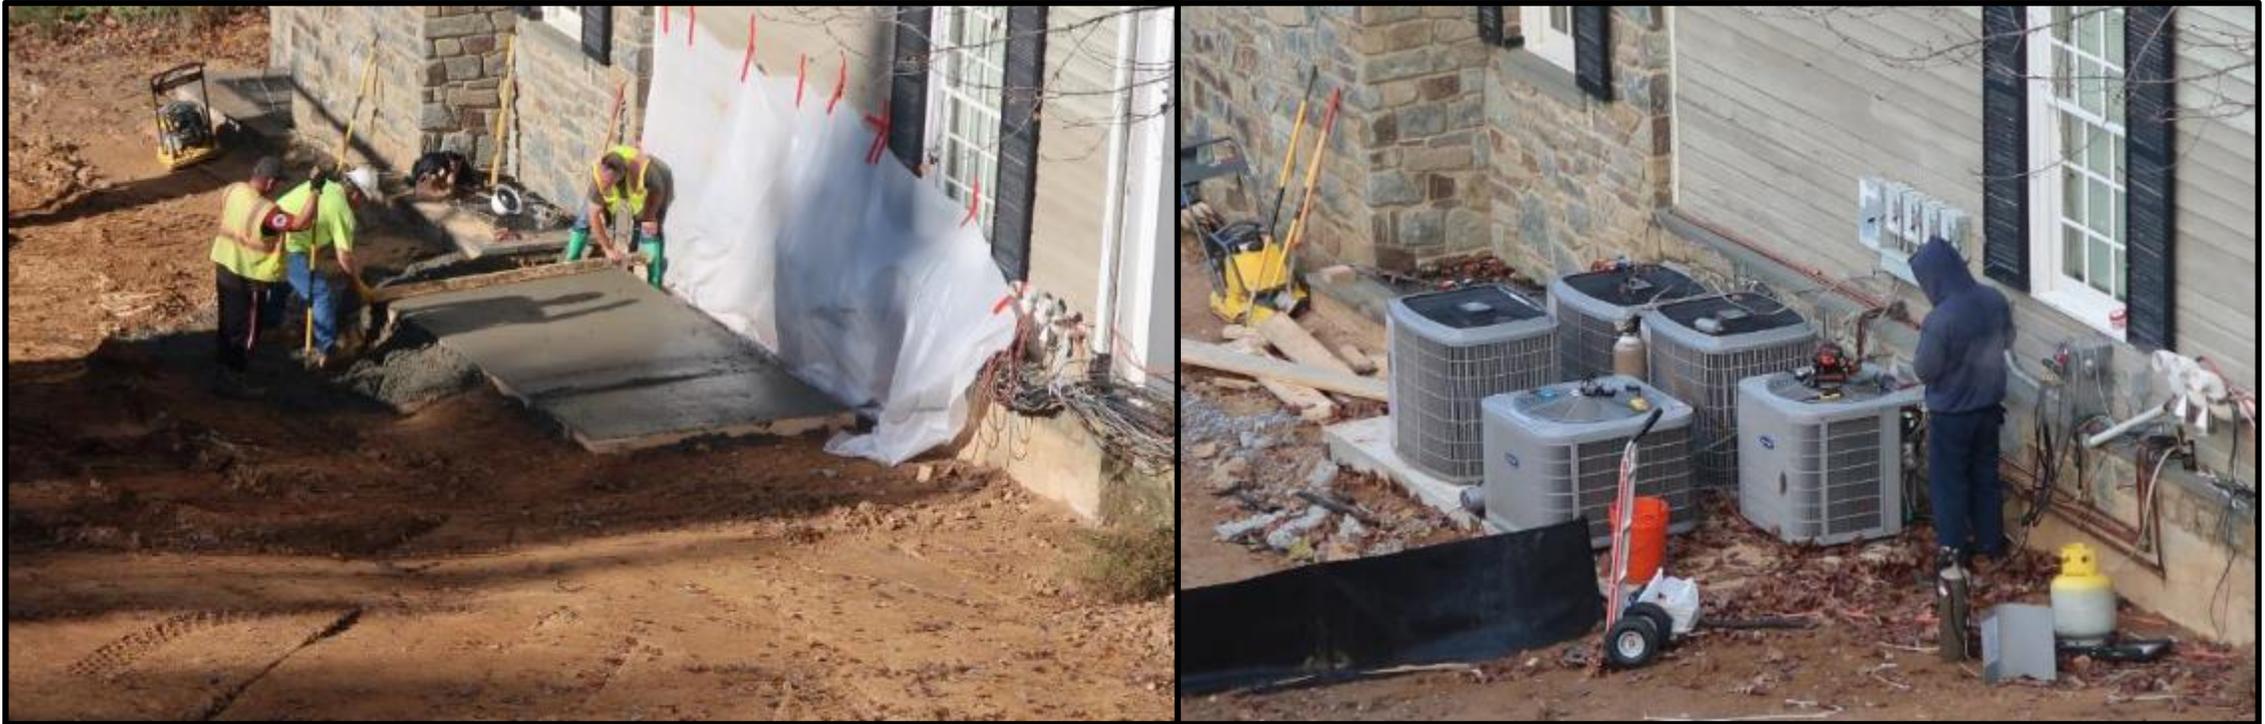
In mid-November, the team built a concrete pad and re-established the exterior air conditioning units servicing 4835 Glenbrook Road.

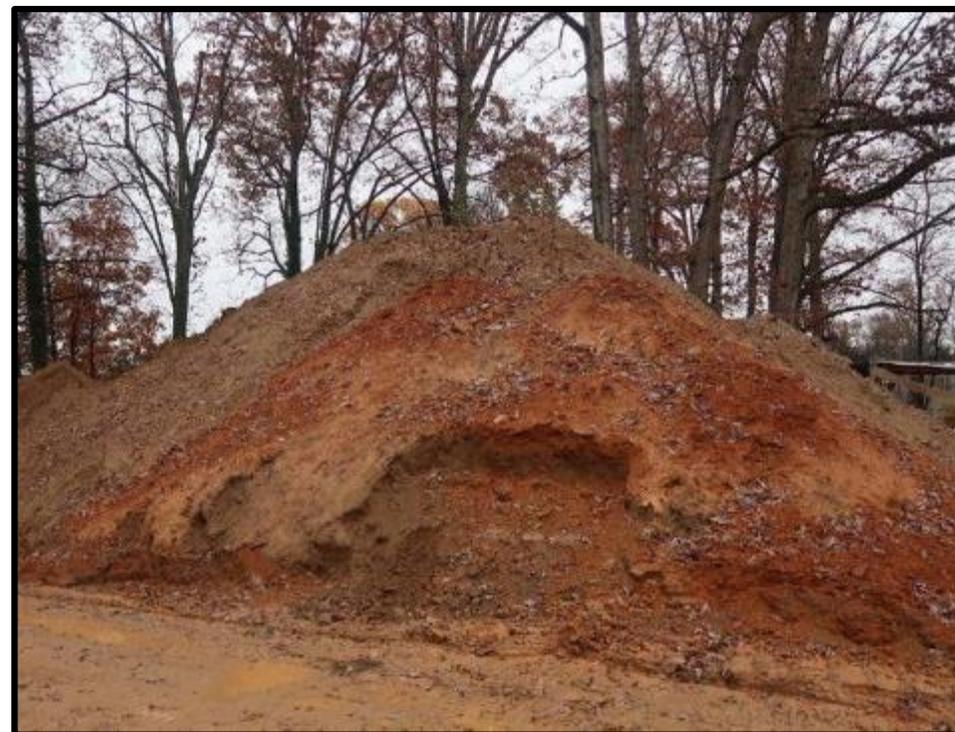
The backfill source sampled in late October was found to contain concentrations of elevated metals, and therefore was not acceptable.

On November 11<sup>th</sup>, the USACE contractor located and sampled a new source in northern Virginia. This sample analysis was good and the backfill source was approved by the USACE and the Partners (USEPA and DDOE) on November 30<sup>th</sup>.

**Soil sample was taken from the new backfill source in northern Virginia**

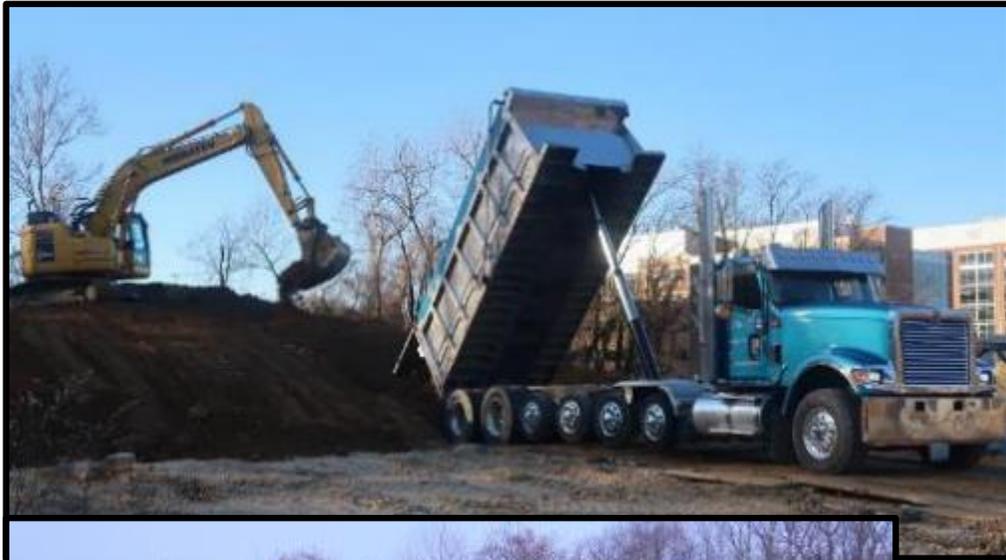
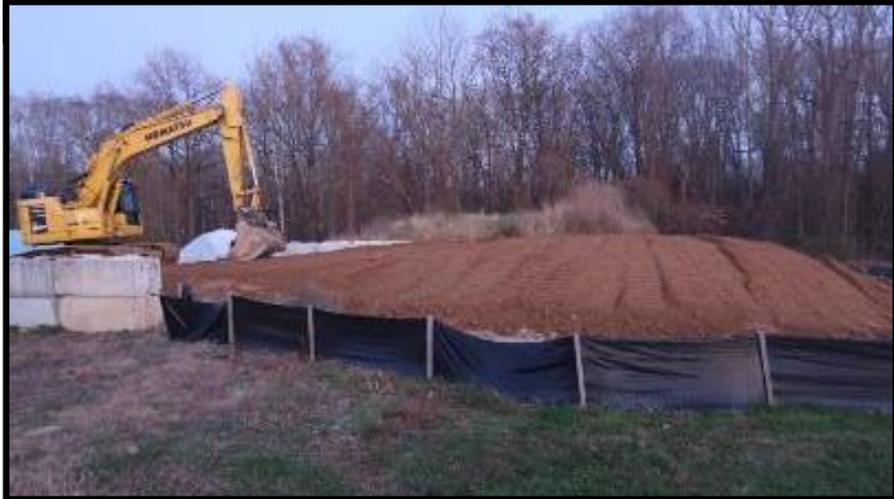
Backfill being brought to the Federal property and stored at staging area.

Once the soil was approved, transport of the new backfill from the northern Virginia site to either the Federal Property for staging or to 4825 Glenbrook Road site for placement was a daily focus in December and included working on Saturdays when weather allowed. Although there were some winter weather delays in December, the team utilized the expanded soil staging area at the Federal Property, transporting over 400 truck loads in December, obtaining all the backfill needed for site completion.

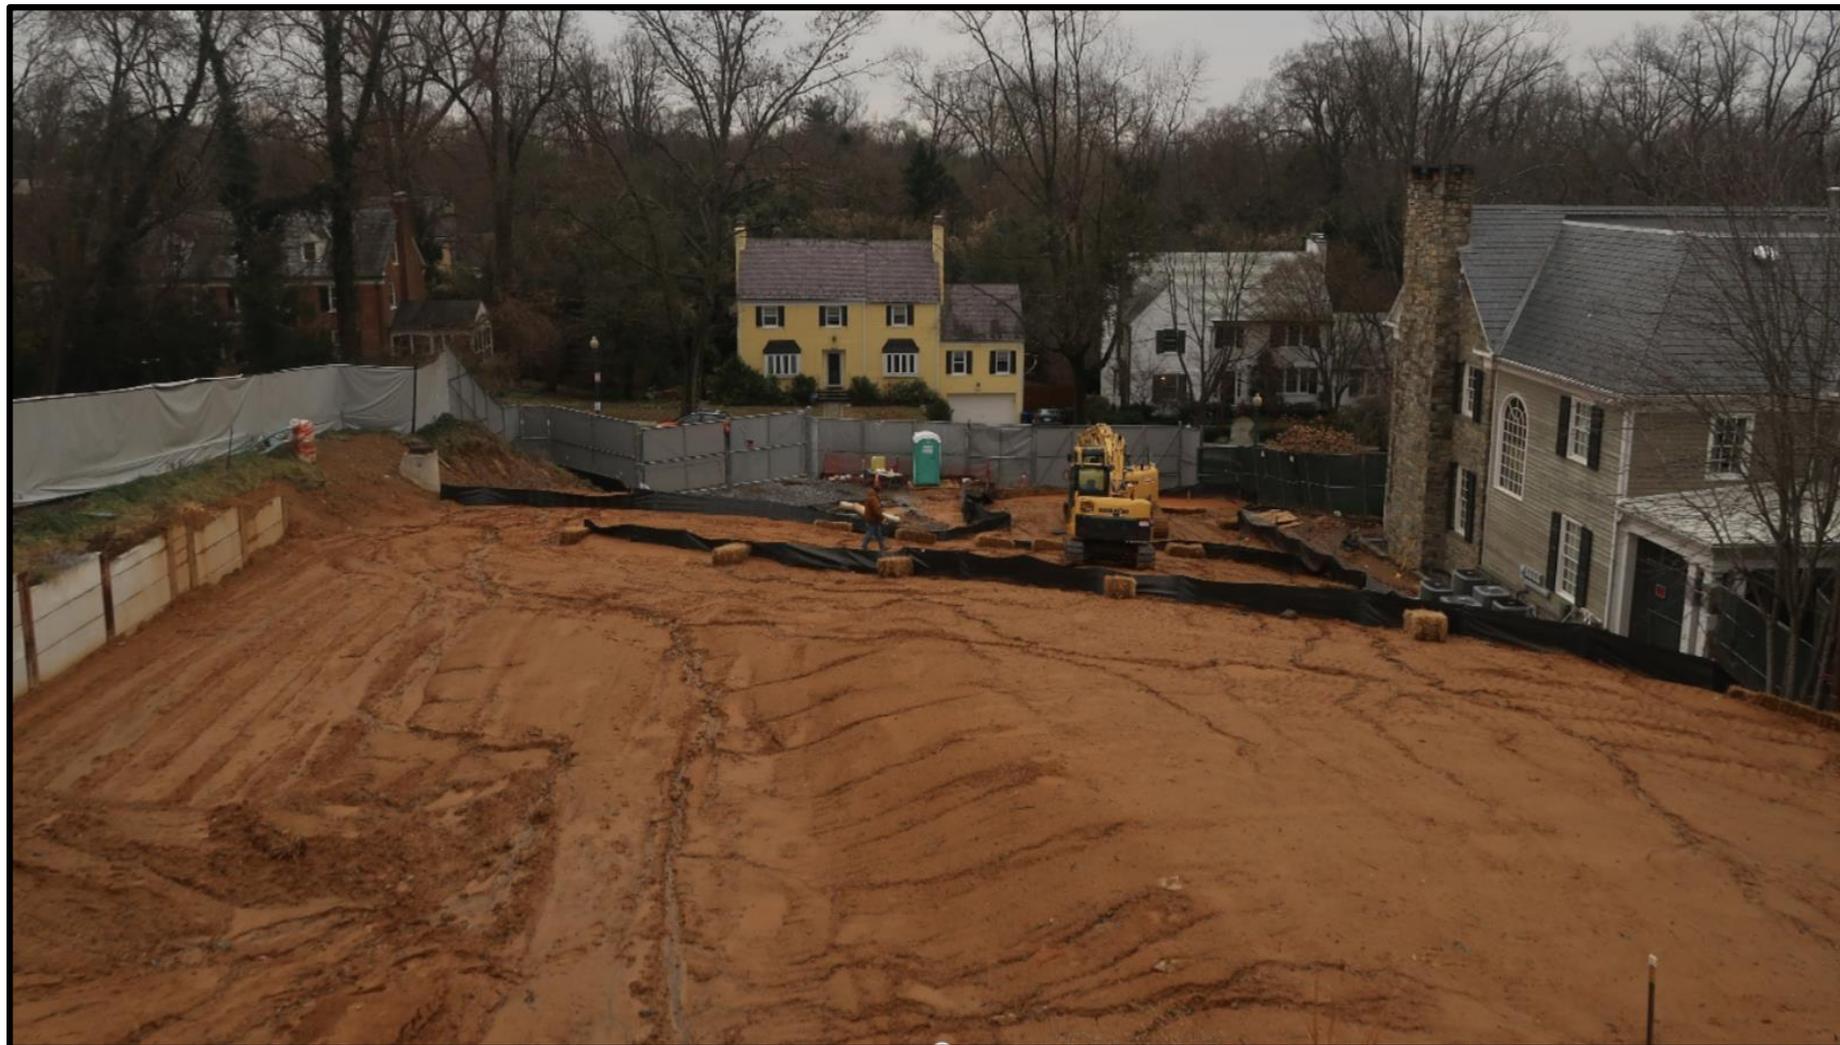
As of this week, the backfill and soil compaction operations are 43% complete.

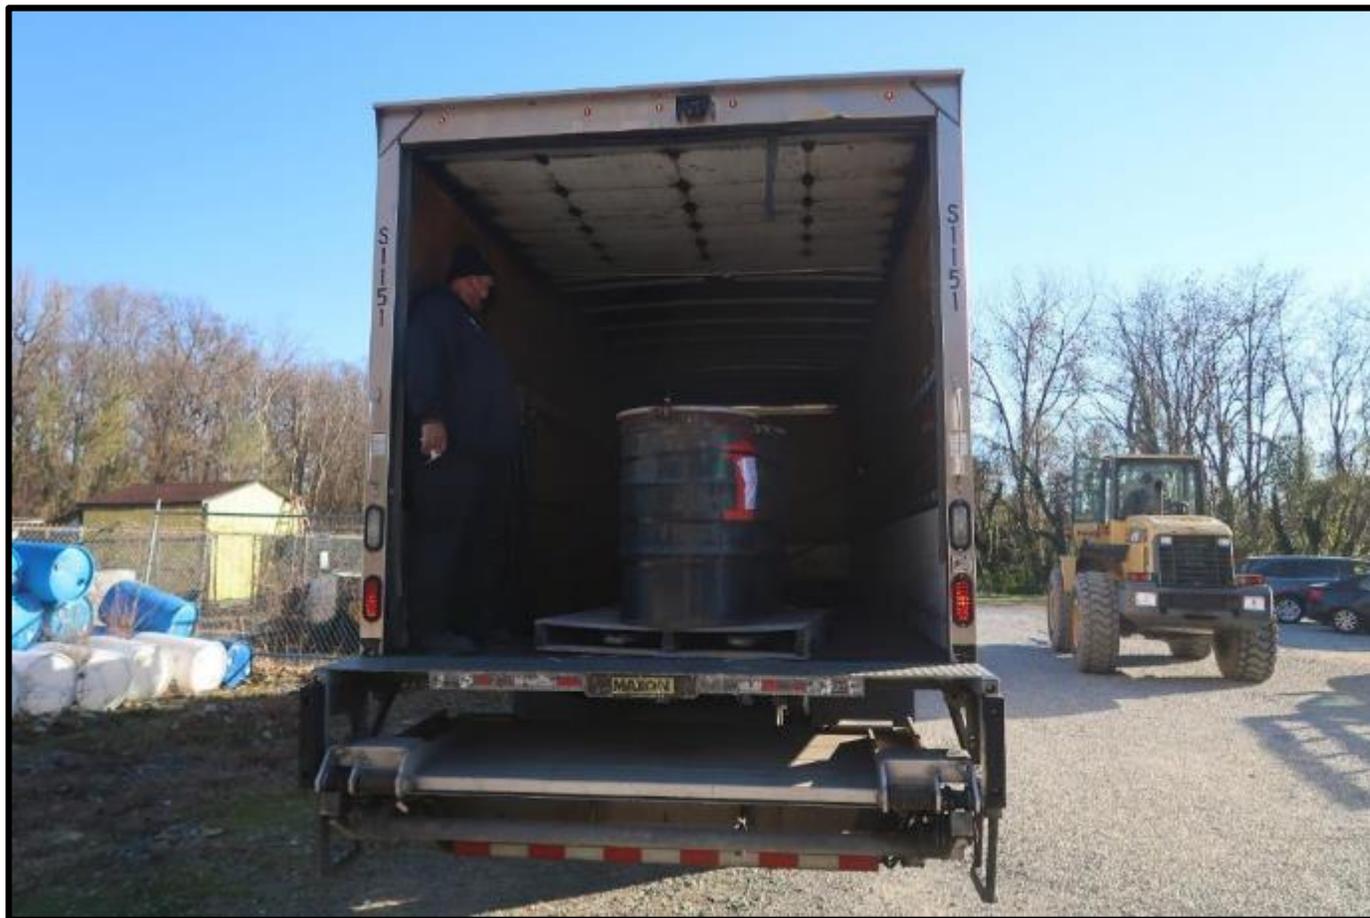
Loads of scrap metal/ munition debris was loaded and transported for disposal.

The team shipped off a load of munitions debris scrap to the smelter on November 18<sup>th</sup>.

The team discussed options on how to potentially treat and transport the remaining munition related waste stored at the site, including 12 intact munitions debris items.

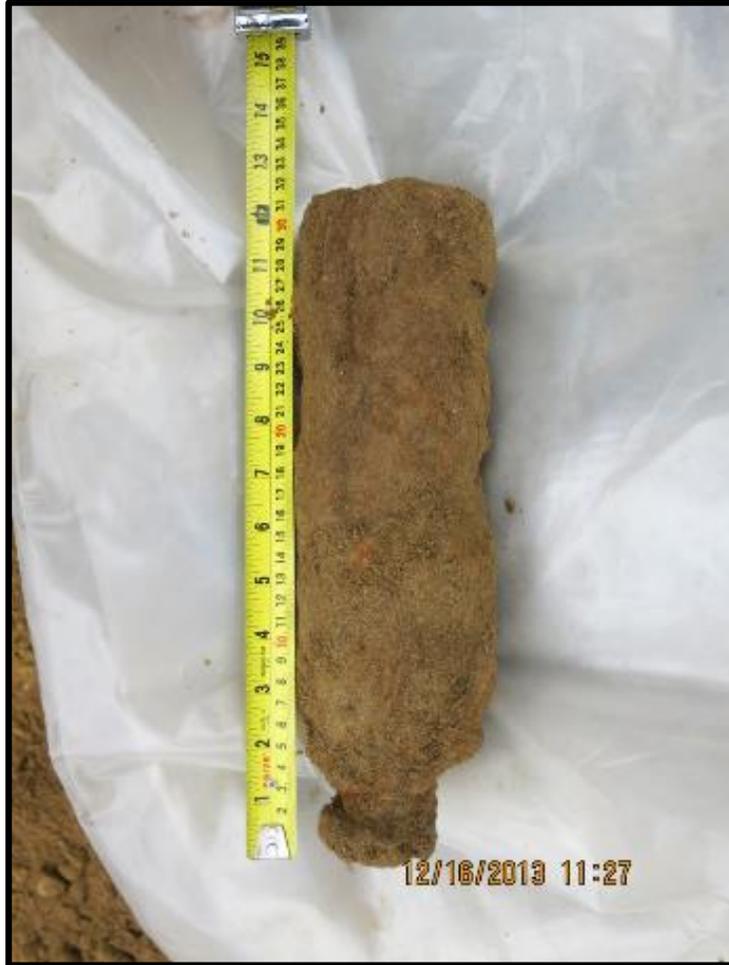
**75mm intact munitions debris item.**

- The small amount of munitions debris, which has been in storage at the Federal Property, needs to be cut up before it can be transported for disposal.
- The team will use a remotely operated saw to cut them in half. This will take place inside an Engineering Control Structure (ECS) at the Federal Property. This is scheduled to take place during the last week of January.

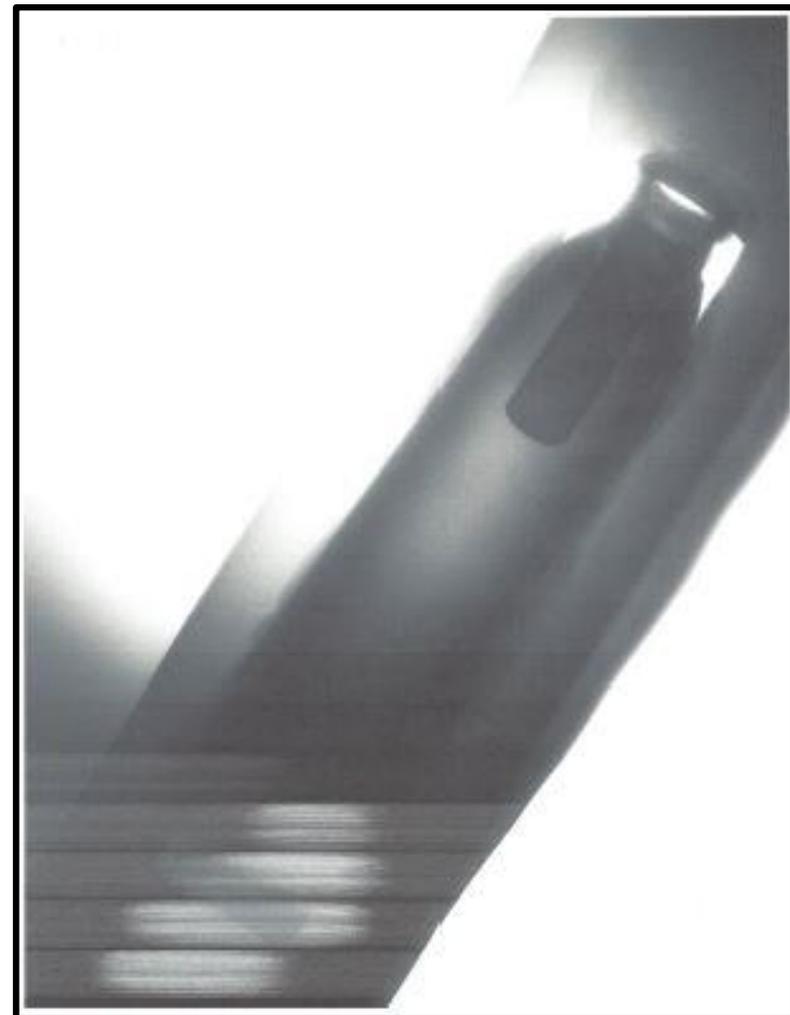
Our Explosive Ordnance Disposal (EOD) safety experts have determined that the items are empty, and there are no explosives present. The team will use a remotely operated saw to cut the items in half. The items will then soak in a bleach solution, be rinsed and allowed to dry, then undergo a headspace analysis and be sent for recycling.

***X-rayed 75mm with no fill inside***

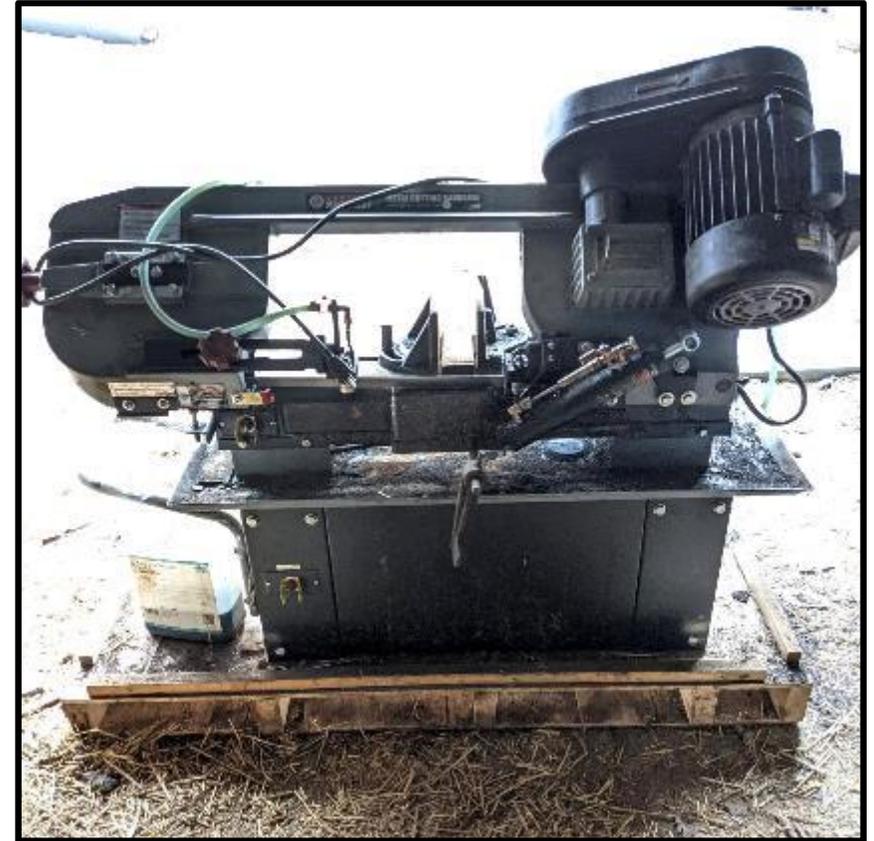
- The cutting operation will take place in a filtered Engineering Control Structure (ECS) with near real-time air monitoring (MiniCAMS). The team has all safety distances needed at the Fed Property for this operation, but will use an ECS out of an abundance of caution.
- The operation will take place in the Interim Holding Facility (IHF) compound so no map or diagram can be shared as we don't publicize the exact location of the IHF.

*A remotely operated saw*

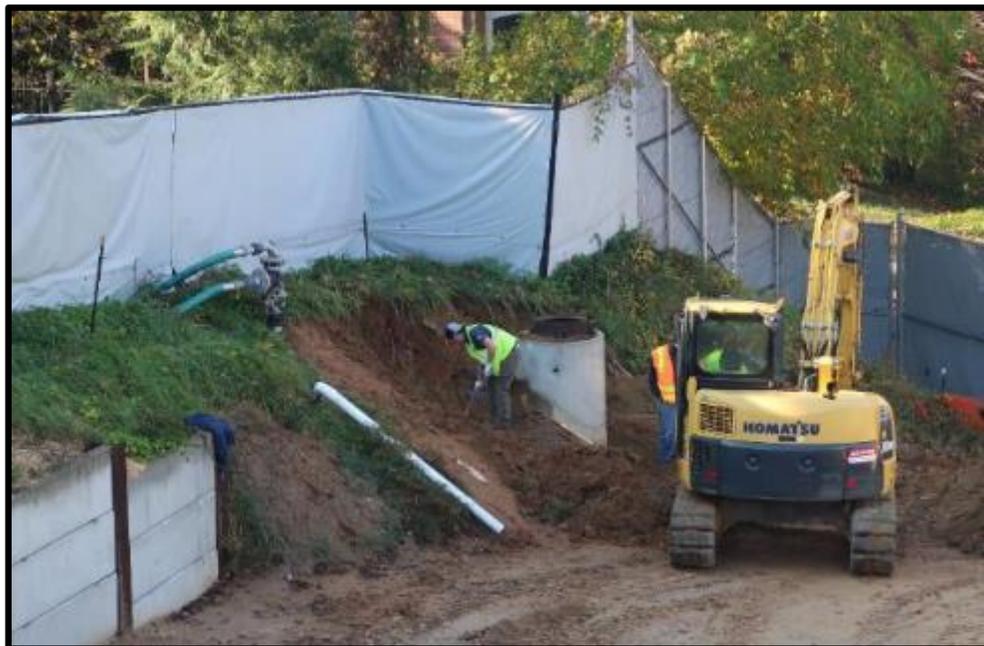
**AU contractor repairing sewage line related to Kreeger Hall, in November.**

Bring site to grade for AU water and sewer installation, including:

- Re-install AU water line
- Re-install AU sanitary sewer line

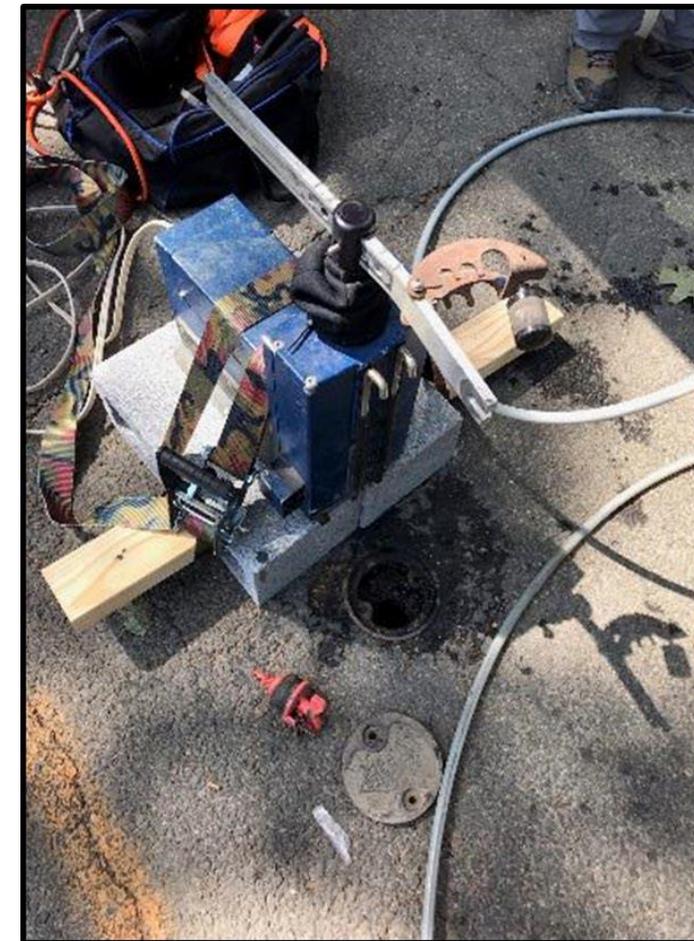
- The Army Corps plans to conduct one more round of groundwater sampling in the Spring at Kreeger Hall where Perchlorate concentrations were above 15 ppb. Sampling will only be done for Perchlorate to confirm if concentrations are steady or decreasing at that location.
- Further details and sampling dates will be confirmed closer to the Spring.
- As a reminder, Arsenic results were below the 10 ppb MCL for two consecutive sampling events and no further action is required for Arsenic.

***Groundwater sampling well***
