SPRING VALLEY FORMERLY USED DEFENSE SITE

Restoration Advisory Board Meeting
July 2020

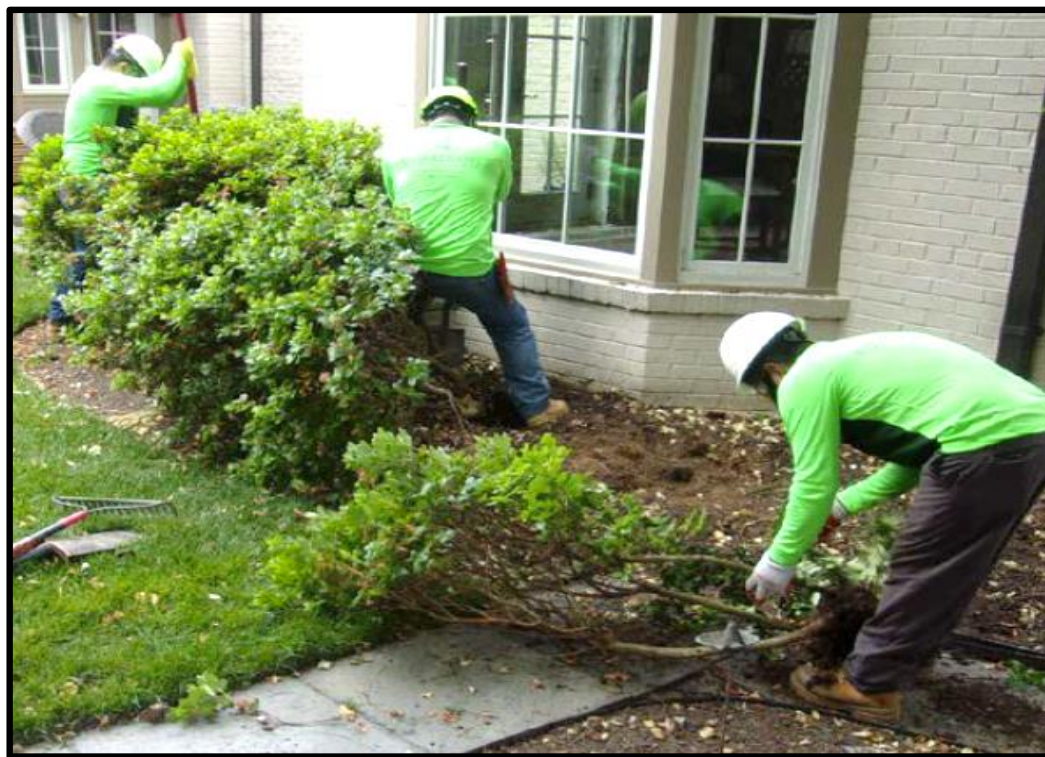
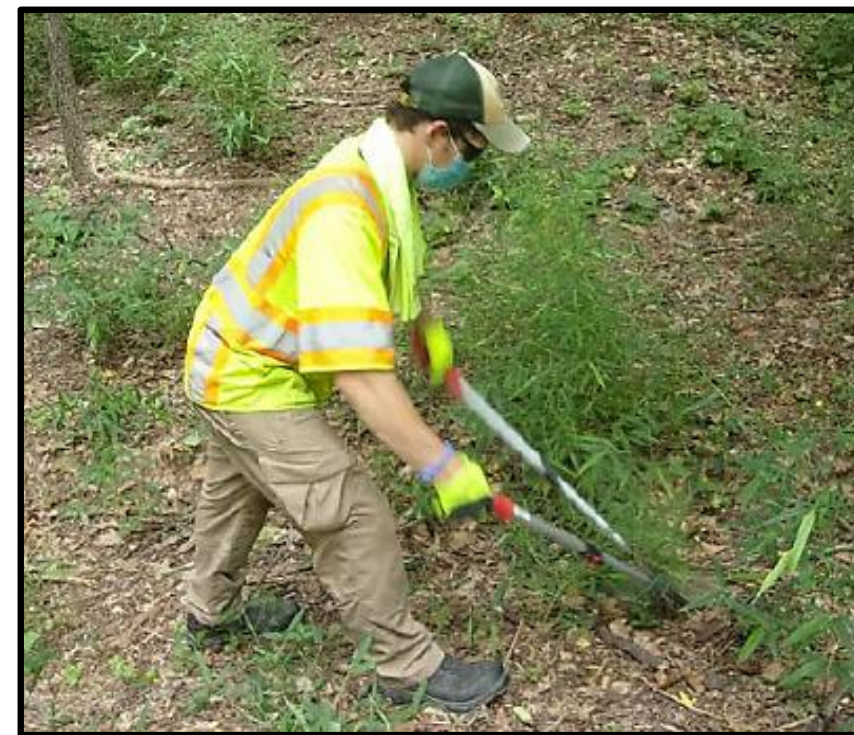
The team continues to work with homeowners to approve of their landscape removal plans.

Once the plans are approved by the homeowners and the Army Corps, the approved plants are removed in preparation for the geophysical surveys.

The team carefully conducting vegetation removal

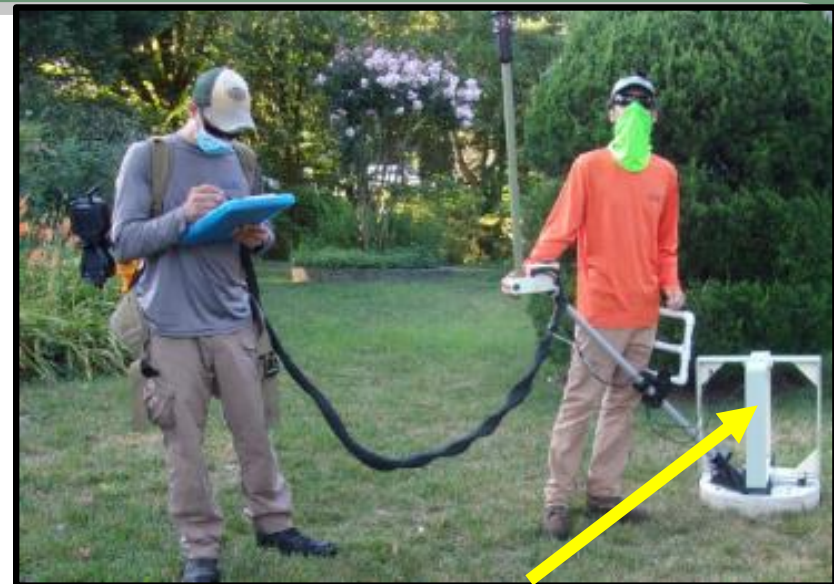
Geophysicists conducting Dynamic and Cued surveys to characterize metallic anomalies (metal) underground with the Man Portable Vector (MPV) at another group of residential properties.

Surveying with the MPV with an additional attachment in Cued mode

After the Dynamic surveys are complete and that data has been processed, the team begins the MPV survey in Cued mode.

The Cued survey collects data for each detected anomaly in order to help the team characterize the metallic anomalies and create a dig list.

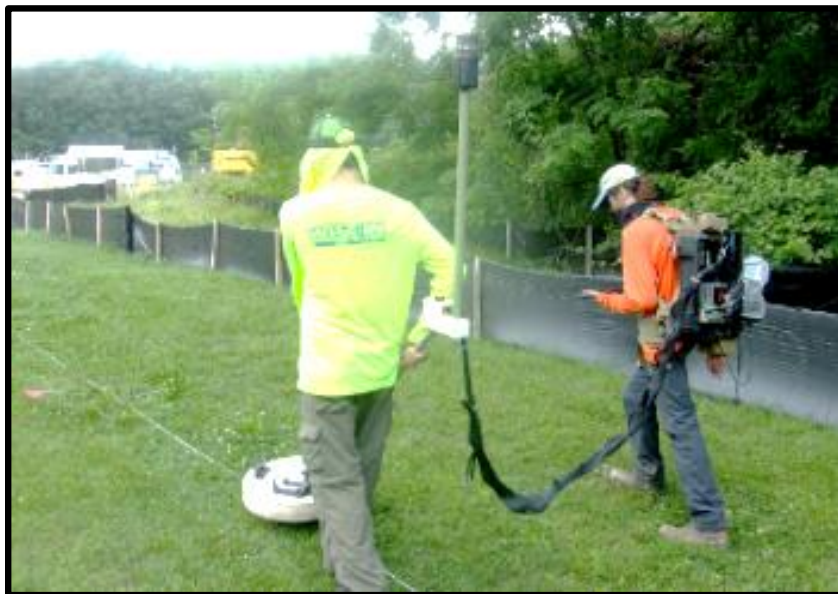
The team routinely conducts Quality Control (QC) function tests of the G-858 and MPV (Man Portable Vector) survey equipment.

These tests act as an additional assurance check on the geophysical survey data being collect by the survey team.

Function test with the MPV

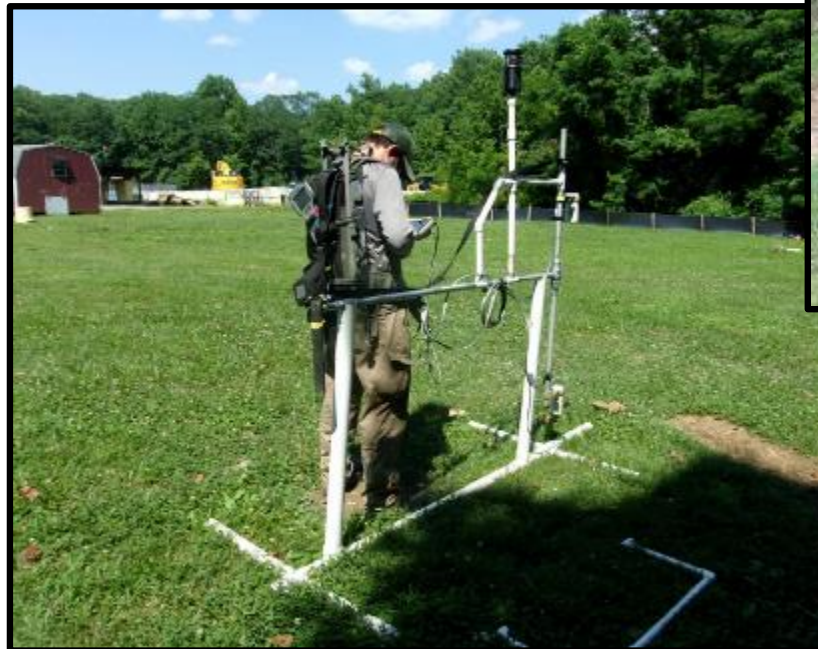
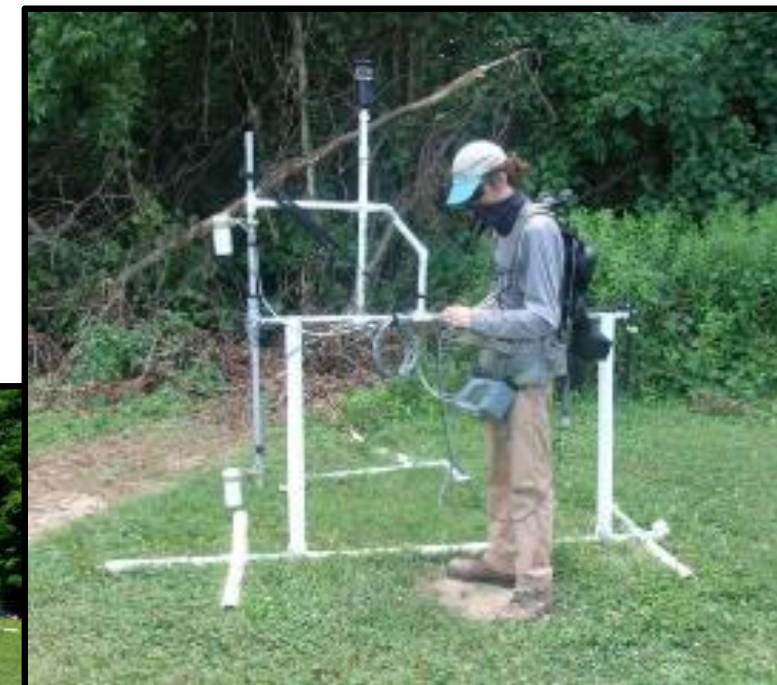
Function tests with the G-858 magnetometer

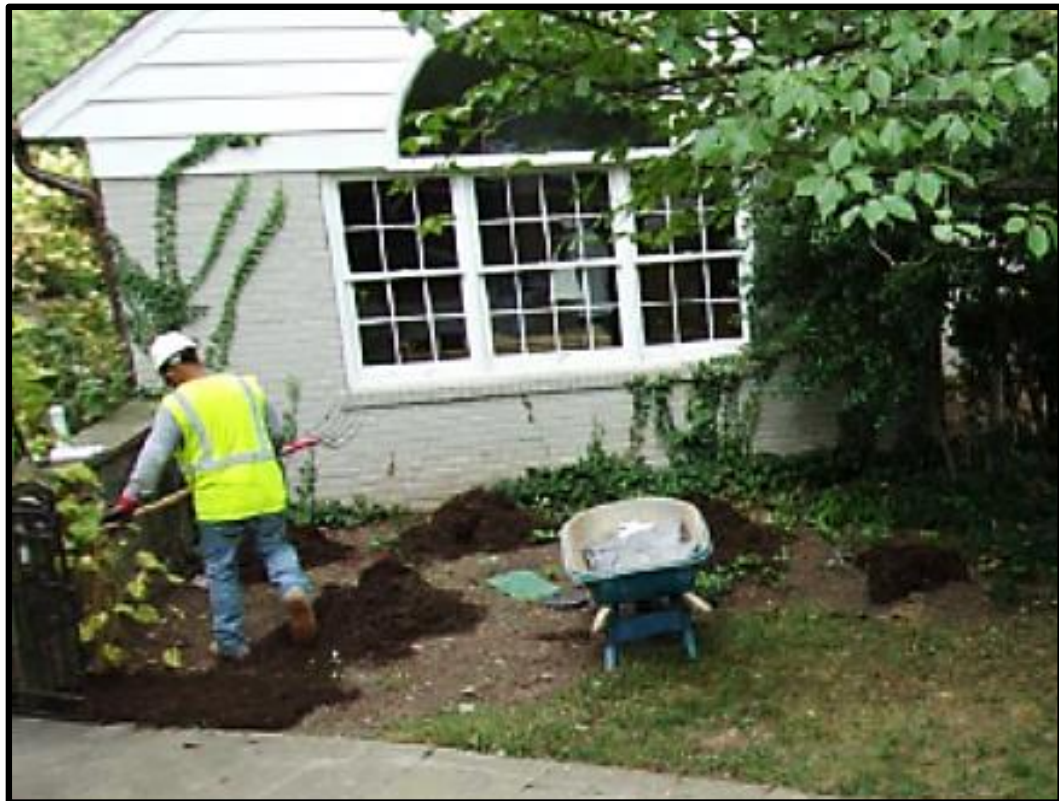
Site restoration efforts following the completion of the most recent intrusive investigation activities

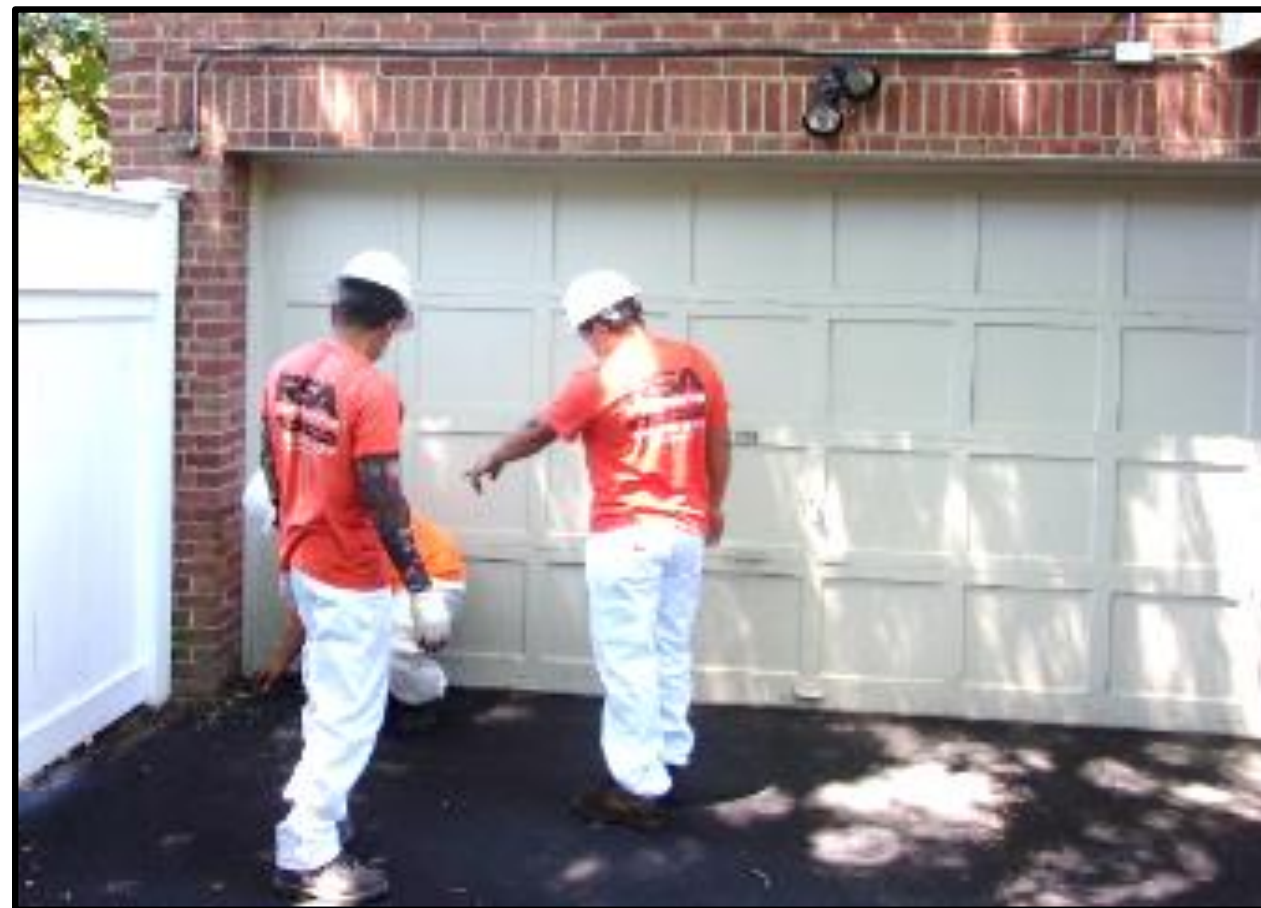
The project team conducting landscape and driveway restorations

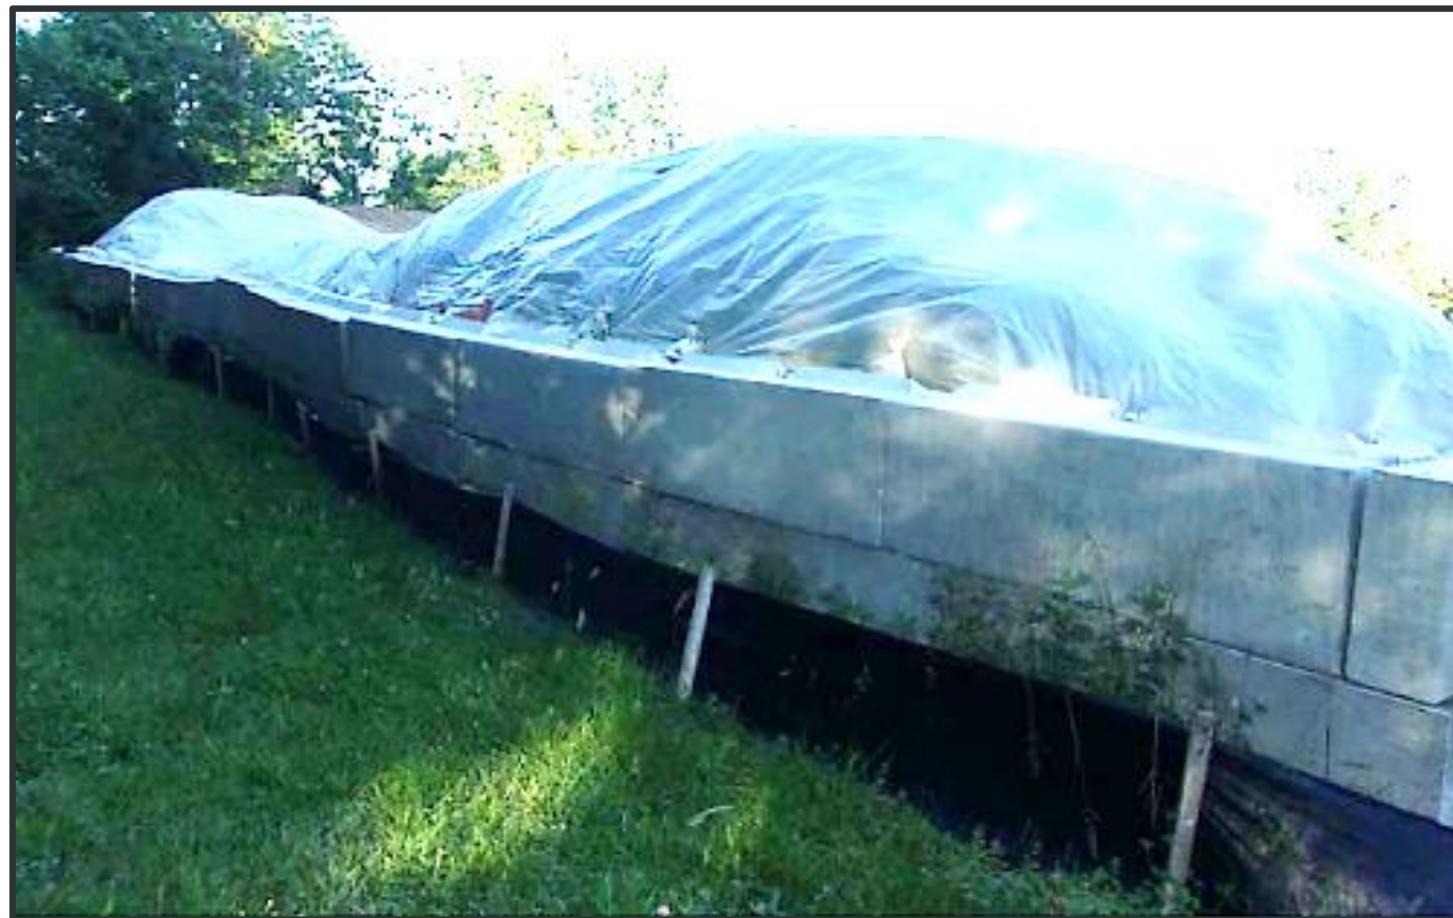
During the investigation and soil removal effort 375 tons have been removed, 165 pounds of munitions debris (29 items) and 178 pounds of laboratory grade glassware was recovered and removed.

Excavated soil from the site covered with plastic sheeting

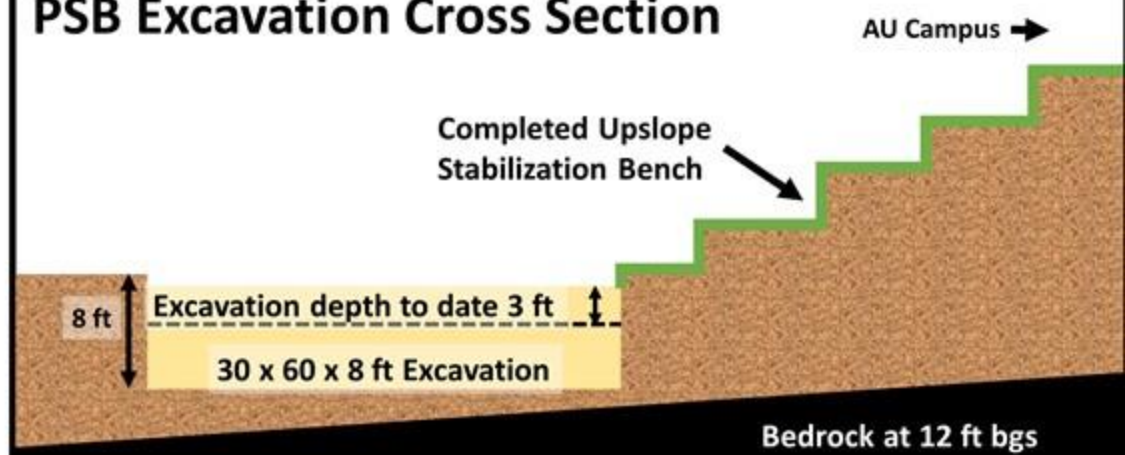
PSB Excavation Cross Section

Approx. location of "black" soil
-

"Black" soil excavated to 4' BGS, backfilled to 3' BGS
-

Area excavated to 3' BGS
-

Area excavated to 4' BGS

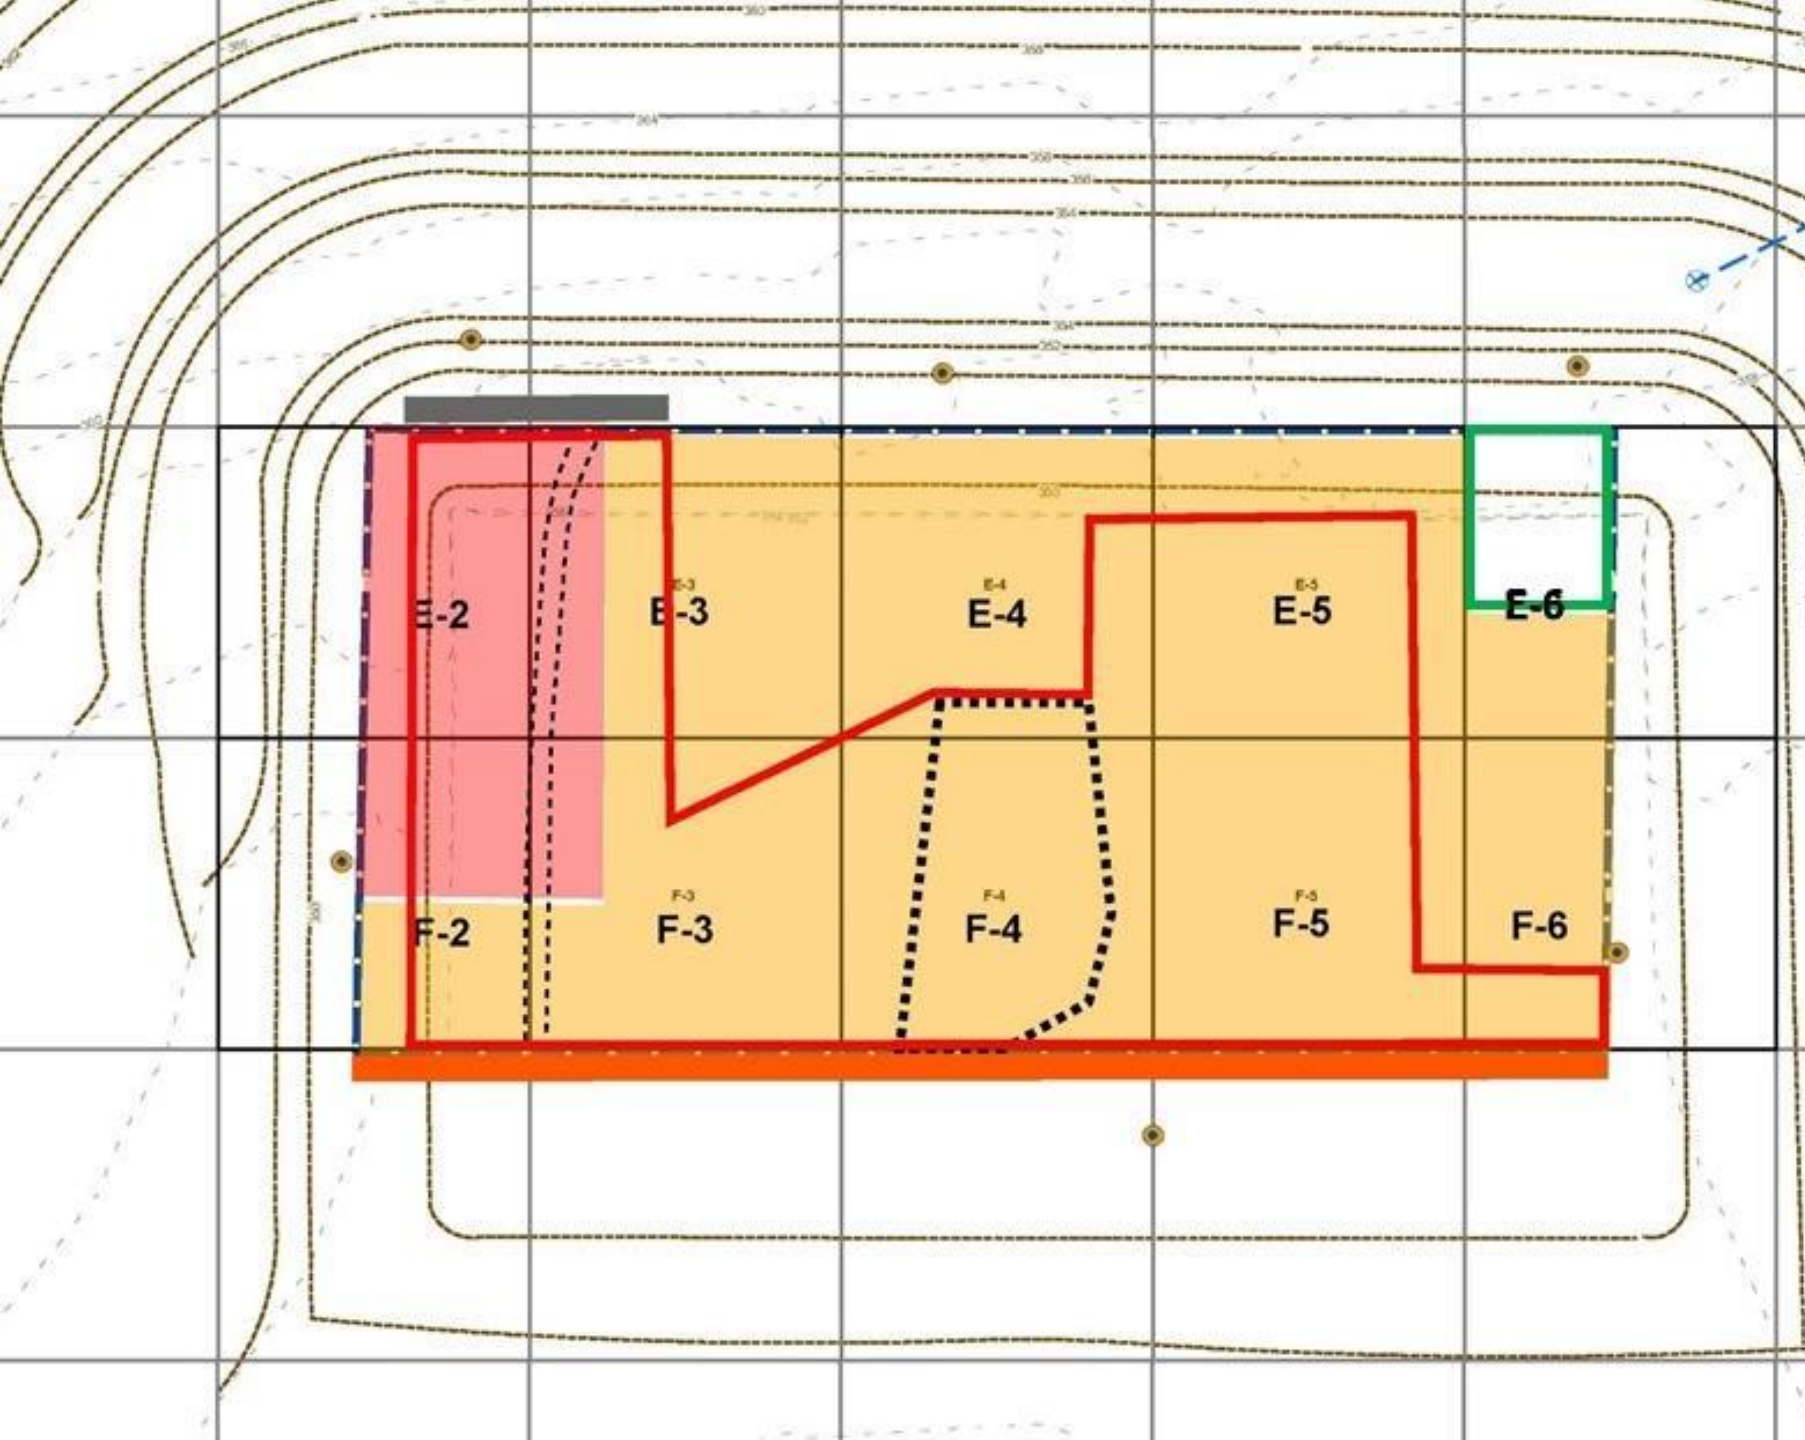
Dark soil with AUES debris observed in this area 1-3' BGS
-

Dark soil excavated to 4' BGS, backfilled to 3' BGS
-

Area excavated to 3' BGS
-

Area excavated to 4' BGS
-   Dark soil observed w/ AUES debris along the excavation wall at 1-3' BGS
-

Clean backfill edge from 2008 Parsons trenching
-

Existing sump to be removed at a later date

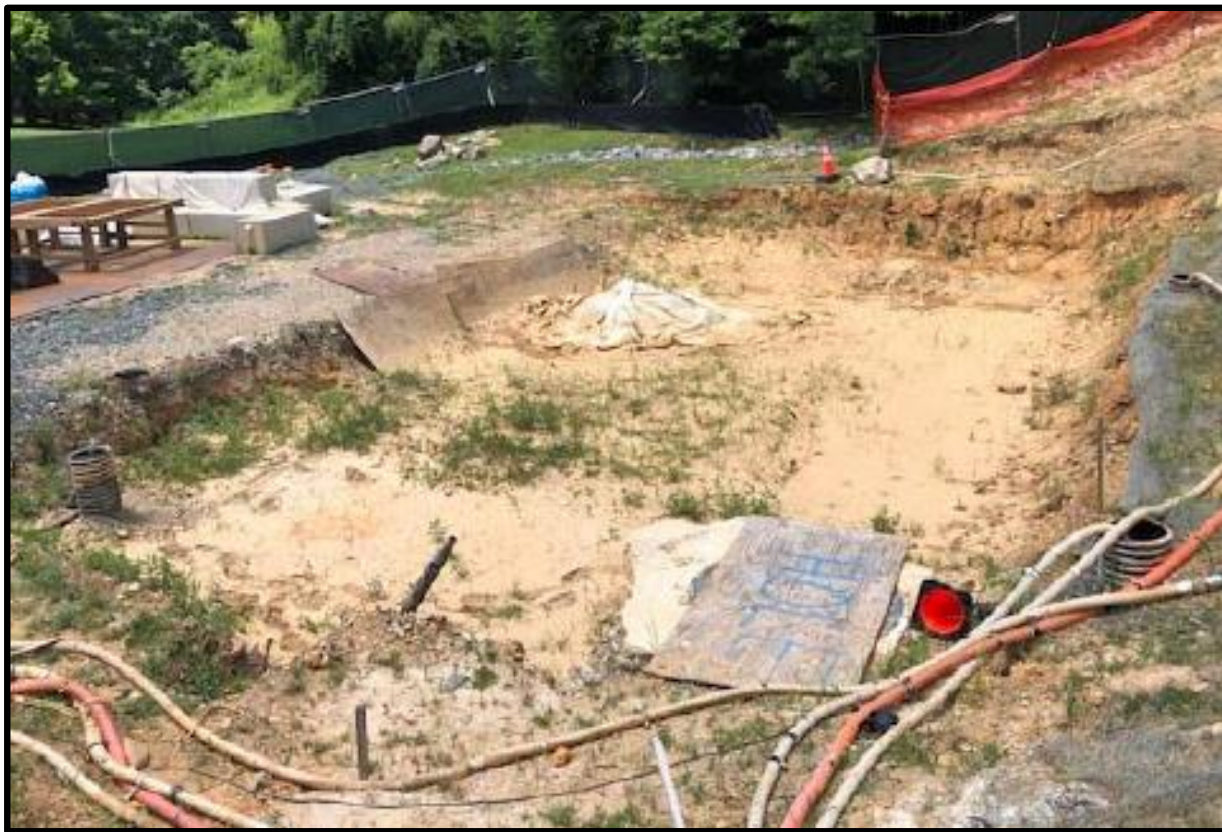
***View from above the former PSB
foundation slab***

Due to traveling restrictions associated with the health concerns surrounding COVID-19, the efforts to continue investigating of the soils under the foundation of American University's former Public Safety Building (PSB) were paused.

The team resumed work in early July with approximately 6 weeks of work remaining. Our team will continue to monitor the situation closely and keep the community updated on our schedule.

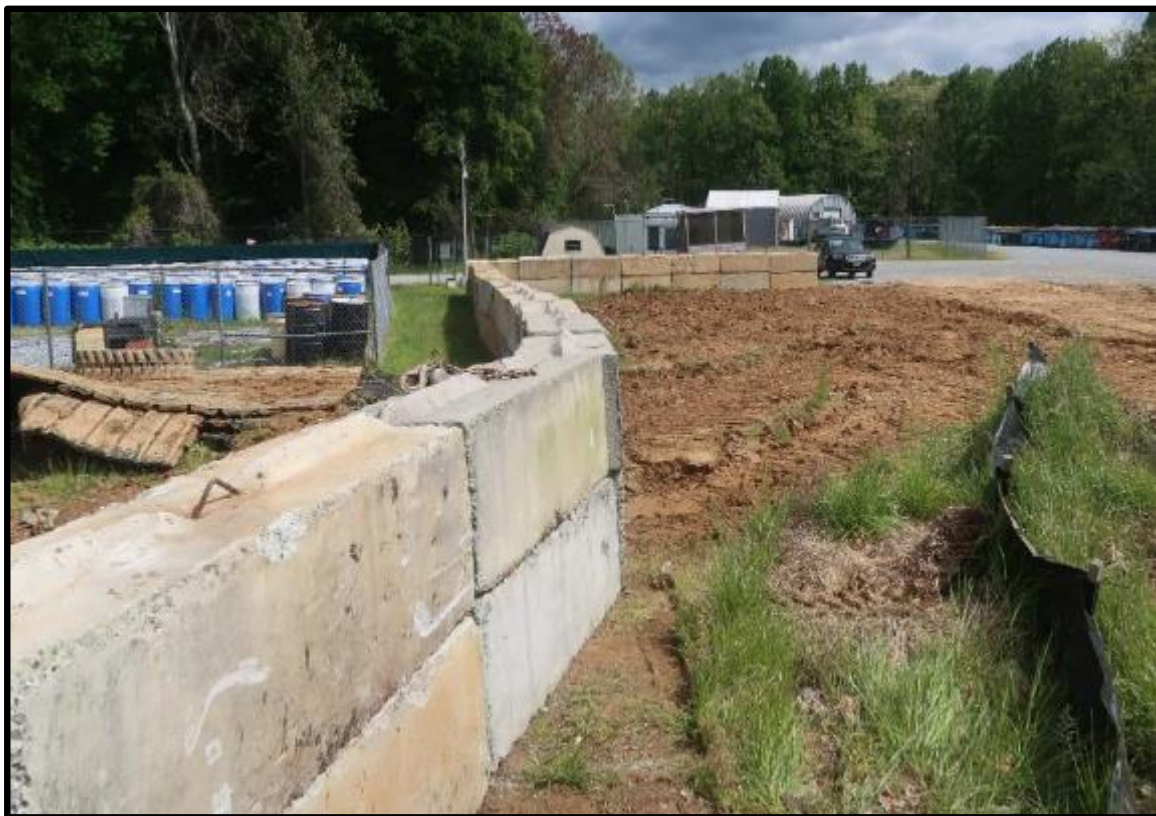
The crew moved concrete blocks and dug a trench to expand the soil/backfill storage area at the Federal Property.

The crew prepared for the arrival of truckloads of clean topsoil at the Federal property, to be used for the final restoration efforts. This included expanding the backfill storage area, and installing a new silt fence.

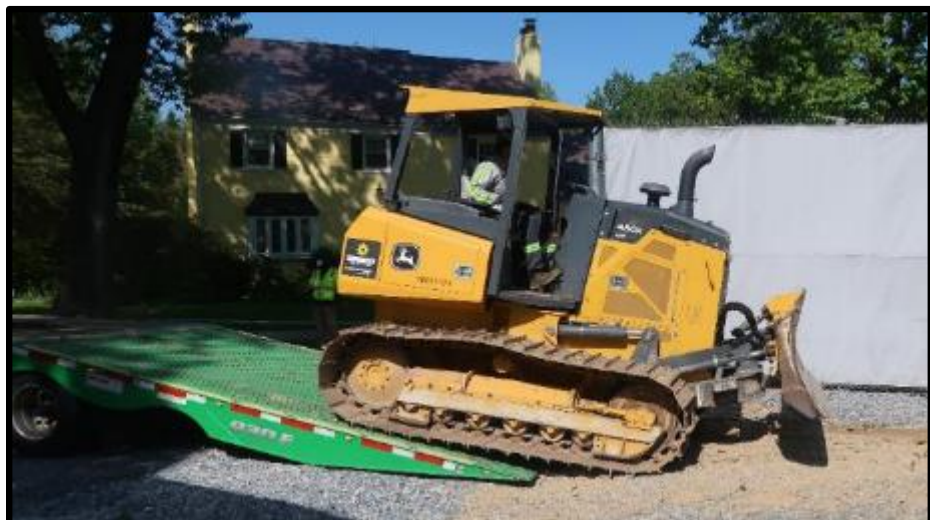
A bulldozer and roller were delivered to the project area to allow the team to work daily on backfilling and compacting soil, until the team could return the intrusive operations.

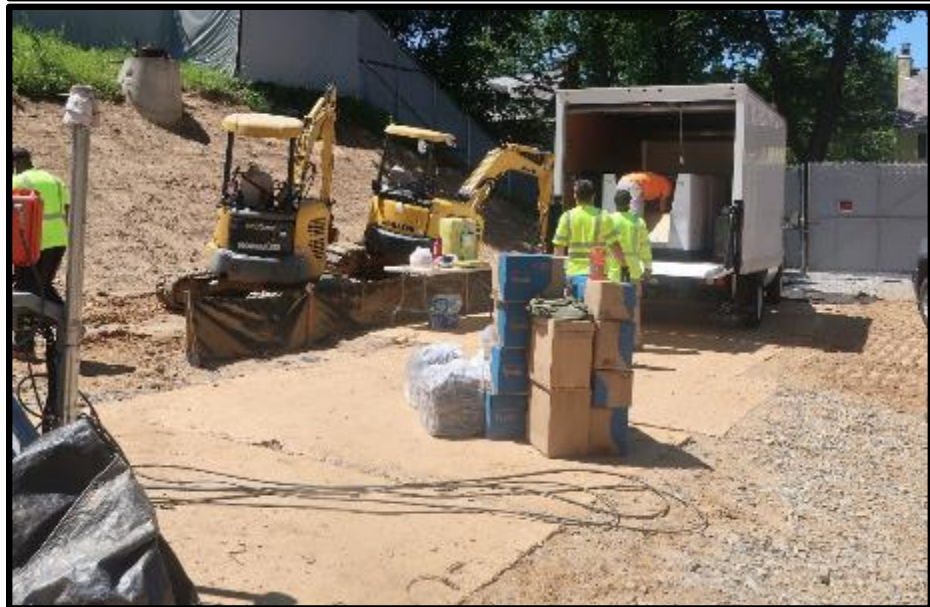
In late May, the crew set up dust monitors at the site and brought over equipment, tents, trailers and supplies from the Federal Property, in preparation for intrusive operations. This included crew fit testing for masks, and all Level B gear training for the excavation of the small remaining area requiring intrusive operations.

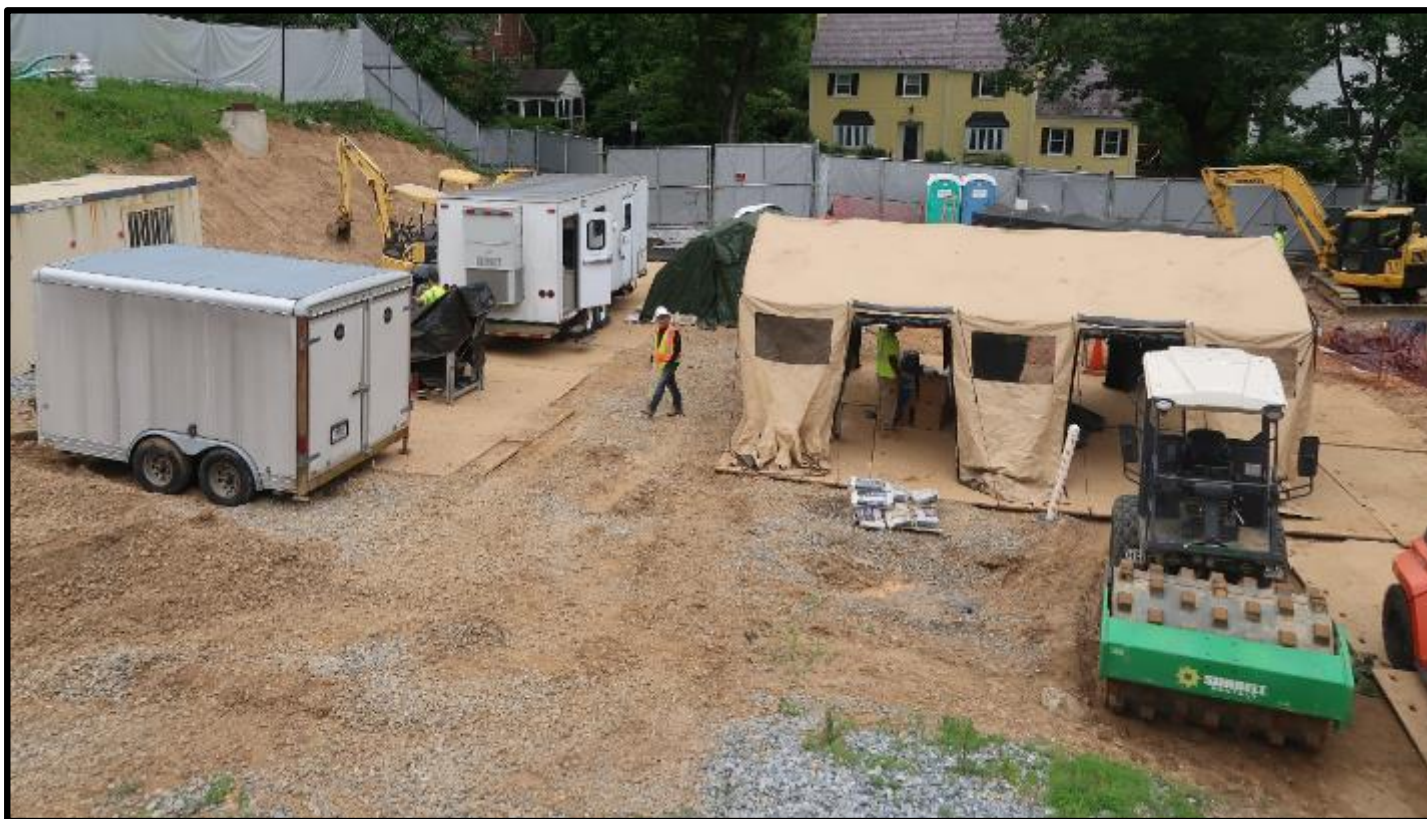
Site layout for the final HTW intrusive operations.

The crew is required to limit intrusive operations to the coolest times of the day, with air *temperatures below 74°F.*

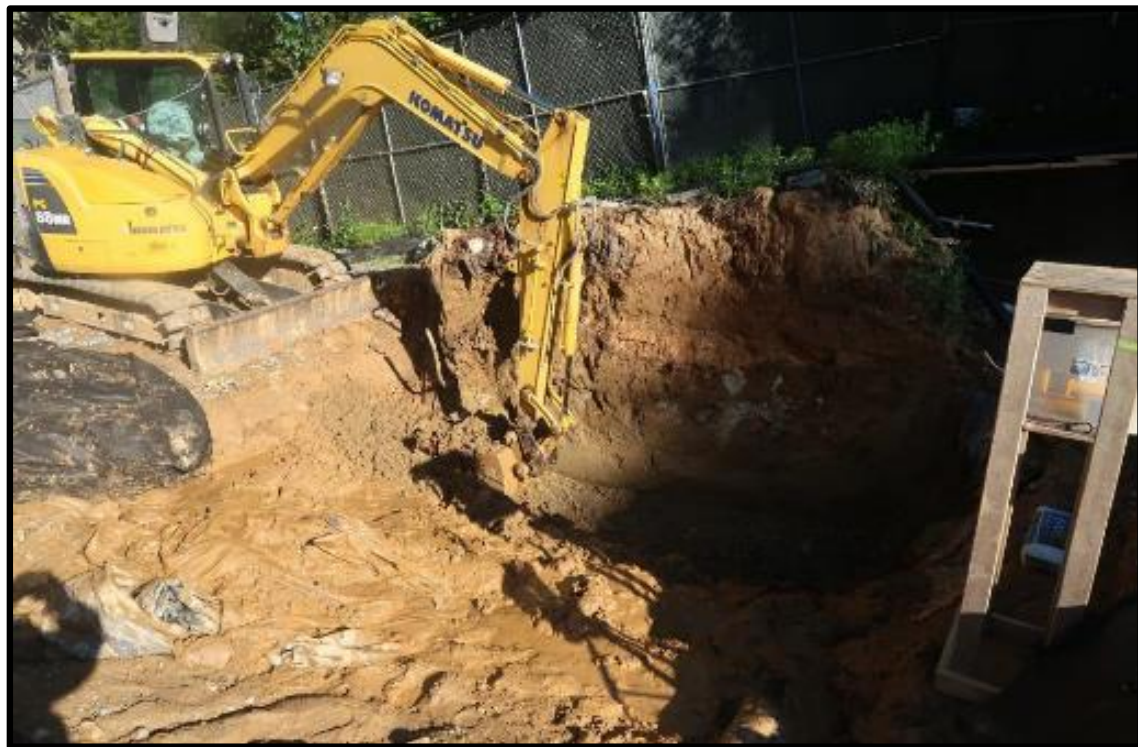
The project team began excavation of the remaining small area of contaminated soil along the shared property line with 4835 Glenbrook Road on Monday, June 8th, and loaded one roll-off with soil and transported it to the Federal Property. On that first day, the field team reported that they had excavated to saprolite and may be done with the excavation. The geologist inspected the saprolite and confirmation soil samples were taken.

The project team received the confirmation sample results on Monday June 15th, and there was one elevated sample from the bottom of the excavation. It was 2 parts per million (ppm) higher than the conservative project wide threshold goal for arsenic in soil of 20 ppm. All of the side wall samples were categorized as 'clean', as they matched the naturally occurring background levels of arsenic in the soil.

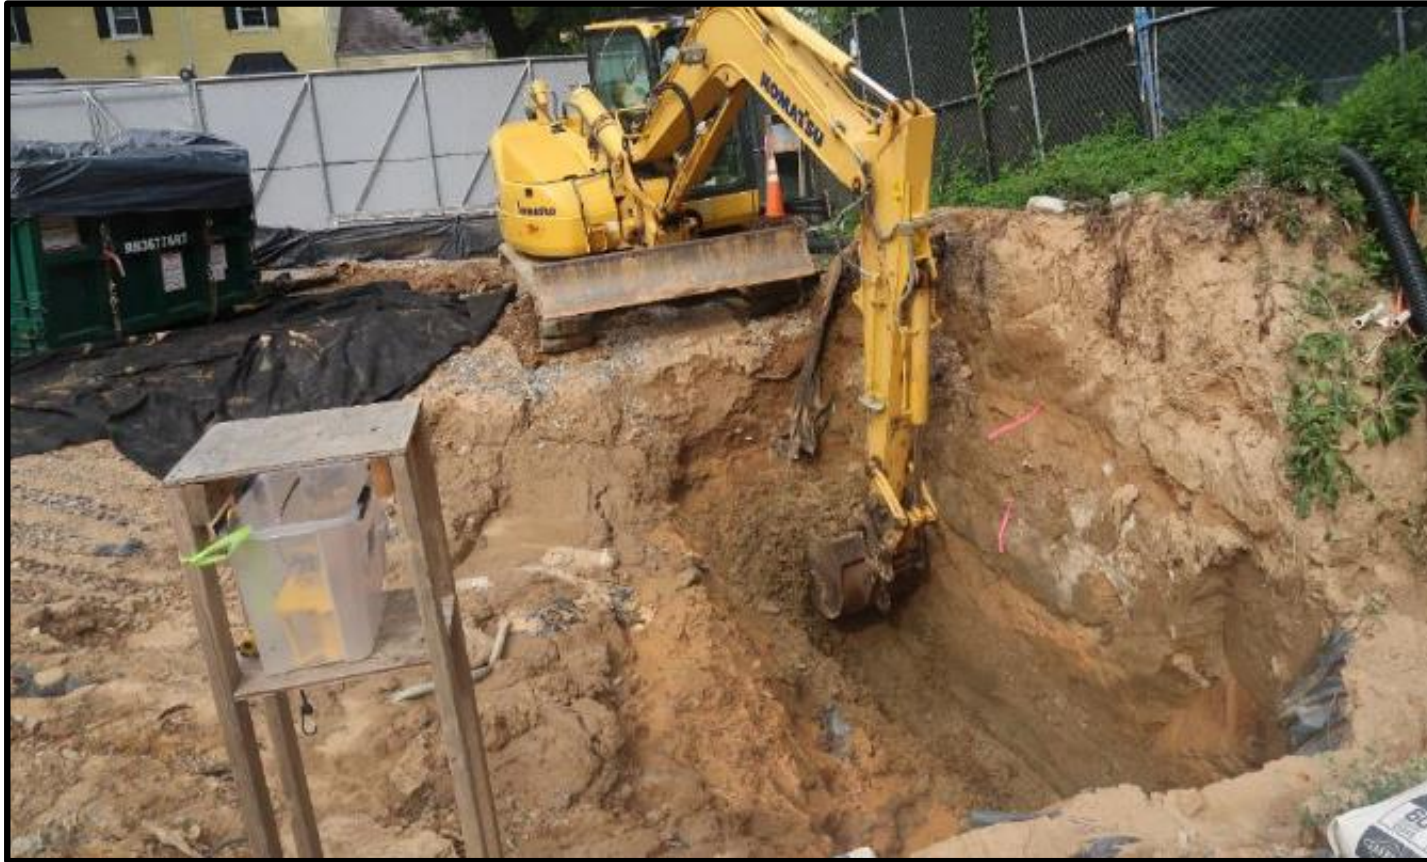
Final contaminated soil excavation effort, with air monitoring equipment in the foreground.

The team began scraping the area with the excavator, and removed two more feet of saprolite, filling one roll-off. When they reached solid bedrock and experienced 'mechanical refusal,' they took confirmation samples from the bottom of the hole.

The lab report for the final soil sampling confirmed we are "clear." The arsenic level was determined to be at 17 ppm, which is below our project-wide standard threshold of 20 ppm for arsenic.

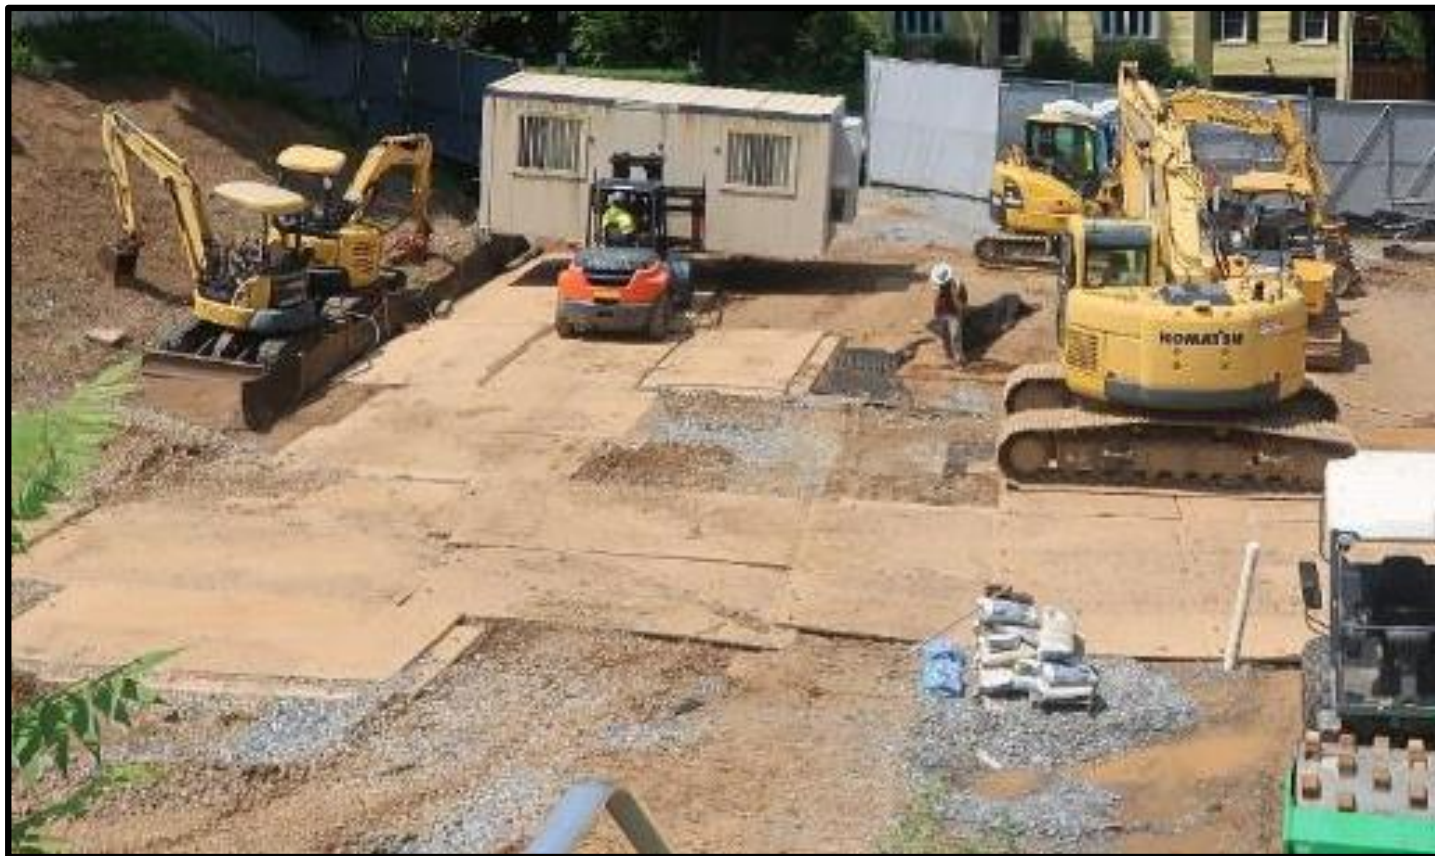
Demobilization of all intrusive operations equipment.

Our onsite team next focused on moving our intrusive operations equipment to the Federal Property. This included loading both MINICAMS trailers, the cascade trailer and compressor.

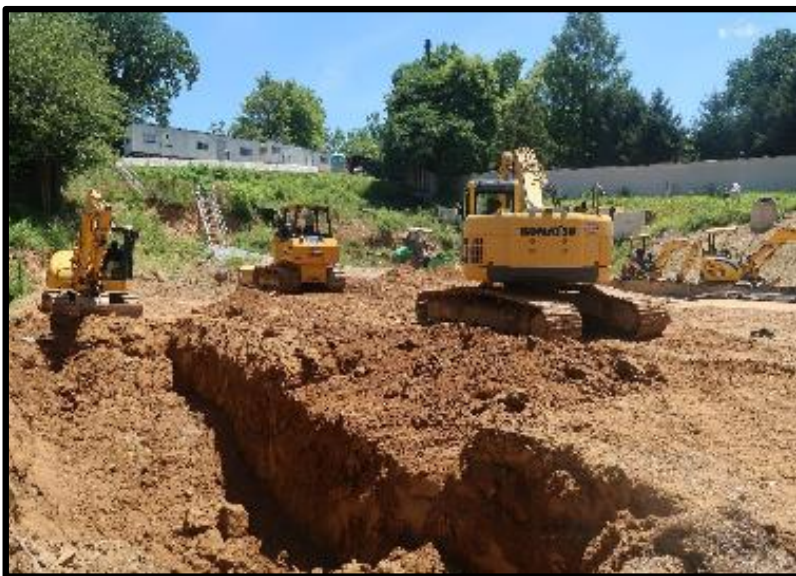
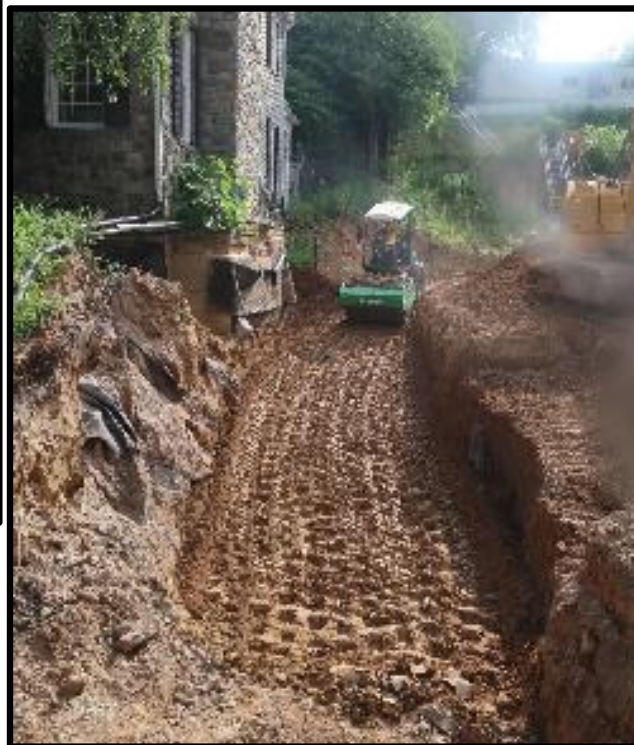
Backfill efforts are being conducted across the site in small areas, per a planned standard construction-grade approach. Clean backfill soil is temporarily stored for site and operational safety.

Next, layers or lifts of clean backfill are put into place, compacted and measured for the standard compaction percentage, before another layer/lift of clean backfill is put down in the select area.

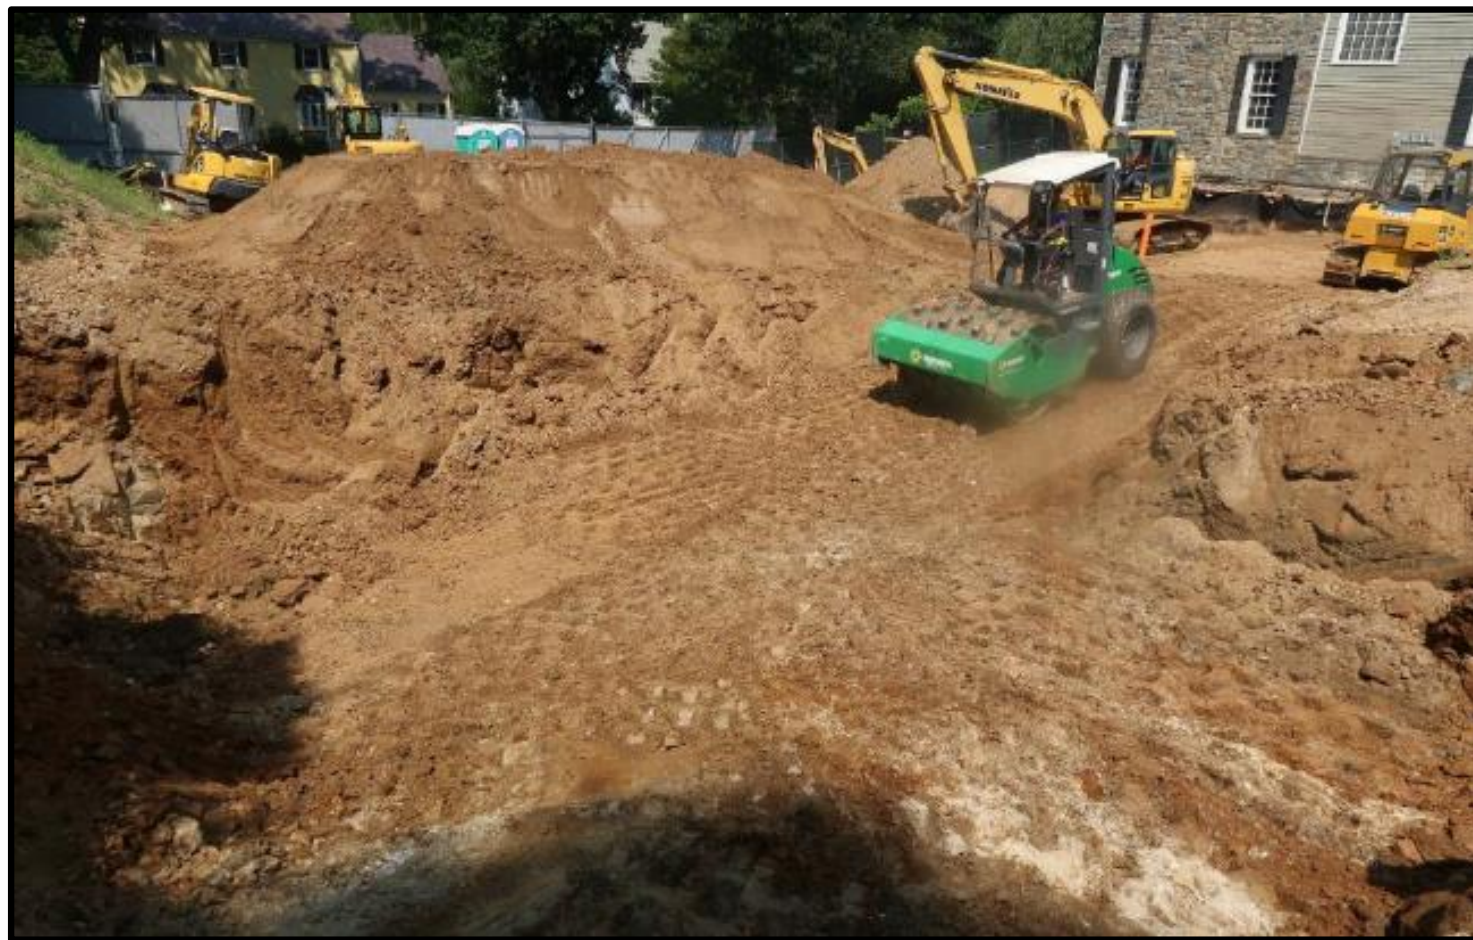
The crew is nearing completion of the backfilling and soil compaction operation of the previously backfilled trenched areas.

Compaction of clean backfill soil

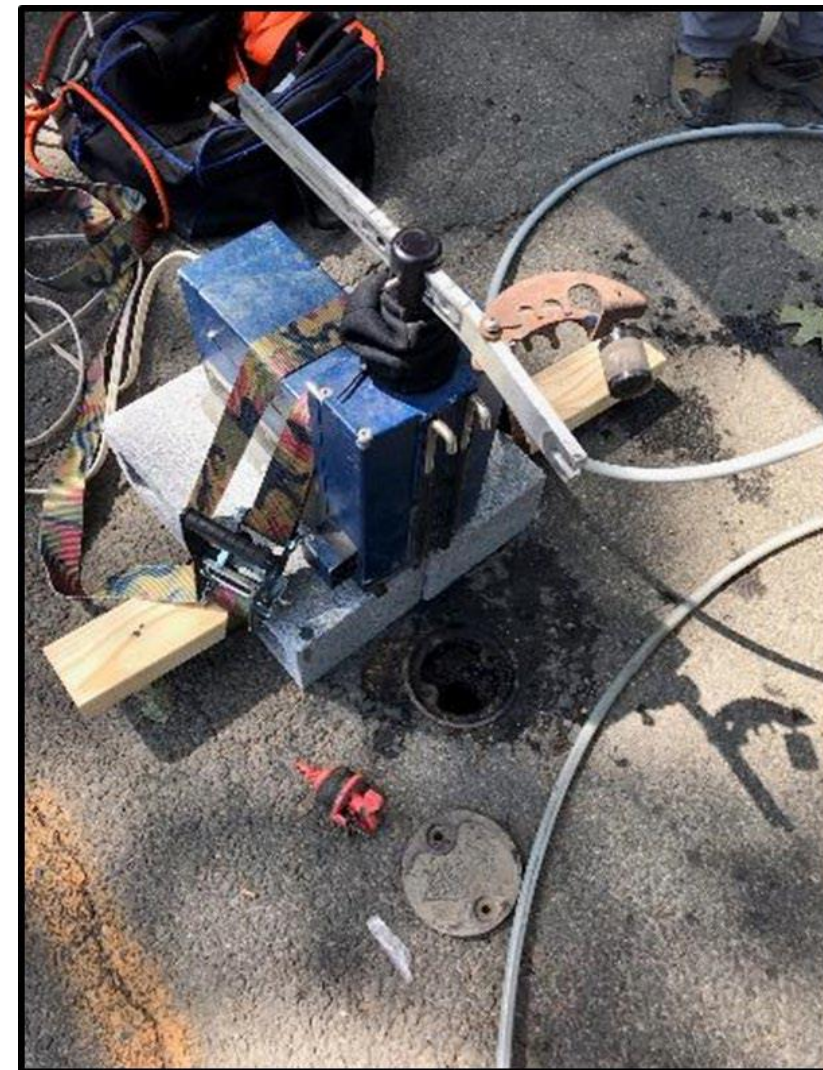
Groundwater sampling well

- The Groundwater Sampling Plan prepared by the Army Corps was approved by the Project Partners and sampling took place between June 23-26. The team anticipates receiving the confirmation sampling results by the end of July.
- The Army Corps and Partners will discuss the results and determine the path forward for the final groundwater approach.
- Confirm that the arsenic concentration are below established drinking water standards.
- Continue to monitor Perchlorate concentrations.
 - The EPA has declined to regulate Perchlorate; the 15 ppb advisory level will be used.
