# SPRING VALLEY FORMERLY USED DEFENSE SITE

Restoration Advisory Board Meeting  
May 2021

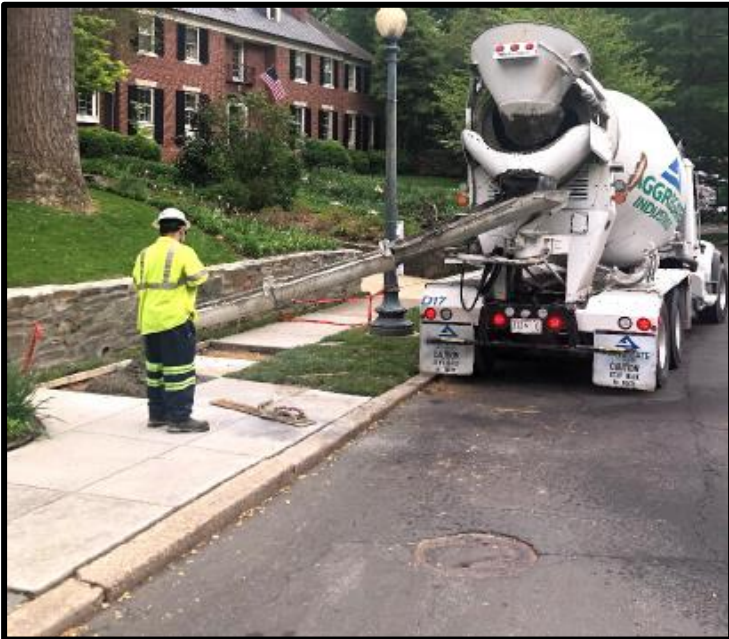
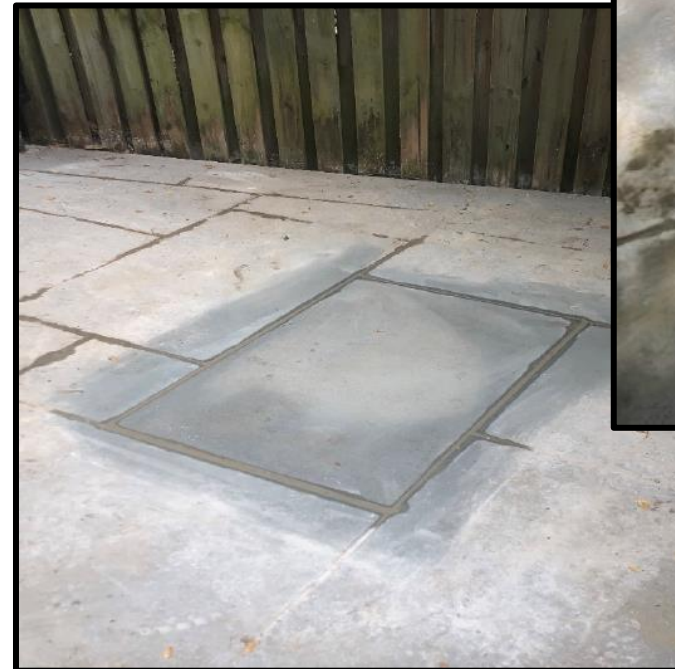
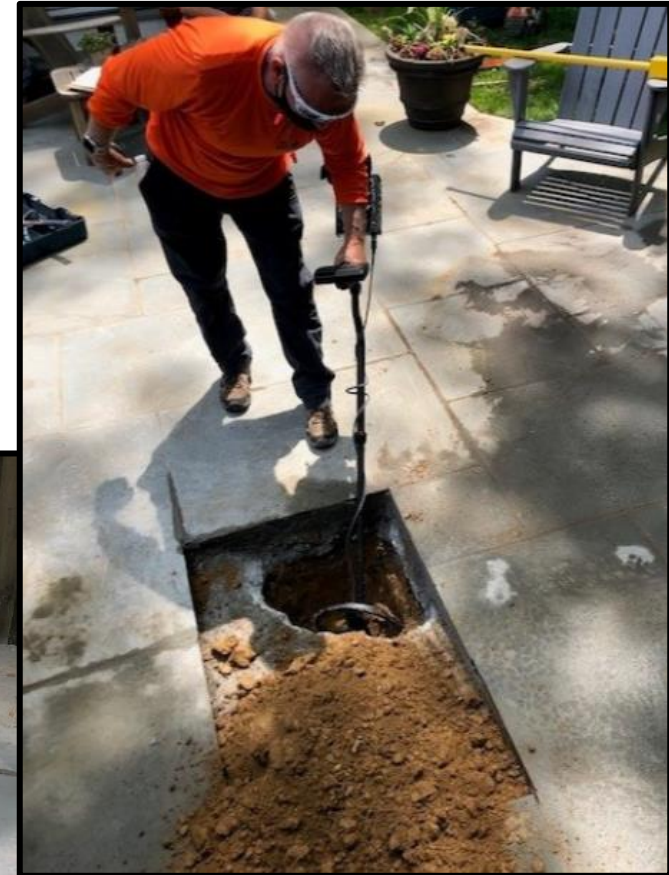
- With the warmer Spring weather, the dig team was able to complete the remaining hardscape from the previous group of properties.
- Each hardscape dig site was promptly restored the next day after completing anomaly removal.

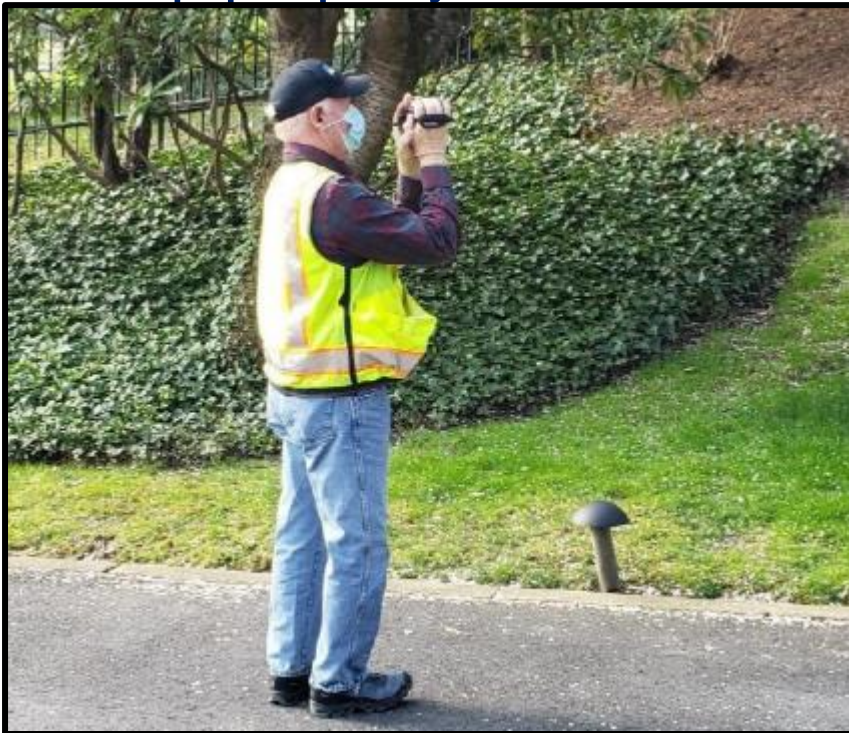
- This Spring, the field team began the Remedial action effort process for the final group of properties with site preparation.
- This includes landscape appraisals, HD videos of properties, and planimetric surveys to map property boundaries.

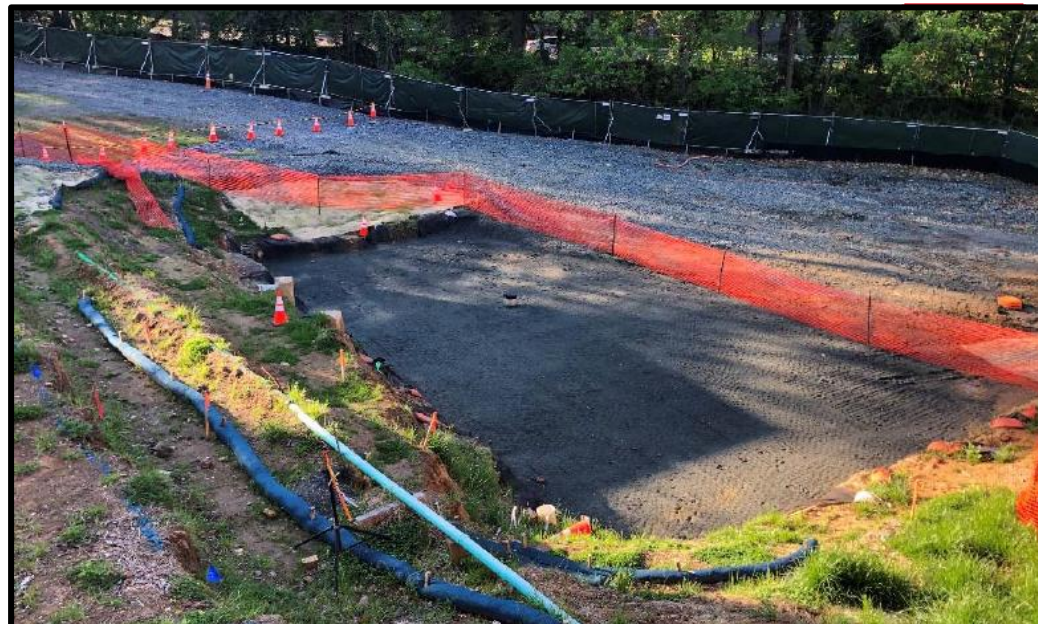
- On March 23<sup>rd</sup>, all backfilling, compaction, and test pitting activities were completed at the PSB excavation site.
- The team demobilized from the PSB excavation site on April 16<sup>th</sup>, leaving truck entrance as well as the security and work fencing.

**Restored Former PSB excavation site**

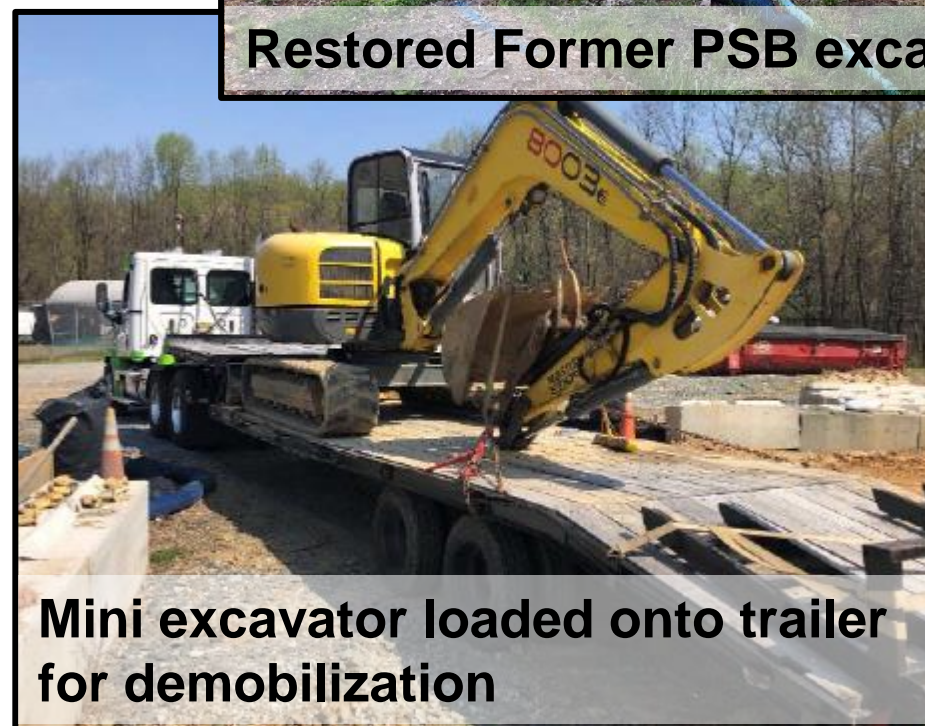
**Mini excavator loaded onto trailer for demobilization**

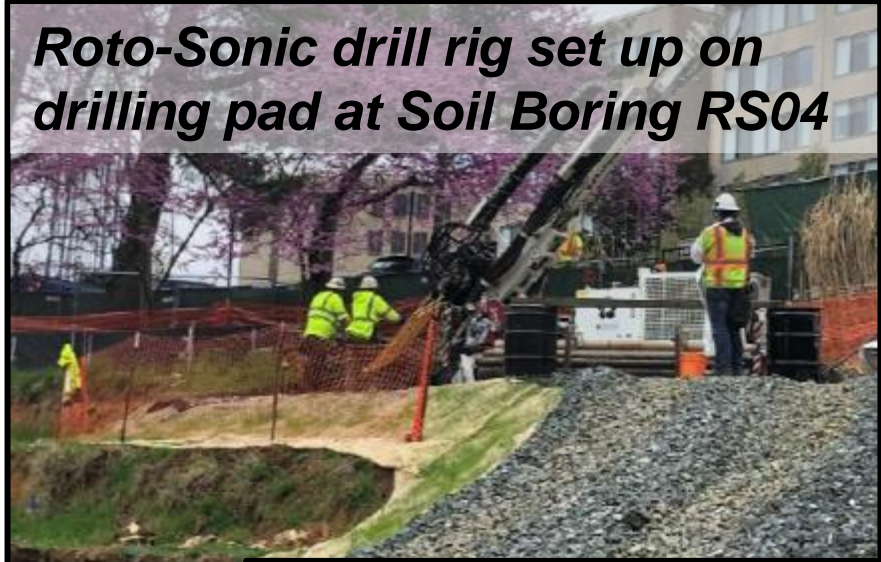
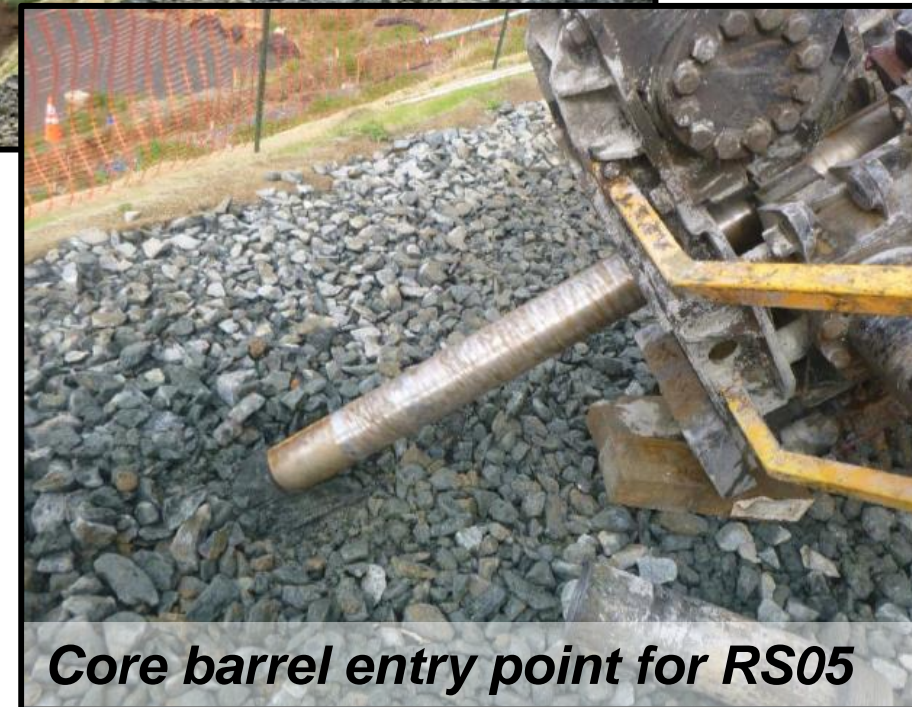
- In April, the team completed the Roto-Sonic drilling into the northern hillside to investigate the trail of debris. The investigation included 6 Soil Boring points (RS01-6).
- Each soil core was processed for AUES debris. Any potential debris encountered was logged and collected for headspace analysis.
- In addition to laboratory grade glassware, some burnt material was also encountered at Soil Boring RS03.

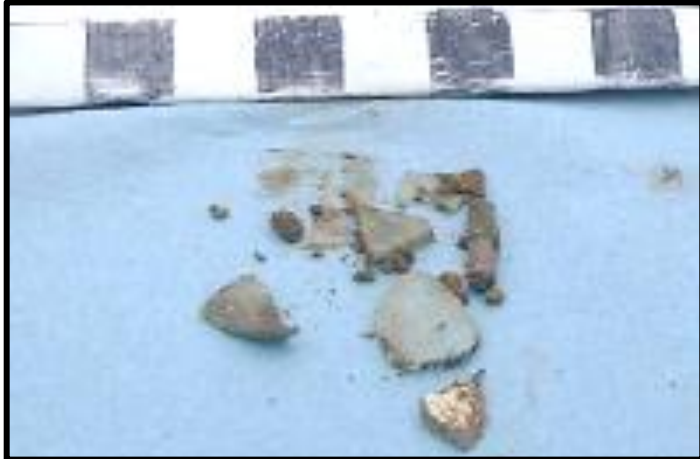
**Batch glass collected from Soil Boring RS03**

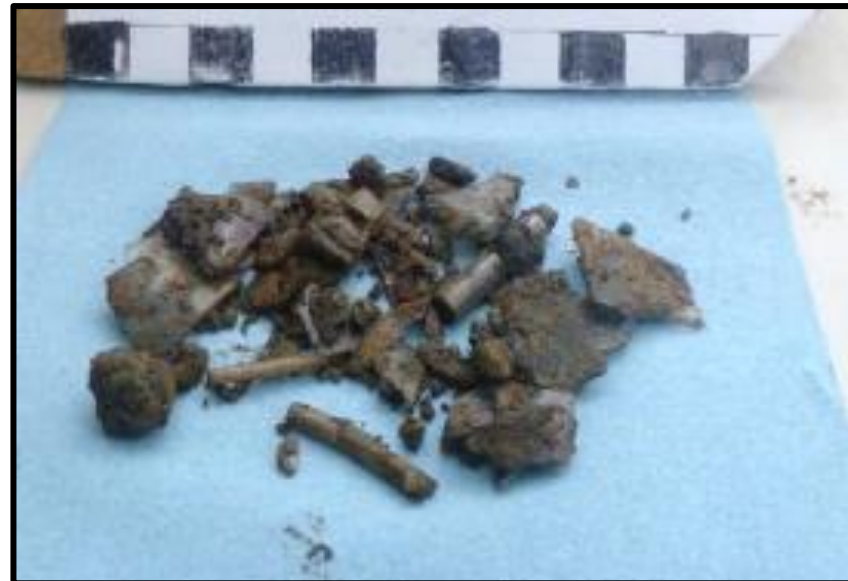
**Batch glass collected from Soil Boring RS04**

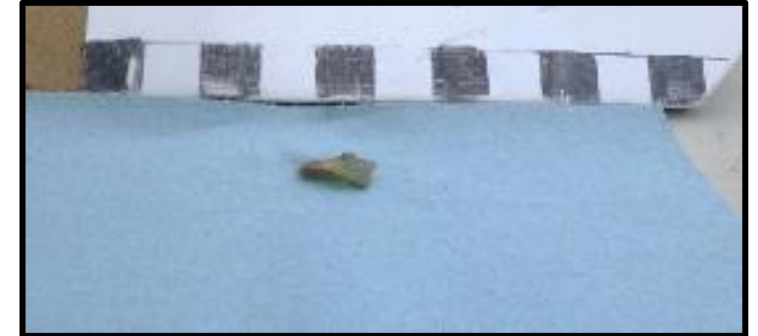
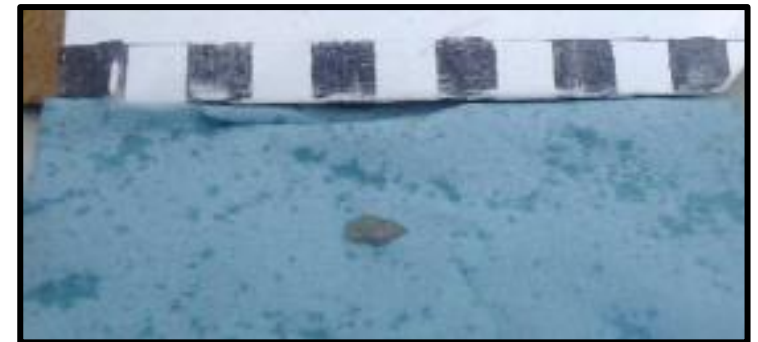
**Potential sample collected from Soil Boring RS05**

**Potential sample collected from Soil Boring RS06**

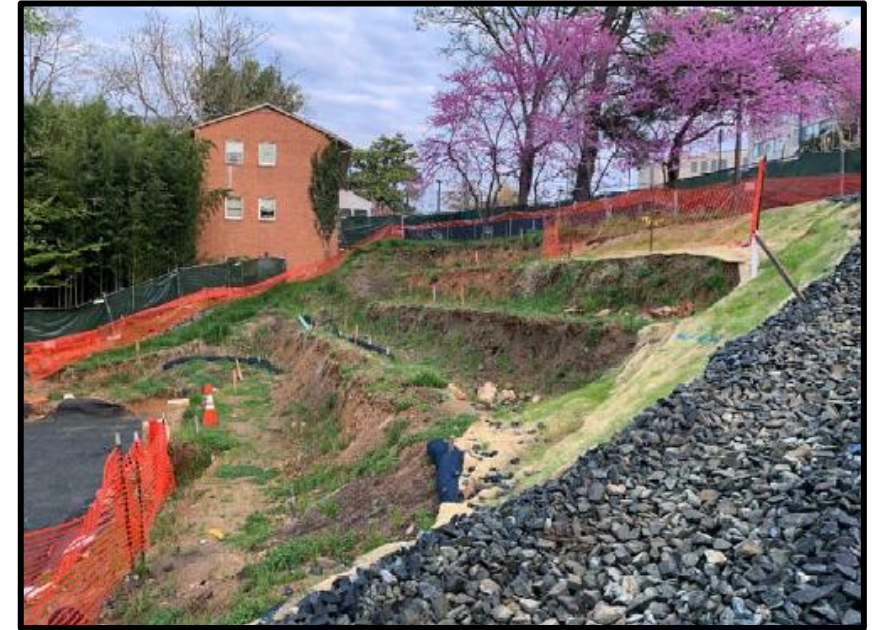
The Army Corps and Partners are reviewing the investigation report following the completion of all the backfilling operations and investigation of the debris trail into the slope. The team will discuss the results to determine the path forward and develop work plans for the final soil remediation approach at AU's former Public Safety Building.

***Terraced slope above AU's former Public Safety Building***

- Develop and finalize work plans
- Award work contract
- Tentative start fall 2021 to complete any remaining work

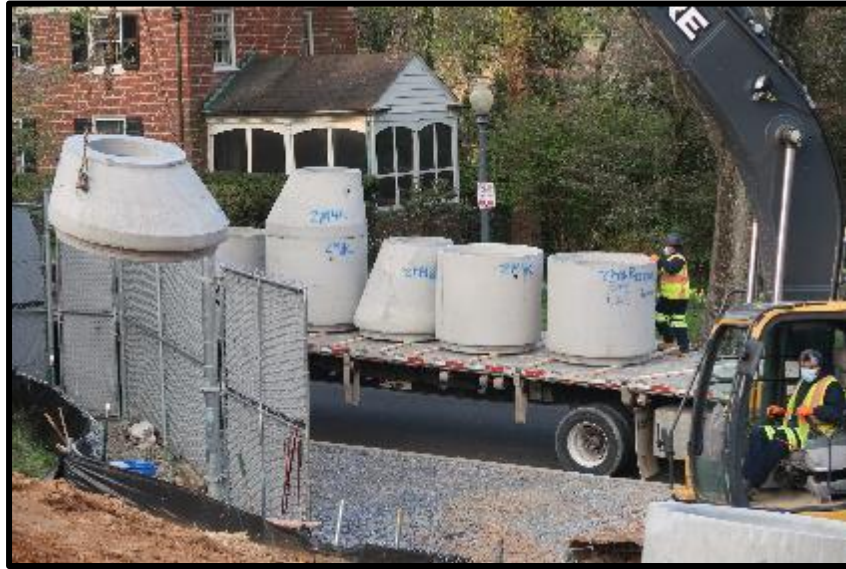
Reinstalling the 3 manholes, sewer and water lines is a complex effort. This includes excavation to prepare the area and install pipes and the manholes underground, and modifying the manholes onsite.

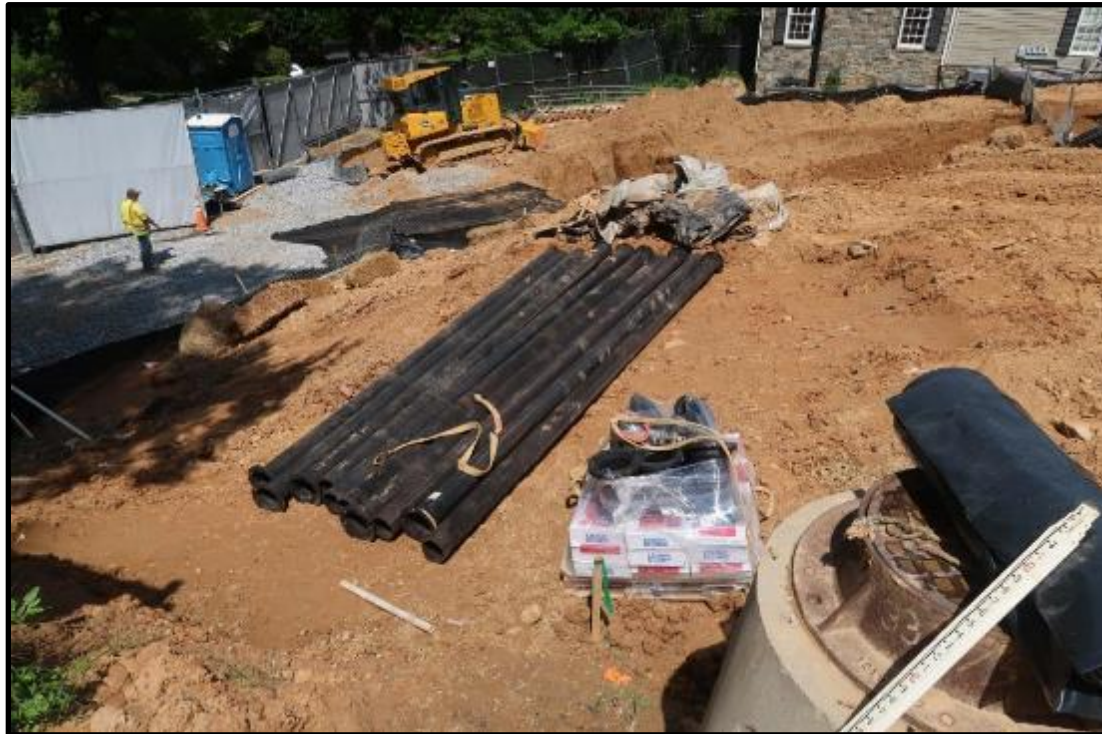
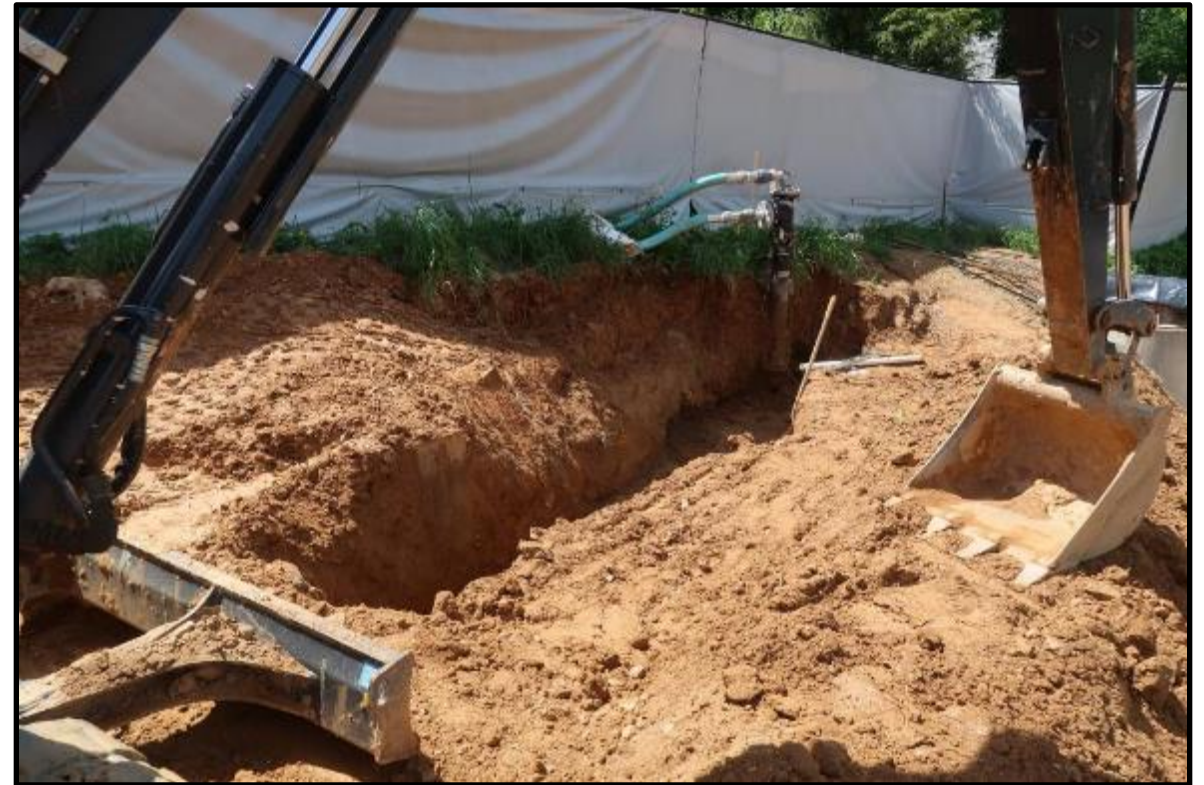
We have received all the needed equipment and materials to complete the utility restoration effort over the next few weeks. A continuous effort has been underway with both our site crew and the utility contractor working together to expedite the effort.

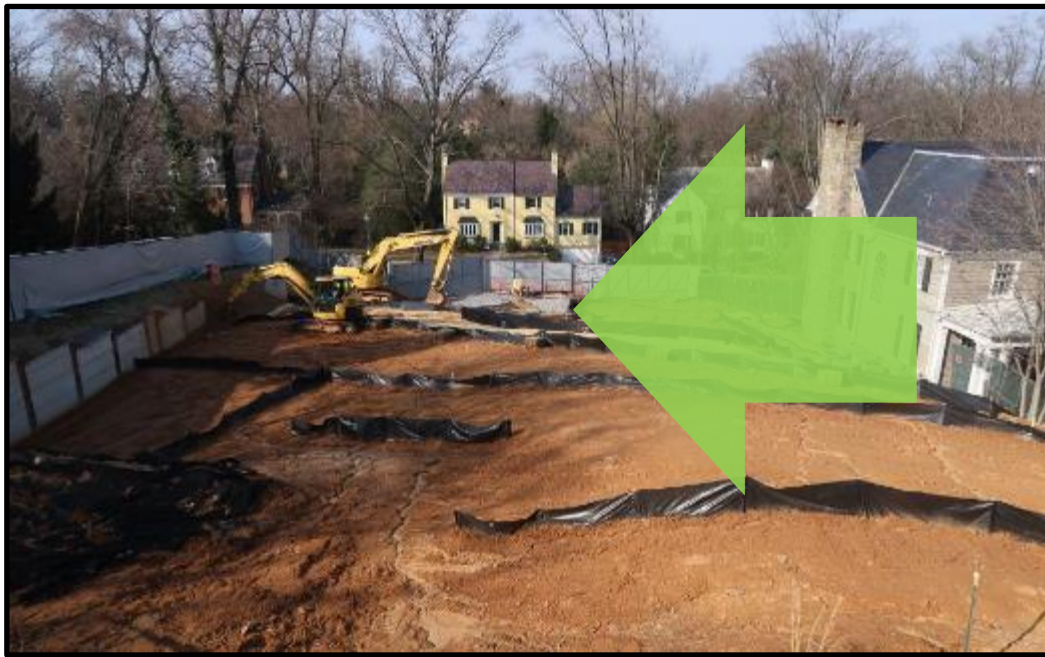
The crew focused much of the soil compaction efforts around the utility installation areas, on the east and north sides of the property, over the past 2 months. The backfill effort at the site is currently at 75% complete.

**Site backfill progress from mid- March to first week of May.**

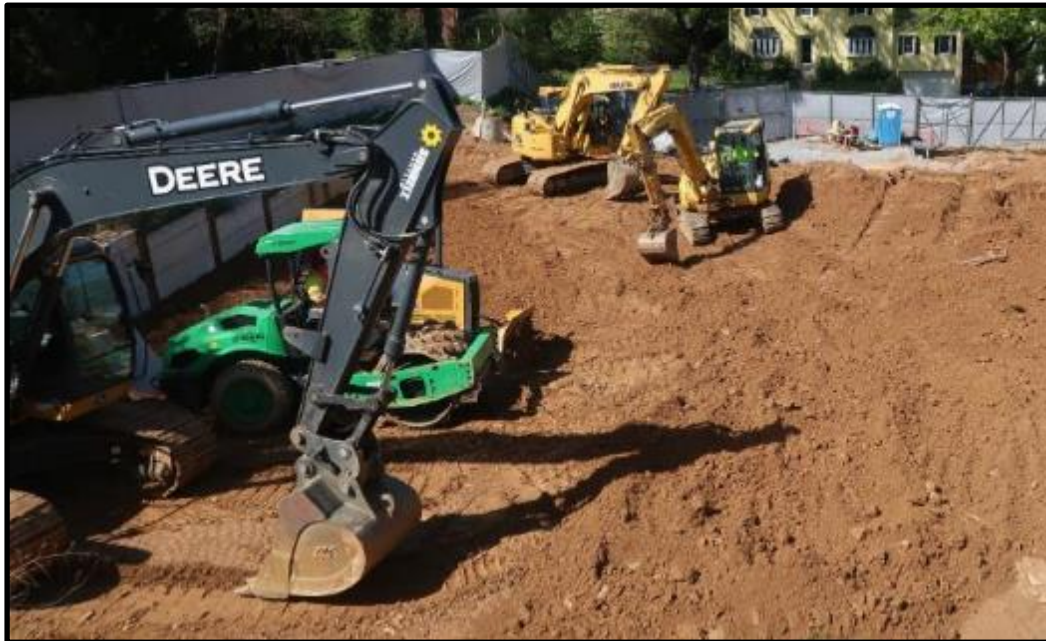
Efforts to dry the soil include spreading the soil around to dry, and we continue to place plastic sheeting prior to rain to keep the soil as dry as we can when wet weather is anticipated.

**Spreading backfill around the site to dry.**

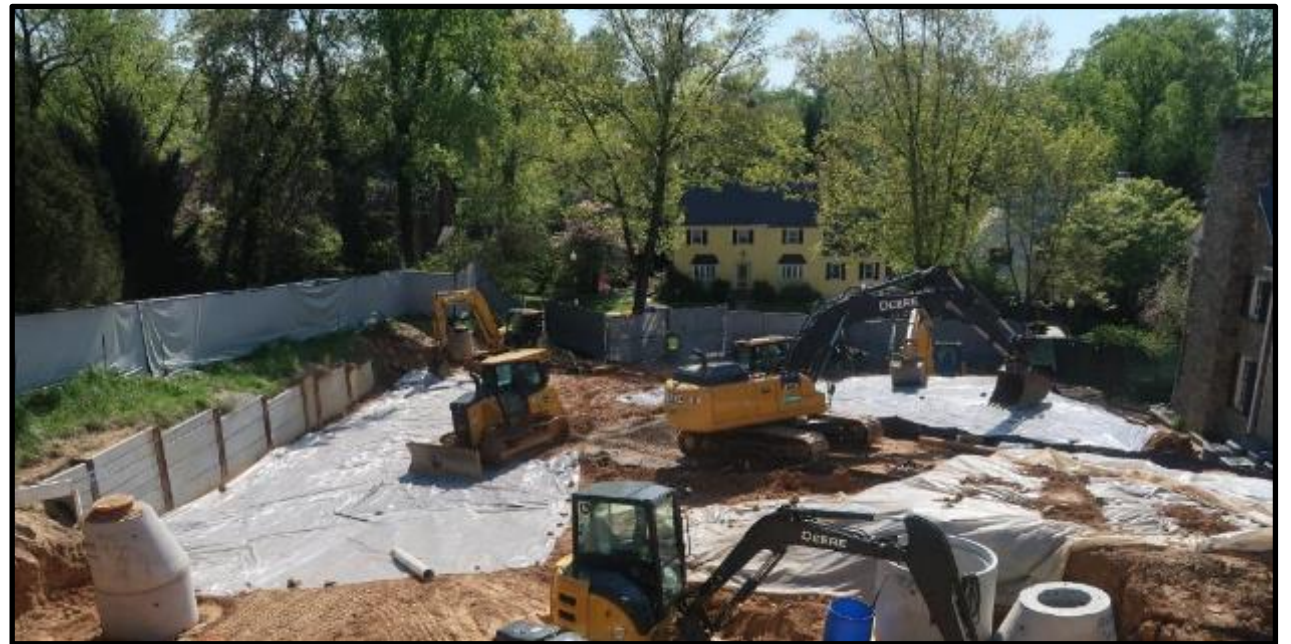
**Covering the soil prior to anticipated rain.**

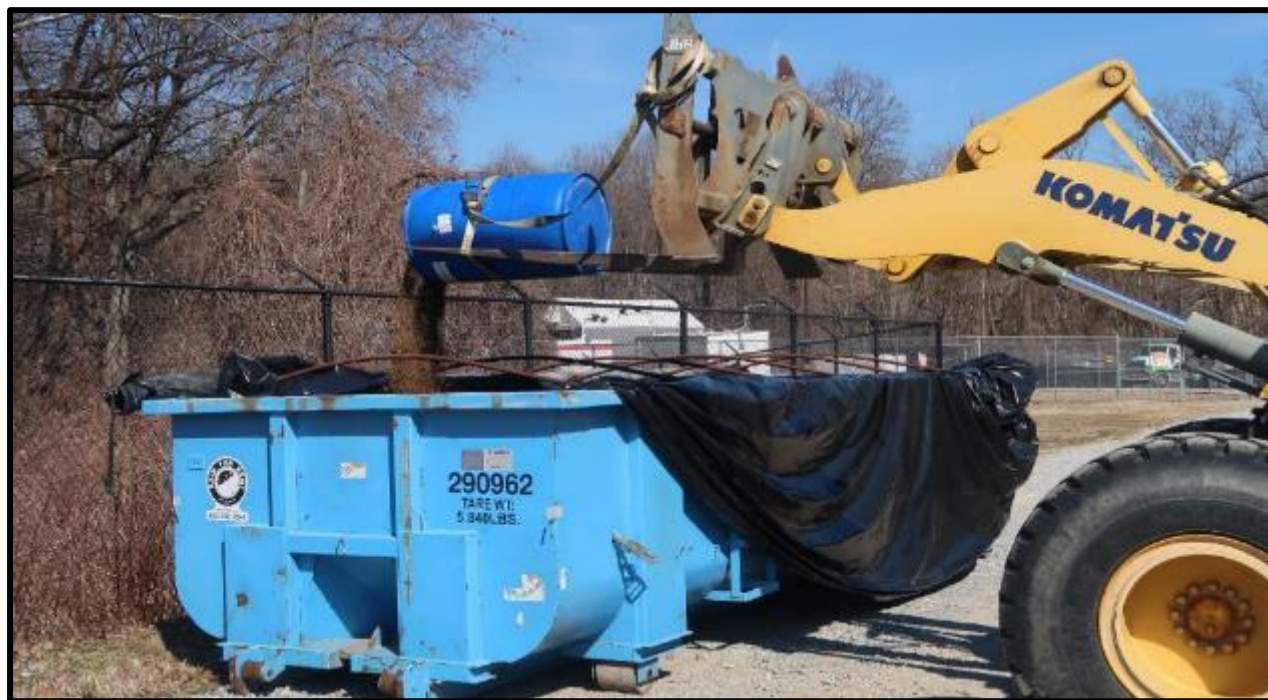
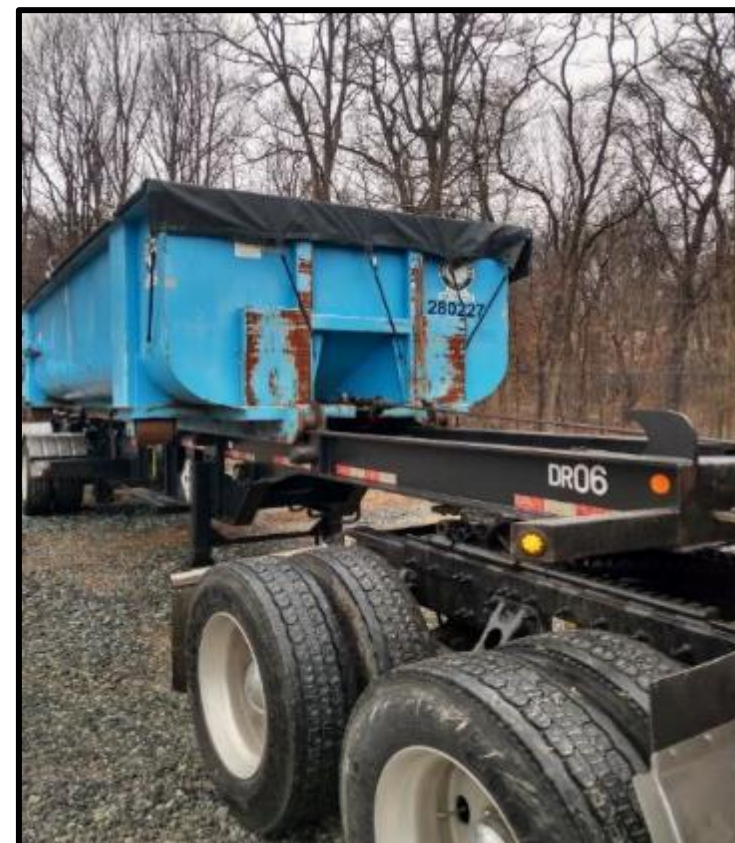
All of the remaining solid waste stored at the Federal Property, including the soil transferred from drums into roll-offs, and the empty drums, have been transported offsite to a Subtitle D landfill.

**Soil being transferred into a roll-off, and a waste filled roll-off leaving the Federal Property site for disposal.**

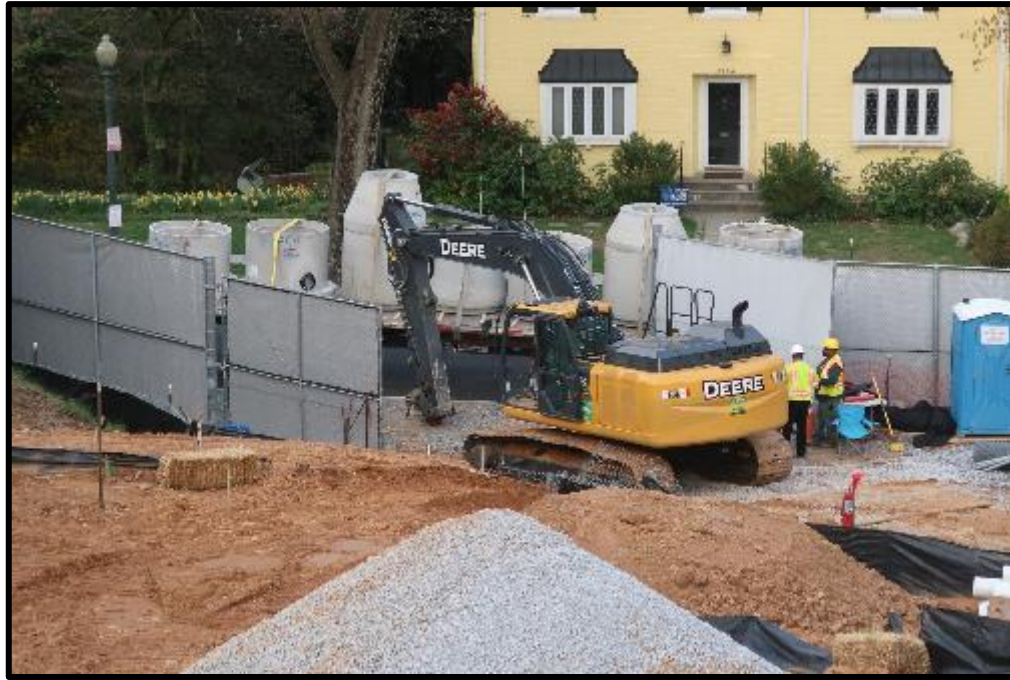
**Materials being unloaded in April for the utility reinstallation effort.**

Complete effort to re-install AU water line and the AU sanitary sewer line.

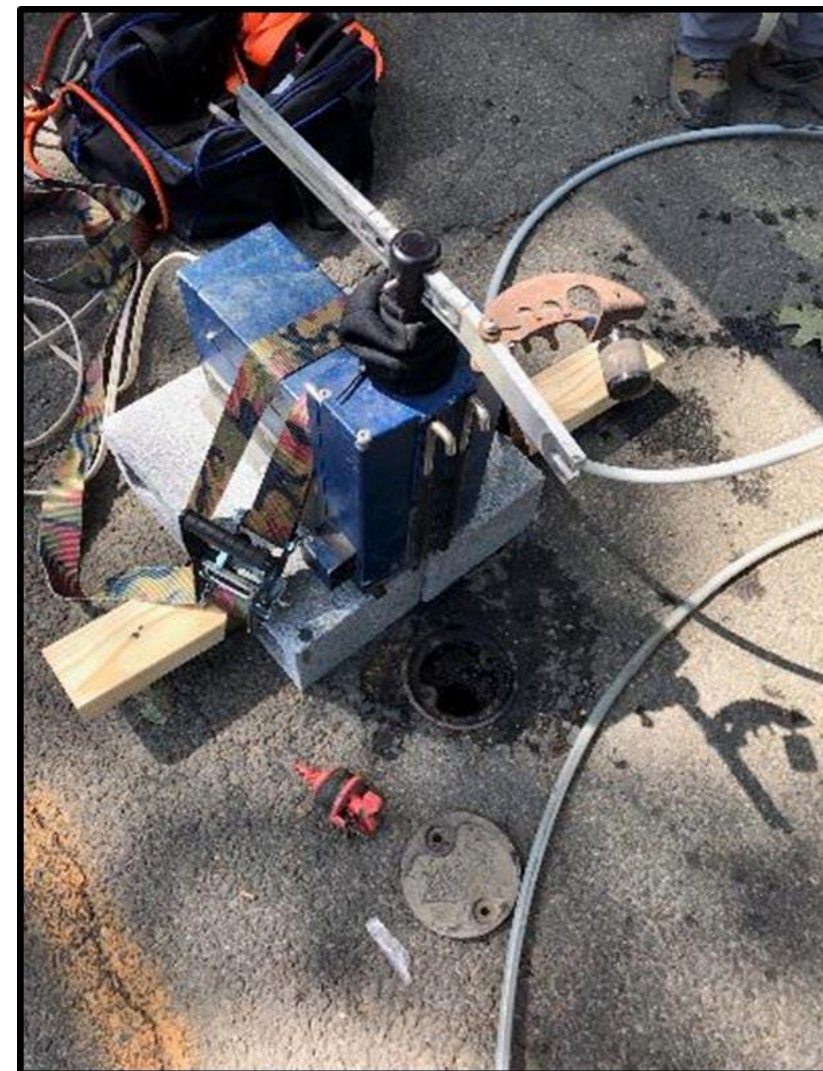
The groundwater sampling event for perchlorate at wells PZ-4D and MW-44 was conducted by the USACE and the U.S. Geological Survey (USGS) on March 1<sup>st</sup>.

*Groundwater sampling well*
