SPRING VALLEY FORMERLY USED DEFENSE SITE

Restoration Advisory Board Meeting
12 May 2020

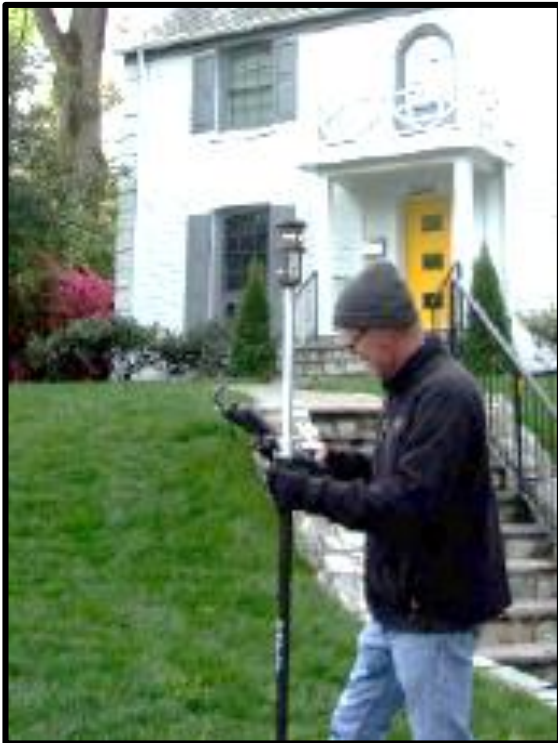
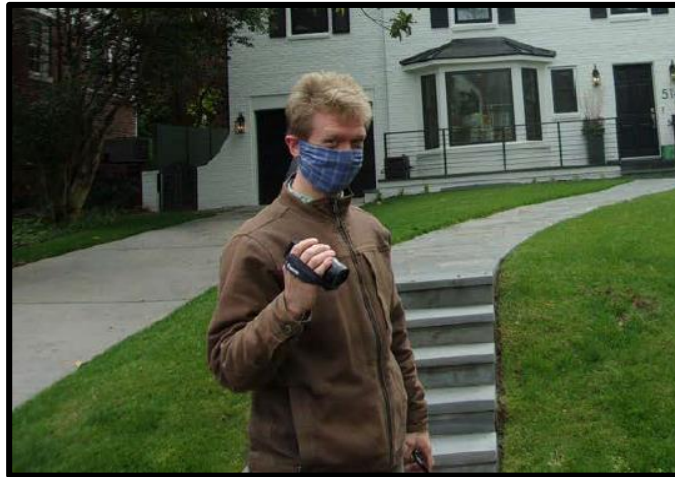
HD videos and civil surveys are conducted at private properties in preparation for geophysical surveys

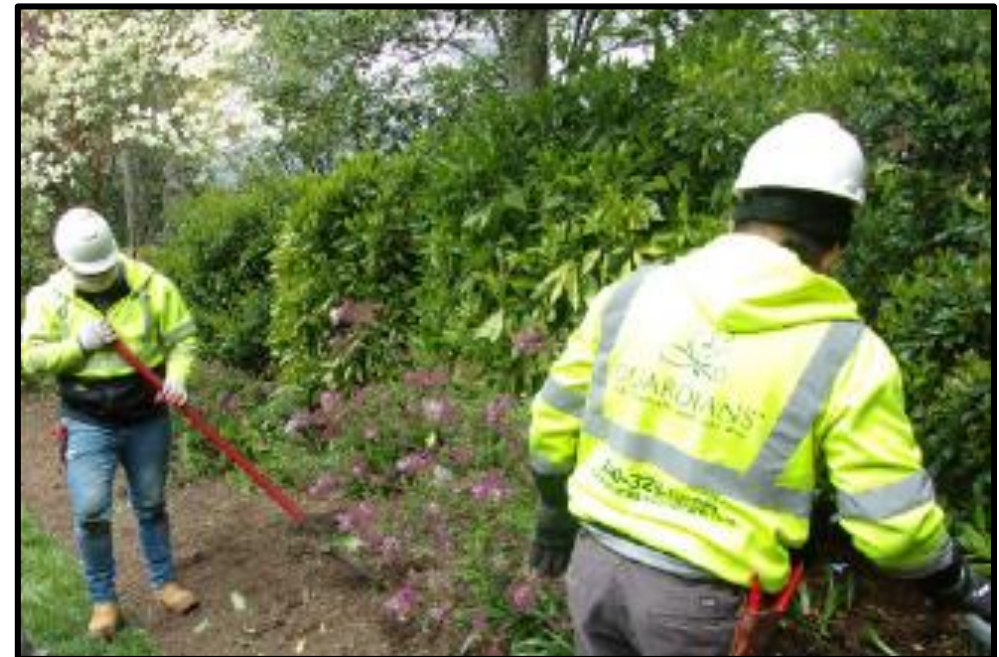
The team conducted vegetation removals prior to the start of geophysical surveys

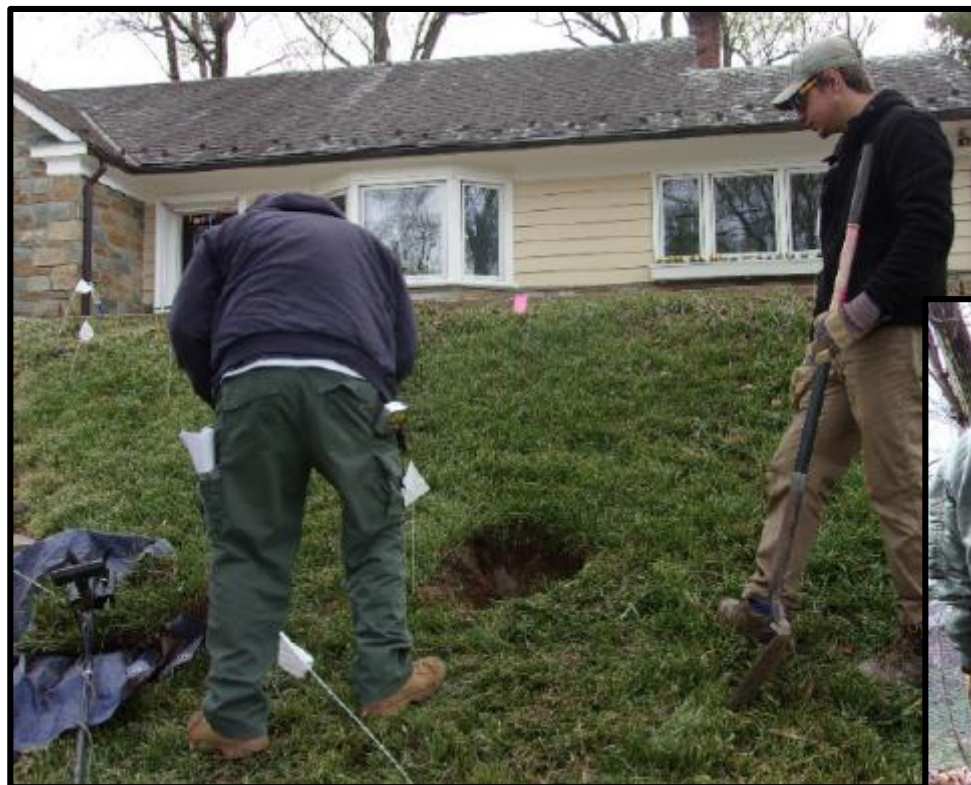
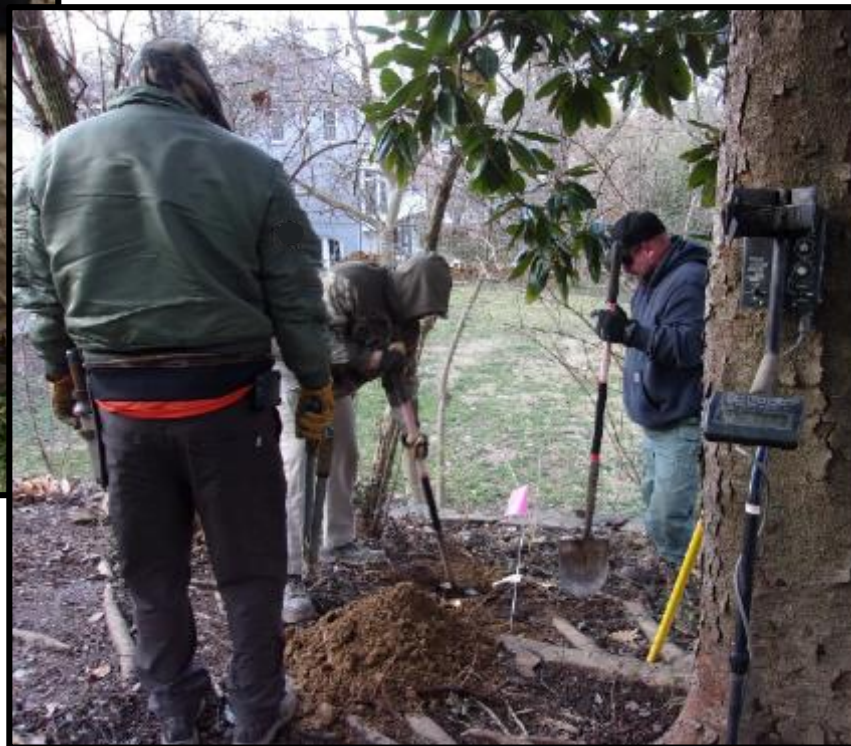
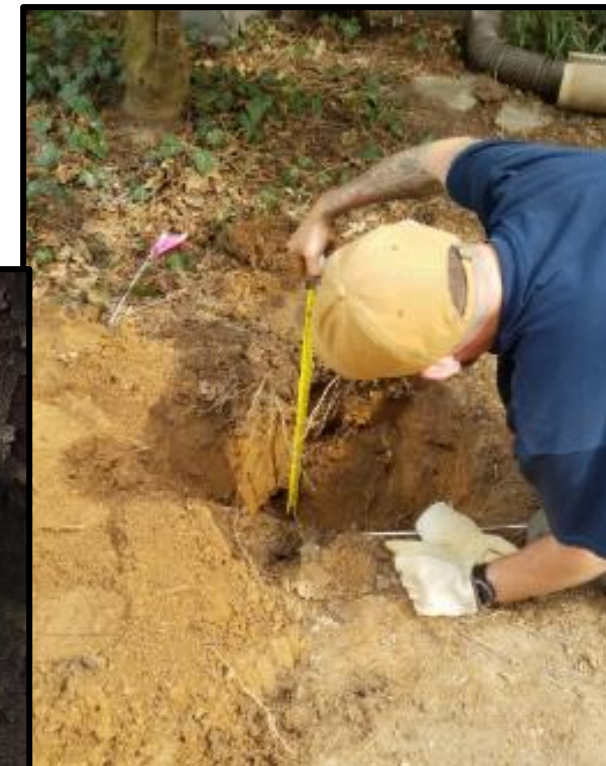
The team carefully excavates each target, checks each location with a metal detector to ensure the metal anomaly was removed, and fills the clear hole with soil.

The depth of each recovered anomaly is documented

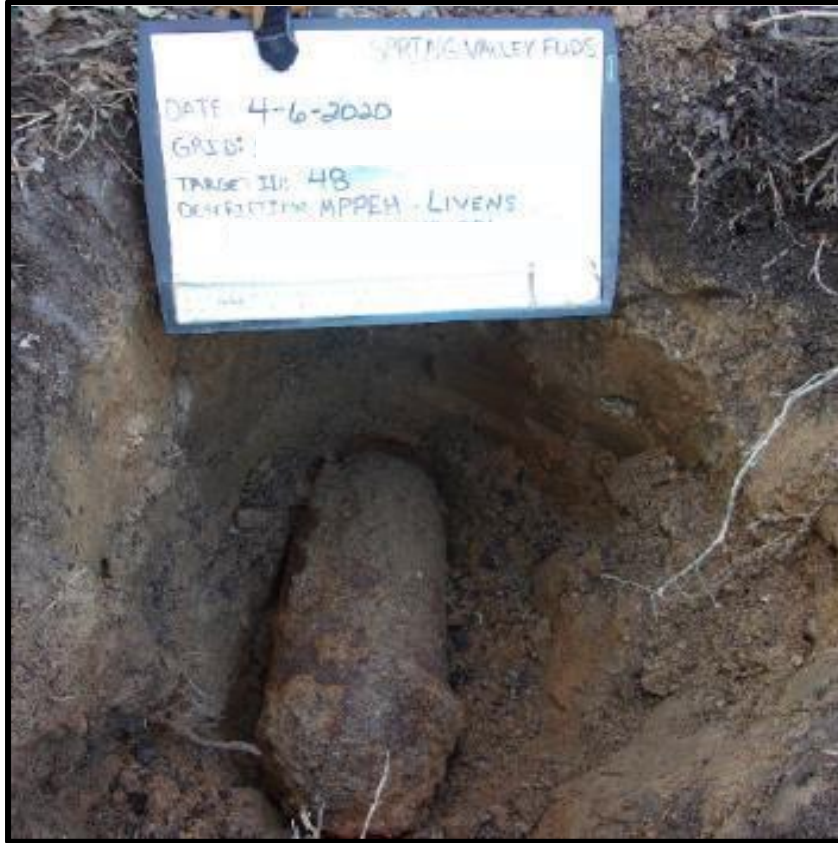
Livens Projectile

During the March intrusive investigation effort the dig team recovered a Livens Projectile. The item was examined and safely removed from the property.

The Explosive Ordnance Disposal (EOD) team came and x-rayed the item in place. The X-ray (right) helped the team confirm that this item was filled with a liquid. That liquid has been tested and has been determined to be bleach water mixture and did not contain chemical warfare material. The livens was classified as a Munitions and Explosives of Concern (MEC) item, having an explosive hazard. The team removed it from the property and it is being securely stored and will be disposed properly.

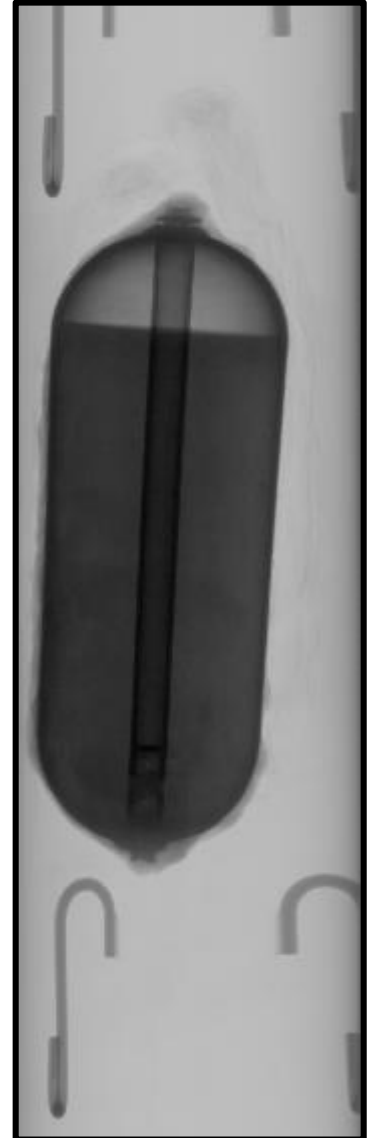
An X-ray image of the recovered Livens

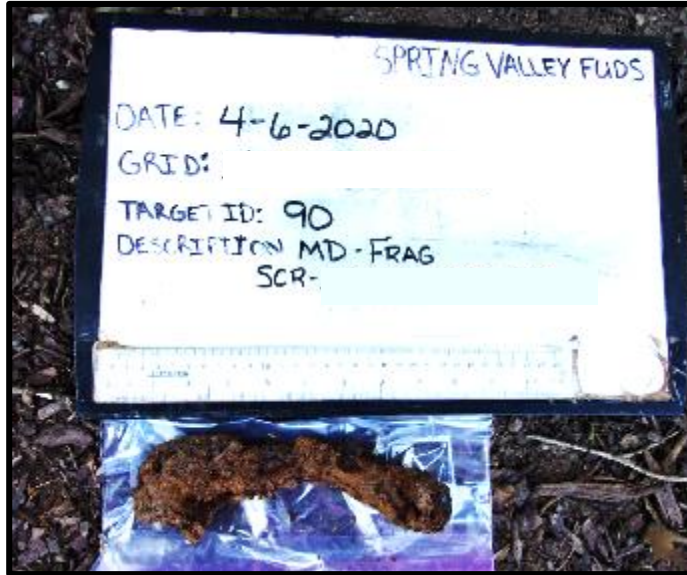
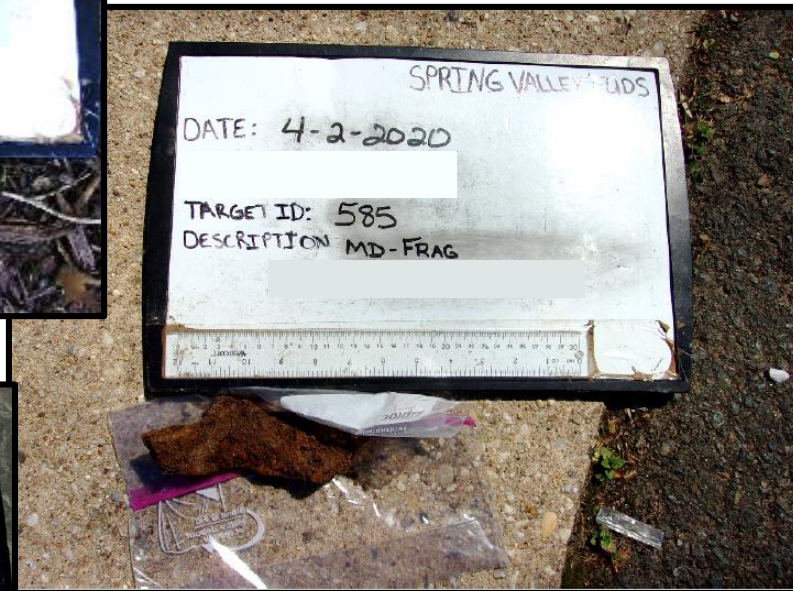
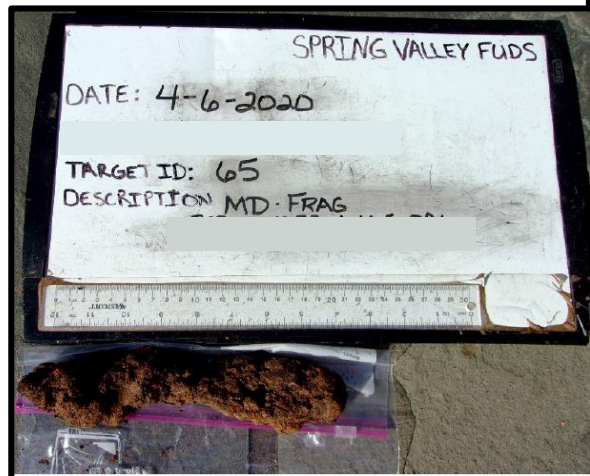
Other items were recovered during anomaly removals. The munitions debris and fragments are double bagged and tested for potential chemical residue (all clear to date).

Munitions debris recovered from private properties

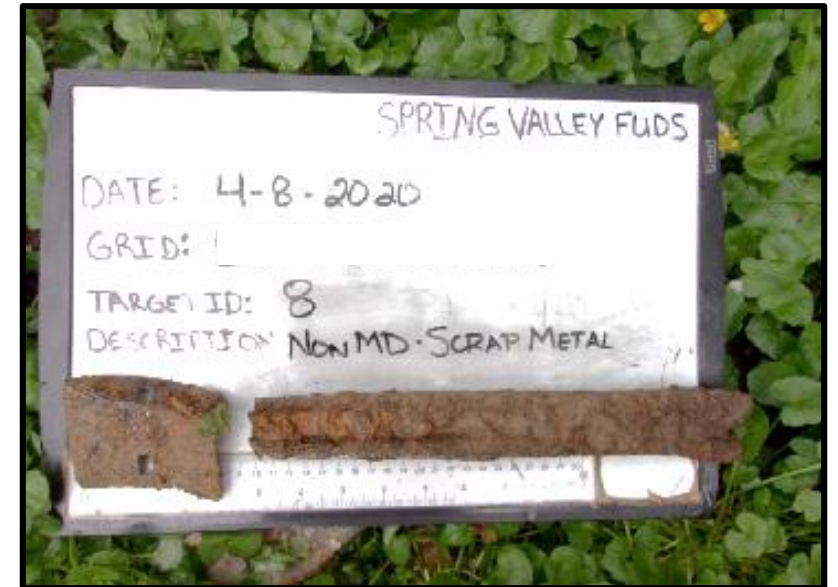
Non-Munitions related debris recovered from private properties

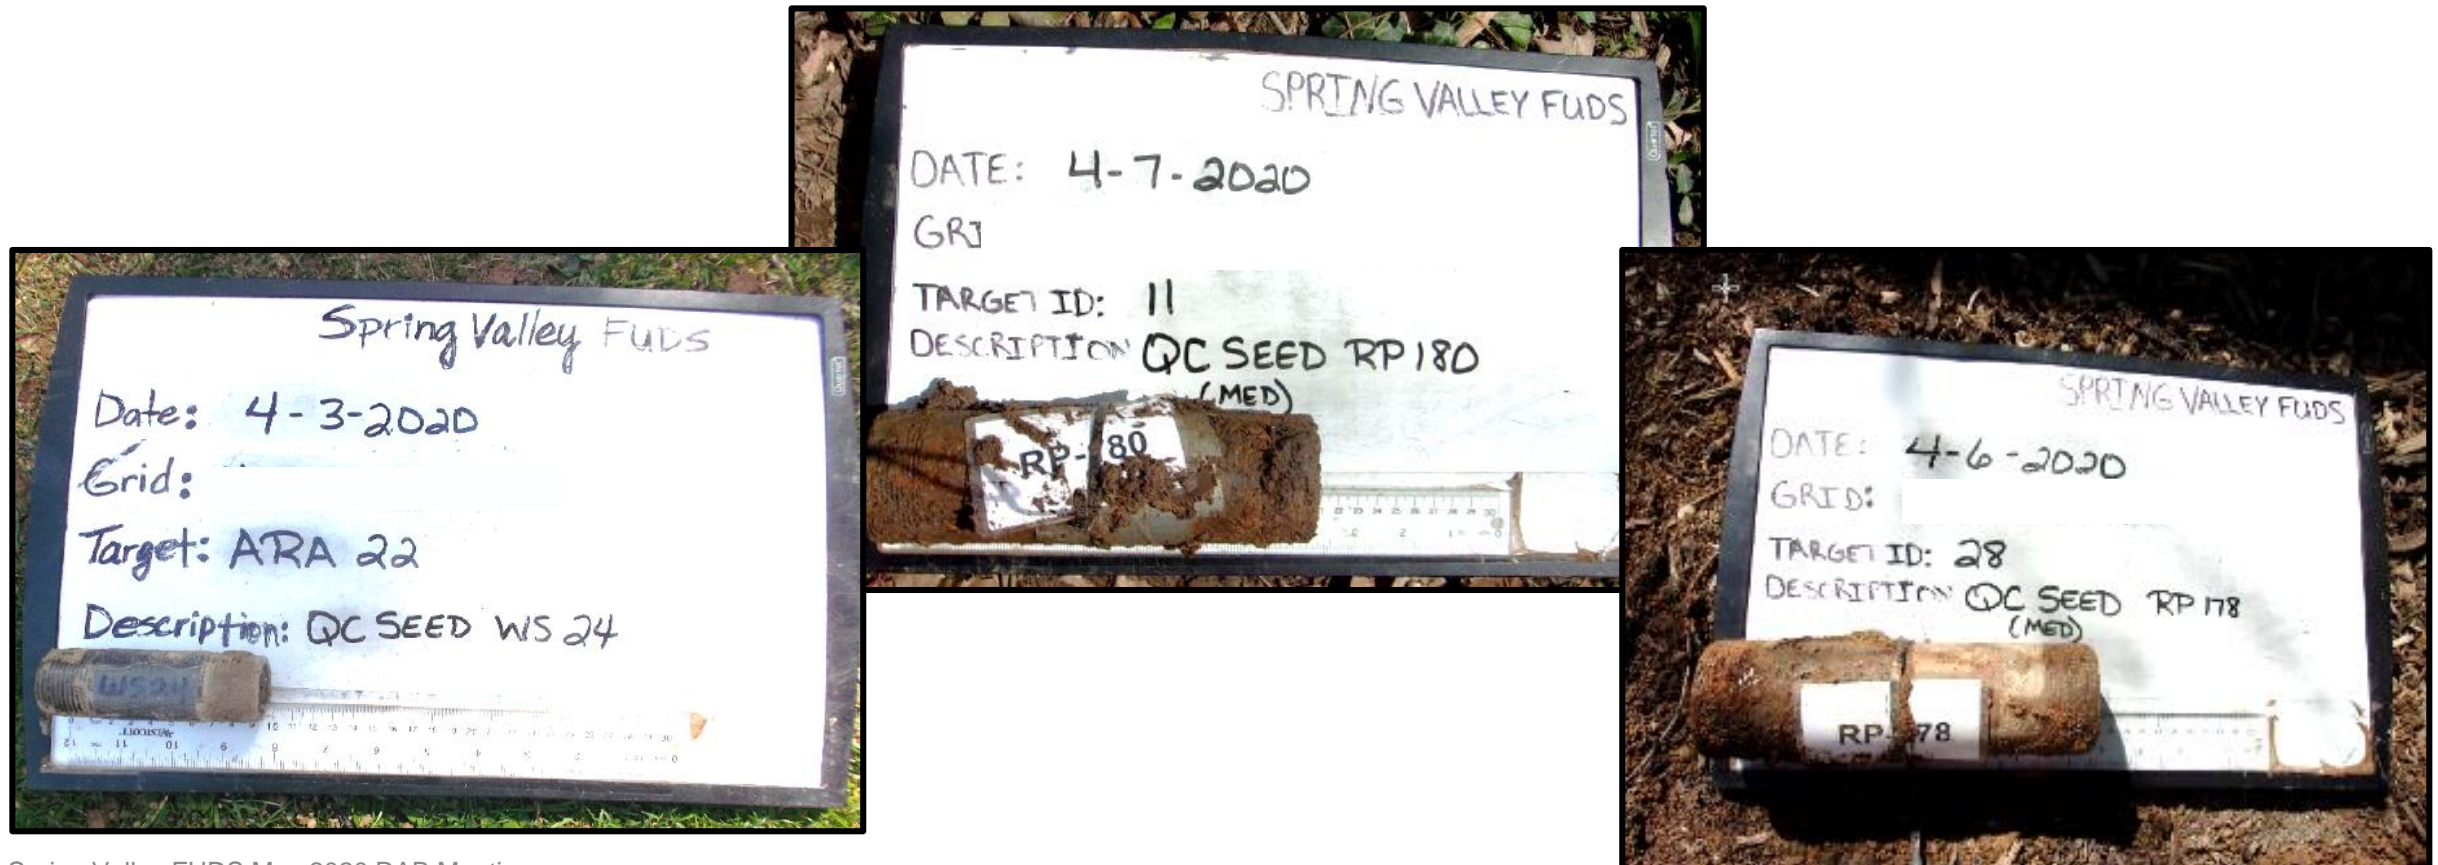
Blind Quality Control (QC) seeds are placed by Weston as an internal data collection and processing check. These act as a check of the work performed by the geophysicists.

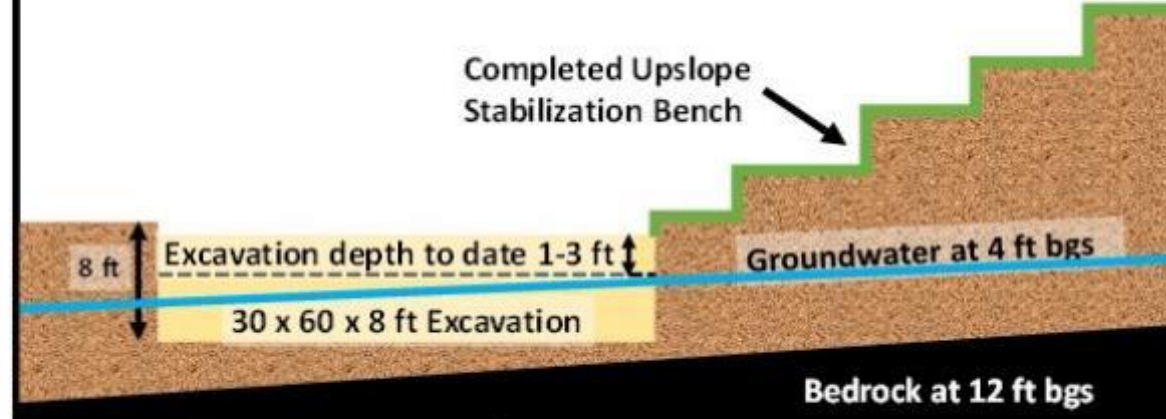
PSB Excavation Cross Section

Approx. location of "black" soil
-

Area excavated to 1' BGS *
-

Area excavated to 2' BGS
-

Area excavated to 3' BGS

"Black soil" refers to higher levels of contamination and debris were found in this soil

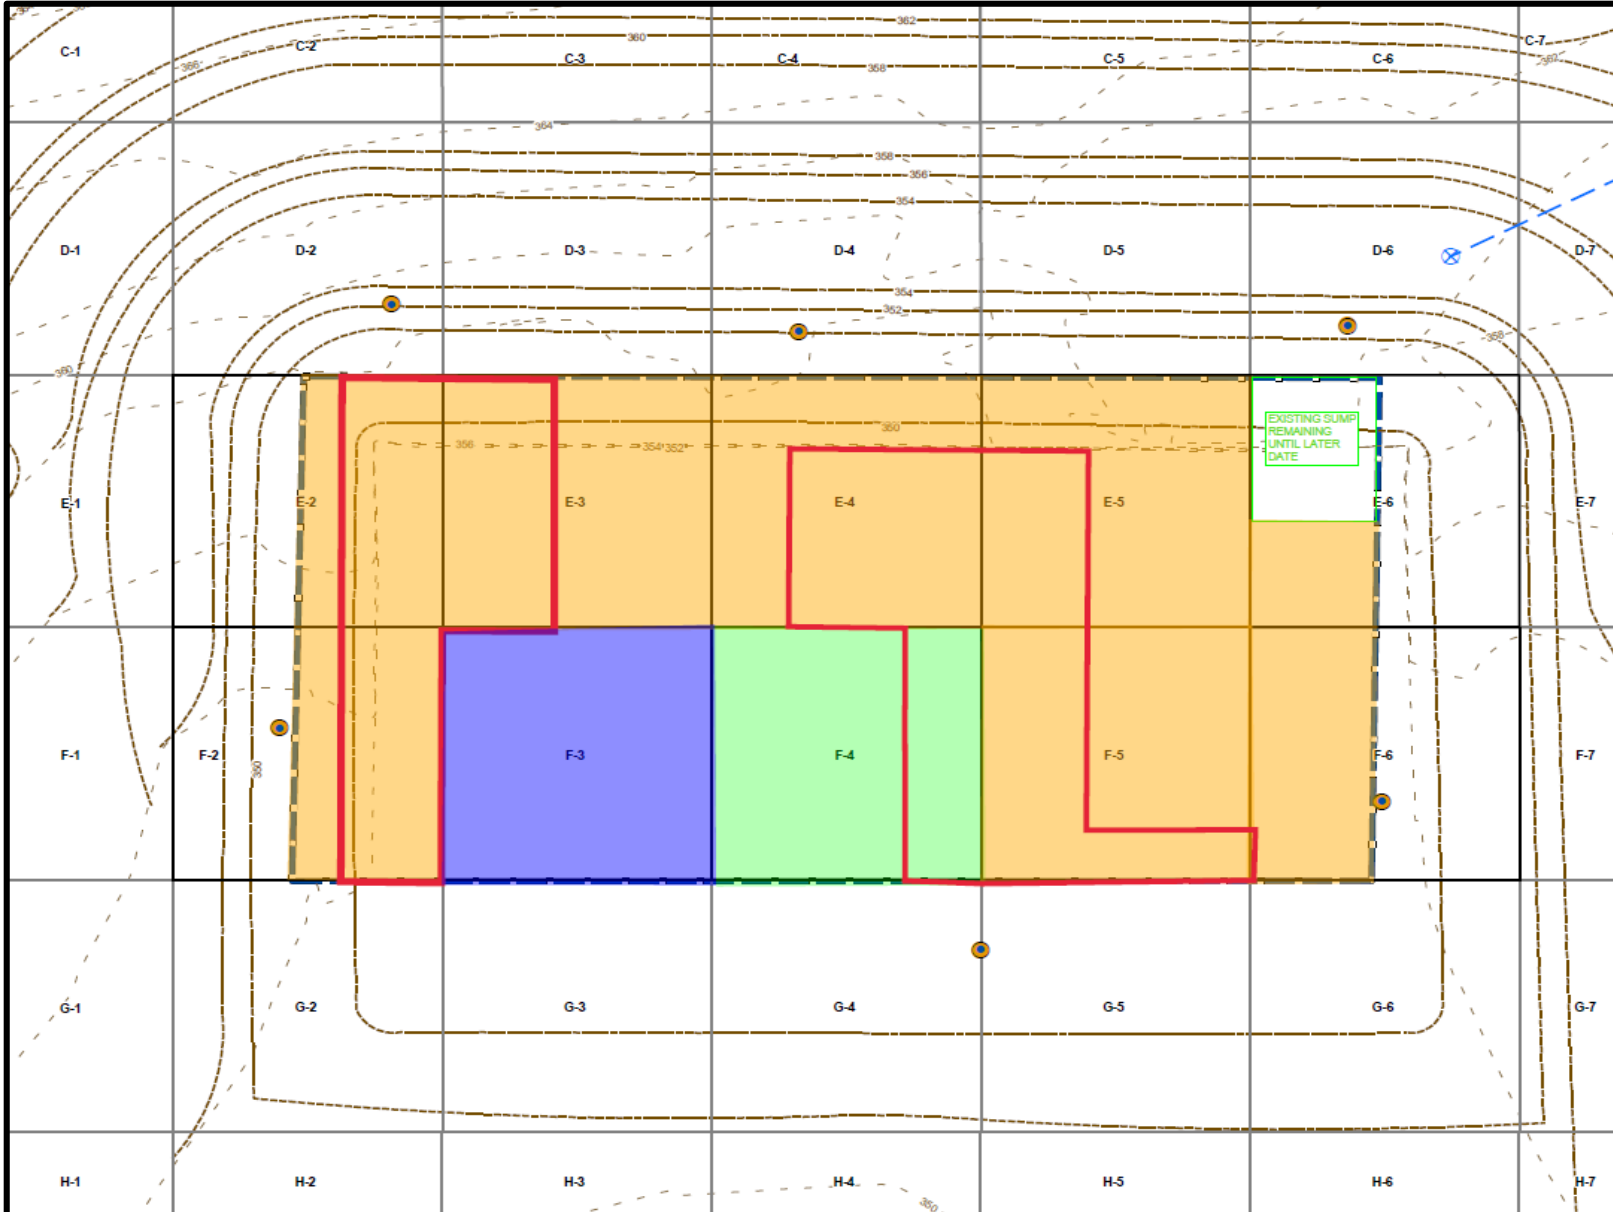
AU's Former Public Safety Building

PSB Foundation Boundary
-

Abandoned Storm Drain Pipe
-

Sump Location
-

Approx. location of "Black Soil"
-

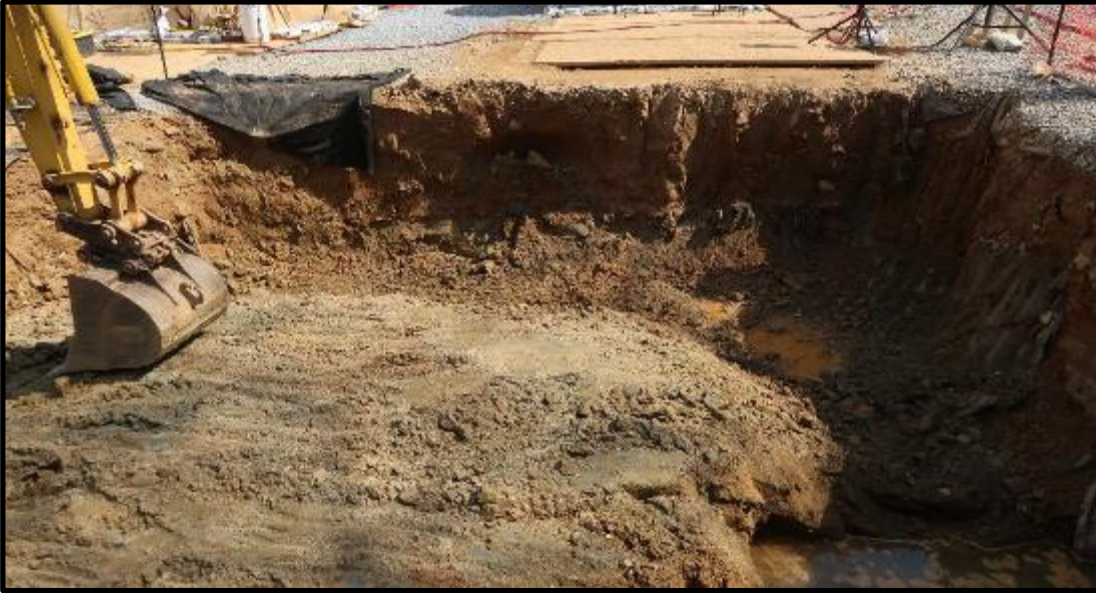
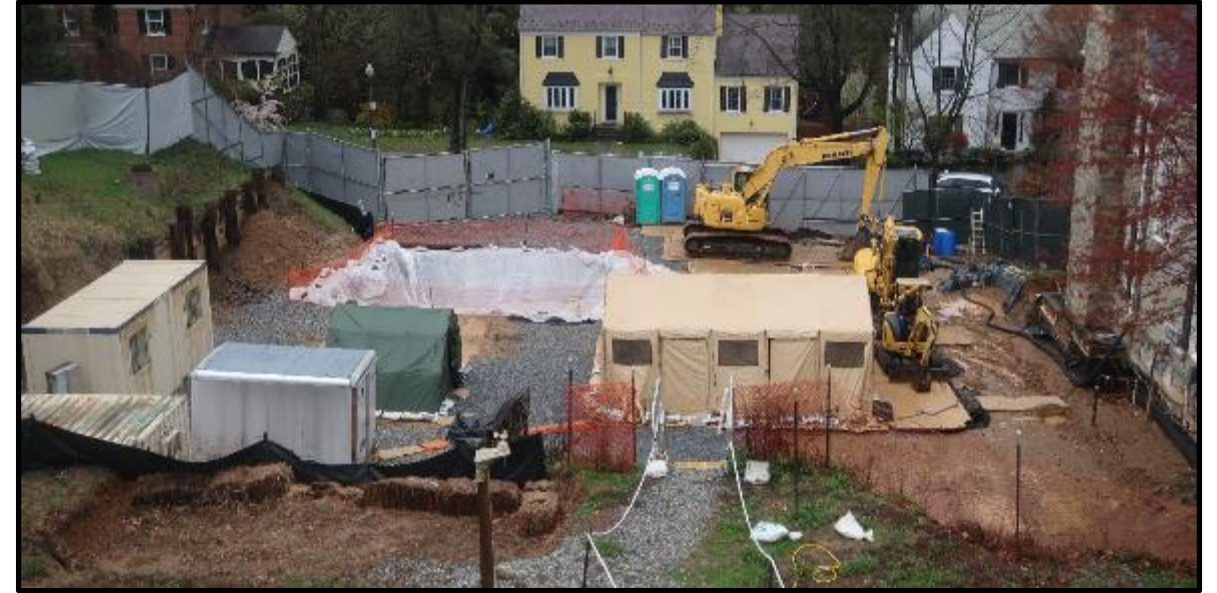
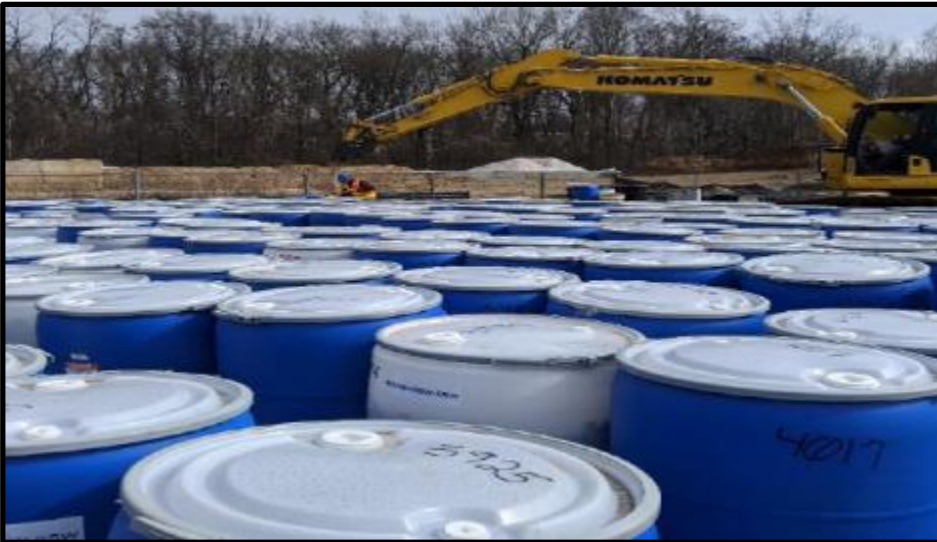
In March, the excavation at Area 4 was tentatively completed and covered with tarp while awaiting the final sampling results.

The filled soil drums were properly labeled and brought to the Federal Property prior to being transported for disposal.

In April, the lab results confirmed Area 4 is complete.

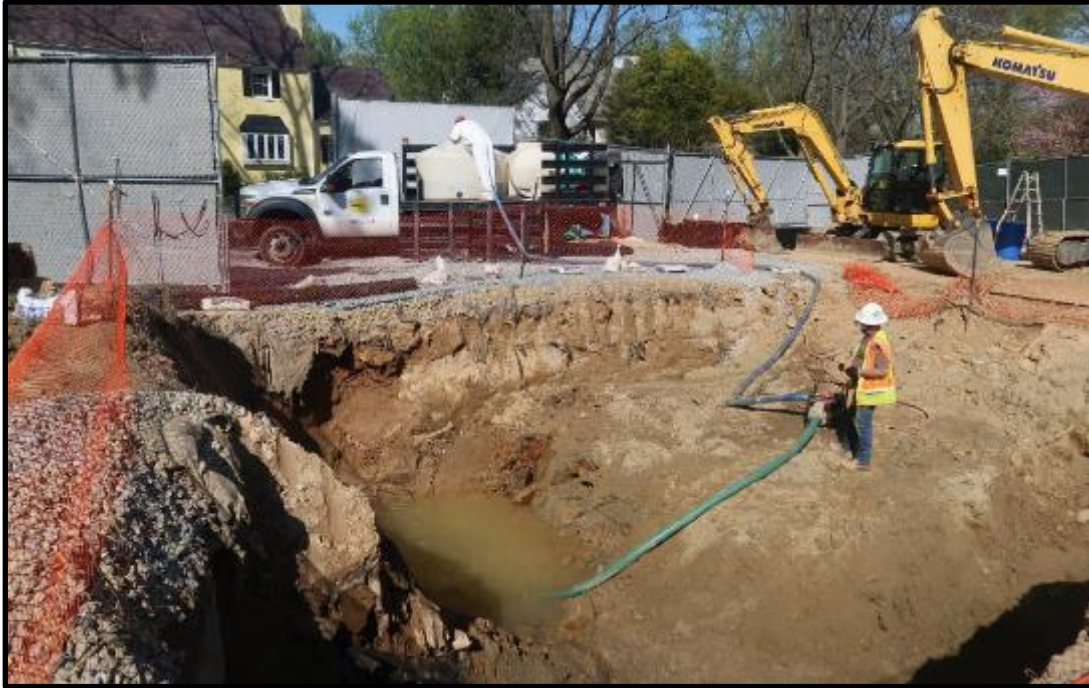
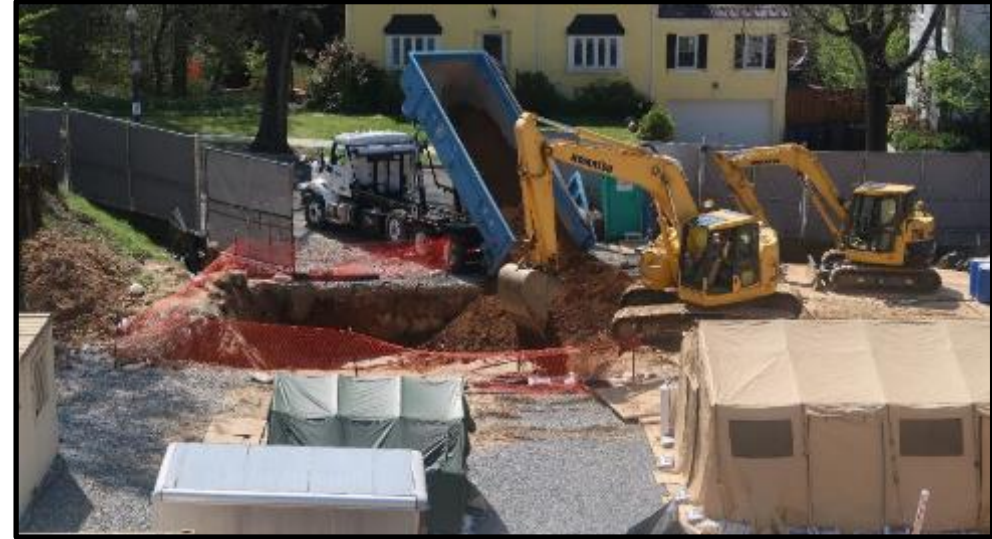
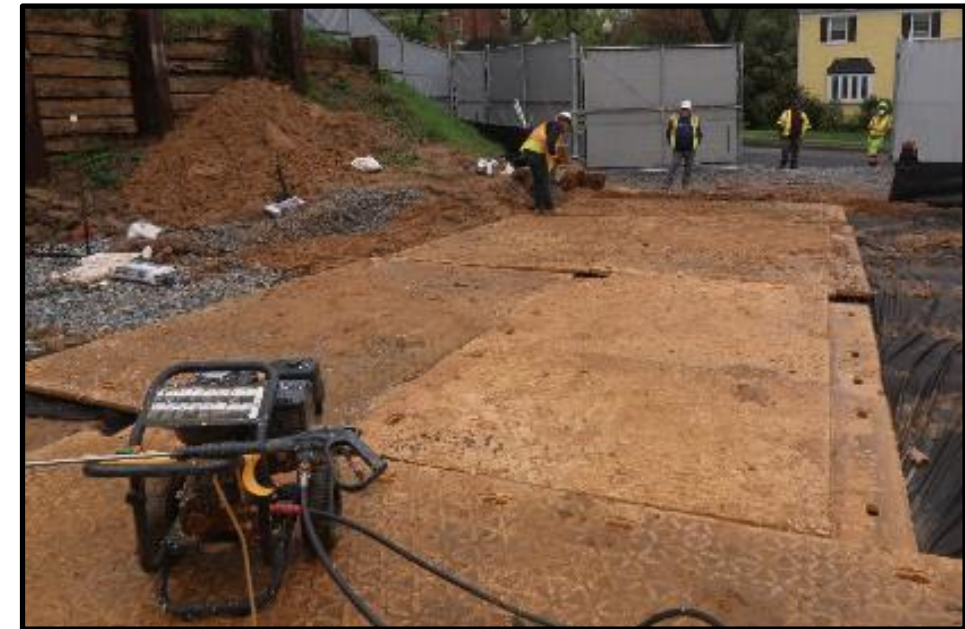
A week after excavating Area 4, the crew pumped over 2500 gallons of water from heavy rains and seeping groundwater.

The excavation area was then backfilled with 15 rollofs of soil, and construction mats were set up for truck access.

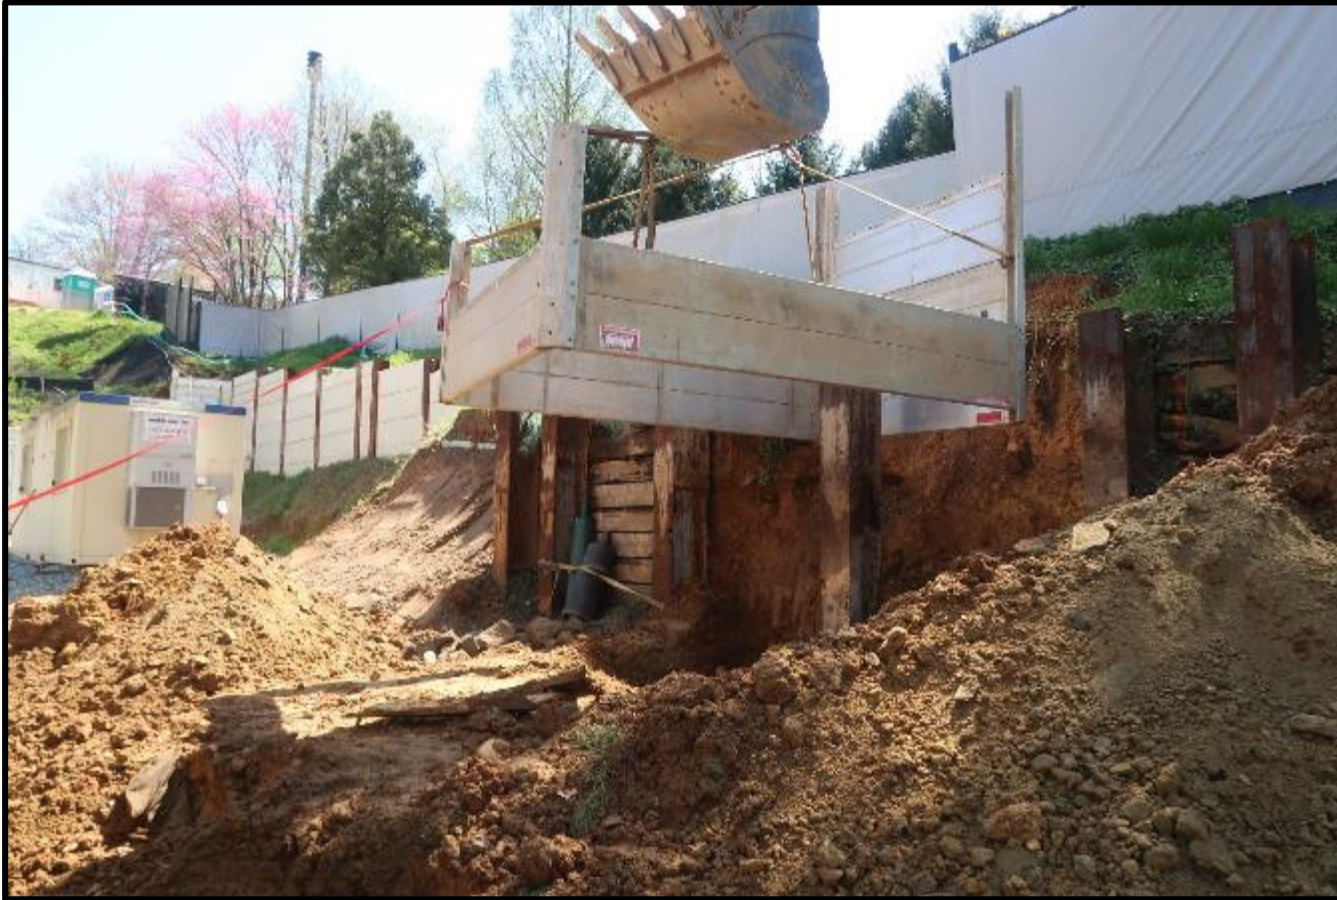
Removing select soldier piles at the front of the property along the shared property line with 4801 Glenbrook Road, involves safely removing the remaining wood shoring and steel I-beams that have held the soil embankment during our deep excavation of the area.

To conduct this effort safely, the crew constructed a reusable shoring box to install at each soldier pile during the removal process.

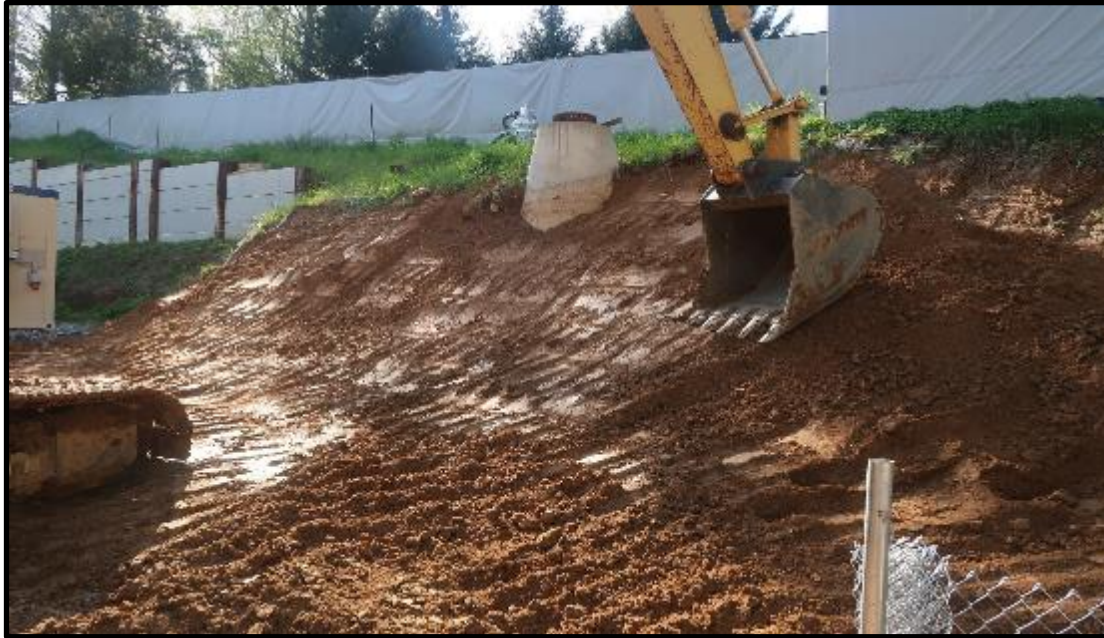
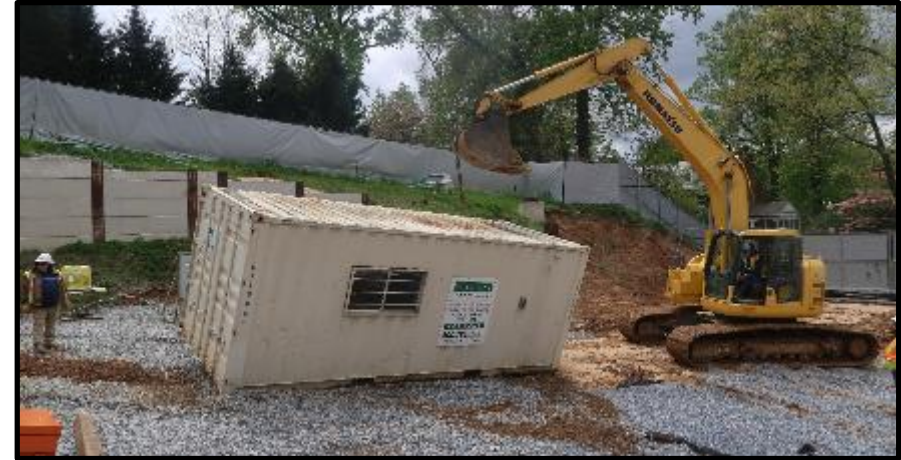
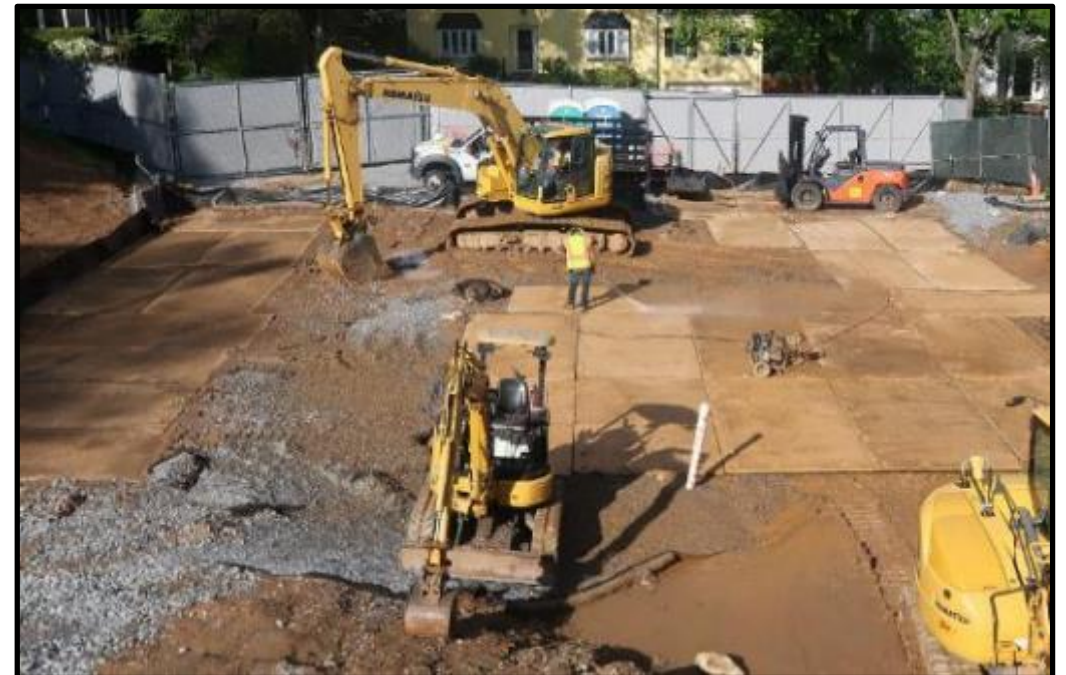
After completing the removal of the solidier piles, backfill was brought to the site to fill and stabilize the slope.

At the end of April into May, sheds, heavy equipment and construction mats are removed to clear the site for further restoration efforts.

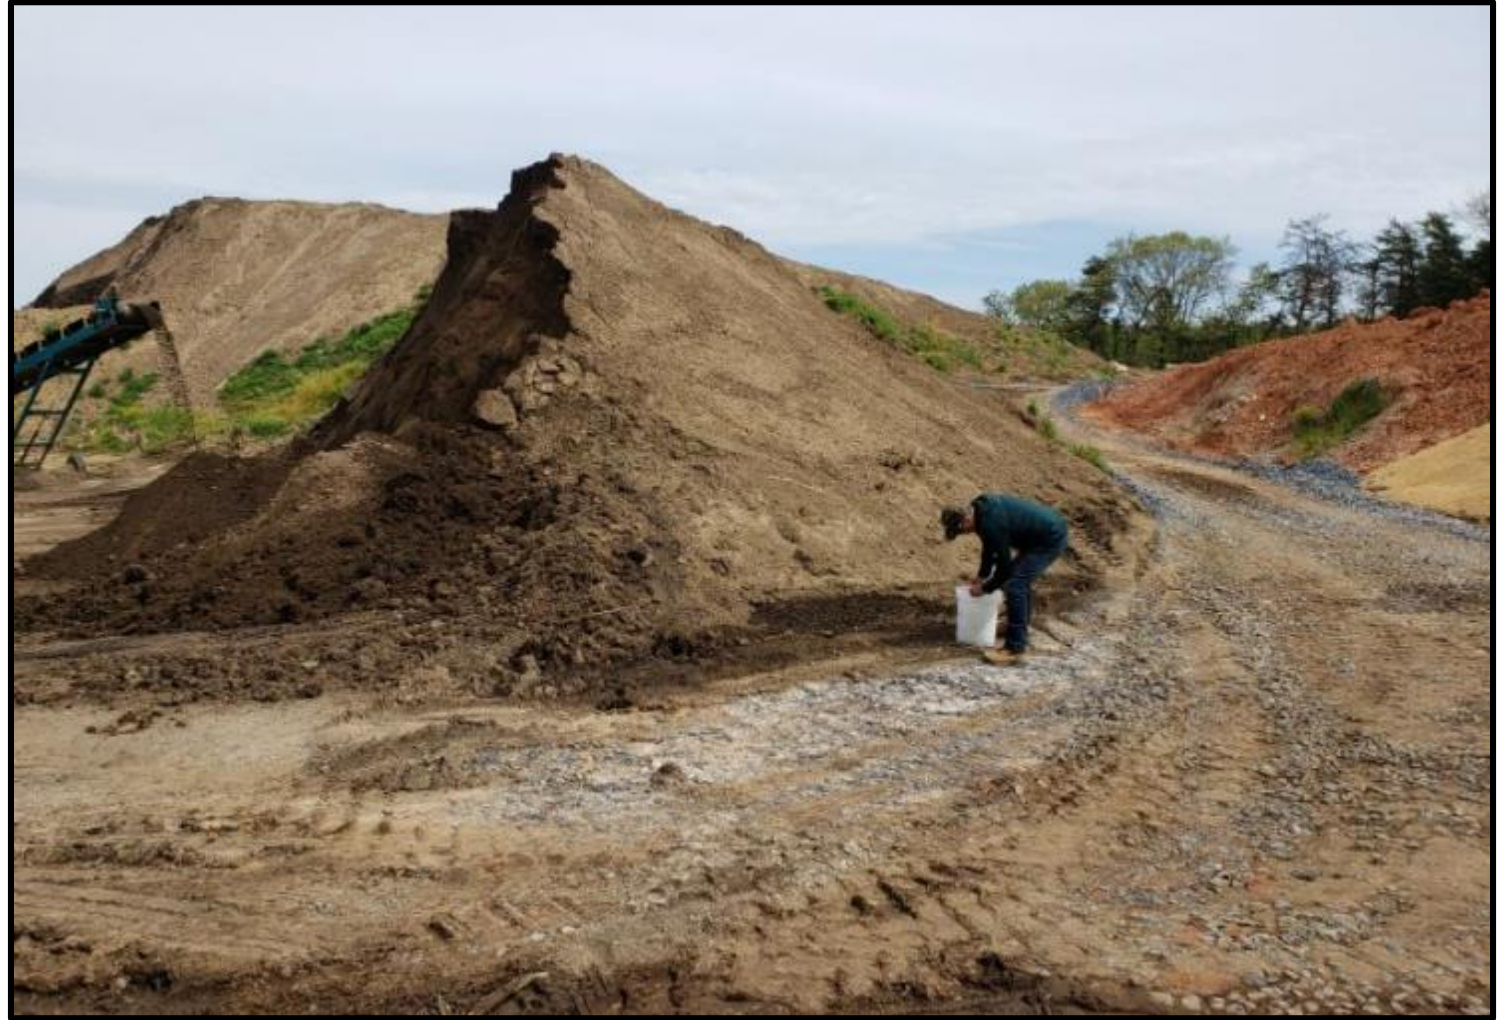
Our onsite team has spent the past few months locating and then sampling potential sources for clean backfill and topsoil. The approved soil will be stored at the Federal Property and then brought to the site for the final restoration effort.

Sampling a potential topsoil supply from Aggtrans.

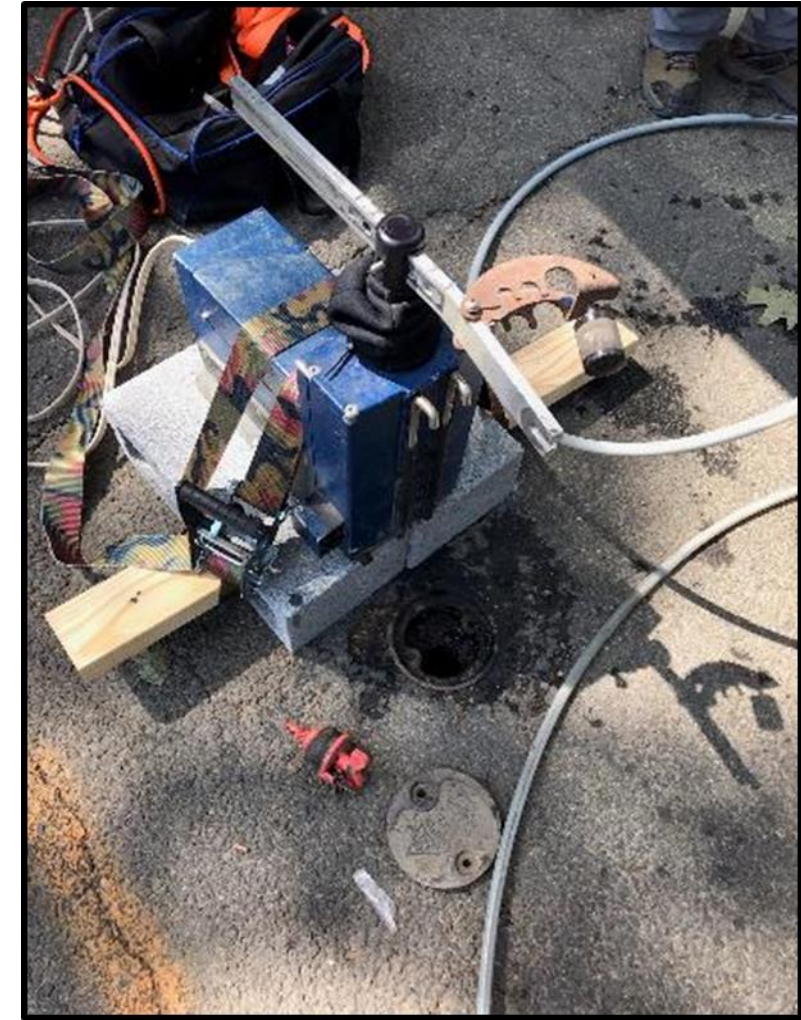
Groundwater sampling well

- The Army Corps has prepared the groundwater sampling plan for the upcoming sampling event. It is currently being reviewed by the regulatory Partners (DOEE and EPA). Once the plan is approved by the Partners, the sampling event will be carried out following COVID-19 guidelines as needed.
- After the confirmation sampling is completed, the Army Corps and Partners will discuss the results and determine the path forward for the final groundwater approach.
