SPRING VALLEY FORMERLY USED DEFENSE SITE

Restoration Advisory Board Meeting
NOVEMBER 2020

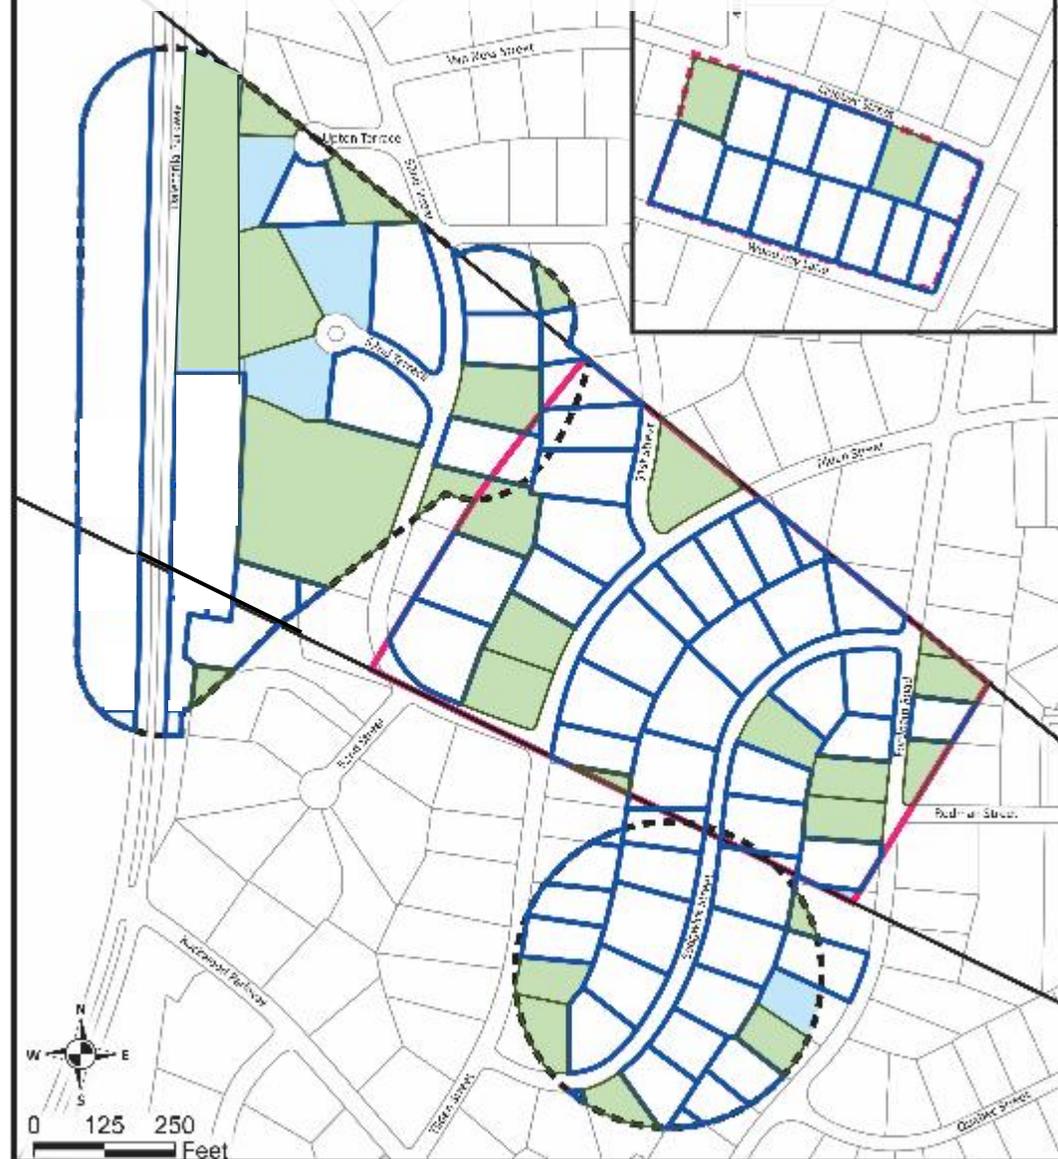
Planned Remedial Action Area

- Future Remedial Action
- Remedial Action work in progress
- Remedial Action Work – No Further Action Required

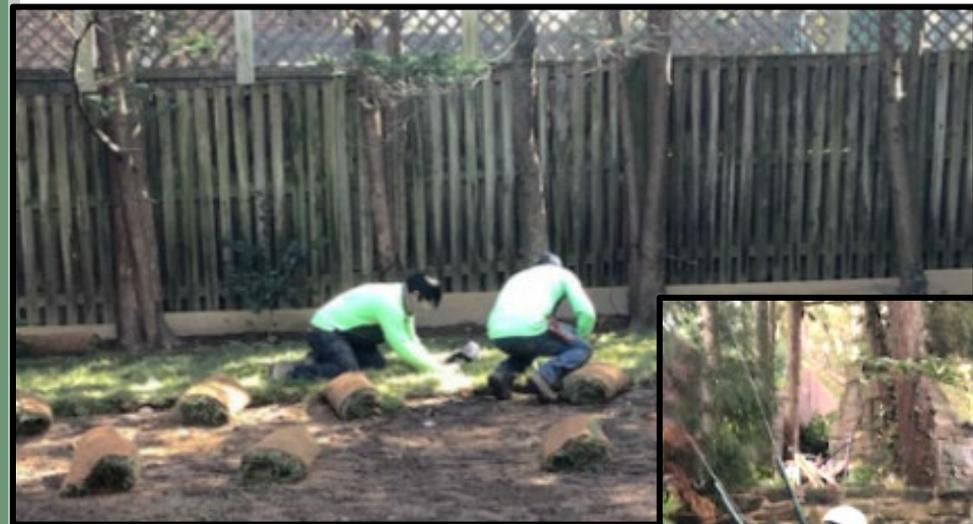
The team carefully replacing sod during restoration.

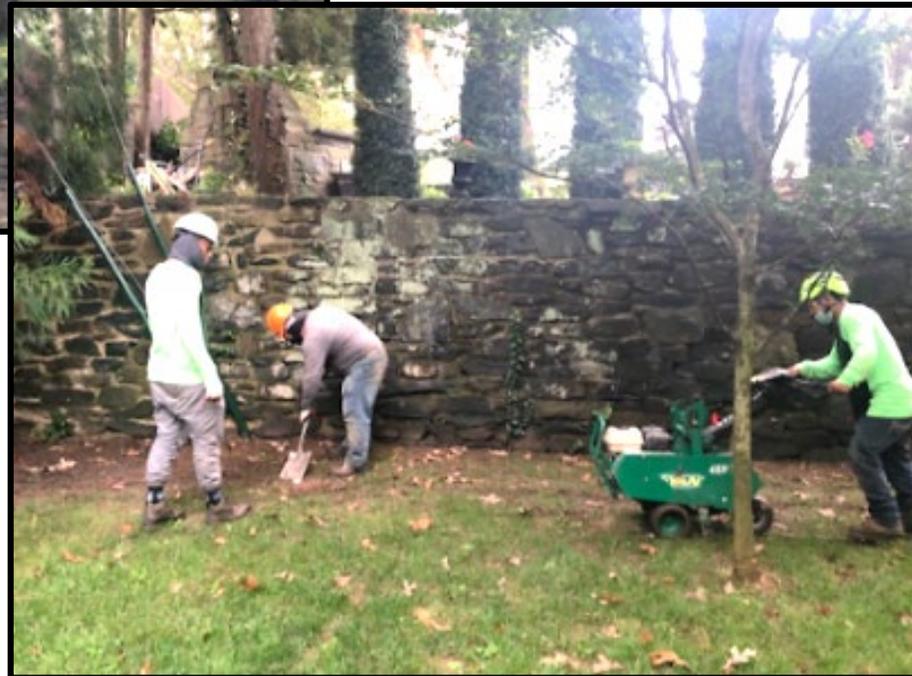
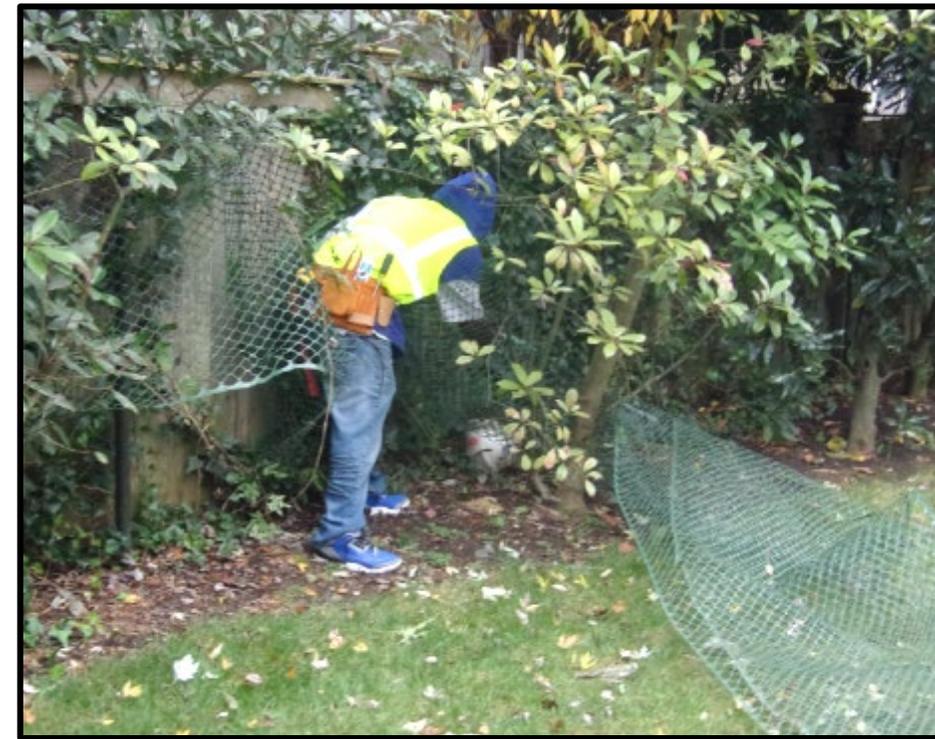
Removing temporary fence to install new fencing during site restoration.

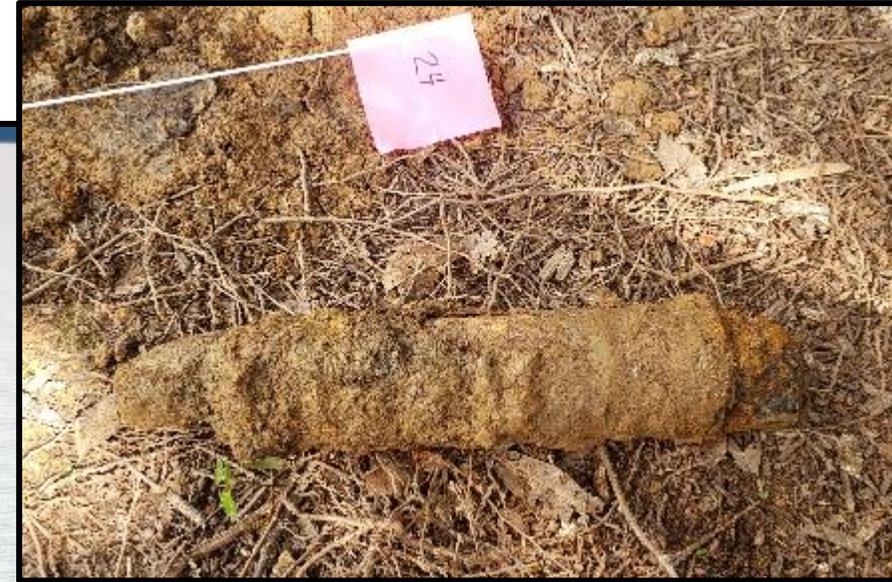
During the intrusive investigations on 16 September, the team encountered an intact 3-inch stokes mortar round on Quebec Street within Area of Interest (AOI) 13.

- The processed survey data classified the 3-inch round as a “target of interest” and it was matched to the ordnance from the site-specific library.
- The Army Corps’ Ordnance and Explosives Safety Specialist and an Explosive Ordnance Disposal (EOD) unit from Joint Base Andrews responded to the site.
- The item was x-rayed in place, examined, and the EOD unit safely transported the item offsite for disposal. The EOD unit reported that the 3” Stokes had a high explosive (HE) filler.

***Recovered
3-inch stokes
mortar round***

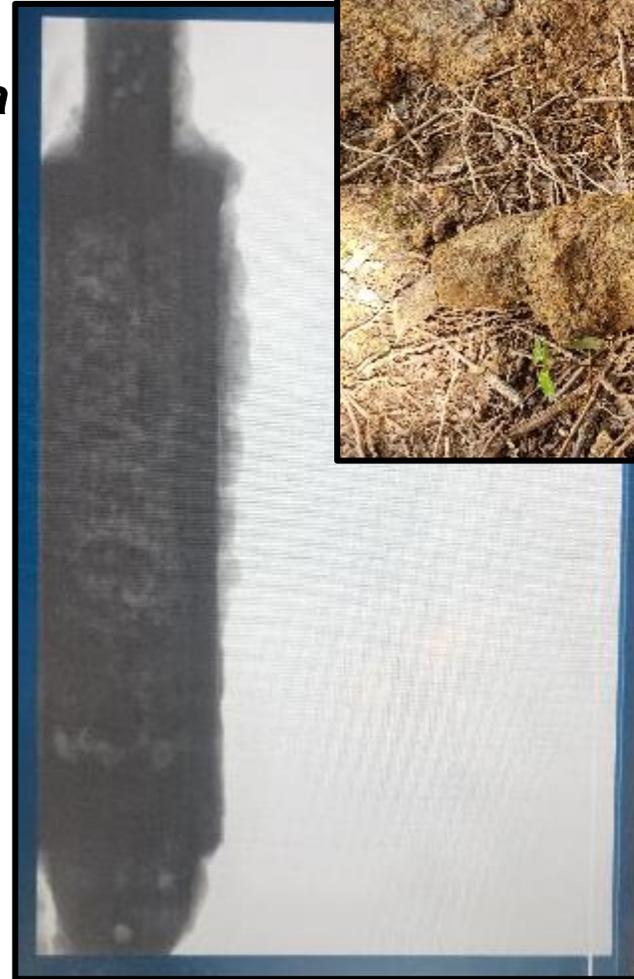
X-ray of the mortar round

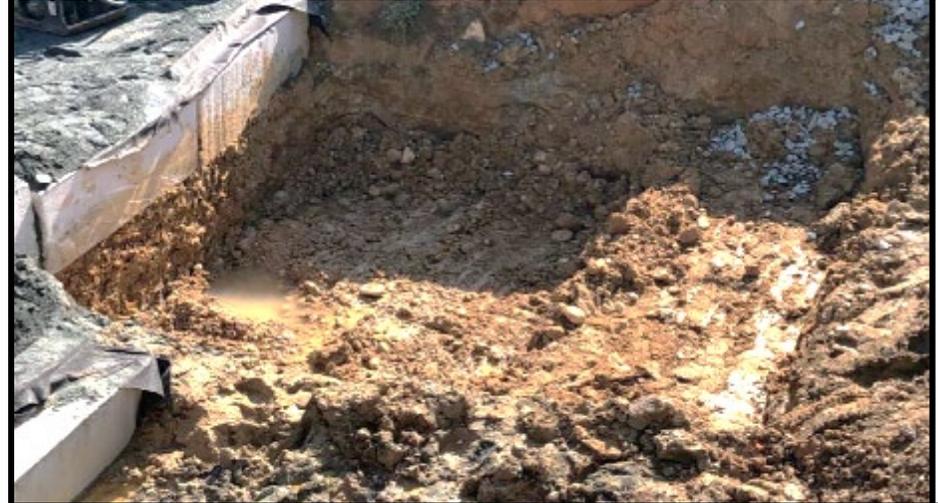
- The team completed digging test pits at the site which helped determine the final excavation boundaries for the for PSB, as well as to conduct confirmation soil sampling.
- Excavation to these final boundaries were initiated in October to depths up to 8 feet below slab grade.
- All excavated material is transferred to the sorting table, processed, and transferred off-site for analysis and disposal. The team continues to encounter lab-grade glassware

Grid Cell F-5 excavated to 8 feet below slab grade

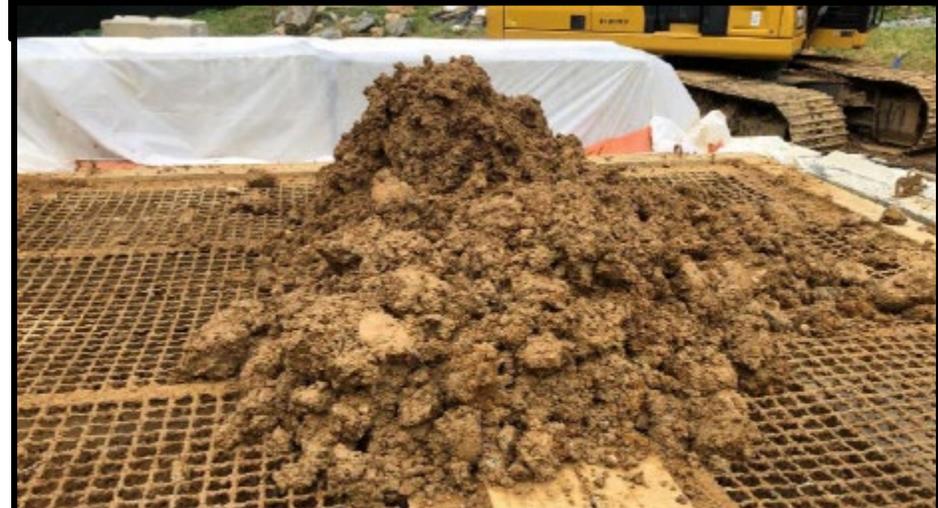
Excavated material from Grid Cell F-5 on soil sorting table

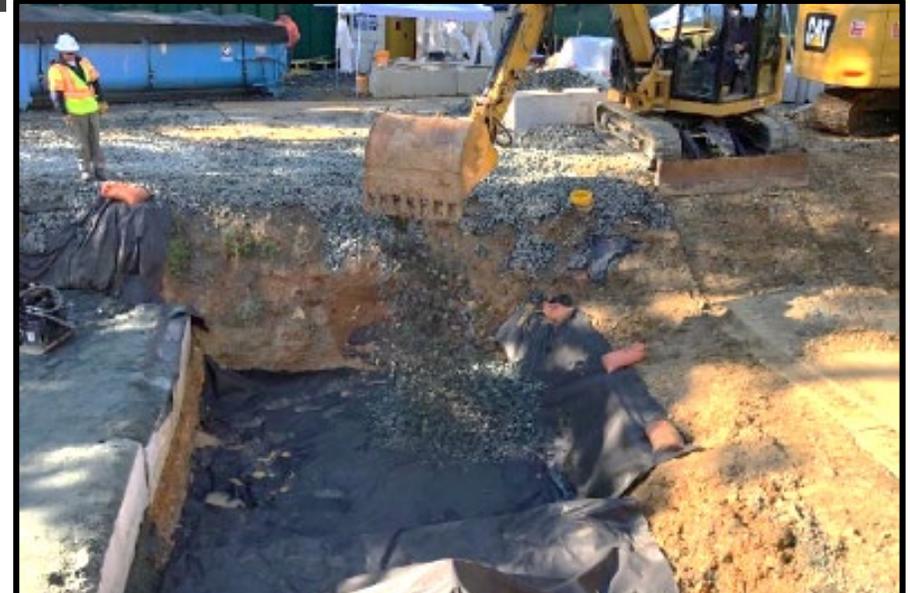
- Once excavation is completed within a grid cell, the team reviews the data to confirm the excavation floor and soil meets the cleanup criteria.
- After this is confirmed, backfilling activities are conducted in the grid cell. This includes non-woven geotextile, No. 2 stone, and imported granular fill.
- Bin blocks are installed around the borders of the grid cell to contain the layers of fill. Once the fill is in place and compacted using a remote-control vibratory drum compactor, the blocks are removed.

No. 2 stone filled on top of geotextile during backfilling activities in Grid cell F5

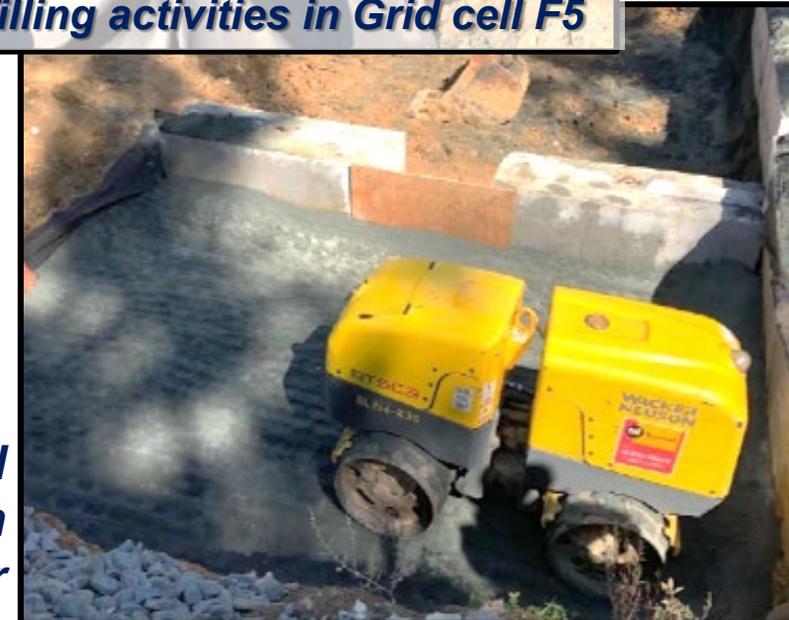
Remote-control vibratory drum compactor

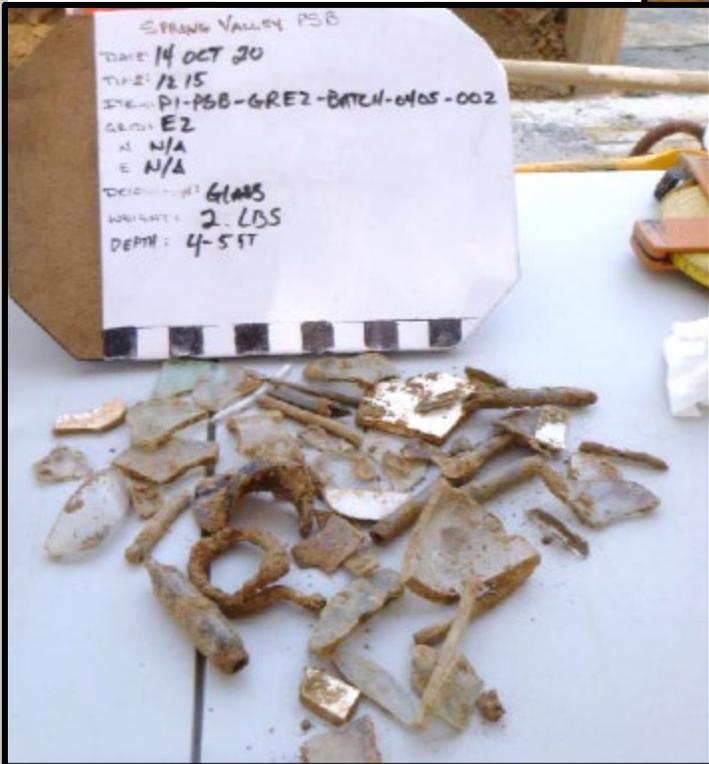
Batch glass collected at 4-5 feet Grid Cell E-2

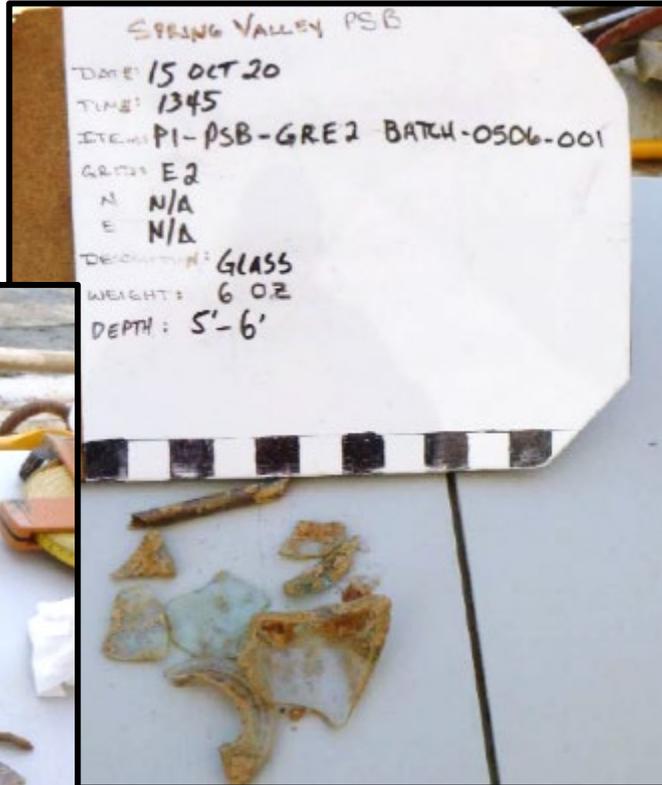
Batch glass collected at 5-6 feet Grid Cell E-2

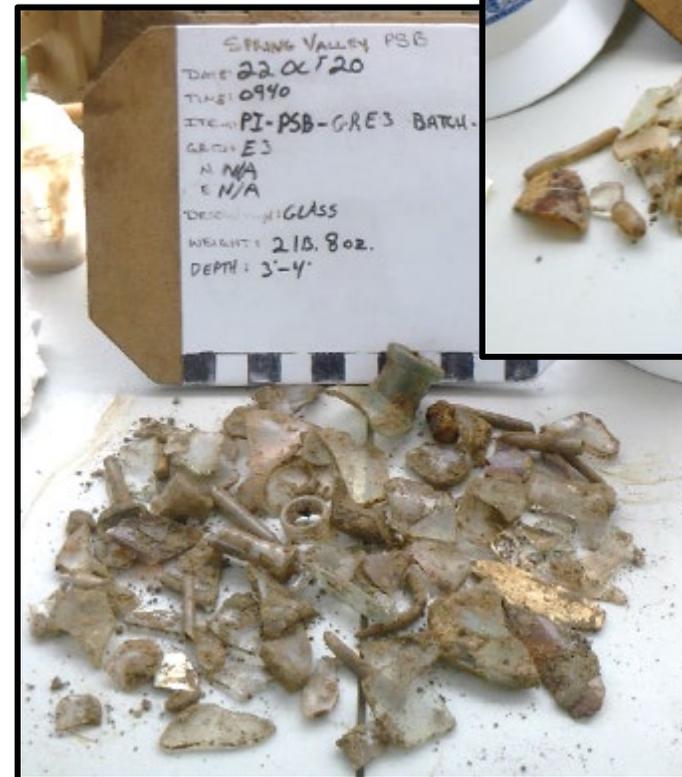
Batch glass collected at 3-4 feet Grid Cell E-3

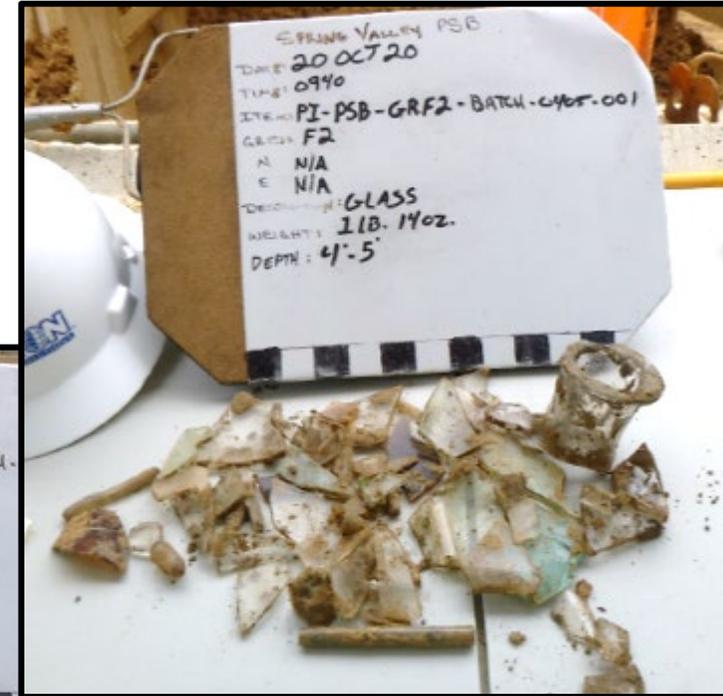
Batch glass collected at 4 to 5 feet Grid Cell F-2

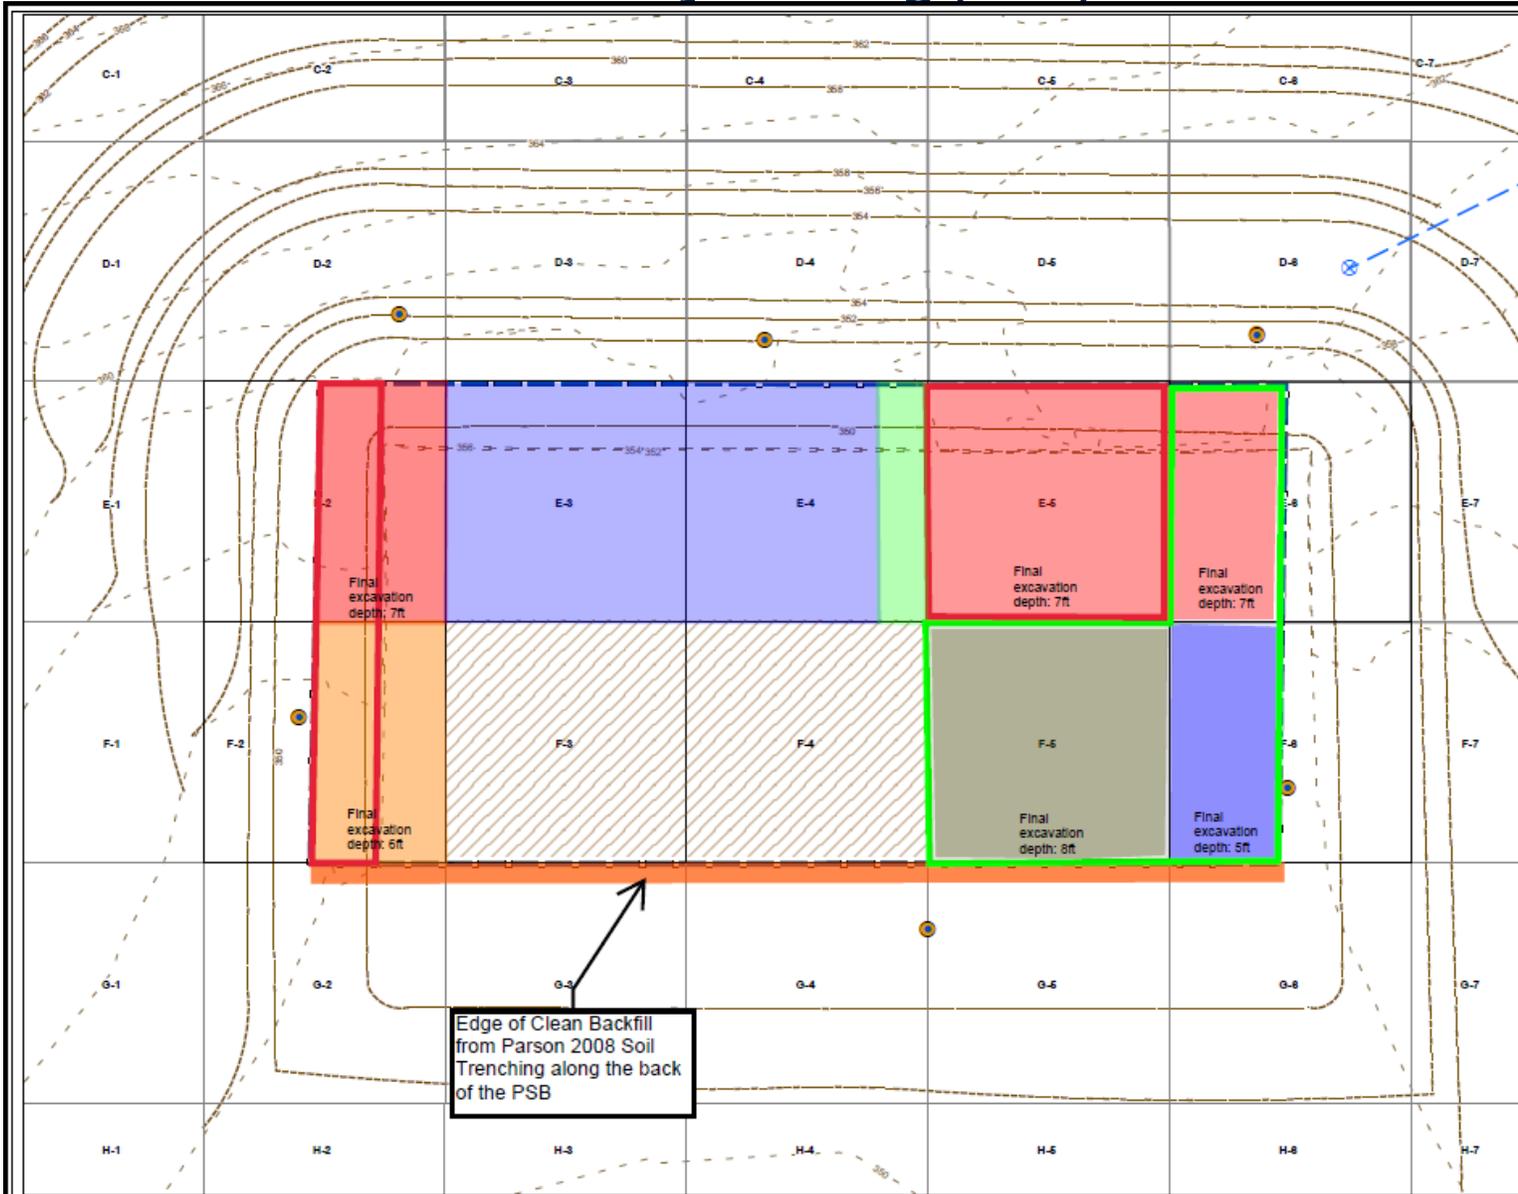
- Public Safety Building Foundation Boundary
- Grids (15 x 15 ft)
- Public Safety Building Foundation Grids
- Public Safety Building Excavation Area Grids
- Contour Elevation (2ft interval)
- Abandoned Storm Drain Pipe
- Abandoned Storm Drain Pipe Location
- Sump Locations
- Backfill operations within grid cell in process.
- Area backfilled up to 3ft below former PSB slab elevation.
- Area that has been excavated down to 4ft below ground surface.
- Area that has been excavated down to 5ft below ground surface.
- Area that has been excavated down to 6ft below ground surface.
- Area that has been excavated down to 7ft below ground surface.
- Area that has been excavated down to 8ft below ground surface.
- Area previously excavated before March 27th COVID-19 shutdown. Depth is 3-4ft below ground surface.

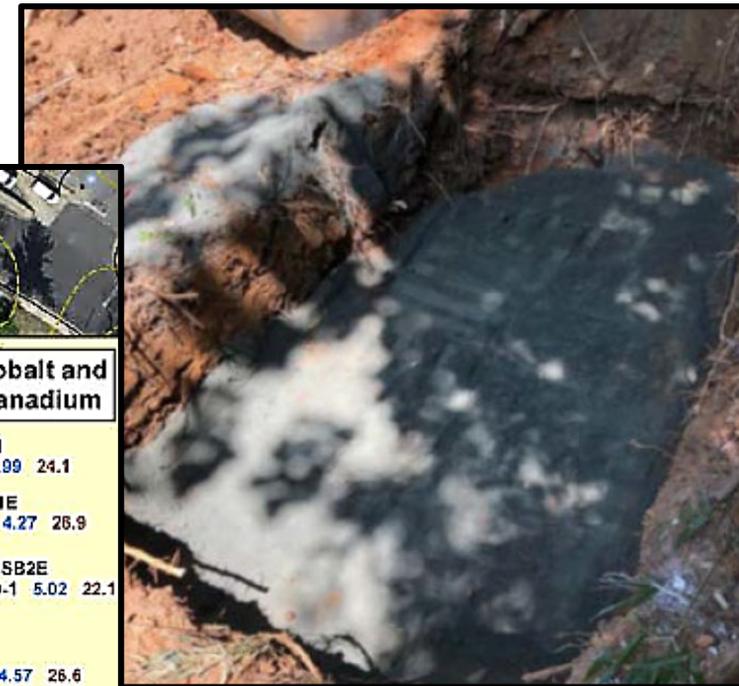
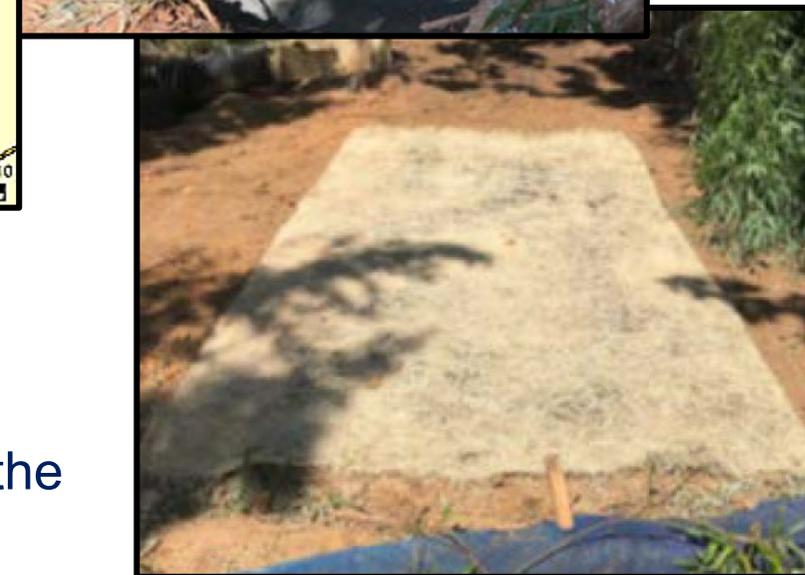
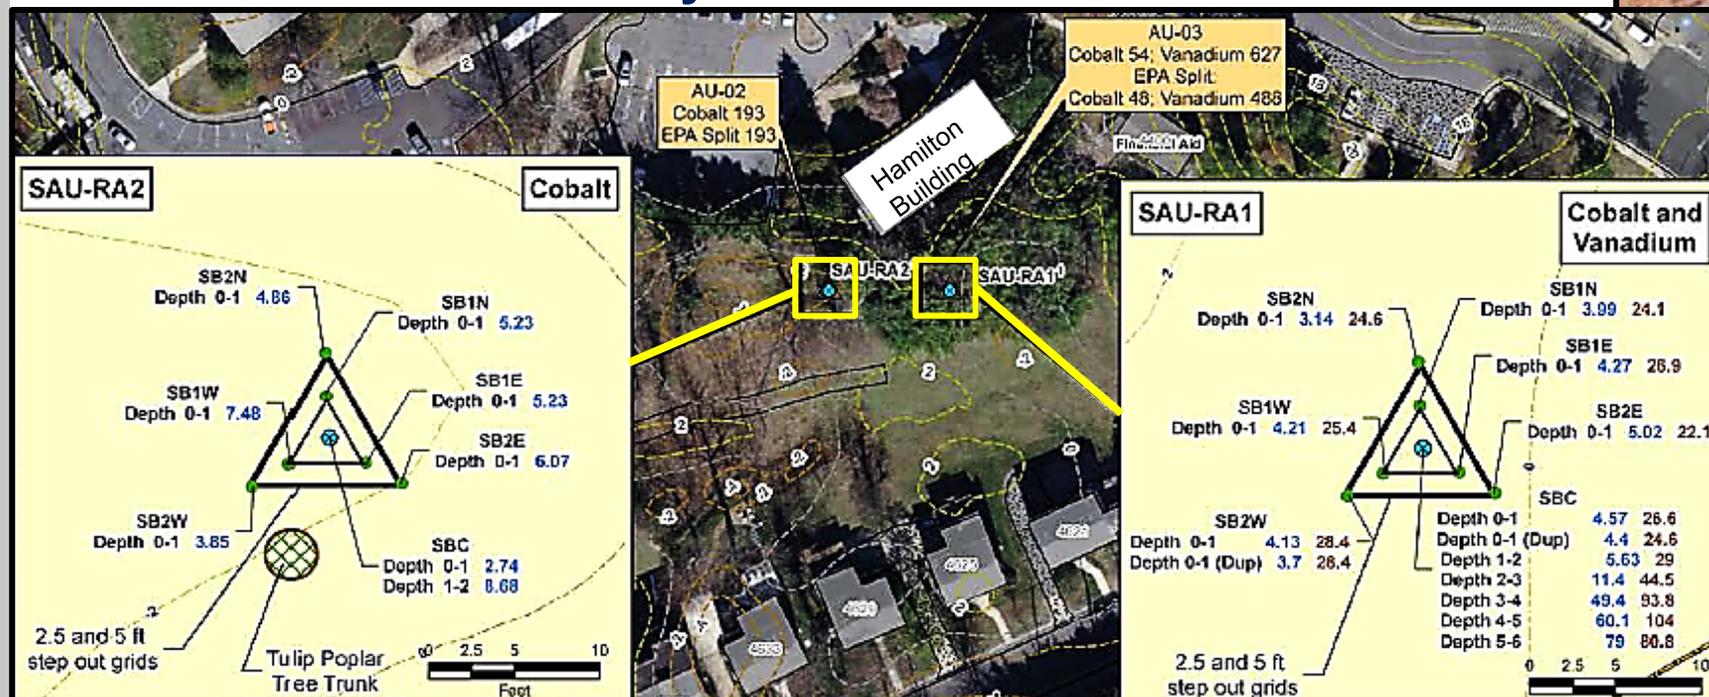
- **RA1 (AU-03) and RA2 (AU-02)** –The excavation work behind the Hamilton Building on AU campus was completed in September.
- The team removed the soil and completed backfill efforts with clean approved fill, topsoil, a grass mix, and an erosion control blanket for the two excavation areas.

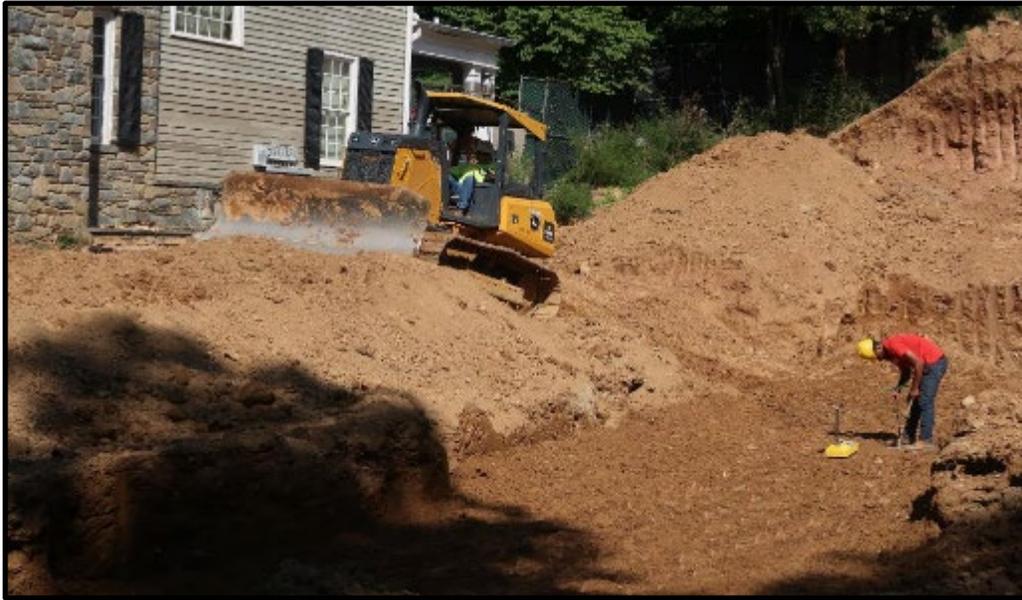
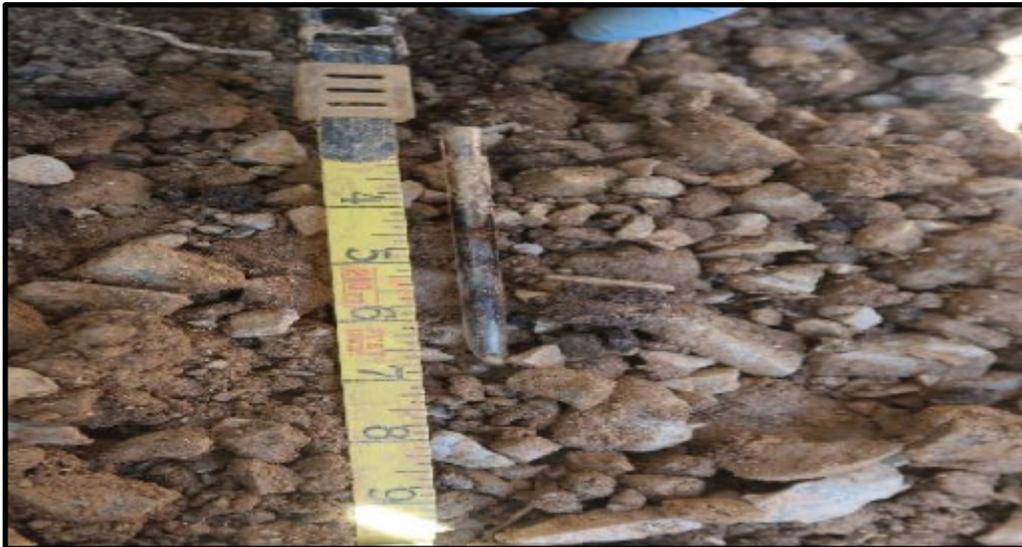
- **At the end of September, the site team continued with backfilling the site and completed installing sewer and water lines along the 4835 shared property line, which included backfilling and compacting the two utility trenches.**
- **While completing the installation of the utilities the crew recovered one piece of broken lab glassware. No odors or soil stain was observed and all testing of the nearby soil and the broken glass determined there was no chemical contamination present.**

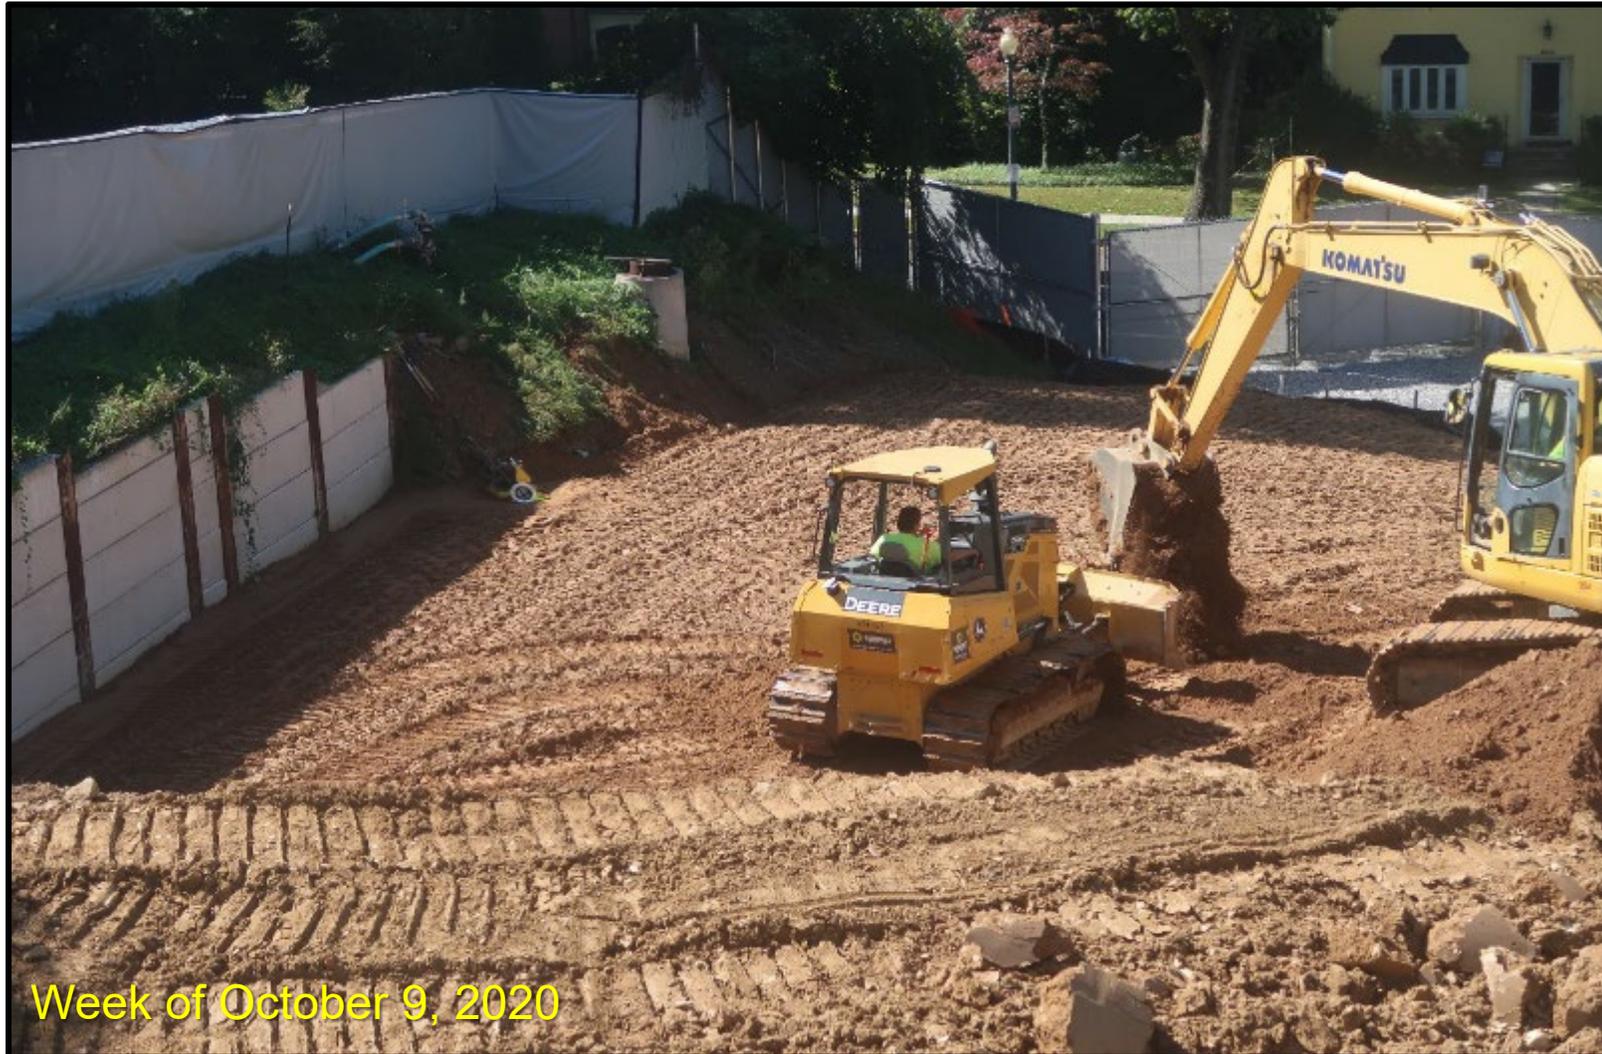
We have completed around 30% of the planned backfill and compaction effort to fully restore the site.

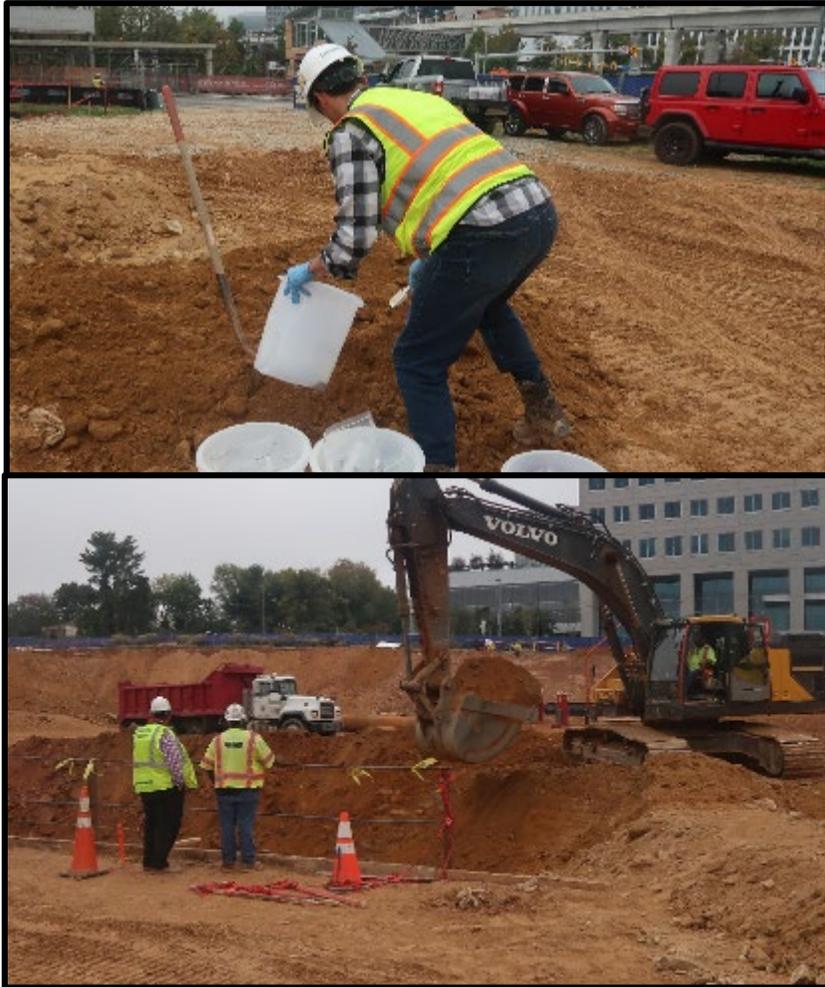
- In October, the crew located and tested additional sources in the nearby surrounding area for the large volume of quality backfill needed.
- **Test kits for the sampling were prepared, and the crew collected and shipped the samples to a commercial lab for analysis. Samples from any potential backfill sources are tested prior to being selected to ensure material is clean and suitable for site restoration activities.**

Sampling soil and inspecting a site for the needed backfill.

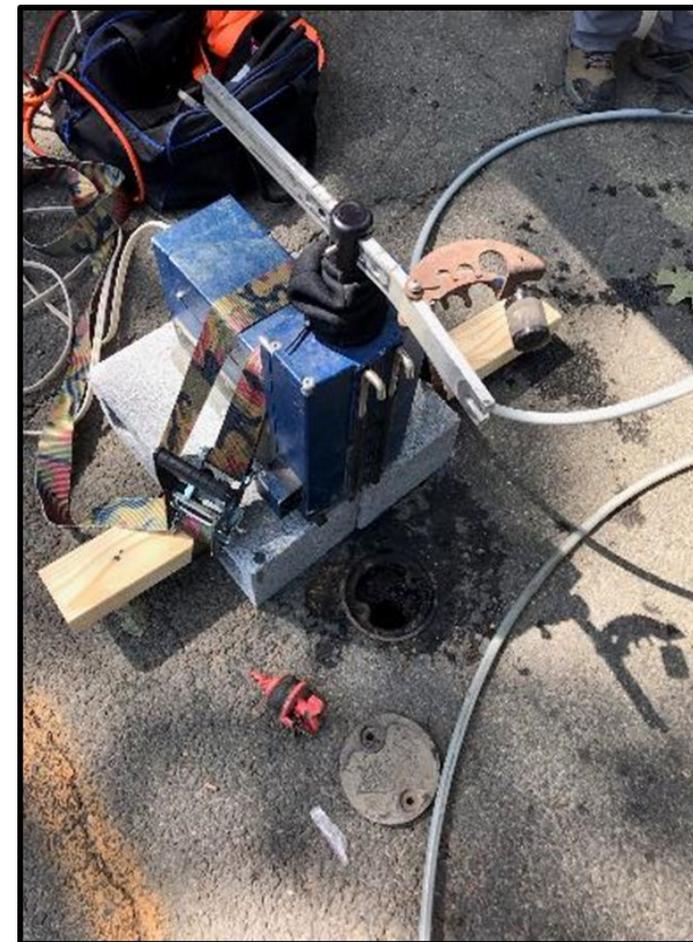
Groundwater sampling well
