SPRING VALLEY FORMERLY USED DEFENSE SITE

Restoration Advisory Board Meeting
SEPTEMBER 2020

SITE-WIDE REMEDIAL ACTION (RA)

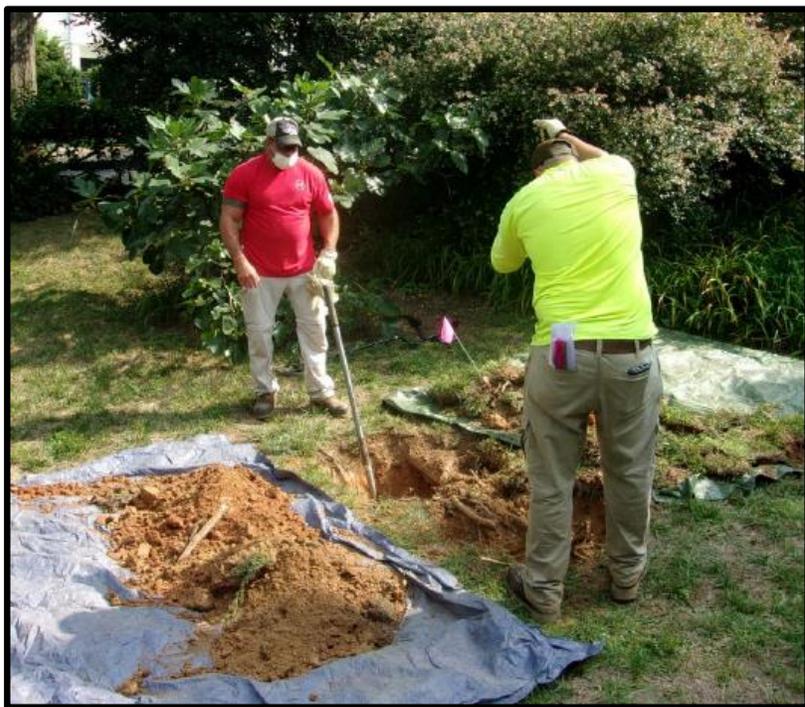
The team carefully excavates each area on the dig list. Grass and soil are placed face down on a tarp, to be seamlessly replaced after removing anomalies.

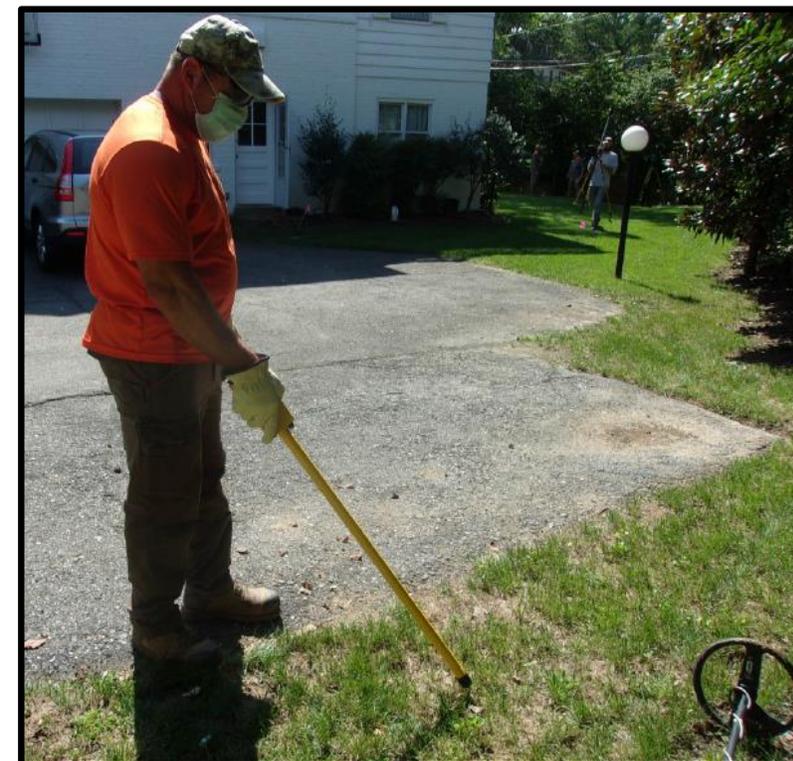
The team uses analog metal detector to detect anomaly before digging

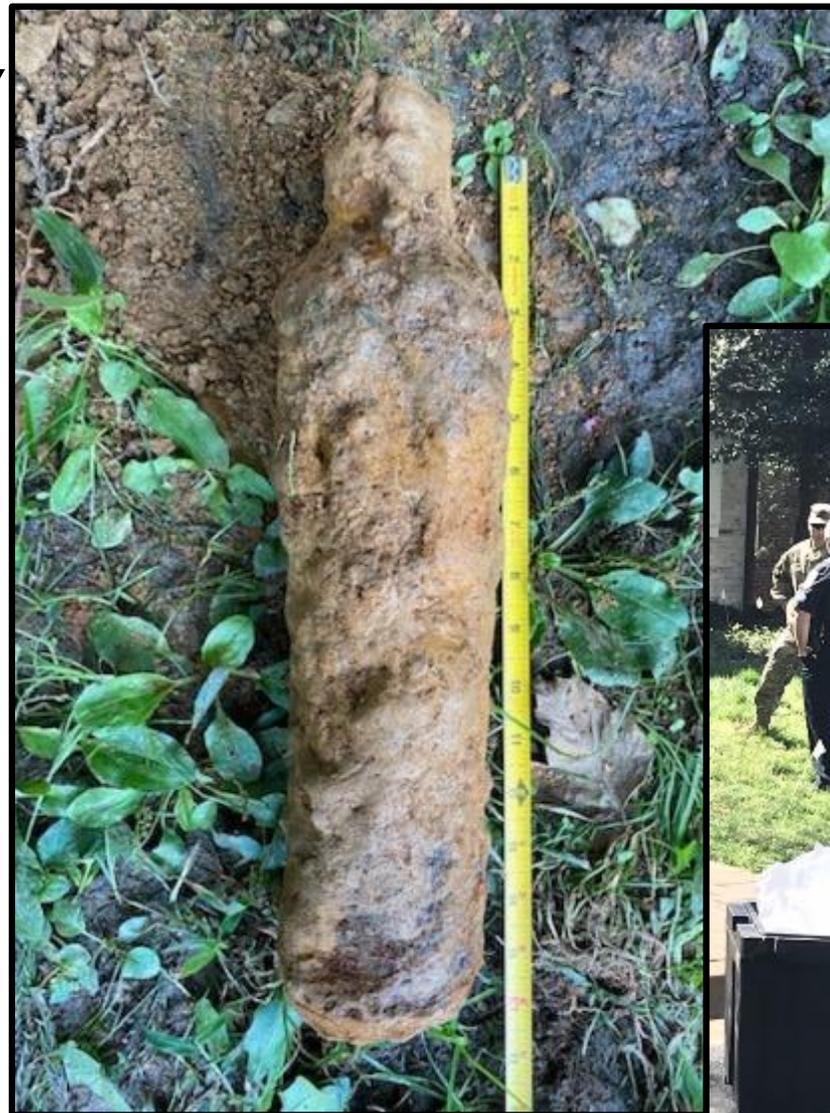
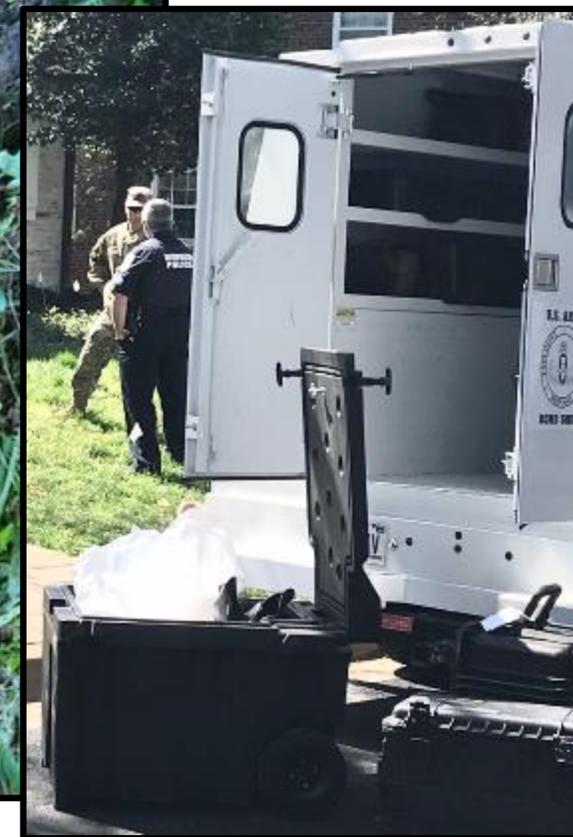
During the intrusive investigations in early September, the team encountered a 3-inch stokes mortar round. It was examined and safely removed from the property.

The Explosive Ordnance Disposal (EOD) team came and x-rayed the item in place.

While the item was initially thought to be an potential Munitions and Explosives of Concern (MEC) item, the x-rays helped EOD determine that it was a sand filled practice round that does not pose an explosive hazard. Therefore, the item is classified as MD (Munitions Debris).

The EOD removed the item from the property to be securely stored and disposed of properly.

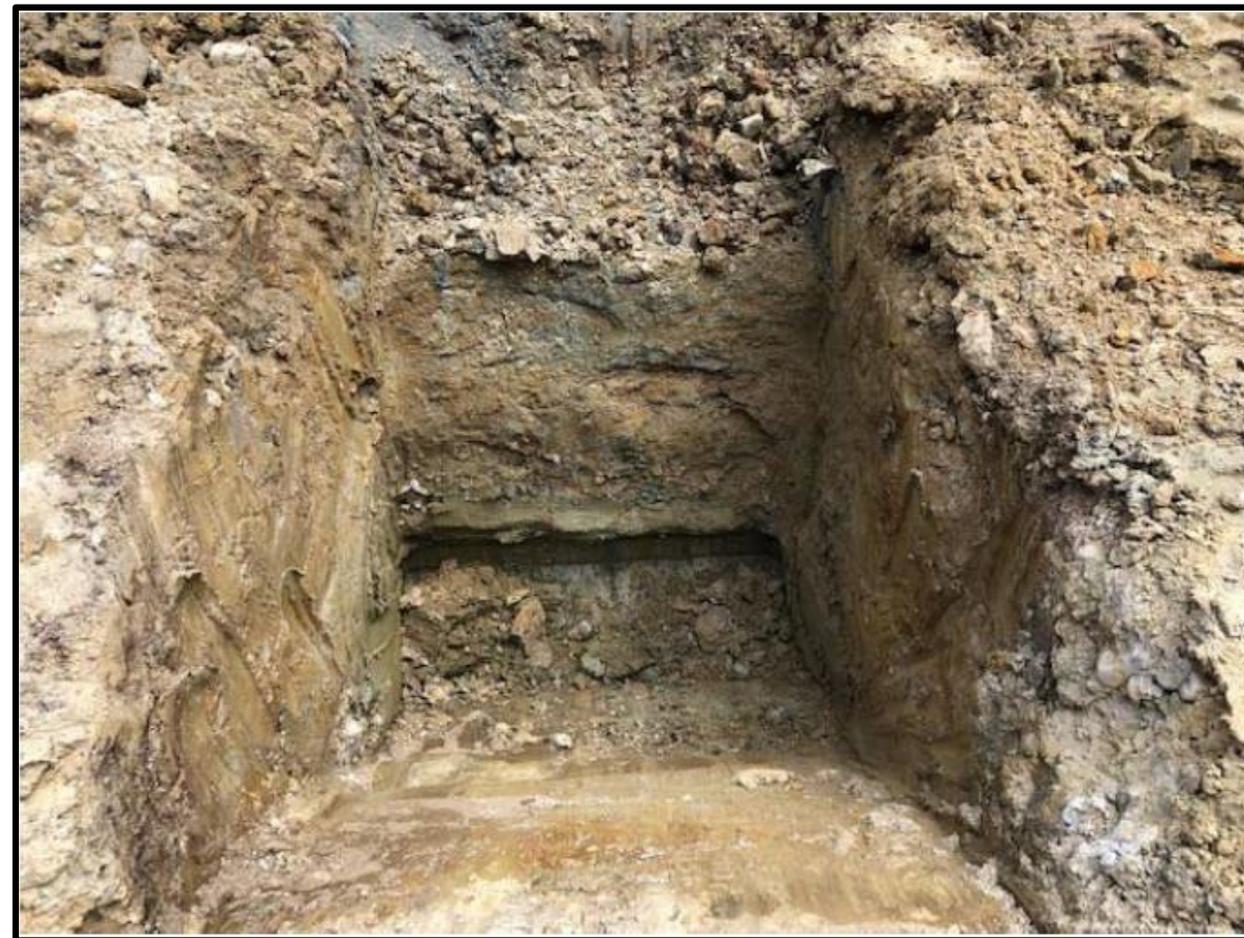
- After resuming field work at AU's former PSB in July, the team began digging test pits at the site in order to determine the final excavation boundaries for the PSB, as well as to conduct confirmation soil sampling.
- These test pits have been excavated to 8 feet below slab grade, with soil samples being collected every 1-foot for head space, metals, and other analyses.

Test pit in Grid E-4 excavated to 8 feet below slab grade

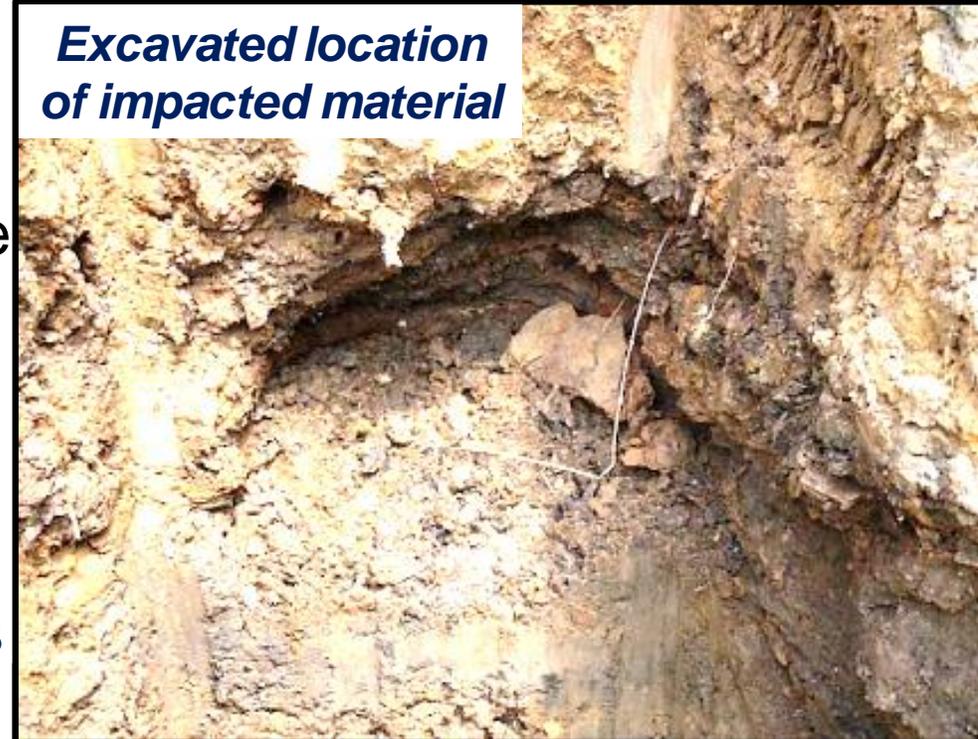
- The team continues to encounter lab grade glassware debris and have followed it into the northern hillside edge of the former PSB footprint.
- Through further investigation the debris appears to extend outside of the northwestern footprint and near the existing sump. The team has prepared work plans and is evaluating the removal of the debris trail into the hillside.
- The uncovered material in the test pit sidewall was screened for munition debris and AU items. The batch glass and metal debris cleared headspace analysis and was shipped for confirmation analysis.

*Excavated location
of impacted material*

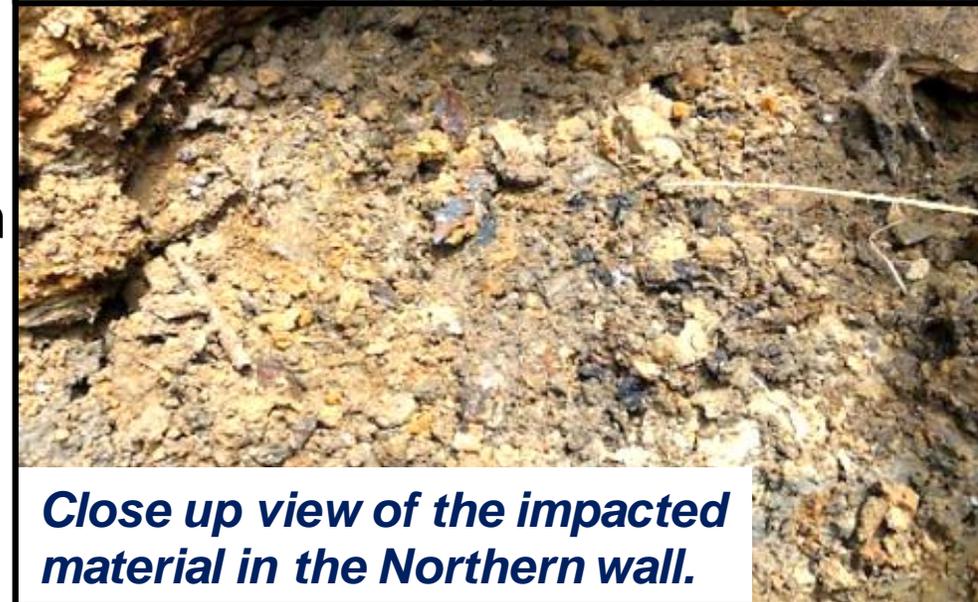
*Close up view of the impacted
material in the Northern wall.*

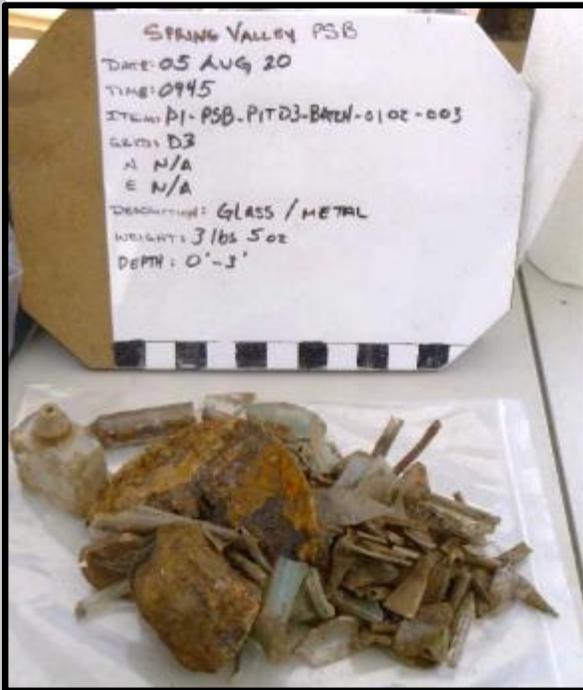
Batch glass collected at 3 to 4 feet Grid Cell F-5

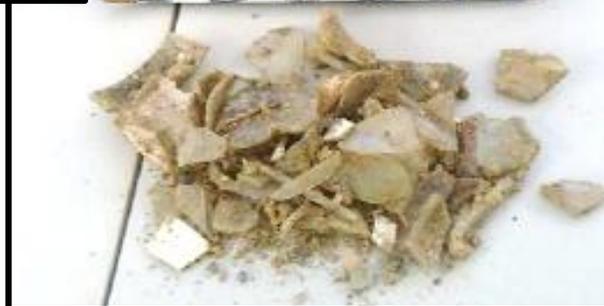
DATE: 20 AUG 20
TIME: 1505
ITEM: PI-PSB-GRFS-BATN-0304-004
GRID: F5
M: N/A
E: N/A
DESCRIPTION: GLASS
WEIGHT: 1 lb 9oz
DEPTH: 3'-4'

DATE: 20 AUG 20
TIME: 1505
ITEM: SCR-PSB-PITD3-001
GRID: D3
M: N/A
E: N/A
DESCRIPTION: BOOSTER COMPONENT
WEIGHT: 12 oz
DEPTH: 1'-2'

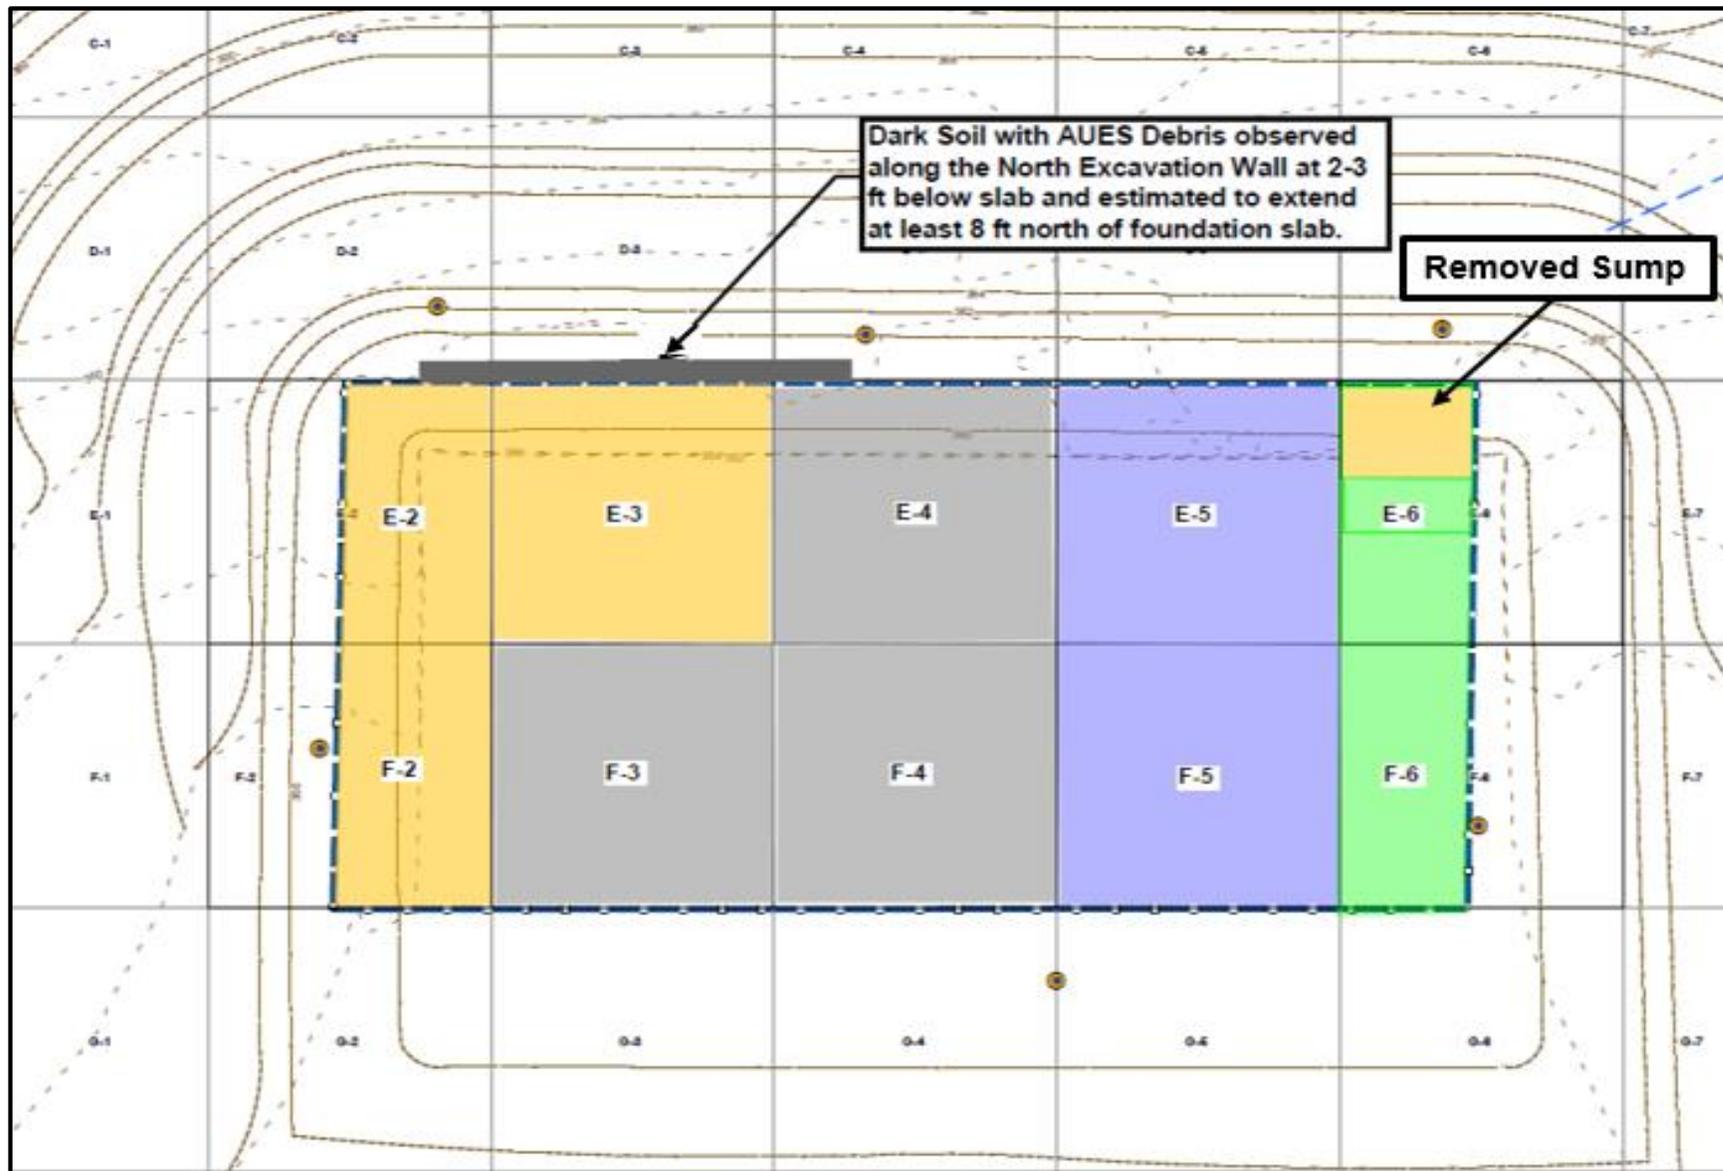
- Public Safety Building Foundation Boundary
- Grids (15 x 15 ft)
- Public Safety Building Foundation Grids
- Public Safety Building Excavation Area Grids
- Contour Elevation (2ft interval)
- Abandoned Storm Drain Pipe
- Abandoned Storm Drain Pipe Location
- Sump Locations
- Grid soil to be excavated to 4 feet below slab.
- Grid soil to be excavated to 5 feet below slab.
- Grid soil to be excavated to 6 feet below slab.
- Grid soil to be excavated to 7 feet below slab.
- Grid soil to be excavated to 8 feet below slab.

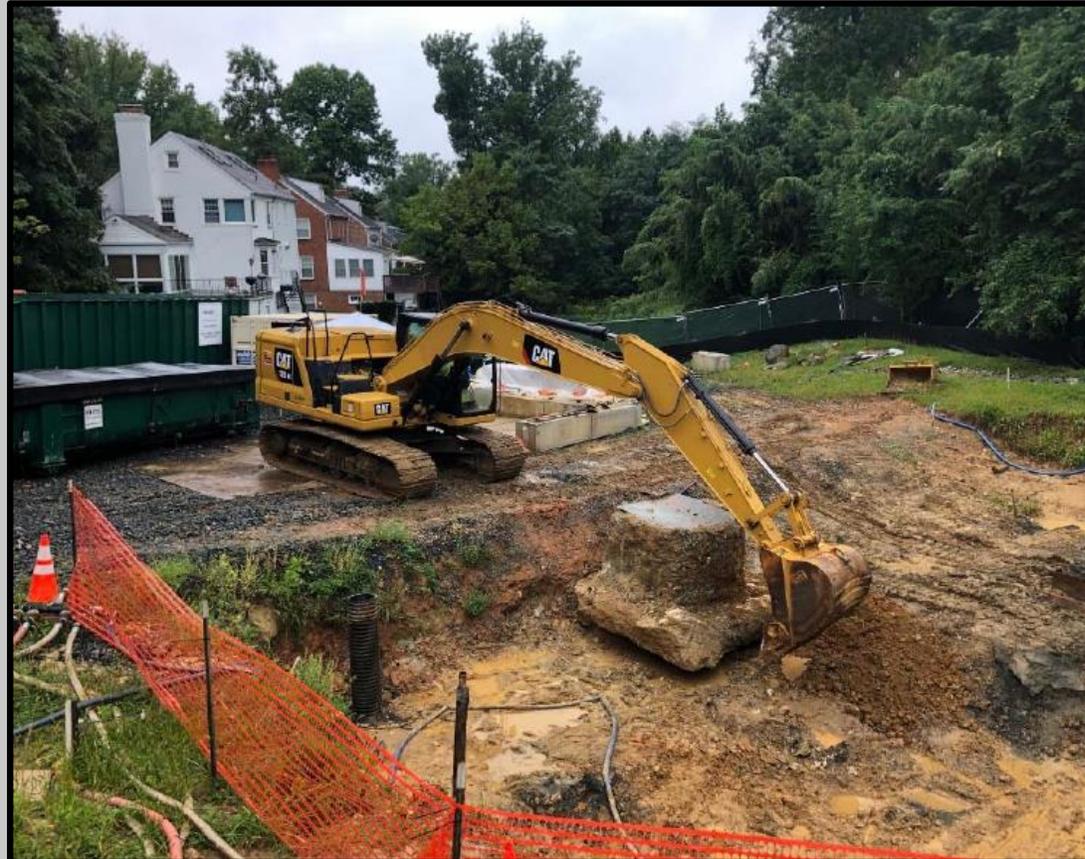
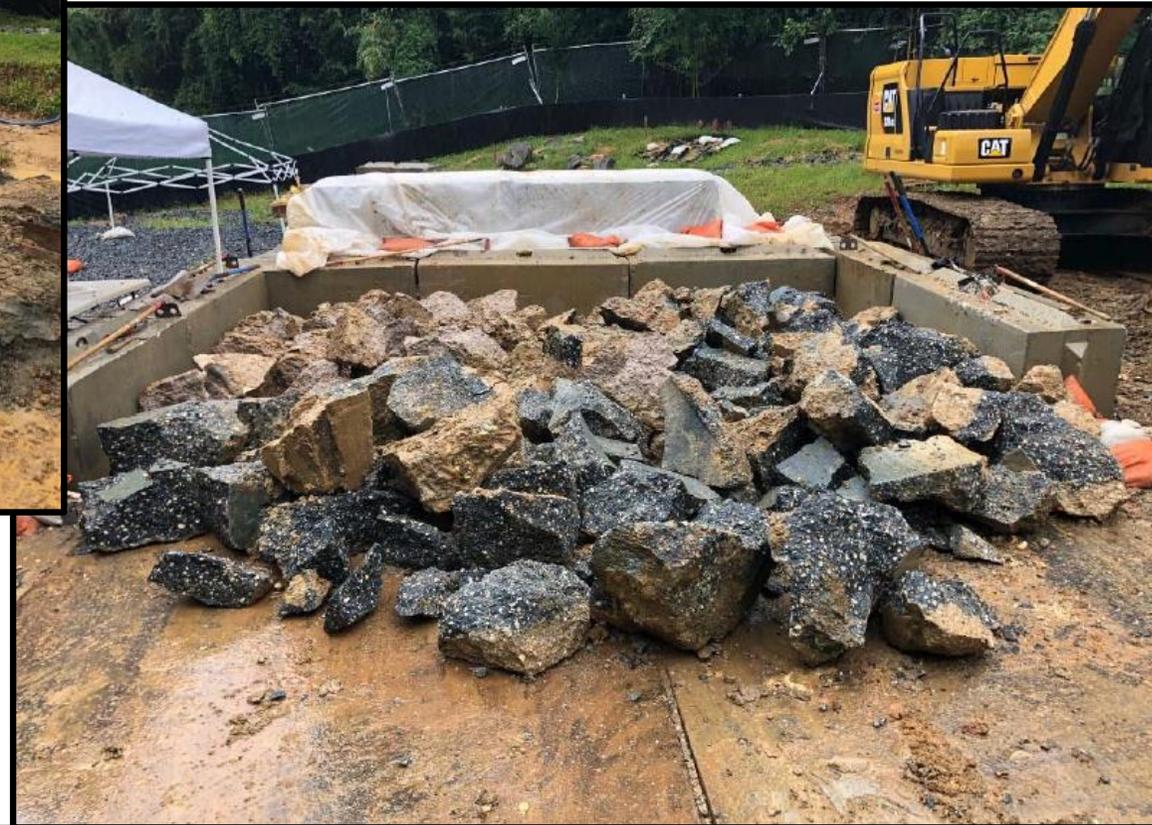
The concrete sump structure was broken down into smaller pieces loaded into a roll-off container, and transported to the staging area at the Federal Compound pending off-site disposal.

Excavator preparing to roll the concrete sump structure out of the excavation for sizing.

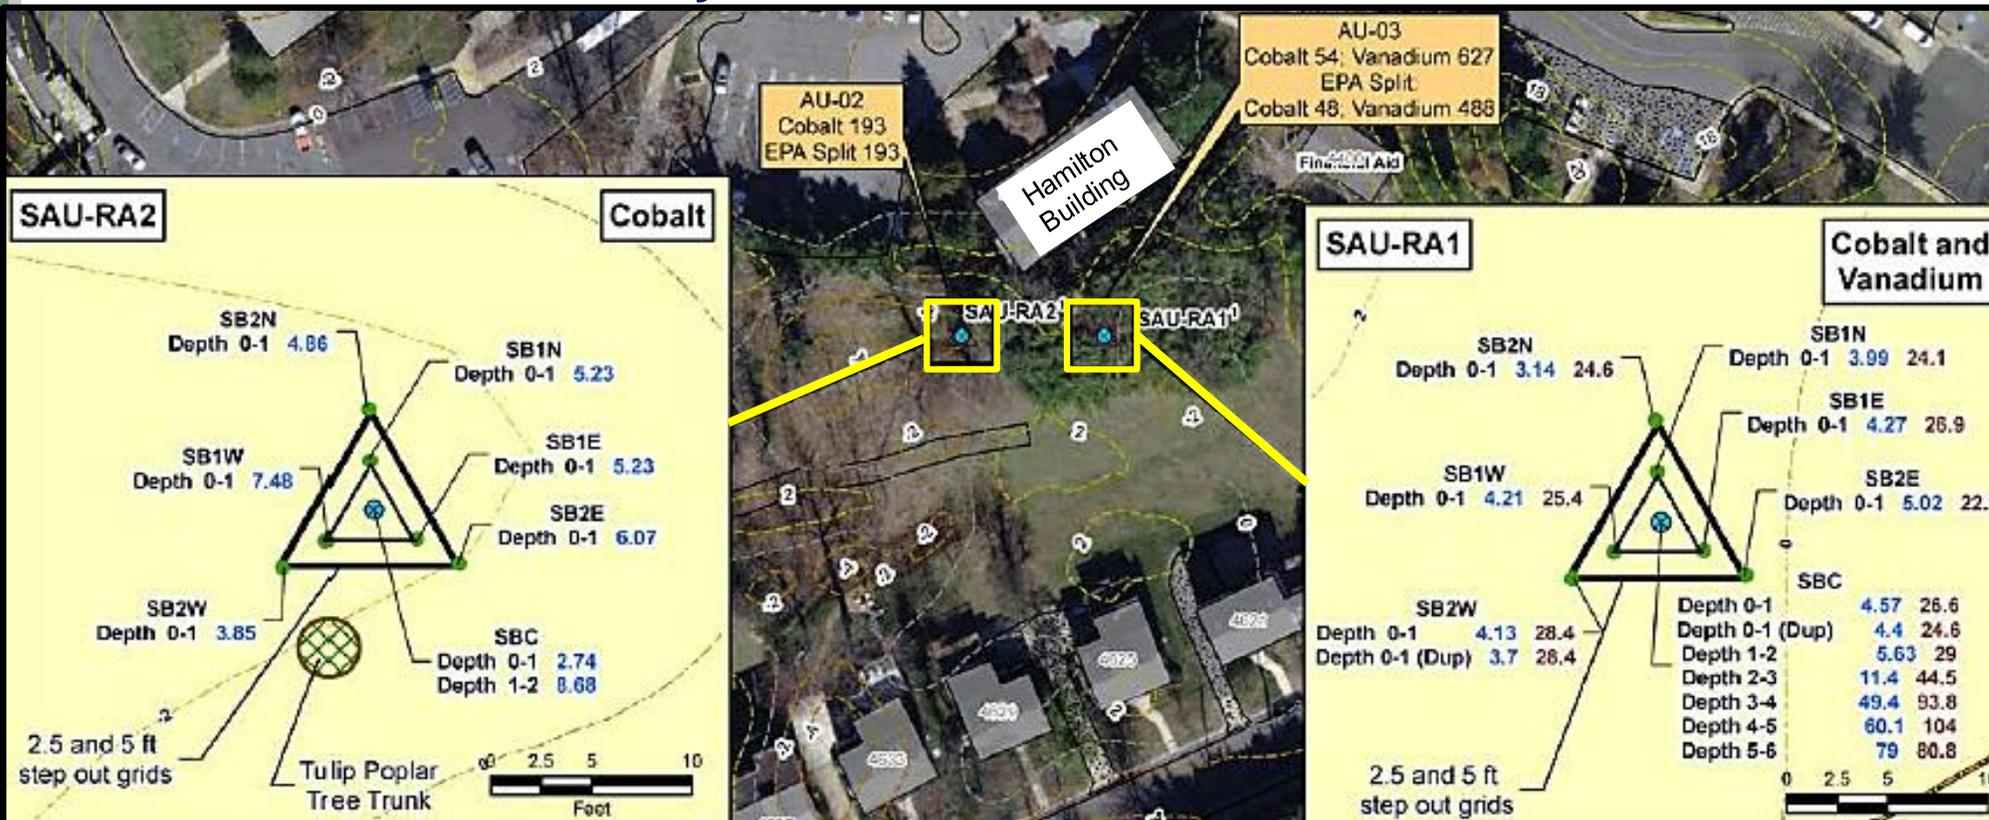
RA1 (AU-03) – The team is proposing to remove the soil with an excavator at the center point down to 10 feet below the ground surface and extending out 2.5 feet (5 ft by 5 ft excavation area).

There was no Cobalt exceedance was detected at the step-out locations.

RA2 (AU-02) – The team is proposing to remove the soil by hand using a digging/air knife (to avoid harming the Poplar tree) to 1 foot below the ground surface around the center point and extending out 2.5 feet (5 ft by 5 ft excavation area).

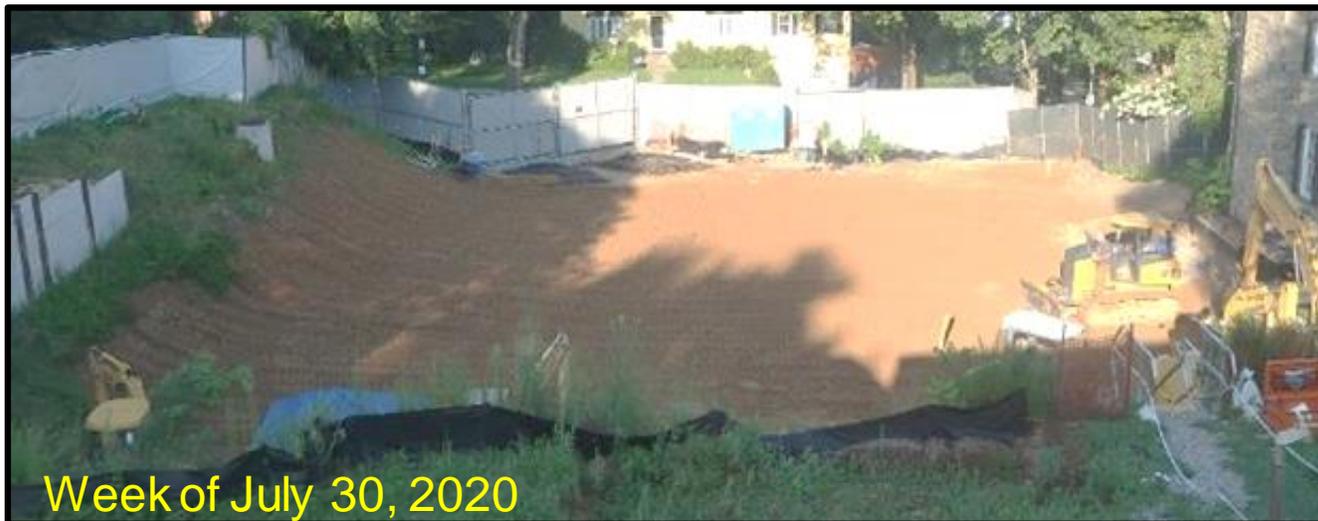
Week of July 30, 2020

As the crew completed backfilling the small excavation areas, the focus moved to restoring the site's planned elevation, compacting to street level during the week of August 7th. Then operations continued on the south side.

The compaction efforts involve close monitoring and inspection of the moisture content in the lifts of soil.

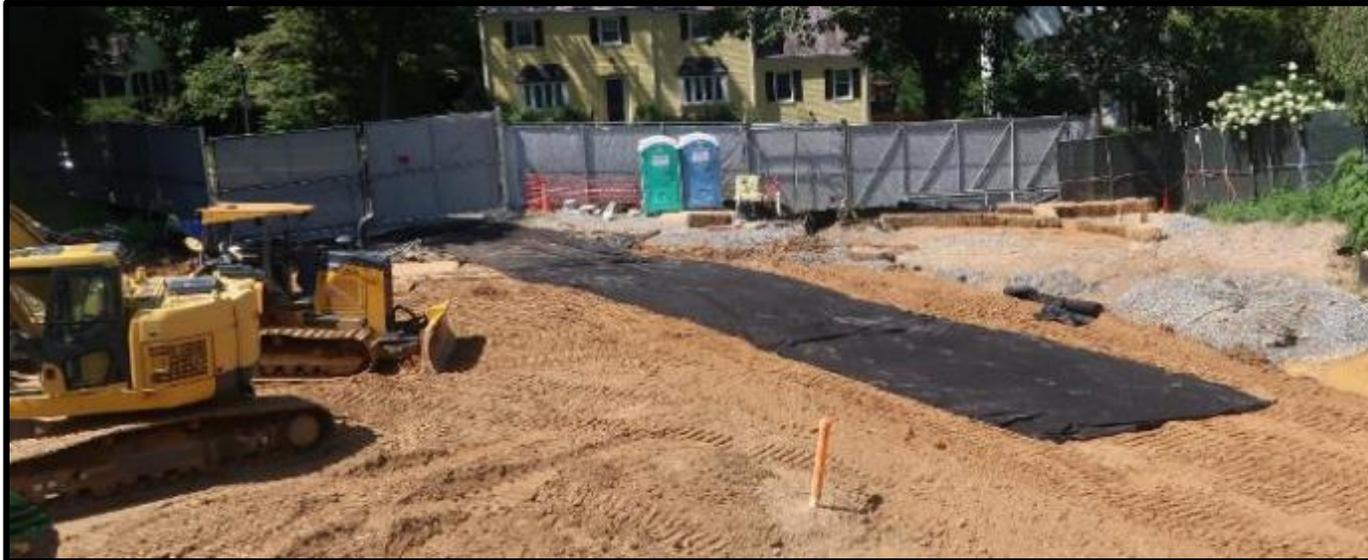
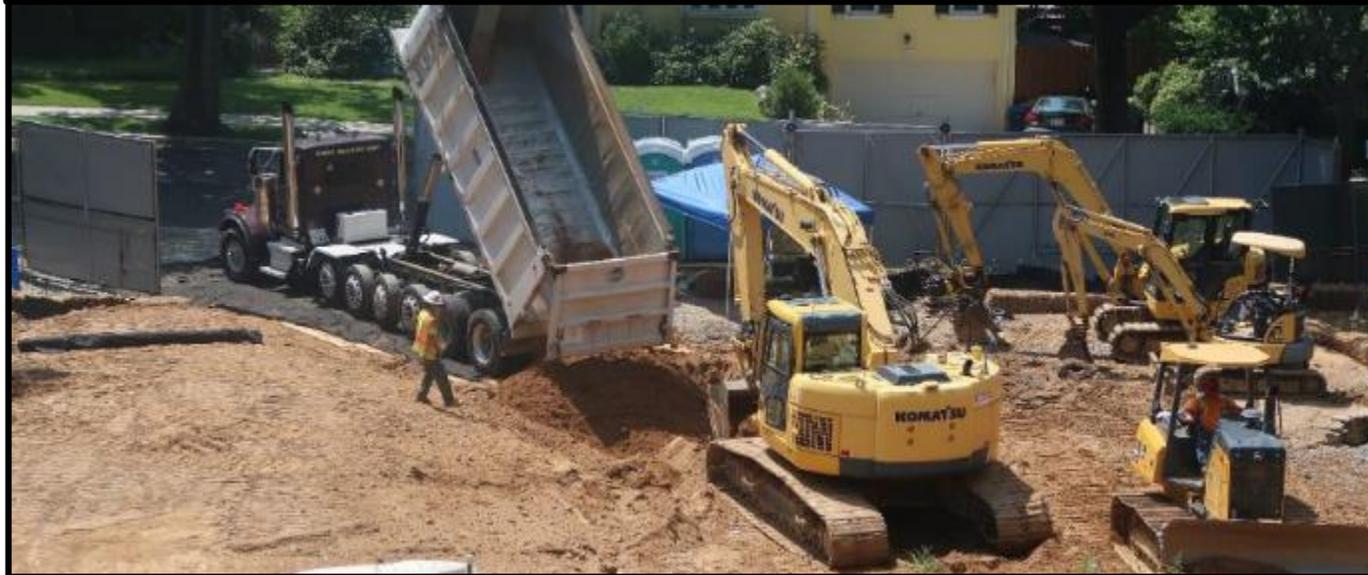
The goal is a low impact operation, with consideration of the impacts our operation could have on a neighborhood street. We have implemented a couple of practices that have been noticed and appreciated by the our Glenbrook Road neighbors.

- No trucks are staged and waiting on the road, to deposit backfill soil at the site. We have only one truck at the area.
- We use a geotextile liner as a ‘runway’ to keep dirt off of the tires.

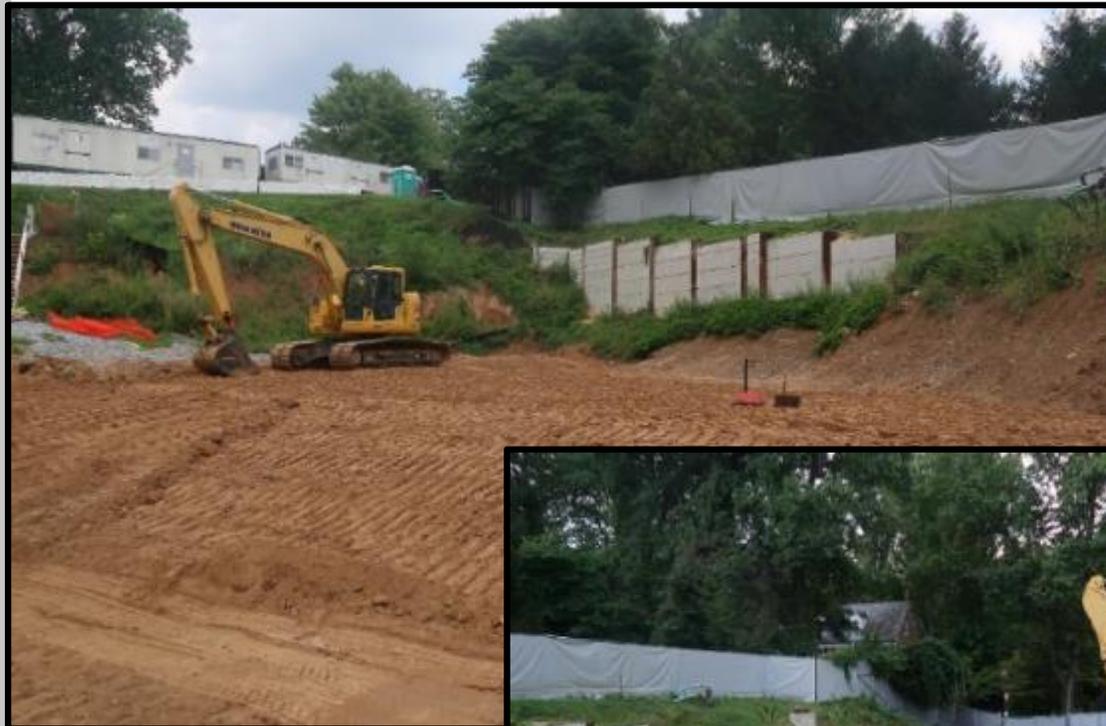
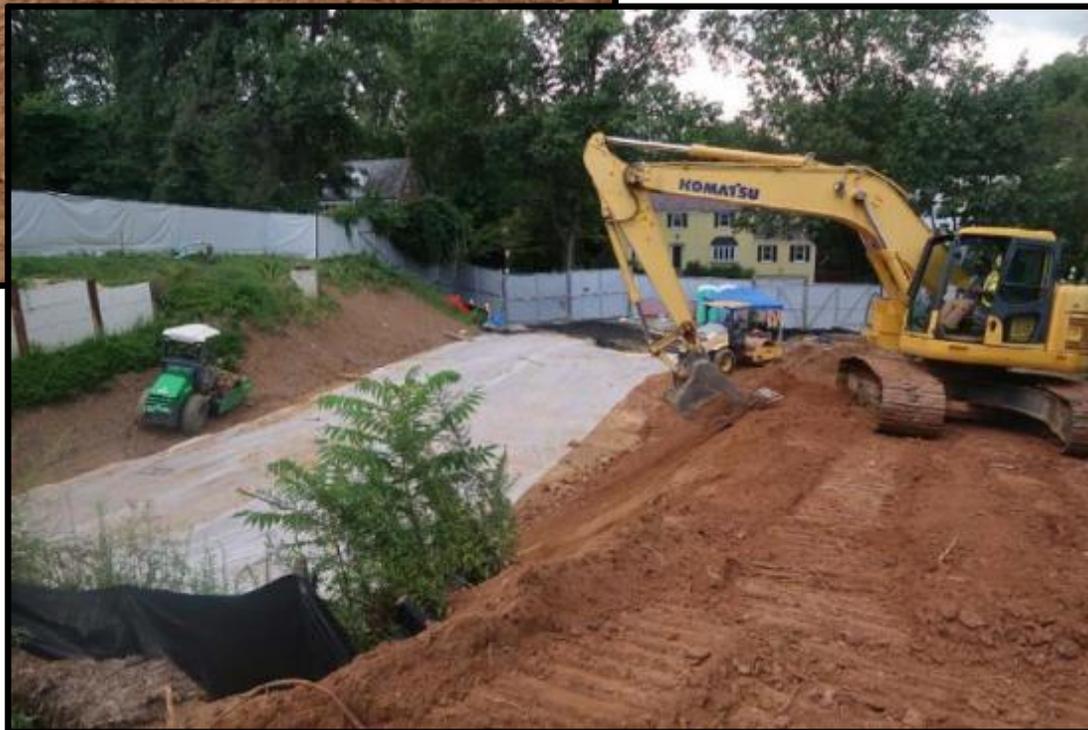
Backfill efforts are currently being conducted at the south end of the property, per a planned standard construction-grade approach. We currently are at around 30% complete with the backfill and compaction efforts at the site.

Covering the lifts with plastic at the end of the day to reduce excess moisture content.

Installing backfill and lifts at the south side of the property.

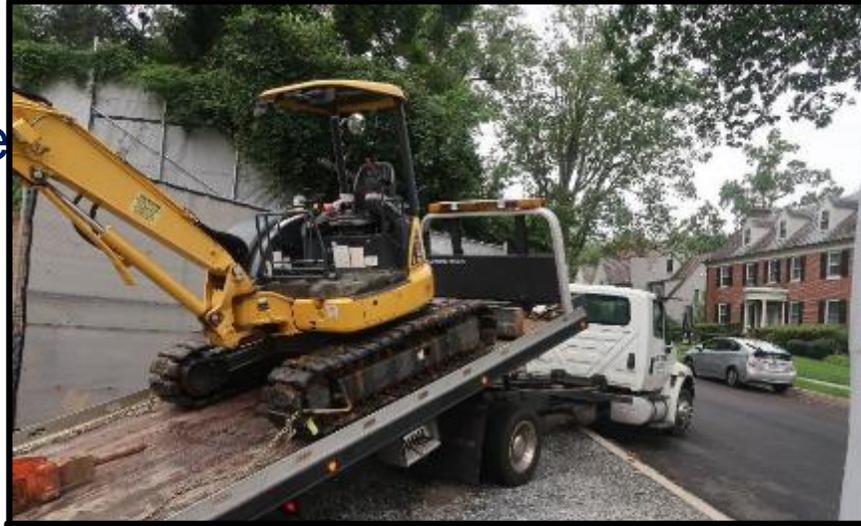
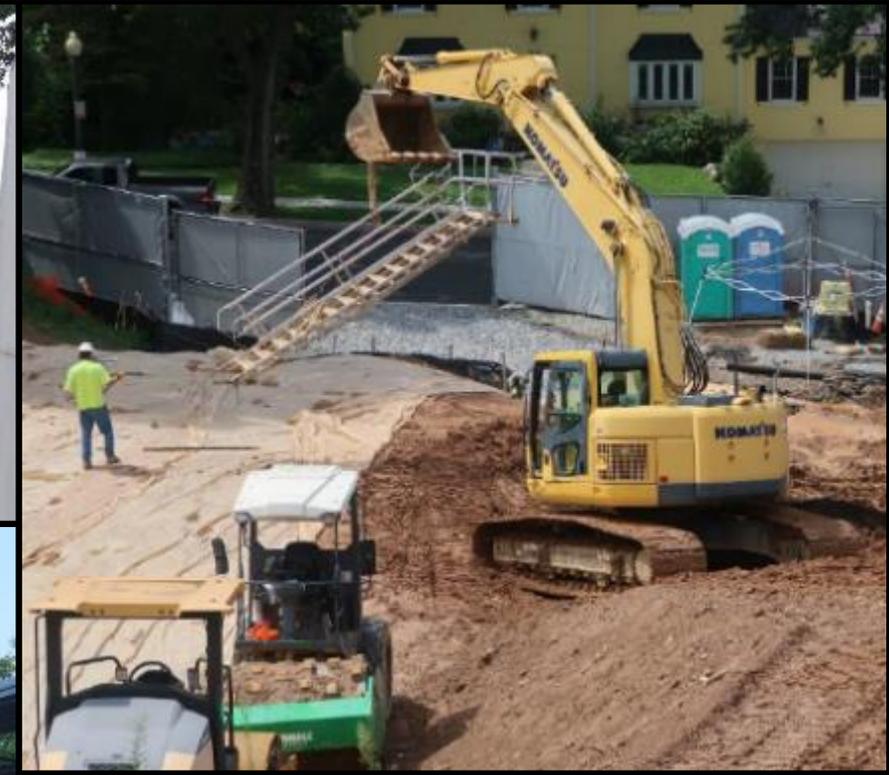
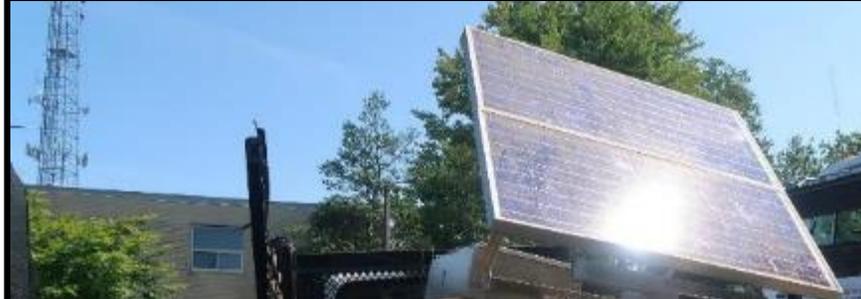
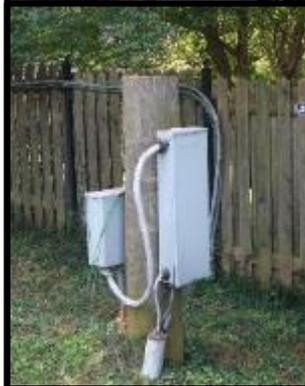
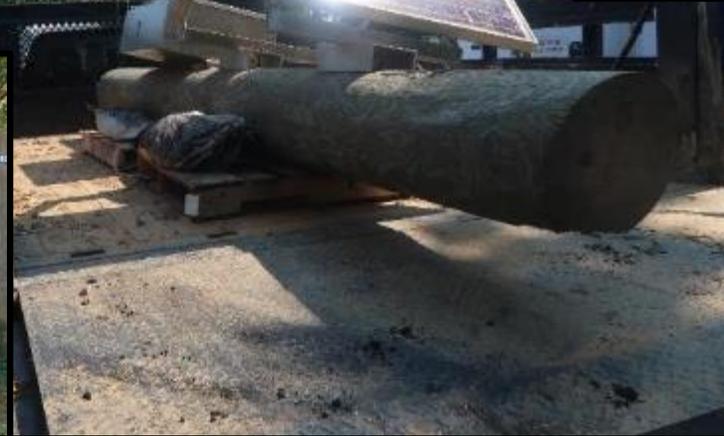
Removing unneeded equipment such as a stair, excavator, and the Shelter-in-Place emergency siren with a solar panel, which was atop a utility pole.

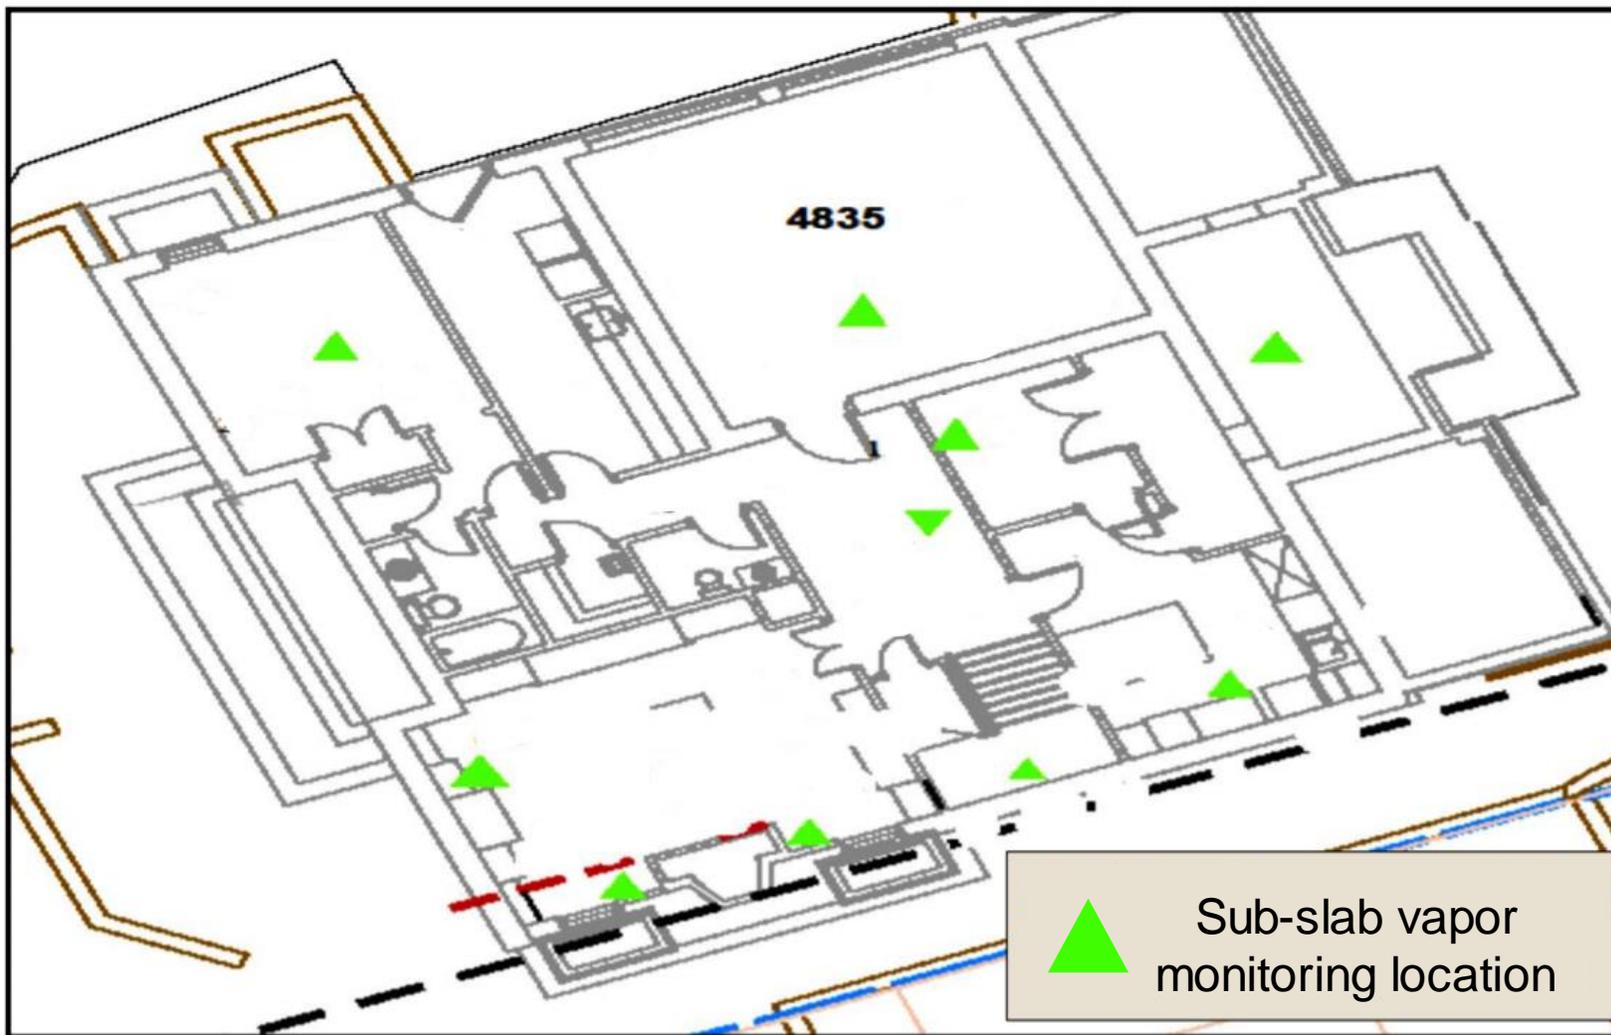
- The team has received the soil gas samplers to begin the third round of confirmation sampling, which is scheduled to occur mid-September.
- Ten locations will be sampled, as shown on the map to the left.

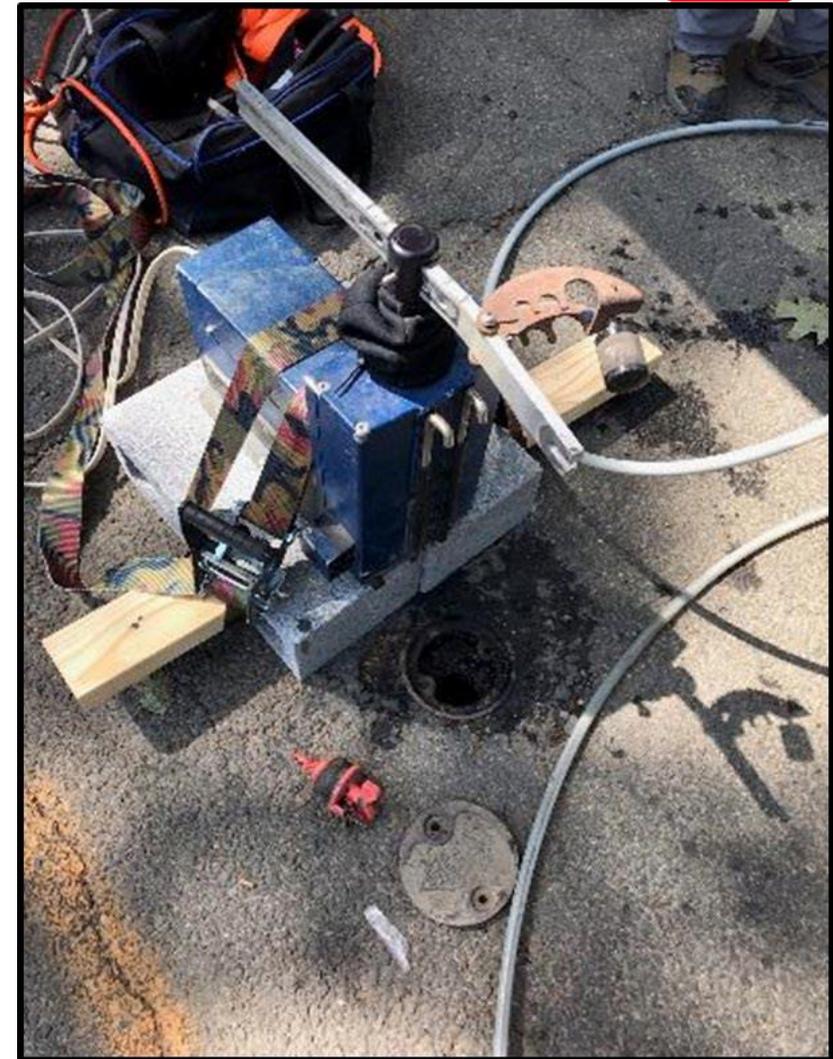
- The groundwater sampling event took place on June 23-26 and was conducted by the Army Corps and the U.S. Geological Survey (USGS).

Groundwater sampling well
