SPRING VALLEY FORMERLY USED DEFENSE SITE

Partners Meeting Presentation
April 2021

SPRING VALLEY GLENBROOK ROAD SITES

SVFUDS SITE-WIDE REMEDIATION STATUS APRIL 2021

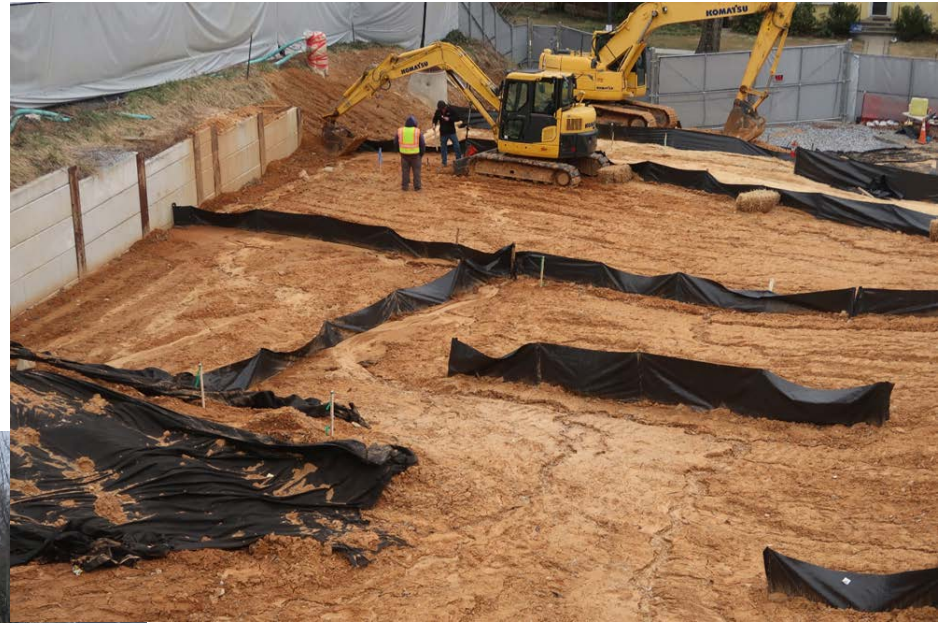
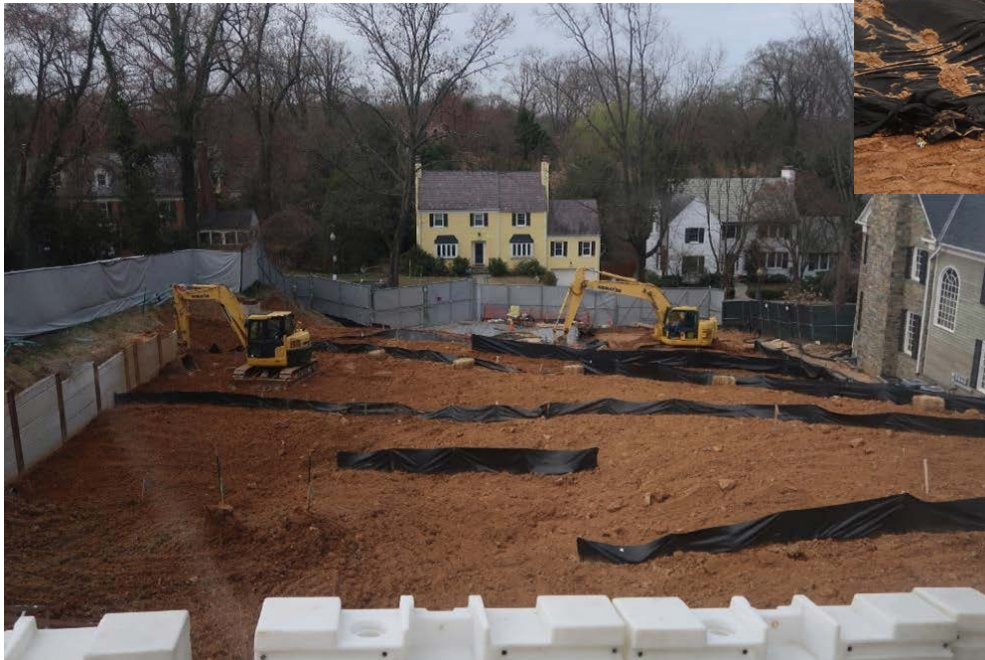
- Continued to perform compaction and E&S control maintenance activities in March, April, and May
- Also continued with waste shipments
- As of April 21st all removal action derived waste from 4825 Glenbrook Rd has been shipped off for disposal

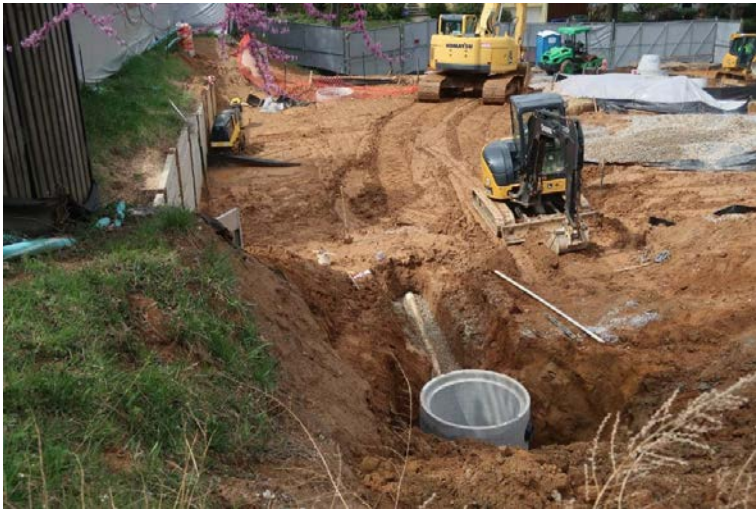
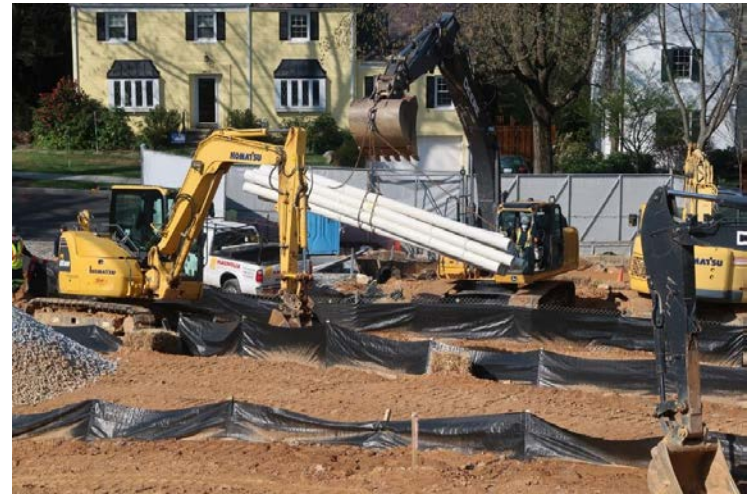
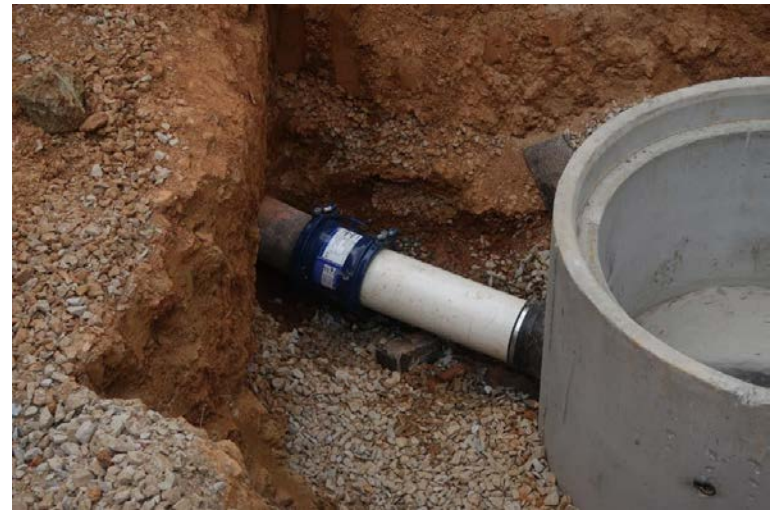
- On April 7th began sewer line restoration work
- Permanent sewer line tied in and completed on April 21st

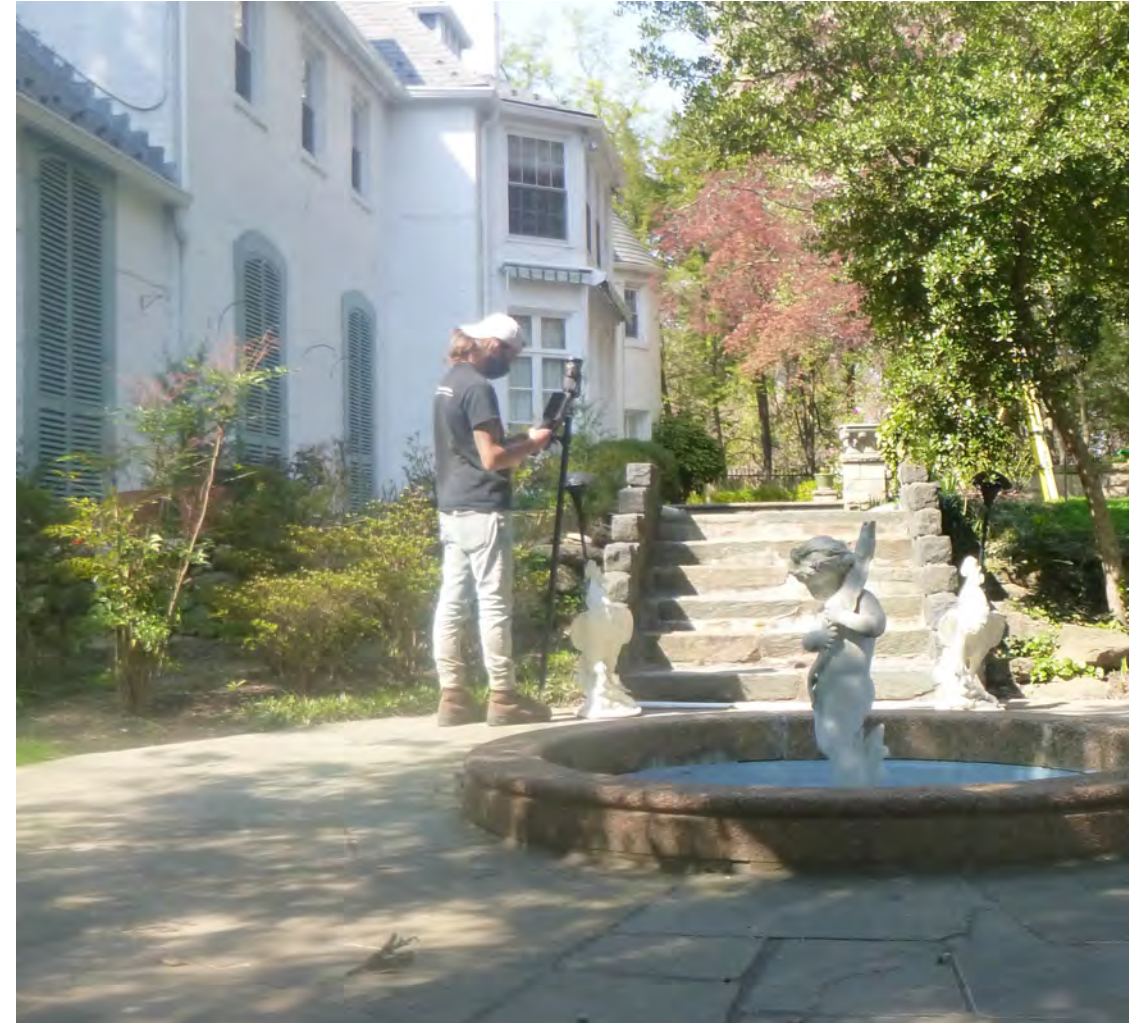
- **Property Availability** – One new property approved their Landscape Plan and became available for geophysical survey. Six property owners yet to approve Landscape Plans.
- **Site Preparation** – Site preparation activities resumed at the beginning of April. HD videos and Civil Surveys completed at two properties. One property remains to start preparation activities.

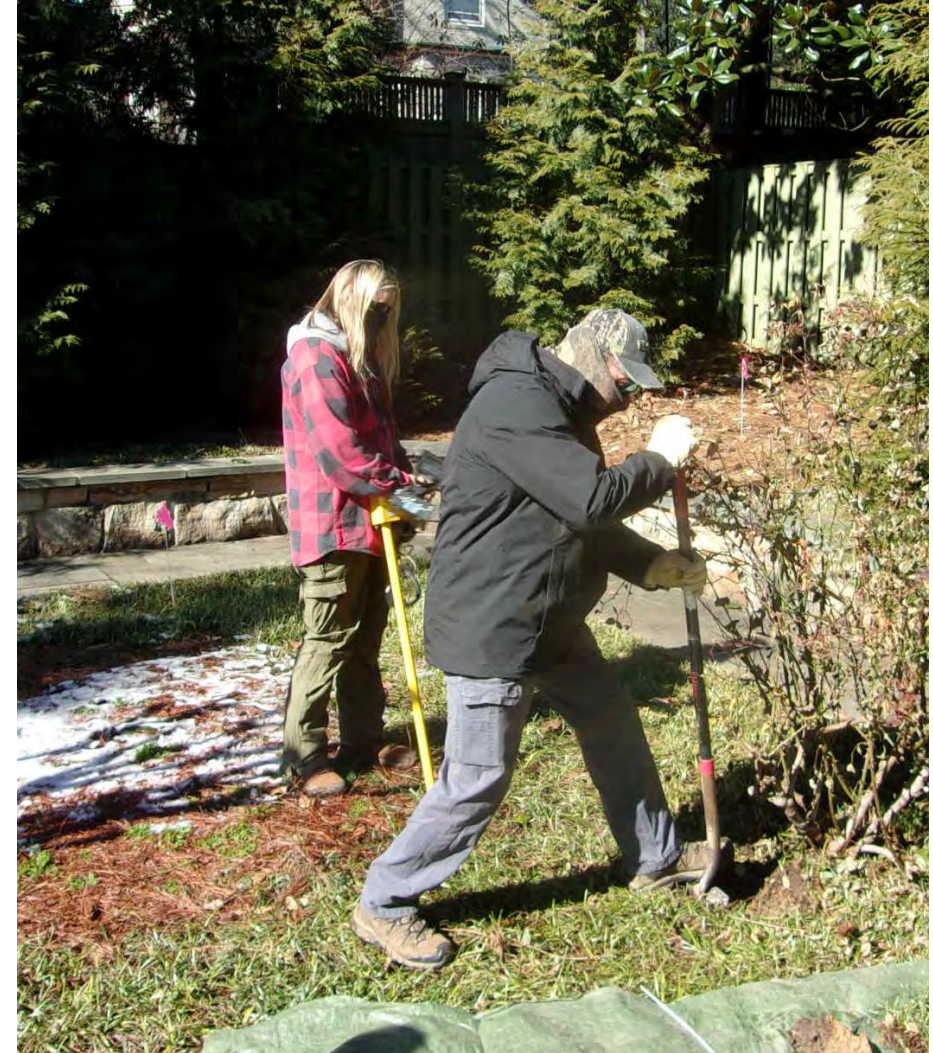
- February intrusive phase (began on 2/8/21) was complete on 2/22/21. This group included Grid I6-Extension.
- Hardscape digs are scheduled for 4/28/21 at three properties.

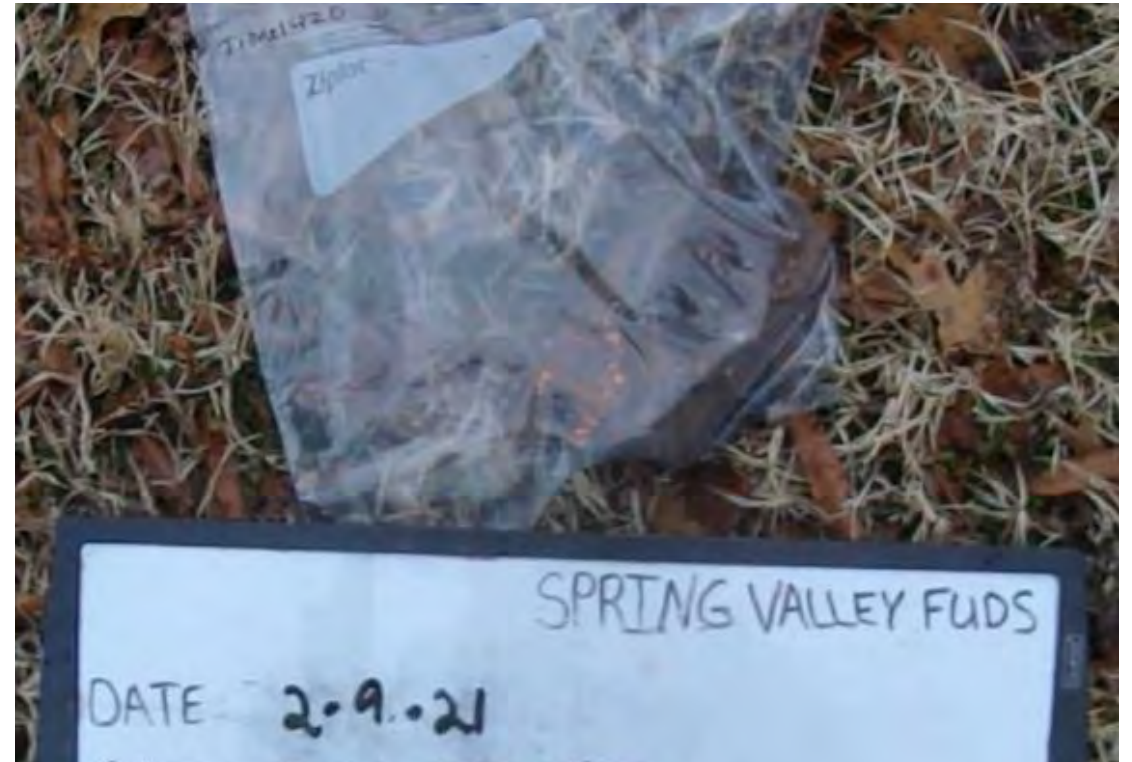
- No MEC/MPPEH items recovered.
- Three MD items recovered.
- Headspace results all non-detect for agent.

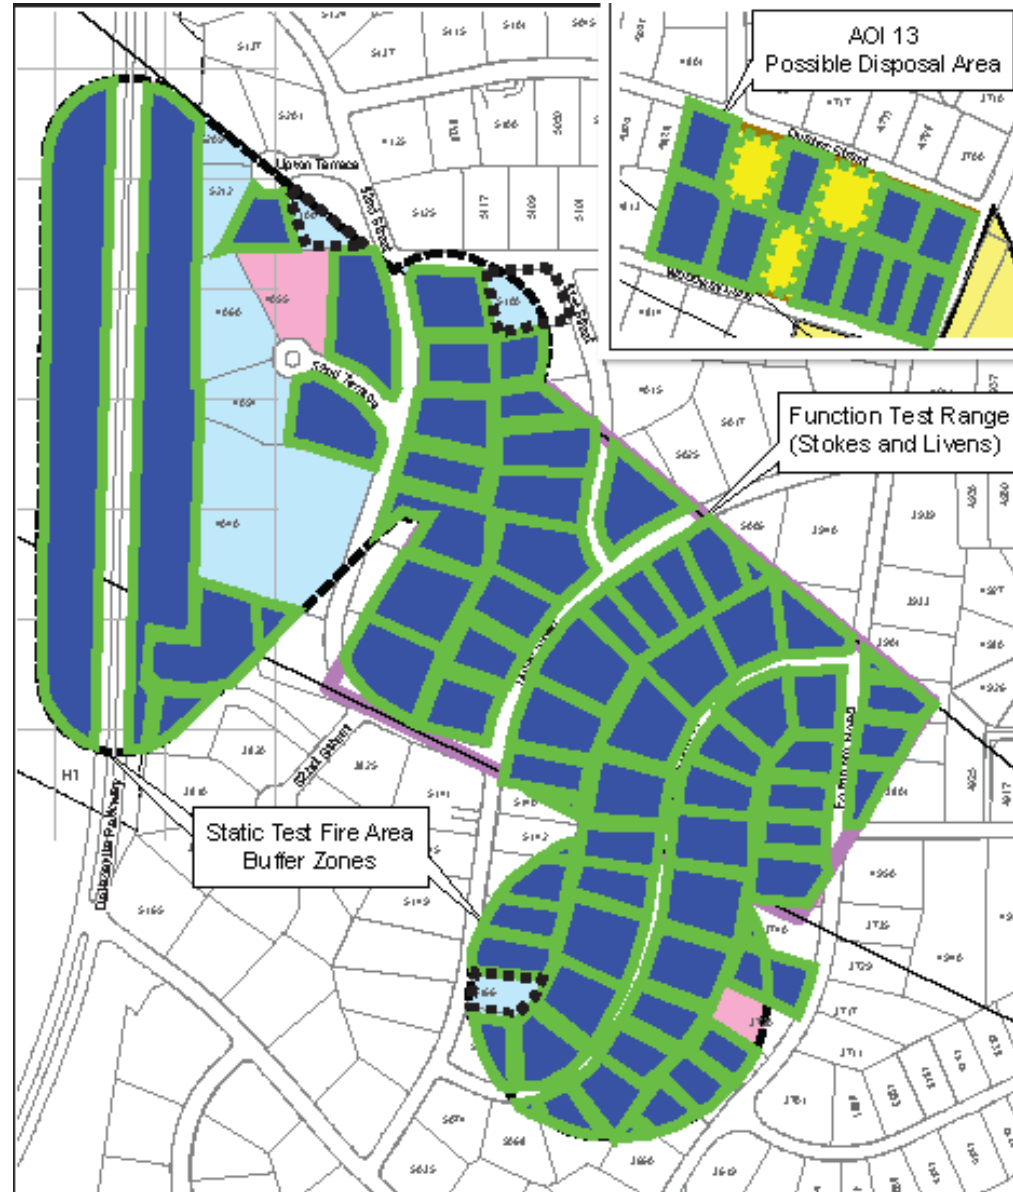
- 82 residential properties completed to date (89%)
- 2791 targets investigated
- MD recovered = 133 (4.7% of total digs)
- MEC recovered (including Civil War cannonball) = 3 (0.11% of total digs)
- WW1-era MEC recovered = 2 (0.07% of total digs)

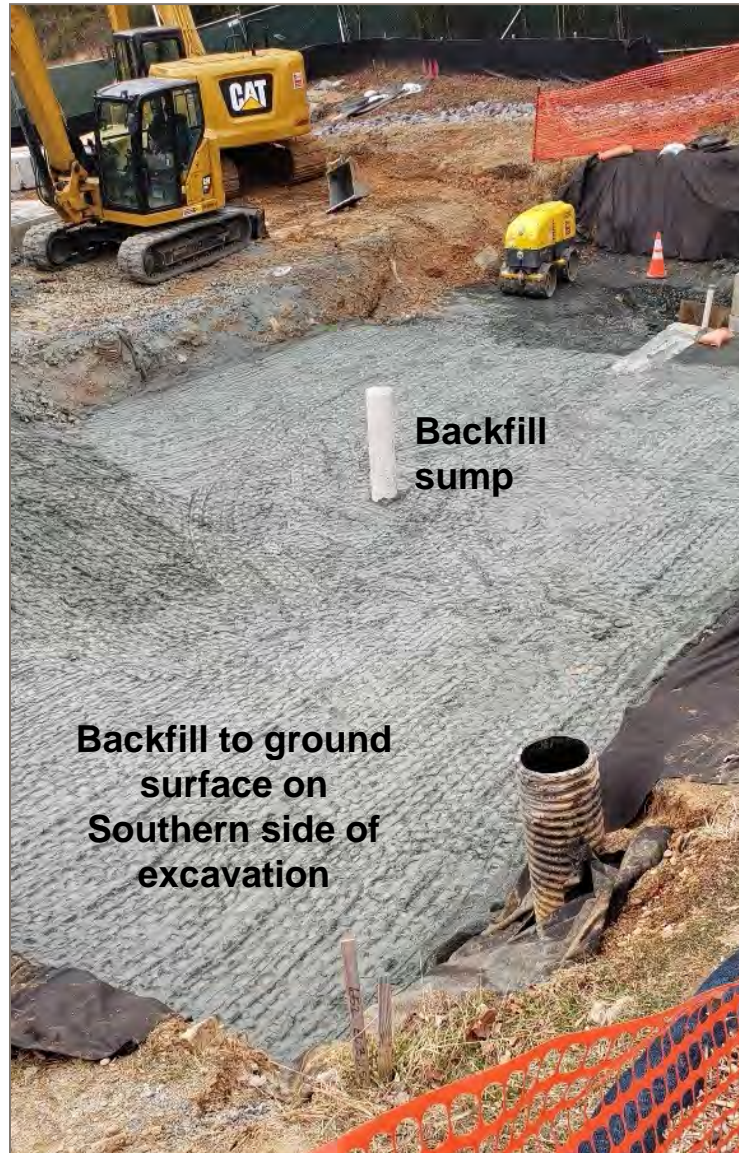
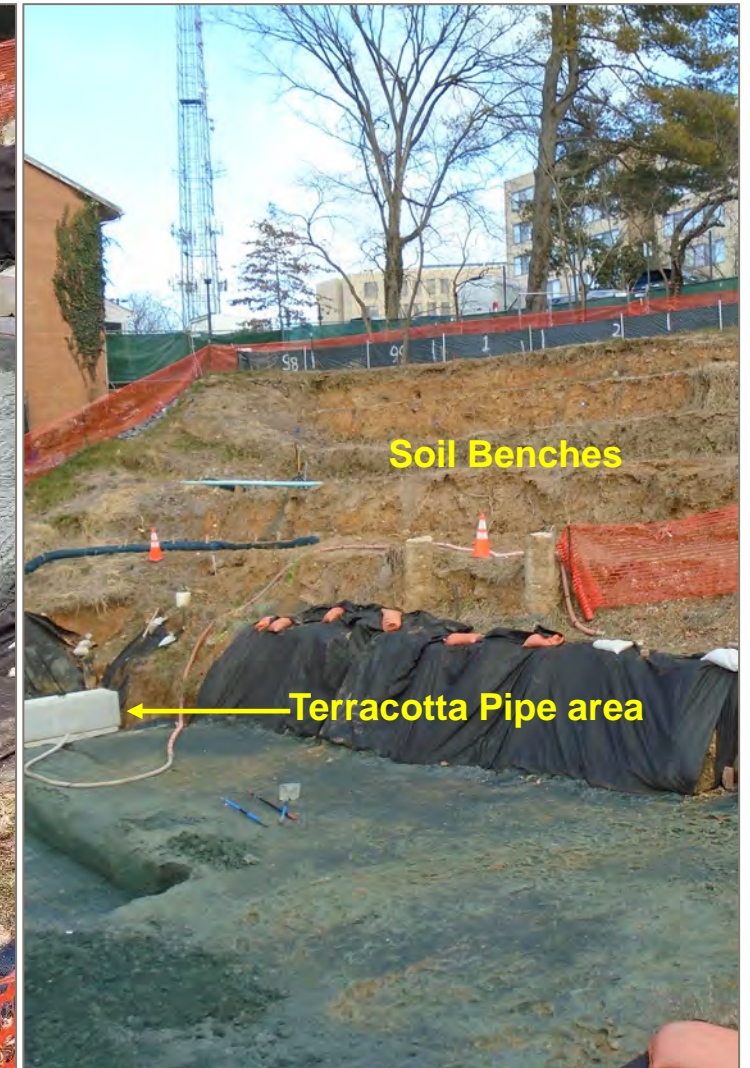
- Completed excavation under the former PSB slab on 21 January 2021.
- Completed terracotta pipe replacement.
- Backfill, compaction & testing to ground surface ended on 23 March 2021.
- Completed Rotosonic drilling & test pit AUES debris slope investigation on 12 April 2021.

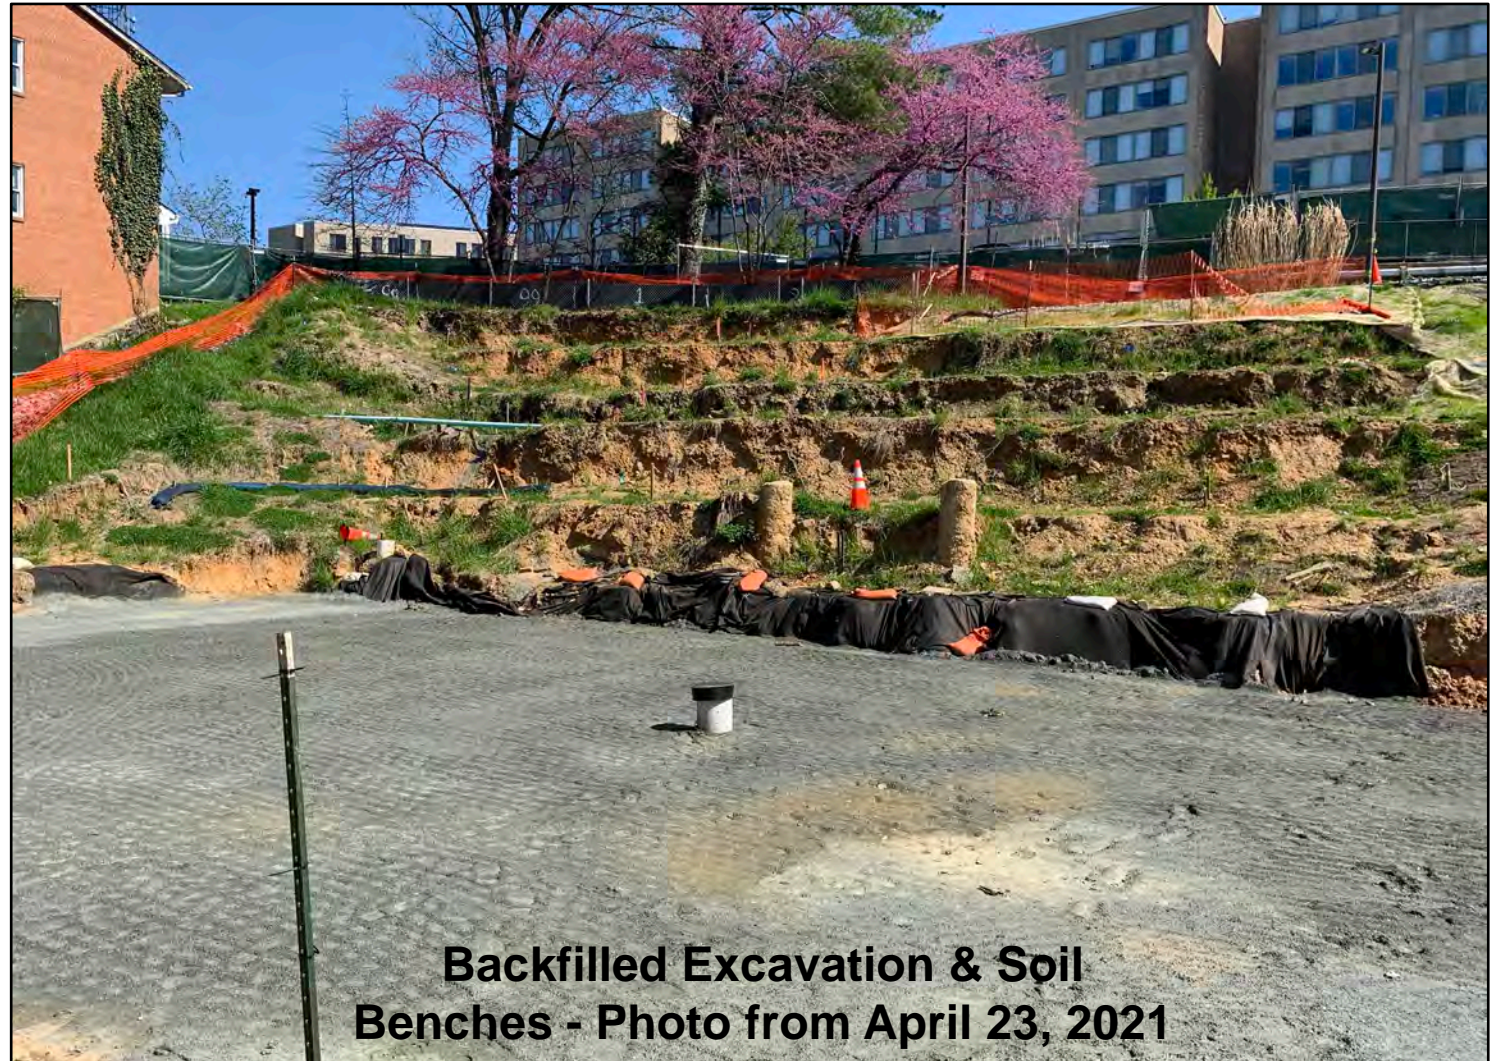
- Demobilized from the PSB site on April 16th.
- Team left the security fence, truck entrance and work area orange fencing at the site during the shutdown.
- Completed first post shutdown Erosion & Sediment Control inspection on April 23rd.

Backfilled Excavation & Soil Benches - Photo from April 23, 2021

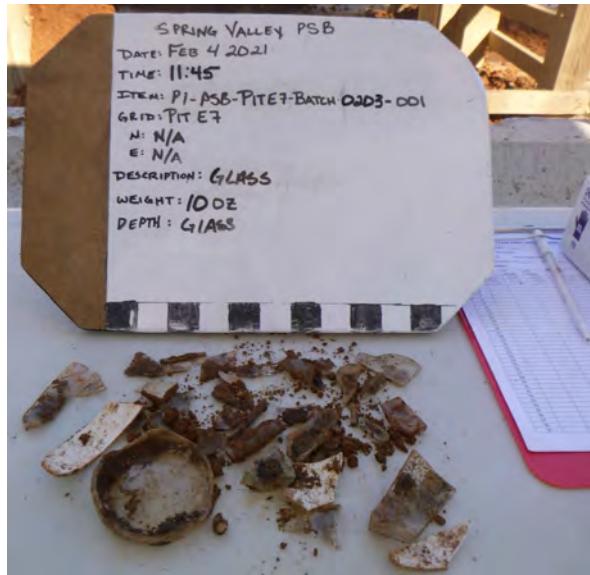
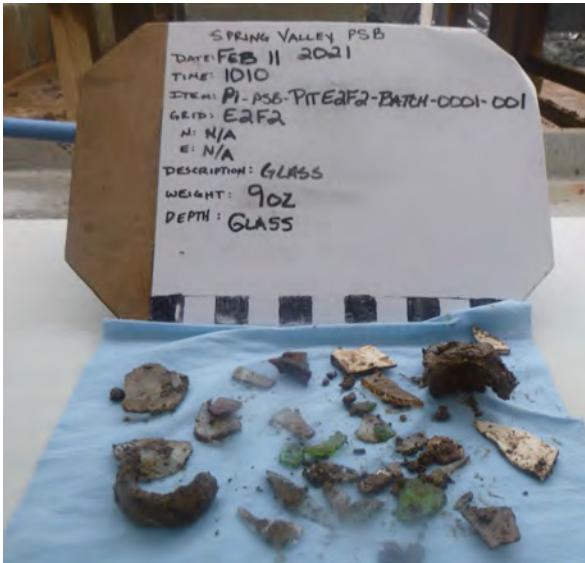
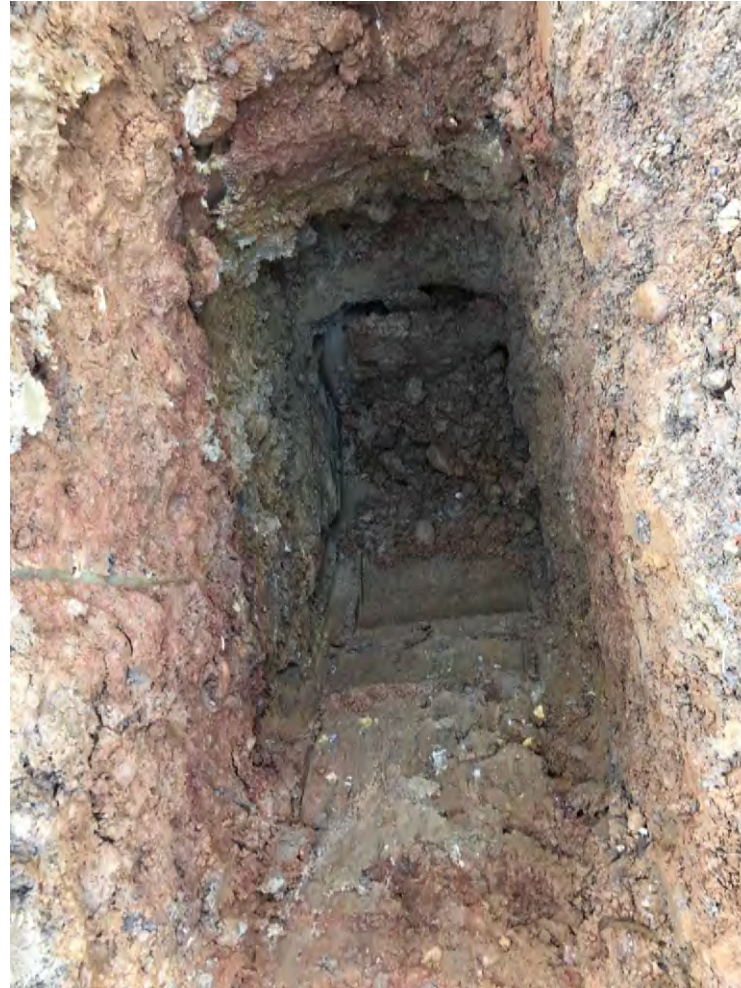
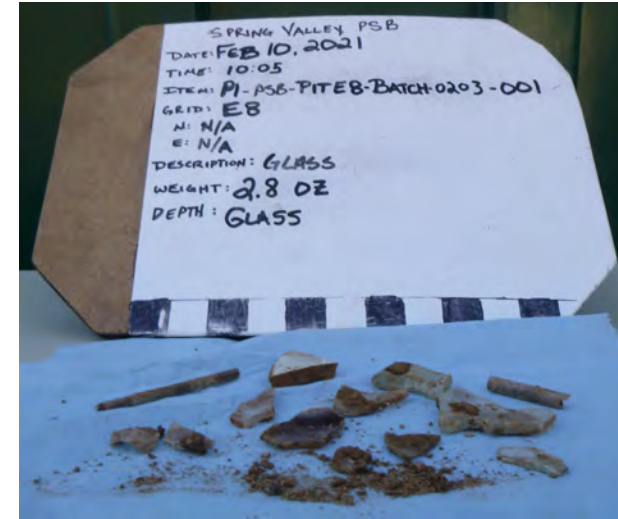
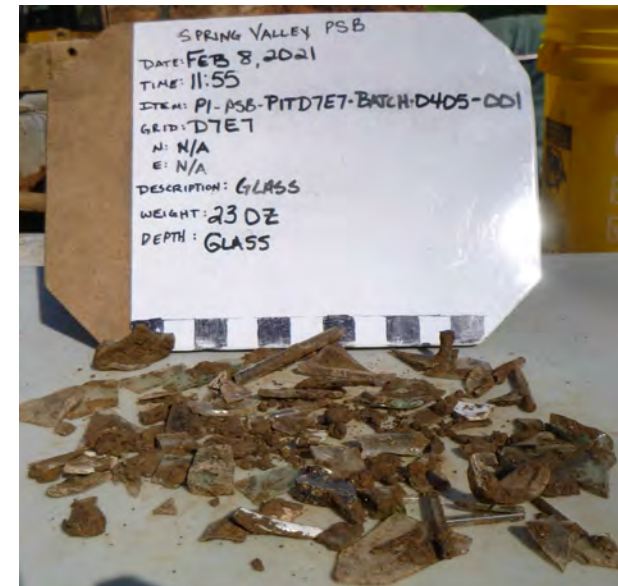
PSB – TEST PIT PHOTOS

Test Pit E8 Excavated to 9 ft

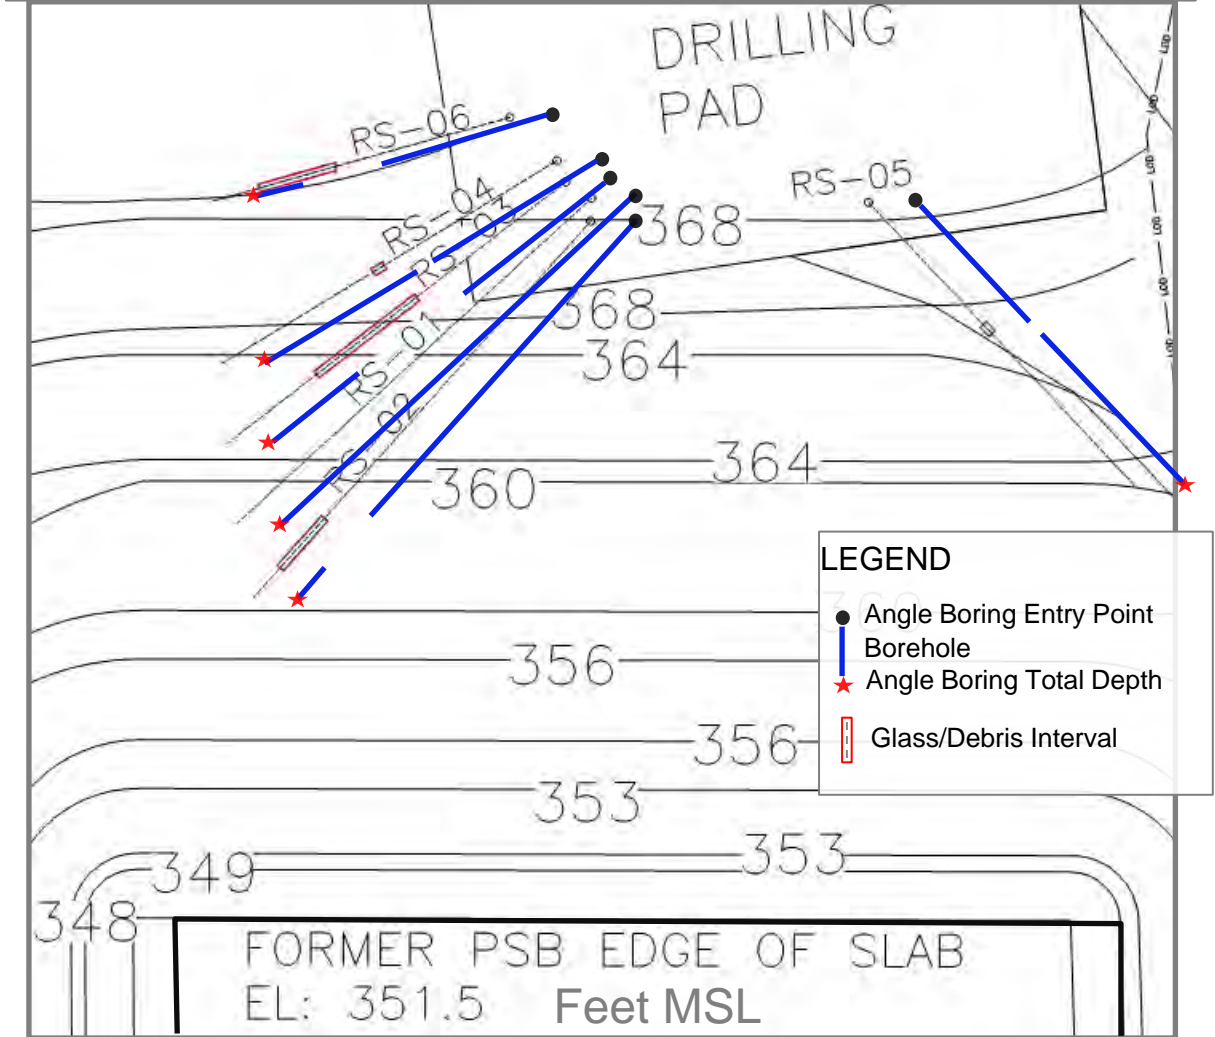
ROTONSONIC BORING INVESTIGATION MAP

Rotosonic Drilling – Proposed Locations

Rotosonic Drill Rig Completed Angled Borings

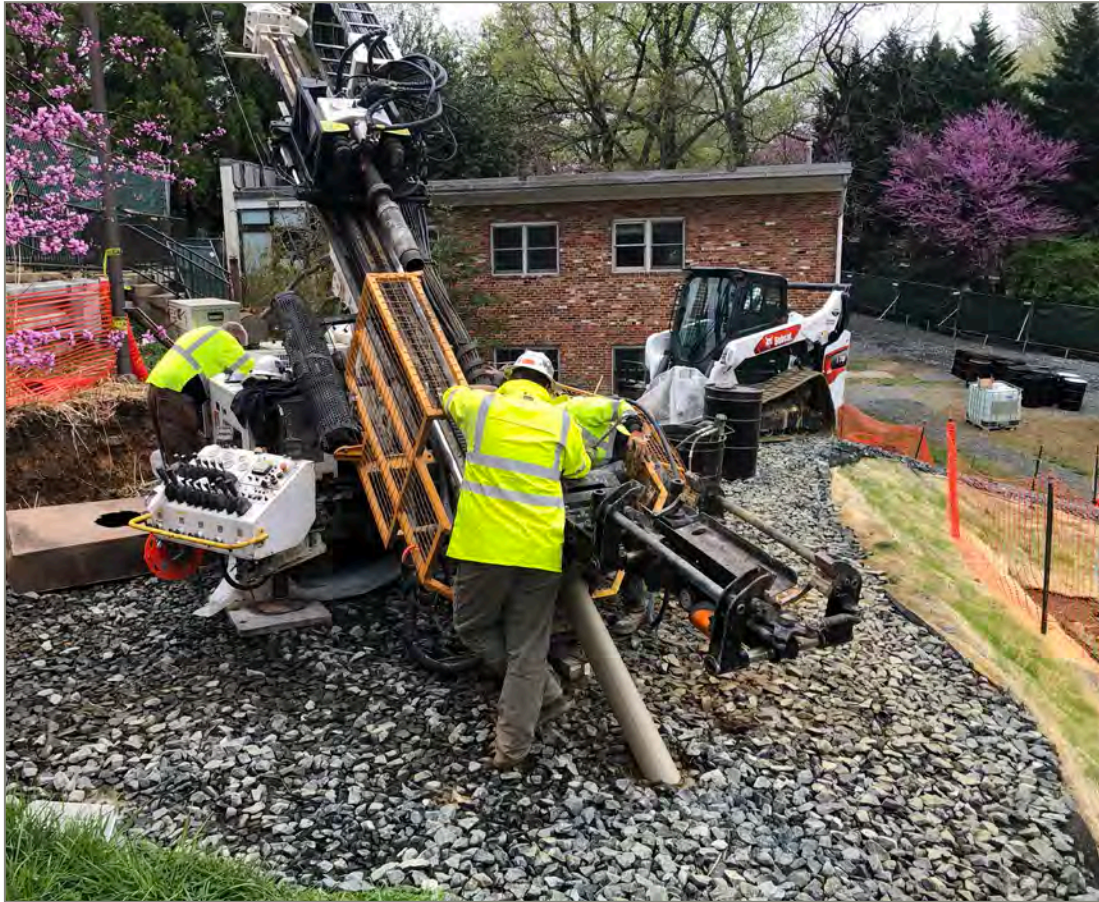
Rotosonic borehole RS-03 on drilling platform at the top of the PSB slope north of the foundation.

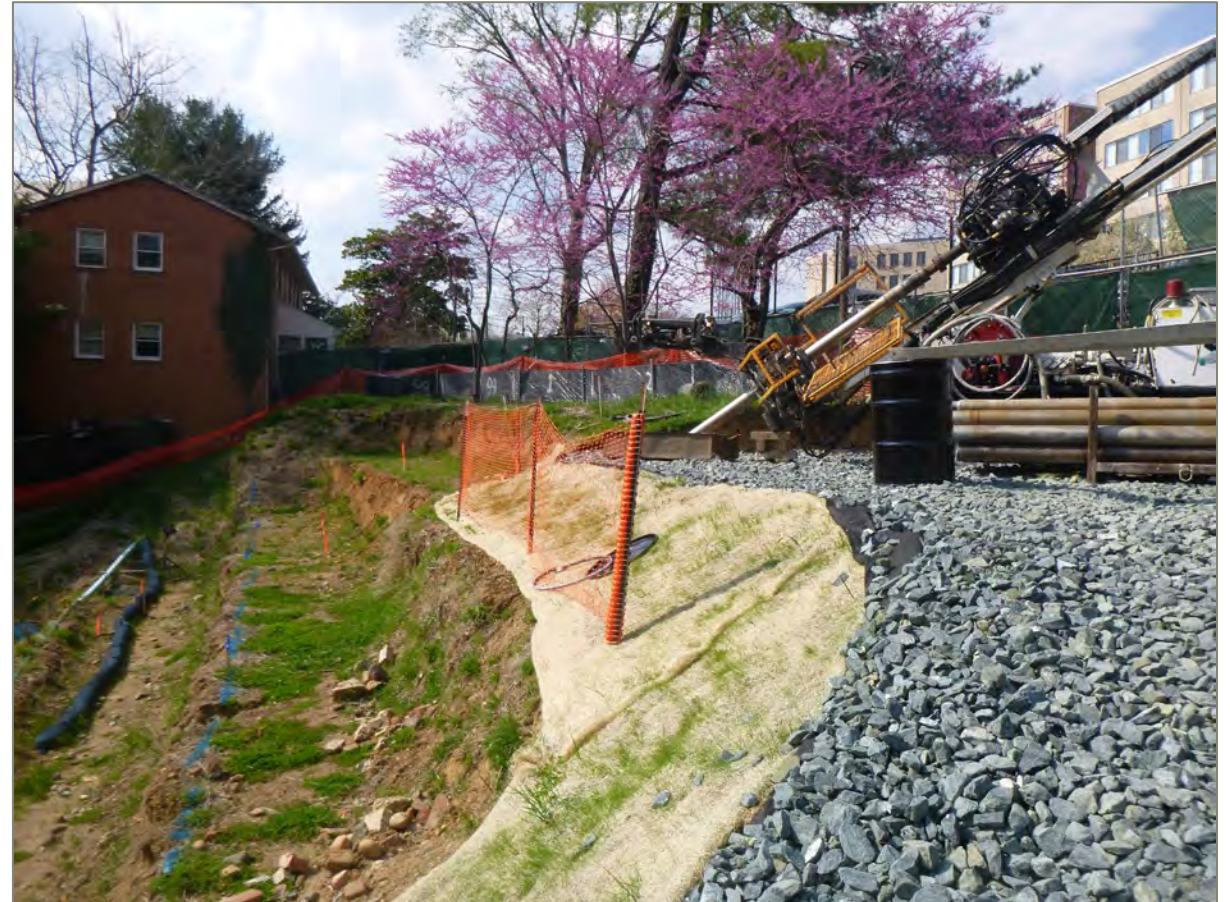
Rotosonic Rig advancing 4-inch diameter soil core barrel & 6-inch casing to collect continuous soil cores for AUES screening.

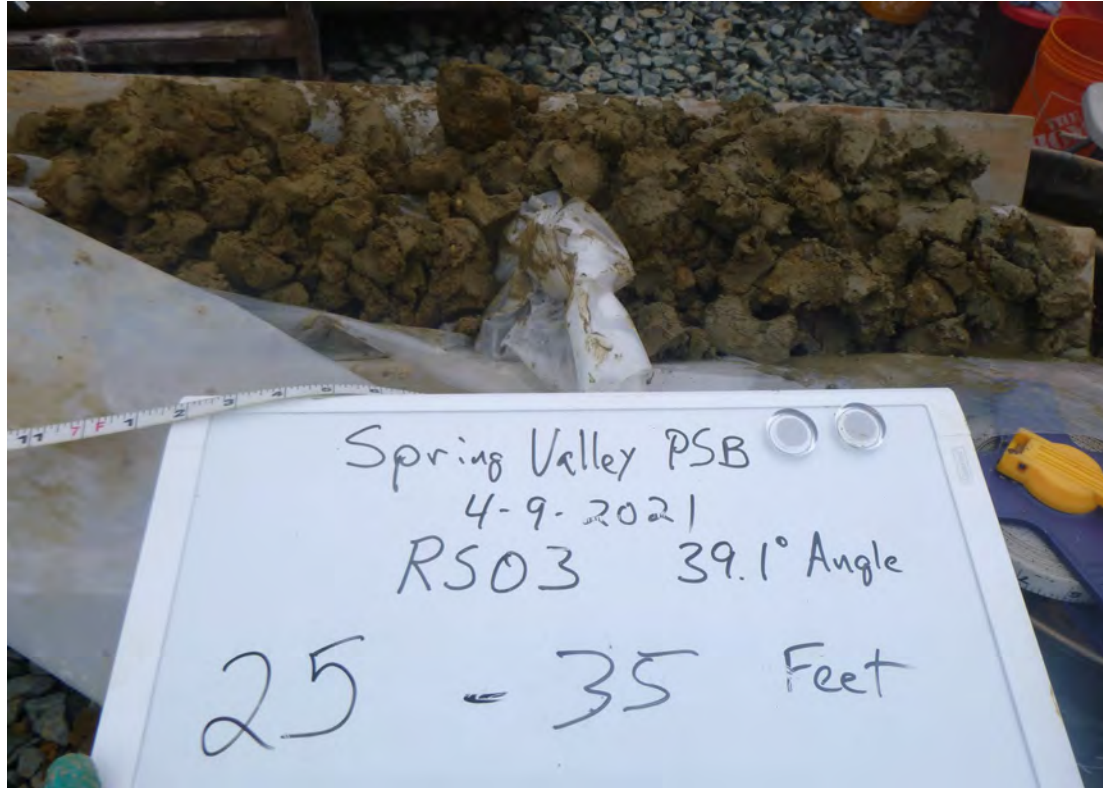
Rotosonic borehole RS-03 soil core on table after UXO Techs checked and sorted any debris and Geologist described the soil properties.

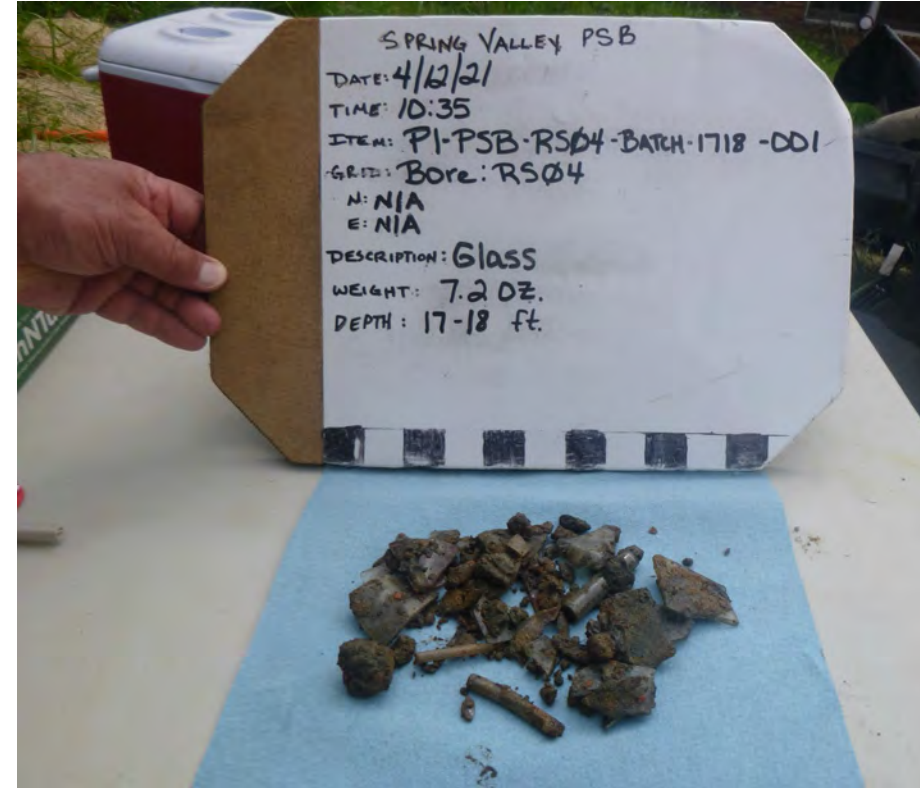
Rotosonic borehole RS-04 glass debris encountered at 17-18 feet with sample collected for CCDC headspace screening.

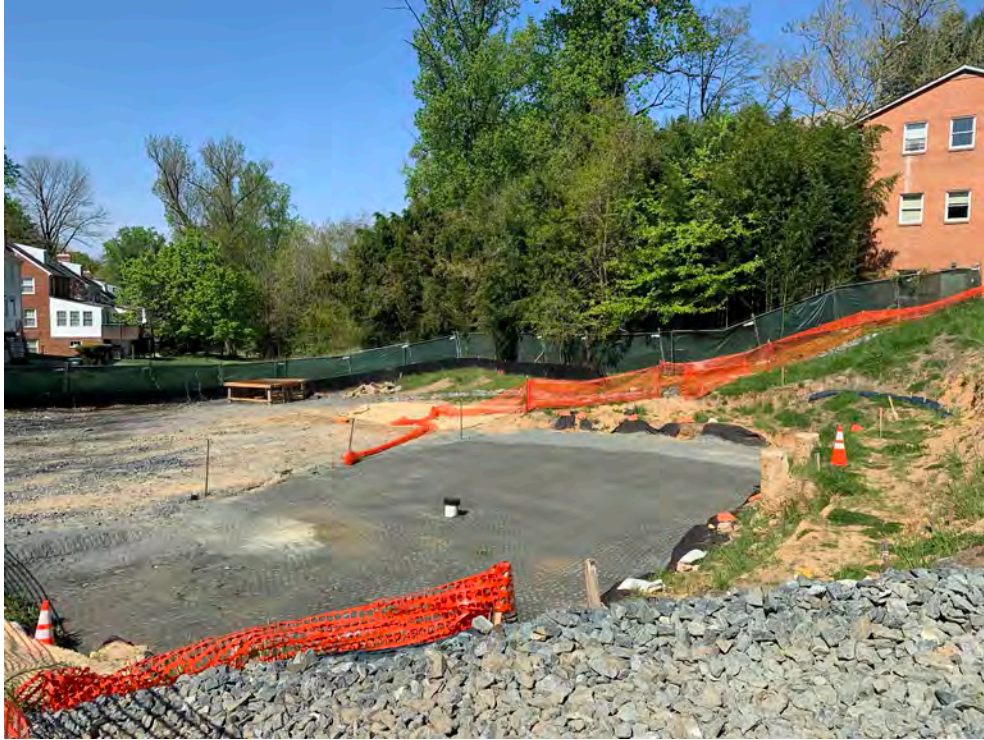
PSB Demobilized – Photo overlooking the site from the Rotosonic Drilling platform north of the PSB foundation excavation.

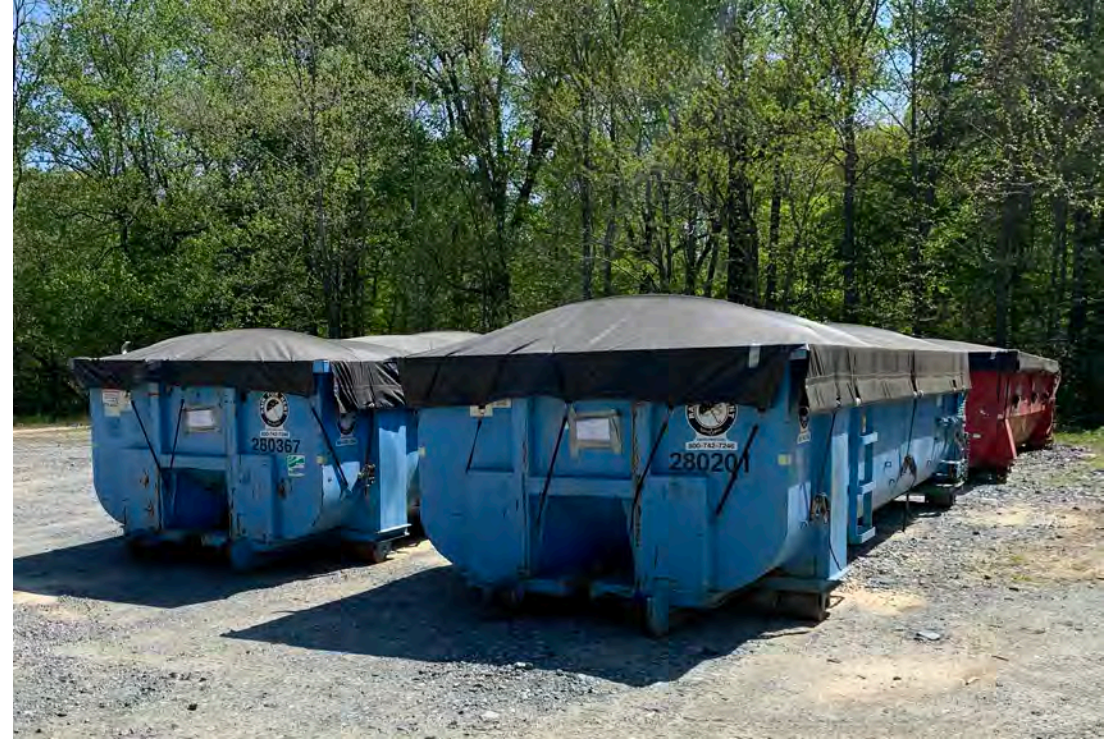
Waste Disposal – Last four excavated soil roll-offs waiting for disposal transport to King & Queen Landfill.

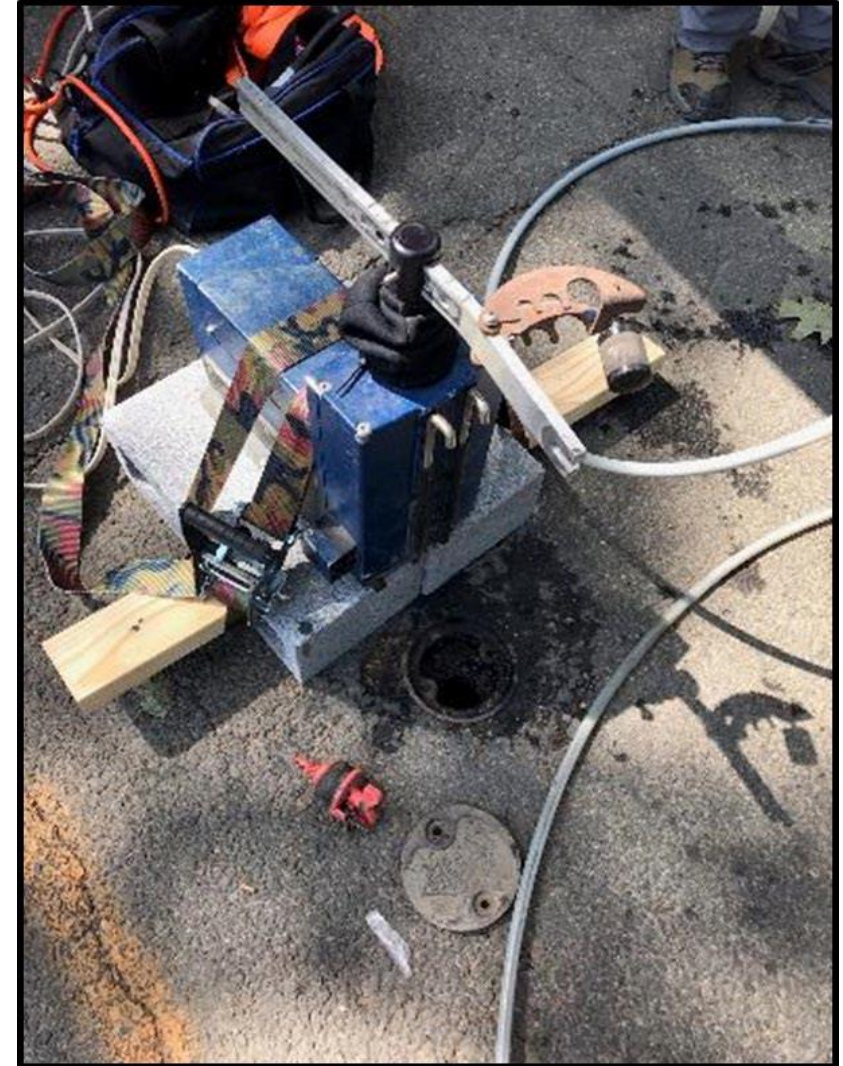
Groundwater sampling well

The groundwater sampling event for perchlorate at wells PZ-4D and MW-44 was conducted by the USACE and the U.S. Geological Survey (USGS) on March 1st.
