# SPRING VALLEY FORMERLY USED DEFENSE SITE

Partners Meeting Presentation  
June 2021

# 4825 Glenbrook Road - Recent Activities

# SVFUDS SITE-WIDE REMEDIATION STATUS JUNE 2021

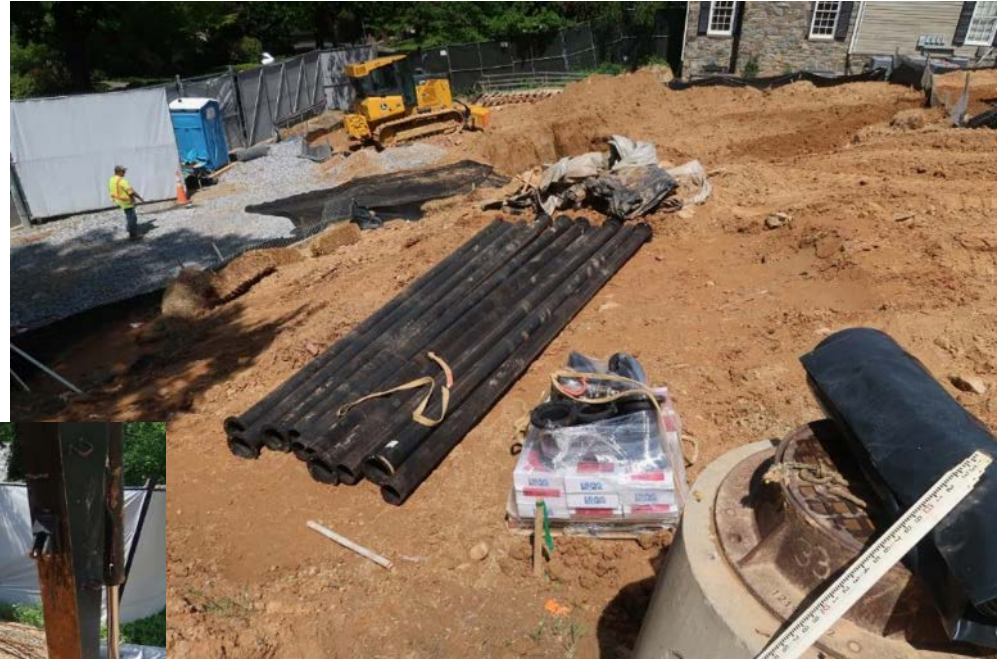
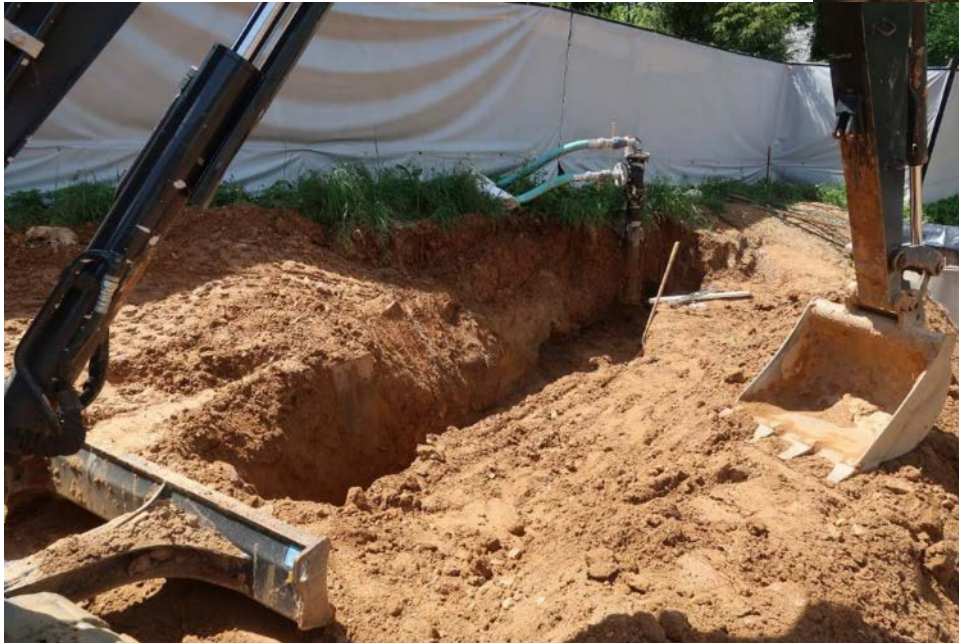
- Continued to perform backfilling, compaction, and erosion and sediment (E&S) controls maintenance activities in May and June
- Began waterline restoration on May 6<sup>th</sup>

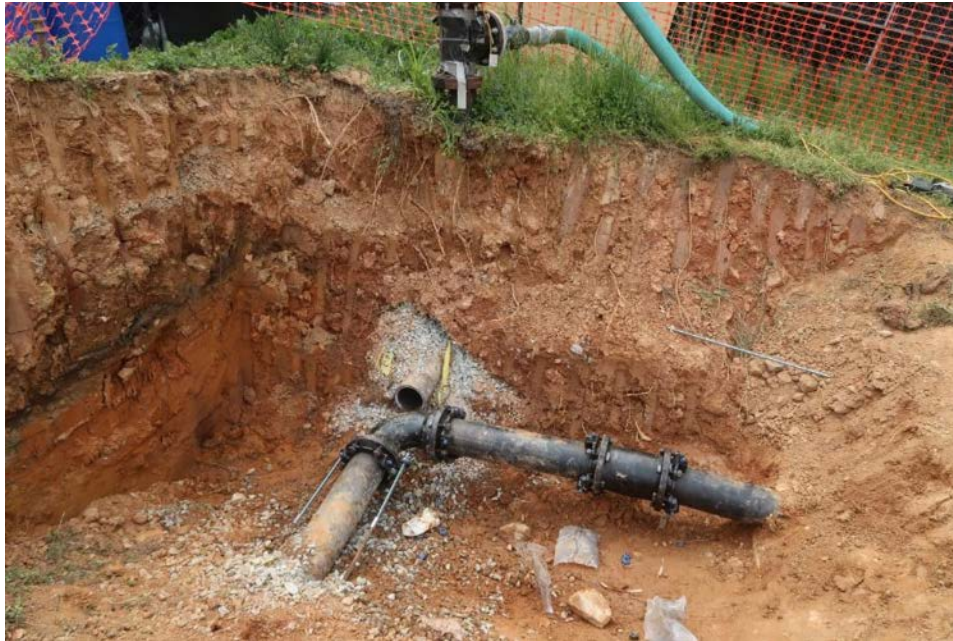
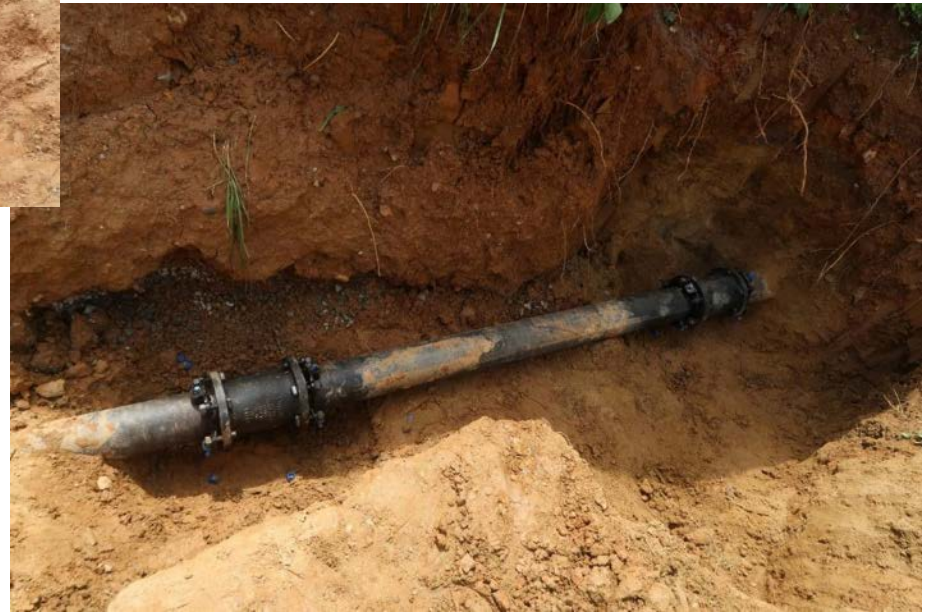
Final waterline connections made May 12<sup>th</sup>

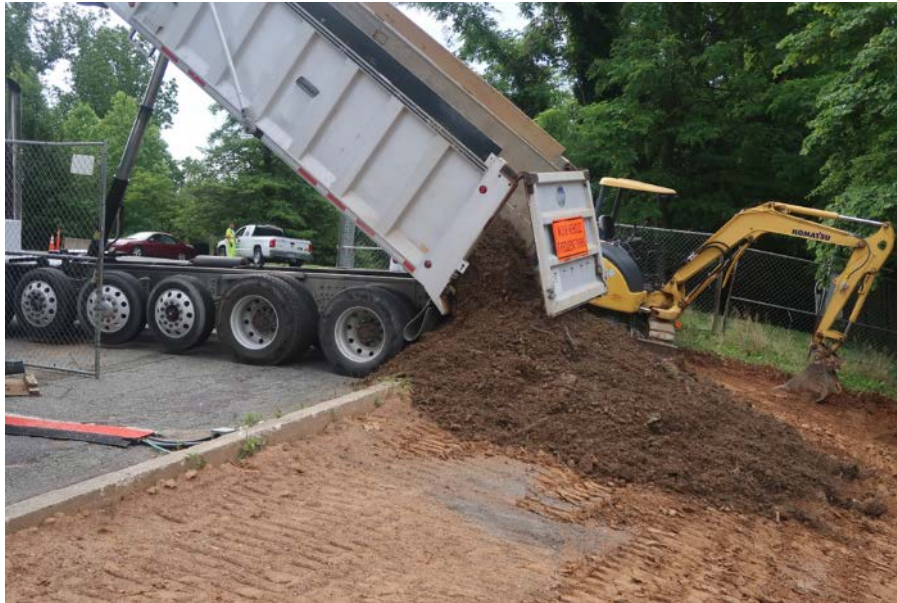
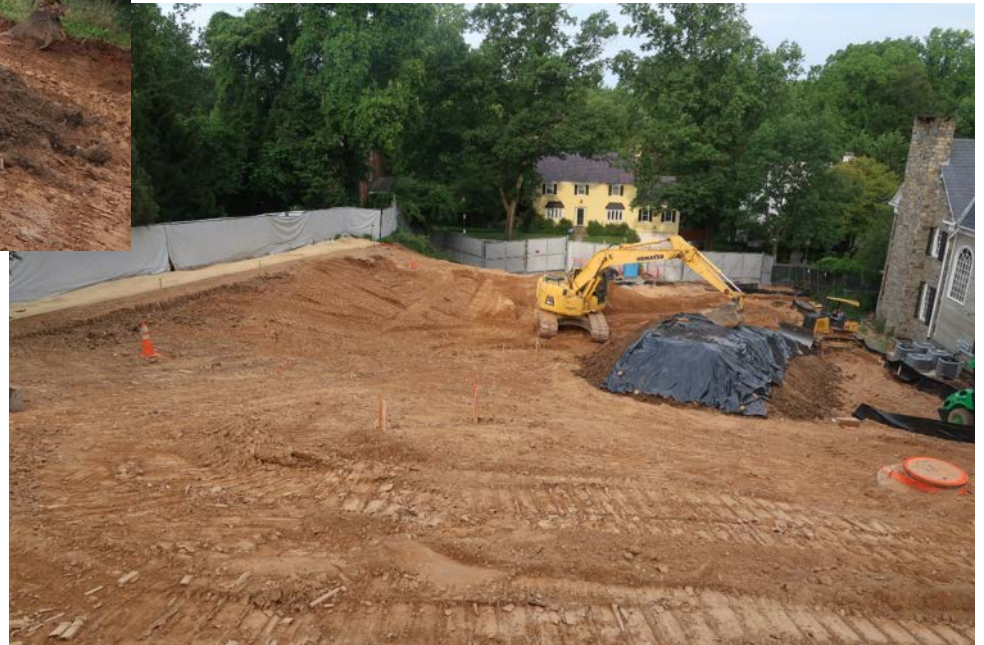
- On June 2<sup>nd</sup> began hauling topsoil to the site
- On June 7<sup>th</sup> the sewer manhole closest to AU was lowered 2 feet to match final grade

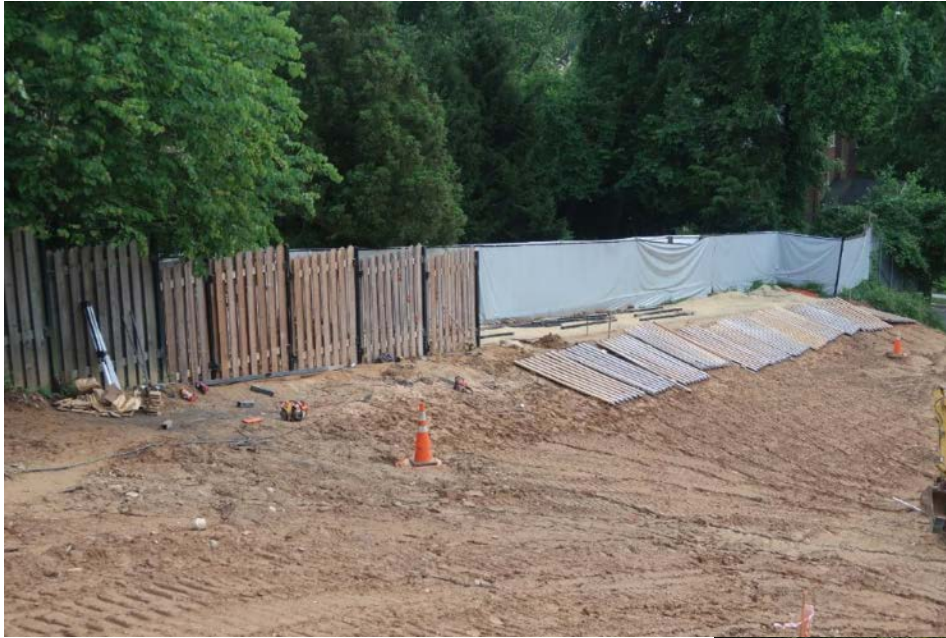
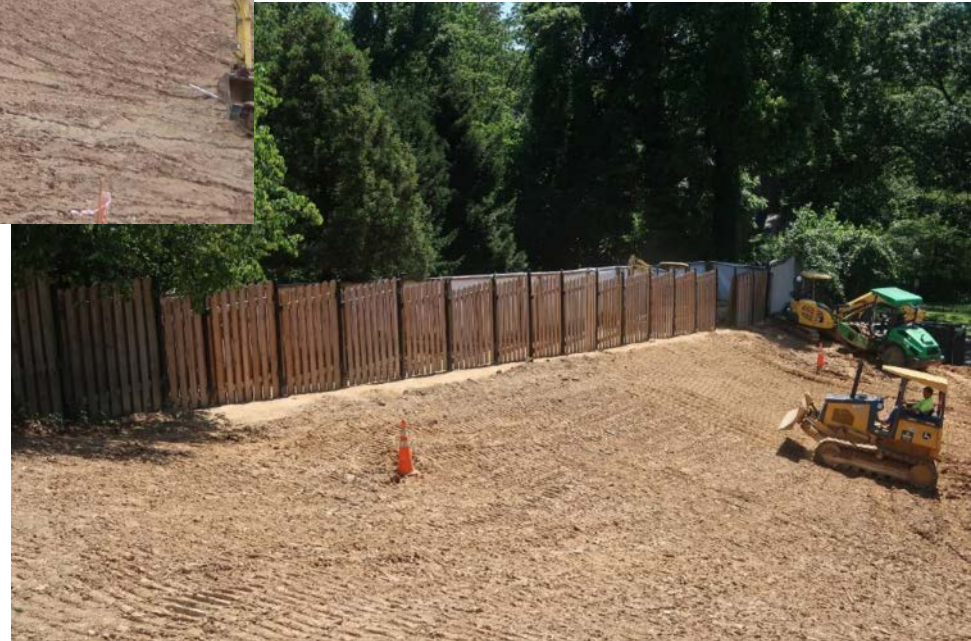
On June 14<sup>th</sup> began restoring fence along 4801/4825 Glenbrook Rd property boundary with fence restoration completed on June 17<sup>th</sup>

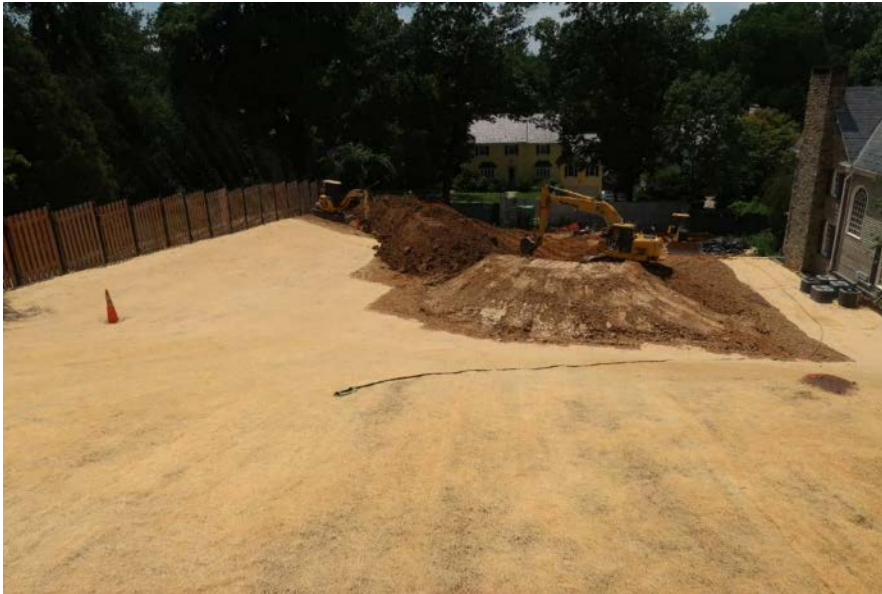
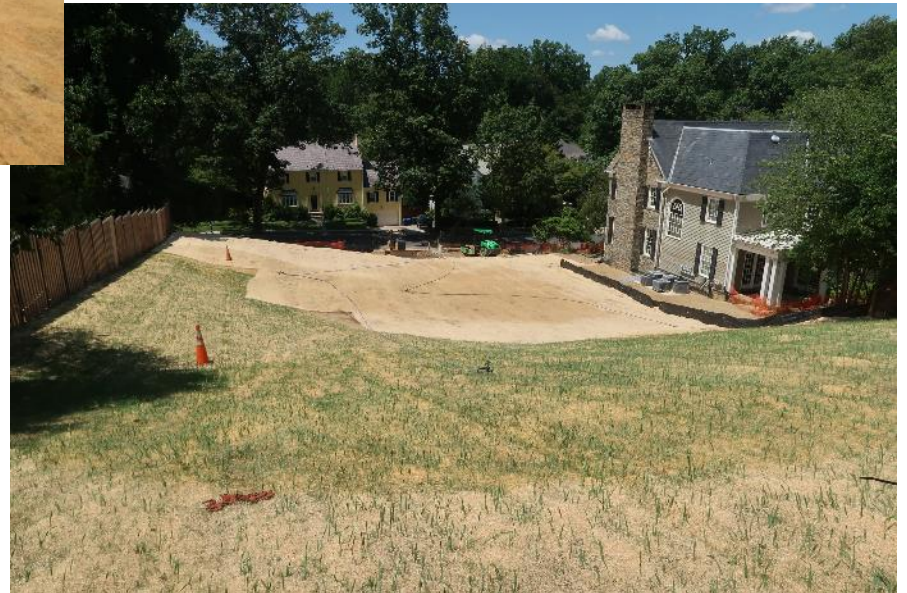
- On June 18<sup>th</sup> first phase of hydroseeding was completed
- On June 25<sup>th</sup> all topsoil was placed
- On June 26<sup>th</sup> and 28<sup>th</sup> final hydroseed and matting was placed.

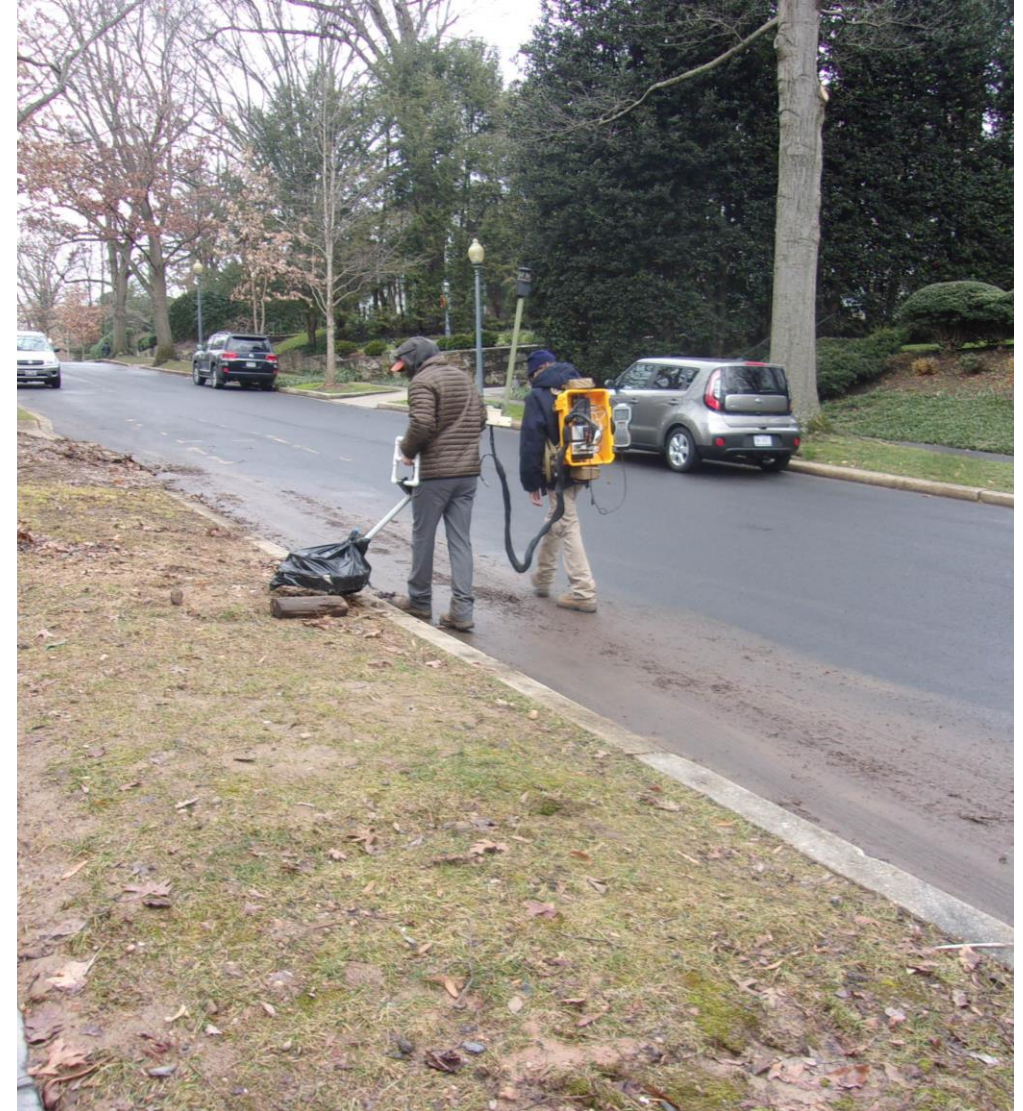
- No geophysical surveys have been conducted since the April 23 Partners update. Next round of geophysical surveys pending completion of site preparation activities and/or property owner approvals of Landscape Plans.
- To date, geophysical surveys have been completed at 13 Fed/city lots and 85 residential properties
- Geophysical surveys remaining to be conducted include 7 residential properties

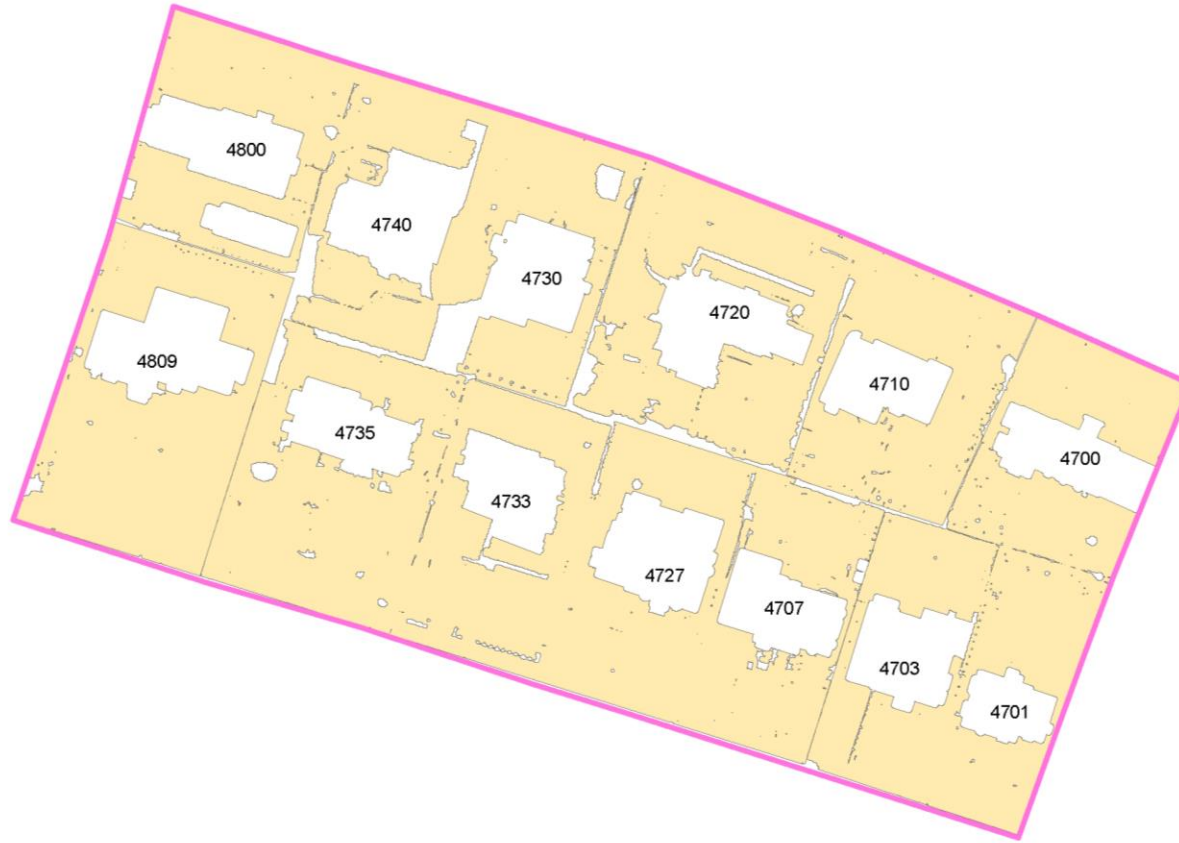
**Figure 2**  
**Area of Interest (AOI)-13**  
**Overall MPV Coverage**

AOI-13 = 141,408.41 square feet (sq ft)  
MPV Coverage Survey Area = 103,943.32 sq ft  
Survey Coverage = 73.5%

- Overall MPV Survey Coverage of Area of Focus = 73.5%
- Includes coverage from MPV surveys conducted at 3 residential properties during the Pilot Study

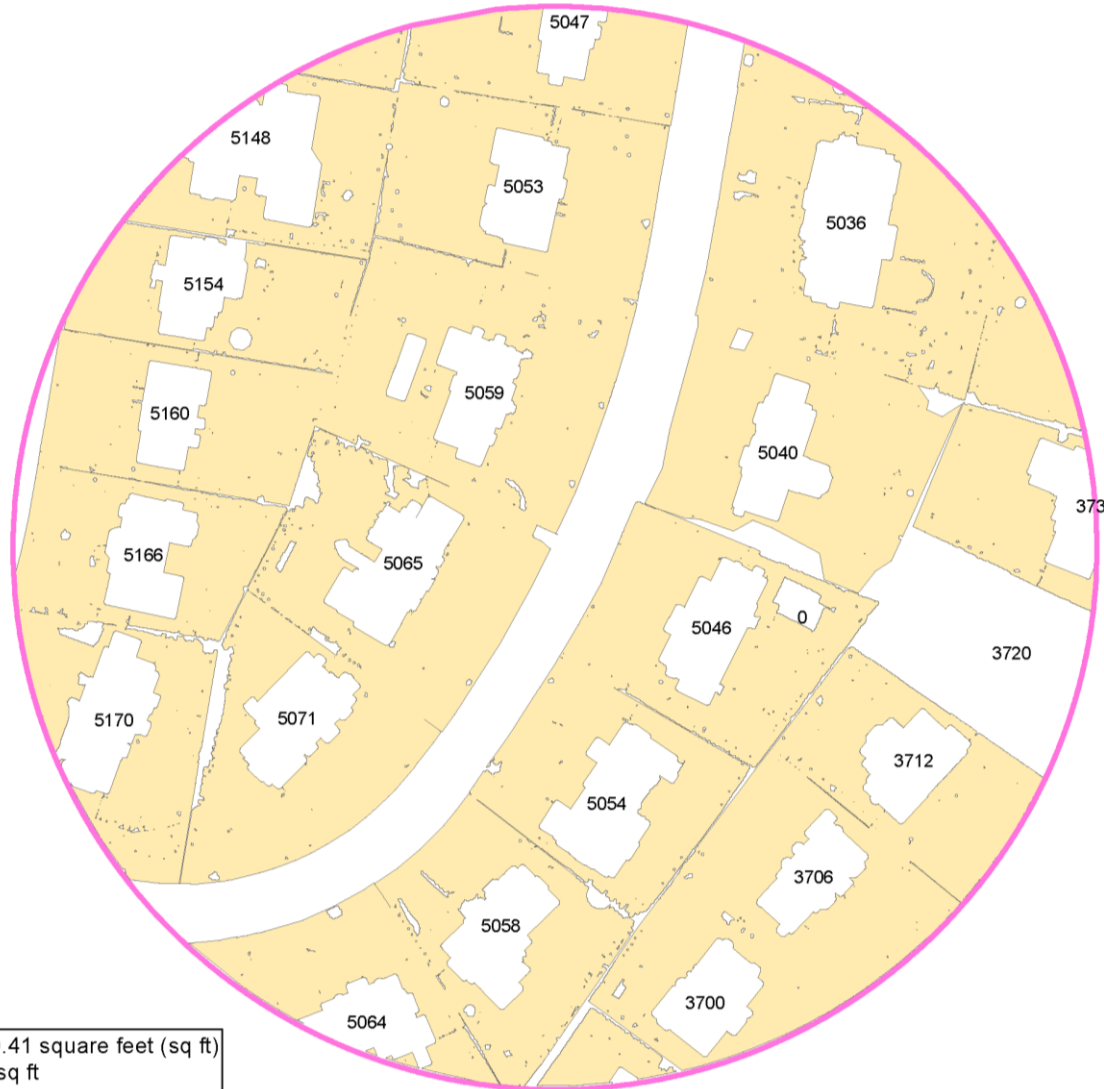
**Figure 6**  
**Static Test Fire Area**  
**Buffer Zone Sedgwick**  
**Overall MPV Coverage**

Static Test Fire Area Buffer Zone = 240,240.41 square feet (sq ft)  
MPV Coverage Survey Area = 160,953.77 sq ft  
Survey Coverage = 66.9%

- Overall MPV Survey Coverage of Area of Focus = 66.9%
- One property has yet to be surveyed

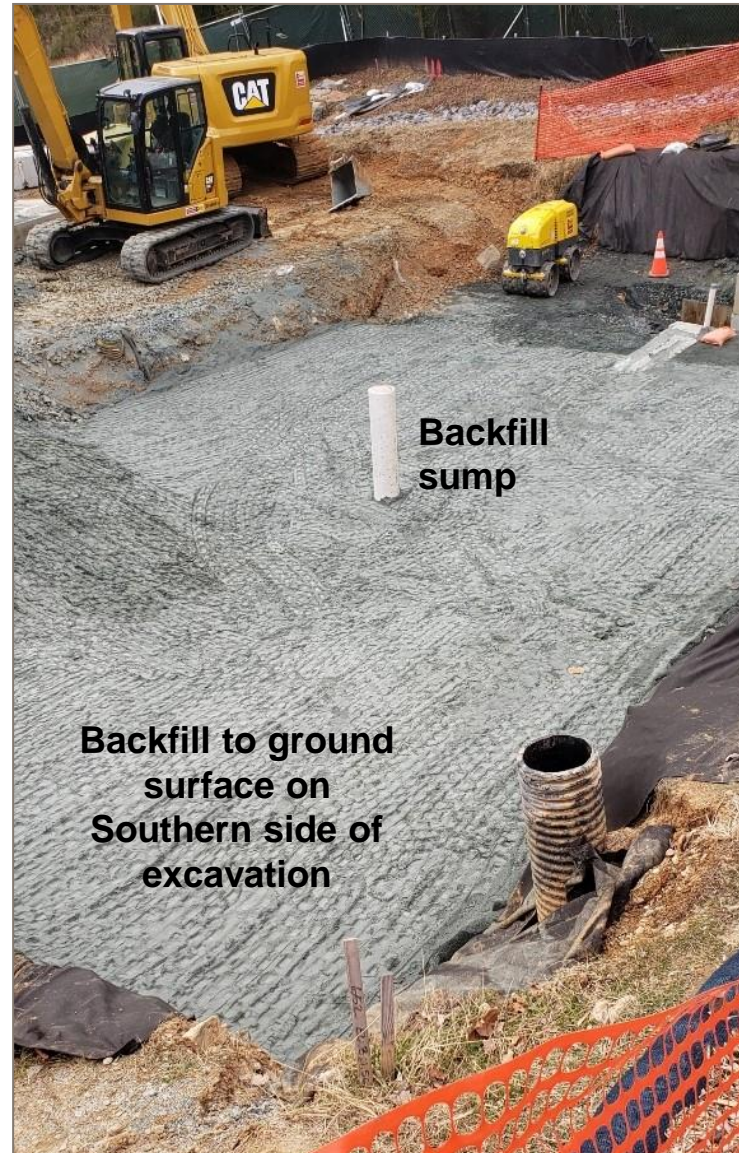
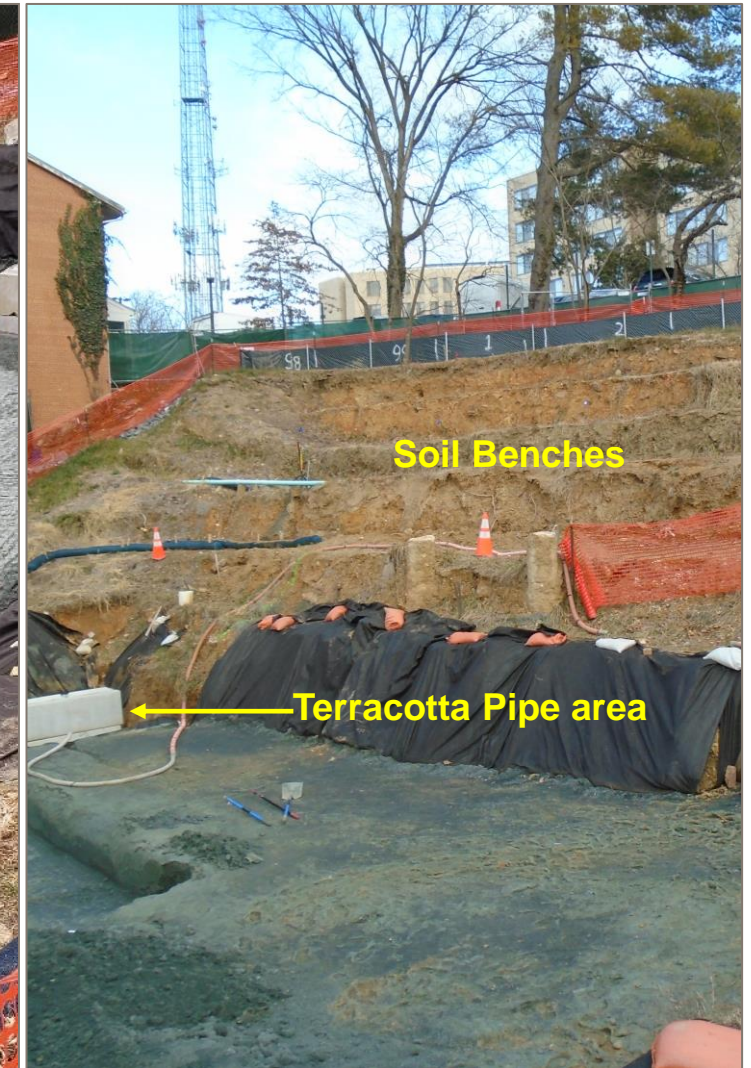
- Completed excavation under the former PSB slab on 21 January 2021 and backfill on 23 March 2021.
- Completed Rotosonic drilling & test pit AUES debris slope investigation on 12 April 2021.
- All PSB Confirmation Soil Sample results for Grids met the cleanup criteria.

- Completed the Rotosonic drilling and Test Pit investigation to determine extent of AUES debris north, east & west of the PSB foundation slab on April 12<sup>th</sup>.
- Submitted the Final Technical Memorandum with the Public Safety Building Test Pit Excavation and Rotosonic Drilling investigation results on June 23<sup>rd</sup>.
- Currently, USACE is developing the scope of work to complete the excavation of AUES debris observed east, north and west of the former PSB foundation.

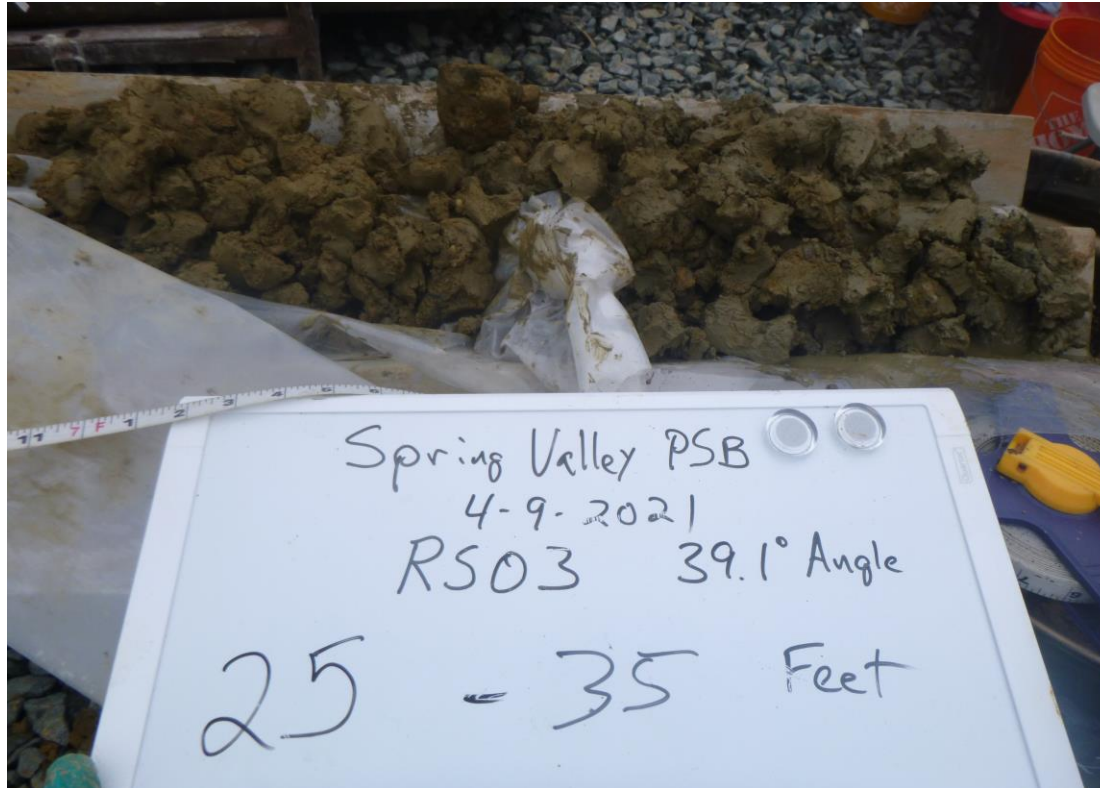
**Rotosonic borehole RS-03** soil core on table after UXO Techs checked and sorted any debris and Geologist described the soil properties.

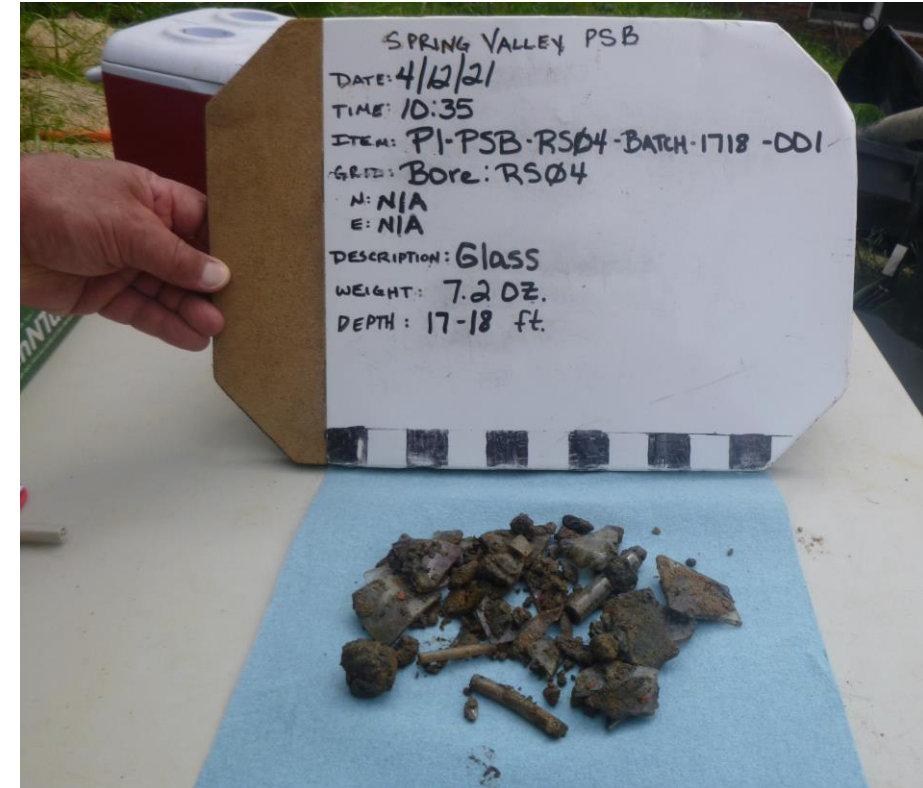
**Rotosonic borehole RS-04** glass debris encountered at 17-18 feet with sample collected for CCDC headspace screening.

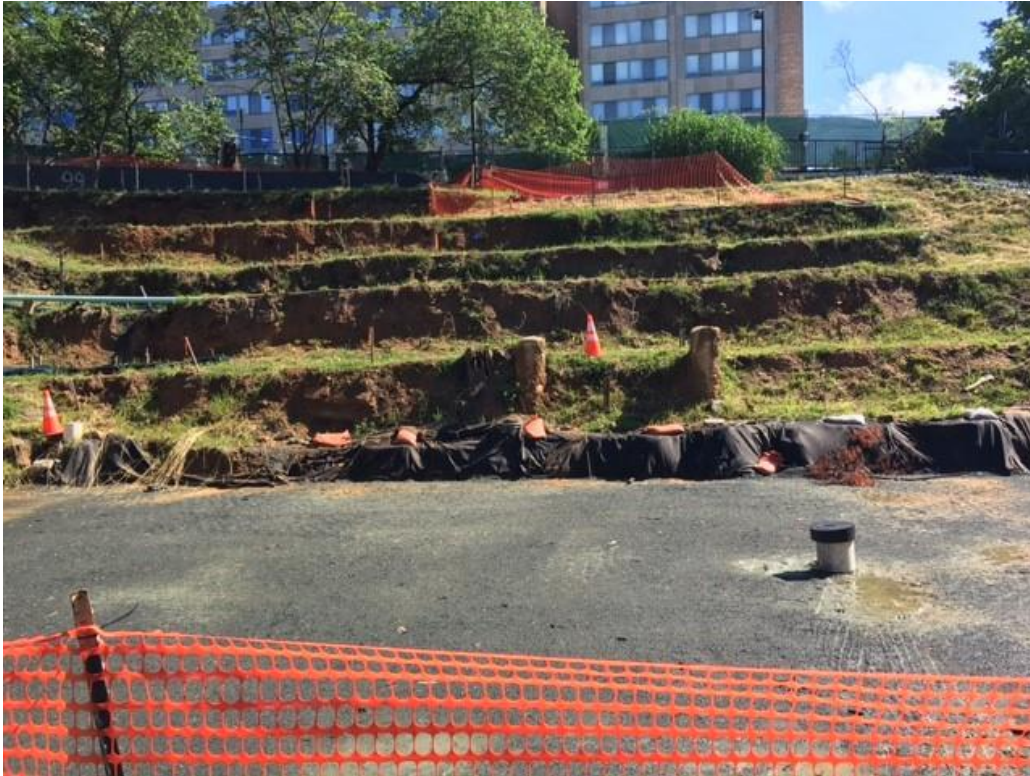
**PSB Demobilized** – June 15<sup>th</sup> Photo looking north up the site from south of the PSB foundation excavation.

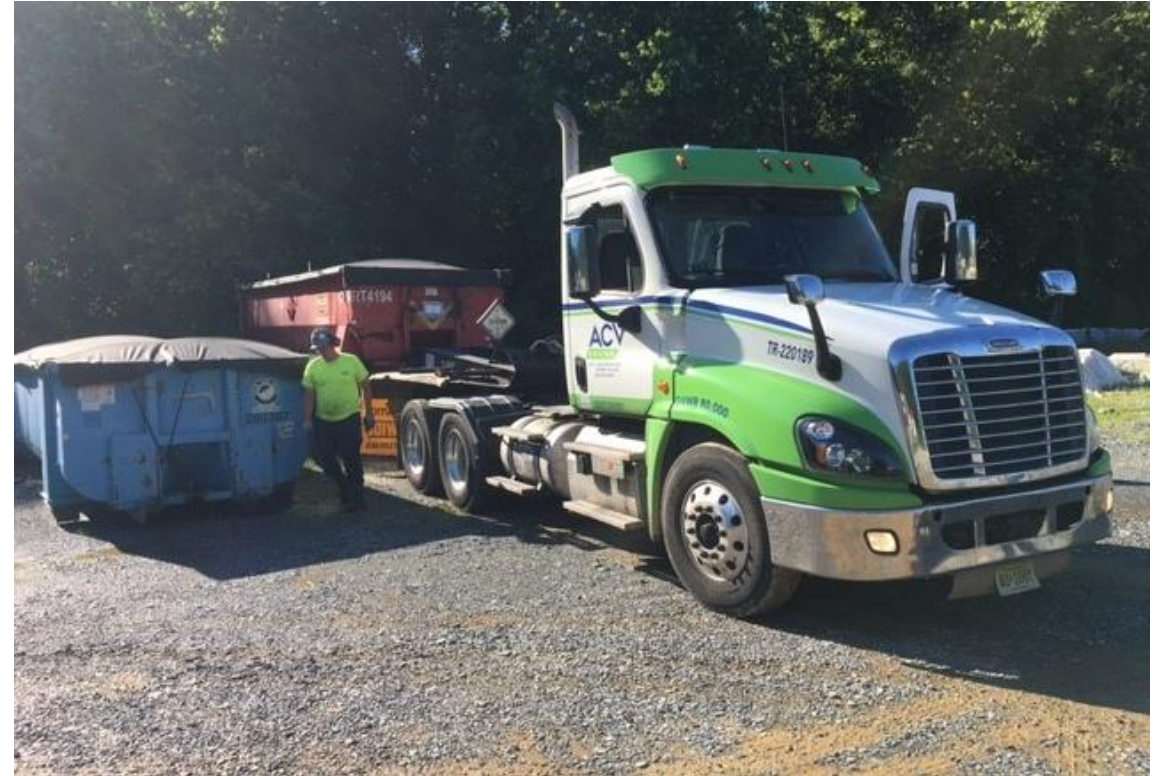
**Waste Disposal** – Loading one of the final four excavated soil roll-offs waiting for disposal transport to King & Queen Landfill.

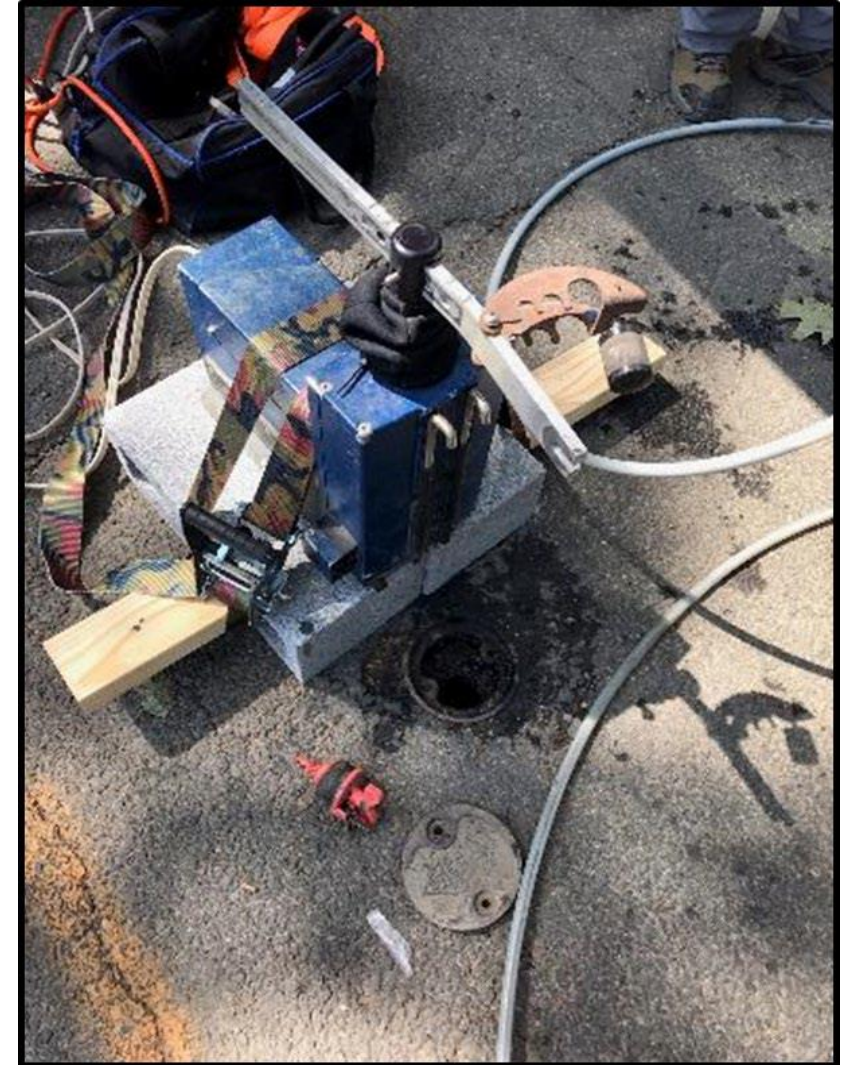
*Groundwater sampling well*
