SPRING VALLEY FORMERLY USED DEFENSE SITE

Partners Meeting Presentation
August 2021

SVFUDS SITE-WIDE REMEDIATION STATUS AUGUST 2021

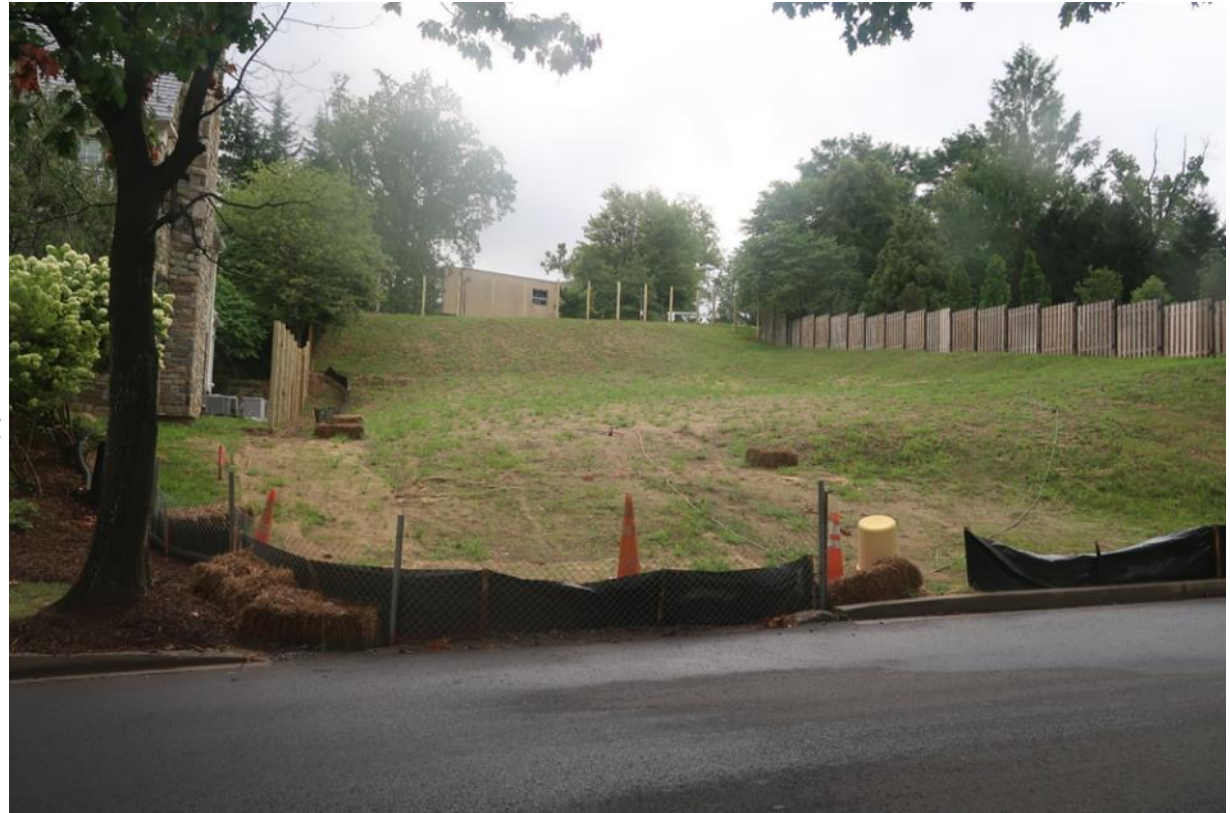
- Parsons continued to water the grass throughout July and August
- The last round of hydroseed was reseeded in early August due to the lack of grass growth
- The challenge remains that growing new grass in hottest part of summer is a challenge in this region

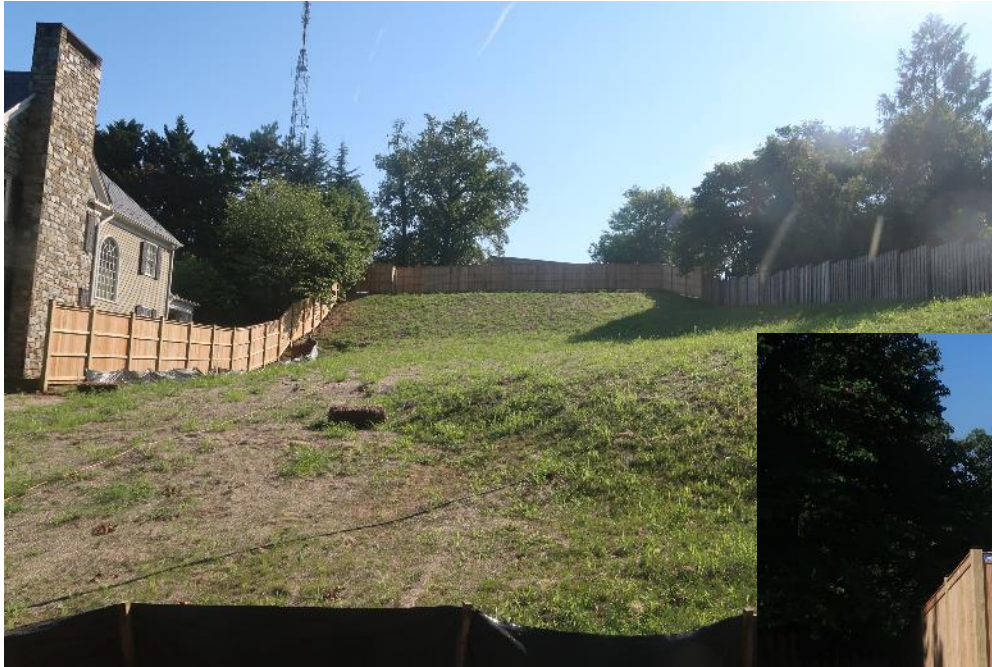
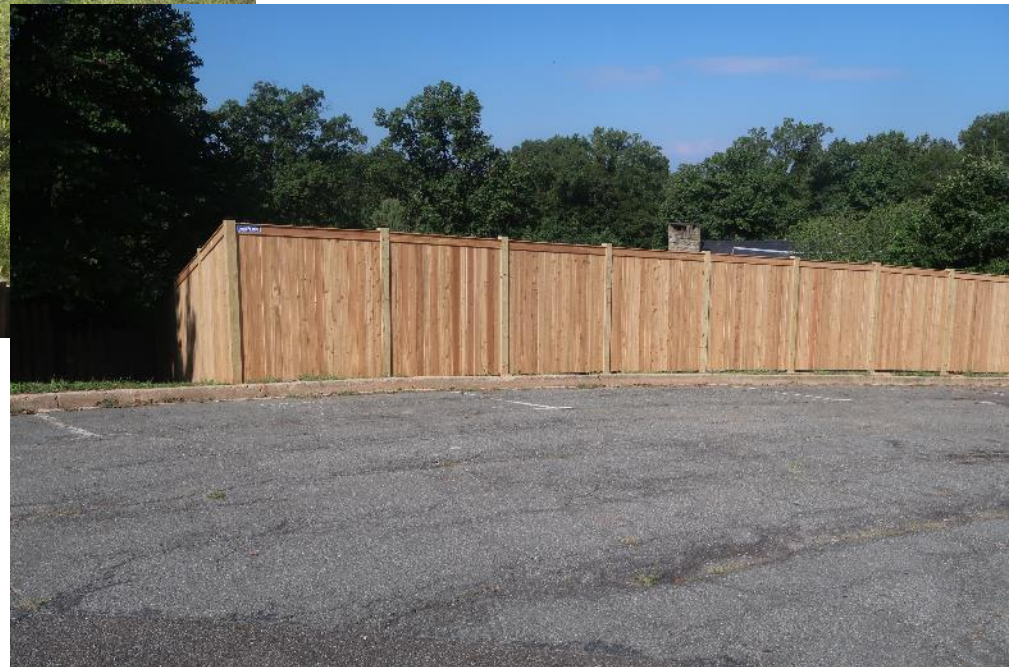
The privacy fence along the backyard and the shared property line up to the front of the 4835 Glenbrook Rd house was installed between August 16th and 23rd.

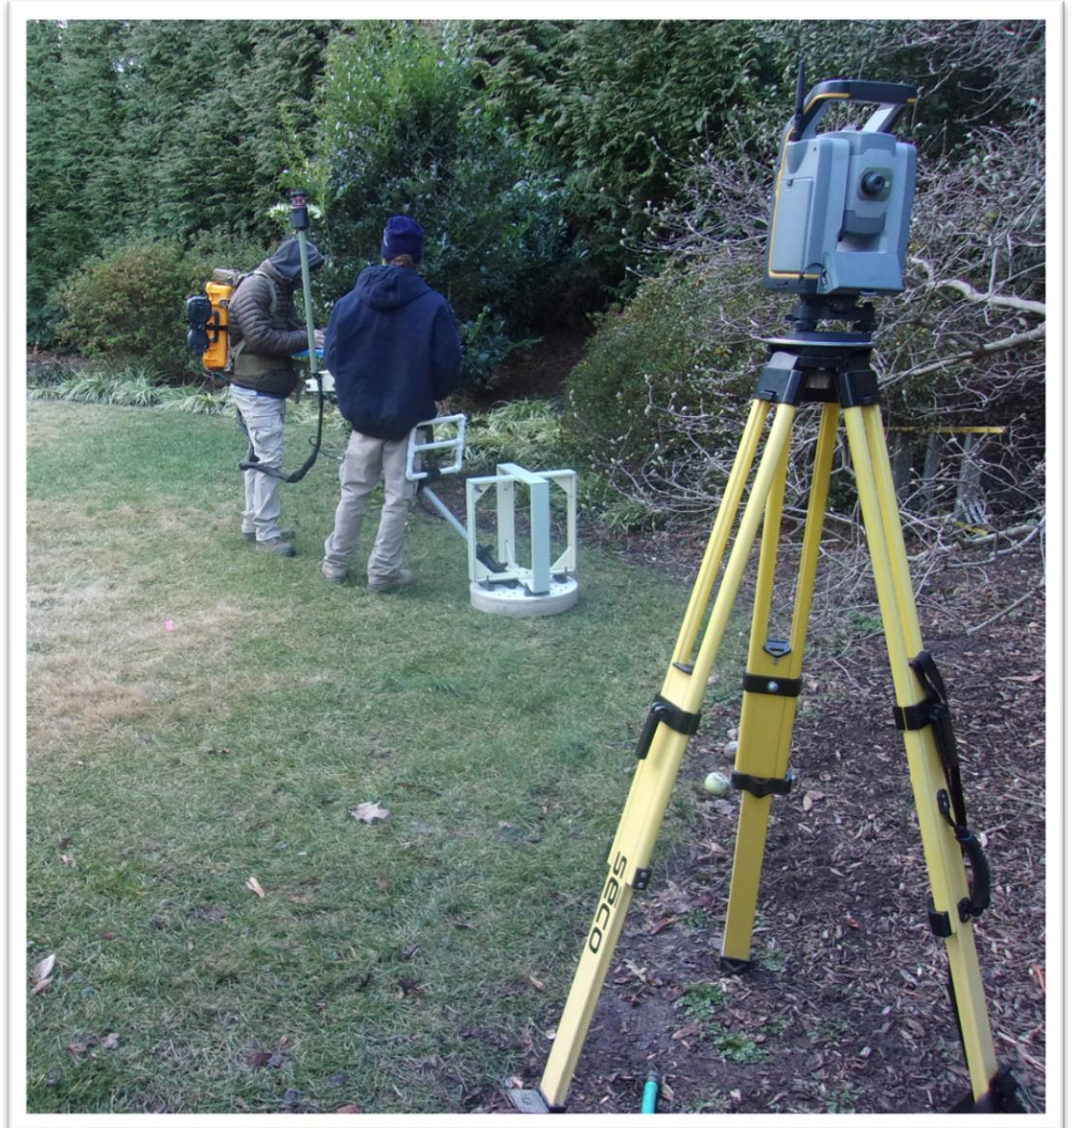
Geophysical surveys:

- No geophysical surveys have been conducted since the June 25 Partners update. The next round of geophysical surveys are pending completion of site preparation activities and/or property owner approvals of Landscape Plans.
- To date, geophysical surveys have been completed at 13 Fed/city lots and 85 residential properties
- Geophysical surveys remaining to be conducted include 7 residential properties

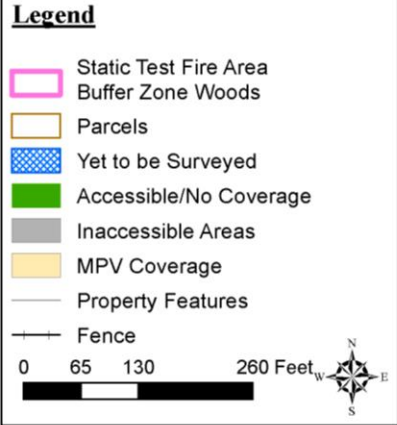
Figure 3
Static Test Fire Area
Buffer Zone Woods
Accessible MPV Coverage

Static Test Fire Area Buffer Zone = 738,357.13 square feet (sq ft)
 Inaccessible Areas (Includes Trees, Buildings, Saturation Buffer, and Streets) = 167,876.65 sq ft
 Property - Inaccessible Area = 570,480.48 sq ft
 Yet to be Surveyed and Accessible/No Coverage = 208,069.65 sq ft
 MPV Coverage Survey Area = 362,410.83 sq ft
 Coverage = 63.5%

- MPV Survey Coverage of accessible areas (Dalecarlia Reservoir property considered inaccessible) = 63.5%
- Additional inaccessible areas include buildings, 18-inch saturation buffer, streets, and trees
- Accessible/No Coverage areas include data gaps caused by vegetation or other obstructions that were not allowed to be removed
- Six properties have yet to be surveyed

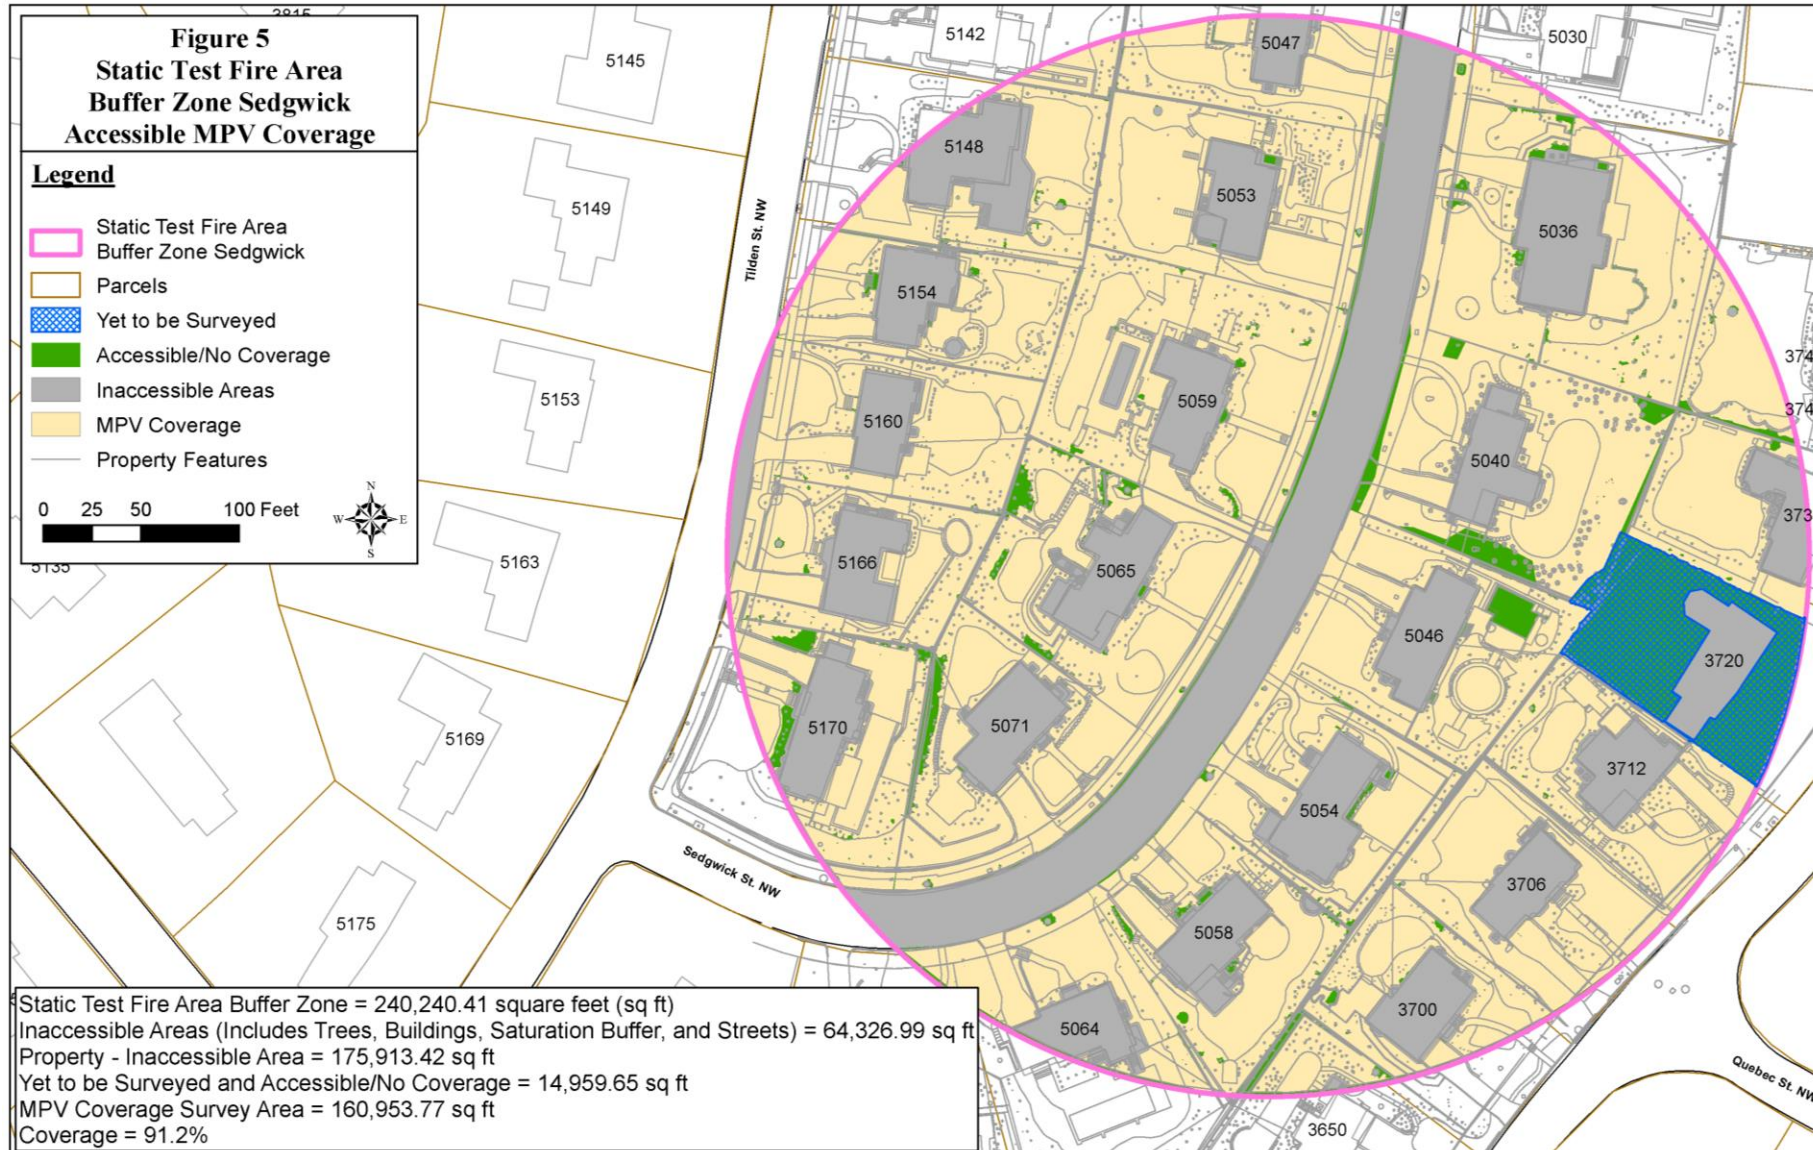
Static Test Fire Area East

- MPV Survey Coverage of accessible areas = 91.2%
- Accessible/No Coverage areas include data gaps caused by vegetation or other obstructions that were not allowed to be removed
- Inaccessible areas include buildings, 18-inch saturation buffer, streets, and trees
- One property has yet to be surveyed

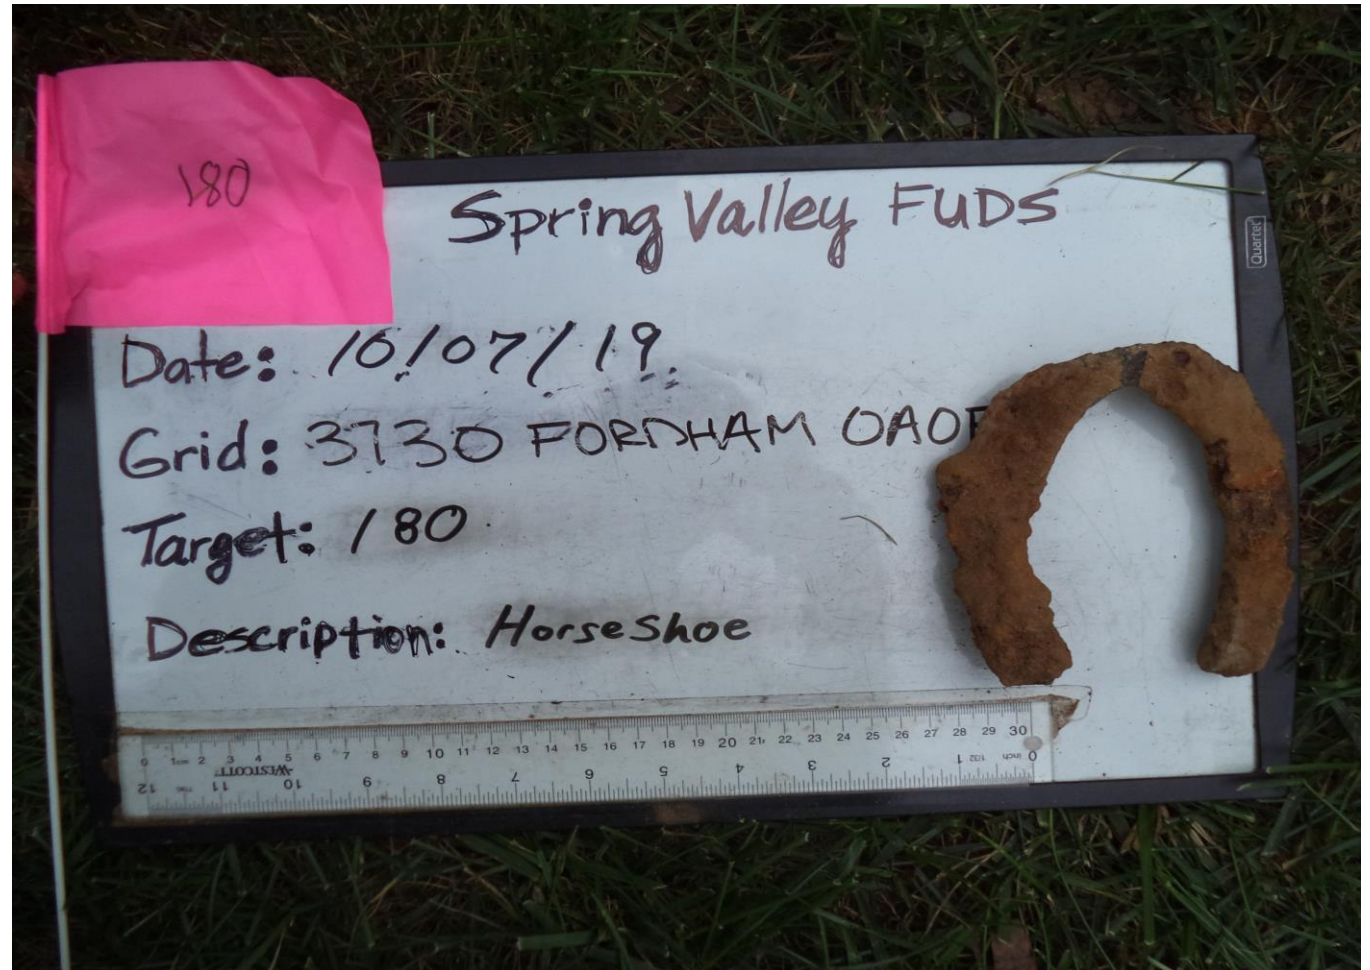
Intrusive Investigations:

- No intrusive investigations have been conducted since the June 25 Partners update.

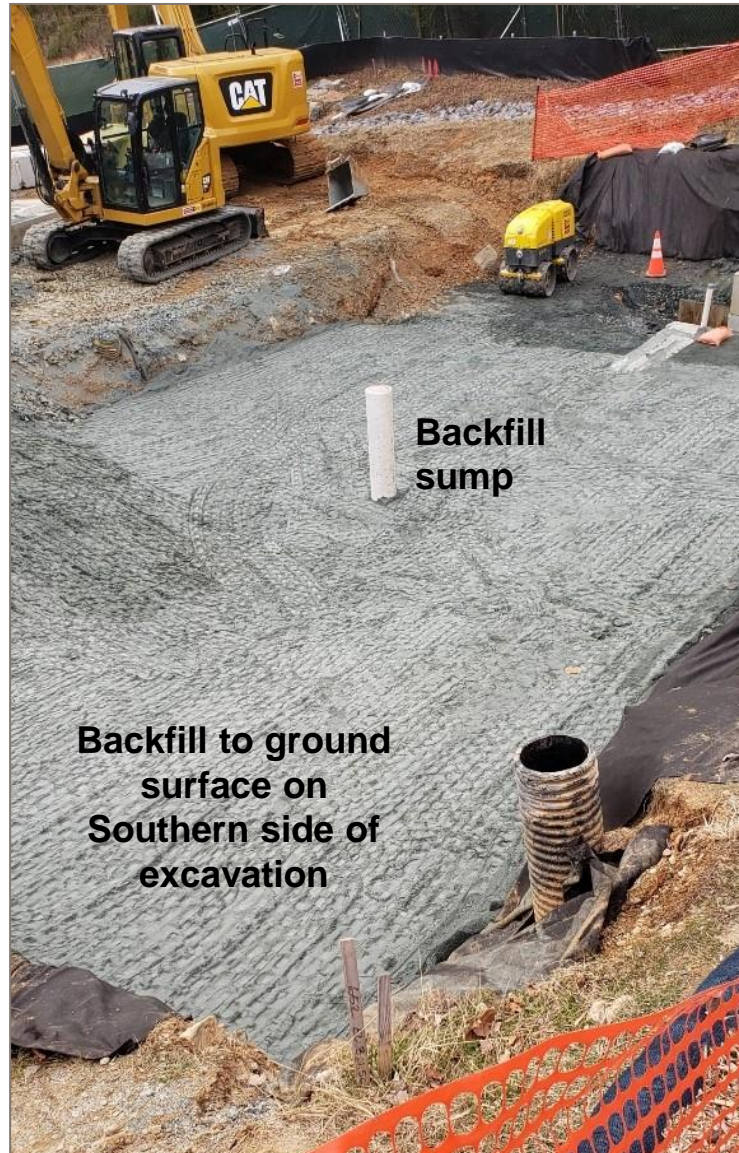
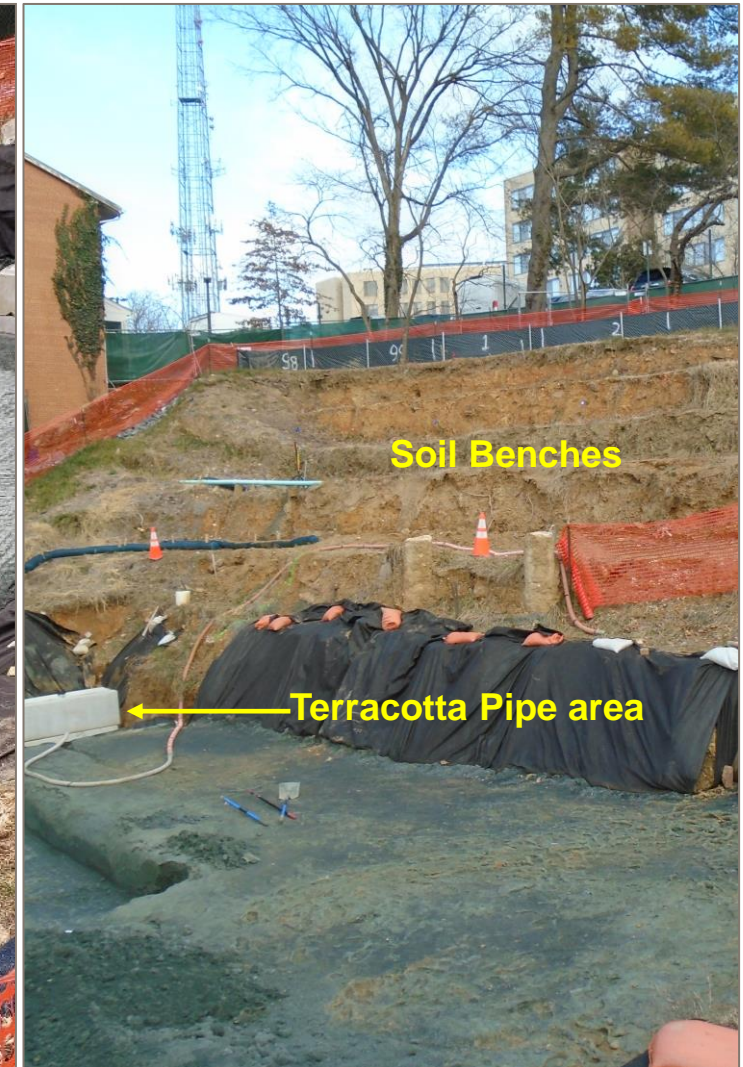
- Completed excavation under the former PSB slab on 21 January 2021 and backfill on 23 March 2021.
- Completed Rotosonic drilling & test pit AUES debris slope investigation on 12 April 2021.
- All PSB Confirmation Soil Sample results for Grids met the cleanup criteria.

- Completed the Rotosonic drilling and Test Pit investigation to determine extent of AUES debris north, east & west of the PSB foundation slab on April 12th.
- Demobilization of the PSB Site was completed on April 16, 2021, and the PSB site has been shut down since then with only maintenance and inspection activities ongoing.
- Submitted the Final Technical Memorandum with the Public Safety Building Test Pit Excavation and Rotosonic Drilling investigation results on June 23rd.
- USACE sent out a Request for Proposal dated 21 July 2021 to complete the excavation of AUES debris observed east, north and west of the former PSB foundation. Proposal preparation is ongoing.

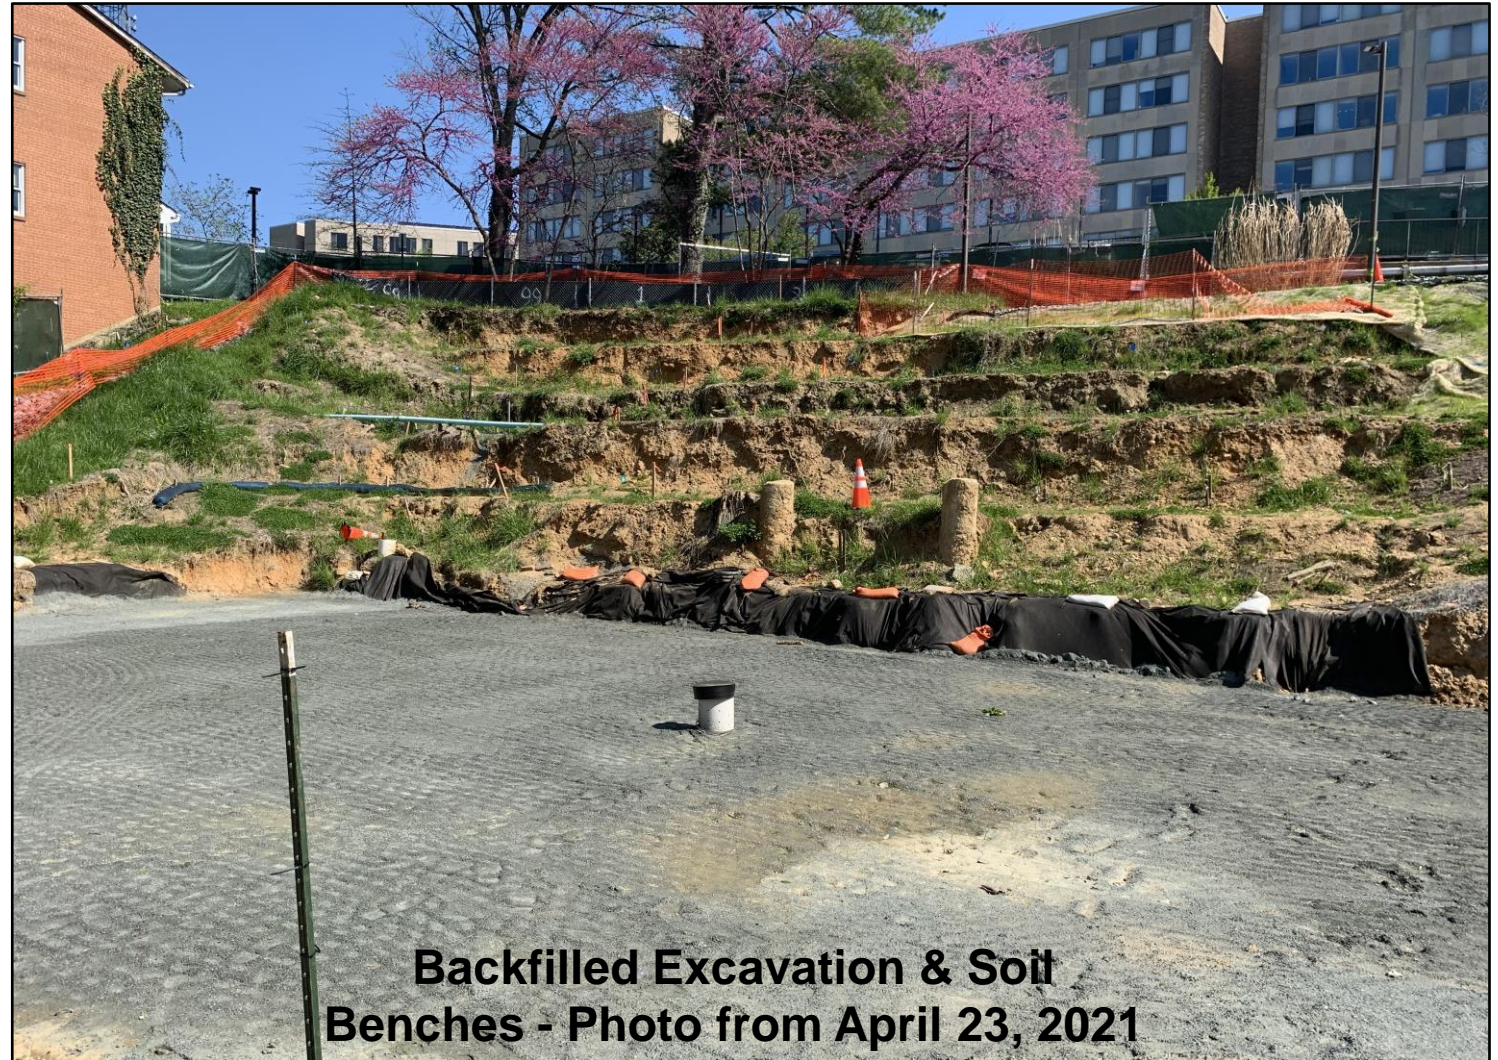
Backfilled Excavation & Soil Benches - Photo from April 23, 2021

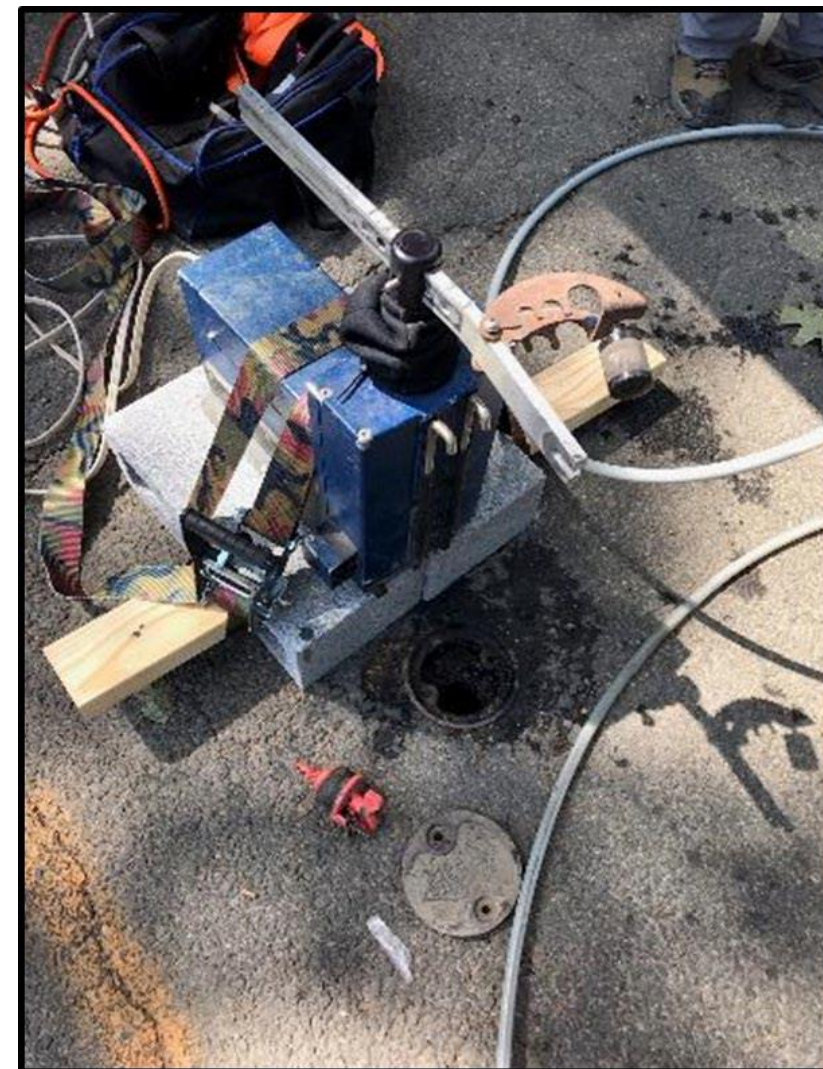
Groundwater sampling well
