# SPRING VALLEY FORMERLY USED DEFENSE SITE

Partners Meeting Presentation  
December 2020

# SPRING VALLEY GLENBROOK ROAD SITES

# SVFUDS SITE-WIDE REMEDIATION STATUS DECEMBER 2020

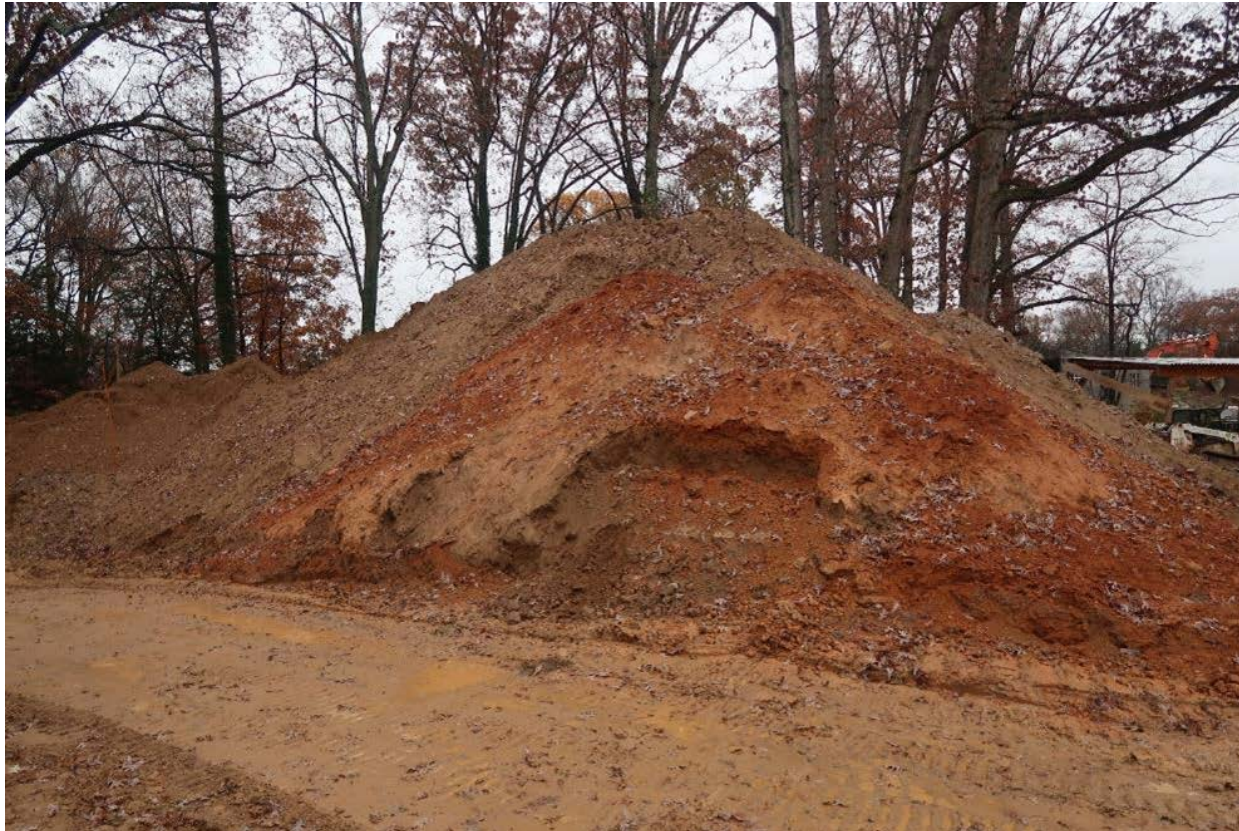
- The previous source sampled in late October found metals concentration to be higher than acceptable
- On November 11<sup>th</sup> Parsons sampled a new source
- This source was approved by the USACE and the regulators (USEPA and DDOE) on November 30<sup>th</sup>

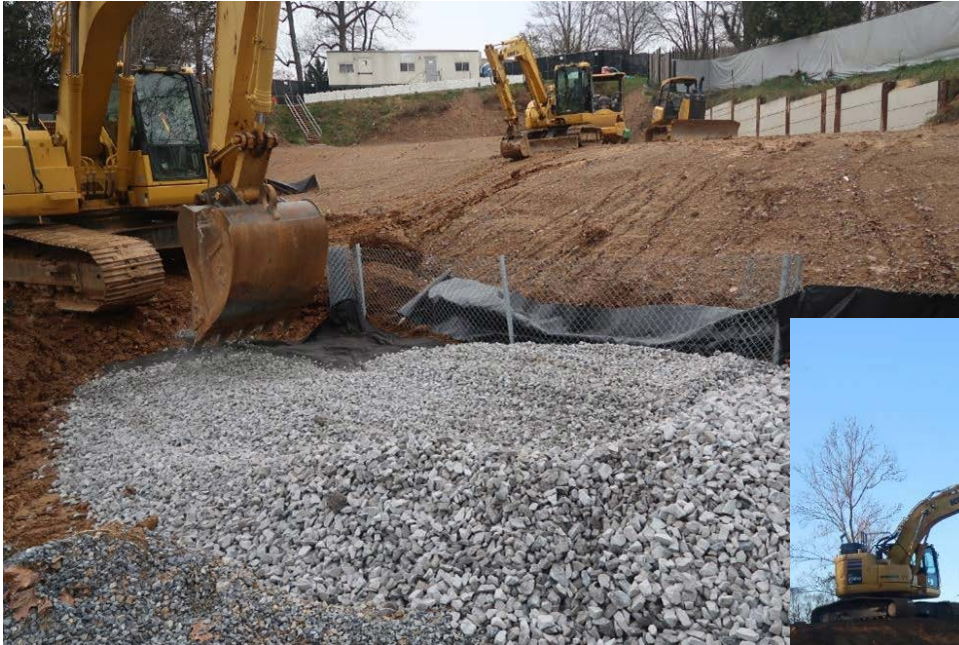
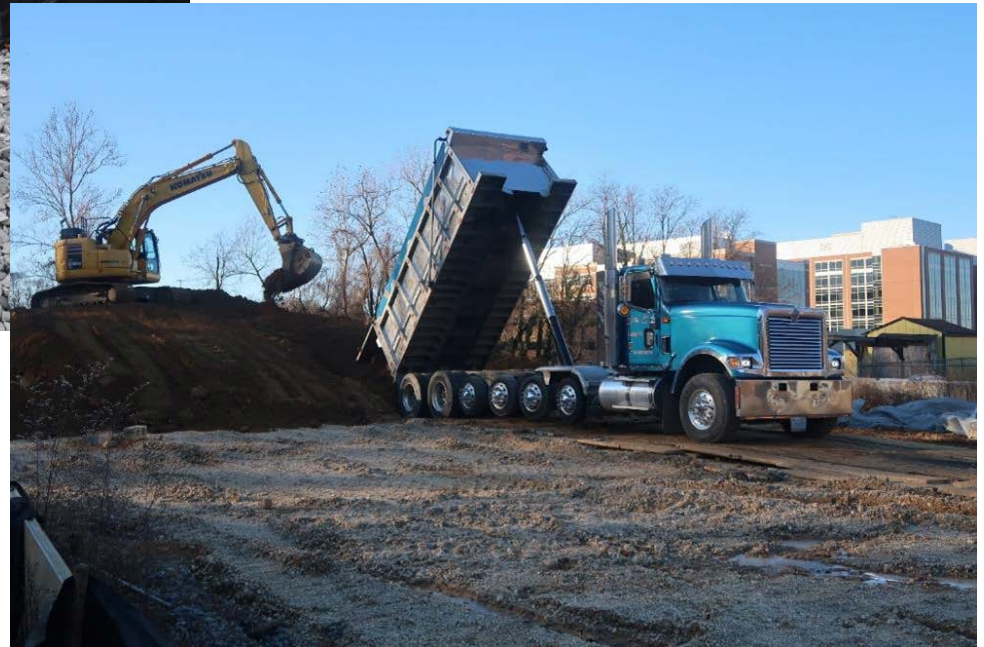
- November and December was spent bringing the new soil from the Mclean site to either the Federal Property for staging or 4825 Glenbrook Rd site for placement

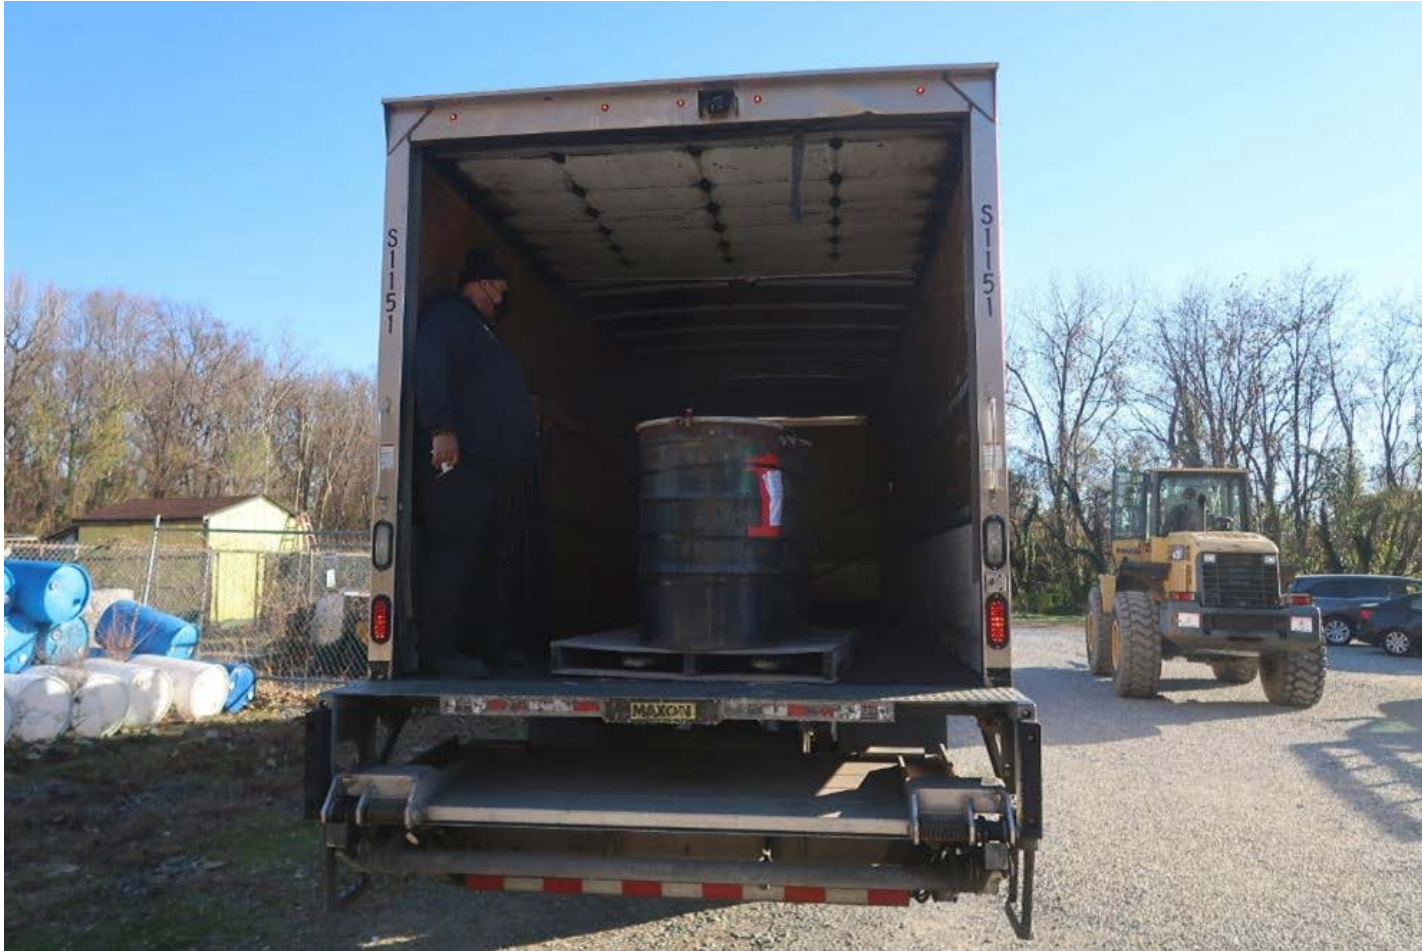
- Shipped off a load of munitions debris scrap to the smelter on November 18th

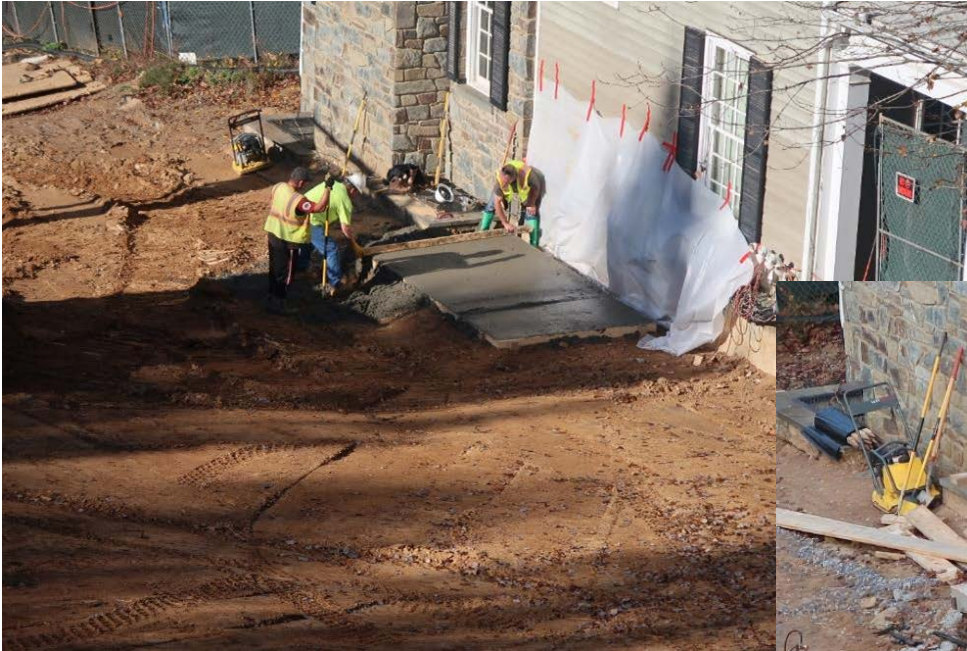
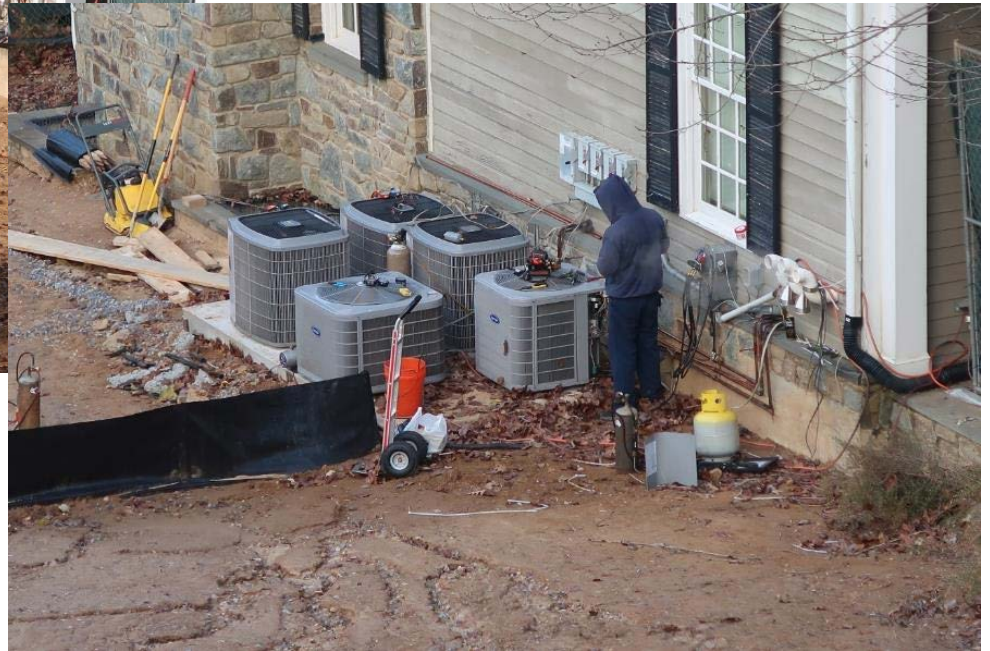
- Built a concrete pad and re-established the exterior air conditioning units servicing 4835 Glenbrook (completed on November 19<sup>th</sup>)

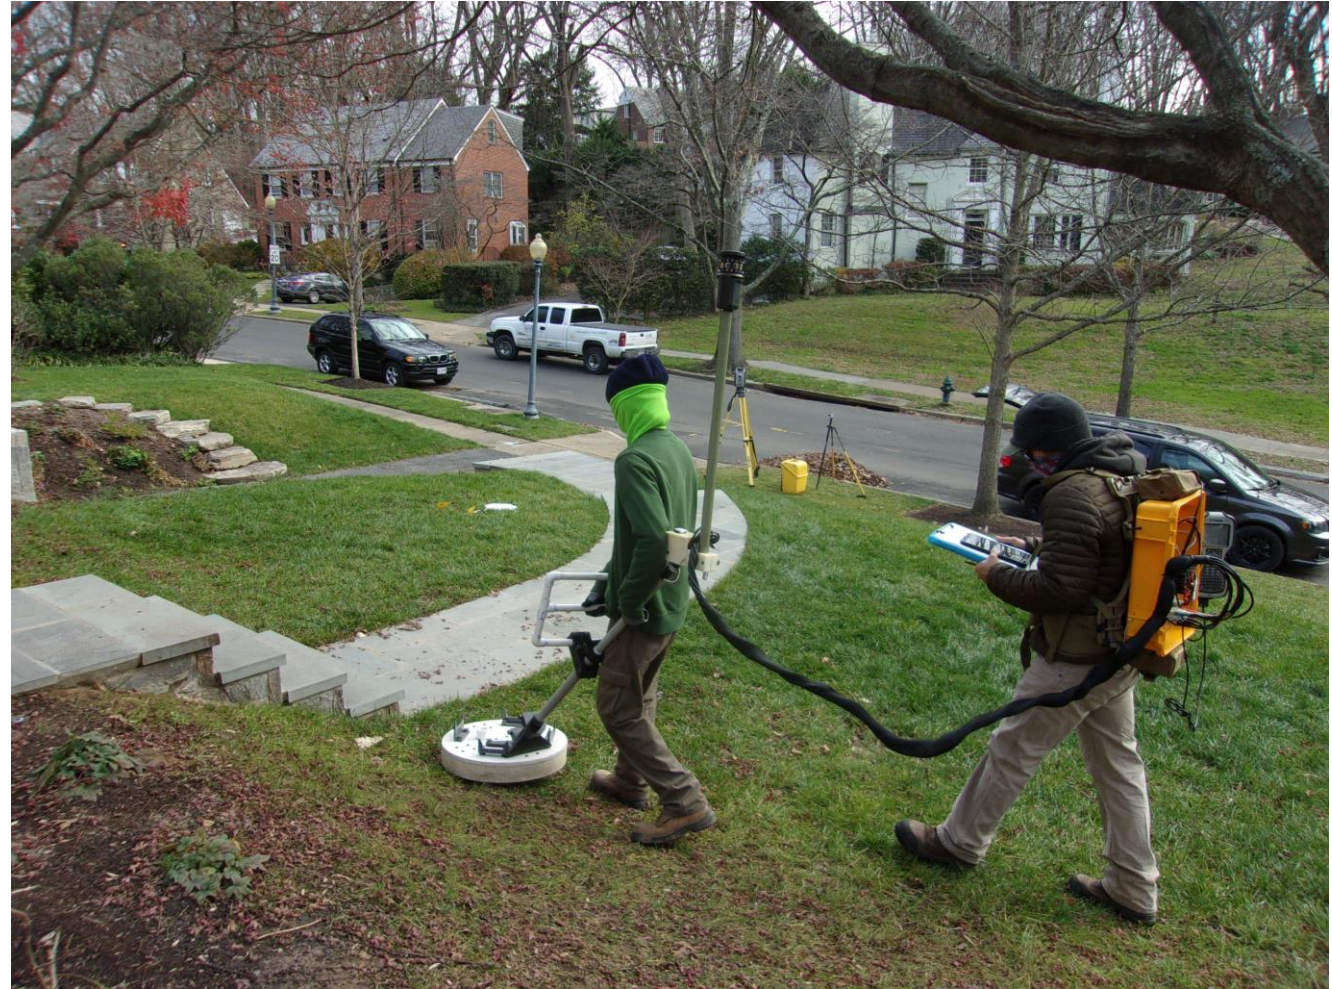
## Geophysical surveys:

- A group of 7 properties and 3 fed/city lots were completed on 11/11/20.
- Geophysical surveys at 7 new properties began on 12/1/20 and are expected to be complete in mid-January.

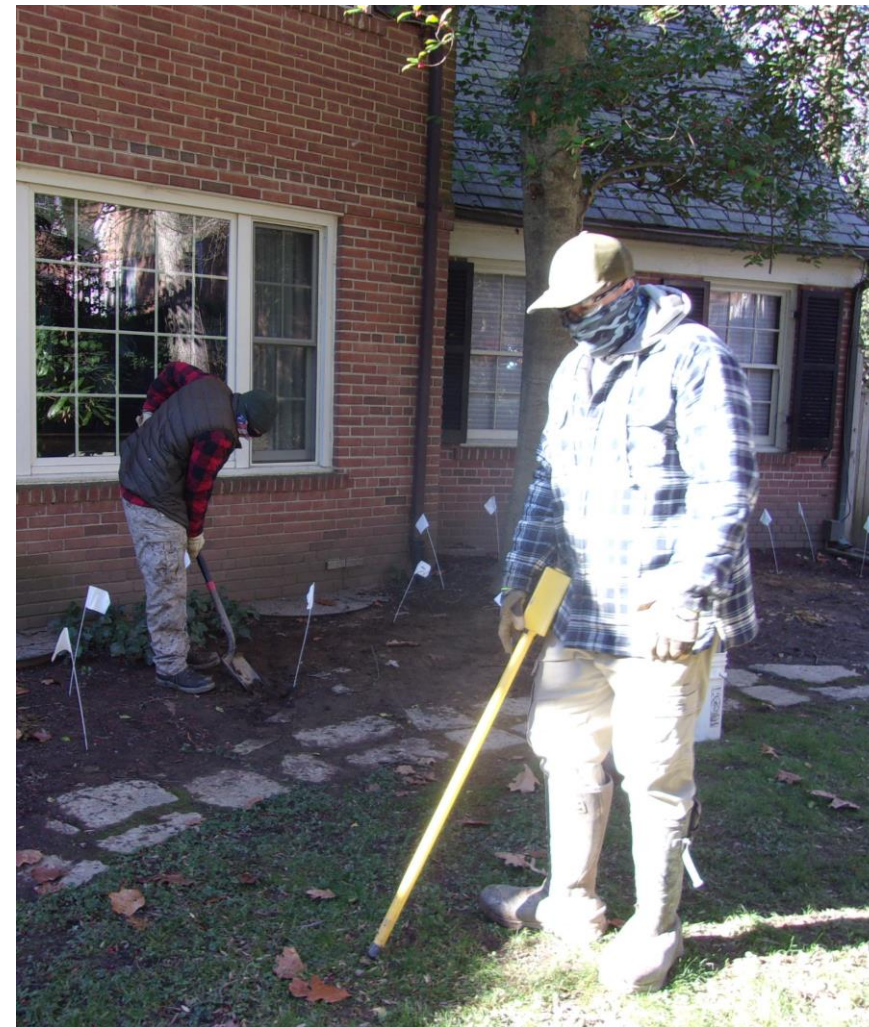
**Intrusive Investigations:** Began on 12/1/20 and are expected to be complete prior to 12/23/20.

- Quebec Property: One MPV target and all of the analog mag & dig areas completed after Intrusive operations at this property were halted on 09/16/20 upon recovery of an intact 3” Stokes Mortar.
- One Hardscape Dig on 52nd Street (permit approved)

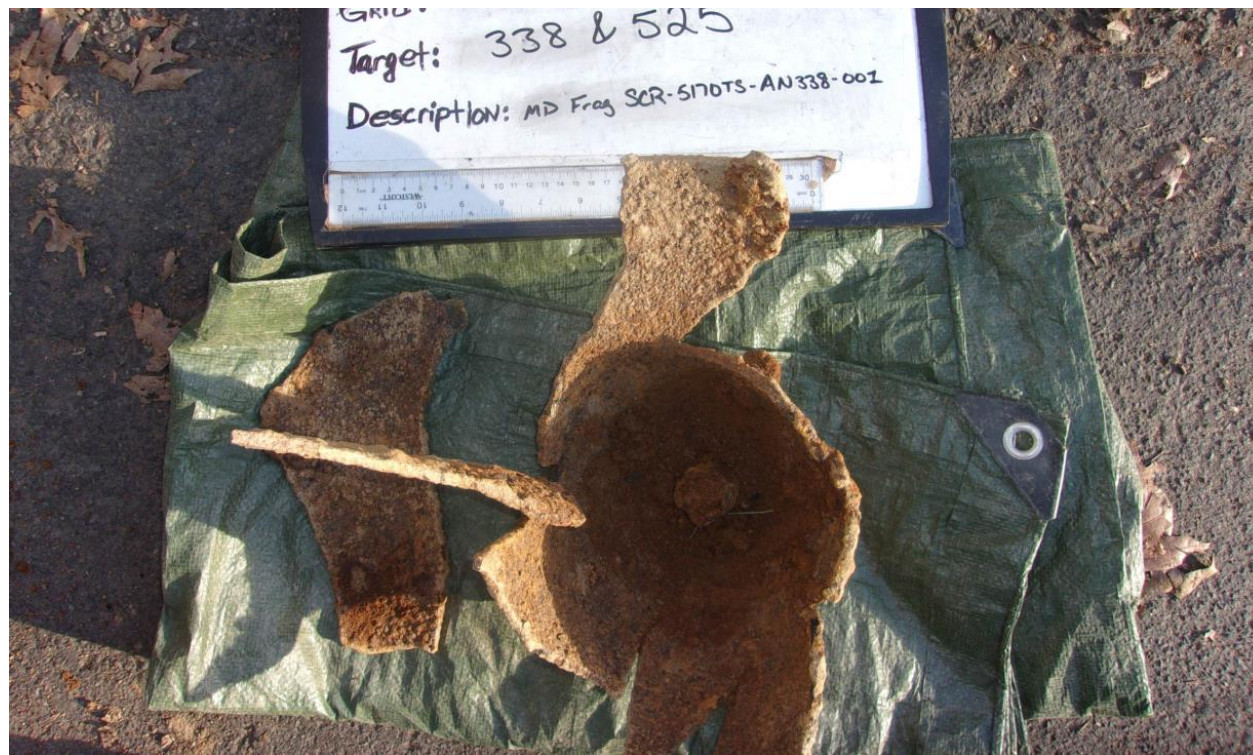
## December 2020 Intrusive Investigation Results (Preliminary):

- No MEC/MPPEH items recovered.
- Seven MD items recovered as of 12/7/2020.
- Headspace results received have all been non-detect for agent.

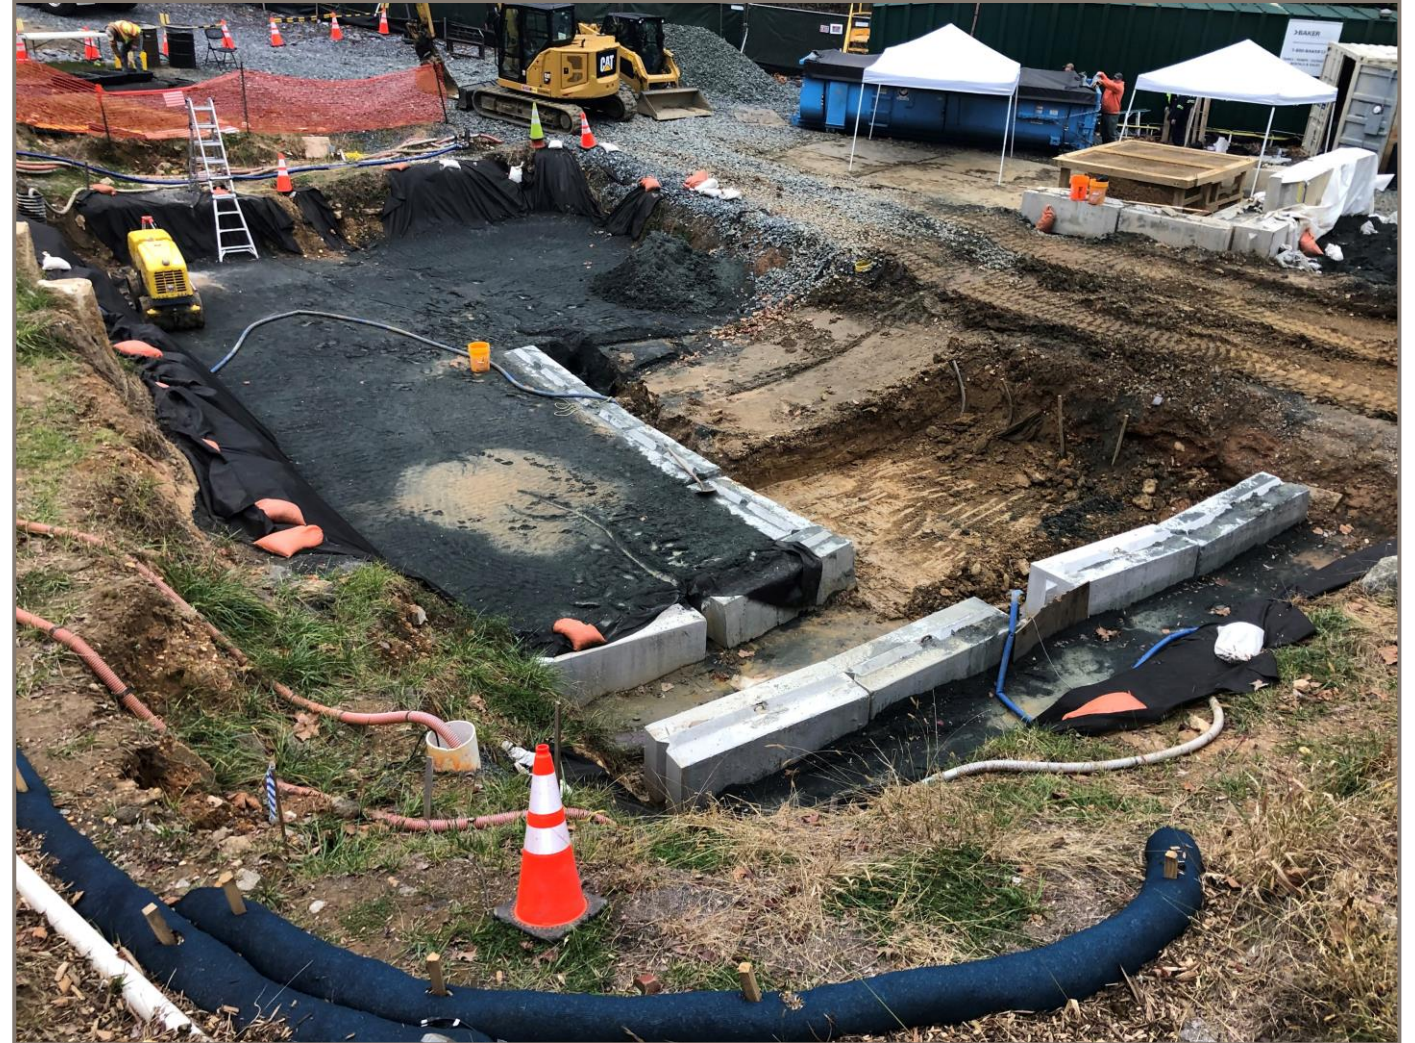
- Completed excavation, backfilling & compaction testing in all but two grids at the PSB: F3 and F4.
- Currently excavating and screening soil in grid F3 from 6-8 feet.
- Preparing to bypass/ excavate under terracotta pipe in grid F2/F3.

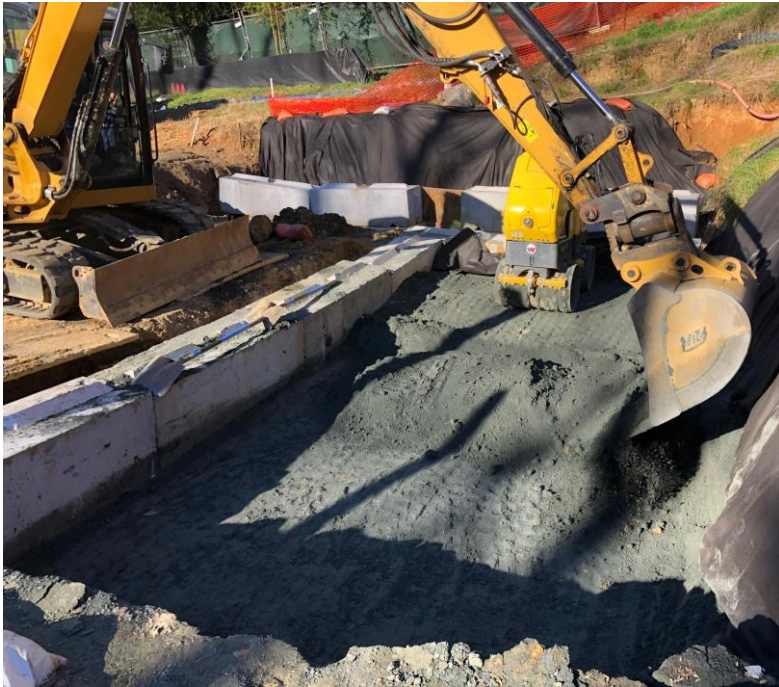
**PSB Operations** – Crushed rock backfill from Aggtrans Savage Quarry, Jessup, MD being placed in excavation.

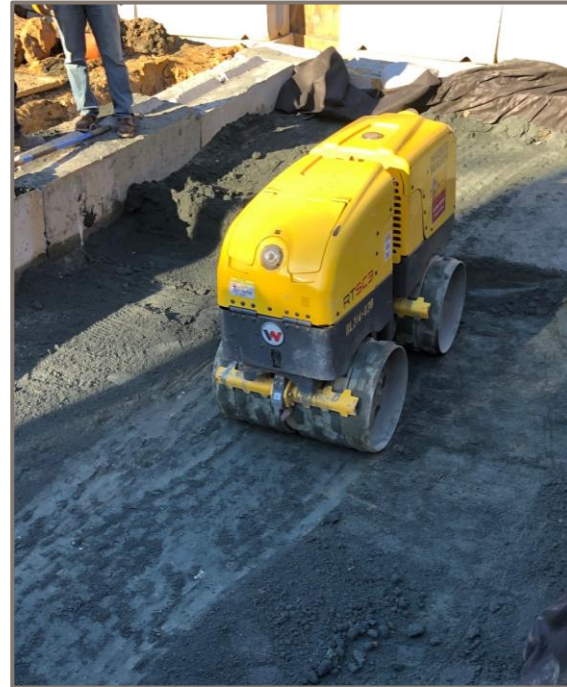
**Compaction** – Using Vibratory drum trench compactor.

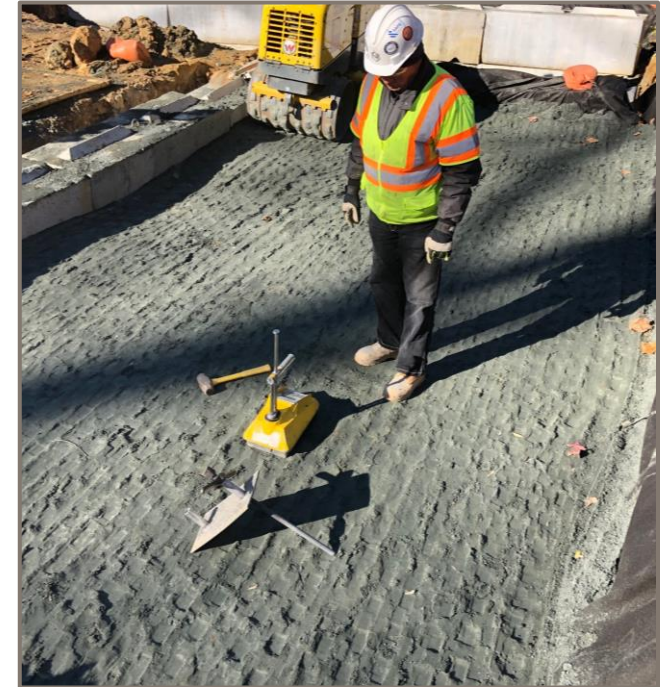
**Density Testing** – Using Troxler nuclear density gauge to test compaction.

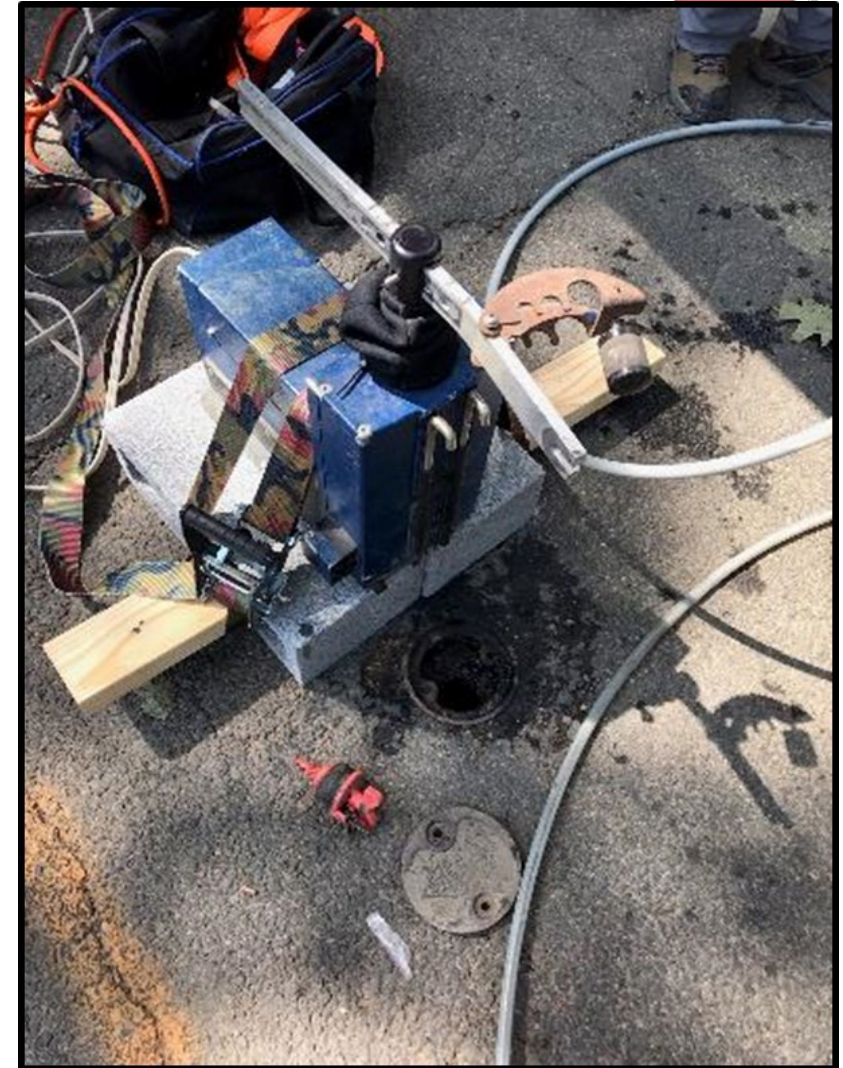
*Groundwater sampling well*
