SPRING VALLEY FORMERLY USED DEFENSE SITE

Partners Meeting Presentation
October 2020

SPRING VALLEY GLENBROOK ROAD SITES

SVFUDS SITE-WIDE REMEDIATION STATUS OCTOBER 2020

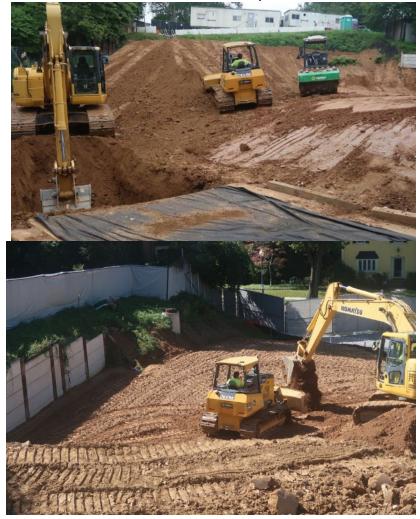
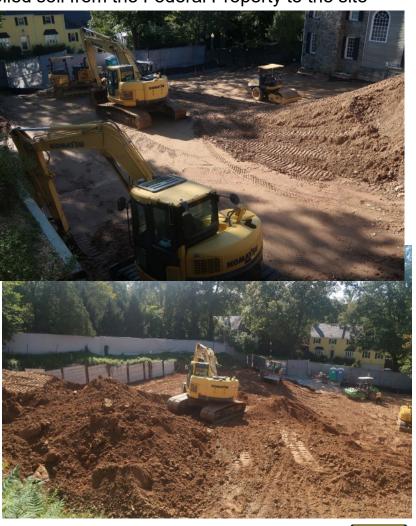
September was spent continuing to bring stockpiled soil from the Federal Property to the site

to add lifts above the post excavation elevation

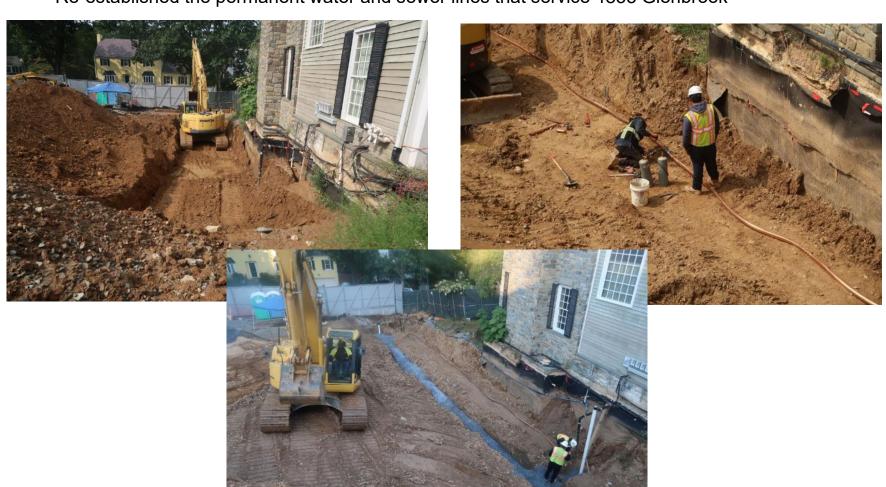
Re-established the permanent water and sewer lines that service 4835 Glenbrook

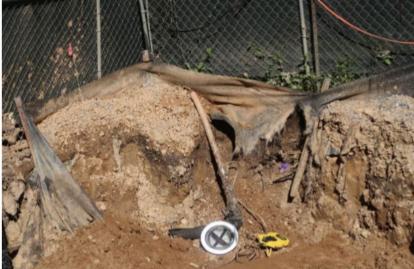
- On September 21st while removing the temporary sewer pipe a small semi-intact pipette was discovered coming from the 4835 Glenbrook Road property
 - ✓ No odors or soil staining observed
 - ✓ Headspace negative for chemical agent
 - ✓ The PDT decided to have the plastic removed and the area was backfilled.

Location of the pipette looking from 4835 Glenbrook Rd

Looking from 4825 Glenbrook

Pipette, not intact

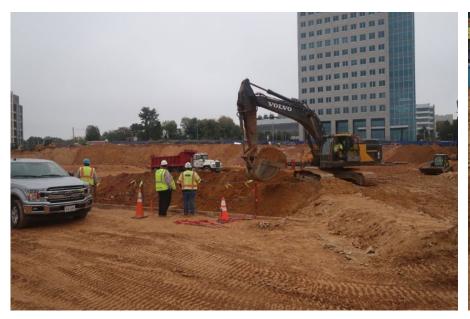
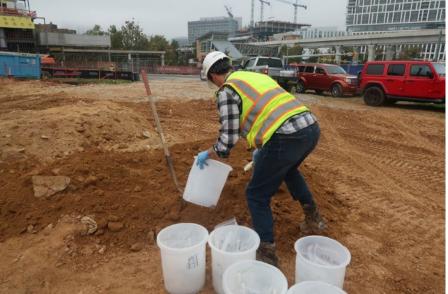
- The previously sampled and approved stockpile was removed by the vendor prior to our use
- On October 21st Parsons identified a new source in Tysons Corner, Virginia that was formerly undeveloped.
- Parsons has asked for a one-week turnaround for the results and expects to be requesting regulator approval early the week of November 2nd

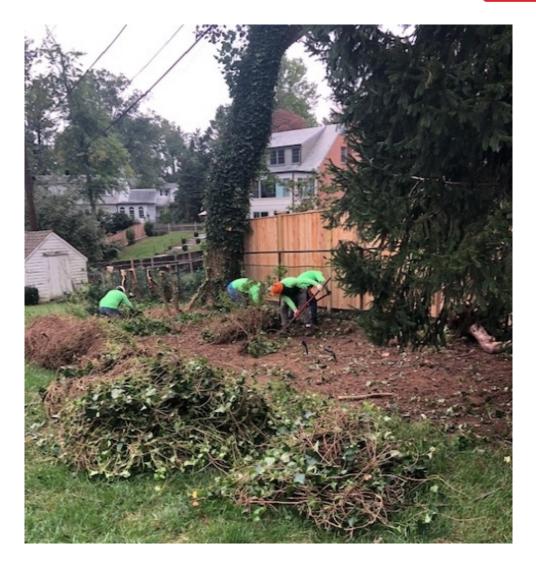
- Property Availability 1 new property approved their landscape plan and became available for geophysical surveys. 14 properties remain.
- Vegetation removal/Blind
 Seeding Vegetation removal and blind seeding completed at 7 properties. 15 properties remain.

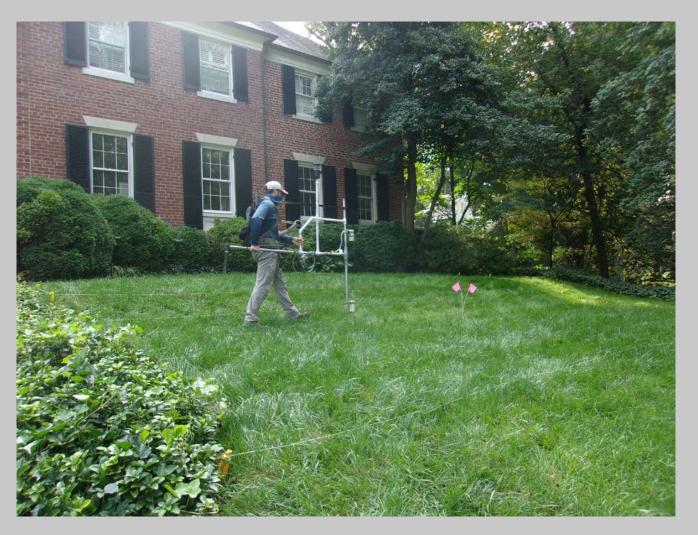
- Geophysical surveys Dynamic surveys completed at 6 properties. Cued surveys completed at 1 property.
- Intrusive Investigations Conducted at 10 properties and 6 fed/city lots between 8/24/20 and 9/23/20.

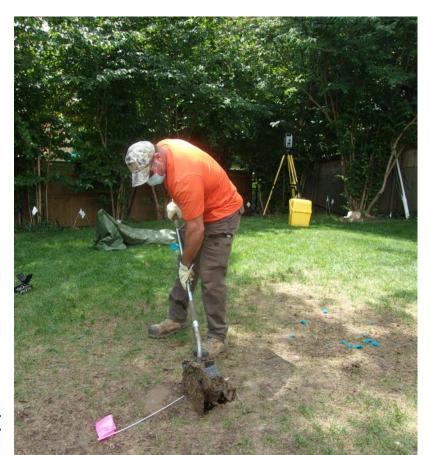
- Two properties (5100 Upton & 5166 Tilden) were partially completed during this intrusive phase. 5100 Upton has one target under hardscape (driveway) remaining to be investigated. 5166 Tilden has two targets under hardscape (sidewalk) remaining to be investigated. Weston will return to investigate these hardscape targets once DDOT permits are approved.
- Intrusive investigation of 19 targets were completed at 4710 Quebec on 09/16/2020. Intrusive operations at the property was halted on 09/16/20 upon recovery of an intact 3" Stokes Mortar.

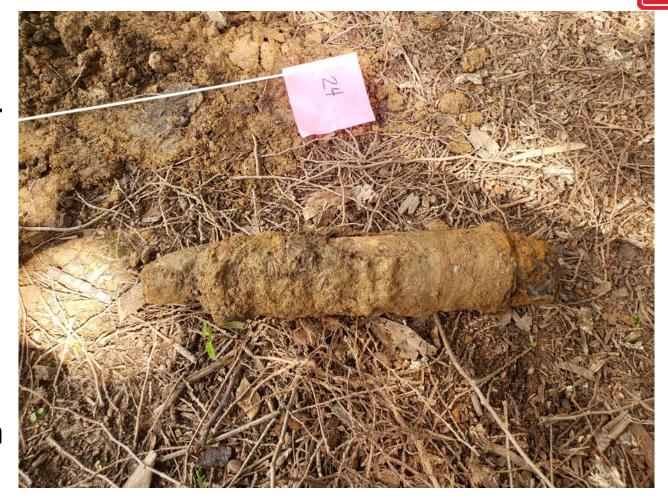
4710 Quebec 3" Stokes Mortar -On 09/16/20, an intact 3" Stokes was found at target ID 24. The **USACE OESS and an EOD unit** from Joint Base Andrews responded to the site. The EOD unit transported the item offsite for disposal. The EOD unit reported that the 3" Stokes had a high explosive (HE) filler.

Note - MPV data classified this target as a "likely TOI" and the best matching ordnance from the site-specific library was a 3" Stokes.

4710 Quebec 3" Stokes Mortar – A Project Delivery Team (PDT) meeting was held on 10/05/20 to determine the path forward for completing work within area of interest-13 (AOI-13). Work remaining at AOI-13 includes:

4710 Quebec 3" Stokes Mortar – The PDT concluded that continuing under Low Probability protocols is still the appropriate choice for AOI-13. Intrusive investigations that remain at 4710 Quebec will be conducted during the next dig phase, scheduled to begin the week of 11/30/20.

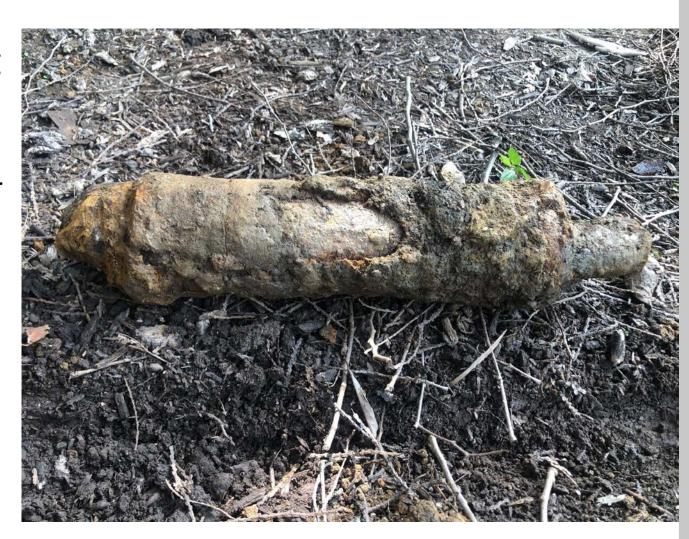
- One (1) MPV target and all of the analog mag & dig areas at 4710
 Quebec
- One property within AOI-13 remains to be surveyed and intrusively investigated (4800 Quebec)

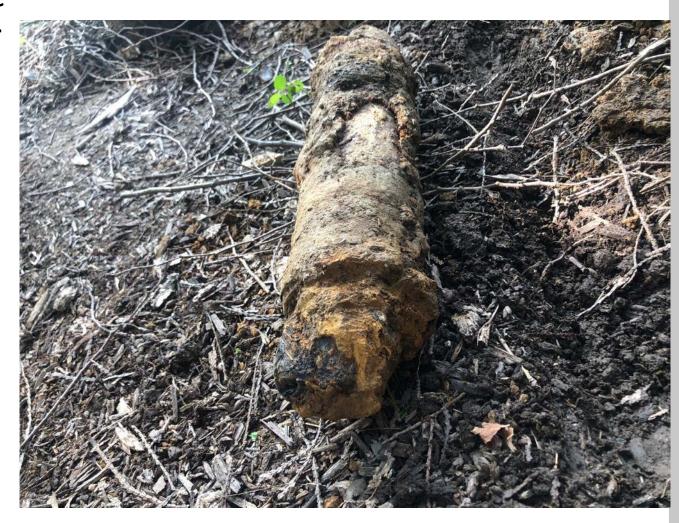
Weston and ERT are working with 4800 Quebec on their landscape plan. Schedule for geophysical surveys and intrusive investigations at 4800 Quebec has yet to be determined.

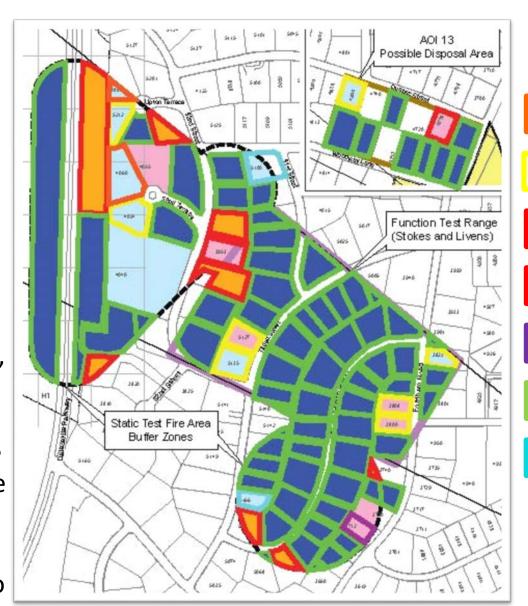
Current Property/Grid Status (92/13):

- Two (2) new properties began the site prep phase
- Property owner approval of landscape plans pending at 8 properties
- AGC surveys ongoing at 7 properties and 3 city lots, to be completed in Nov
- Dec 2020 intrusive phase includes 7 new properties,
 2 partially completed properties, and 3 city lots
- One (1) property available for next AGC Survey phase
- Work initiated at 89 of 92 properties
- Three (3) properties yet to begin RA process

Video, Survey & Landscape (2)

Pending Homeowner LSP Approval (8)

Current AGC Survey/Dec Intrusive (7/3)

Previous AGC Survey/Dec Intrusive (2/0)

Next AGC Survey Phase (1/0)

Intrusive Complete (67/10)

Intrusive Pending Permit Approval (2/0)

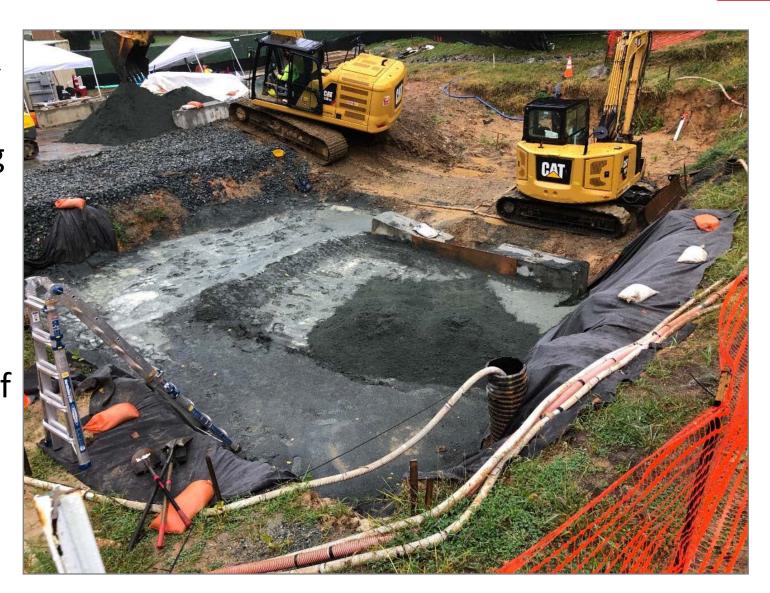
- Re-started intrusive work on 20 July 2020.
- Excavating and backfilling grids from east to west starting at Grids E6/F6 and continuing through Grids E5 and F5.
- Removed and disposed of the sanitary sewer sump from the northeast corner of the PSB foundation.

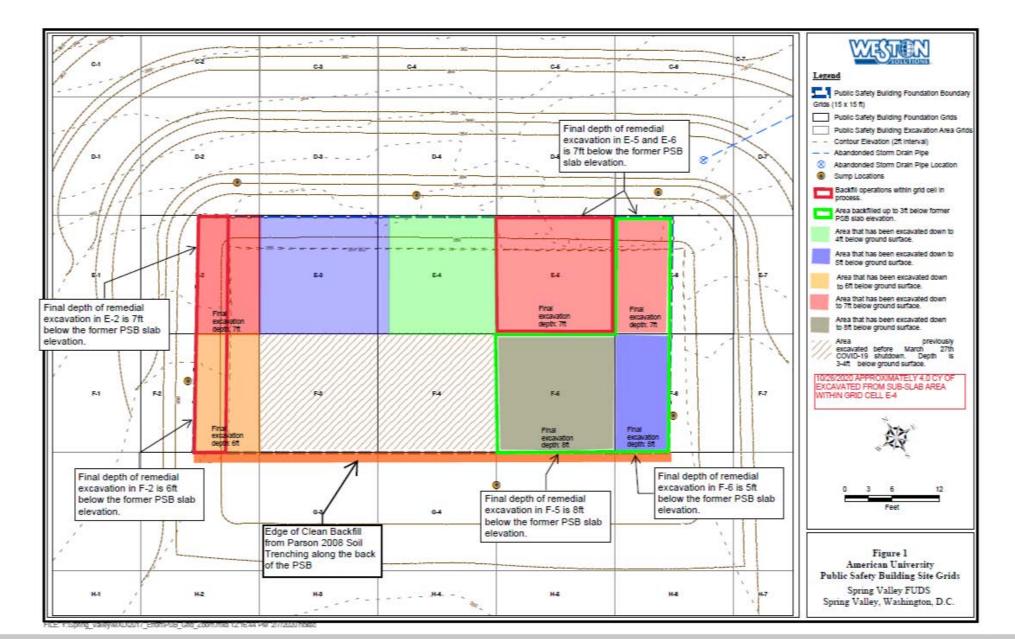
PSB GRID EXCAVATION AND BACKFILL DEPTHS

- Prior to last update, test pitting was conducted into the north sidewall of PSB excavation (grid D-3) to determine the extent of the dark soil layer with AUES debris identified at approximately 2 to 3.5 feet below the slab. Advanced 8 feet north of former PSB slab – AUES debris was still evident, but Team stopped due to slope stability concerns.
- Engineering team met at the PSB site on September 16th to discuss options to investigate and later excavate this layer of AUES debris seen in the north wall of the excavation. Currently, USACE is preparing a request for proposal to investigate the extent of this AUES debris layer.
- During excavation operations, additional small amounts of AUES debris were encountered and Grid excavation depths were increased at Grid F6 (4 to 5 ft), Grid E6 (4 to 7 ft), Grid E5 (5 to 7 ft), & Grid F5 (5 to 8 ft).

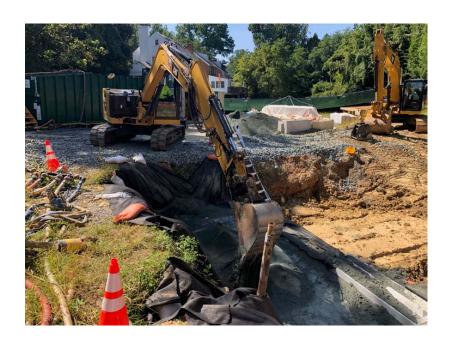
■ Backfill, fill compaction, and compaction density testing operations began at Grids E6/F6, E5 and F5 using approved backfill. Currently these grid cells have been backfilled to 3 feet below the former PSB slab elevation — to allow future access to the dark AUES debris layer which extends outside the former PSB footprint.

Excavator dumping backfill in Grid F6 and using compaction attachment in Grids E6 & F6.

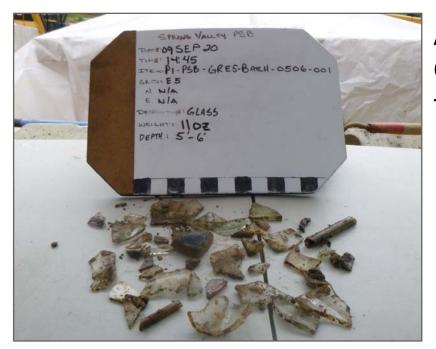
AUES glassware in Grid E5 at 5 to 6 feet below the slab.

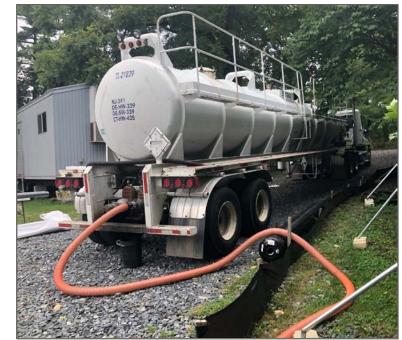
- All Excavation floor Confirmation Soil Sample results for Grids have meet the cleanup criteria for CWA, metals, SVOCs, Cyanide, Explosives (Grid F3 only) and VOCs (none detected).
- Controlling water table and rainwater successfully. Each frac tank of water is sampled & analyzed prior to disposal.

Tanker truck pumping frac tank water for transport to disposal facility.

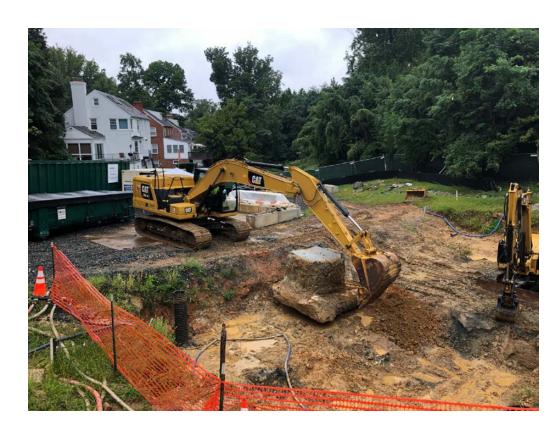
PSB Operations – Excavator moving the sanitary sump and footer prior to breaking it up for disposal.

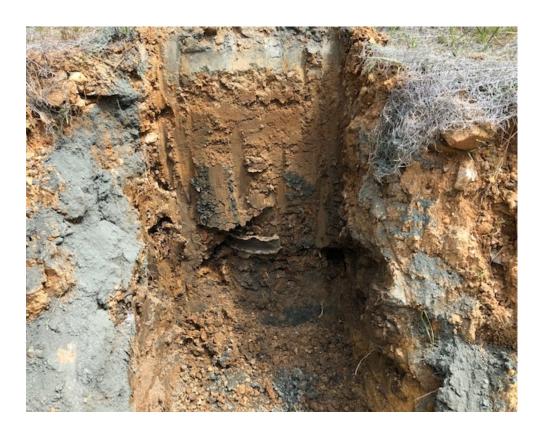
North Wall Grid D3 – Test pit into the North Sidewall – chasing the dark AUES debris layer @ 6 feet from slab.

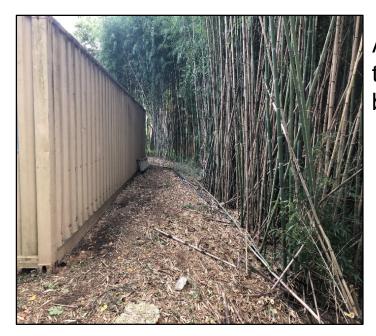
Access path to RA2 through bamboo behind Hamilton Bldg.

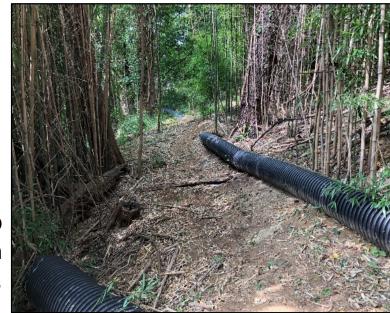
Access path to RA1 through bamboo from RA2 location with AU drain lines.

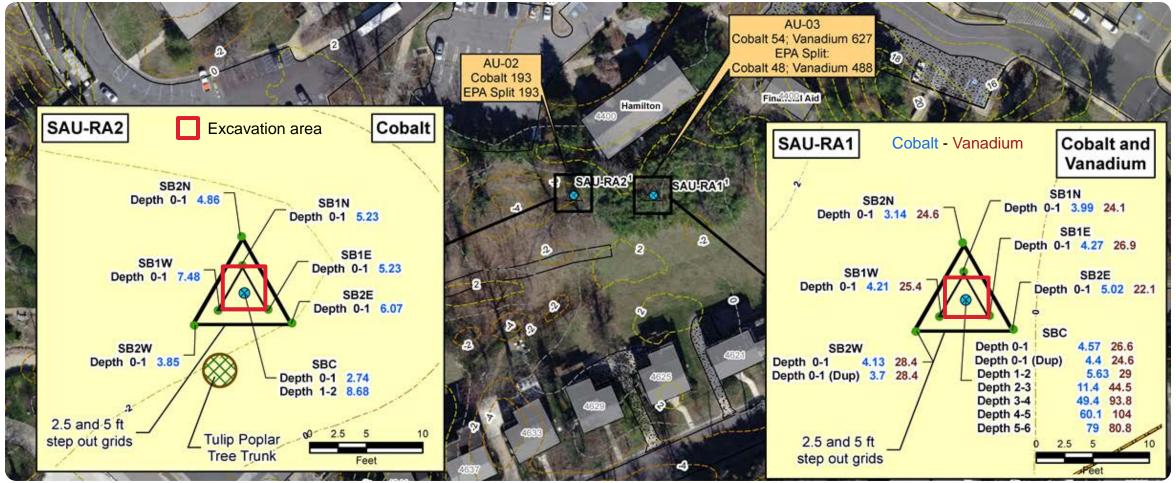
SOUTHERN AU EXPOSURE UNIT MAP

RA1 (AU-03) – Soil removal at the center point down to 10 feet bgs and extending out 2.5 ft (5 ft by 5 ft excavation area). **RA2 (AU-02)** – Soil removal to 1 ft bgs around the center point and extending out 2.5 feet (5 ft by 5 ft excavation area) to remove the soil associated with original sample AU-02.

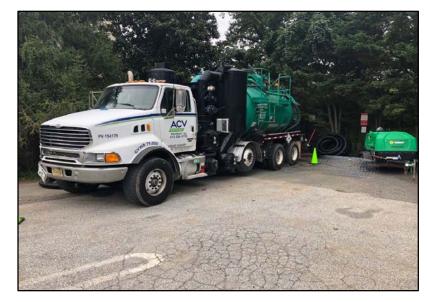
Completed the shallow (1-foot) excavation at SAU-RA2 on September 17,
 2020 using an air-knife and soil vacuum to protect the nearby Poplar tree.

Soil vacuum truck and air compressor used for air-knife operations.

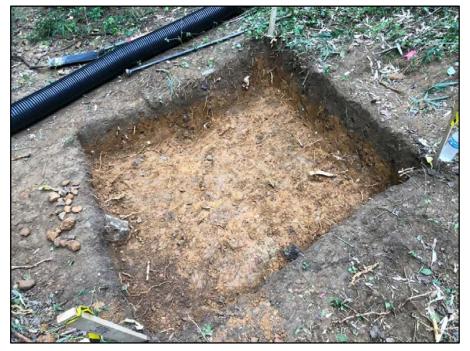
Completed RA1 excavation at 5 ft by 5 ft by 1 ft deep.

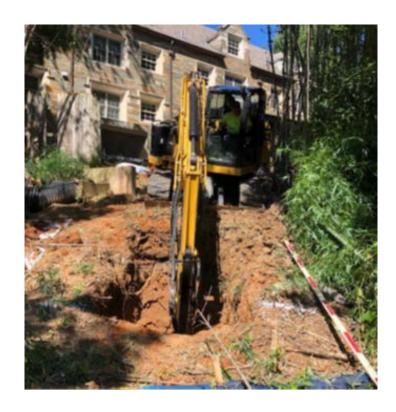
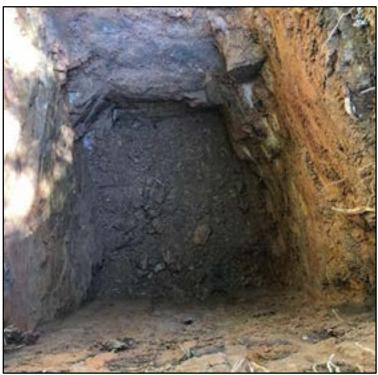
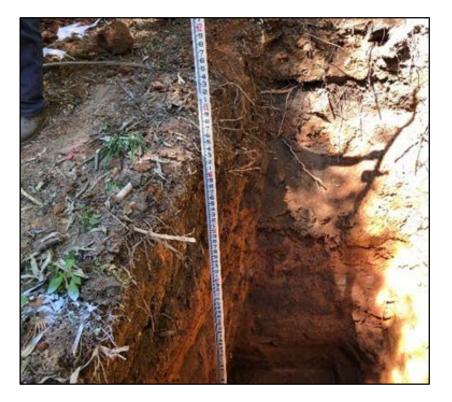
Completed the deeper (10-foot) excavation at SAU-RA1 on 21 Sep. 2020 using a mini excavator. Cobalt exceeded the cleanup criterion (46.8 mg/kg) from 3 to 10 ft at the center point.

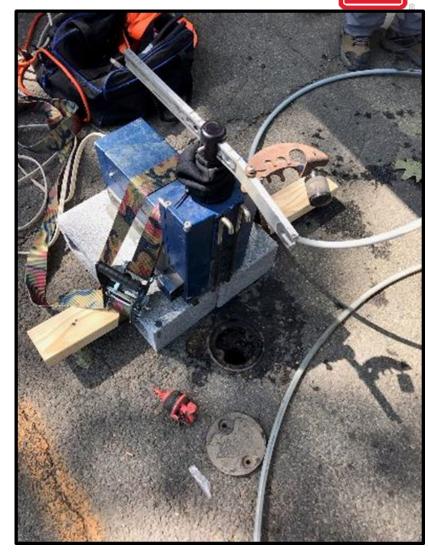
Groundwater sampling well

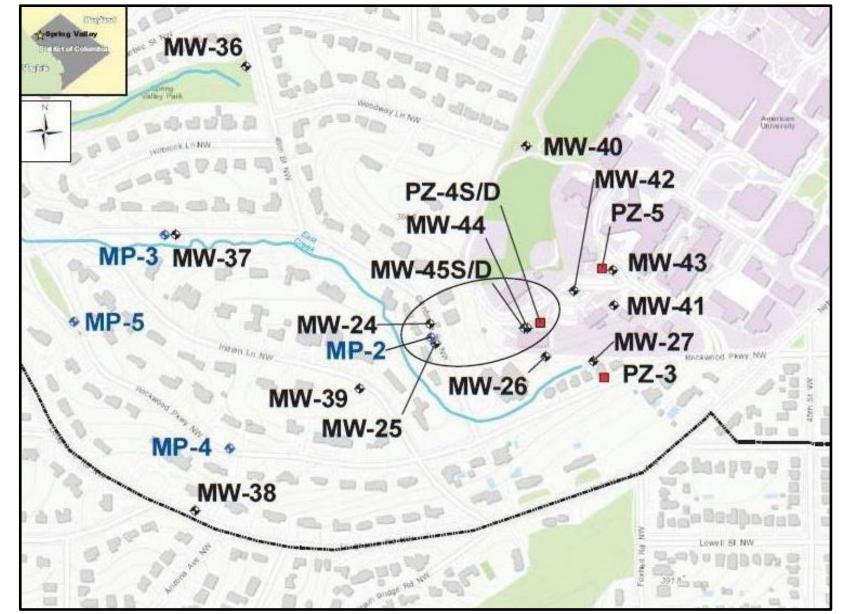
GROUNDWATER STUDY: EXPOSURE UNIT 2

S/D = Monitoring well or piezometer with screened intervals in the same borehole.
