SPRING VALLEY FORMERLY USED DEFENSE SITE

Partners Meeting Presentation

June 2020

SPRING VALLEY GLENBROOK ROAD SITES

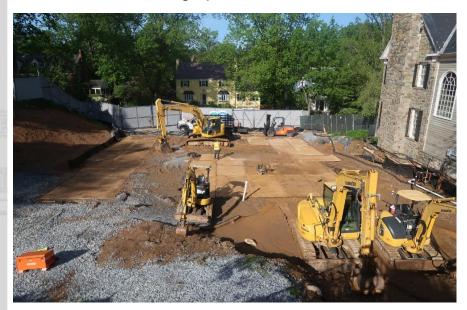
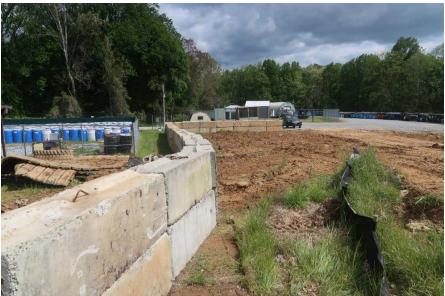
- May was spent:
 - Performing site maintenance
 - ✓ Expanding the backfill storage area at the Federal Property
 - ✓ Setting up the site for -10, -90 activities

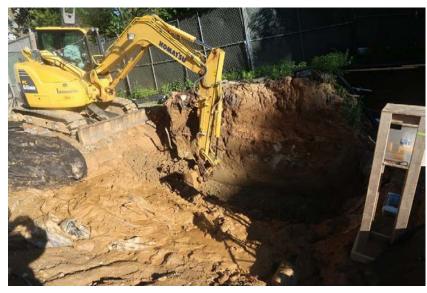
Excavation of the remaining portion of the north wall of Grid -10,-90 on June 7th

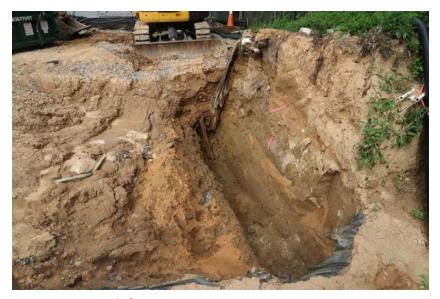
- On June 15th attempted advance the excavation another 2 feet in Grid -10,-90
 - ✓ Mechanical refusal was achieved after about 1.5 feet
 - ✓ Collected 1 floor Confirmation sample for Agent, ABPs, and Arsenic

- ✓ No agent or ABPs were detected
 - ✓ Arsenic results are pending
 - ✓ Further excavation is not possible

North wall of Grid -10,-90 Excavated Down to Bedrock

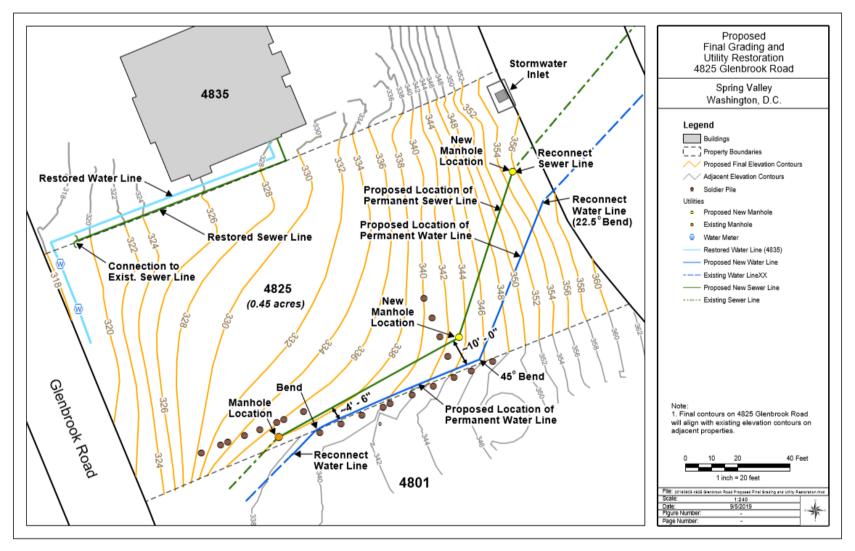
Final grading and utility restoration plan

- Begin final site restoration
 - ✓ Re-install American University (AU) water line
 - ✓ Re-install AU sanitary sewer line
 - ✓ Re-install 4835 waterline lateral
 - ✓ Re-install 4835 sanitary sewer lateral
 - ✓ Move 4835 AC units to original location
 - ✓ Restore fence along 4801 and 4825 Glenbrook Road properties
 - ✓ Restore site to final grade in 6-inch lifts with compaction in accordance with the Work Plan
 - ✓ Remove Siren from AU Property

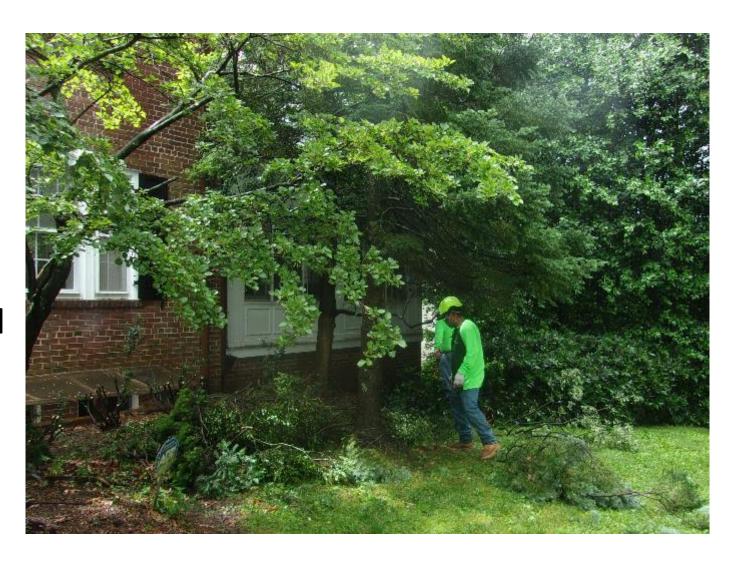
- Property Availability 3 new properties approved their landscape plans and became available for geophysical surveys.
- Vegetation removal/Blind Seeding – Vegetation removal completed at 4 properties and blind seeding completed at 3 properties.

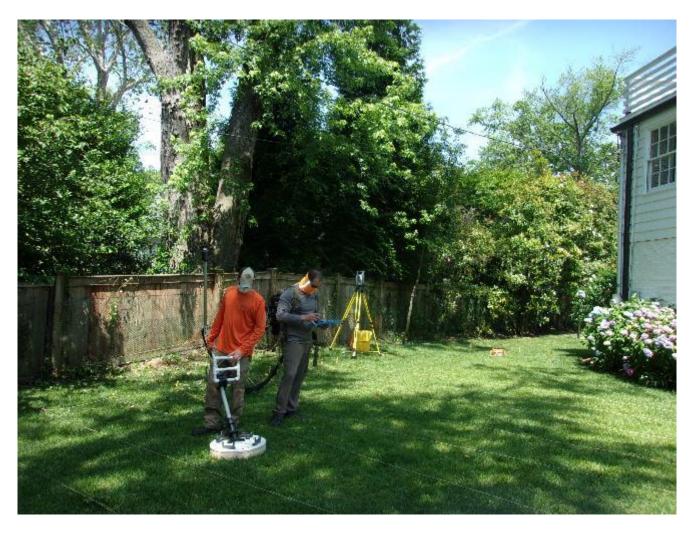
- Geophysical surveys Dynamic surveys completed at 2 properties. Cued surveys completed at 1 property.
- Intrusive Investigations Intrusive investigations completed at 11 properties between 05/12/20 and 06/01/20.

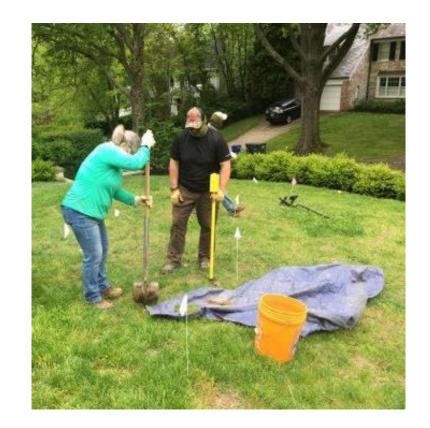
- Intrusive Investigations (continued) Intrusive investigations completed at 11 properties between 05/12/20 and 06/01/20.
- Intrusive investigations were conducted at 1 additional property during the May intrusive phase; however, one target under hard-scape (driveway apron) remains to be investigated. Weston will return to investigate the hardscape target during the next intrusive mobilization.
- Intrusive investigations including 3 Manned Portable Vector (MPV) targets and 26 analog removal areas were completed on the Sedgwick block on 05/12/2020. Intrusive work at the property was halted on 04/06/20 upon identification of an intact livens. The livens is currently stored at the interim holding facility at the Fed Property pending final disposition.

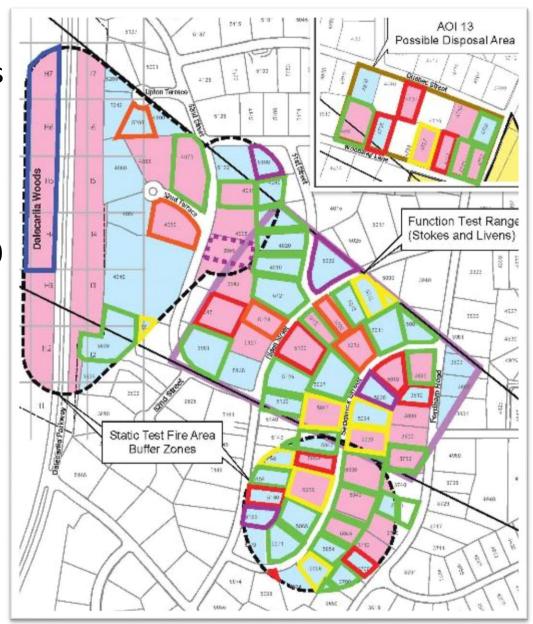
- 60 residential properties and 4 federal/city lots completed to date
- One hard-scape target will be intrusively investigated in July 2020 pending permit approval
- Intrusive investigations to begin at 4 properties in July 2020

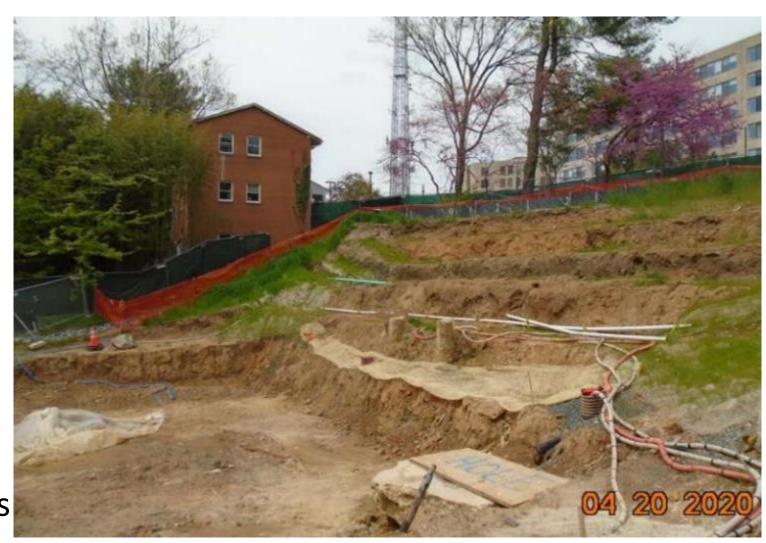
- PSB Site has remained shut down since 28
 March 2020
- Excavation is at 3-4 feet below the slab
- Site is secure and in stable condition
- Weekly inspections of site security and erosion and sedimentation controls are being conducted

- The PSB Site is currently shut down, but remobilization will commence once CCDC is able to provide air monitoring support and Weston is directed by USACE to restart the work. Estimated restart in July 2020.
- Transported roll-off container No. 29, holding soil that exceeded the Regulatory Level for lead, to an off-site facility for disposal as hazardous material, on 1 June 2020.
- Waiting on final approval of revisions to the Draft Final Standard Operating Procedure (SOP) for Determining Final Excavation Boundaries and Post-Excavation Confirmation Sampling at the PSB.

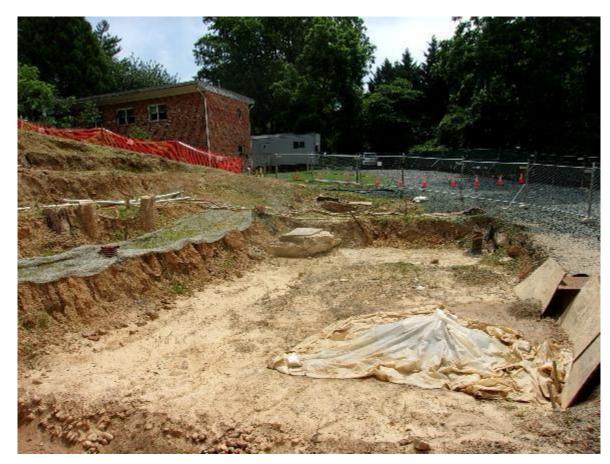
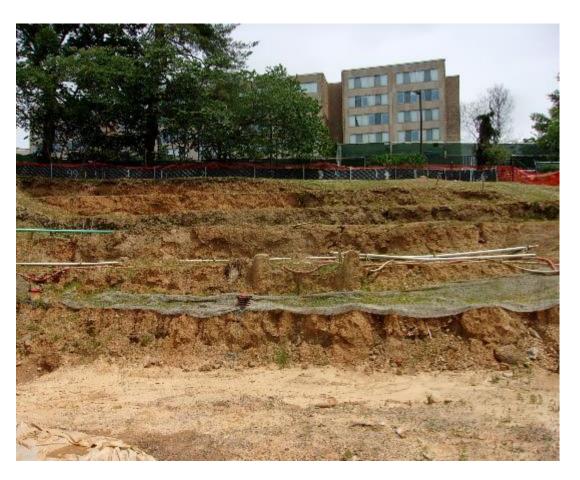
Current PSB Site Conditions (as of 15 June) – At the PSB, earthwork benches and excavation remain stable. Erosion and sedimentation controls are intact and functional.

- Weekly security plus erosion & sediment (E&S) control inspections are being conducted at the PSB site. The E&S control inspections are also targeted to occur after major rain events.
- Excess water in the excavation will be pumped off into the Frac tank, as needed to keep the excavation from filling up with water.
- Grass mowing operations are being conducted every other week.
- Management of PSB waste containers stored at the Federal Compound will continue during the PSB Site shut down.
- The site gates are locked but access is available using combination lock.
- The SOP for Determining Final Excavation Boundaries and Post-Excavation Confirmation Sampling are currently in review by USACE.

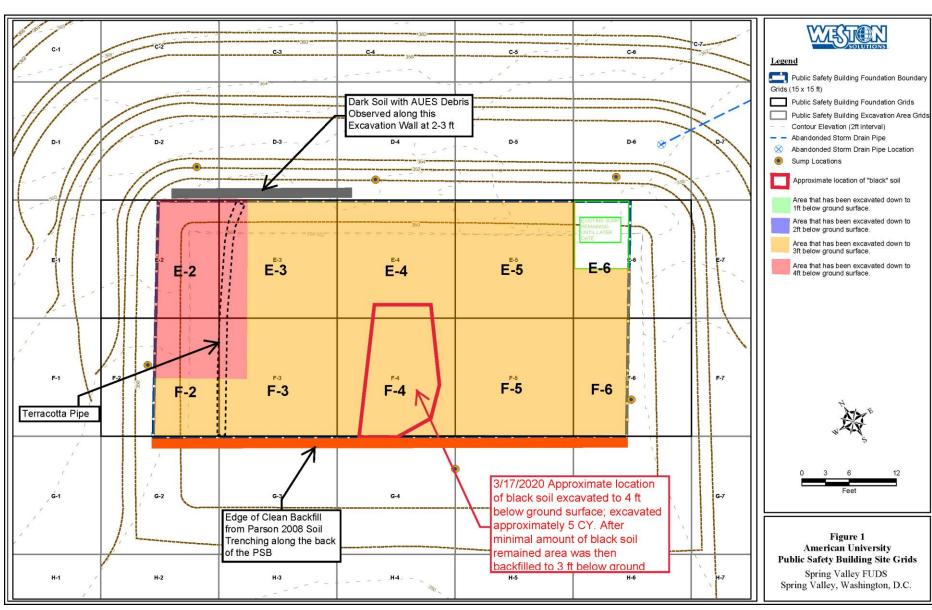
- PSB excavation extent as of March 28th shut down
- Excavation depths range from 3-4 feet.
- Excavated dark AUES debris field mostly from 1-3 feet but with one area 1-4 feet.

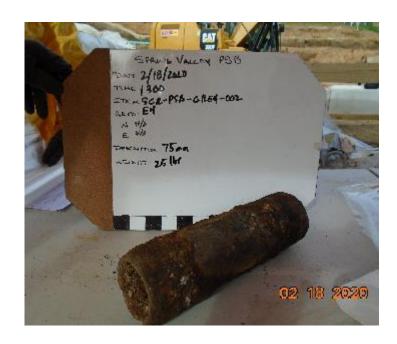
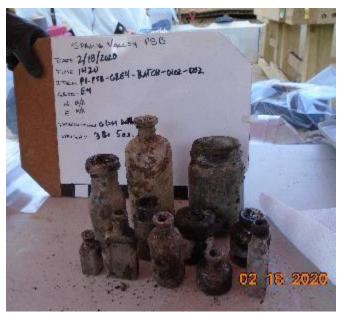
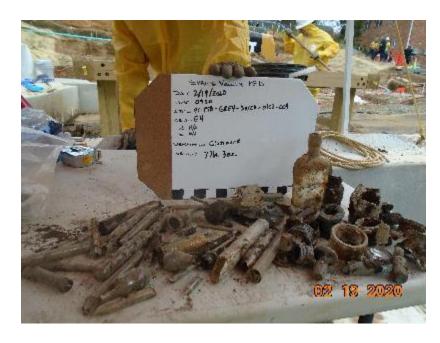
AUES DEBRIS ENCOUNTERED

AUES Debris: The AUES Debris layer contained dark brown soil, abundant unsealed lab glassware bottles, pipettes & tubes, plus munitions debris (non-explosive 75-mm projectiles and 4" Stokes mortar rounds). All items have been negative for CWA headspace analysis and soil samples were non-detect for low-level chemical agent and agent breakdown product analyses.

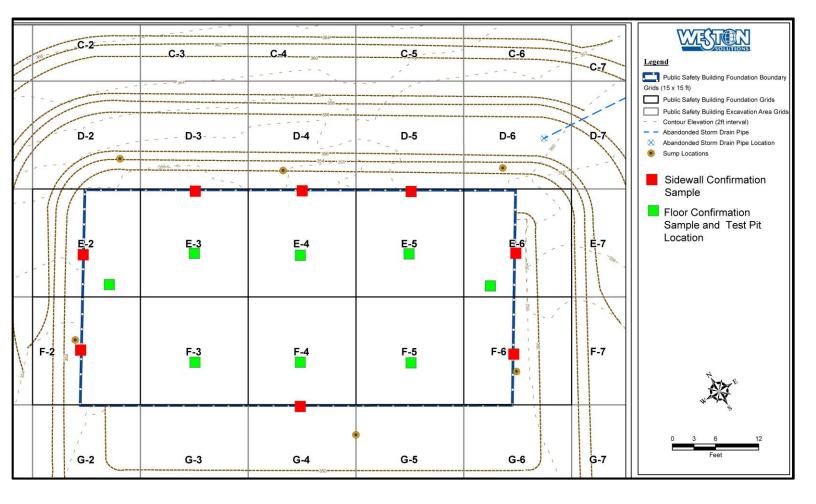
TEST PIT & CONFIRMATION SAMPLE LOCATIONS

Eight test pits are proposed within the grid cells to evaluate the extent of AUES debris and collect confirmation soil samples. The test pits will be excavated at the center of each grid cell in 1-foot depth increments from the existing excavation floor to 8 feet below slab elevation.

Each 1-foot depth increment will be inspected for munitions and explosives of concern (MEC) and AUES items by UXO Technicians and confirmation samples collected for each interval.

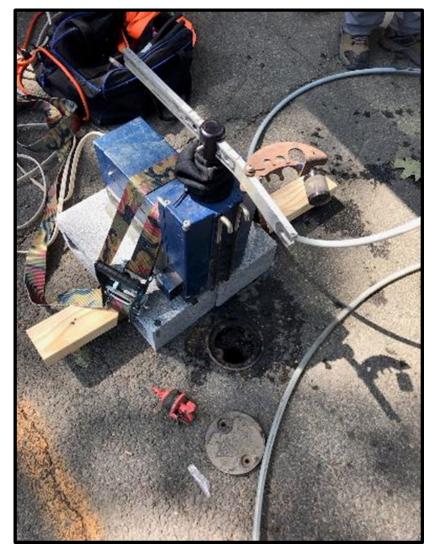
Groundwater sampling well

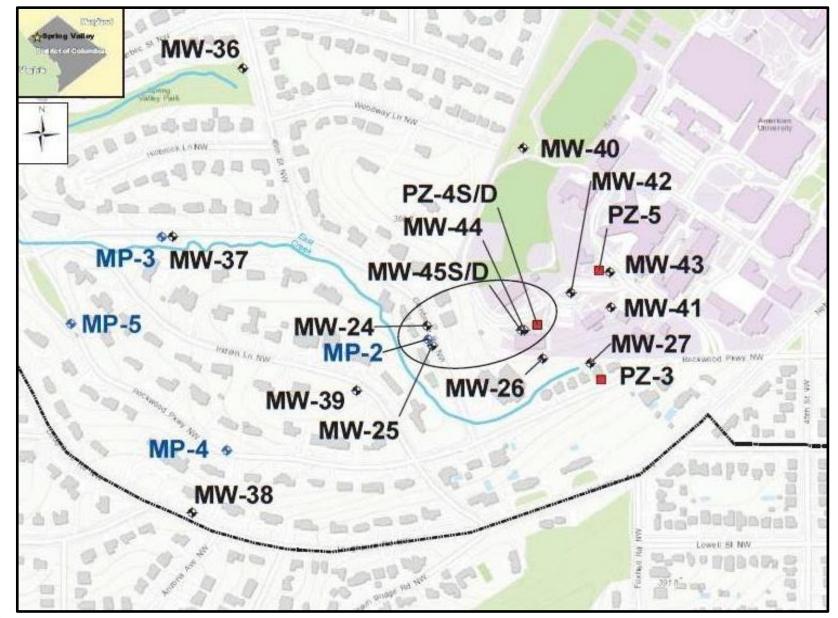
GROUNDWATER STUDY: EXPOSURE UNIT 2

S/D = Monitoring well or piezometer with screened intervals in the same borehole.
