SPRING VALLEY FORMERLY USED DEFENSE SITE

Partners Meeting Presentation
February 2021

SPRING VALLEY GLENBROOK ROAD SITES

SVFUDS SITE-WIDE REMEDIATION STATUS FEBRUARY 2021

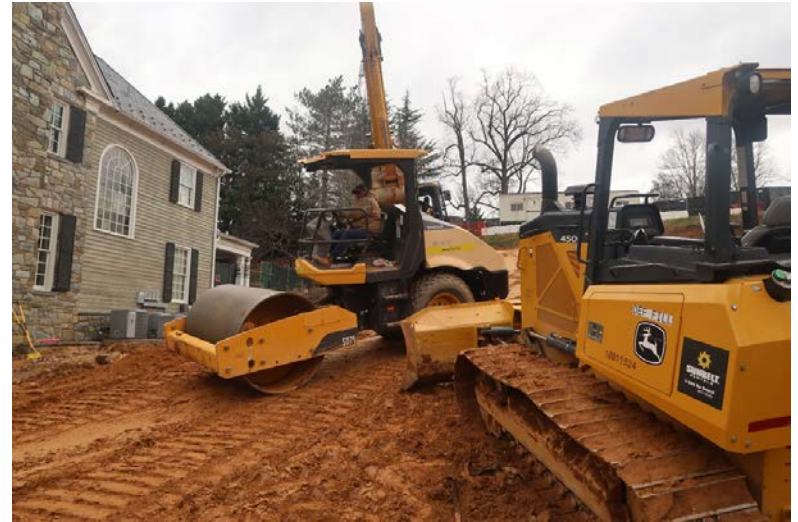
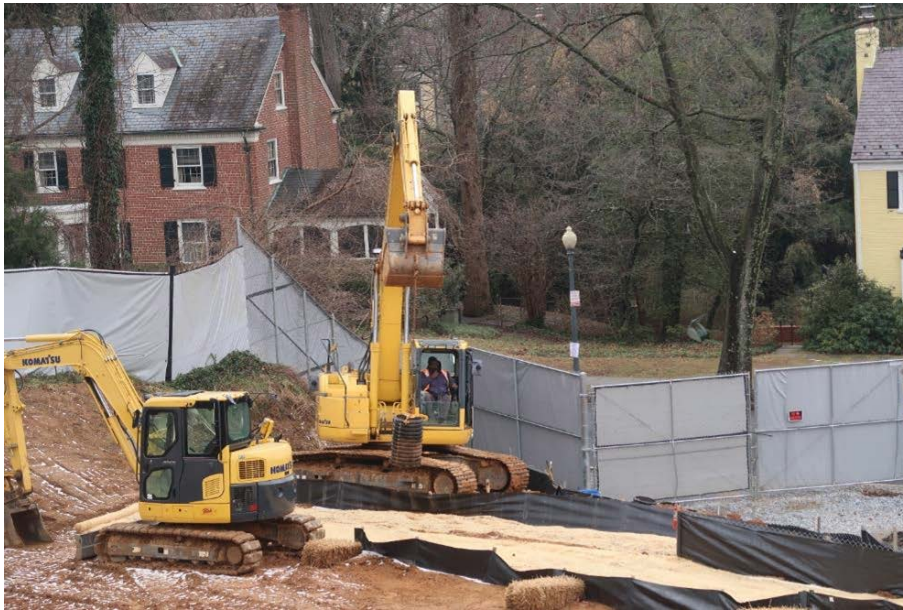
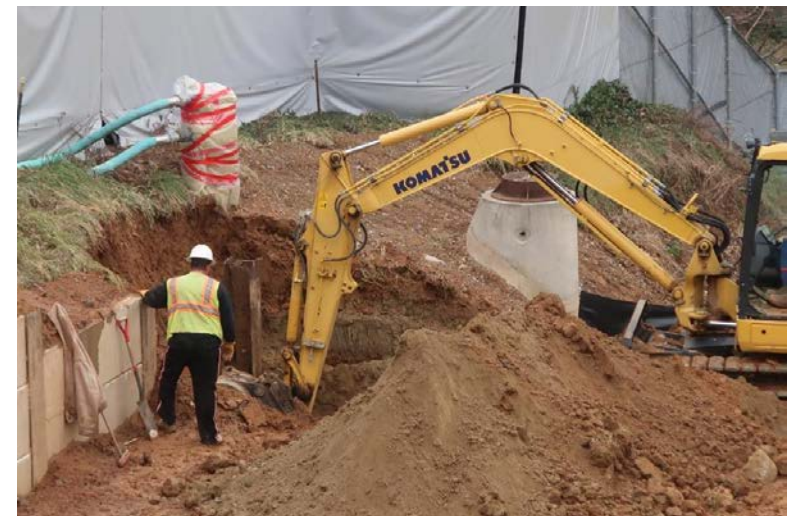
4825 Glenbrook Road - Recent Activities

- Continued to perform compaction activities in December
- In early January removed a soldier pile that was in the way of utility restoration
- In January also removed dead bamboo from 4801 Glenbrook that had been moved for temporary utility right-of-way

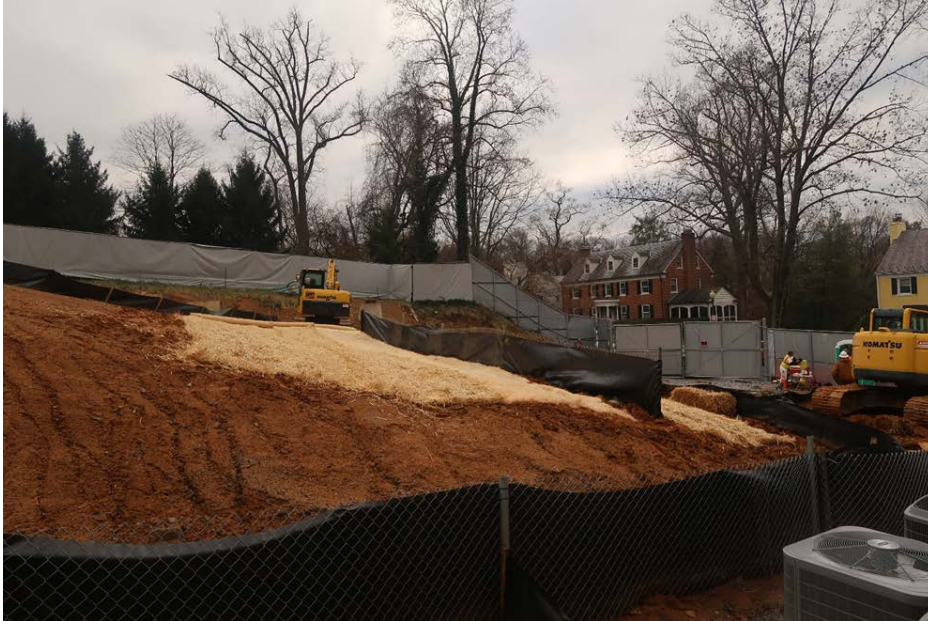
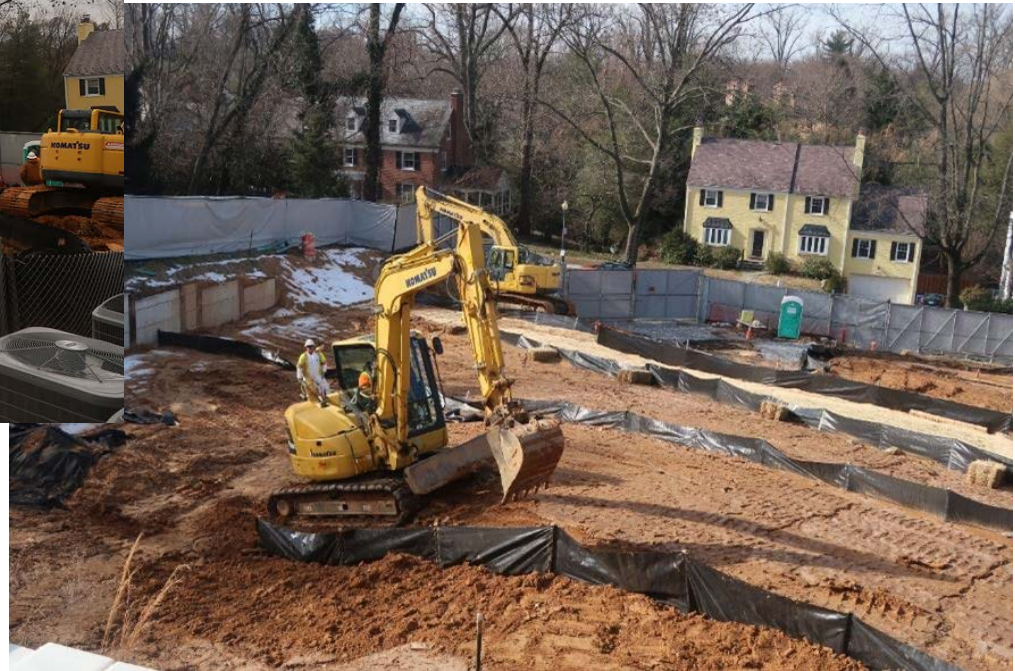
4825 Glenbrook Road - Recent Activities (Cont.)

- Throughout January and February have maintained sediment and erosion controls
- No backfilling since December due to weather/soil moisture conditions

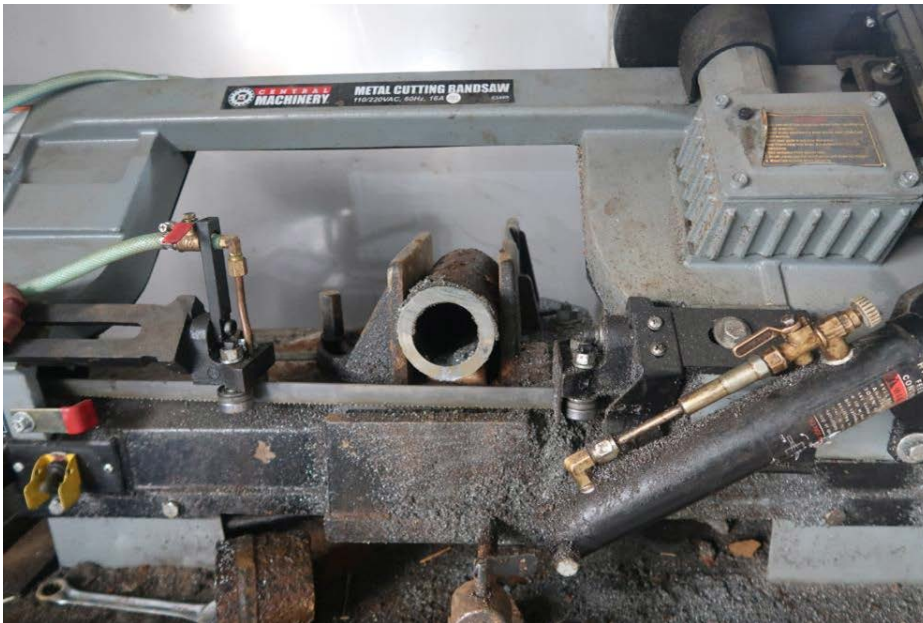
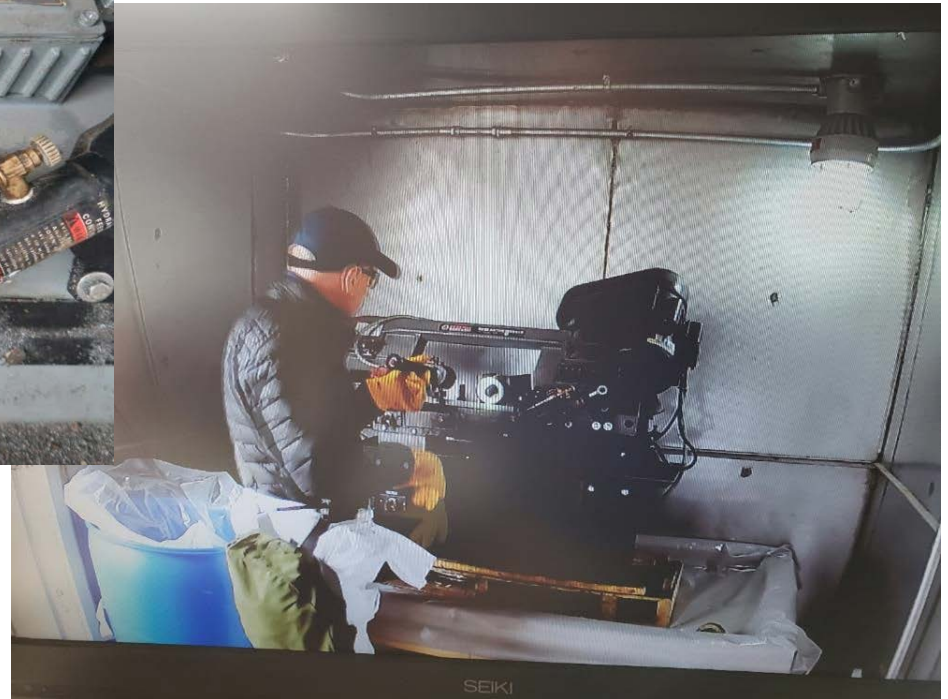
- On January 28th successfully and remotely cut twelve intact 75mm projectiles and one “livens like” projectile with video monitoring, air monitoring, and engineering controls.
- The cutting operation was needed to confirm the items were safe to dispose of as Material Documented as Safe (MDAS)

- No chemical agent (CA) was detected during cutting ops. and all items cleared headspacing for CA after cutting

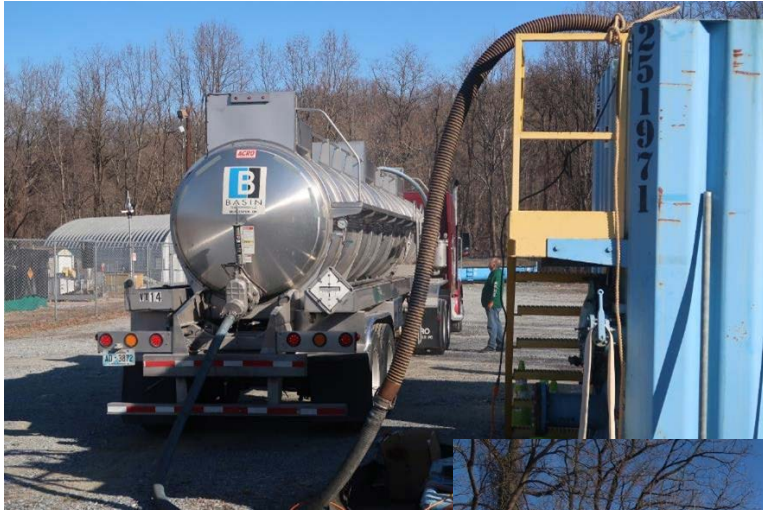
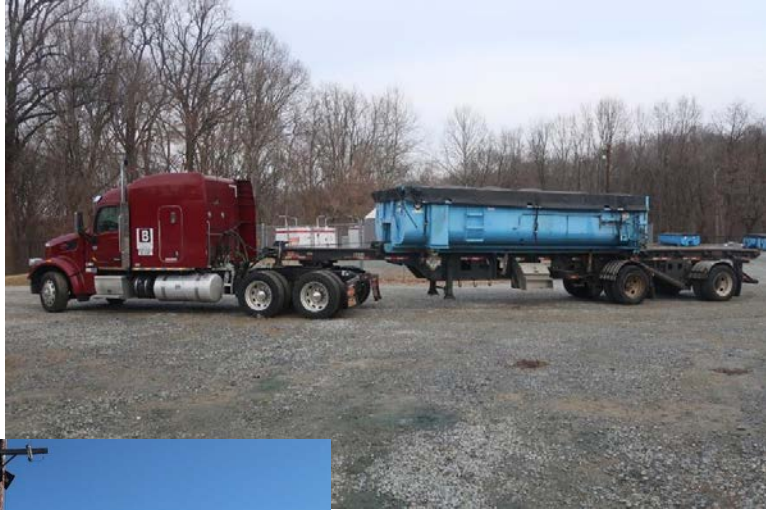
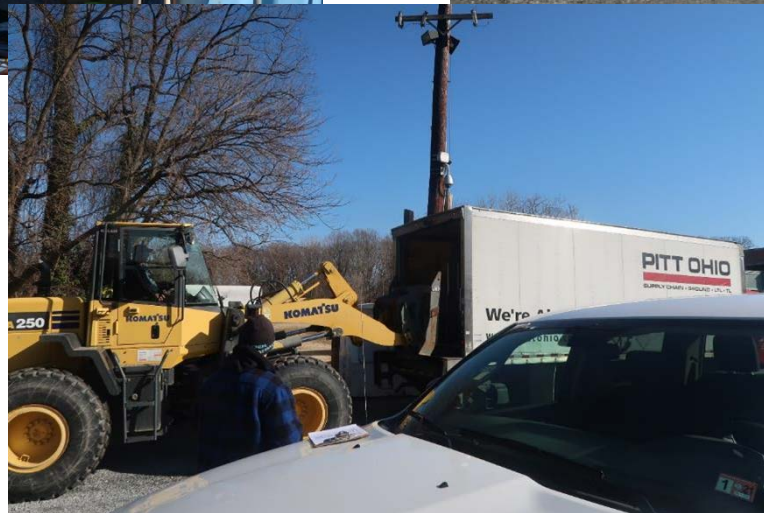
4825 Glenbrook Road - Recent Activities (Cont.)

- Beginning in February began shipping soil, liquid, and removal-derived waste to the waste incinerator
- Waste shipments expected to occur throughout February and into early March

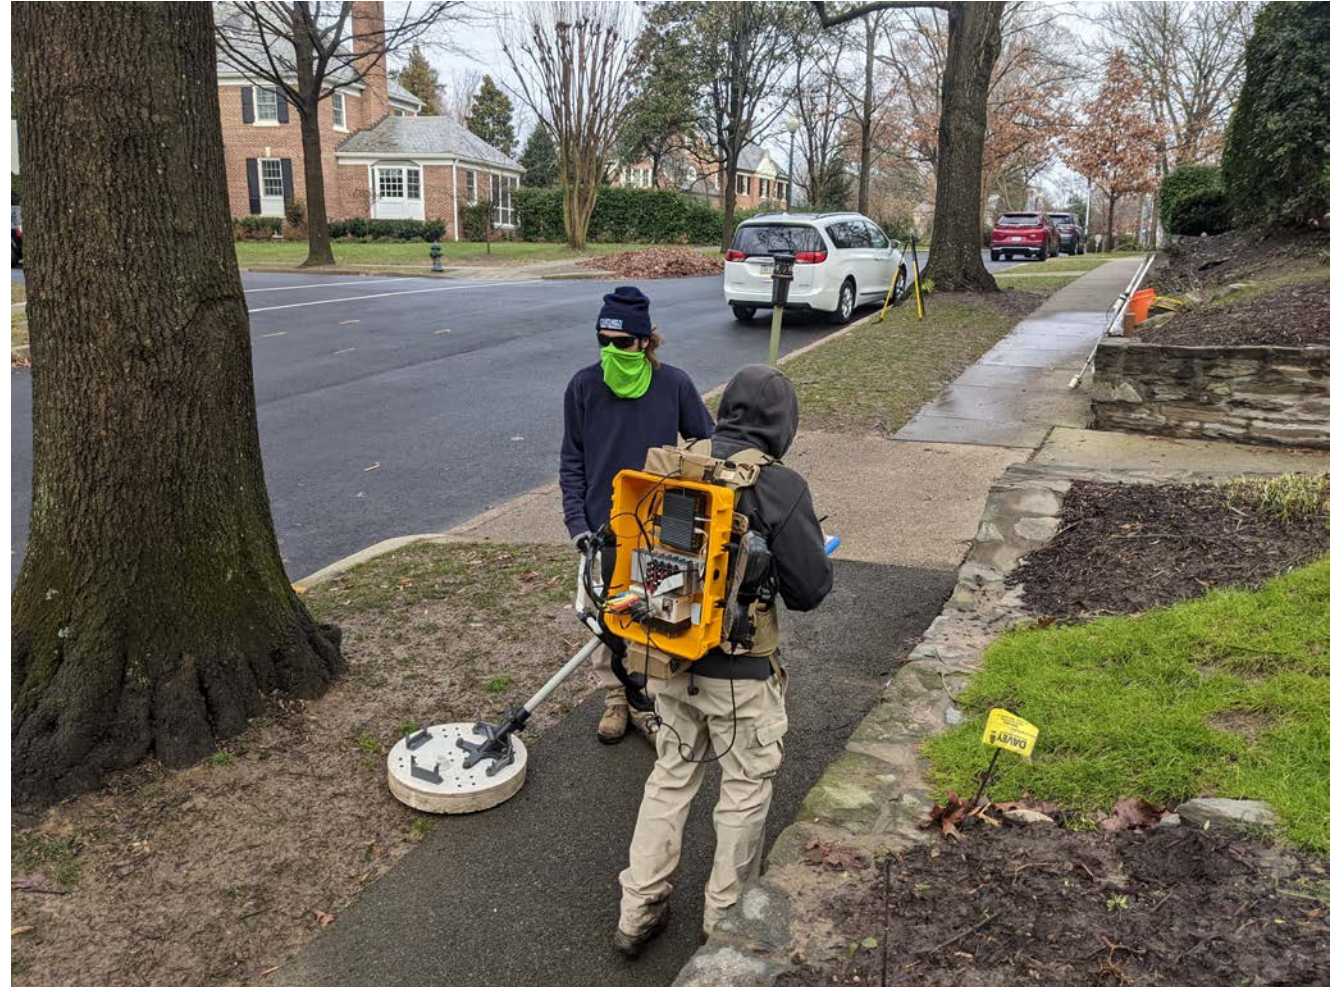
- Geophysical surveys at 7 properties and one grid began on 12/1/20 and were completed on 1/20/21 .
- To date, geophysical surveys have been completed at 13 fed/city lots and 82 residential properties
- Geophysical surveys remaining to be conducted include 7 residential properties

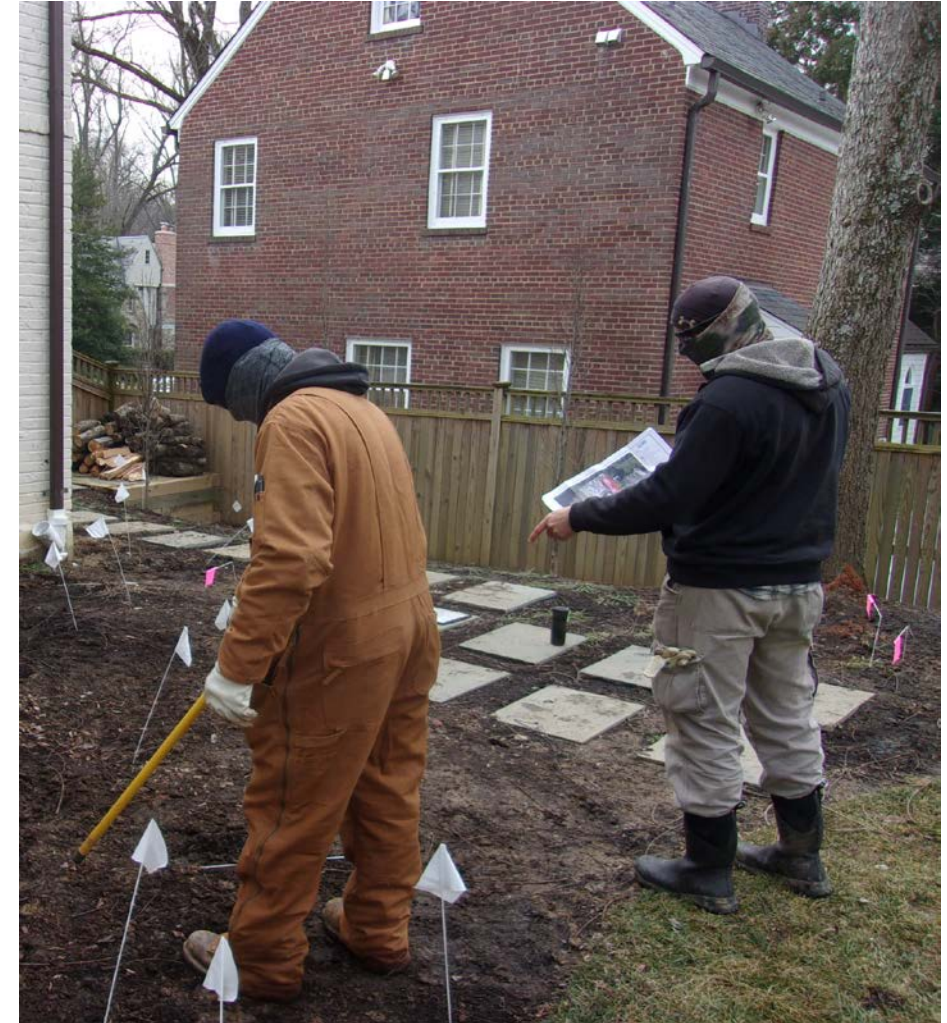
INTRUSIVE INVESTIGATIONS UPDATE

- December intrusive phase (began on 12/1/20) was complete on 12/21/20.
- February intrusive phase began on 2/8/21 and is expected to be complete the week of 2/22/21.

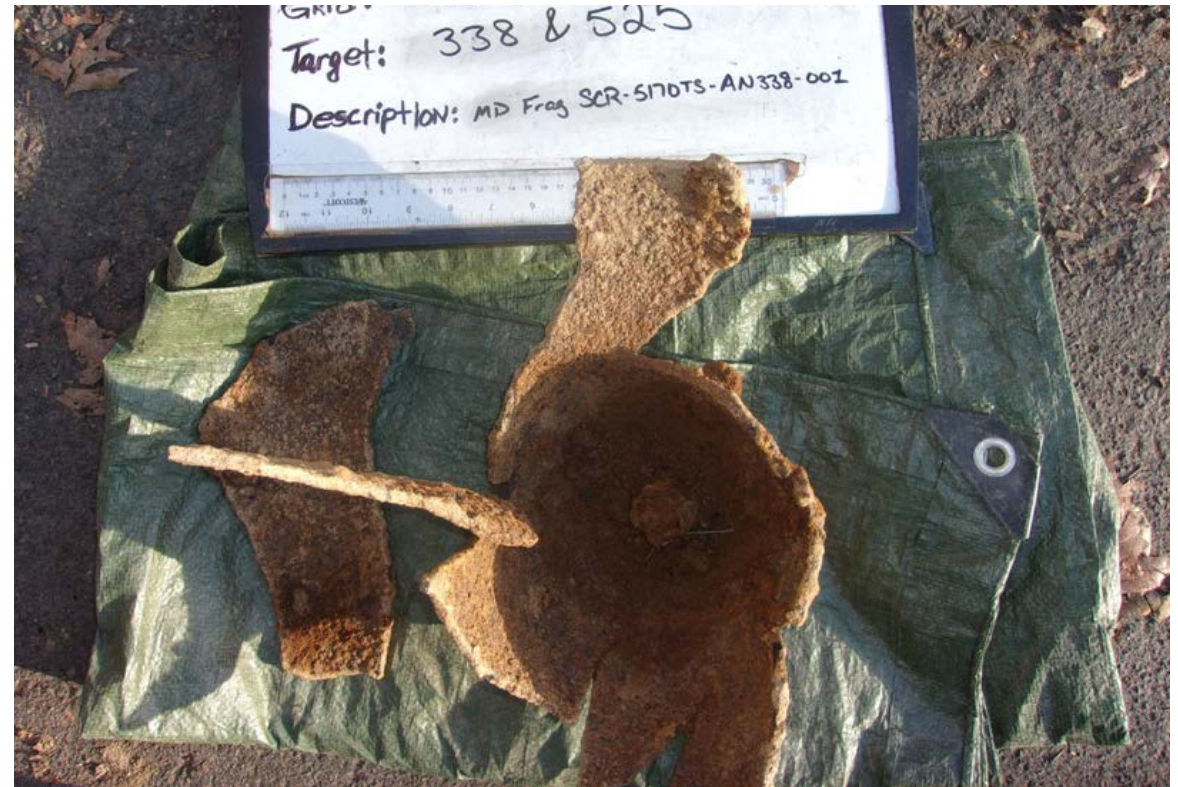
INTRUSIVE INVESTIGATIONS UPDATE

December 2020 Intrusive Investigation Results:

- No MEC/MPPEH items recovered.
- Seven MD items recovered.
- Headspace results all non-detect for agent.

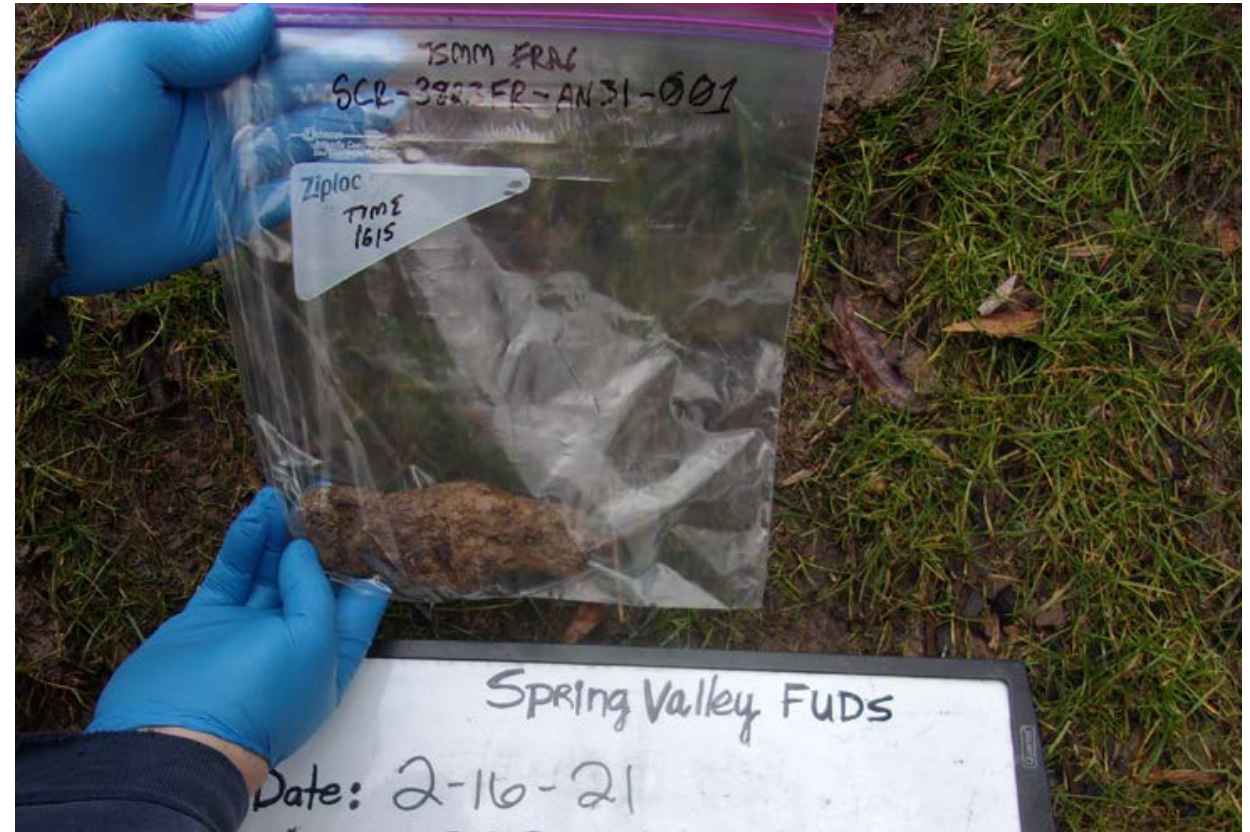
RESIDENTIAL PROPERTIES – INTRUSIVE STATUS

As of 2/16/2021:

- No MEC/MPPEH items recovered.
- Three MD items recovered.
- Headspace results pending.

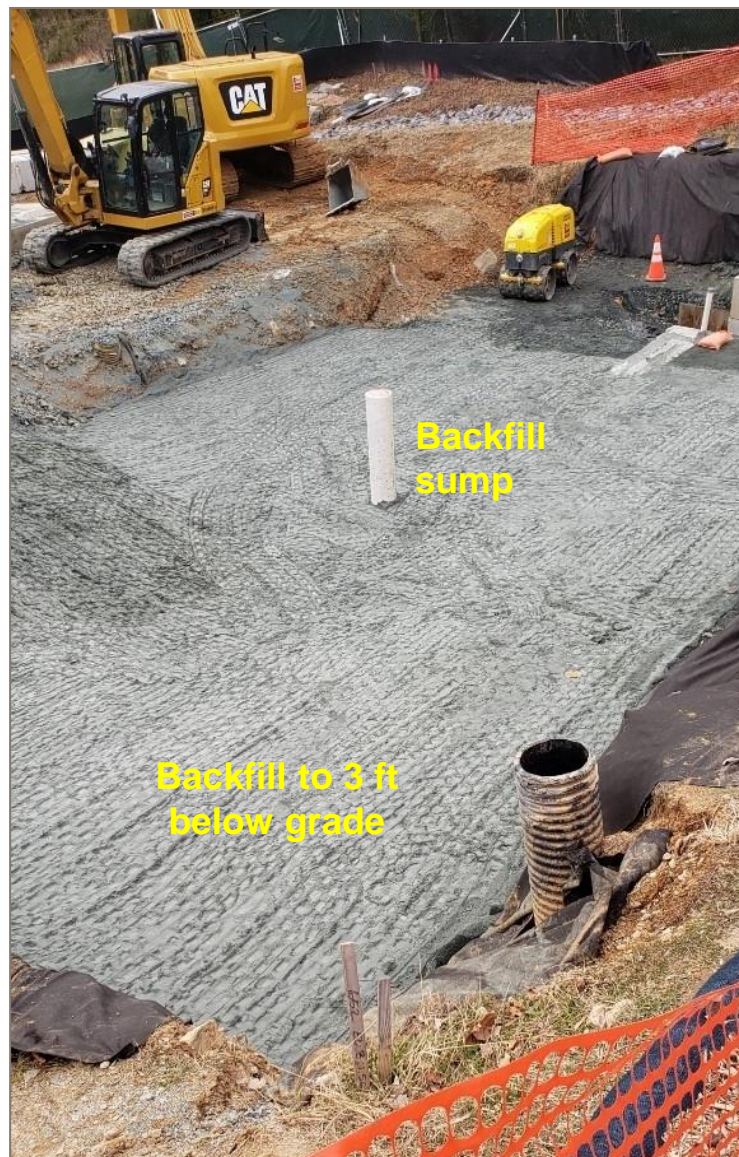
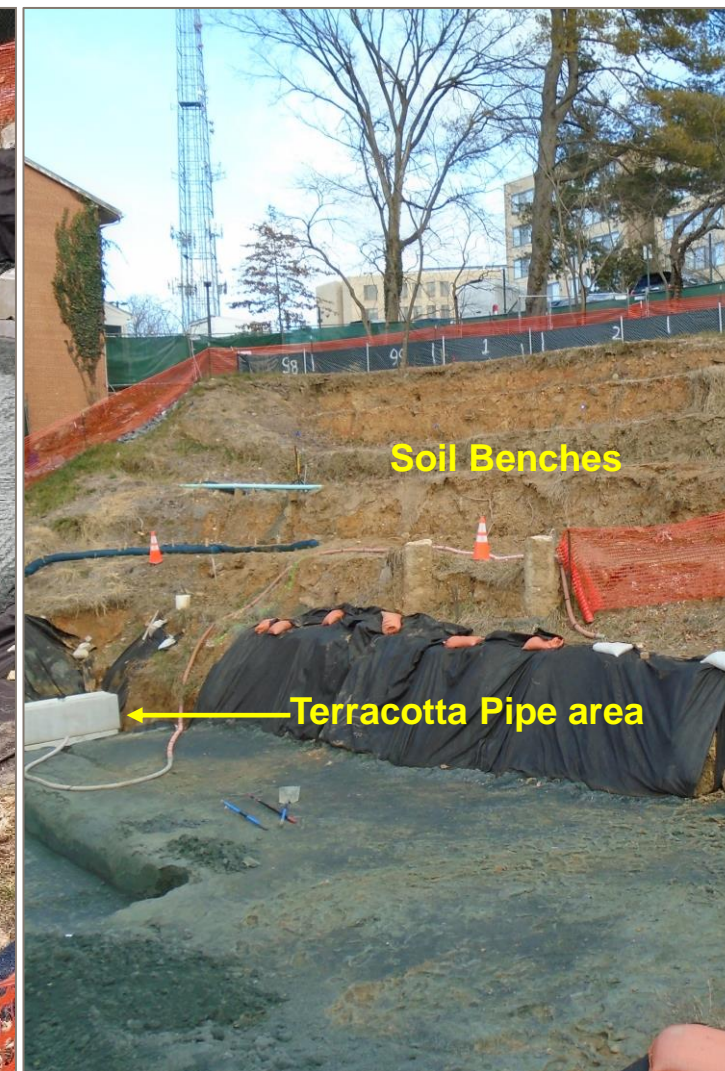
PSB GRID EXCAVATION AND BACKFILL DEPTHS

- Completed excavation of final grid (E3) under the former PSB building slab.
- Completed backfill, compaction & testing to 3 feet below grade.
- Preparing terracotta pipe replacement in grid E2/E3.
- Completed test pits east and west of the PSB foundation to evaluate the extent of AUES debris.

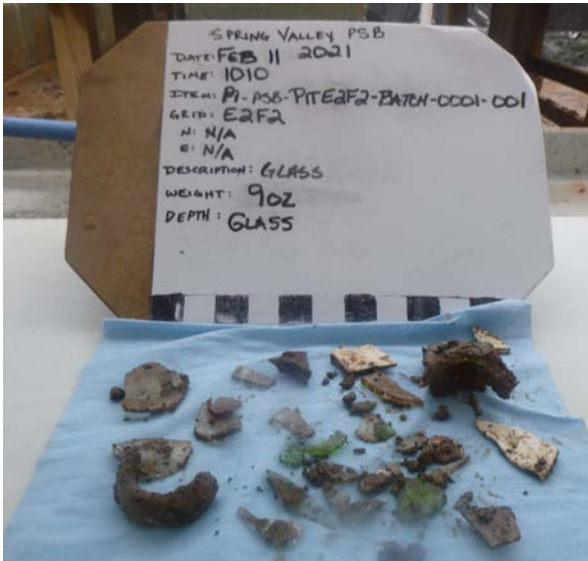
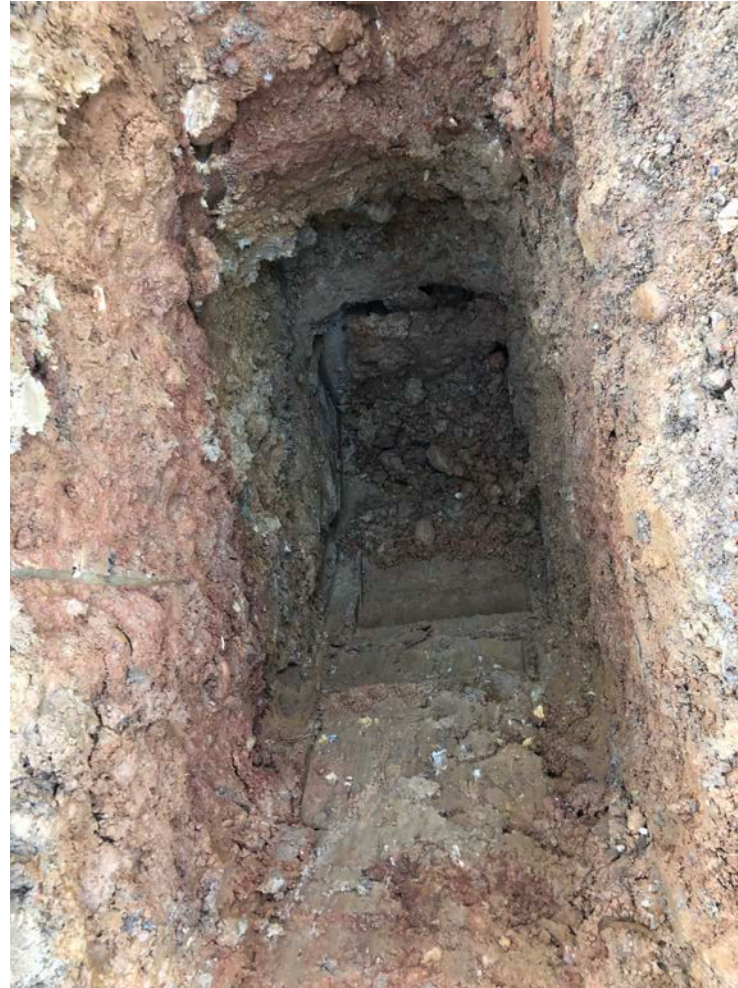
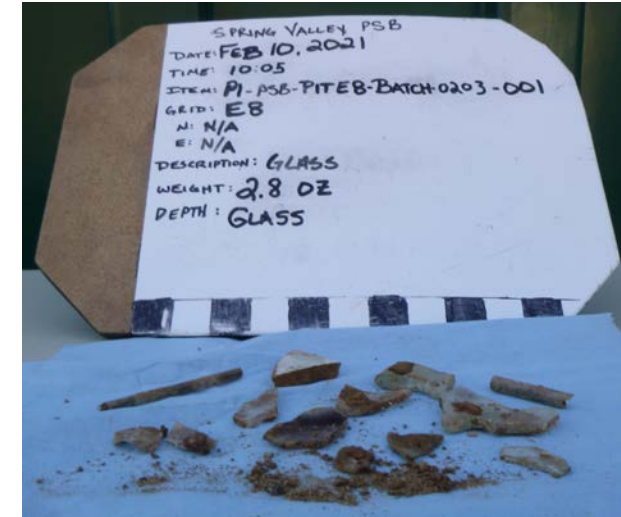
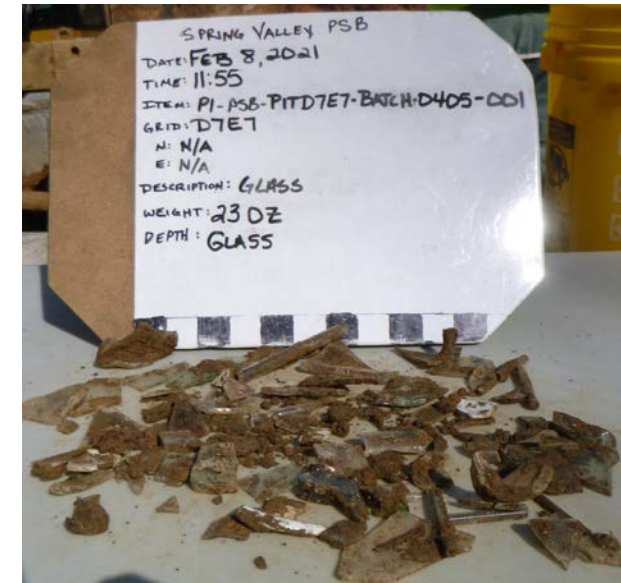
PSB – TEST PIT PHOTOS

Test Pit	Initial Elevation (ft)	Final Depth (ft)	Final Elevation (ft)	Depth/Elev. Last AUES Glass (ft)	Observations
E7	353.0	6 ft	347.0	5 ft/ 348 ft	Lab glass observed from 0-5 ft
F7	352.7	5 ft	347.7	4 ft/ 348.7 ft	Lab glass observed from 0-4 ft
F7/G7	354.0	5 ft	349.0	4 ft/ 350 ft	Small amounts of glass from 0-4 ft
D7/E7	358.1	9 ft	349.1	8 ft/ 350 ft	Lab glass observed from 0-5 & 7-8 ft
E7/F7	354.9	6 ft	348.9	5 ft/ 350 ft	Small amounts of glass from 0-1 & 4-5 ft
E8	357.3	9 ft	348.3	5 ft/ 352 ft	Small amounts of glass from 1-3 & 4-5 ft
E2/F2	355.0	6 ft	349.0	3 ft/ 352 ft	Significant AUES glass from 0-3 ft

Test Pit E8 Excavated to 9 ft

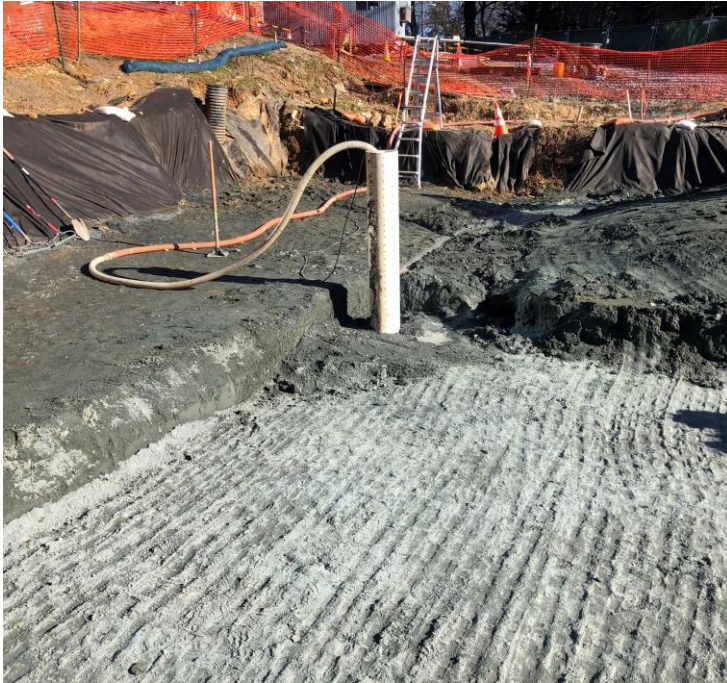
PSB Operations – Pumping groundwater from sump at 8 feet in Grid F4 to help complete proper backfill compaction.

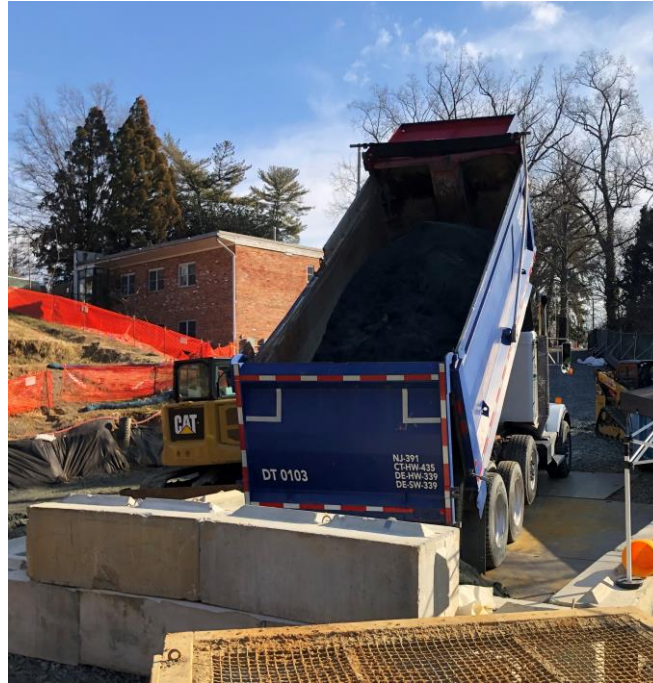
Backfill – Delivering approved backfill from Savage Quarry.

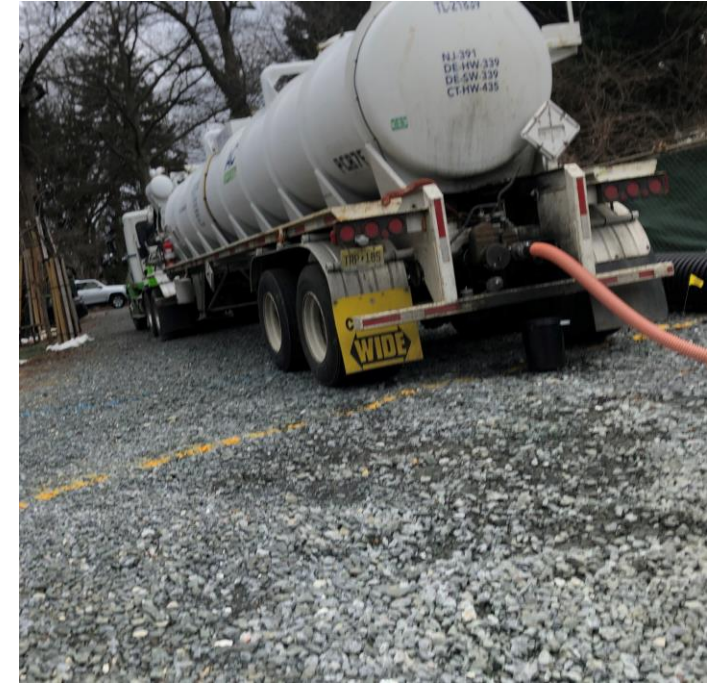
Water Disposal – Emptying groundwater from sumps stored in Frac tank into tanker truck for disposal.

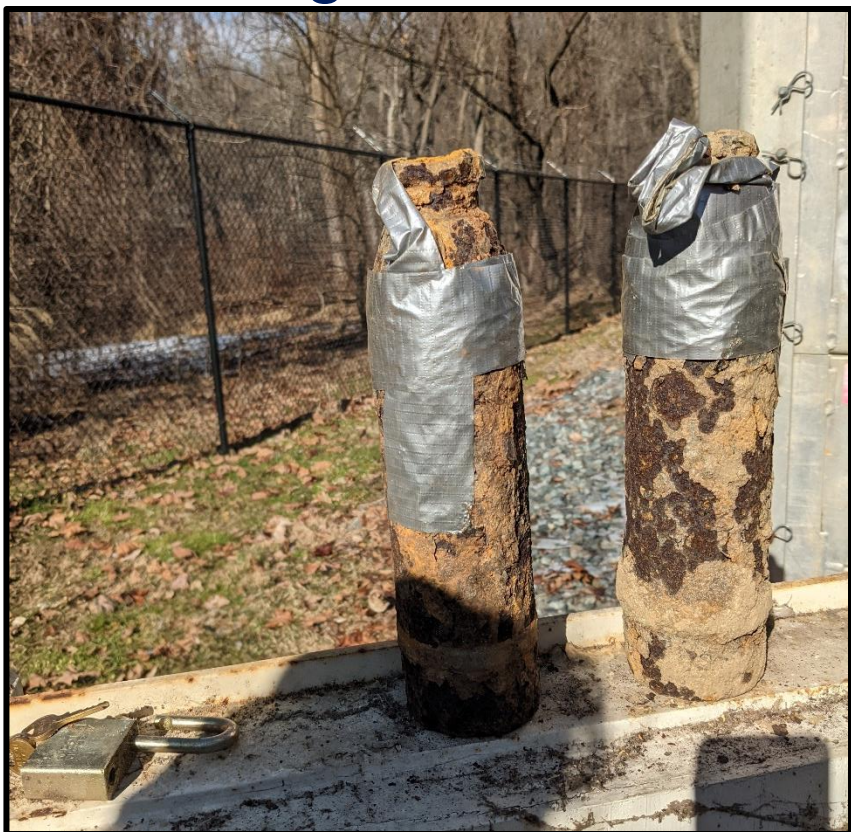
During a recent inspection of the Federal Property fence line, the Army Corps on-site explosive safety specialist discovered a padlocked day box containing two 75mm items.

- These items are open cavity and include duct tape handles. The agencies, contractors, and personnel on site in recent years were unable provide any information; speculation is that these items may have been used as training aids.
- EOD was called and a formal assessment process of the items began on February 16. The items are currently stored in the Assessment Holding Facility (AHF) under negative pressure carbon filtration.

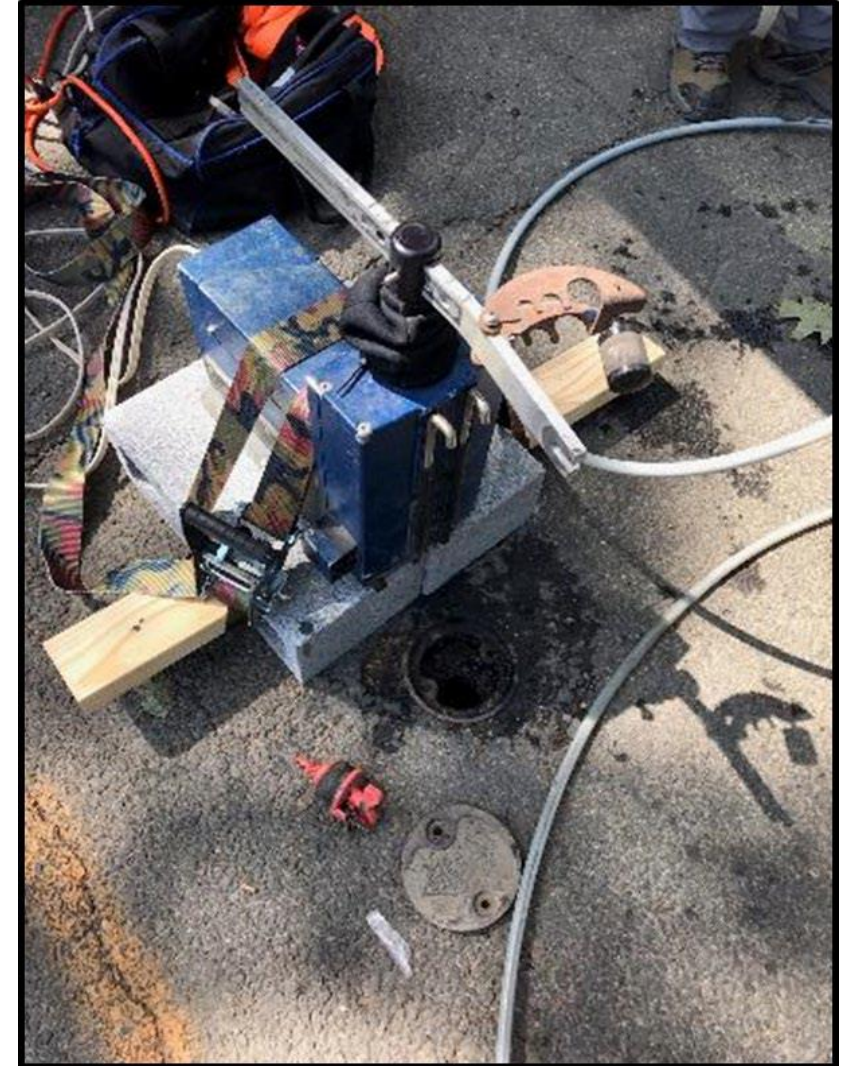
Groundwater sampling well

- A groundwater sampling event for perchlorate at wells PZ-4D and MW-44 will be conducted by the USACE and the U.S. Geological Survey (USGS) the week of February 22nd. The event was pushed from mid-February due to icy conditions.
- The June 2020 sampling results were very similar to the results from September 2019. The Army Corps and Partners agreed on additional sampling for perchlorate after the November update to the Regional Screening Level (RSL), to confirm concentrations consistent with the September results.
