## **APPENDIX H – GEOTECHNICAL STUDIES**

This appendix includes the text and Appendices A and B from Findling’s Geotechnical Study for Harbor Sites Feasibility Study - Masonville Marine Terminal -Baltimore, Maryland (Findling 2006). Not included in this appendix are the Findling 2006 Masonville Geotechnical Study appendices containing boring logs, lab test data (for the boring samples and strength tests of dried dredged material at Cox Creek Dredged Material Containment Facility), and slope stability analyses. The full Findling 2006 Masonville Geotechnical Study is available on request from the United States Army Corps of Engineers - Baltimore District.

### **1.0 INTRODUCTION**

This report presents the results of the geotechnical investigation conducted in association with the design of Dredged Material Containment Facility (DMCF) at the Masonville Marine Terminal, Baltimore, Maryland. This investigation was conducted for Gahagan & Bryant Associates, Inc., in general accordance with Findling, Inc.’s proposal dated February 24, 2004.

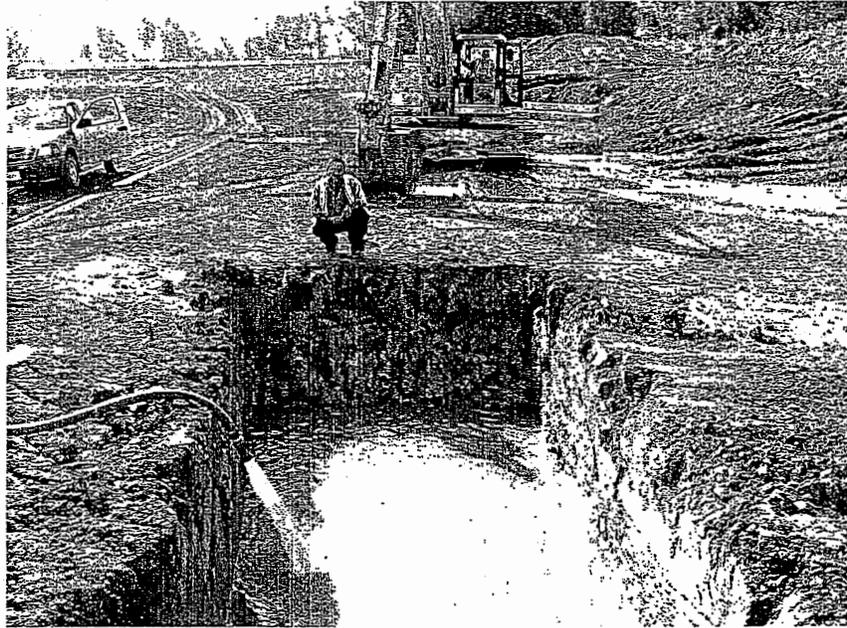
**FIGURE 13: TESTING CLAY FILL UNDERWATER**

**Test Pit Being Filled With Water**

**Plate Load Test on Clay Fill**

In attempt to more accurately model field condition, Findling conducted a large scale field test on clay backfill in water at the Cox Creek DMCF in the fall of 2005. The clay material used for the field test was dark red-gray-tan stiff to hard clay, which was encountered at the Cox Creek Site. This material is the Arundel Clay of the Potomac Group, which also underlies the Masonville Site and is identified as Stratum III. The Liquid Limit and Plastic Index of the Cox Creek material (clay) were 52 to 34 respectively. The plate bearing test was conducted by excavating a pit about 6 feet wide by 10 feet long by 6 feet deep, filling the pit with water then filling the pit to 2 feet above the water level with clay balls. The clay size chunks were generally 4 to 8 inches size and they were allowed to set in the pit for 2 weeks before testing. A 2-foot diameter steel plate was placed on top of the clay and a wood frame to support a drill rig was constructed over the pit. The steel plate was loaded to failure by jacking against the drill rig. Failure was defined as the maximum load that could be developed and held on the plate. The load on the plate was computed from recording the pressure on the hydraulic jack and conversion charts provided by the jack supplier. See Figure 13. The shear strength of the clay was back calculated using the bearing capacity equations. Several methods have been developed to calculate the soil bearing capacity based on strength parameter of the soil, i.e. cohesion and angle of internal friction. For our analysis we assumed a cohesive soil with the angle of internal friction of 0. The most common correlation for bearing capacity was developed by Terzaghi, which utilizes bearing capacity factor ( $N_c$ ,  $N_q$  and  $N_j$ ), depth of footing, and size of footing. Since we have assumed a friction angle of zero we only use the bearing capacity factor related to cohesion and cohesion is our analysis. Terzaghi developed bearing capacity factor for two conditions, local shear and general shear, and Meyerhof developed similar correlations. Based on the various methods and test data the cohesion of the clay mass was estimated to vary from about 300 psf to 425 psf. A plot of load verses settlement is shown in Figure 17 in Appendix A.
