# **EAST BRANCH CODORUS CREEK MITIGATION BANK DRAFT MITIGATION SITE PLAN**

**Springfield Township,  
York County, Pennsylvania**

First Pennsylvania Resource, LLC  
A wholly owned subsidiary of  
Resource Environmental Solutions, LLC

April 2020

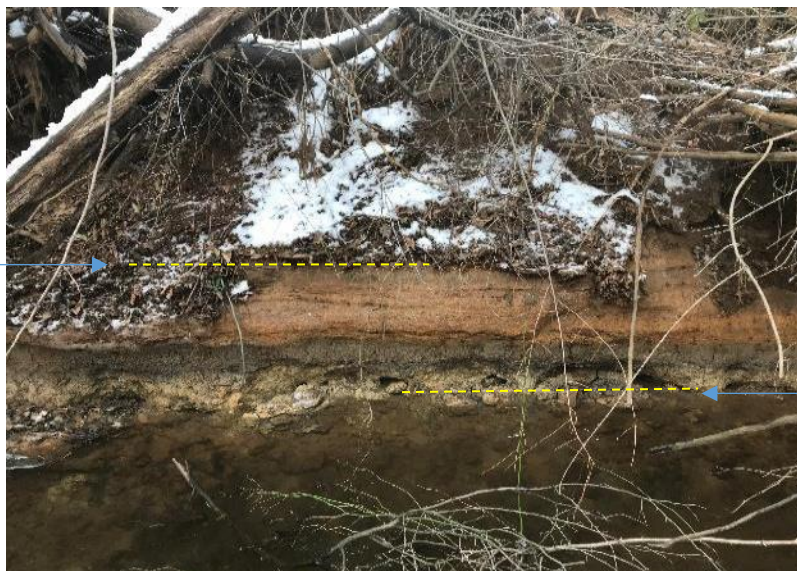
*Top of historic  
hydric layer.*

*Gravel/cobble  
layer*

*Photo 1. Photo evidence of legacy sediment accumulation and streambank incision. The groundwater table is above the surface water. This is evidenced by the leaching of groundwater through the historic hydric layer above the elevation of the stream.*

Sediment stored in the valley bottom that now covers the historic hydric layer was established by the effect of increased sediment supply from surrounding uplands. The valley fill surfaces and associated stream incision produced from sediment accumulation and increased runoff can readily be seen in photos 1 and 2 below. Photo 1 demonstrates the accumulating layers of sediment atop the historic floodplain layer. The top brown-colored layer represents the new floodplain, which sits above a second darker gray layer. This second layer is the historic hydric layer. And finally, the bottom lighter gray layer represents the gravel/cobble layer. The groundwater table and stream bed should otherwise sit at the top of this bottom layer, but due to degradation occurring throughout the system, the stream has vertically incised and now exists below the groundwater table. Because the groundwater table is below the surface water elevation, the hyporheic zone within the floodplain is drained, which explains the sporadic presence of floodplain wetlands within and across the valley bottom.

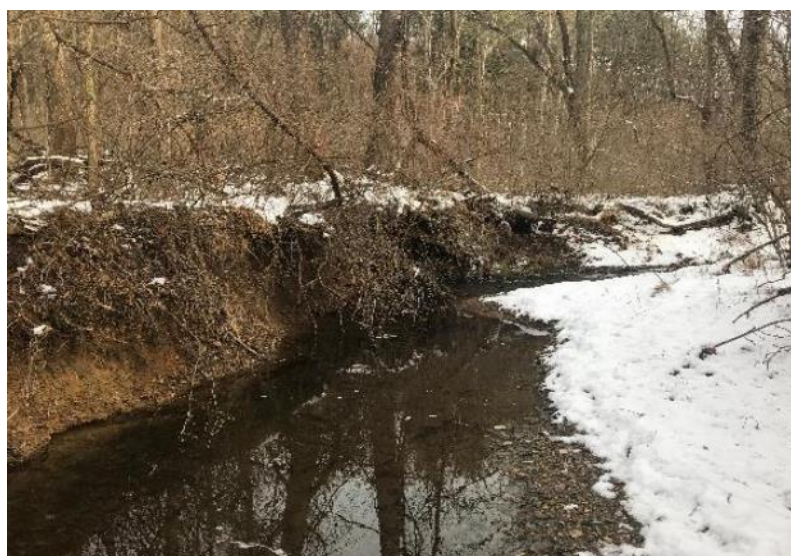
*Photo 2: Photo evidence of the eroded bank into the valley side slope due to relocation, sediment covered stream bottom and historic hydric and gravel layers covered by sediment accumulation from surrounding upland hillslopes.*

Photographs 2 demonstrates the extent of the vertical and lateral erosion occurring within the Bank Site. The stream was pushed to the valley side slope and began to erode into the hill. The height of the bank at this location is approximately four feet. Piping of groundwater within the water table layer (the layer below the historic hydric/floodplain layer) is also evidence of the accumulation of sediment over time. Trees that once grew comfortably along stream banks now either slough into the stream channel, or are approaching that condition as the banks continue to erode from underneath them, as shown in Photo 3. The bank has eroded back approximately

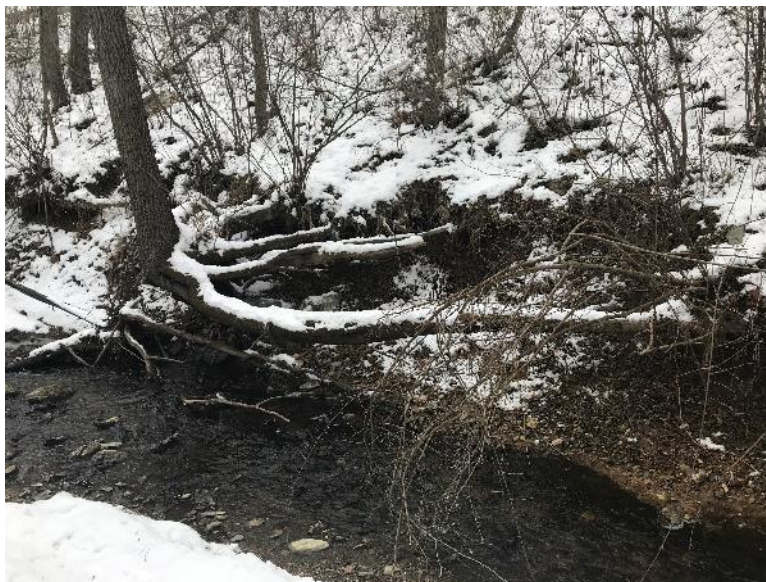
*Photo 3. The above photo demonstrates how lateral and horizontal movement of the stream has caused severe undercutting of the tree.*
