**SPRING VALLEY FORMERLY USED DEFENSE SITE PROJECT**  
**RAB Meeting**

**September 12, 2017**  
**7:00 – 8:30 p.m.**

# SUMMARY OF HISTORICAL AND CURRENT WORK AT 4835 GLENBROOK ROAD

# 4835 GLENBROOK APEX REPORT

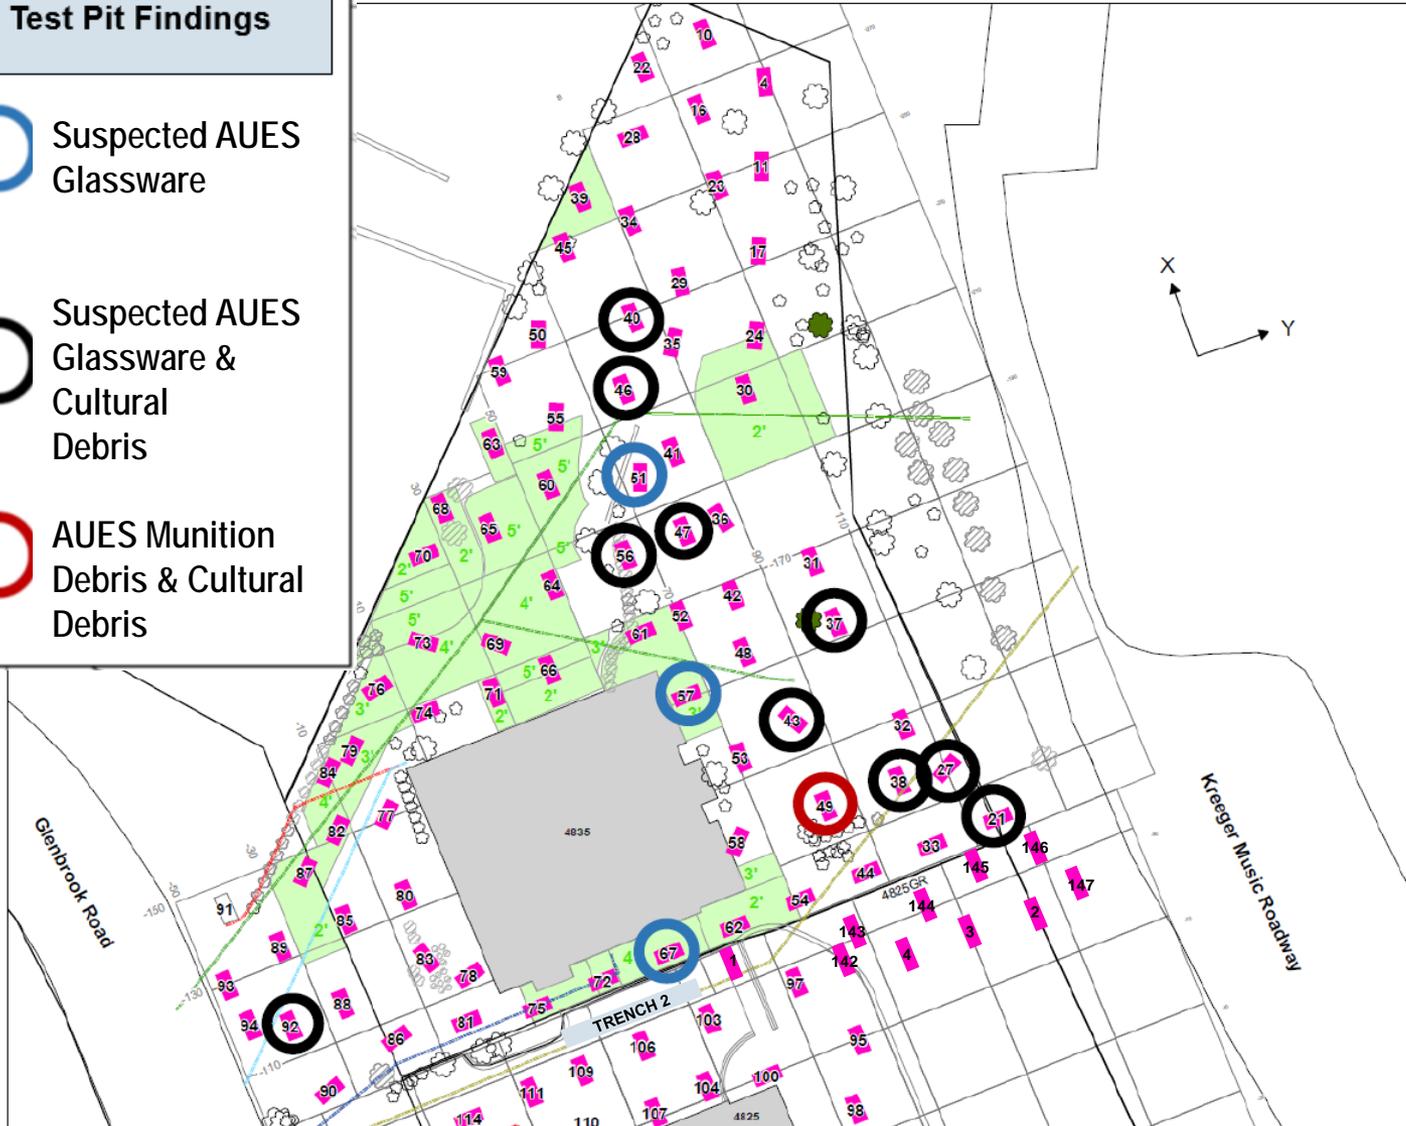
Working Map-Extents  
Driveway Arsenic  
4835 Glenbrook Road

AUES Munition Debris & Cultural Debris

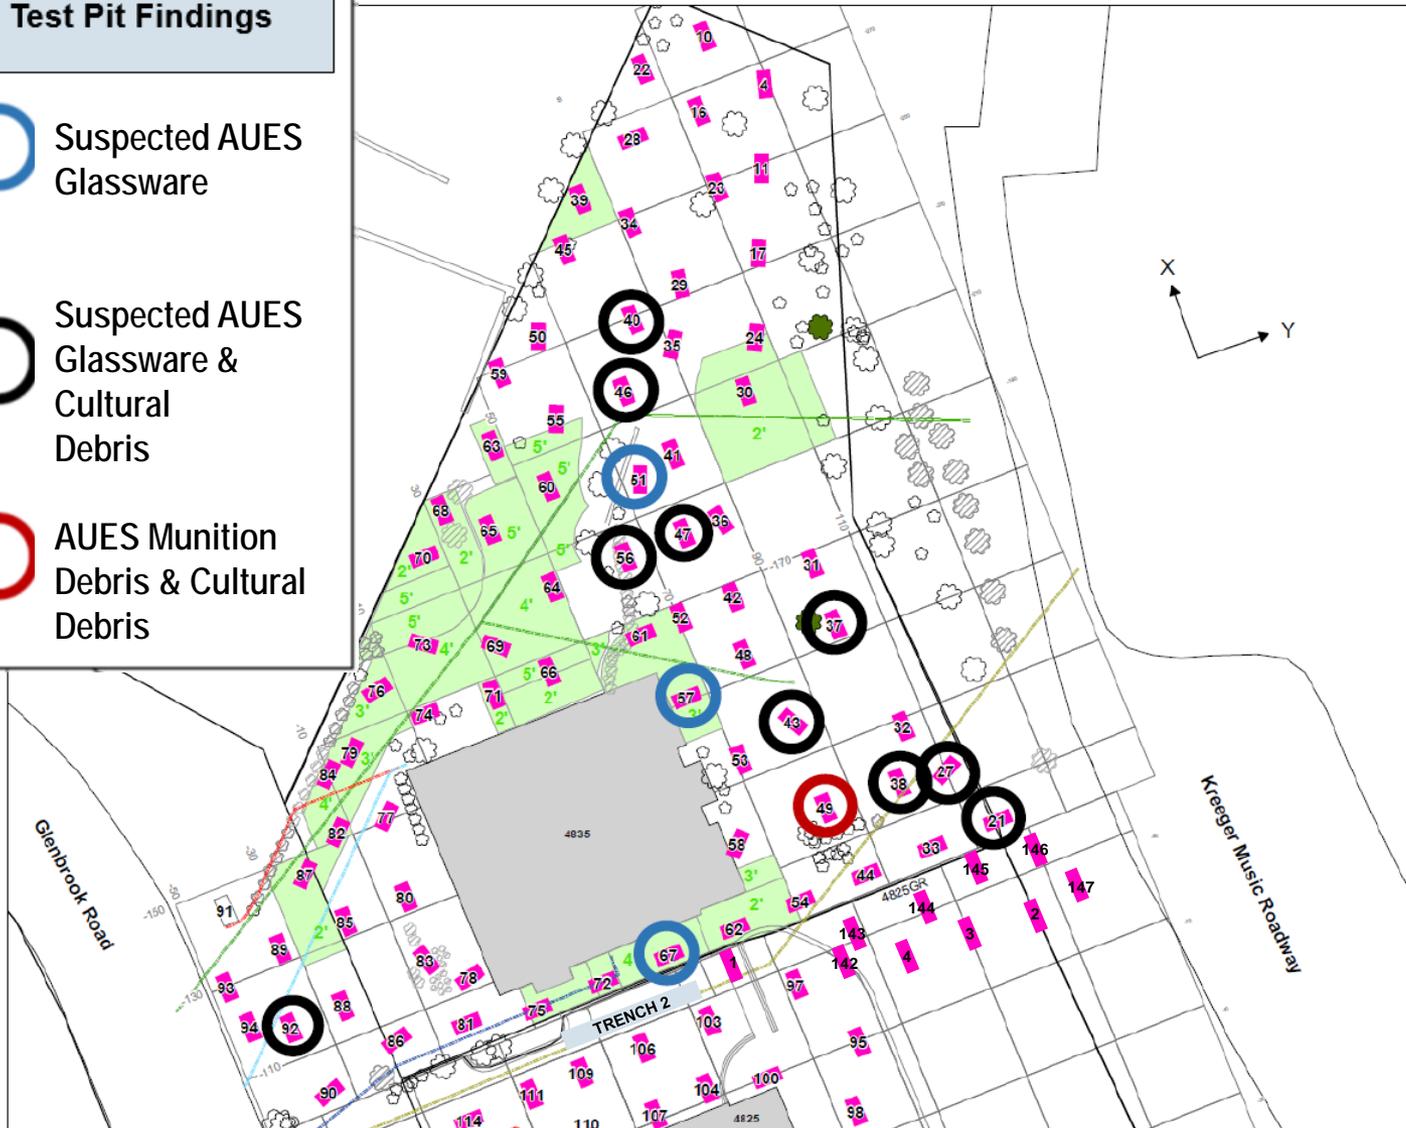
Working Map-Extents  
Driveway Arsenic  
4835 Glenbrook Road

AUES Munition Debris & Cultural Debris

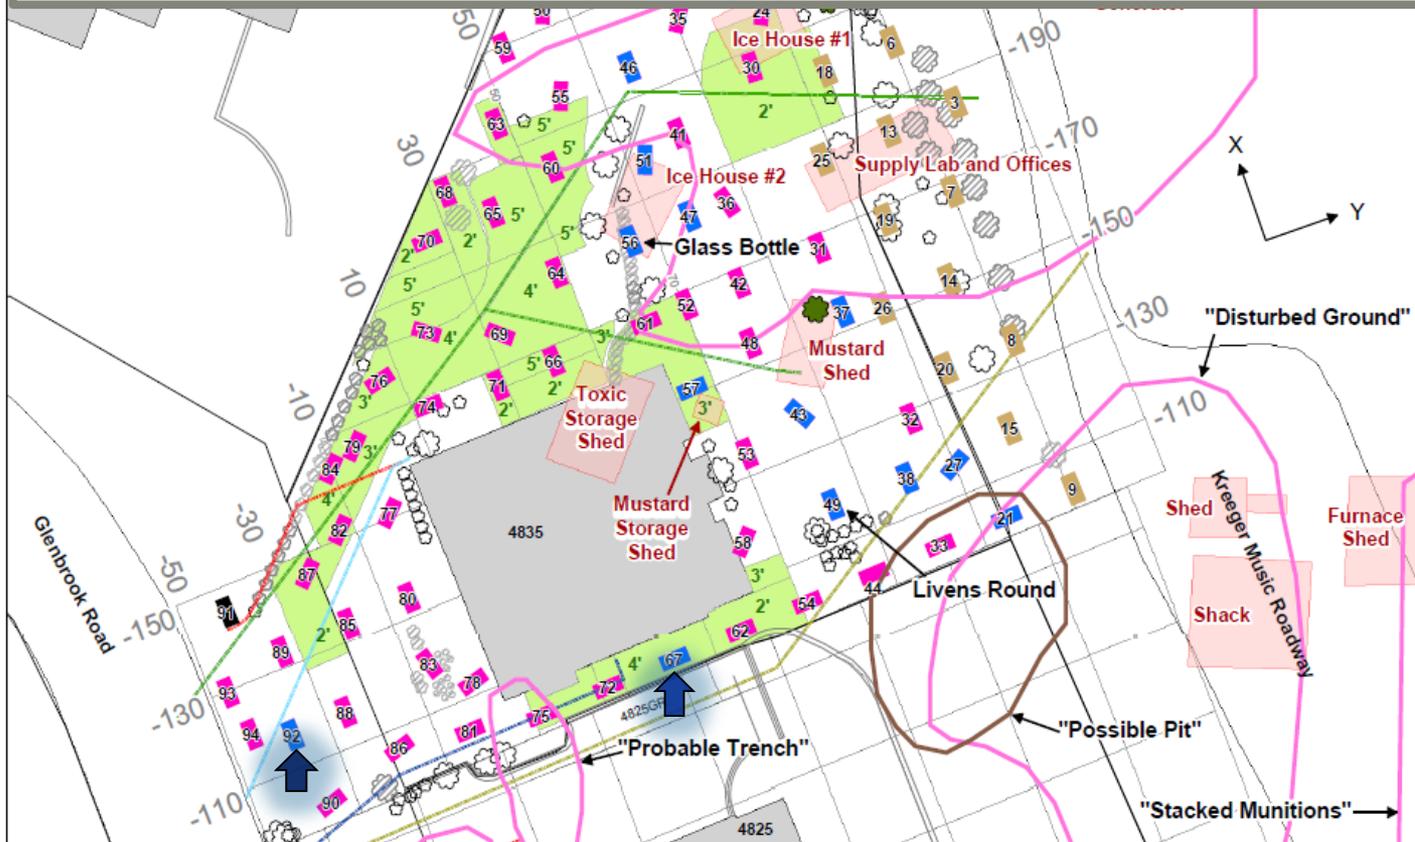
Figure 2-2  
Locations of the Test Pits and  
Areas of Arsenic-Impacted Soil  
4835 Glenbrook Road

In 2008, USACE recovered suspected AUES-related items in two test pits at 4835 Glenbrook near the current excavation area, and both cleared headspace.

- Test Pit 67 – Small glass pipette at 6 ft. deep (bgs)
- Test Pit 92 – Broken glass stopper at 1.5 ft. deep (bgs)

There was an AUES-related item found in one of the test pits that was along the property line between 4835 GR and 4825 GR. These previously investigated test pits were near the current area, and where we began encountering the chemical agent containing media (CACM) and bits of glass earlier this year, which was originally found in the bump-out of the retaining wall on the 4825 GR side of the property line. As we continued to excavate along the side of the house removing the retaining wall, we had to dig on both sides of the retaining wall in order to remove it safely. The team noticed a layer of clean fill that had been placed there after the arsenic contamination removal and test pitting in this area. Our workers then noticed a layer with pieces of glass and bits of CACM. We tested the soil and saw low levels of mustard and lewisite. None of this was observed during the test pit investigation that occurred in 2007/2008. It puzzles us why our workers didn't notice these irregularities in 2007/2008, considering that our workers noticed it right away in 2017. As our workers went below that 4 ft. level, we can see the soil that was probably put behind the retaining wall by the builder of the homes. It is a very distinct horizon where we stopped digging in 2007/2008 and where we started seeing the CACM and bits of glass in 2017.

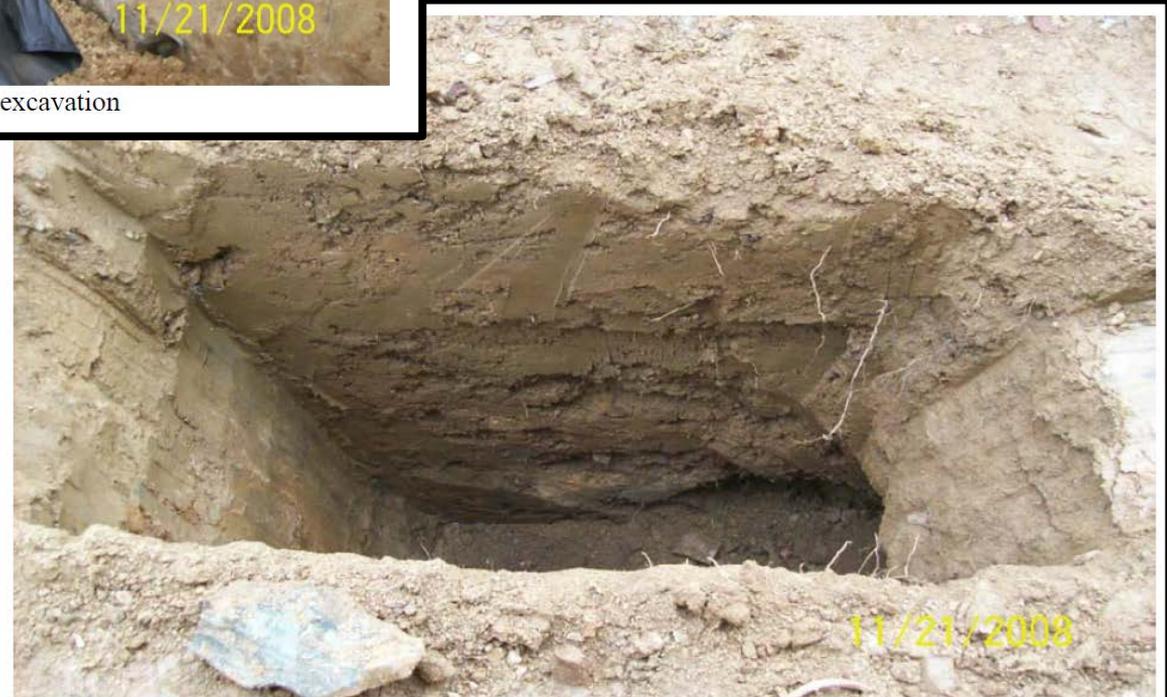
Figure D-186 Test Pit 62 excavation complete

TEST PIT DESCRIPTION				
Dimensions in feet (W/L/D)	3' x 6' x 9'			
Depth to saprolite or bedrock				
Soil Description	CLAY W/ SANDY LOAM			
Magnetometer Clearance	<input checked="" type="checkbox"/> N	Comments:		
AIR MONITORING				
	Task performed?	Alarms?	Comments	
MINICAMS	<input checked="" type="checkbox"/> N	Y <input checked="" type="checkbox"/>		
ARSINE	<input checked="" type="checkbox"/> N	Y <input checked="" type="checkbox"/>		
PID	<input checked="" type="checkbox"/> N	Y <input checked="" type="checkbox"/>		
Dust monitoring	<input checked="" type="checkbox"/> N	Y <input checked="" type="checkbox"/>		
Dust samples ID				
SAMPLING				
Samples Collected	Y <input checked="" type="checkbox"/>			
Sample Description				
Sample ID				
ITEMS FOUND				
Type <small>(cultural debris, glassware, MD, etc.)</small>	Depth Found	Item ID	Photograph #	Size, Weight and Description
CULTURAL	2'	REBAR Y2	N/A	Y2 REBAR 2' IN LENGTH

Going back to the photos that were taken of the test pits along the shared property line, we looked to see if there was any CACM that had gone unnoticed. CACM usually stands out because it looks like chunks of black charcoal in beige soil. There doesn't appear to be obvious CACM in the photo, but a photo is never going to do the justice that standing over a hole and looking into it does. Dig sheets were also filled out for each pit. For Test Pit 62, in November 2008, there was nothing unusual noted.

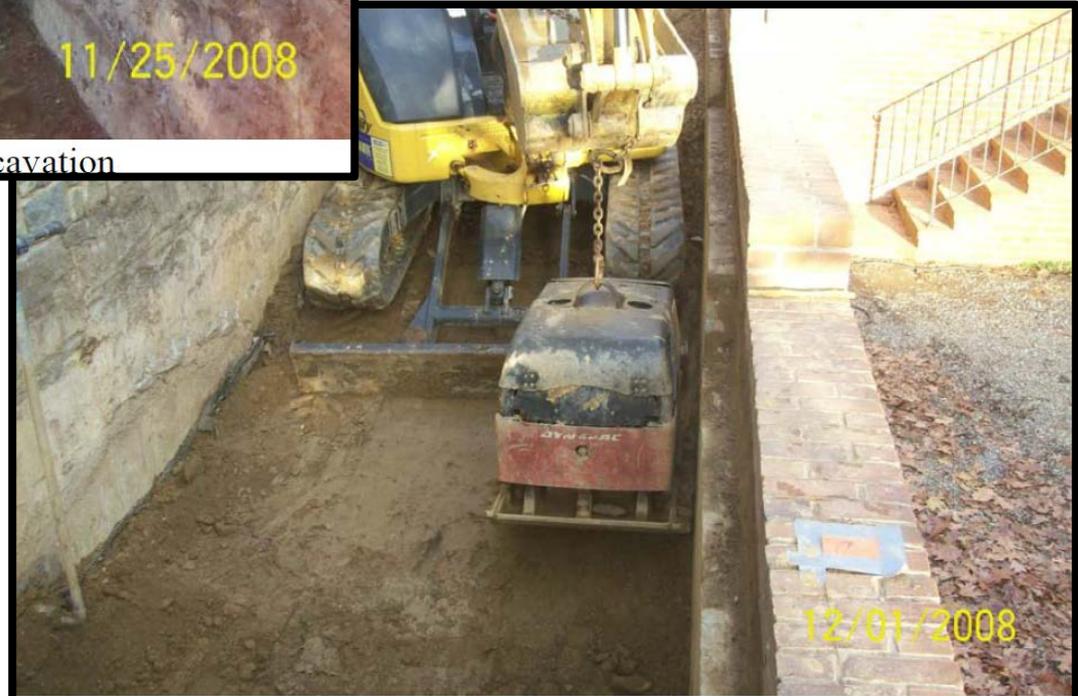
Figure D-202 Test Pit 67 backfill complete

TEST PIT DESCRIPTION				
Dimensions in feet (W/L/D)	<u>3' x 6' x 10' RGS</u>			
Depth to saprolite or bedrock				
Soil Description	<u>Clay w/ sandy loam</u>			
Magnetometer Clearance	<u>0</u> / N	Comments:		
AIR MONITORING	Task performed?	Alarms?	Comments	
MINICAMS	<u>0</u> / N	<u>Y</u> / <u>0</u>		
ARSINE	<u>0</u> / N	<u>Y</u> / <u>0</u>		
PID	<u>0</u> / N	<u>Y</u> / <u>0</u>		
Dust monitoring	<u>0</u> / N	<u>Y</u> / <u>0</u>		
Dust samples ID				
SAMPLING				
Samples Collected	<u>Y</u> / <u>N</u>			
Sample Description				
Sample ID				
ITEMS FOUND				
Type (cultural debris, glassware, MD, etc.)	Depth Found	Item ID	Photograph #	Size, Weight and Description
<u>GLASS</u>	<u>2'</u>	<u>P149356819</u>	<u>NA</u>	<u>3" x 1/2" GLASS TUBE</u>

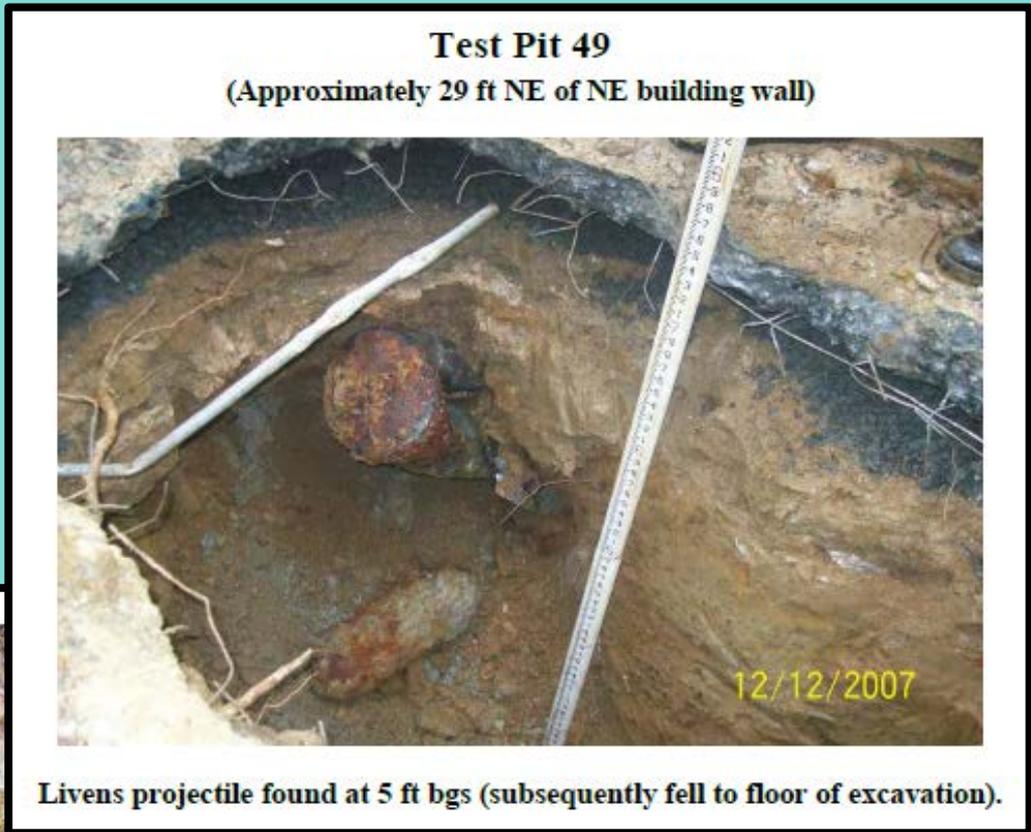
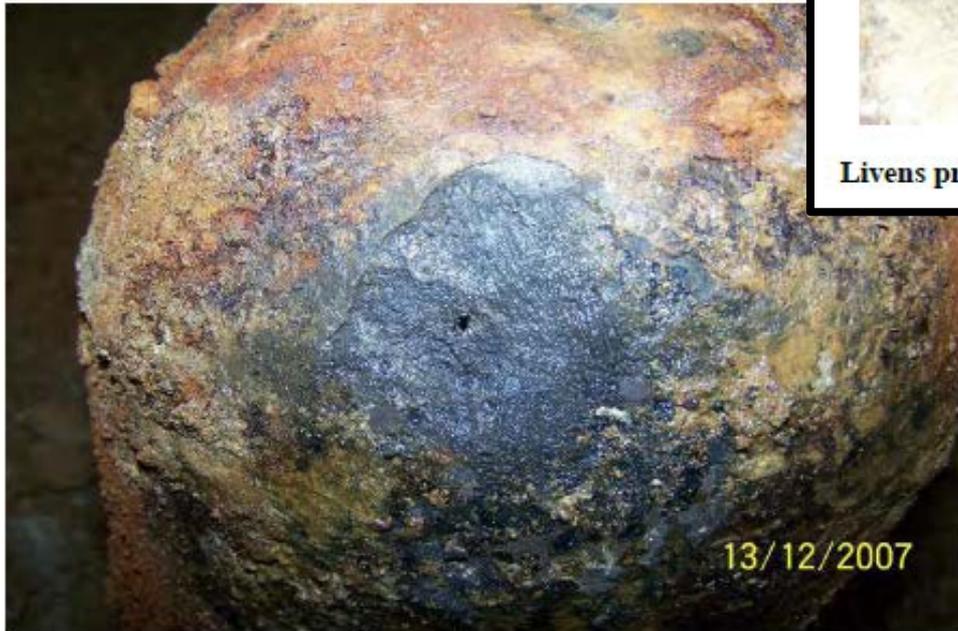
One Livens projectile  
(munitions debris)

Livens projectile found at 5 ft bgs.

Other AUES-related items were found at 4835 GR. In Test Pit 49, there was a large metal reactor vessel and a piece of munition debris, or scrap, which was found. The munitions debris, an intact Livens, was full of liquid the day it was found. Upon close examination, we found there was a pin hole in the device. When the liquid was subsequently analyzed, we found out it was water. These were the two significant finds in the test pit operation at 4835 GR. Other modern items found were like rusted steel beer cans and PVC tubing, which were categorized as 'cultural debris,' not from AUES.

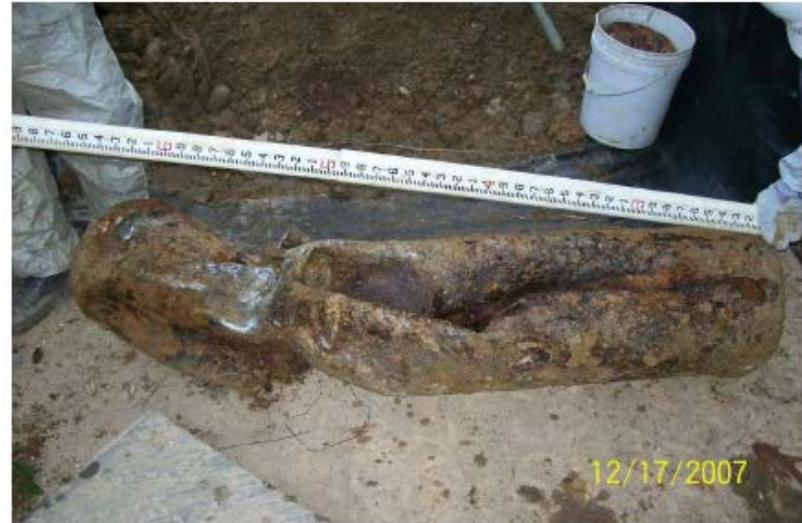
**Test Pit 49 (continued)**  
(Approximately 29 ft NE of NE building wall)

Suspect scrap item found at 5 ft bgs. Metal cylinder 5-6 ft long by 12 inches in diameter.

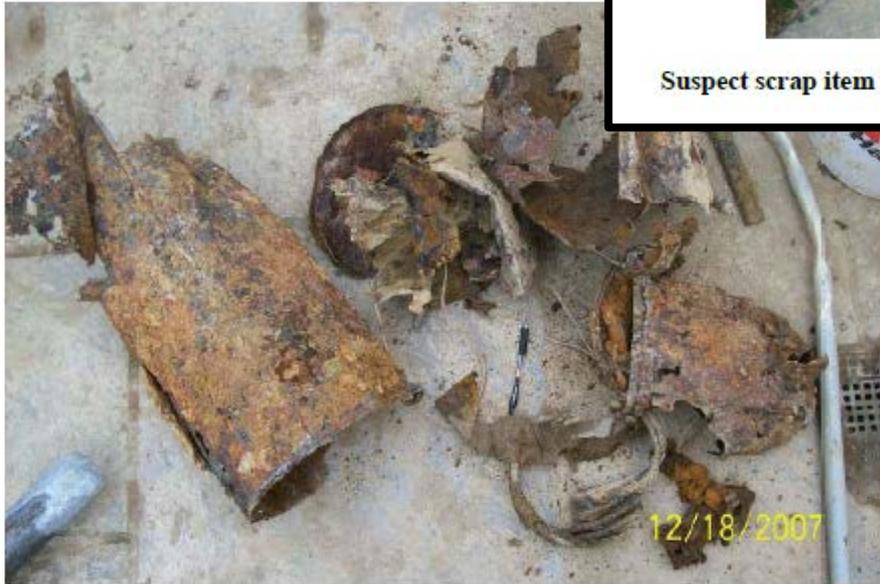
Cultural debris consisting of PVC tubing, metal pipe, and metal debris present from 0 to 1 ft bgs and from 4 to 5 ft bgs.

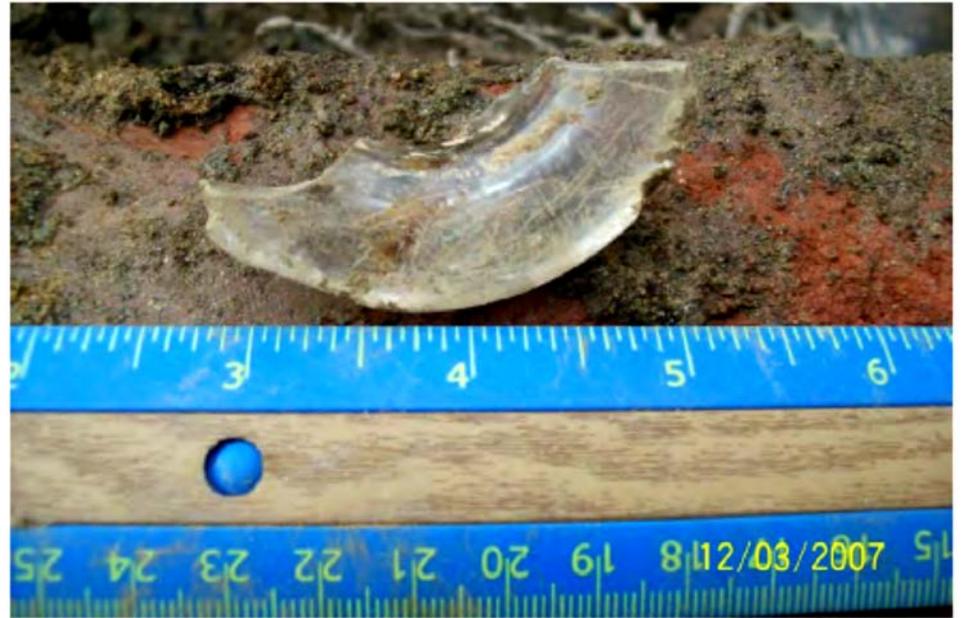
Test Pit 56 (Continued)  
(Approximately 25 ft NNW of N building corner)

Suspect AUES glassware recovered from 9.5 ft bgs.

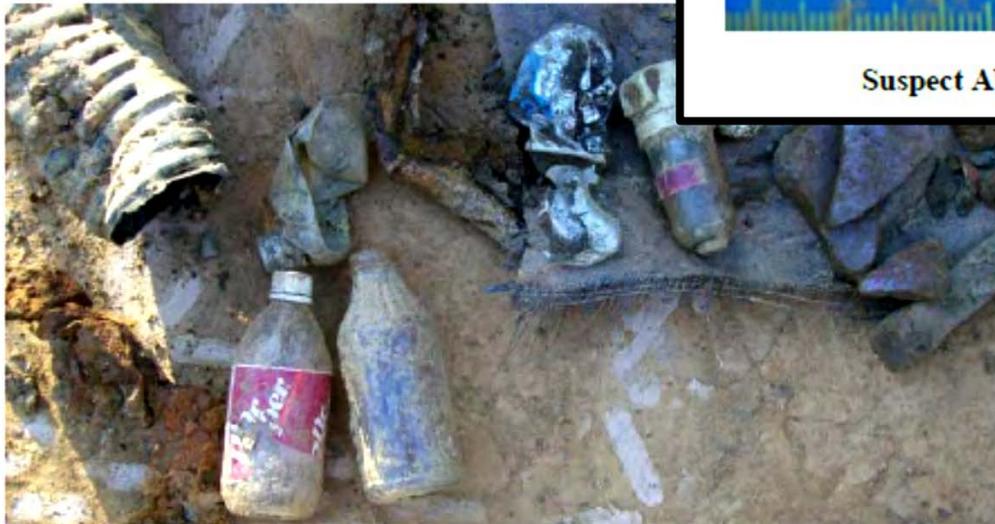
Cultural debris present as follows: root basket, bricks (1 ft bgs); metal, plastic, soda bottles, piping, golf ball (4 to 11 ft bgs).

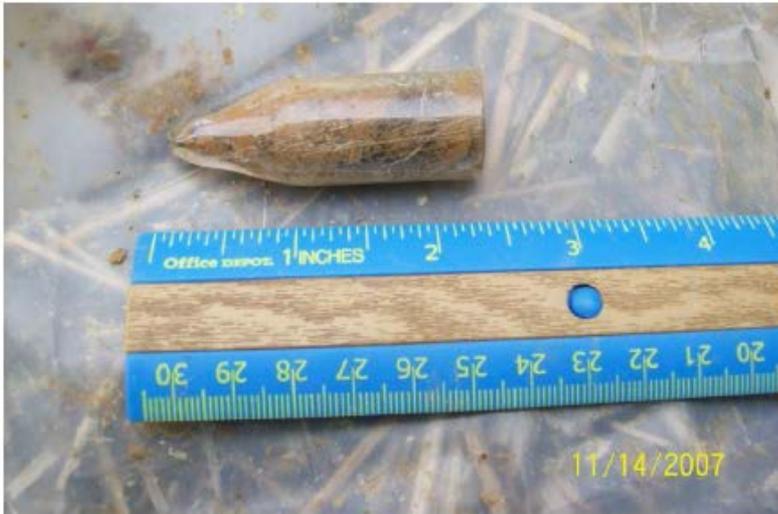
**Test Pit 27**  
(Approximately 47 ft NE of NE building wall)

**Suspect AUES glassware. One of several items recovered from 1, 6, and 8 ft bgs.**

There were some test pits that had materials we believe were related to Army activity during WWI. There was one test pit that had a munition debris item. There were other test pits that had some suspect AUES glassware or a mixture of glassware and modern day cultural debris. While we did notice the presence of AUES related material in 14 test pits, it was not extensive. In some of the pits, the find was a single piece of broken glass that we could say it was probably AUES lab related. However, it was in a test pit 3 ft. x 6 ft. x 8 ft. deep and in that entire column of soil, we only found this one lone piece of glass. These finds were interesting, and it was noted as part of the results of the report, but these kinds of finds do not indicate a major disposal area.

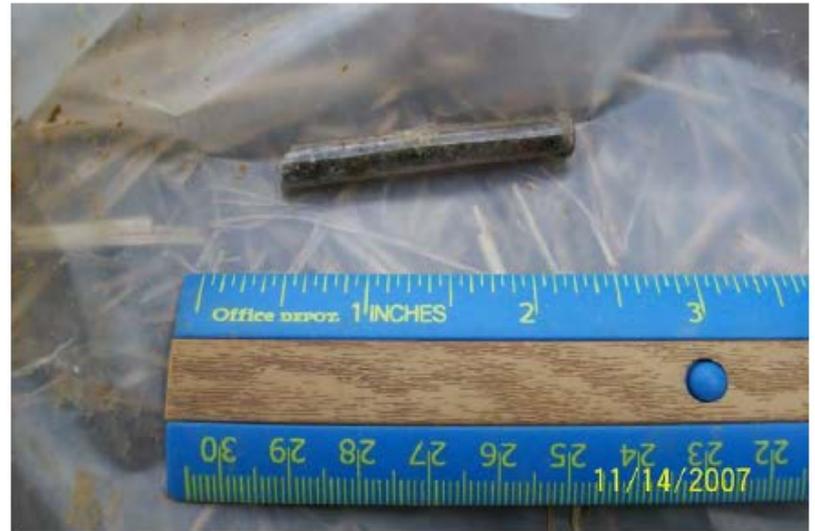
**Test Pit 27 (continued)**  
(Approximately 47 ft NE of NE building wall)

**Suspect AUES glassware. One of several items recovered from 1, 6, and 8 ft bgs.**

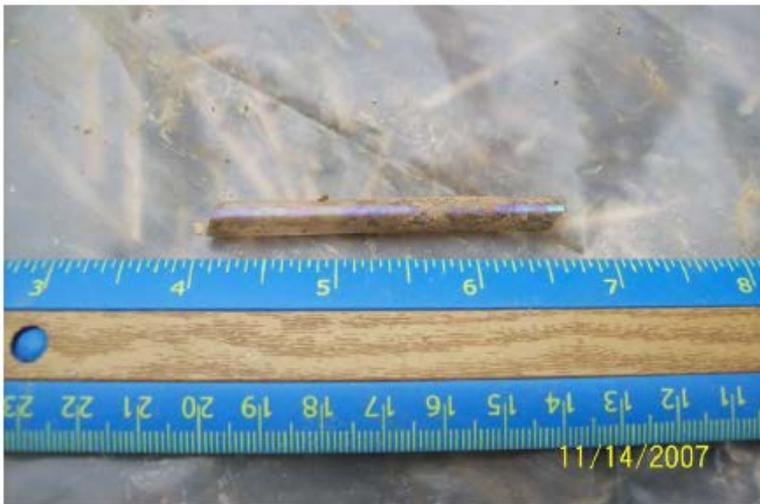
**Suspect AUES glassware. One of several items recovered from 1, 6, and 8 ft bgs.**

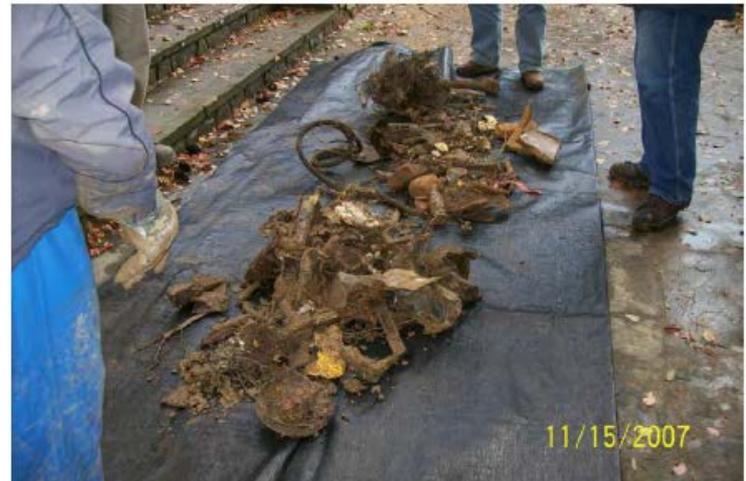
**Cultural debris consisting primarily of construction debris with bricks, metal, insulation, wire, terracotta pipe, pulley, wire rope, soda bottle fragments, chicken wire, and porcelain, was recovered from depths between 4 and 12 ft bgs.**

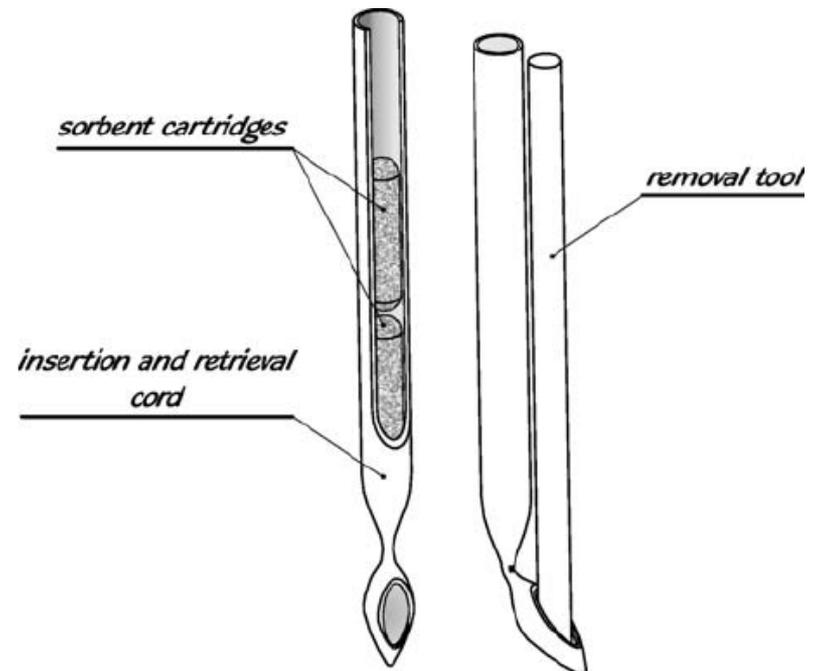
# SOIL GAS GORE-SORBER® SAMPLING (4825 GLENBROOK RD)

In 2007, USACE collected soil gas samples which were analyzed for select VOCs and semi-volatile organic compounds (SVOCs), select explosives, and select Agent Breakdown Products.

The Mustard breakdown products 1,4-dithiane and 1,4-oxathiane, were detected in one sample (Gore/SG-4 (2')).

In 2007, a soil gas sampling effort was conducted on 4825 GR, and some of the samples came close to the 4835 GR property and yielded data at the time that is interesting now. In 2009, as the test pit investigation was concluding, there was interest in understanding how both houses were constructed with respect to the bottom of the basements, and the location of the foundation and the footers with respect to bedrock and the soil profile at the sites. The question being, are these houses sitting on bedrock or are they sitting on soil and bedrock. If there is soil underneath the houses we could conclude that there could still be burials underneath the houses, but if the houses are sitting directly on top of bedrock it would be unlikely that there would still be burials underneath a home.

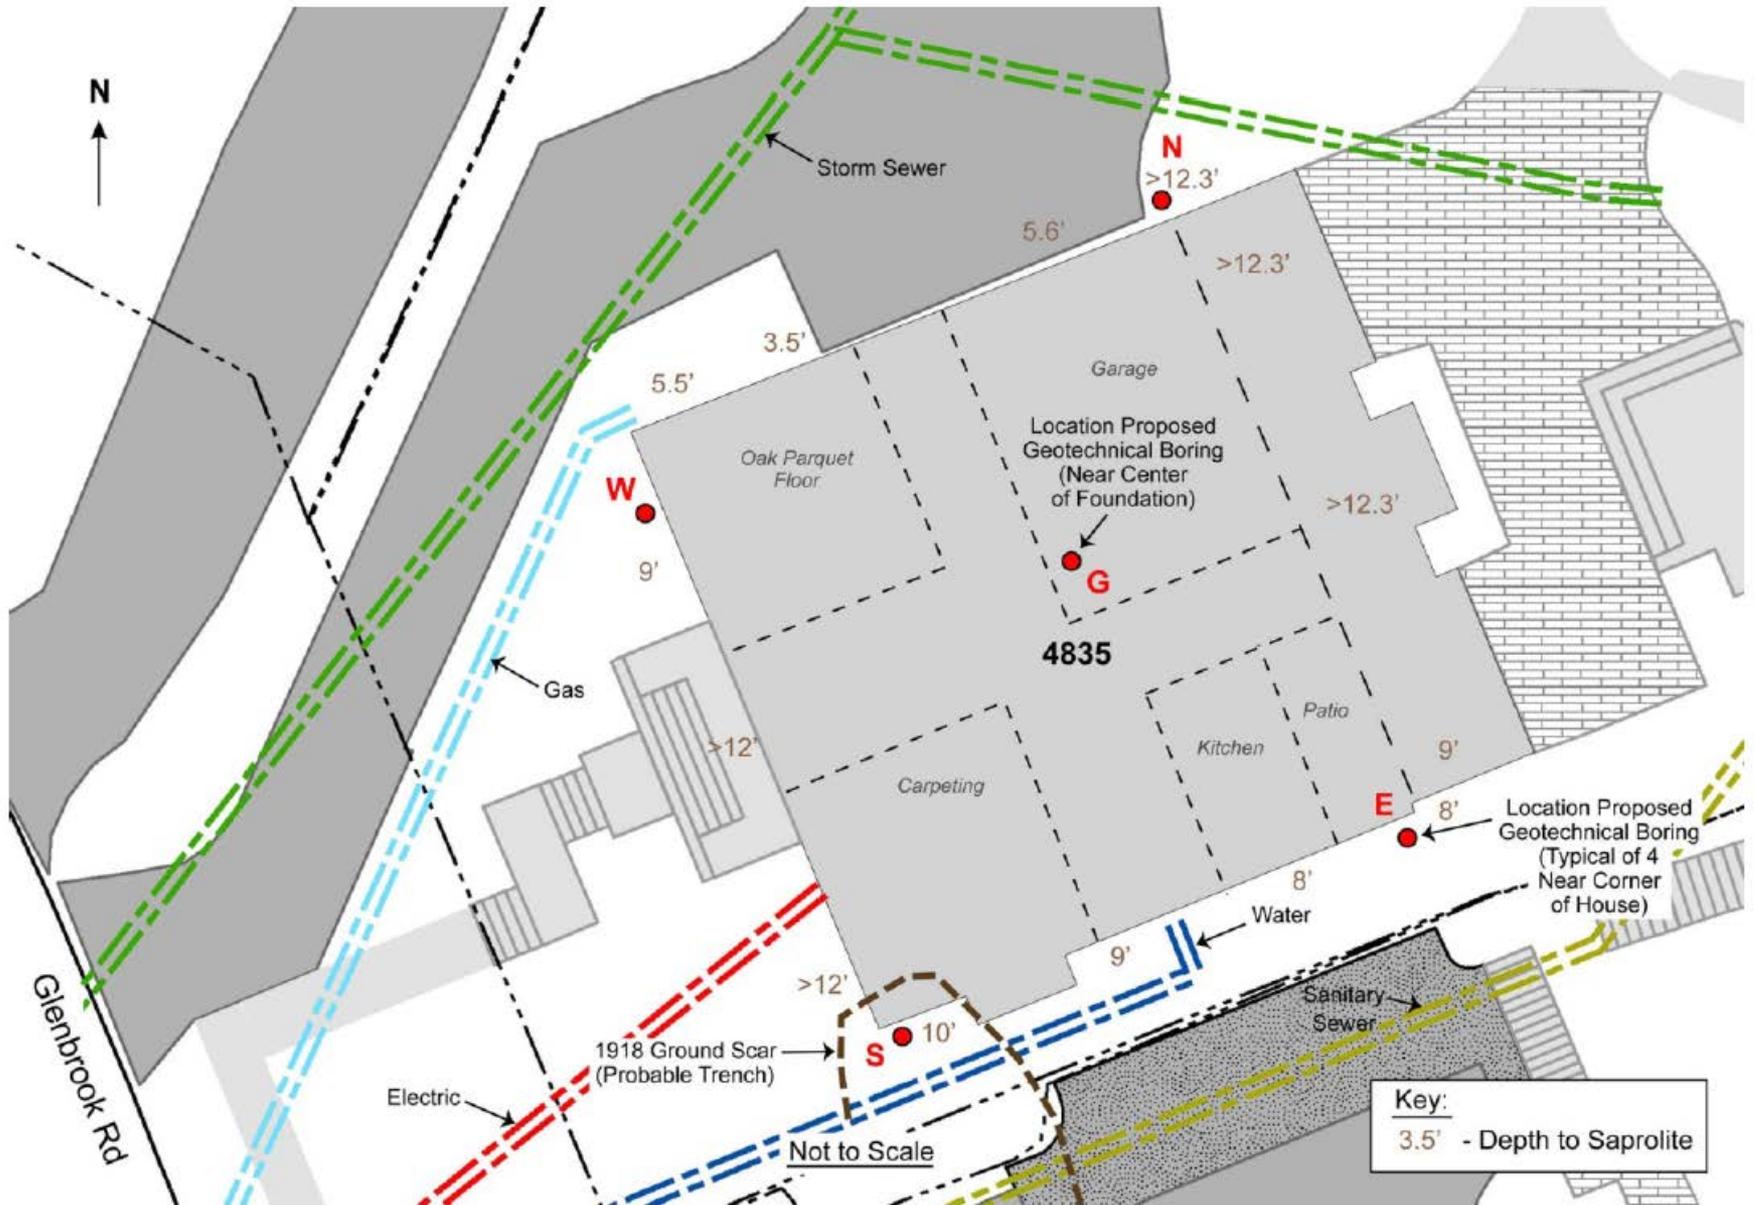
# Geotechnical Boring Locations Map

Five geotechnical borings were completed to investigate the geological condition beneath the building, determine soil stratigraphy, define depth to the saprolite bedrock, and complete soil sampling.

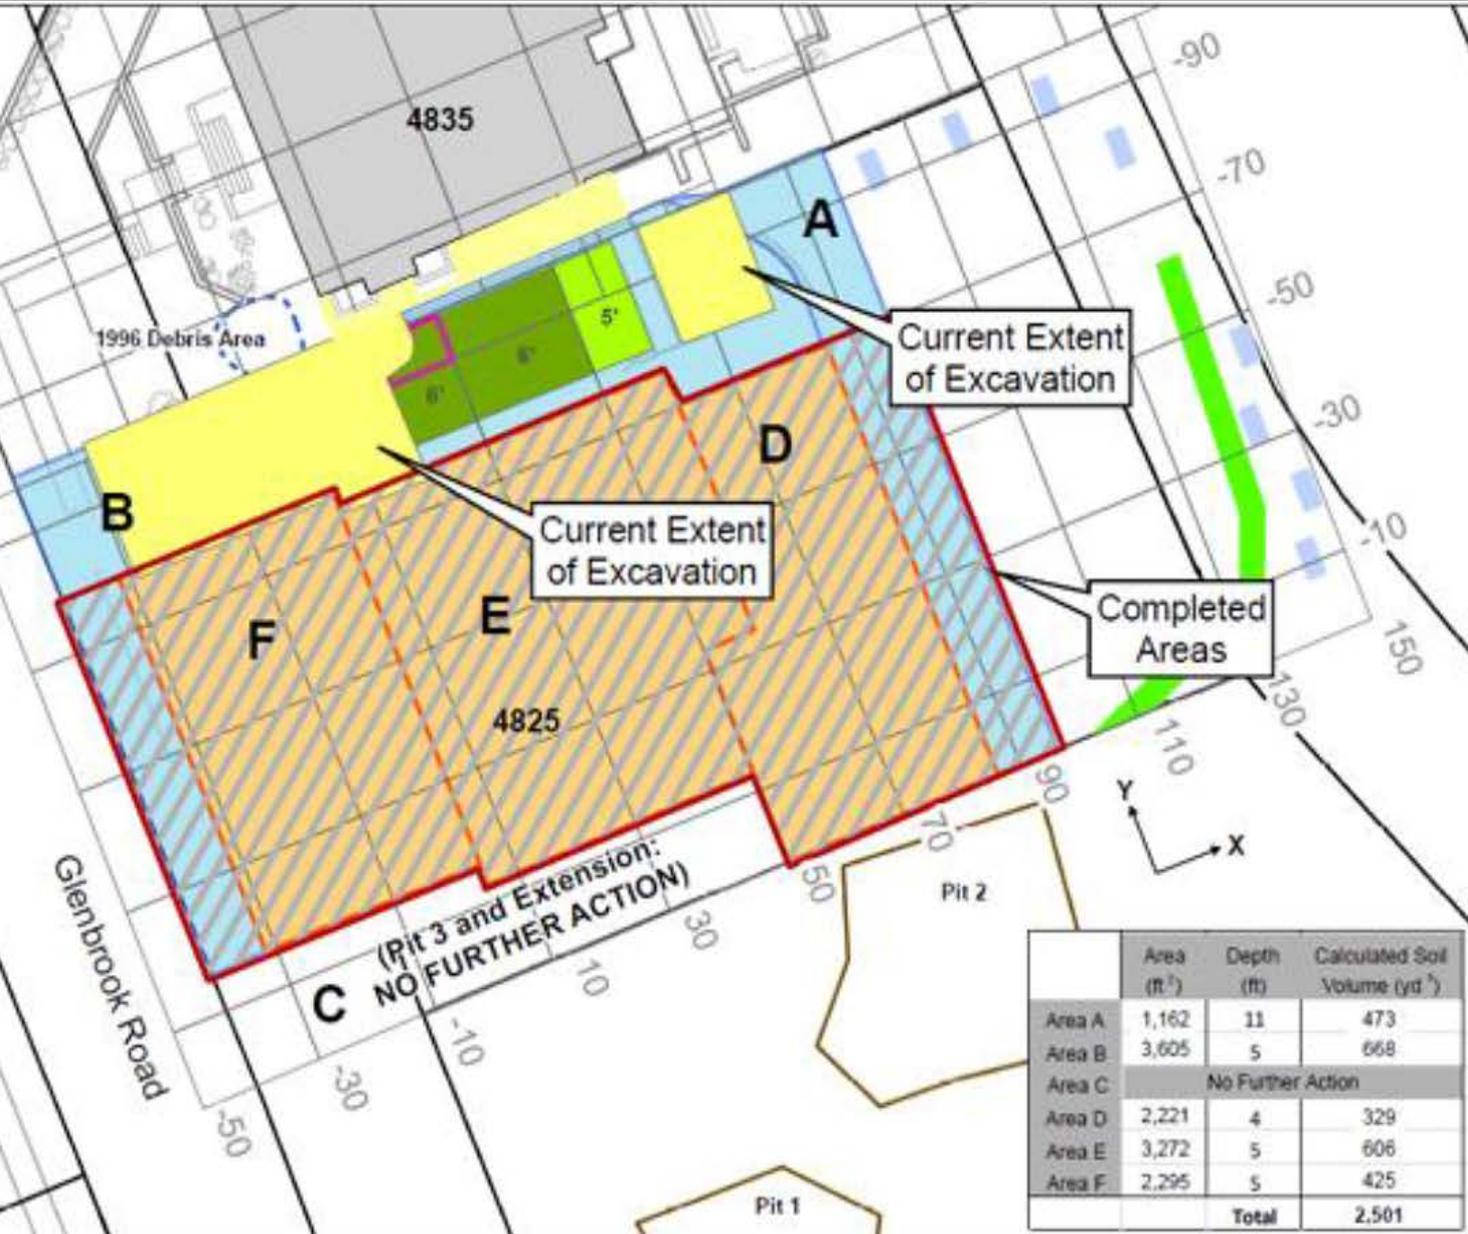
# CURRENT EXCAVATIONS ON SHARED PROPERTY LINE

Current Excavation Status  
4825 Glenbrook Road

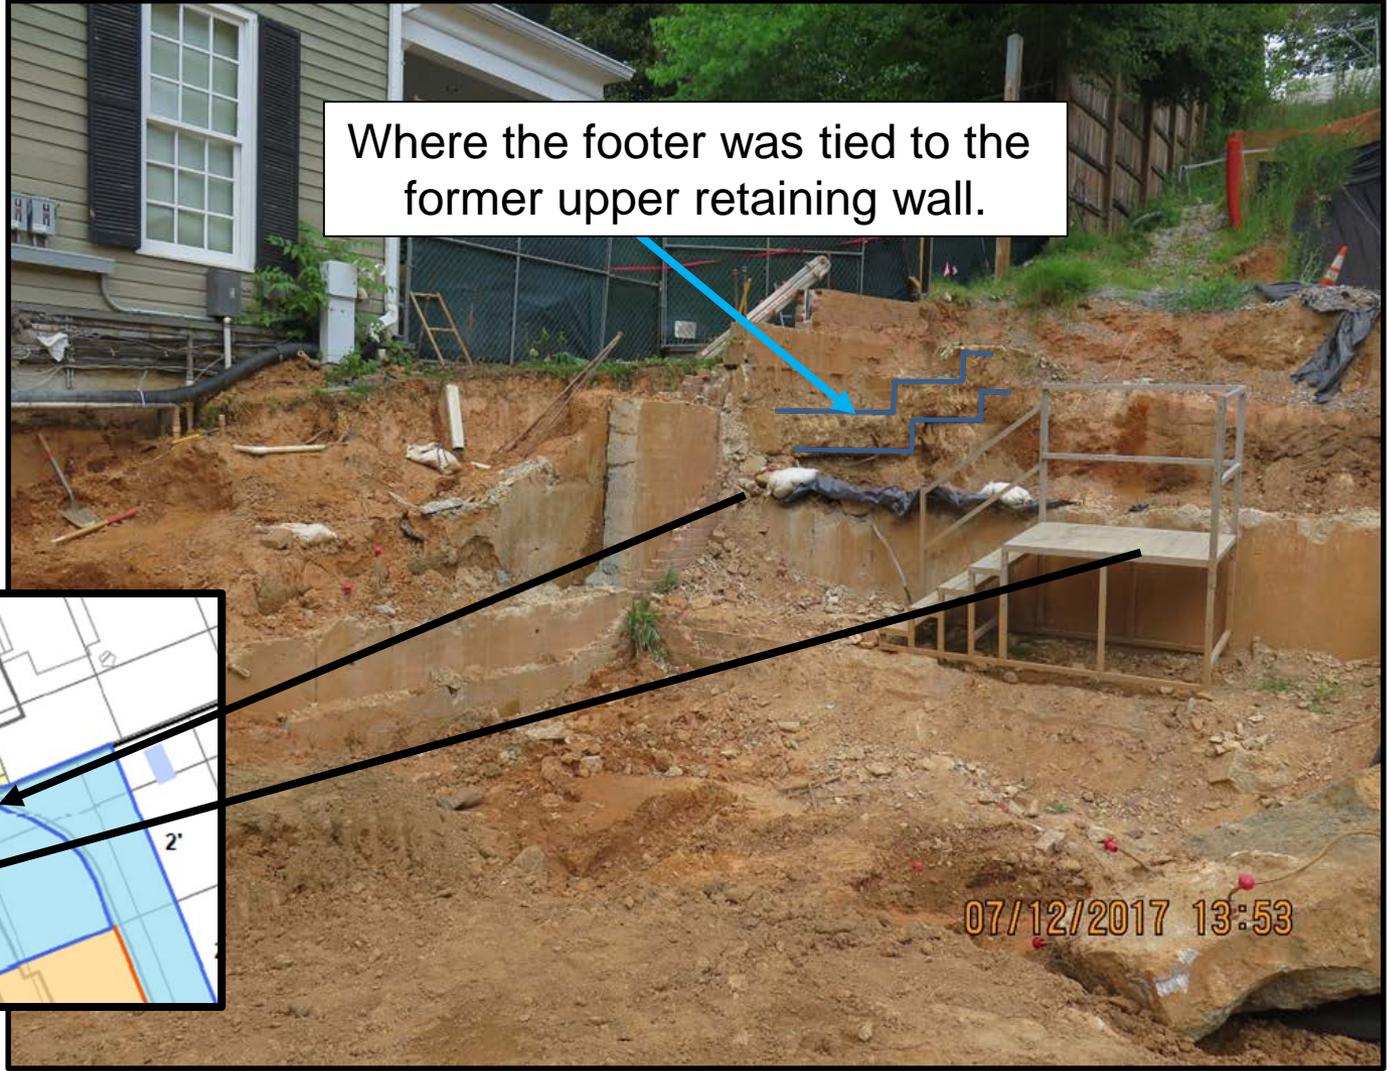
By July 12<sup>th</sup> a good portion of the retaining wall had been removed.

The work of removing soil along the shared property line was then continued.

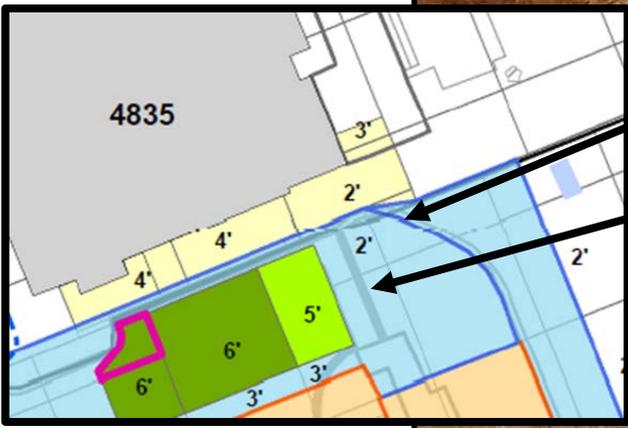
Where the footer was tied to the former upper retaining wall.
