**SPRING VALLEY FORMERLY USED DEFENSE SITE PROJECT**  
**RAB Meeting**

**September 12, 2017**  
**7:00 – 8:30 p.m.**

# SUMMARY OF HISTORICAL AND CURRENT WORK AT 4835 GLENBROOK ROAD

# 4835 GLENBROOK APEX REPORT

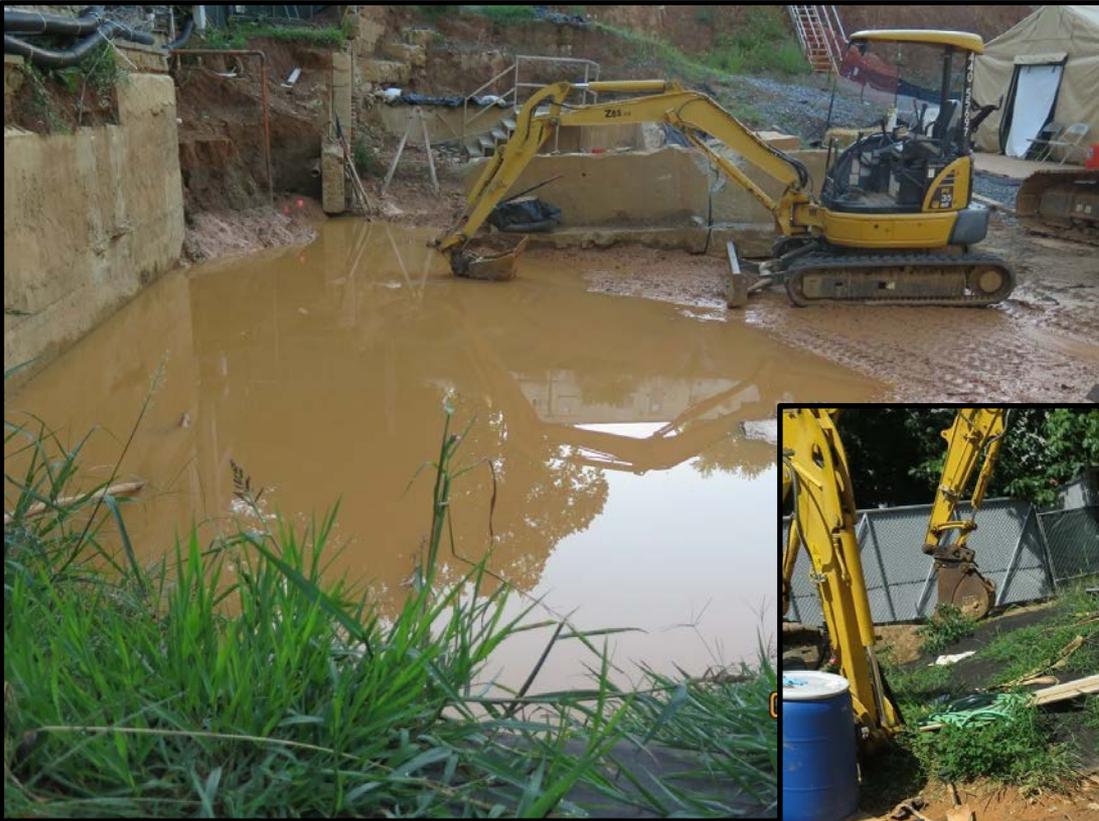
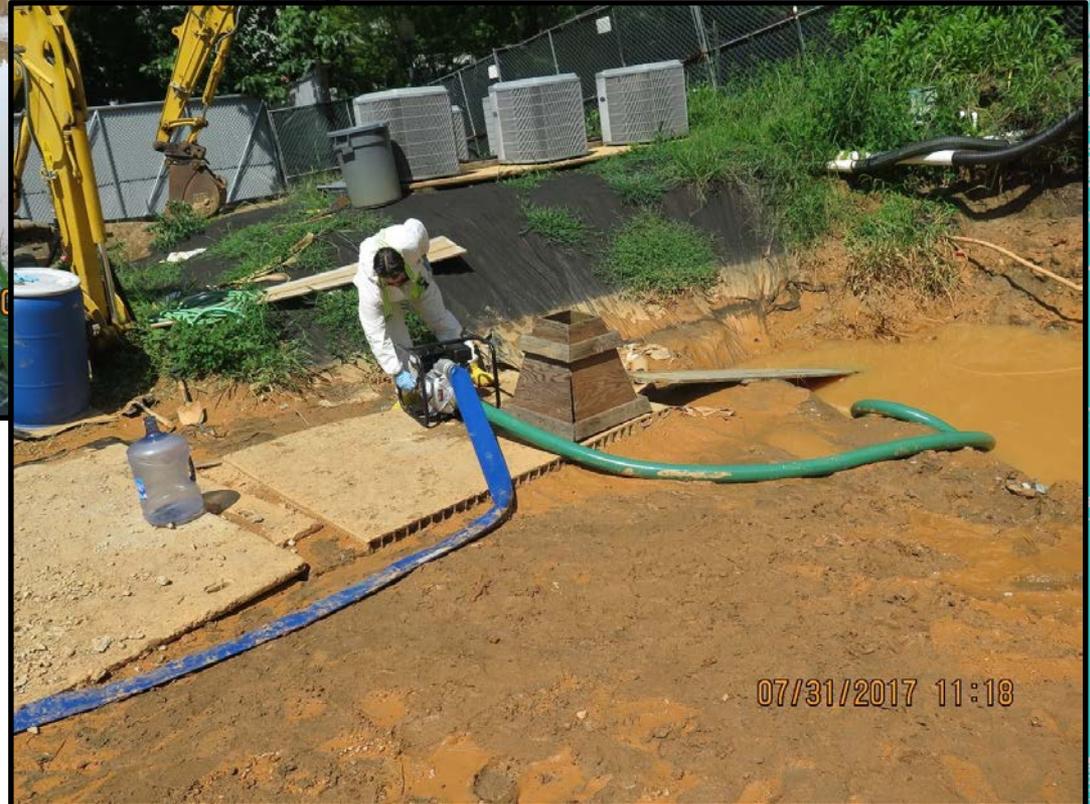
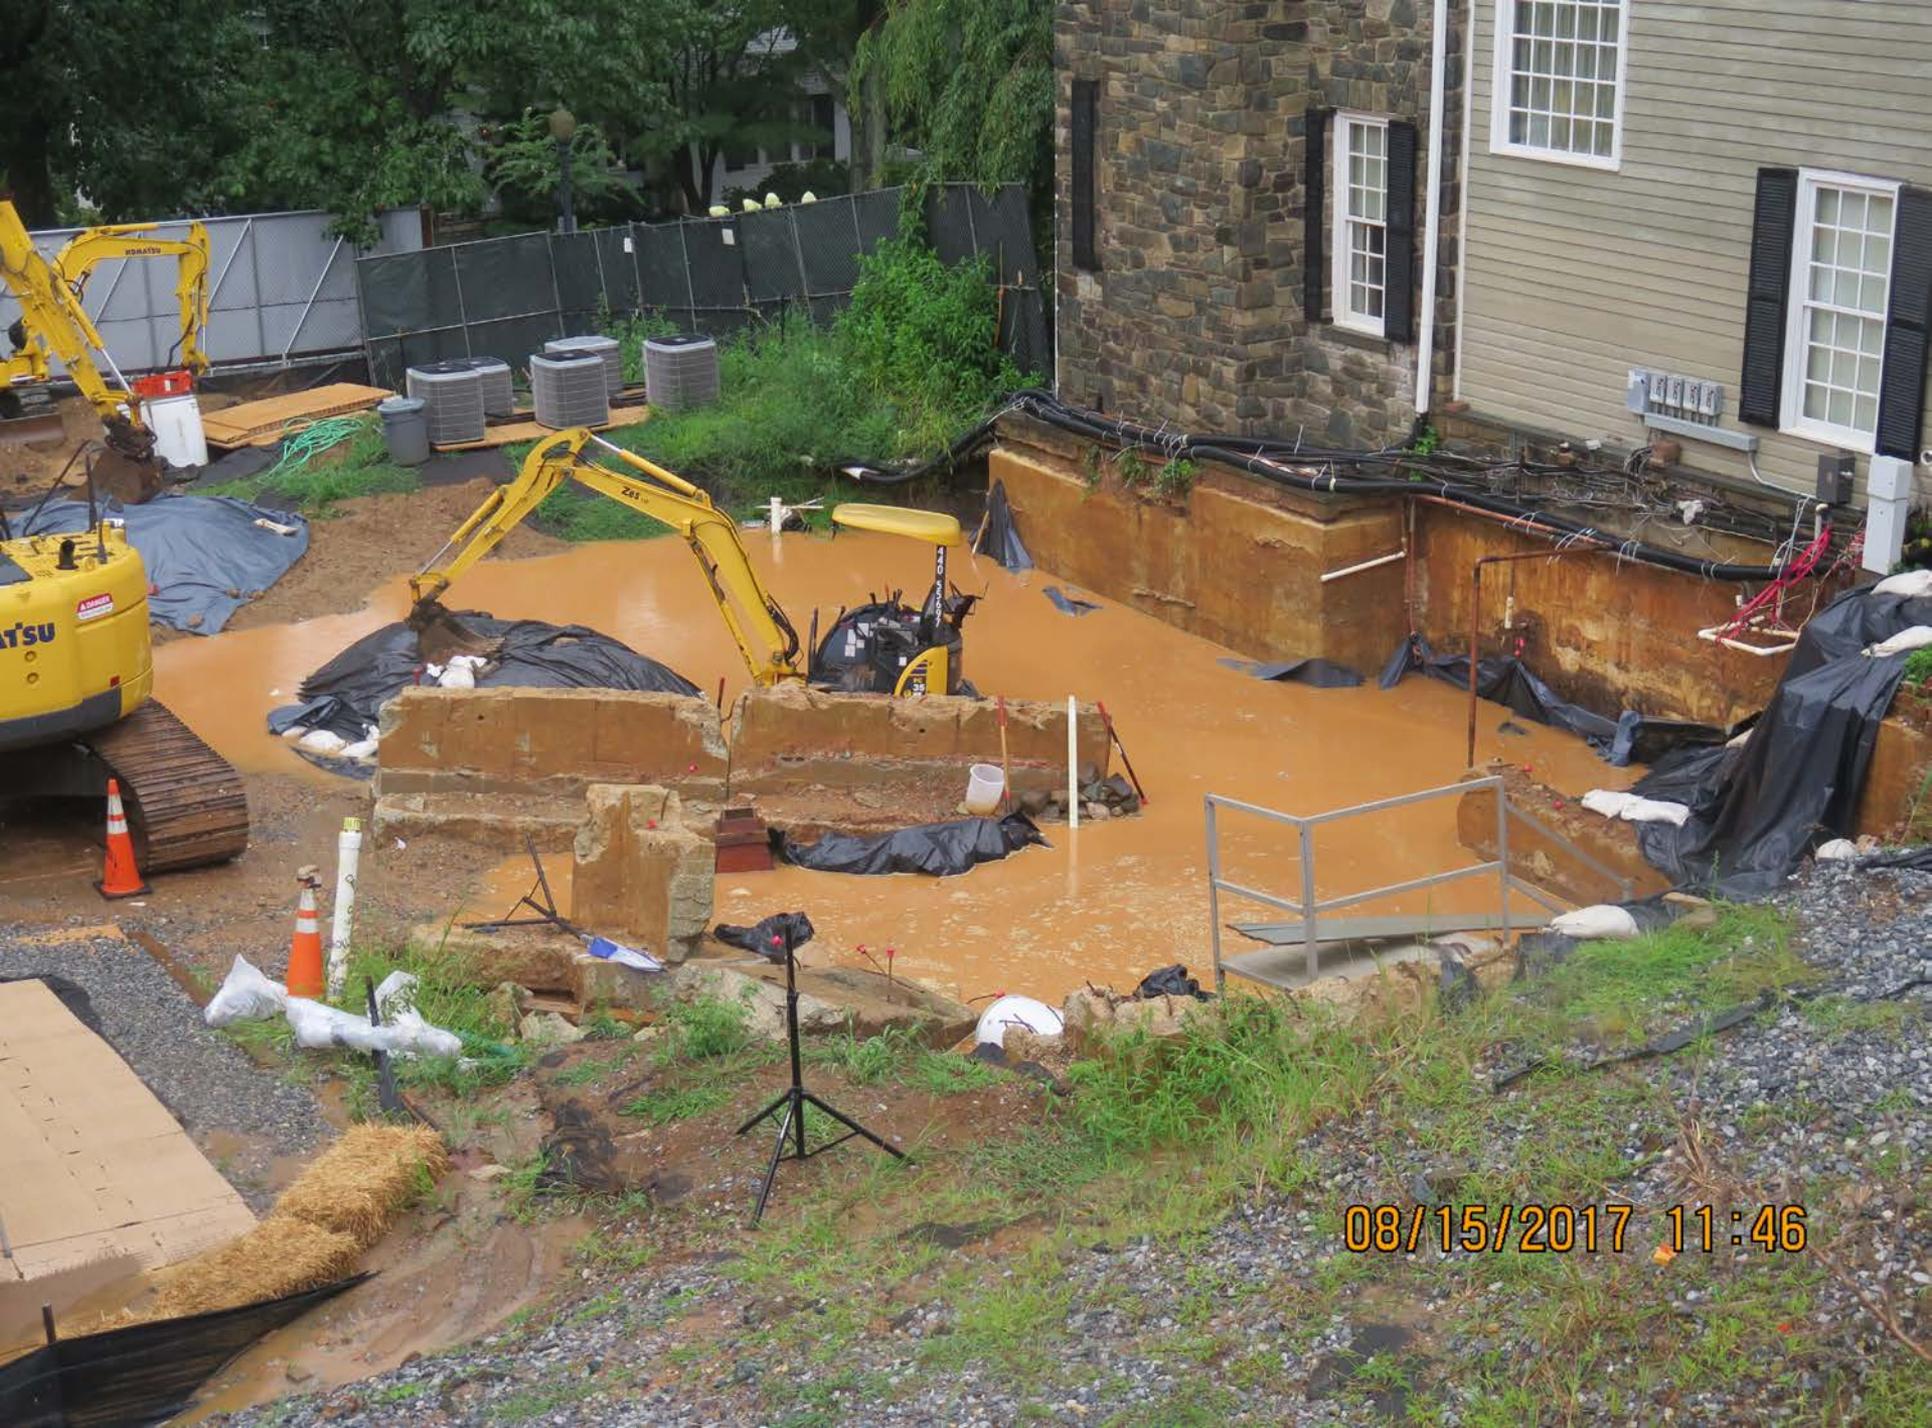
# PUMPING WATER DUE TO HEAVY RAINS AT THE SITE

July 31, 2017

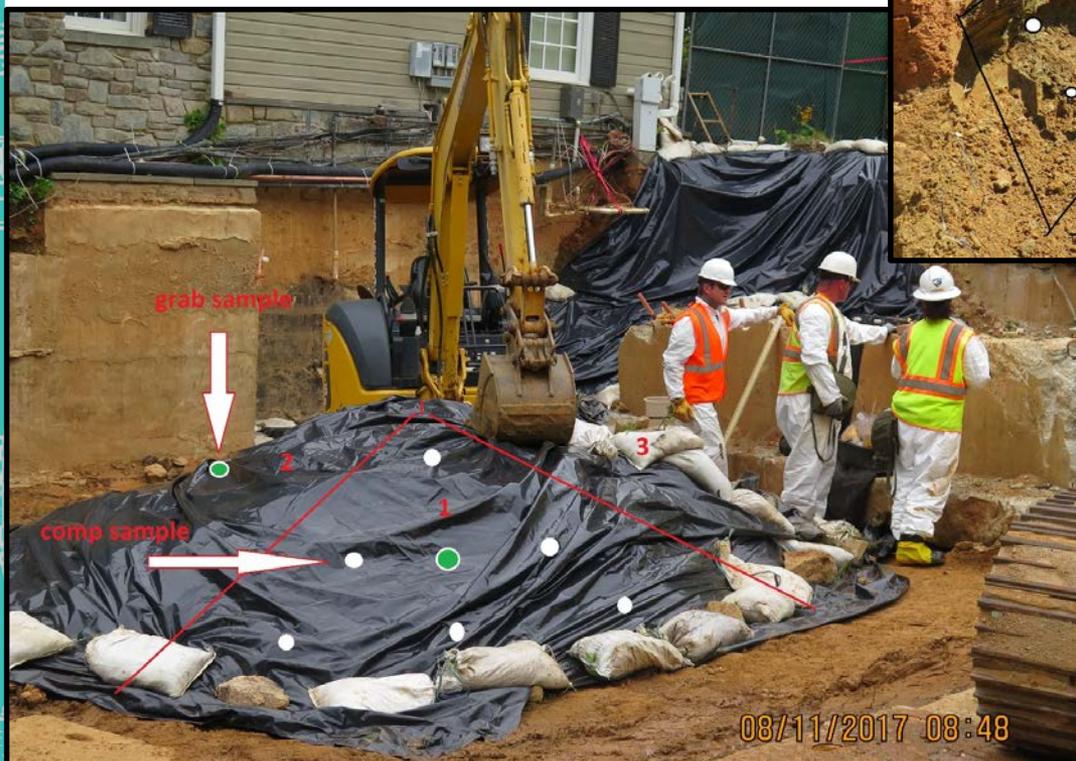
# SAMPLING EFFORT FOR INVESTIGATIVE PURPOSES

The team sampled the excavation area and the soils stockpile on August 25<sup>th</sup>.

Sampling was completed by a Level B team. Mitigation remained in place for the sampling effort to ensure the safety of the public.

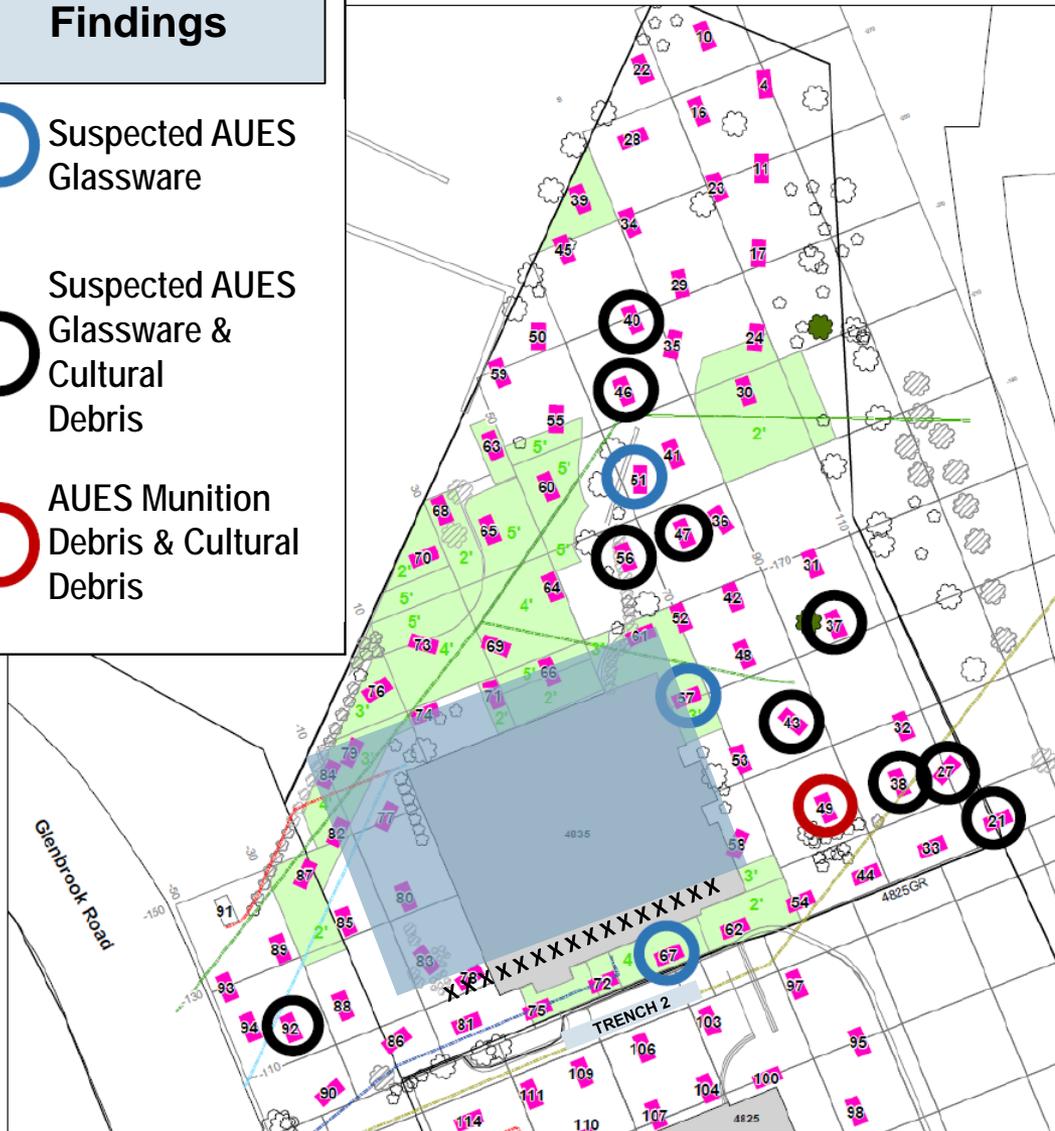
AUES Munition Debris & Cultural Debris

## USACE proposes the following:

- A single row of samples will be completed first
  - Samples in the front yard.
  - Samples through the basement floor into the subgrade below the house.
- Sample the exposed concrete foundation wall along the shared property line.
