### **SPRING VALLEY FORMERLY USED DEFENSE SITE PROJECT** RAB Meeting

Restoration Advisory Board Meeting 12 November 2019

### U.S. Army Corps of Engineers Spring Valley Restoration Advisory Board St. David's Episcopal Church Minutes of the November 2019 Meeting

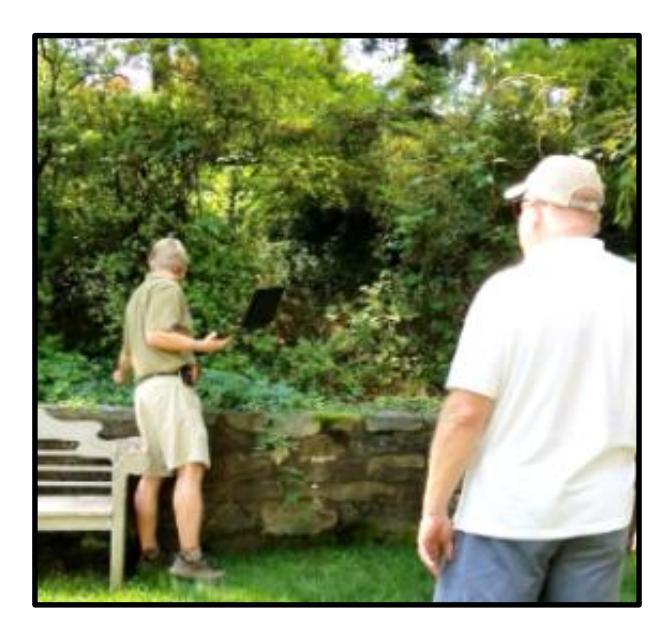
Arborists conduct landscape inventory to thoroughly document all plant life on a property.

Site preparation activities include putting together a landscape plan to identify plants that need to be either removed or trimmed for the team to conduct the geophysical survey. The landscape plan process begins with a professional arborist visiting a property to perform a thorough inventory and appraisal of each plant on the property. The arborist then creates a table that itemizes all of the plants; including names of the plant species, condition of the plants, and an appraised value. The arborist also creates a map figure that shows the location of each plant. The map figure is reviewed by the geophysical team to determine which plants need to be removed, trimmed, or left in place in order to perform the geophysical survey.

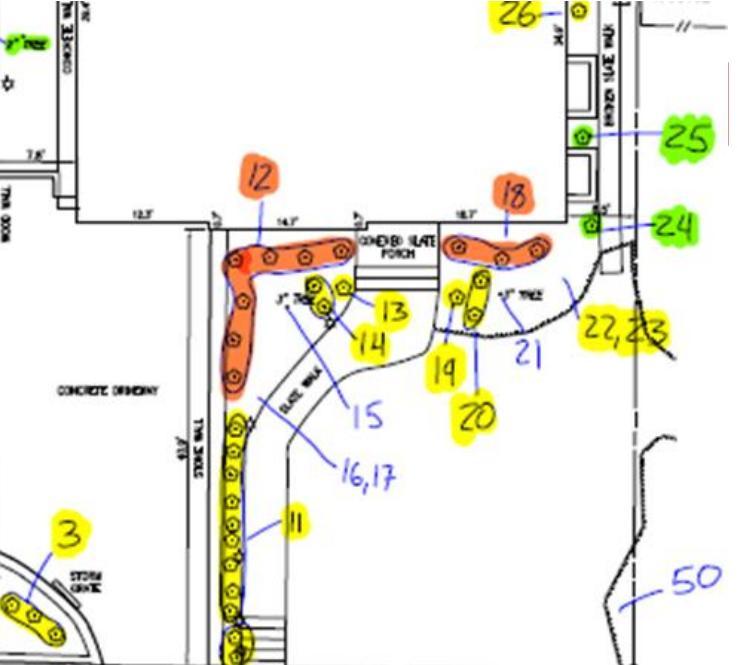
This map (above) illustrates the proposed actions for landscaping items, which corresponds with a key (left).

Once the geophysicists have made their recommendations, the USACE contractor puts together a color-coded table and figure indicating the proposed actions the geophysicists recommend. The table and figure are included in the landscape plan and reviewed by USACE. The landscape plan is then sent to the homeowner and the Outreach Team meets with the homeowner to review the plan and discuss the proposed actions. It is during this step that the homeowner may choose to not allow the team to remove or trim specific plants. The team encourages the homeowner to allow the proposed actions so the team can achieve the most survey coverage of the property as possible. Once the landscape plan is approved by the homeowner, the plan is executed by a professional landscaper that removes the plants or performs the trimming.

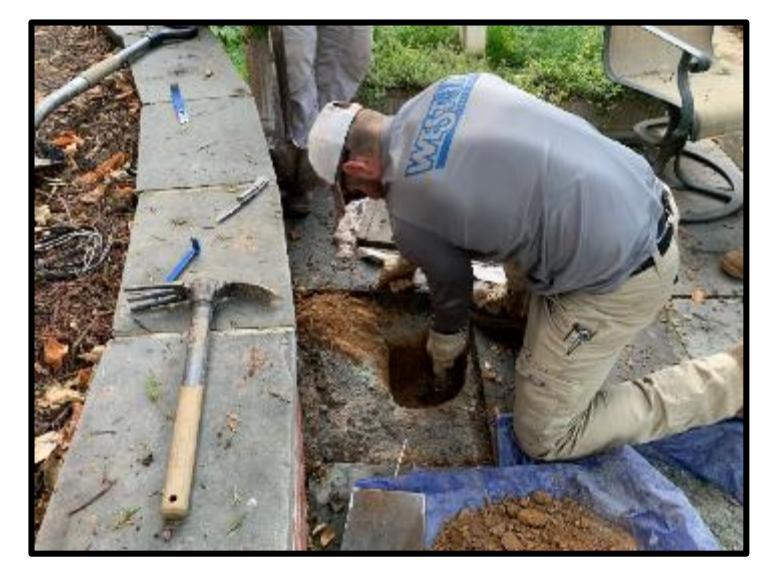
Some anomalies are detected underneath hardscape which are not reinforced with metal.

Once the dig team recovers the anomaly, a professional hardscape company completes the restoration or temporary patching.

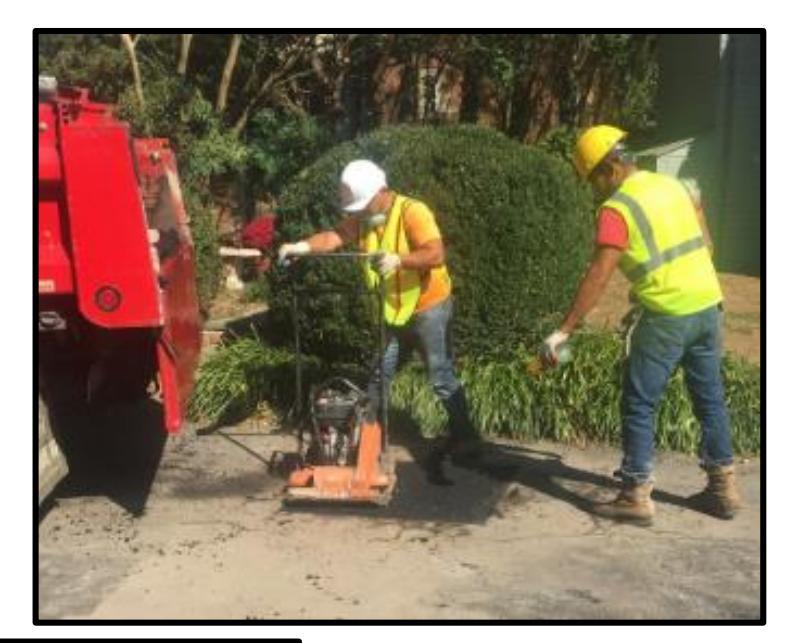
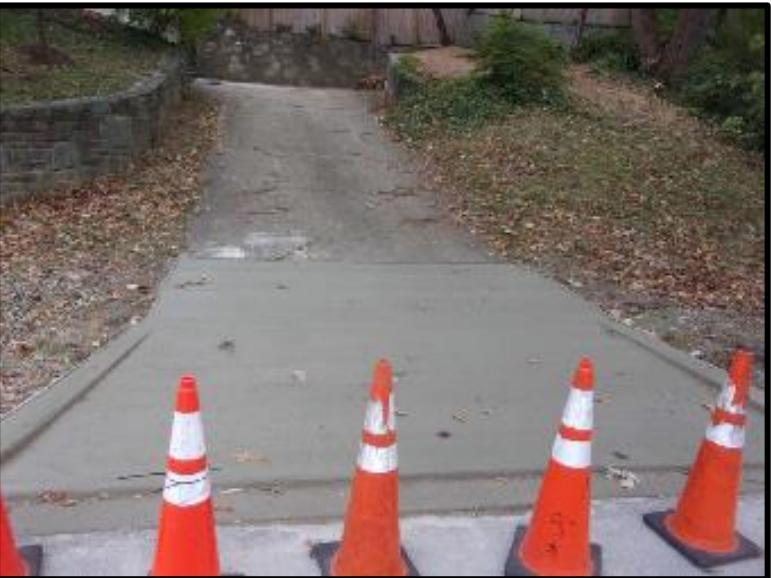
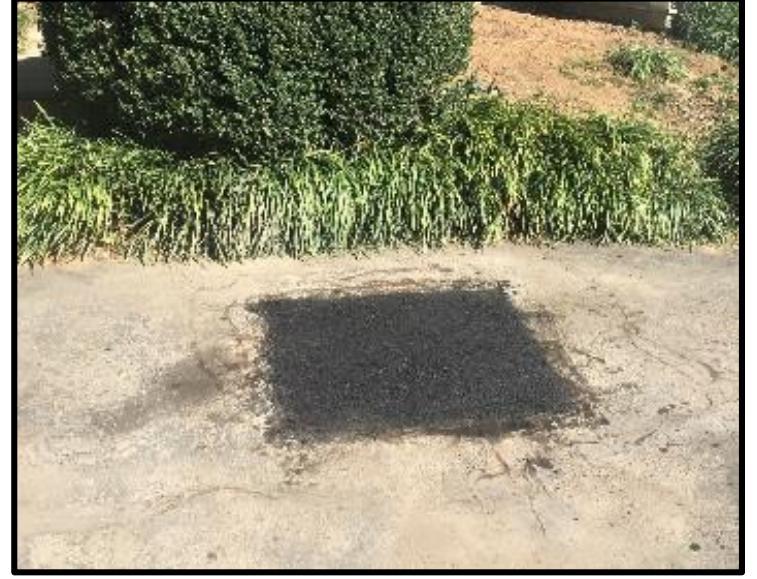
In order to avoid trip hazards, holes are temporarily patched until final restoration is complete.

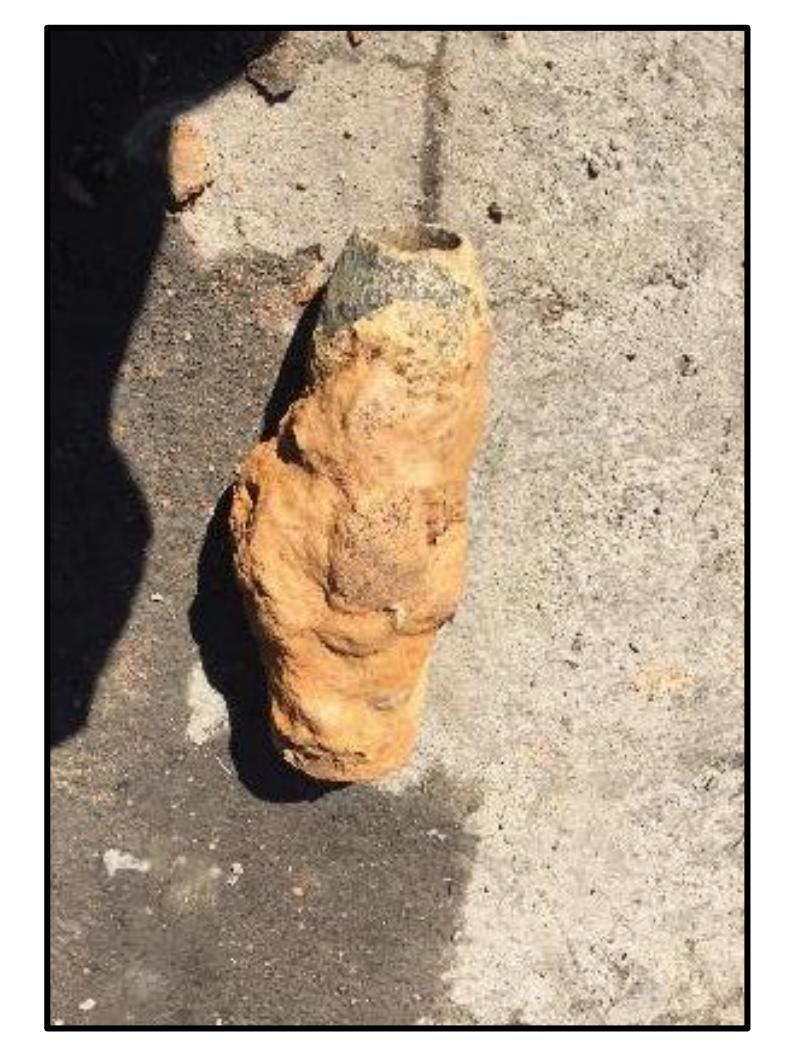
An intact empty 75mm projectile shell was recovered from underneath a asphalt driveway in October.

The item was deemed non-hazardous and cleared headspace for any mustard or lewisite.

An intact 75mm projectile shell was found under an asphalt driveway in October. The item was full of dirt when uncovered and upon further investigation was determined by the onsite ordnance safety team to be a non-hazardous MD item. The item underwent headspace analysis and tested negative for L and HD.

I. Goldsberry explained that the item was found approximately 2 feet in depth.

I. Goldsberry and Rebecca Yahiel, Spring Valley Community Outreach explained that the item was found in an asphalt driveway on 52<sup>nd</sup> Street.

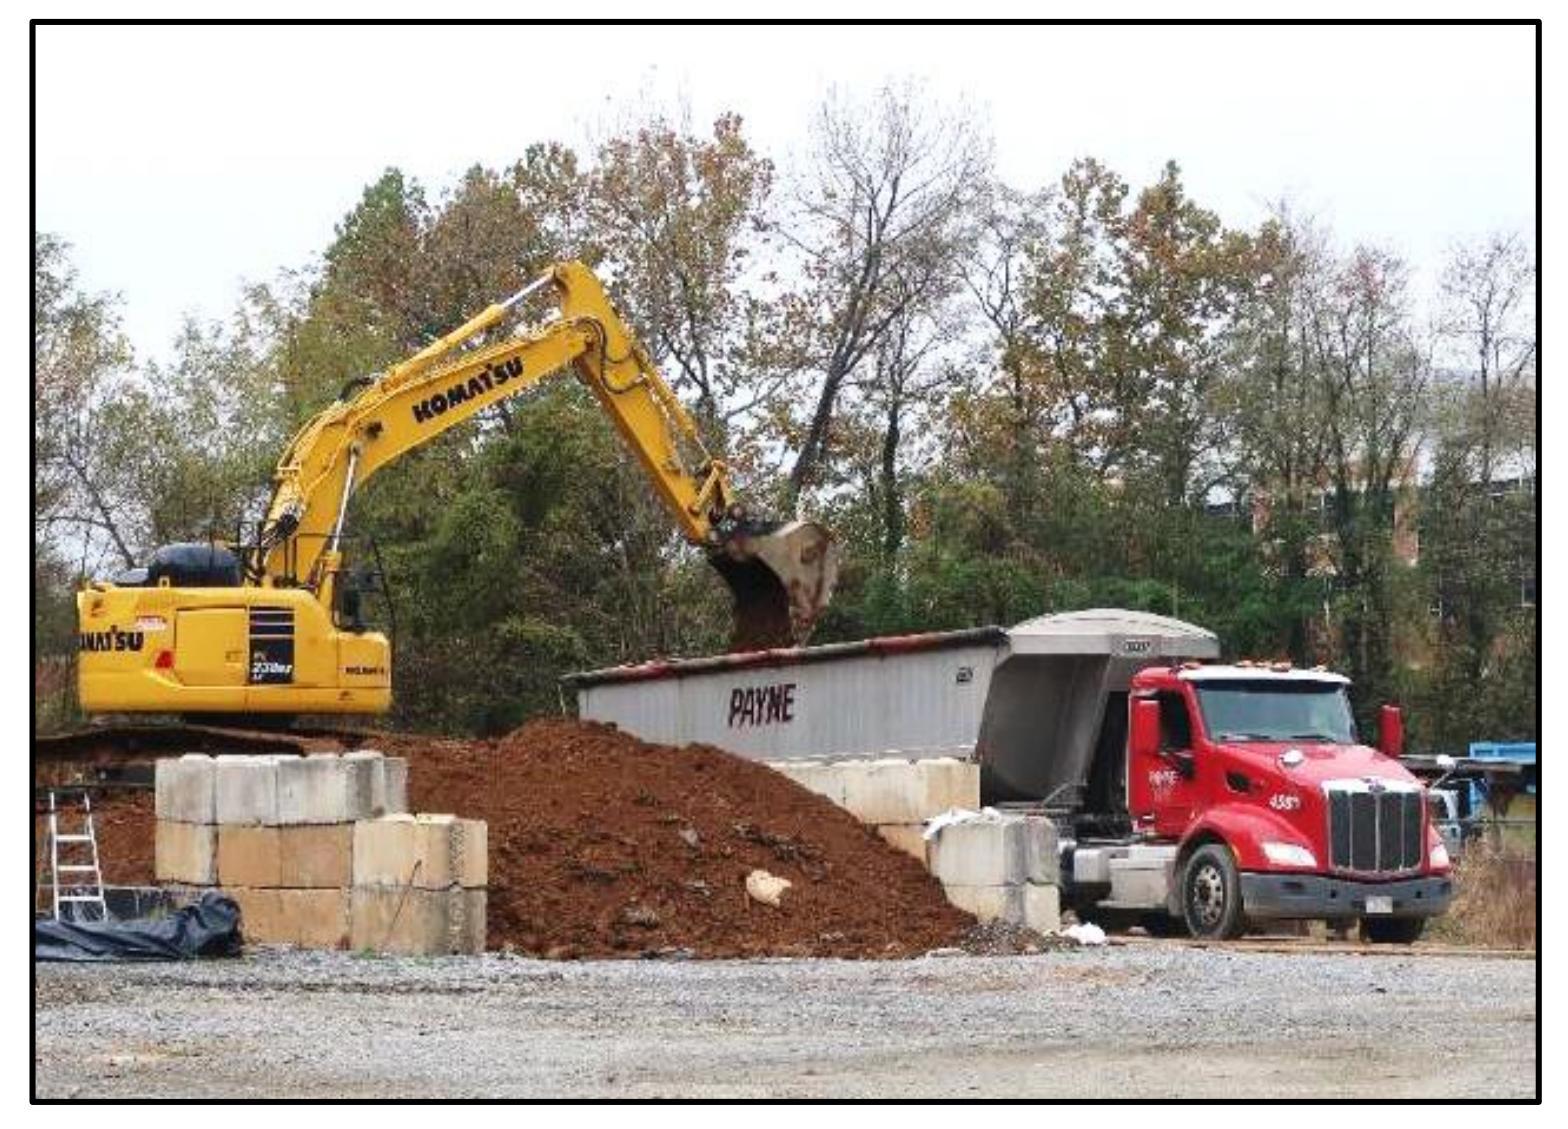
Loading a truck with soil for the Subtitle D landfill.
