Anacostia Watershed Restoration Prince George's County, Maryland

ECOSYSTEM RESTORATION FEASIBILITY STUDY AND
INTEGRATED ENVIRONMENTAL ASSESSMENT

FINAL REPORT AND APPENDICES

**US Army Corps
of Engineers**
Baltimore District

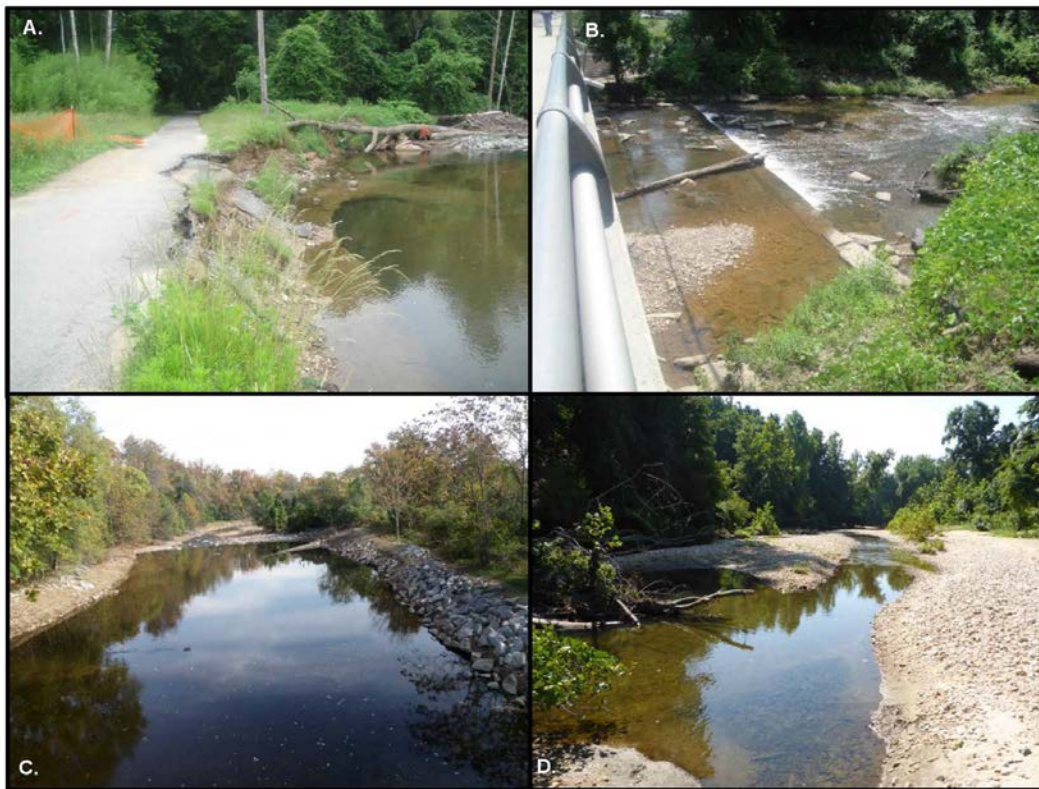
Figure 1-11. Problems in the study stream reaches. A. Erosion along study stream reach (site 13) undermining a pedestrian trail system. B. Concrete sill inhibiting fish migration upstream on Northwest Branch (site 3). C. Homogeneous habitat conditions as a result of USACE channelization (site 3). D. Excess sediment deposition and formation of large sediment bars (site 5).

Historical channelization, including both channel straightening and armoring with rock, concrete, and gabion baskets, is identified as an important stressor impacting stream aquatic biodiversity throughout Maryland (MDDNR, 2005d). Field assessments conducted by USACE for this study in 2014 and 2015 found lengthy reaches with uniformly shallow depths, inadequate woody debris, and homogenous habitat conditions, particularly in the reaches channelized by USACE.

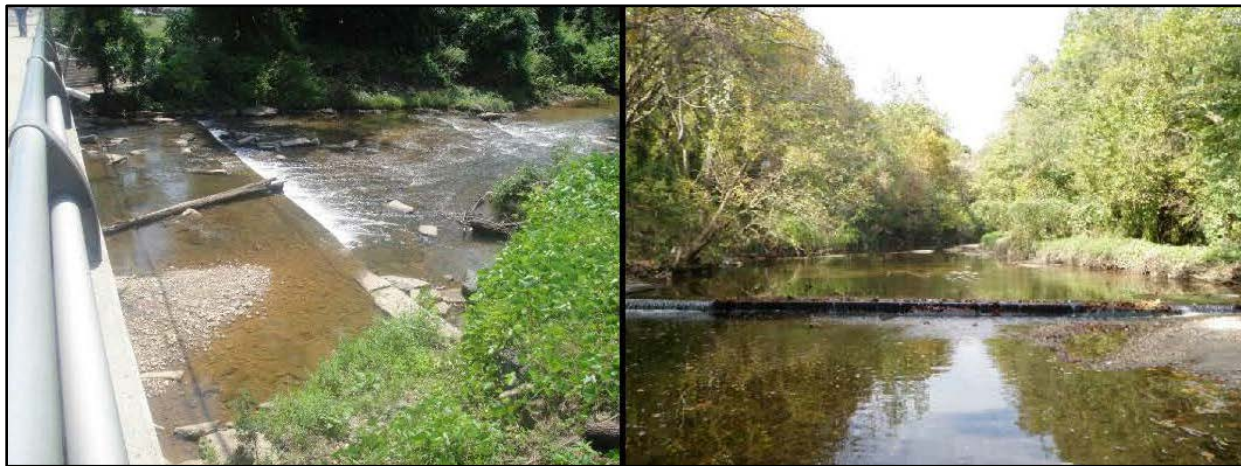
Figure 2-3. Fish blockages on Northwest Branch (site 3) and Sligo Creek (site 9).

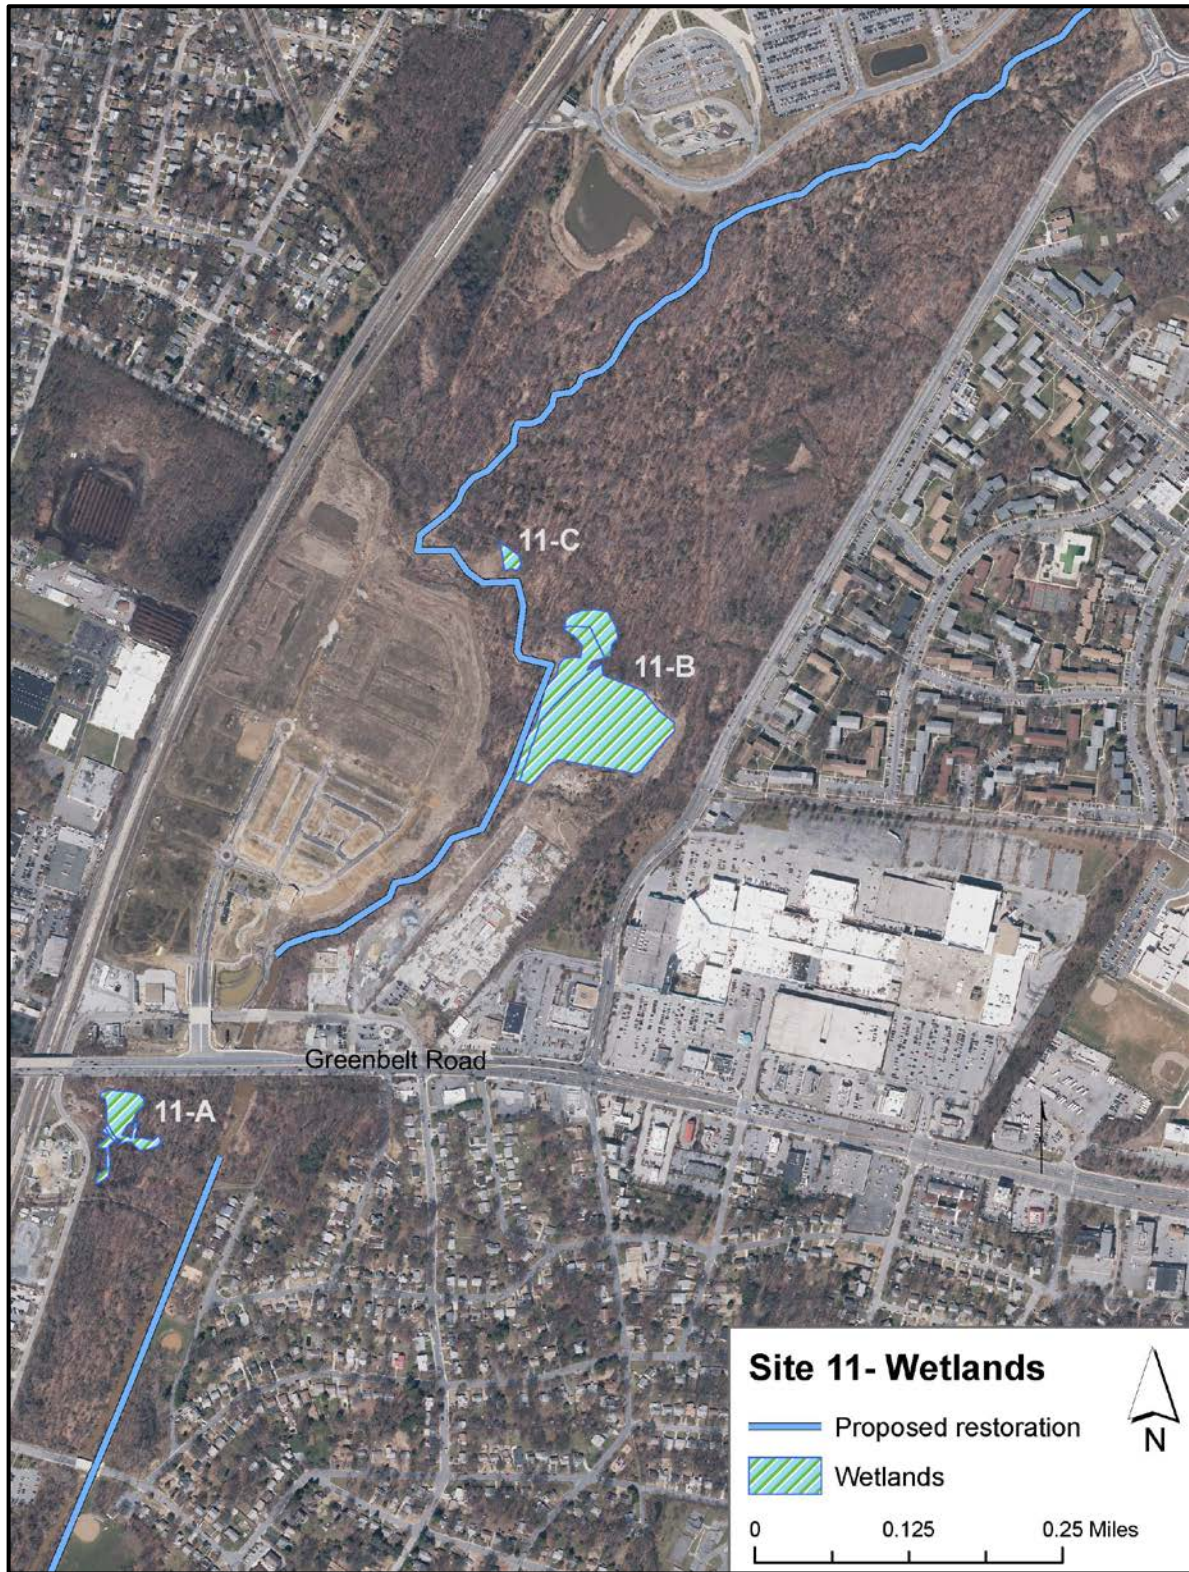
Figure 2-4. Field verified wetlands in the project area at site 11, Indian Creek.

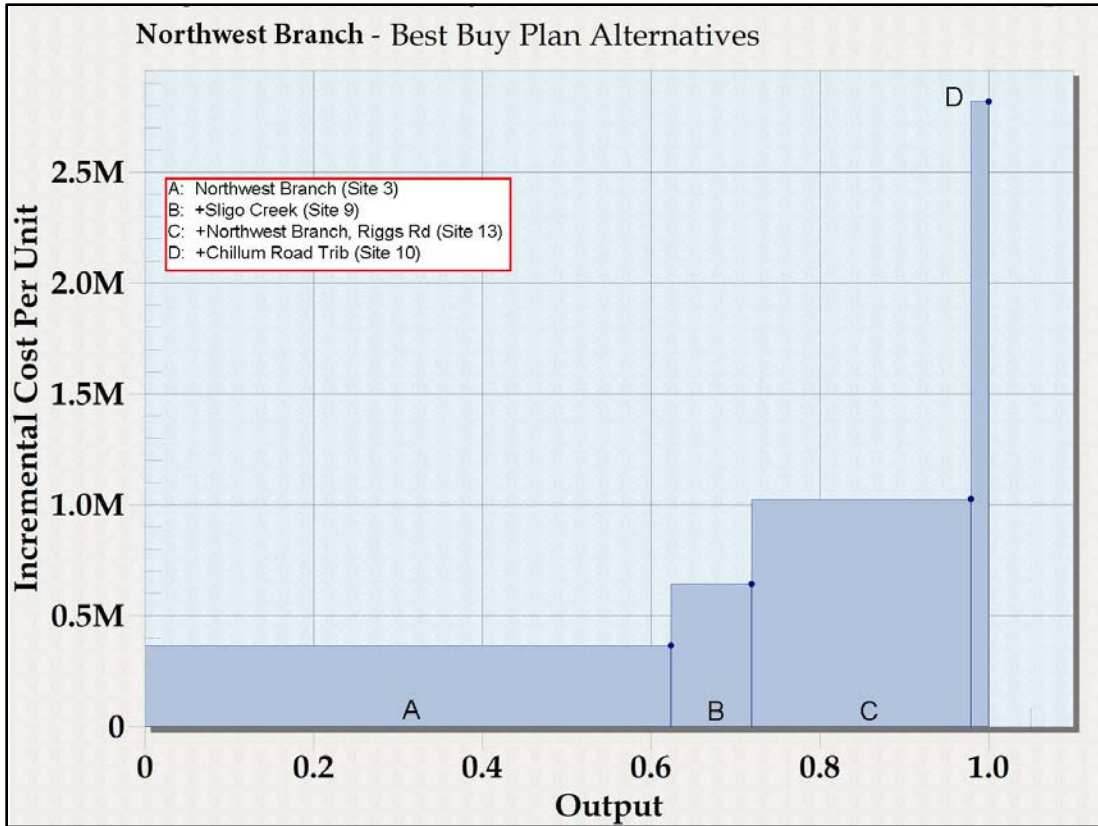
Figure 3-5. CE/ICA graph for Northwest Branch showing best buy plans.

These best buy plans represent the most efficient means of achieving each given level of benefit among all the identified cost-effective plans. The recommended plan for a project is usually chosen from the array of best buy plans determined using the CE/ICA, since the benefits for each of these plans are maximized compared to all the other plans under consideration for that project. The benefit output is the “Combined Index,” shown from 0 to 1. The 0 to 1 range is necessary as a result of the normalization required for the multi-metric analysis.

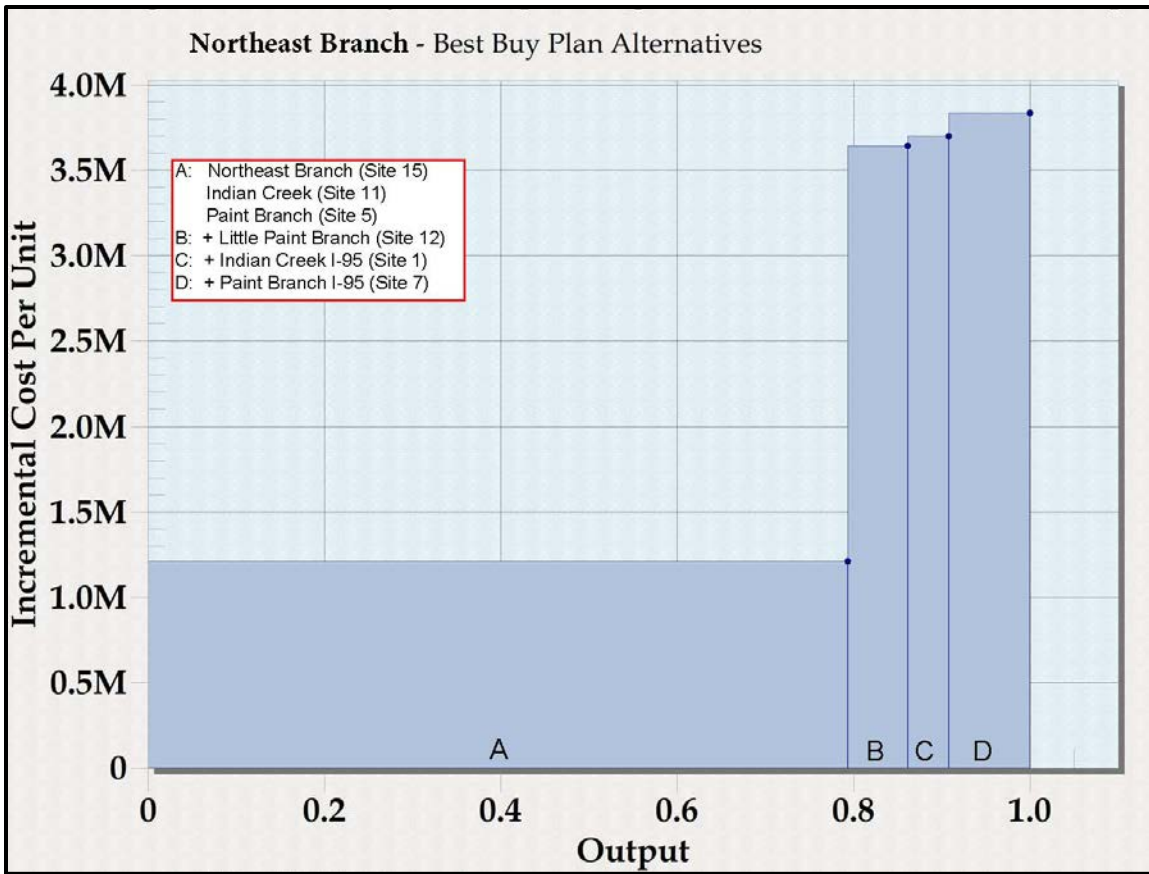
Figure 3-6. CE/ICA graph for Northeast Branch showing best buy plans.

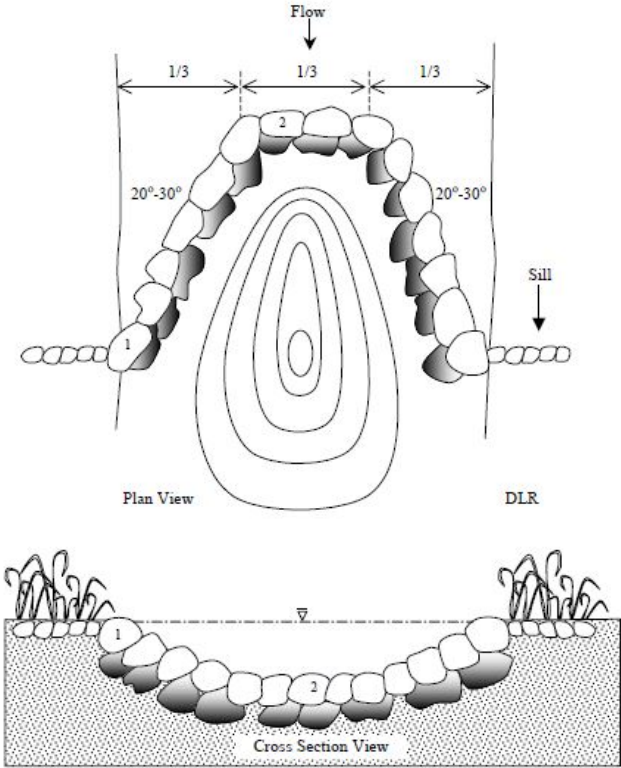
Feature Description	Typical Plan and Section View
<p><i>Cross vanes</i> – rocks placed to guide the flow away from bank, to reduce bank erosion, promote local sedimentation, and encourage vegetation growth. Made up of a set of upstream angled lines of boulders, connected by a section of smaller rocks upstream. While water usually covers the shorter section during normal flows, the taller sections deflect flow away from the banks of the stream. Flow is diverted over the rock walls and concentrated down the center of the channel. The scouring associated with high flow velocities in the center of the channel and the "waterfalling" over the structure itself creates a deep, elongated pool. Cross vanes may also control the grade in meandering and step pool streams.</p>

<p>The diagram illustrates a cross vane structure. The Plan View shows a top-down perspective of the structure, which is a semi-circular arrangement of boulders. The structure is divided into three sections, each labeled $1/3$. The outer edges of the boulders are angled at 20°-30° relative to the flow direction. A central section is labeled '2'. Flow is indicated by a downward arrow labeled 'Flow'. A dashed line labeled 'DLR' (Downstream Limit Reference) is shown to the right. The Cross Section View shows a side view of the structure, with a dashed line representing the water surface. The structure is labeled '1' and '2'. A 'Sill' is indicated by a downward arrow on the right side.</p>

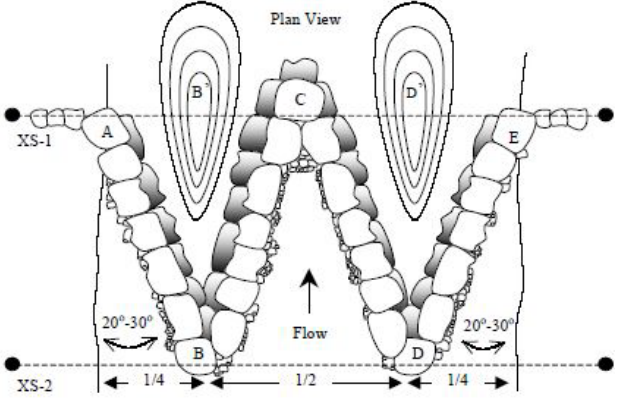
<p><i>W-Weir</i> - similar to a cross-vane in that it maintains the grade of the streambed and provides aquatic habitat. The structure appears as a W formation in the downstream direction, similar to two cross-vanes joined in the center of the channel. The double-cross vane effect produces two thalwegs. The structure provides grade control, stabilizes stream banks, enhances fish habitat, and reduces bridge center pier and foundation scour.</p>

<p>The diagram illustrates a W-weir structure. The Plan View shows a top-down perspective of the structure, which is a W-shaped arrangement of boulders. The structure is divided into five sections, labeled A, B, C, D, and E. The outer edges of the boulders are angled at 20°-30° relative to the flow direction. The central section is labeled 'C'. Flow is indicated by an upward arrow labeled 'Flow'. The structure is labeled 'B' and 'D'. The diagram also shows cross-section lines 'XS-1' and 'XS-2'. The width of the sections is indicated as $1/4$, $1/2$, and $1/4$.</p>

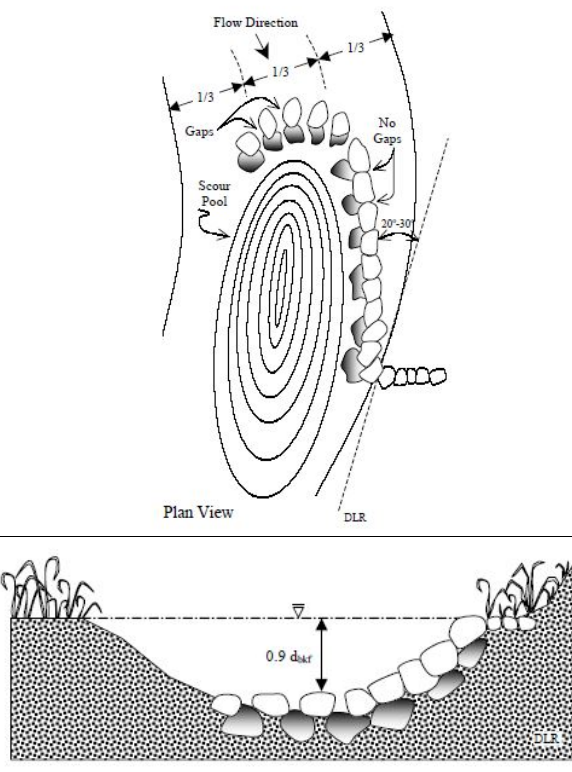
<p><i>J-Hooks</i> - an upstream pointing line of rocks (or log) that originates at one bank and terminates somewhere in the middle of the stream. These direct flow to the center of the channel, taking stress off banks, and allowing for re-vegetation. Usually placed just downstream of where the stream flow encounters the streambank at acute angles.</p>

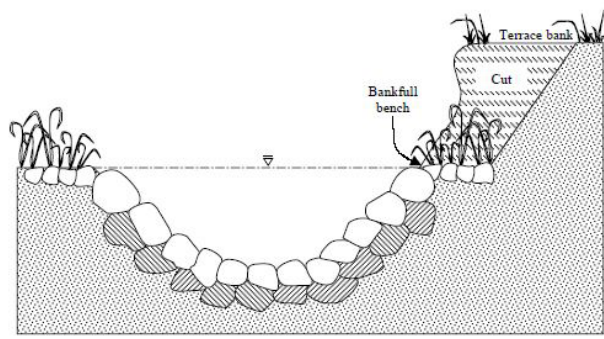
<p><i>Benches</i> - For channels that are too wide and carry most of the flood flows within the channel, a flat terrace is created within a channel to reconnect the stream with its floodplain and reduce the stress of high velocity flows within the channel. Vegetation on the floodplain benches will provide stability and catch suspended sediment. Bankfull benches can also be created at bankfull elevation.</p>

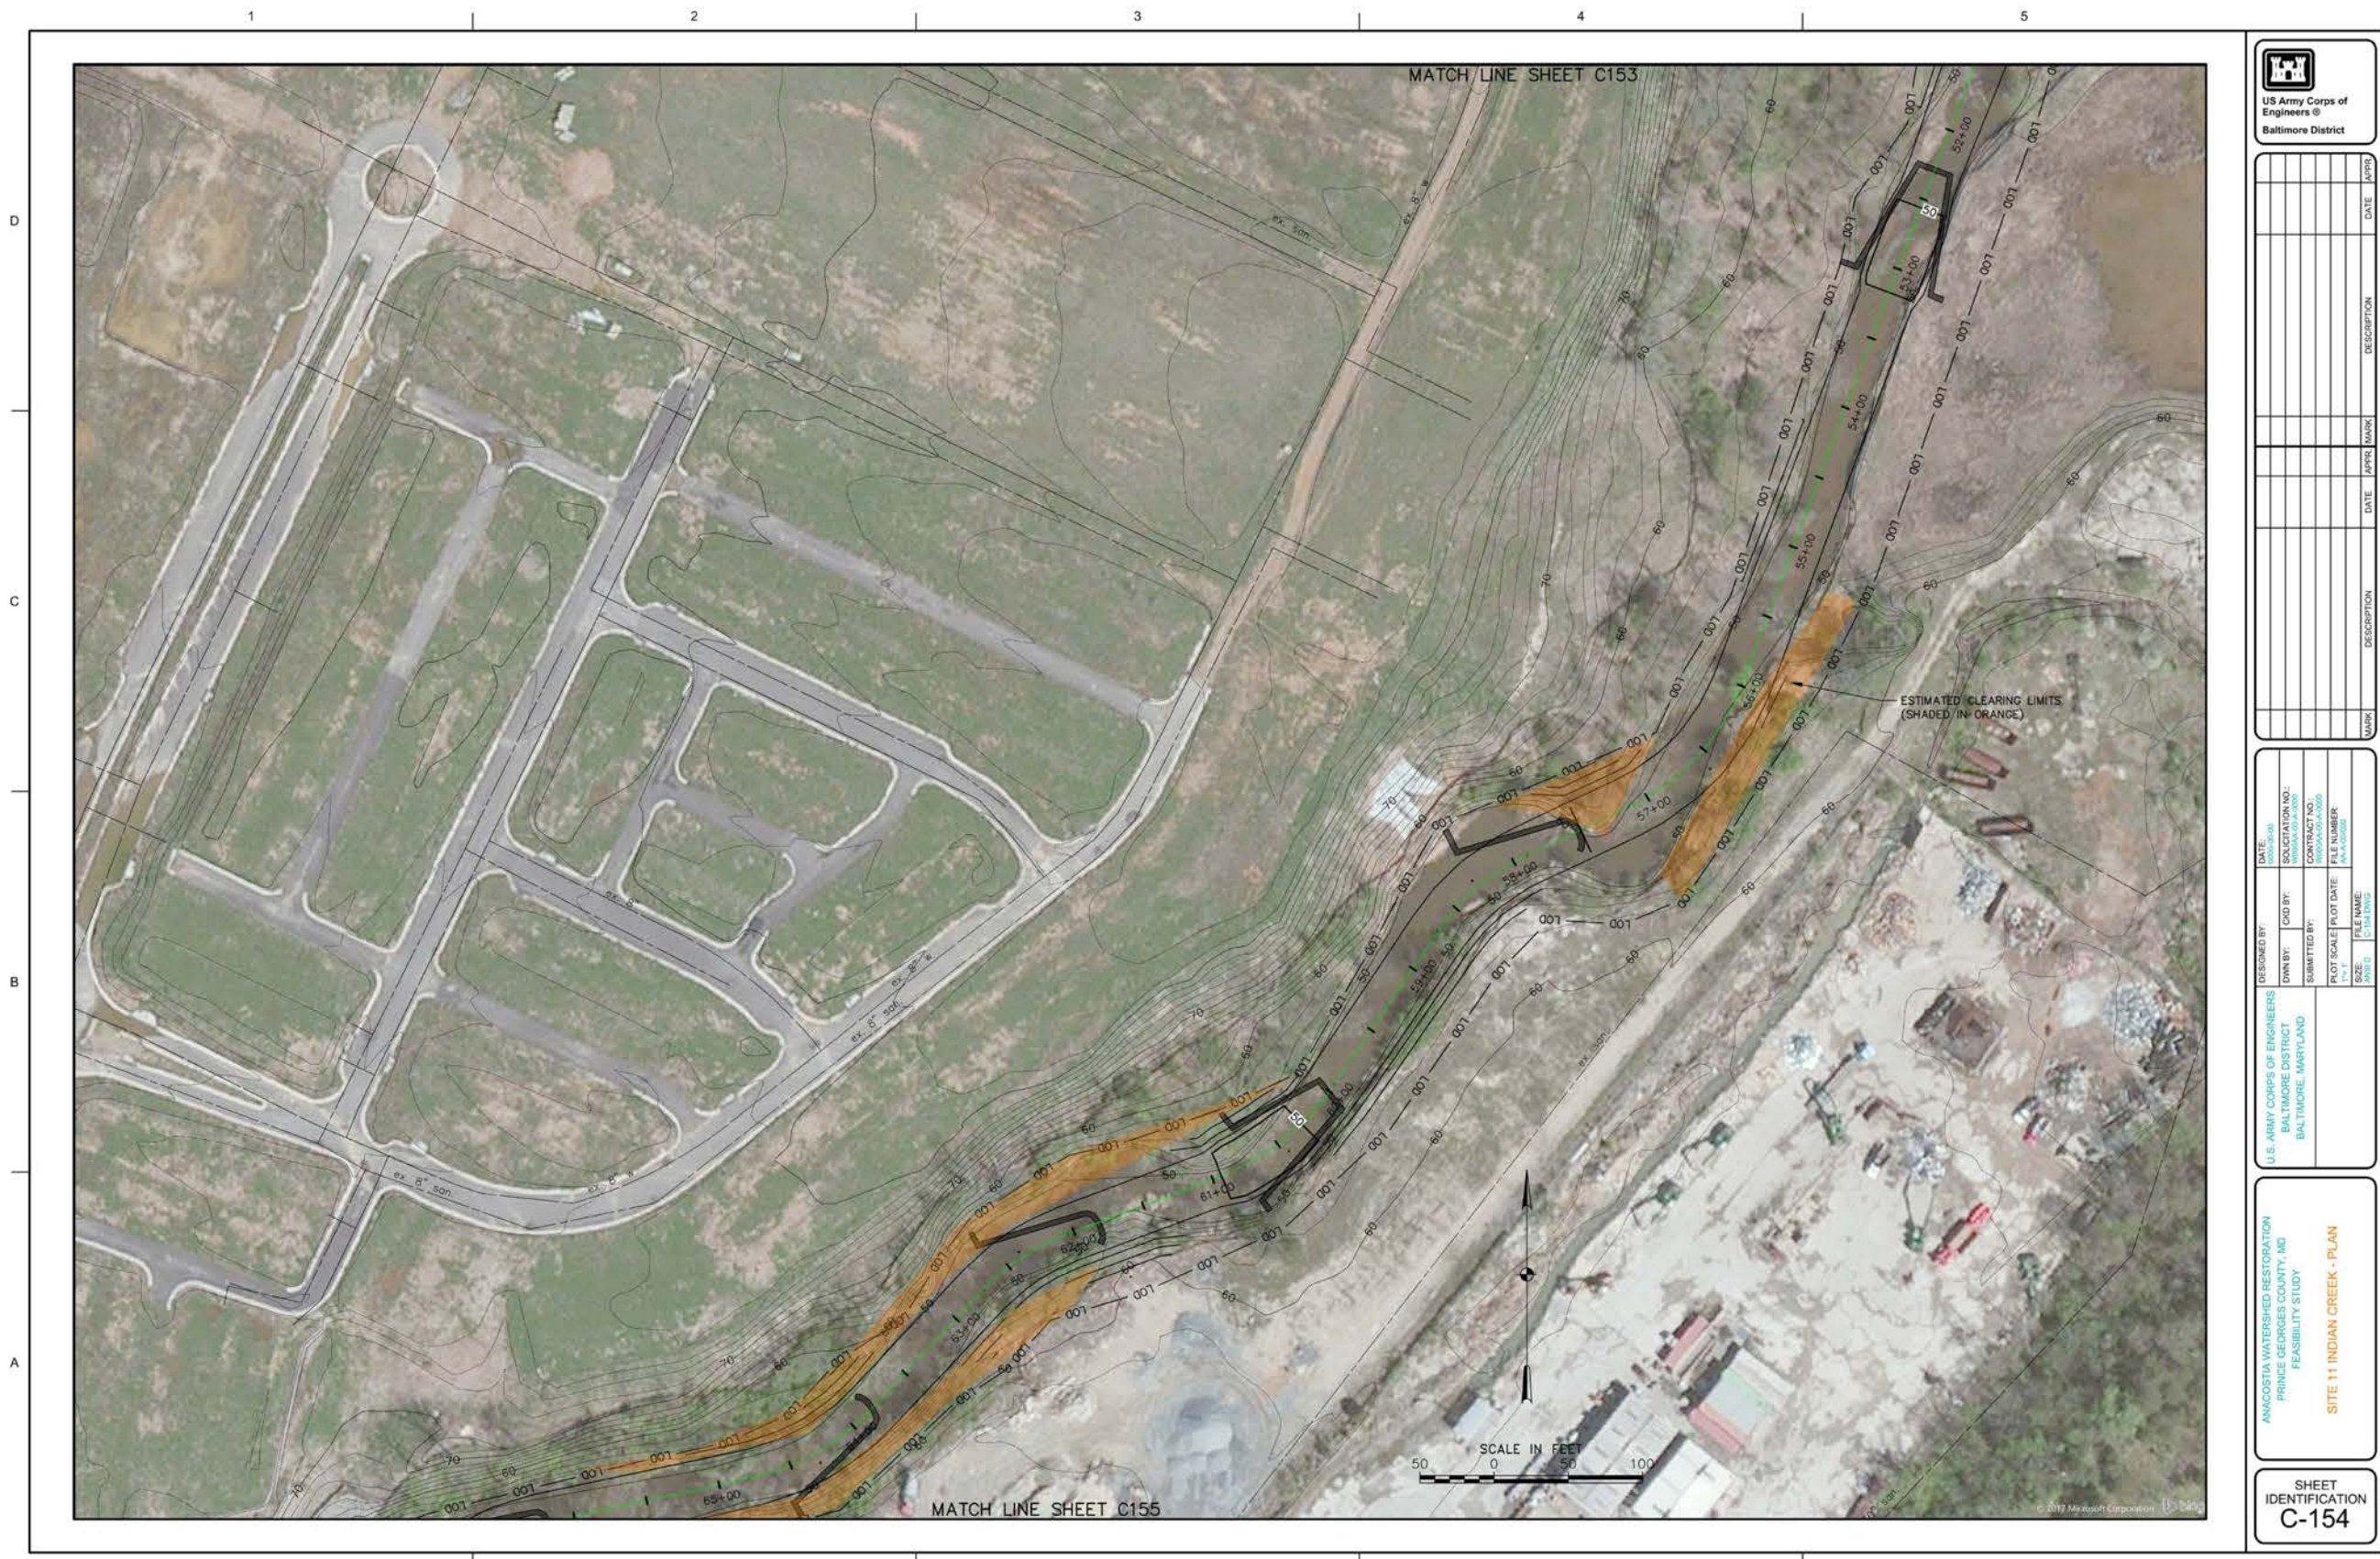
Figure 4-4. Design Sheet #154 - An example of structures, contouring, and clearing for Site 11 on Indian Creek.
