SITE-WIDE REMEDIAL INVESTIGATION REPORT SPRING VALLEY FORMERLY USED DEFENSE SITE

SPRING VALLEY, WASHINGTON, DC

**Contract No.: W912DR-09-D-0061, Delivery Order 0011
DERP FUDS MMRP/CWM Project No. C03DC091801 and
DERP FUDS HTRW Project No. C03DC091802**

FINAL
SITE-WIDE REMEDIAL INVESTIGATION REPORT
Integrated Site-Wide
Remedial Investigation/Feasibility Study Project
Spring Valley Formerly Used Defense Site (SVFUDS)
Washington, D.C.

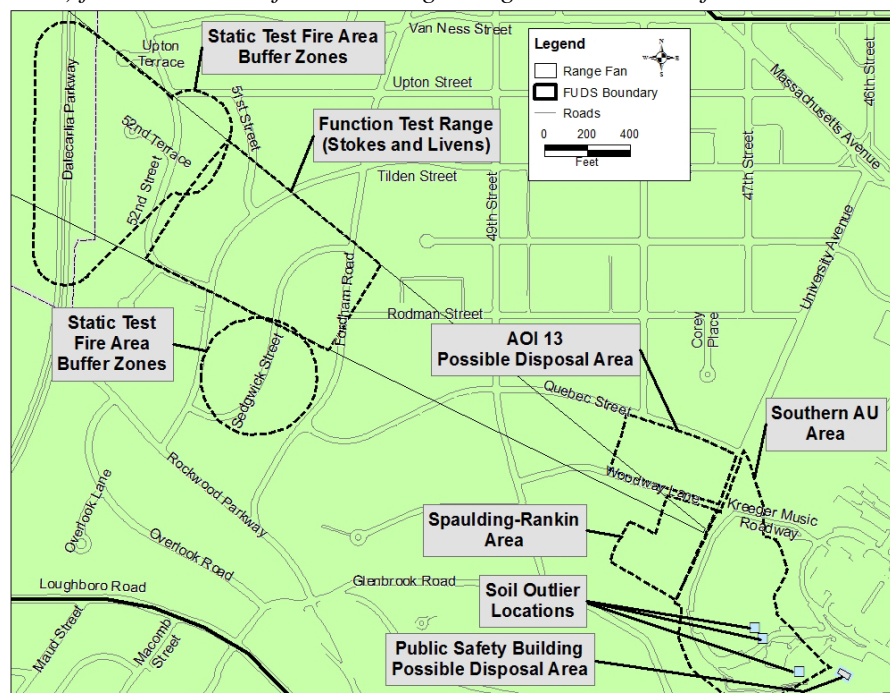
- Conduct a FS to address chemical risks in soil:
 - At a few locations on the American University campus/Spaulding Captain Rankin Area.
- Conduct a FS to address potential explosive hazards associated with:
 - Munitions related items possibly remaining within the impact areas of the ballistic test ranges (*See map: Function Test Range*).
 - Munitions burial pits within the static test fire areas and their surrounding buffer zones (*See map: Static Test Fire Areas*).
 - Possible munitions disposal pits associated with the identified possible disposal areas (*See map: Possible Disposal Area*).

See map (below) for additional information regarding the areas to be further evaluated in the FS.

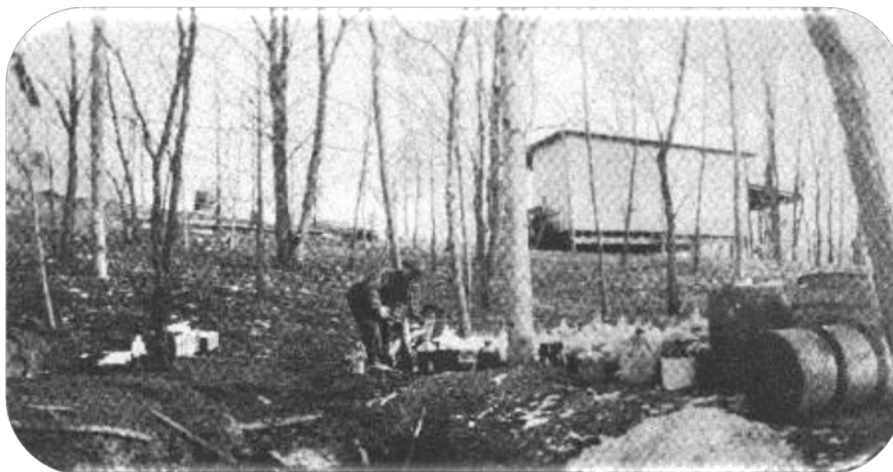
Exhibit 1-2. SGT Maurer Photo

The student newspaper articles provide the clearest written reference to potential burials. Only one known photograph exists, showing disposal of chemicals and munitions at an unidentified location presumably on AUES grounds (Exhibit 1-2). The photo referred to as the SGT Maurer photo was provided to USACE following the initiation of SVFUDS investigations, around 1994. The inscription on the back of the photo states: "The Pit, the most feared and respected place in the ground. The bottles are full of mustard, to be destroyed here in Death Valley. The hole called Hades. You know me? C.W. Maurer at A.U."

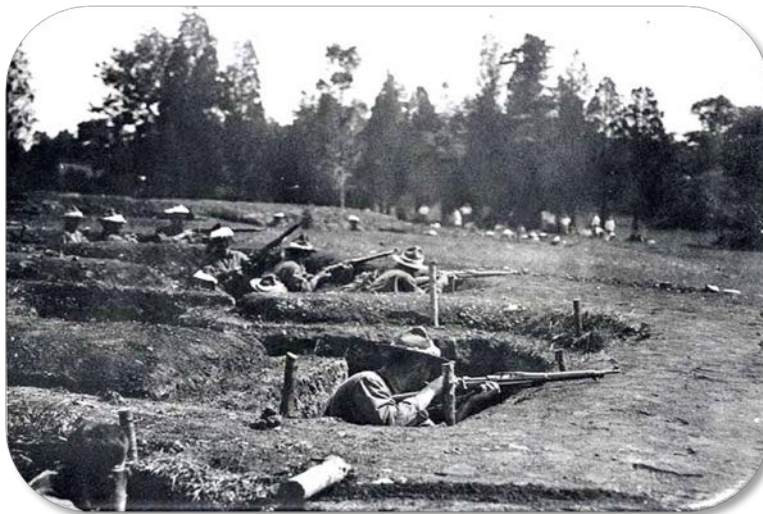
Exhibit 1-3. Trench Training at Camp Leach

On December 23, 1918, the immediate cessation of operations was ordered for Camp Leach. Engineer Units were demobilized from the camp, temporary buildings were salvaged, and remaining supplies, transportation, and equipment were disposed of as appropriate for the time. Prior to transfer back to AU and private property owners, the Chief of Engineers ordered training trenches, pits and dugouts be filled in, per agreements regarding the properties (USACE, 1994).

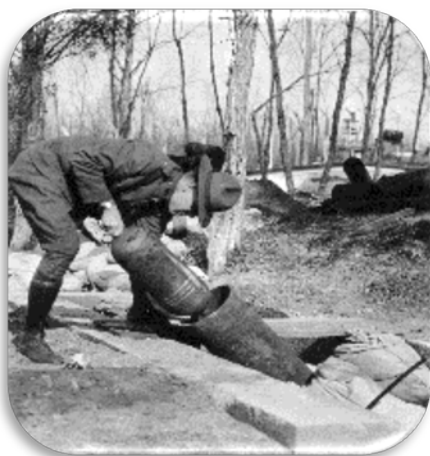
Exhibit 1-6. Loading Livens Projector

The Range Fan is an elongated, cone-shaped area defined by a firing point and potential impact areas down range (Figure 1-8). Historical records for the AUES suggest that Livens projectiles, and 3-inch and 4-inch Stokes mortars may have been fired from the Livens Battery Pit and Stokes Mortar Gun Placement near AU and Woodway Lane and, in turn, may have impacted downrange locations to the northwest towards the Federal property. Historical photographs including Exhibit 1-6 and Exhibit 1-7, established the historical use of a firing range and range

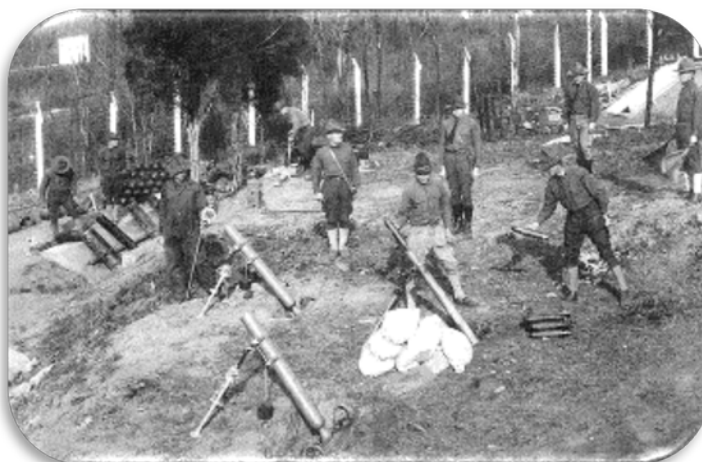
Exhibit 1-7. Loading Stokes Mortars for Firing
Note: Livens gun pit is located in left background

USACE surveyed the intact concrete gun pit and developed an ‘as-built’ to assist in developing the projected trajectory for the range. USACE munitions experts developed probable maximum range and trajectories for the types of munitions fired. The Range Fan covers the maximum ranges and buffer zones: the 3-inch and 4-inch Stokes mortar maximum ranges are calculated to be 750 yards and 840 yards, respectively, with a variance of 2.5 degrees transverse from center. The Livens projectile maximum range is calculated to be 1550 yards with a deflection accuracy of 5 percent and a directional accuracy of 7 percent (USACE, 2005c). The POIs and AOIs listed below are possibly associated with the Livens Battery Pit and Stokes Mortar Gun Placement, projected range fans, and the associated impact areas (see Figures 1-5 and 1-6). POI 18, also located within the Range Fan, was initially included in Range Fan investigations. However, it was later determined to be unrelated to the Range Fan.

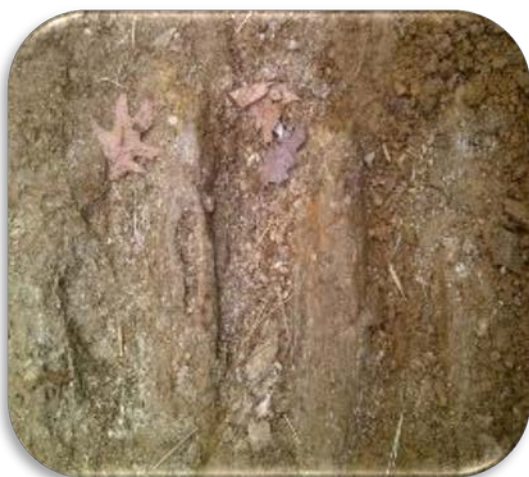
Exhibit 2-8. Competent Saprolite

Saprolite is thoroughly decomposed parent rock formed by in-place chemical weathering. The metasedimentary bedrock weathers to a relatively competent saprolite material that is encountered at depths that range between 3 to 15 feet below ground surface (bgs). This material appears to be the transition between loose soil material and highly competent bedrock. Unaltered saprolite retains characteristics (such as foliation) that were present in the original rock

from which it was derived, thus providing a strong indication that man-made activities have not impacted the layer. For this reason saprolite has been used throughout SVFUDS investigations to provide an indication of the limits of past intrusive activities. That is, field geologists can often determine that the saprolite layer in a given area has not been disturbed, and that therefore, it is unlikely that AUES intrusive activities (burial pits, penetrating munitions, etc.) occurred there. Exhibits 2-1 and 2-2 show examples of saprolite at the SVFUDS.

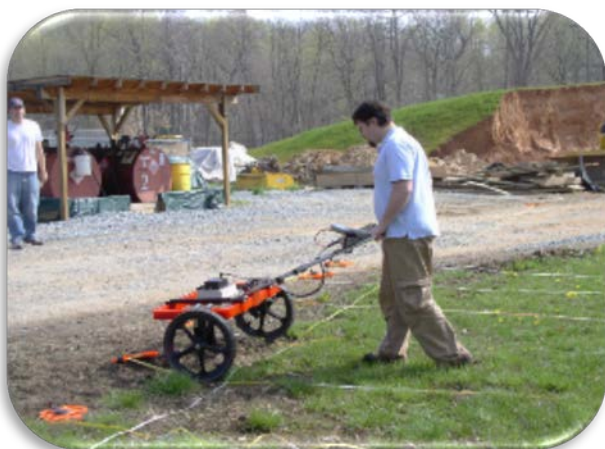
Exhibit 4-10. EM61 used at GPO

- The EM-31 performed poorly. Though used in the early SVFUDS geophysical investigations, the EM-31 is not well suited for detecting small metallic items. This instrument was not retained for use on future geophysical investigations.
- The primary instruments to be used to conduct geophysical surveys at the SVFUDS were both the EM-61 and G-858.

Exhibits 4-1 and 4-2 show the EM61 and the G-858, respectively, being used at the GPO.

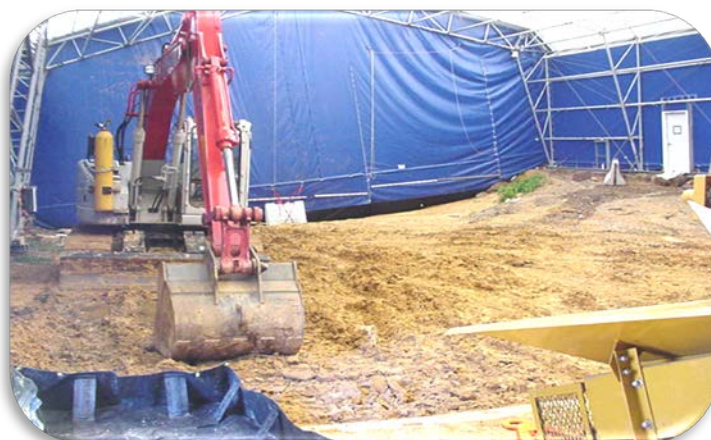
Exhibit 4-3. High Probability Work Inside an ECS

The Site-Wide Work Plan (USACE, 2007d) is the current SVFUDS document intended to be all-inclusive and tailored to address all foreseeable potential investigation actions at various sites throughout the SVFUDS. However, since that work plan could not realistically address all site-specific contingencies, Site-Specific Work Plans were prepared for each individual site to be investigated at the SVFUDS, whether under low or high probability protocols.

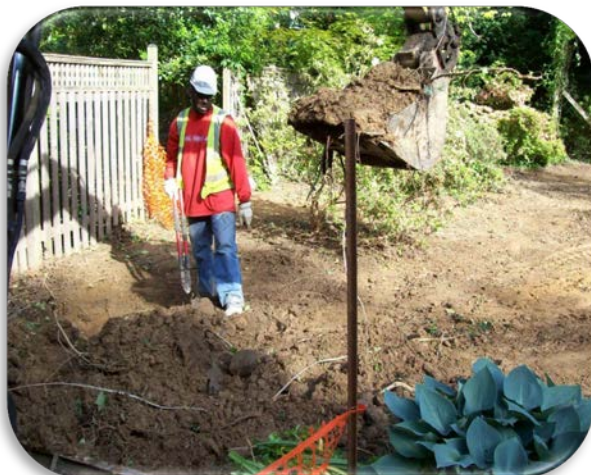
Exhibit 4-4. During Grid Excavation

The procedure was to remove soils from grids in two foot lifts. Excavation utilized standard construction equipment such as excavators, loaders and backhoes to remove contaminated soil and place it into shipping containers. For removals on private residential properties, the smallest, most efficient construction equipment was used, when possible, to minimize noise and to reduce homeowner concerns regarding property damage risks. Care was taken to minimize the impact of construction traffic in the work area and to keep open access to homes. During excavation activities, dust abatement and control procedures were employed to minimize the transport and inhalation of fugitive dust by site workers and nearby personnel. These procedures included the monitoring and cleaning of visible surface soil on roads, dust suppression with water, and air monitoring for dust downwind of excavation operations.

Clean fill and topsoil was used to fill the excavation. Clean backfill was obtained through soil brokers to find supplies near the SVFUDS; it was always sampled and approved by USEPA and DDOE before it could be used. Once approved, backfill was often stockpiled at the Federal property for later use, or if possible, was delivered directly to the specific removal location to avoid double handling. Geotechnical testing, including standard and modified Proctor testing was performed to meet compaction requirements. Upon completion of the excavation to original grade, sod was placed upon the re-graded surface to establish grass. Exhibits 4-4 and 4-5 show during and after excavation pictures at a typical residential property.

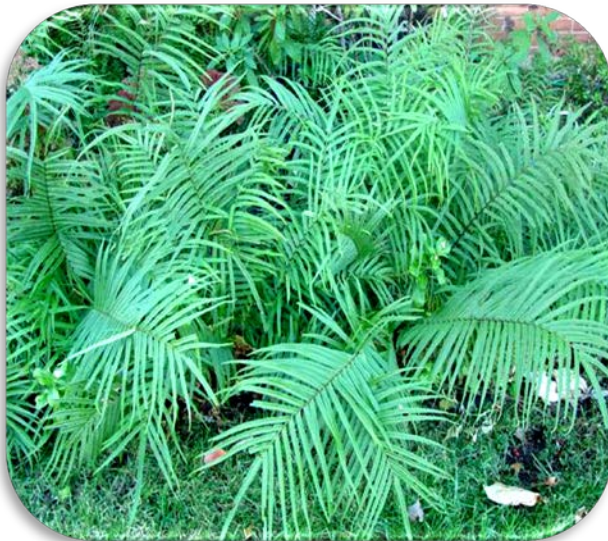
Exhibit 4-6. *Pteris vittata* Ferns

Each plot area was fertilized prior to transplanting. Fern plants were then established in the test plots through transplanting of four-inch high live plants. Where existing turf grass or sod was present, the soil was rototilled to a maximum depth of four inches or turned over by hand using a shovel in preparation for planting. Where existing vegetation or other landscape features prevented rototilling, the ferns were transplanted directly into the soil to avoid disruption of existing vegetation. The selected Edenfern species (*Victory*, *Moonlight*, *P. cretica nervosa*, *Pteris vittata*, *P. cretica parkerii*, or *Arctic*) were transplanted into the soil using a 12-inch plant spacing. The fern species were selected based on site specific conditions favoring growth of a specific variety with a goal of maintaining uniformity and consistency in experimental design.

At each residence, a surface irrigation system was designed and installed to accommodate the moisture requirements of the ferns at each plot. Plant growth and development was monitored by USACE. During the growing season, diagnostic leaf and frond samples were obtained on an as needed basis, depending on weather conditions and the physiological condition of the plants to monitor the progress and status of the plants for removing arsenic. Samples of the biomass were collected for laboratory analysis; all remaining biomass was properly disposed. Post-harvest soil samples were collected after the collection of the plant samples in the same manner as in the pre-planting soil sampling. At the conclusion of site activities, the plots were restored and former grass areas were resodded. Bare soil areas were mulched to prevent erosion. Exhibits 4-6 and 4-7 depict different varieties of ferns planted at two of the selected SVFUDS properties.
